## Phase I-Environmental Site Assessment

316, 320, 324, 326 and 332 Clifton Road  
Ottawa, Ontario

Insight Ottawa Realty Corporation

Report: PE4500-1

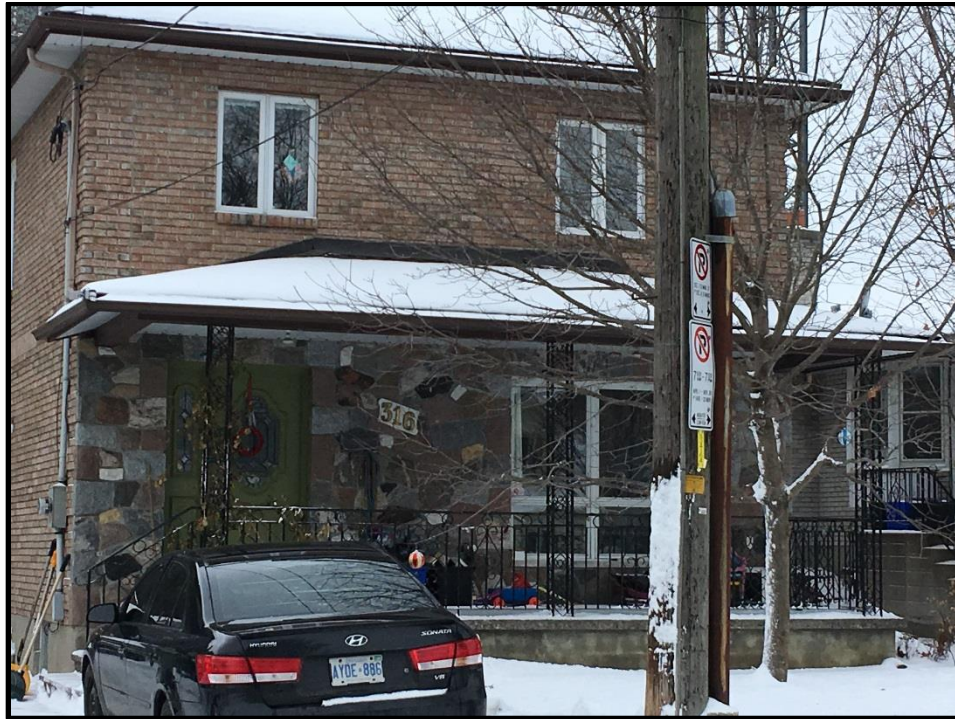
316 Clifton Road is occupied by a two (2) storey single-family dwelling and a detached private garage. The dwelling was constructed circa 1953 with a poured concrete foundation, finished with a brick and stone style exterior and a peaked roof covered with shingles. The private garage is a wood frame structure with a poured slab-on-grade foundation and finished on the exterior with plywood and vinyl siding and a peaked roof covered with asphaltic shingles.

Photograph 1: East face of subject building addressed 316 Clifton Road, looking west.

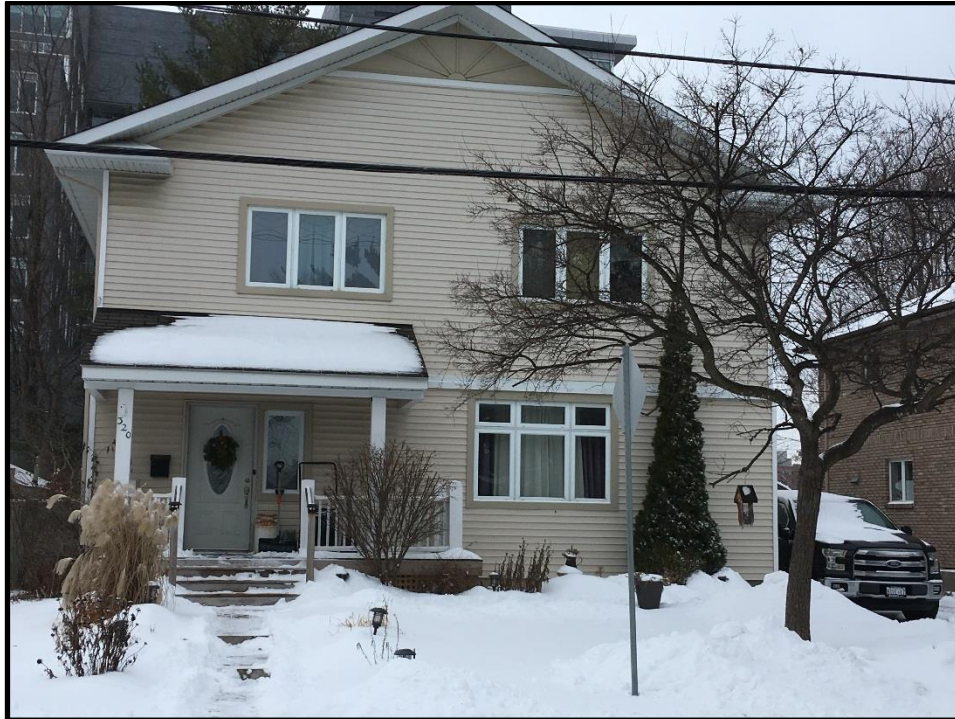
320 Clifton Road is occupied by a 2-storey residence and a detached private garage. The dwelling was constructed in 1949 with a poured concrete foundation, finished with vinyl siding exterior and a sloped shingle roof. The private garage is a wood frame structure with a poured slab-on-grade foundation and finished on the exterior with vinyl siding with a sloped shingle roof.

Photograph 2: East face of subject building addressed 320 Clifton Road, looking west.

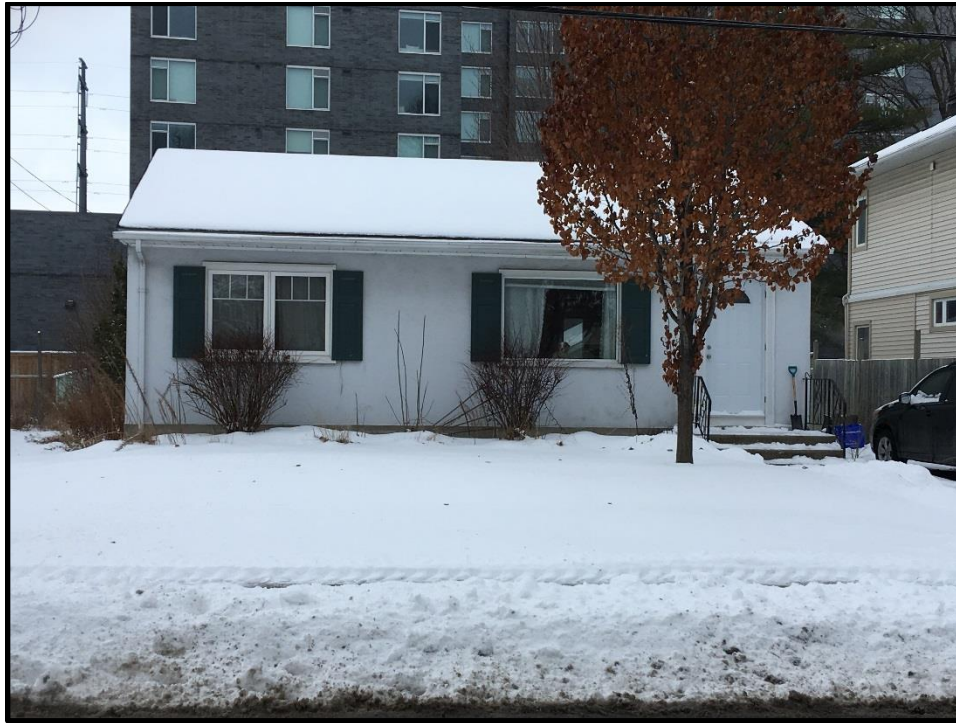
324 Clifton Road is occupied by a single storey dwelling and detached garage, constructed in 1953 with a poured concrete foundation, finished with a cream coloured stucco exterior and a peak covered shingle roof. The private garage is a wood frame structure with a poured slab-on-grade foundation and finished on the exterior with vinyl siding with a sloped shingle roof.

Photograph 3: East face of subject building addressed 324 Clifton Road, looking west.

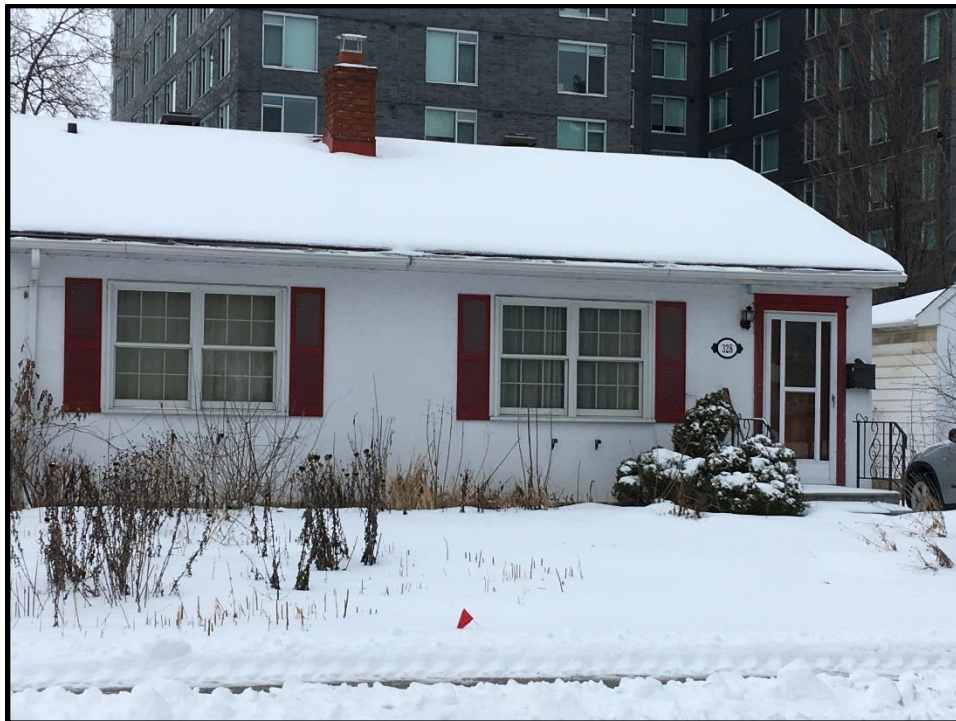
Photograph 4: East face of subject building addressed 328 Clifton Road, looking west.

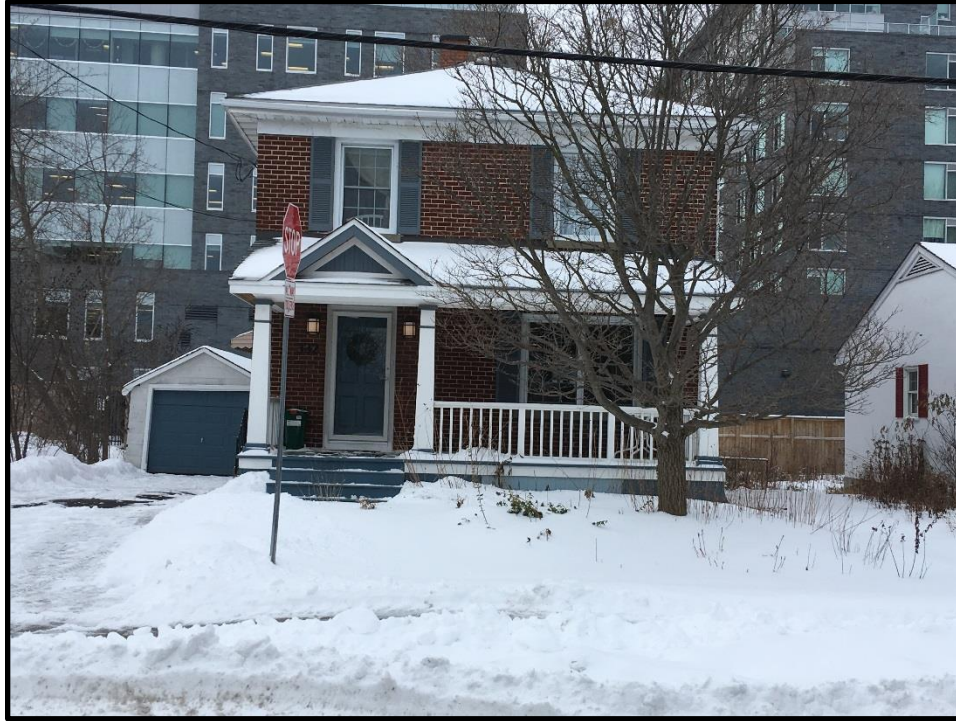
332 Clifton Road is occupied by a 2-storey residence and a private garage. The dwelling was constructed in 1948 with a poured concrete foundation, finished with a red brick exterior and a peak covered shingle roof. The private garage is a wood frame structure with a poured slab-on-grade foundation and finished on the exterior with vinyl siding with a sloped shingle roof.

Photograph 5: East face of subject building addressed 332 Clifton Road, looking west.
