5494, 5500 and 5510 Boundary Road

Headwater Drainage Feature Assessment

April 2021

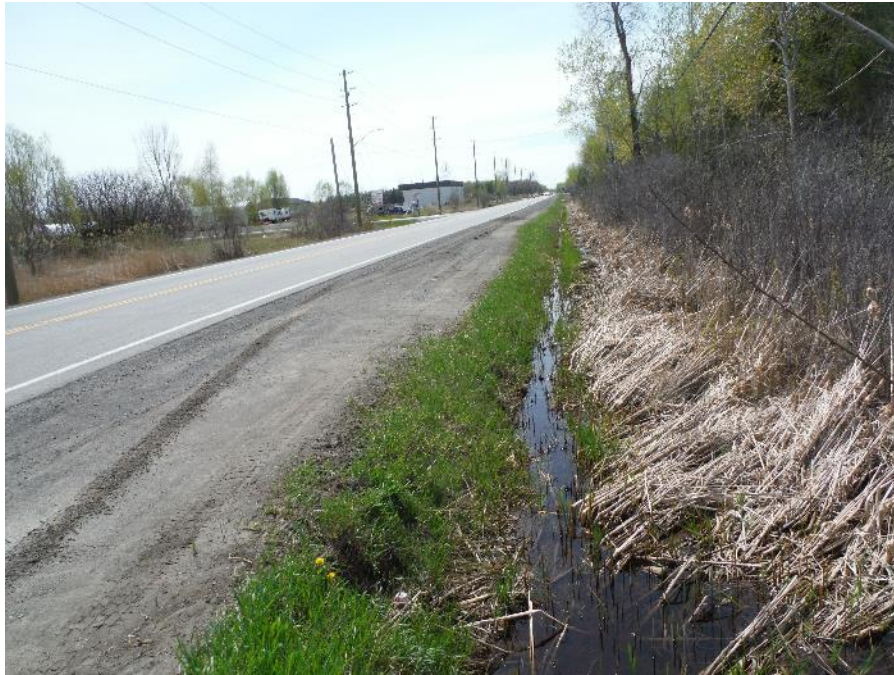
Photo 1: Roadside ditch, looking south (May 17, 2020)

- Boundary Road ditch (referred to herein as Roadside Ditch) drain south into Simpson Municipal Drain roughly 200 m downstream.
- Headwater Drainage Feature 1 (HDF 1) is found along the southeast perimeter of the site, to the east of HDF 2. One part of HDF 1 (HDF 1a) inclines towards the roadside ditch, the other (HDF 1b) towards HDF 2. HDF 1a and 1b were frozen and snow covered on April 7, 2020. There was <2 cm or no water on April 12, 2021. There was no sorting of substrate, and the features were choked with vegetation. Both are a swale.

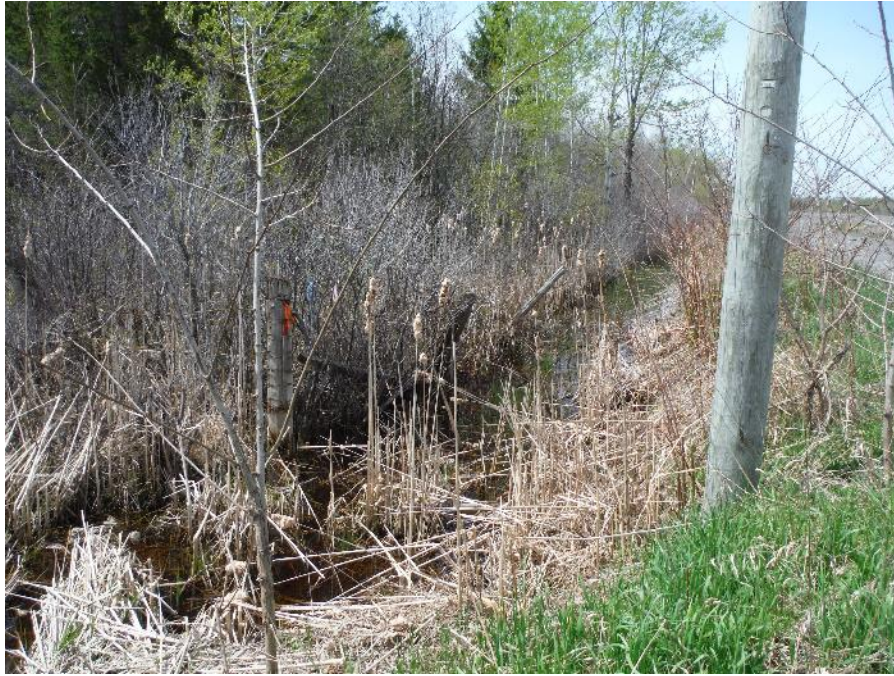
Photo 2: Headwater feature 1a, looking west from Boundary Road (May 17, 2020)

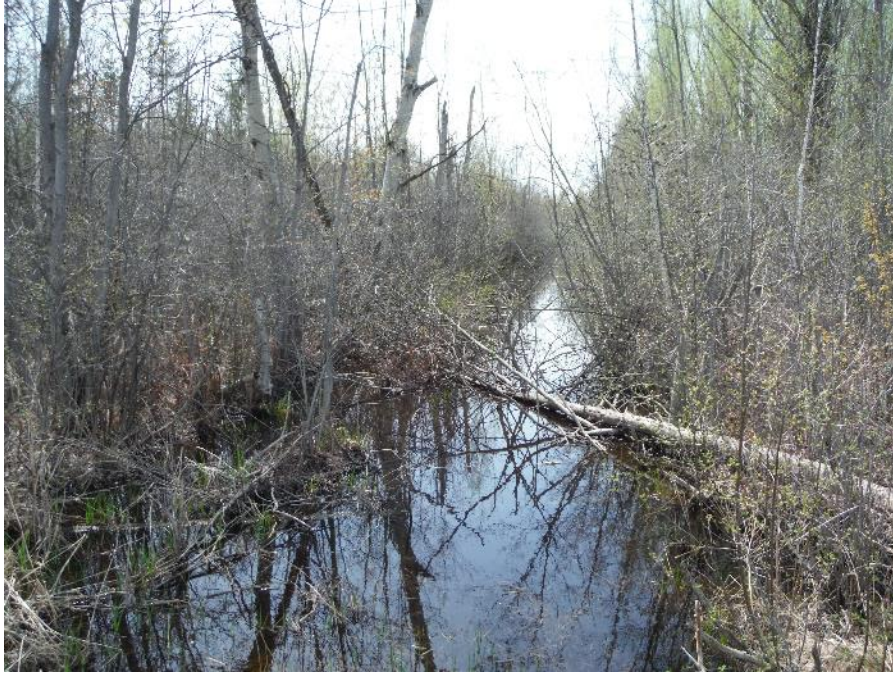
Photo 4: Headwater feature 2, looking south (May 17, 2020)

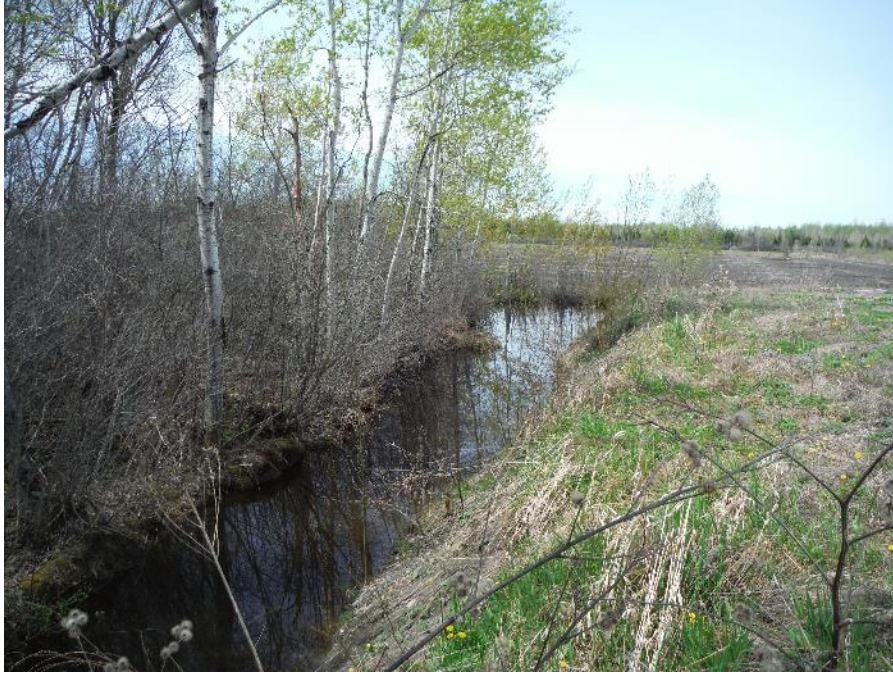
Photo 6: Headwater feature 3b, looking west (May 17, 2020)

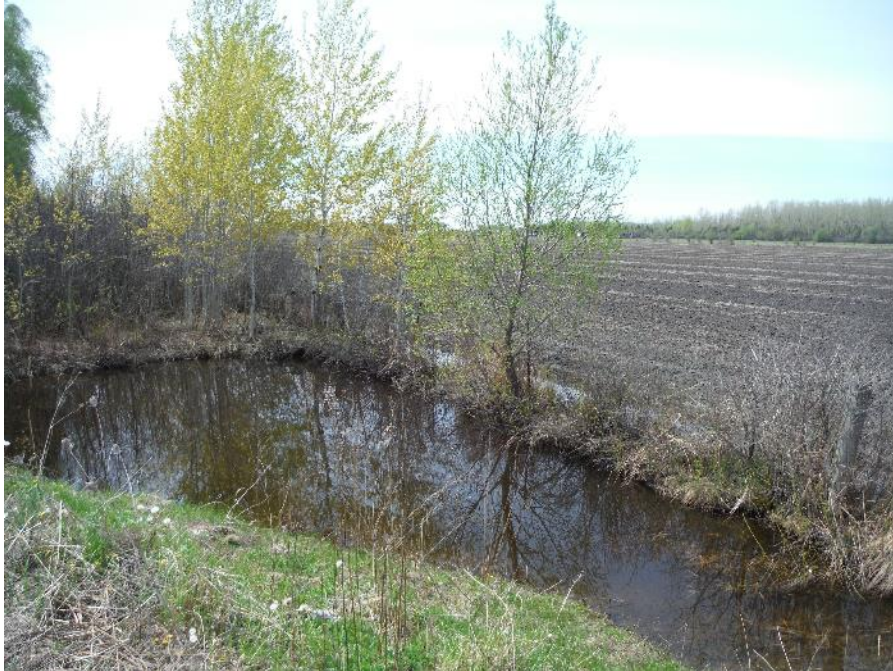
Photo 8: Pooling of water created by HDF 3b and 4 (May 17, 2020)

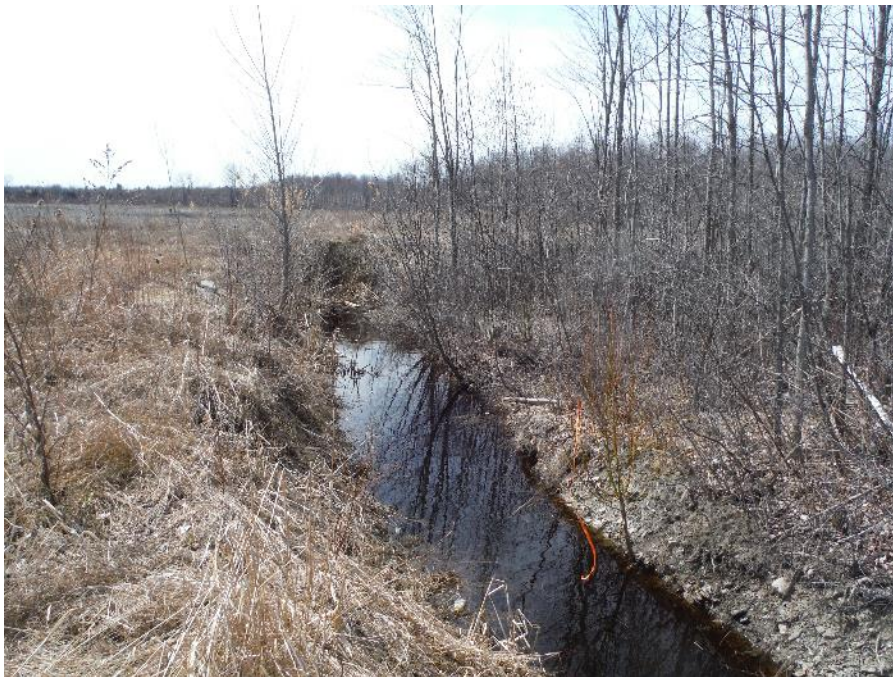
Photo 9: Headwater feature 5, looking west (April 7, 2020)

- Headwater Drainage Feature 5 (HDF 5) is situated within the northeast side of the site. The west side consists of ponds (labelled as Ponds) and the remainder is a ditch that is connected to the Roadside Ditch. The ponds were created by the fill activities on-site. One portion of the ponds branched south approximately 80 m into the site. This branch was seasonally separated from the other ponds by a soil berm.

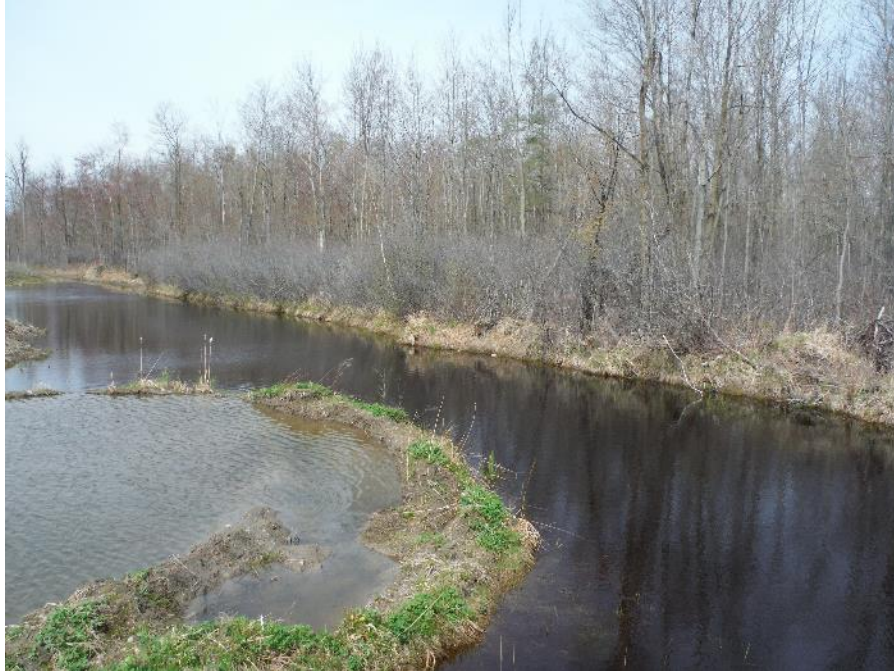
Photo 10: Ponds, with the soil berm, looking west (May 17, 2020)

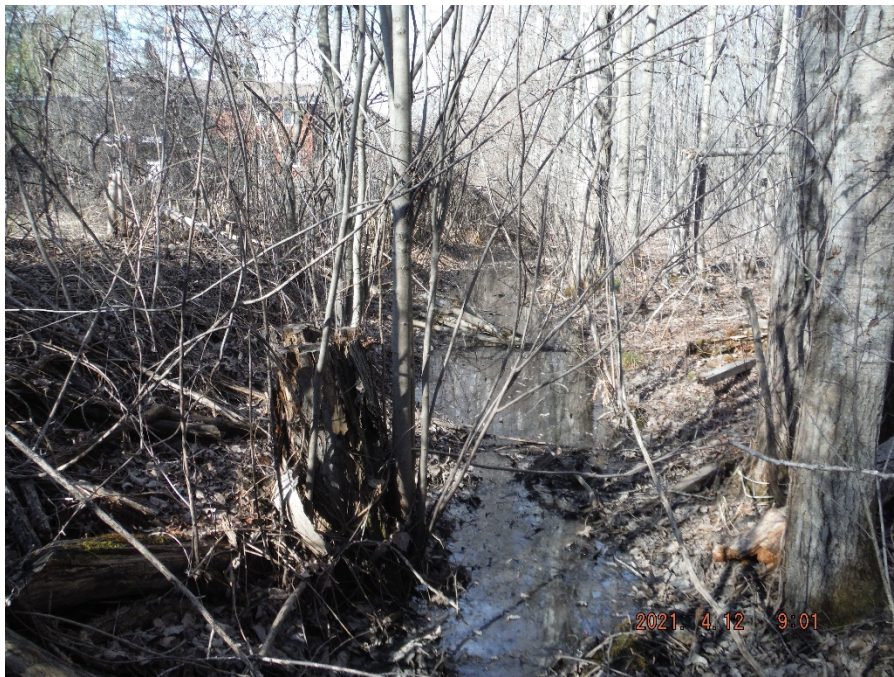
Photo 11: Headwater feature 6, looking at a ponded portion (April 12, 2021)

- Headwater Drainage Feature 6 (HDF 6) is situated within the most northeast side of the site. This feature had a barrier to fish movement its downstream end, isolating it from the Roadside Ditch. This was not fish habitat.

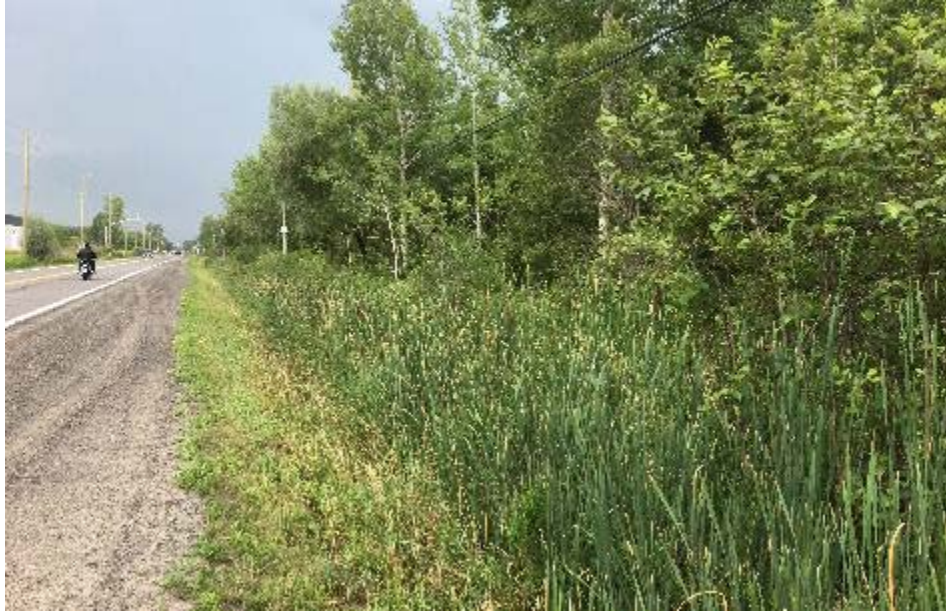
The substrate consisted primarily of fines and the stream morphology was a glide. The in-water cover throughout the station was provided mostly by aquatic vegetation (cattails and purple loosestrife), with some overhanging vegetation. The top of the banks was fully vegetated (purple loosestrife, Canada goldenrod, cow vetch, American hog-peanut, bird’s-foot trefoil, glossy buckthorn, and narrow-leaved meadowsweet). There was some glossy buckthorn and trembling aspen on the west bank. Much of the station contained no or poor canopy cover.

During the April 7, 2020 visit, the station was electroshocked over an area of approximately 72 m² for 648 seconds. A total of 5 central mudminnow were captured (size range: 30 – 50 mm). The electrofishing effort was of 9 s/m². No sampling took place during the summer as the station was dry (July 29, 2020).

Photo 12: Roadside Ditch, upstream of station 1, looking downstream (July 29, 2020)

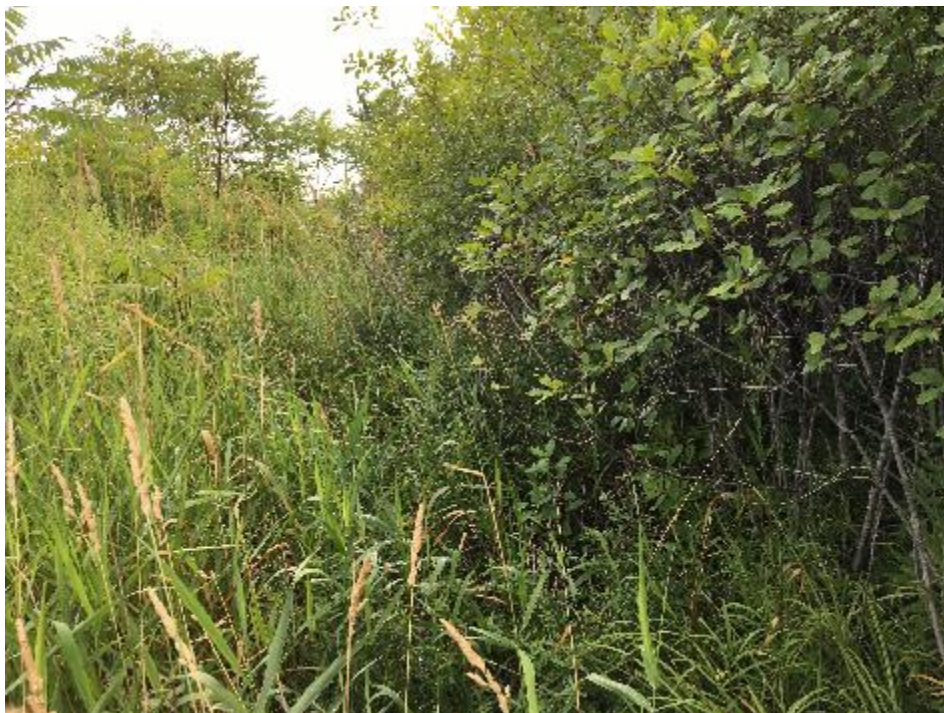
The substrate consisted primarily of fines and the stream morphology was standing water. The in-water cover throughout the station was provided by aquatic vegetation (reed canary grasses, cut-leaved water horehound, lakebank sedge, purple loosestrife, smartweed, broad-leaved cattail, and cow vetch). The top of the banks was fully vegetated (reed canary grass, water horehound, lakebank sedge, purple loosestrife, smart weed, broad-leaved cattails, willow, speckled alder, and glossy buckthorn). Much of the station contained areas of no canopy cover on the north side but was entirely shaded by the dense woody vegetation on the south and inside the channel by the dense common reed.

Photo 13: Feature 1a, upstream of station 2, looking downstream (July 29, 2020)

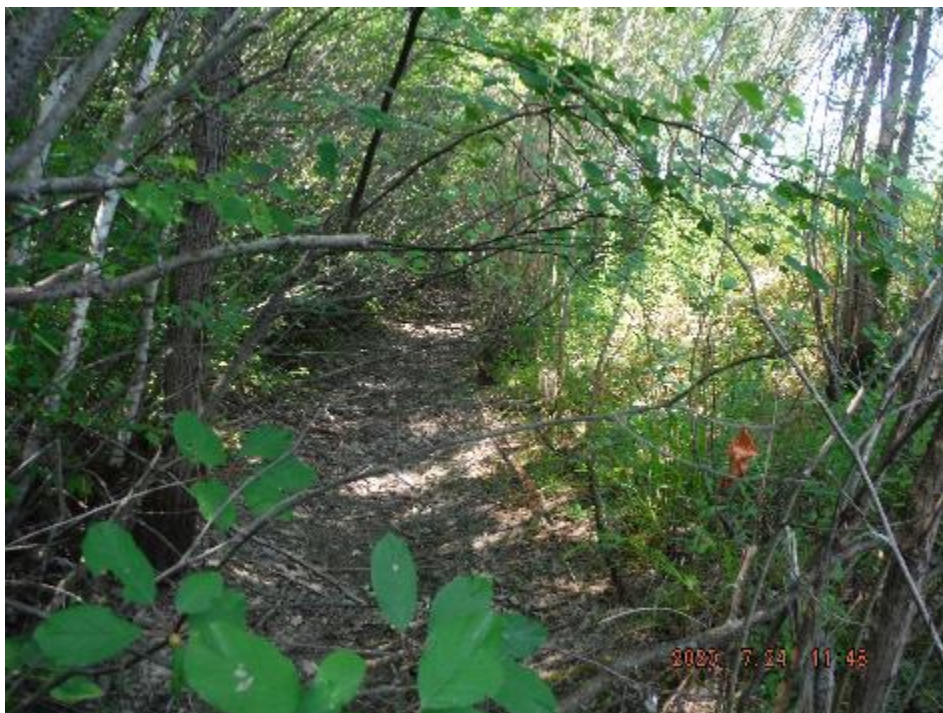
The substrate consisted primarily of fines and the stream morphology was standing water. The in-water cover throughout the station was provided by overhanging vegetation, aquatic vegetation, and small wooded debris. The top of the banks was fully vegetated (speckled alder, glossy buckthorn, willow, lakebank sedge, sensitive fern, purple loosestrife, glossy buckthorn, grasses, and horsetail). The left bank was a treed swamp (willow, red maple). Much of the station had complete canopy cover.

Photo 16: Feature 3a, upstream of station 4, looking downstream (July 24, 2020)

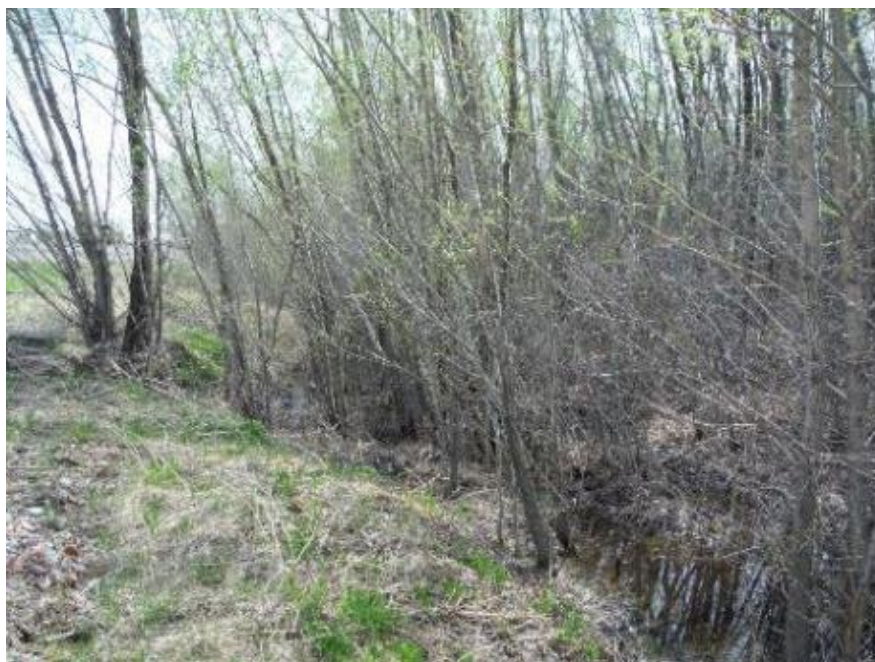
Feature 3b also ran along the southwest perimeter of the site and measured 80 m. This feature contained some water in the spring but was only connected to Feature 4. That feature was isolated from all fish bearing watercourses. No stations were created.

Photo 17: Feature 3b, downstream of station 4, looking upstream (May 17, 2020)

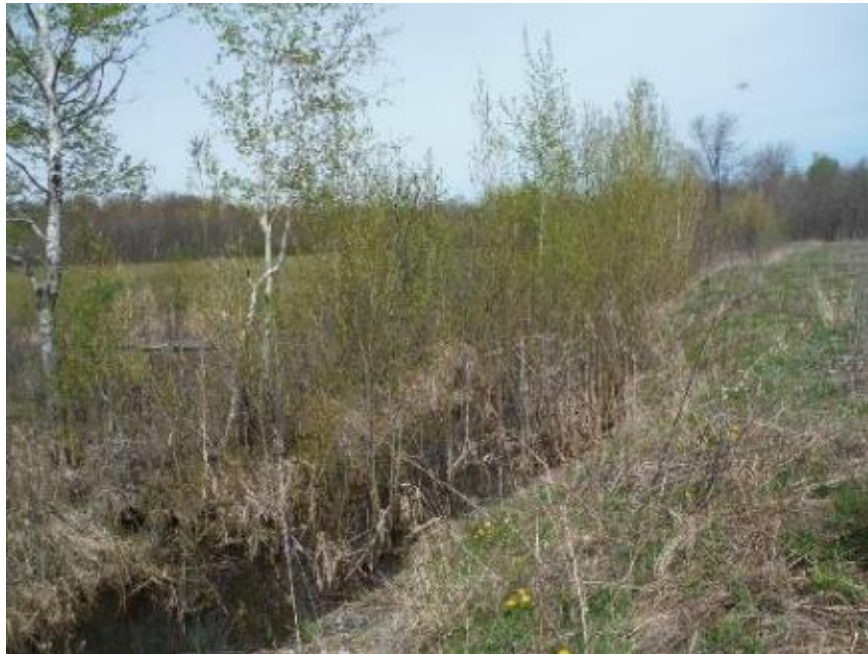
The substrate consisted primarily of fines and the stream morphology was standing water, with a few pools. The in-water cover throughout the station was provided by terrestrial and aquatic vegetation (purple loosestrife, reed canary grass, grasses, purple clover, bird's-foot trefoil, cow vetch, and willows). The top of the banks was fully vegetated (wild carrot, cow vetch, bird's-foot trefoil, sow thistle, glossy buckthorn, trembling aspen, willow, purple loosestrife). Much of the drain had no canopy cover but some had complete cover from the willows growing within the channel.

Photo 18: Feature 4, downstream of Station 5, looking upstream (May 17, 2020)

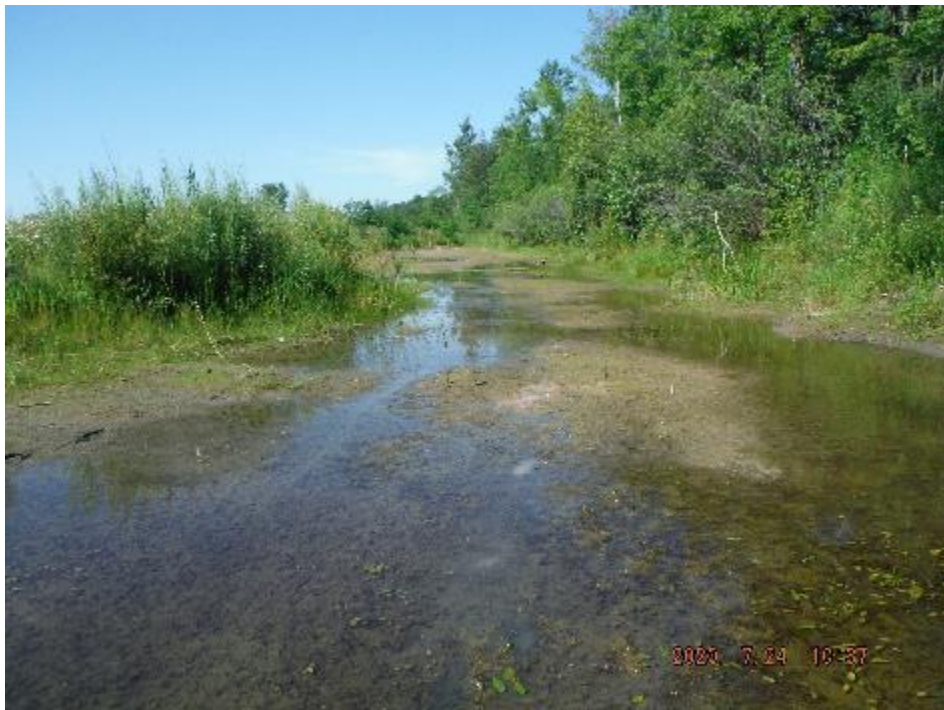
Photo 21: Feature 5 (upper ponds), downstream of station 6, looking upstream (July 24, 2020)

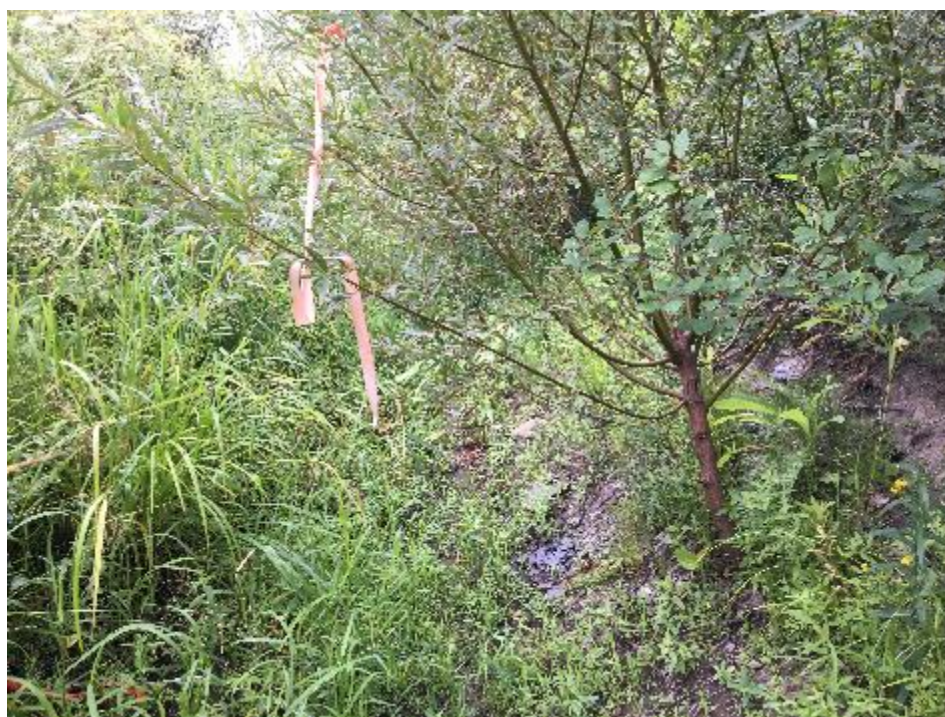
The substrate consisted primarily of fines and the hydrological flow was a glide. The in-water cover consisted of aquatic vegetation (narrow-leaved cattail, and purple loosestrife). The top of the banks was mostly vegetated with grasses and shrubs (goldenrod, cow vetch, willows, Manitoba maple, and sensitive fern). Most of the station contained areas of good canopy cover.

Photo 23: Feature 5 (ditch), upstream of station 8, looking downstream (July 29, 2020)

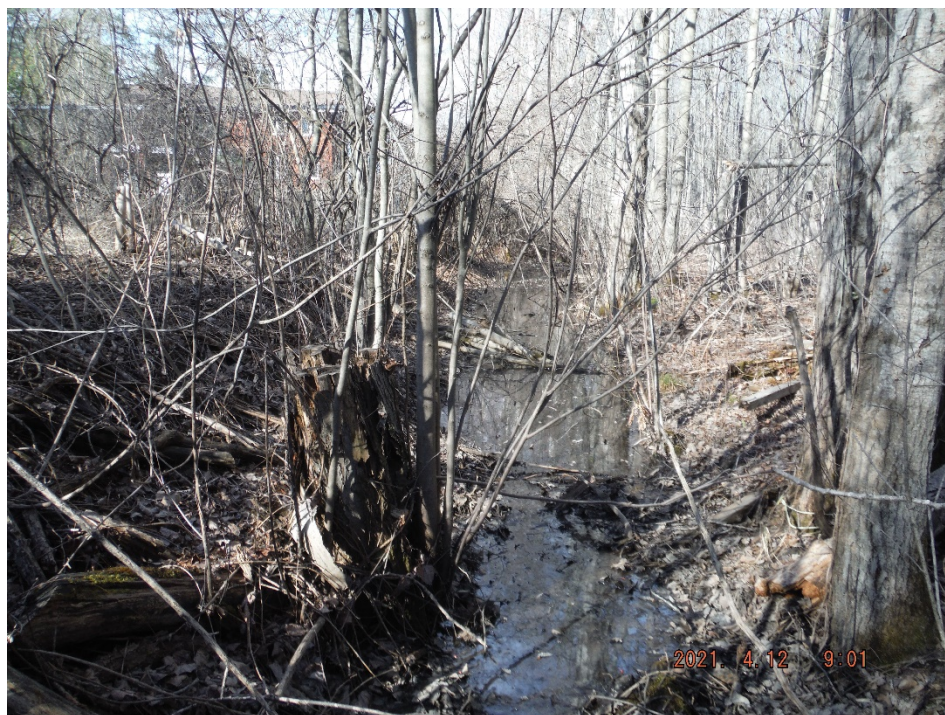
The substrate consisted primarily of soil (no sorting) and the hydrological flow consisted of standing water. The in-water cover consisted of leaf litter. The top of the banks was mostly vegetated with trees and shrubs. The station had good canopy cover overall.

Photo 24: Downstream of the station, looking upstream (April 12, 2021)

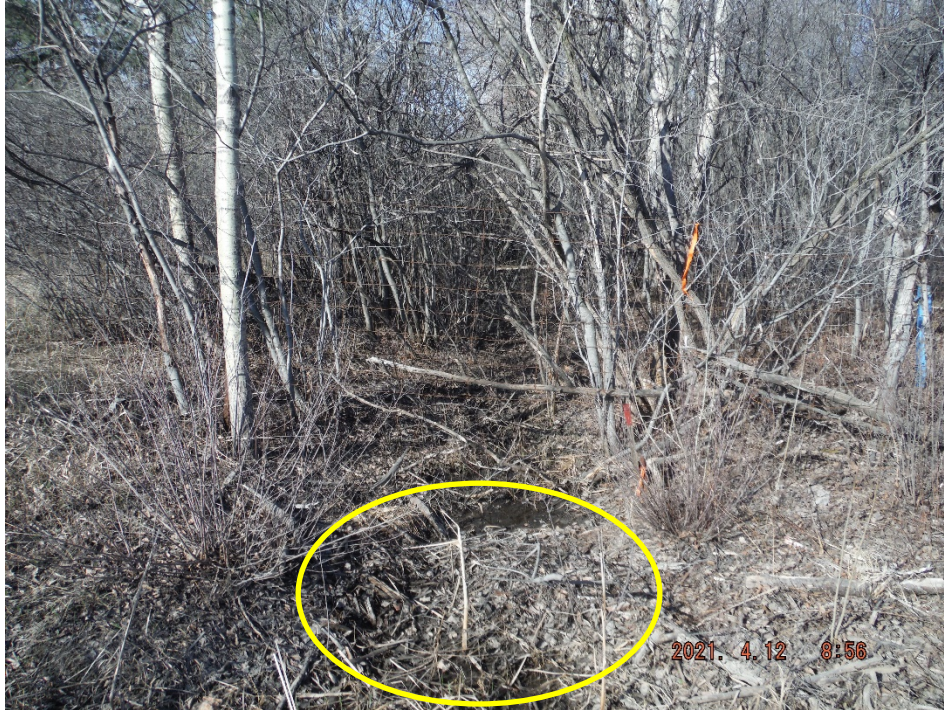
Information was collected from a shallow ephemeral swale without defined banks located north-east of the site, in the forest. There was no connection with the roadside ditch (there was a soil berm between this feature and the ditch, no exit location was found).

Photo 25: Looking upstream at the soil berm separating the feature from the roadside ditch (April 12, 2021)
