Phase I Environmental Site Assessment

3437 Innes Road
Ottawa, Ontario

May 25, 2021

Report: PE4282-1

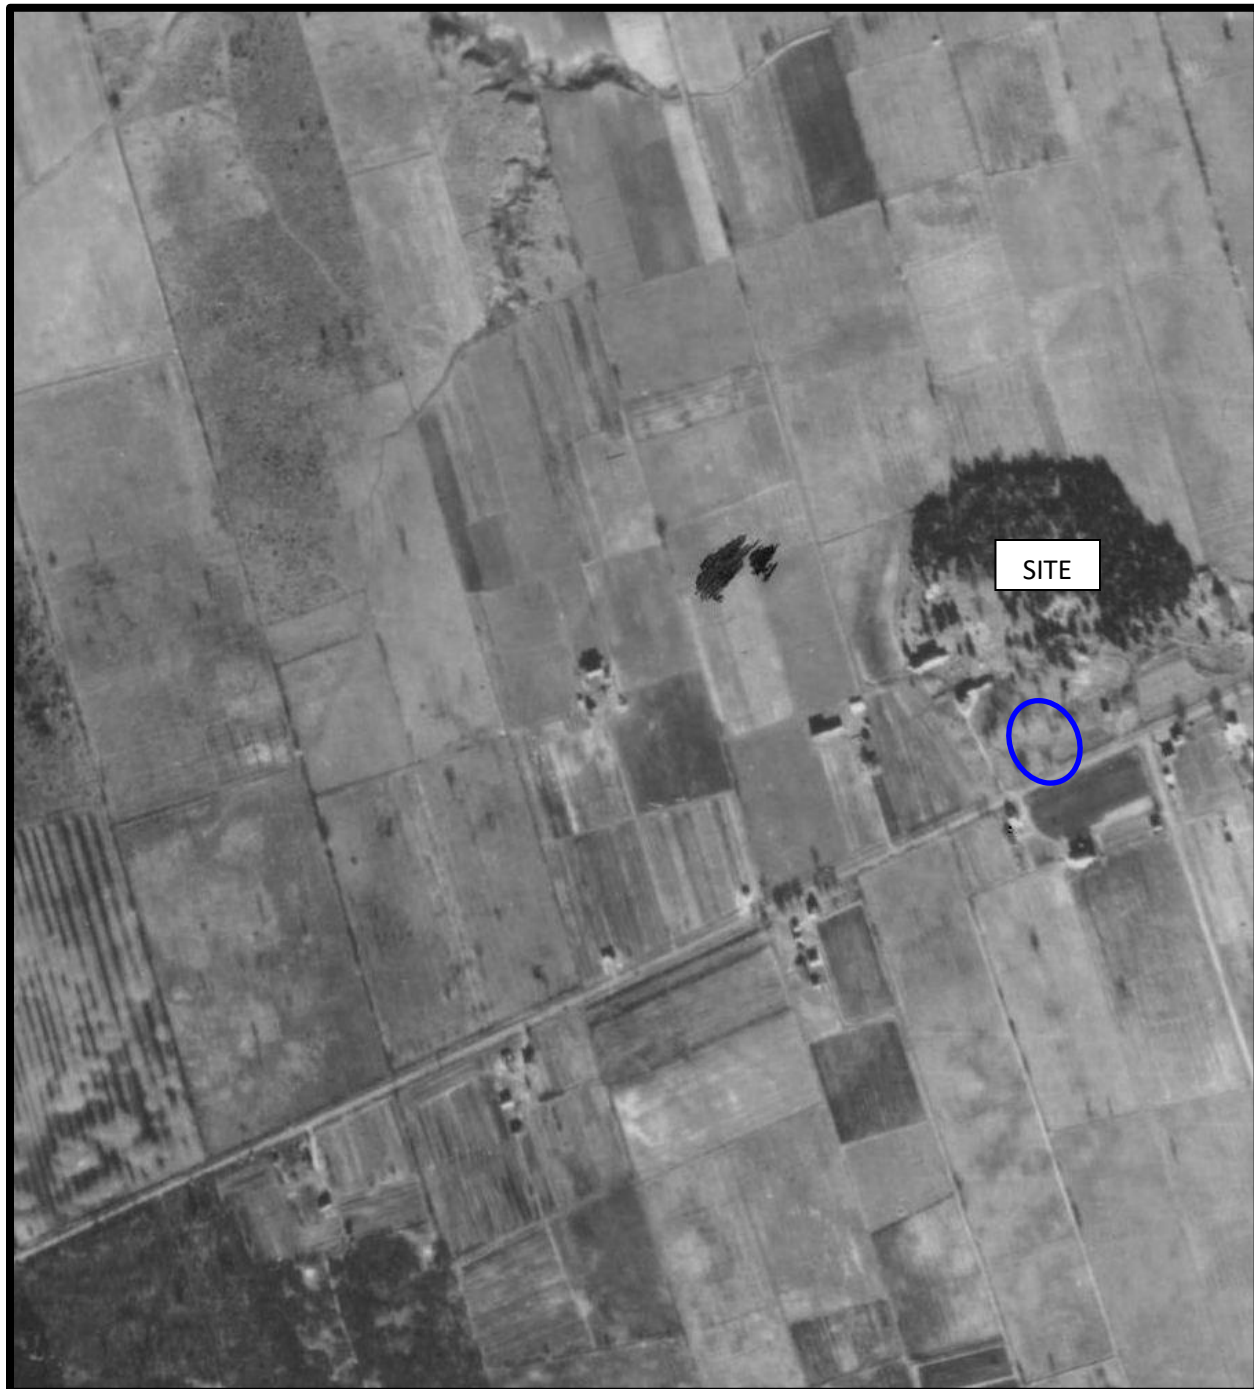
AERIAL PHOTOGRAPH
1945

1945	The Phase I ESA Property appears to be occupied by a residential dwelling at this time. The surrounding lands are occupied by residential dwellings and agricultural lands.
1956	No apparent changes to the Phase I ESA Property or surrounding lands at this time.
1965	No changes are apparent on the Phase I ESA Property. The surrounding lands to the south, across Innes Road, are more densely developed with residential dwellings at this time.
1976	A private garage is present on the Phase I ESA Property at this time, while the surrounding lands appear to remain unchanged from the previous photograph.
1991	The Phase I ESA Property remains unchanged from the previous photograph. Lands further east are occupied by a residential development. A retail fuel outlet can be seen on the adjacent property, approximately 80 m to the east.
2002	No significant changes are apparent on the Phase I ESA Property and neighbouring lands.

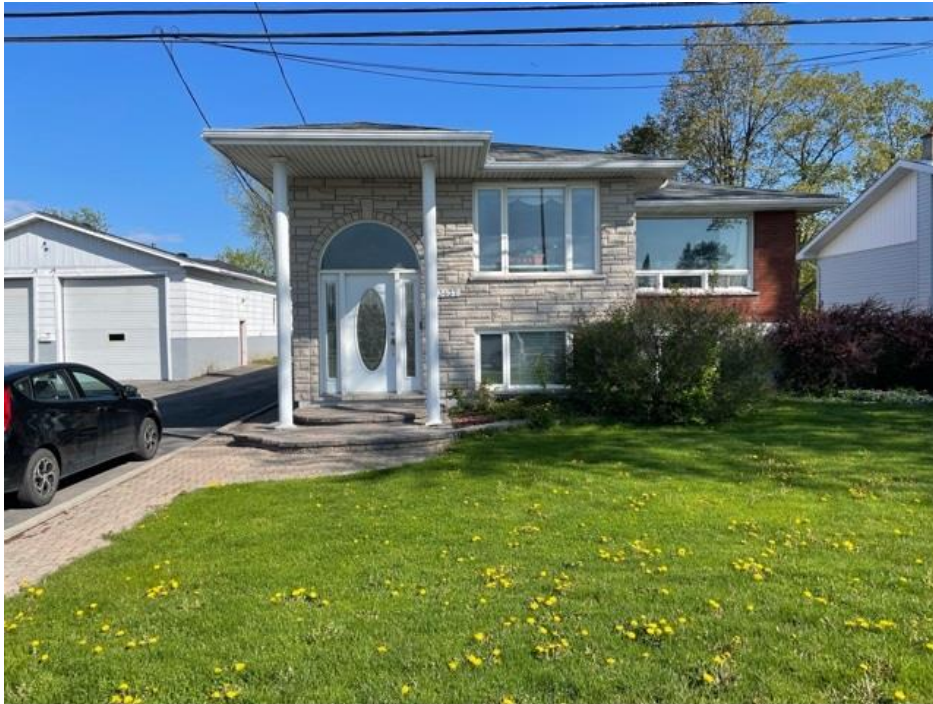
The Phase I ESA Property is occupied by a 2-storey residence with a basement and a private garage. The dwelling is constructed with a concrete block foundation circa 1956. The exterior is finished in brick with a sloped style shingle roof. The subject building is heated by natural gas fired equipment.

Photograph 1: View of the residential dwelling, taken from Innes Road.

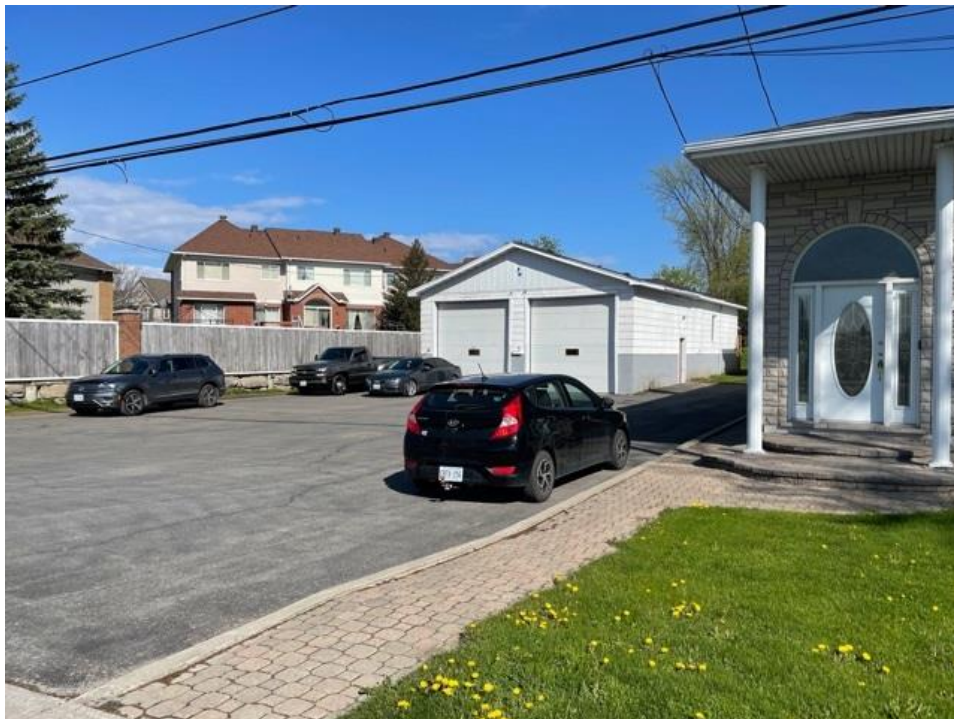
Photograph 2: View of the southern portion of the Phase I ESA Property.

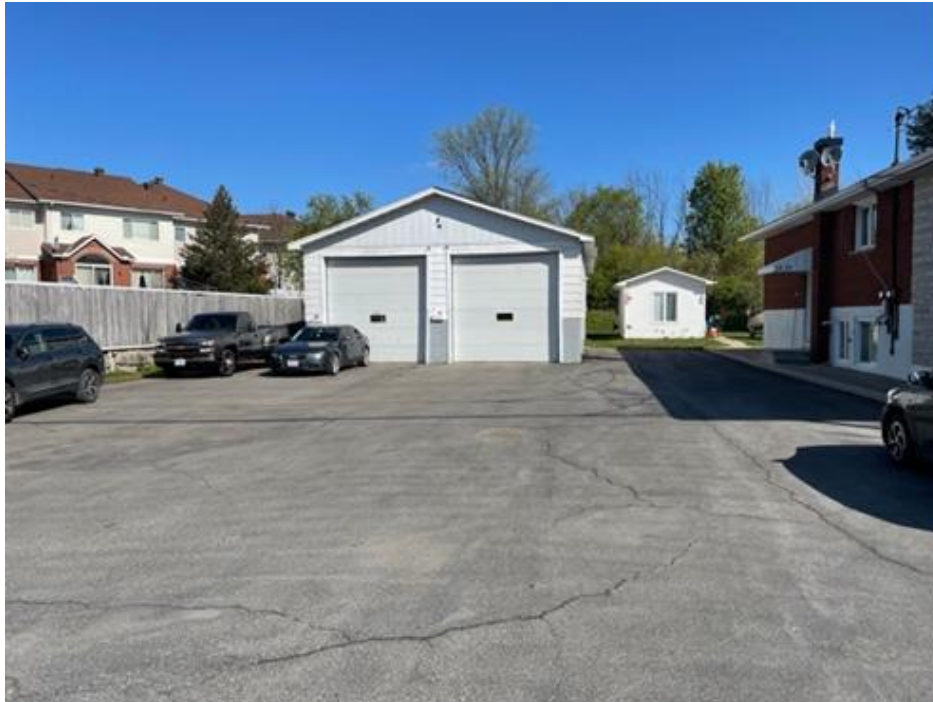
The private garage is constructed with a slab-on-grade foundation finished in vinyl siding and a sloped shingle style roof.

Photograph 3: View of the private garage, situated on the western side of the subject property.

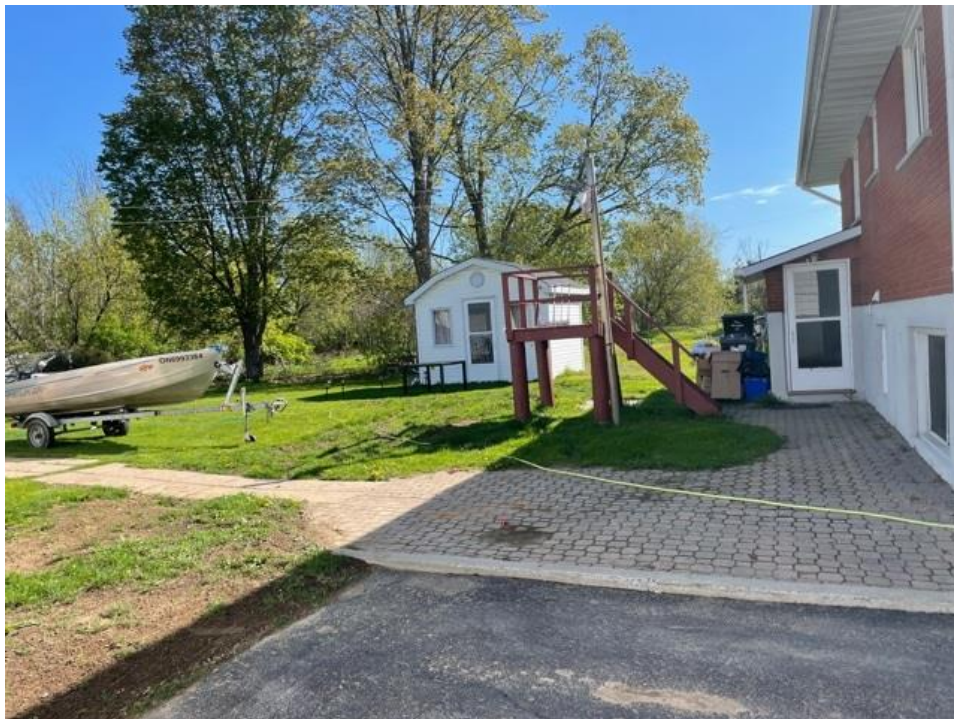
Photograph 4: View of the northern portion or backyard subject property.
