**Phase II Environmental Site Assessment**

7000 Campeau Drive  
Ottawa, Ontario

**Prepared For**  
ClubLink Corporation ULC

**April 1, 2021**  
Report: PE4321-2 Rev 2

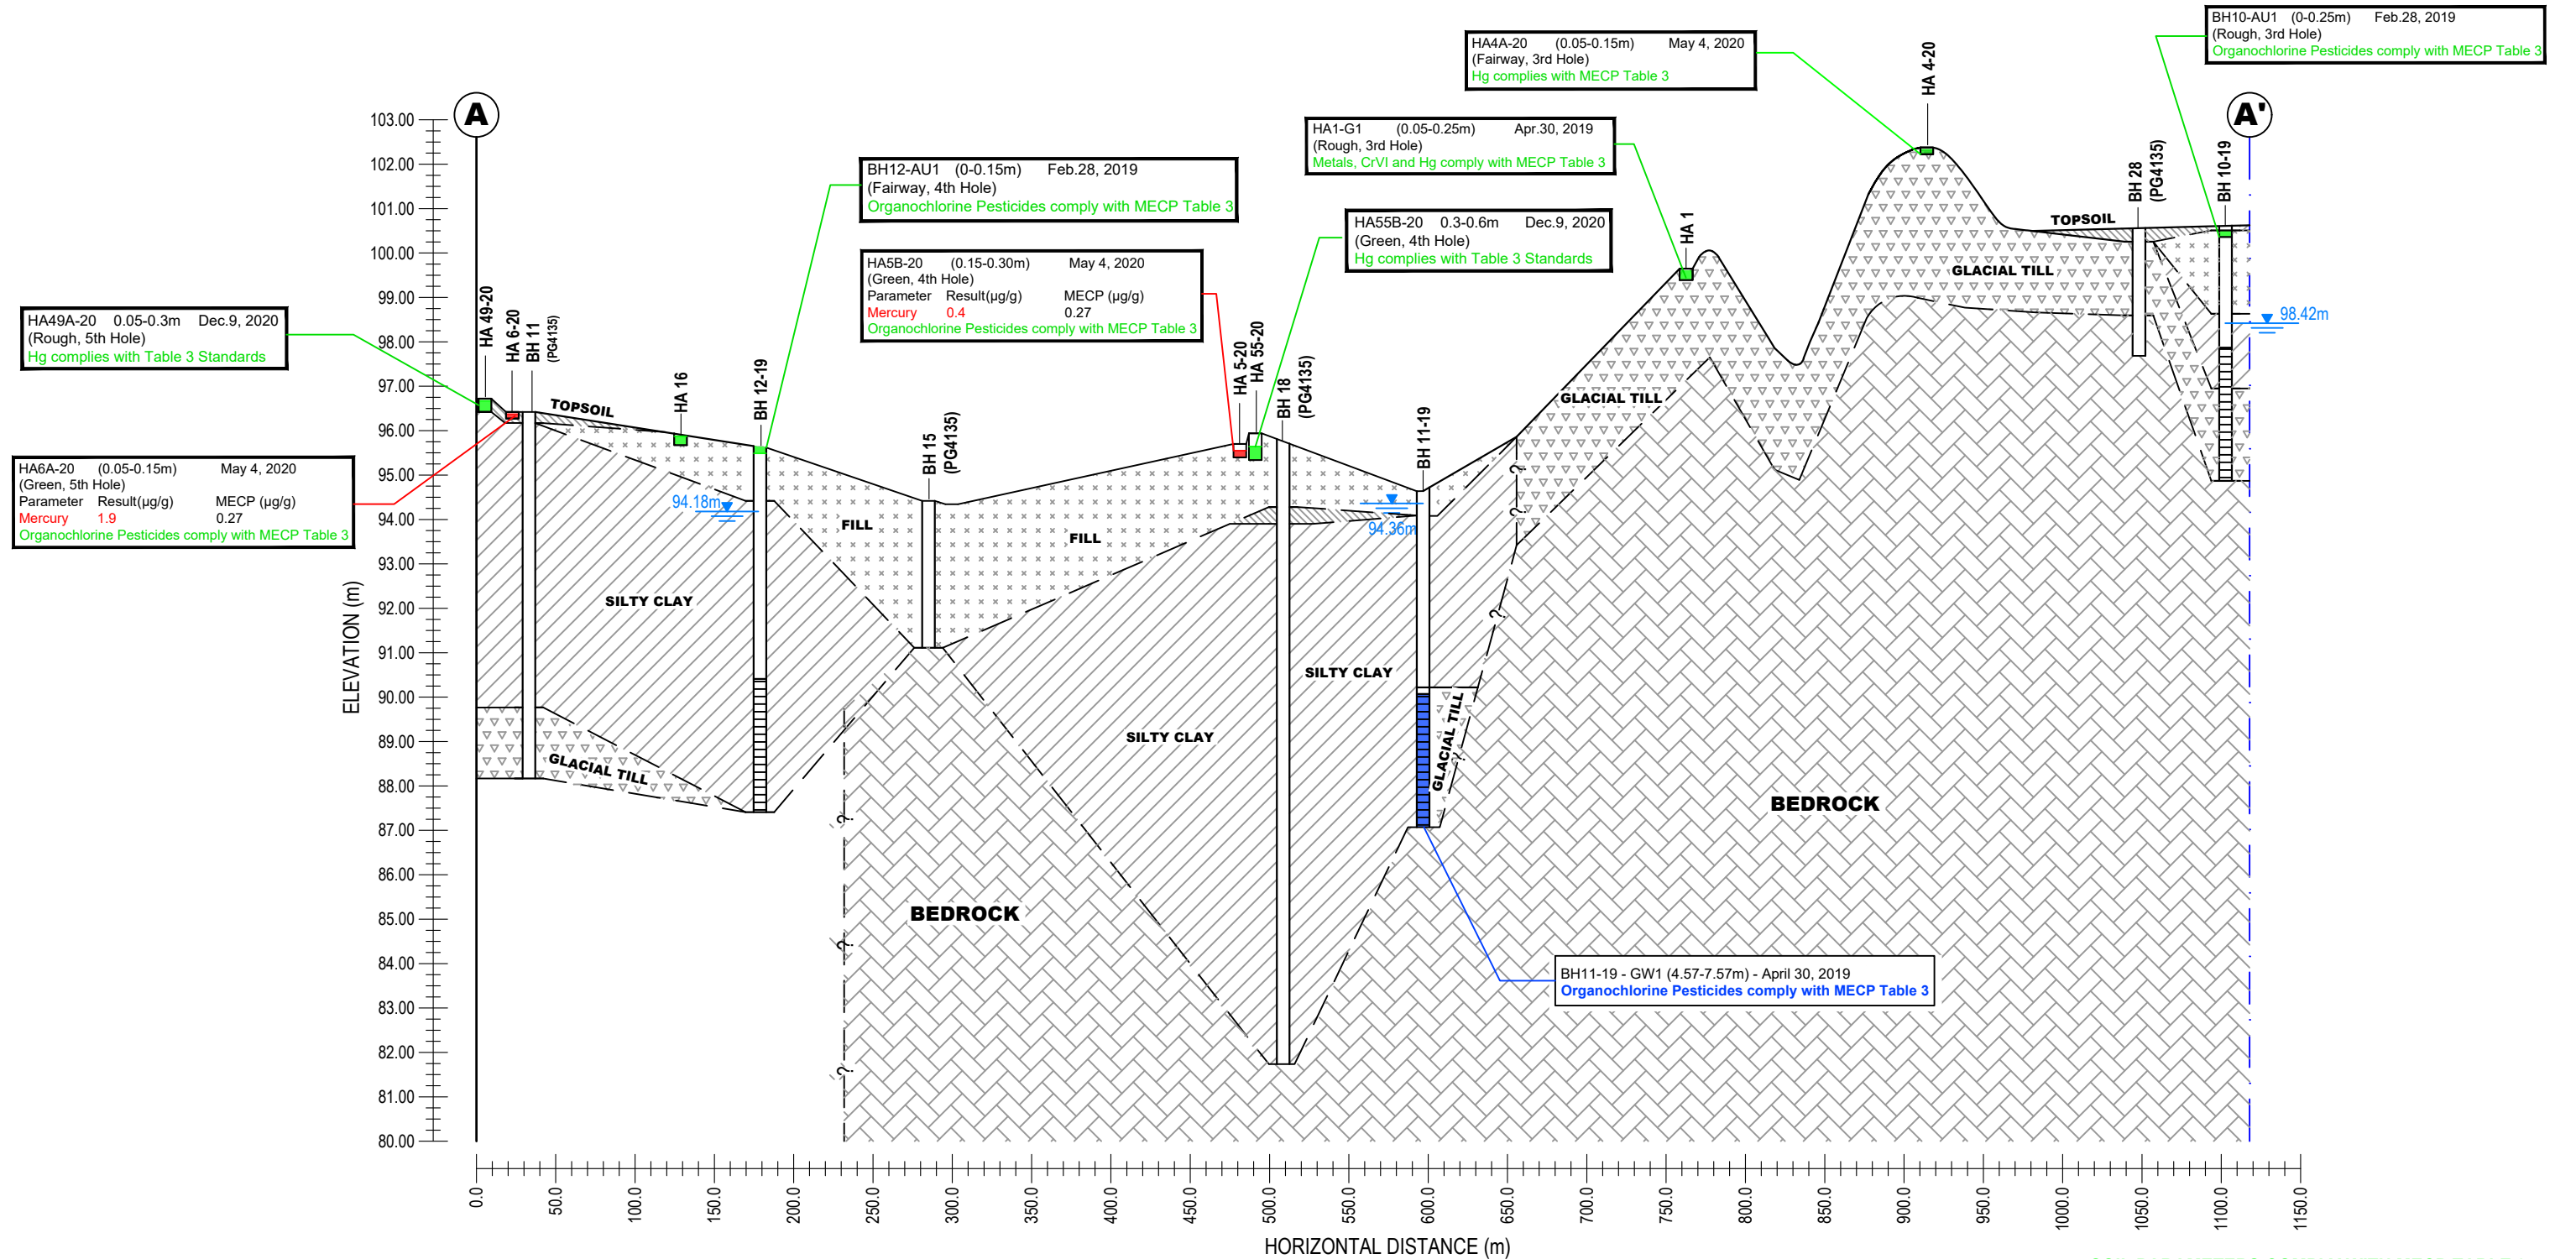
SOIL PARAMETERS COMPLY WITH MECP TABLE 3 STANDARDS

GROUNDWATER PARAMETERS COMPLY WITH MECP TABLE 3 STANDARDS

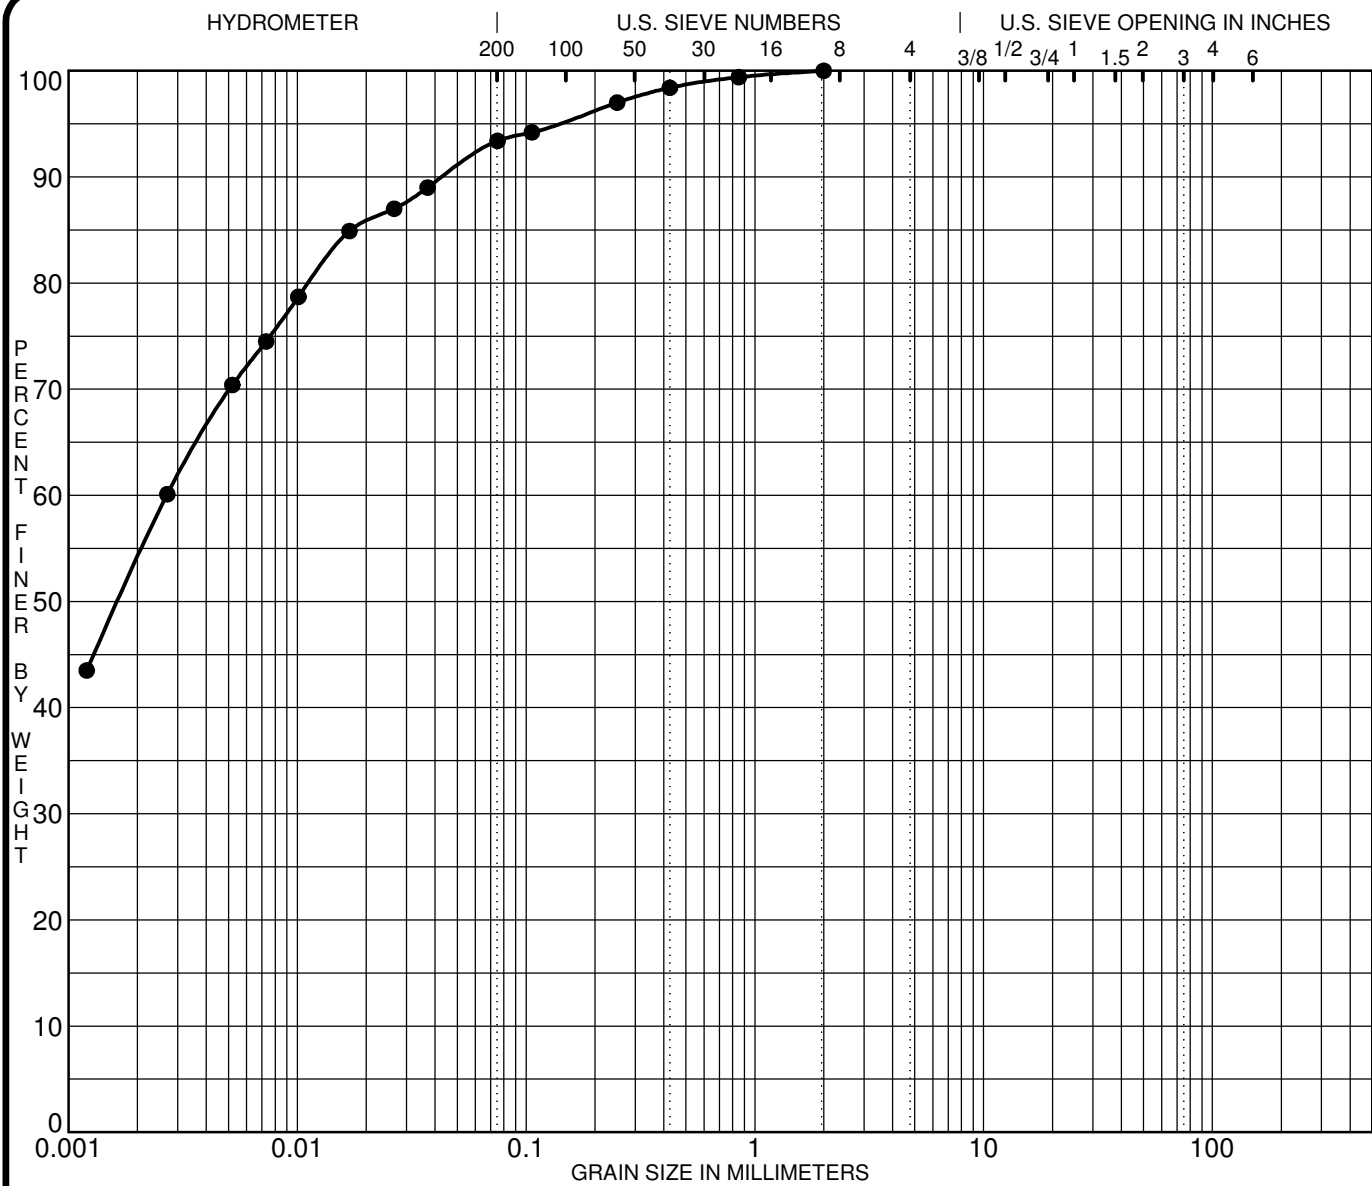
**GRAIN SIZE DISTRIBUTION**

Grain size-analyses were conducted at four (4) different locations across the Phase II Property, identifying the soil as fine-grained. However, due to the size of the Phase II Property, additional grain-size analysis would be recommended to confirm that fine-grained standards are applicable. The more stringent coarse-grained standards have therefore been selected at this time.
