**Headwater Drainage Features Assessment Report  
37 Wildpine Court, Stittsville, Ottawa, Ontario**

**Draft Report**

**December 11, 2020**

**KILGOUR & ASSOCIATES LTD.**  
[www.kilgourassociates.com](http://www.kilgourassociates.com)

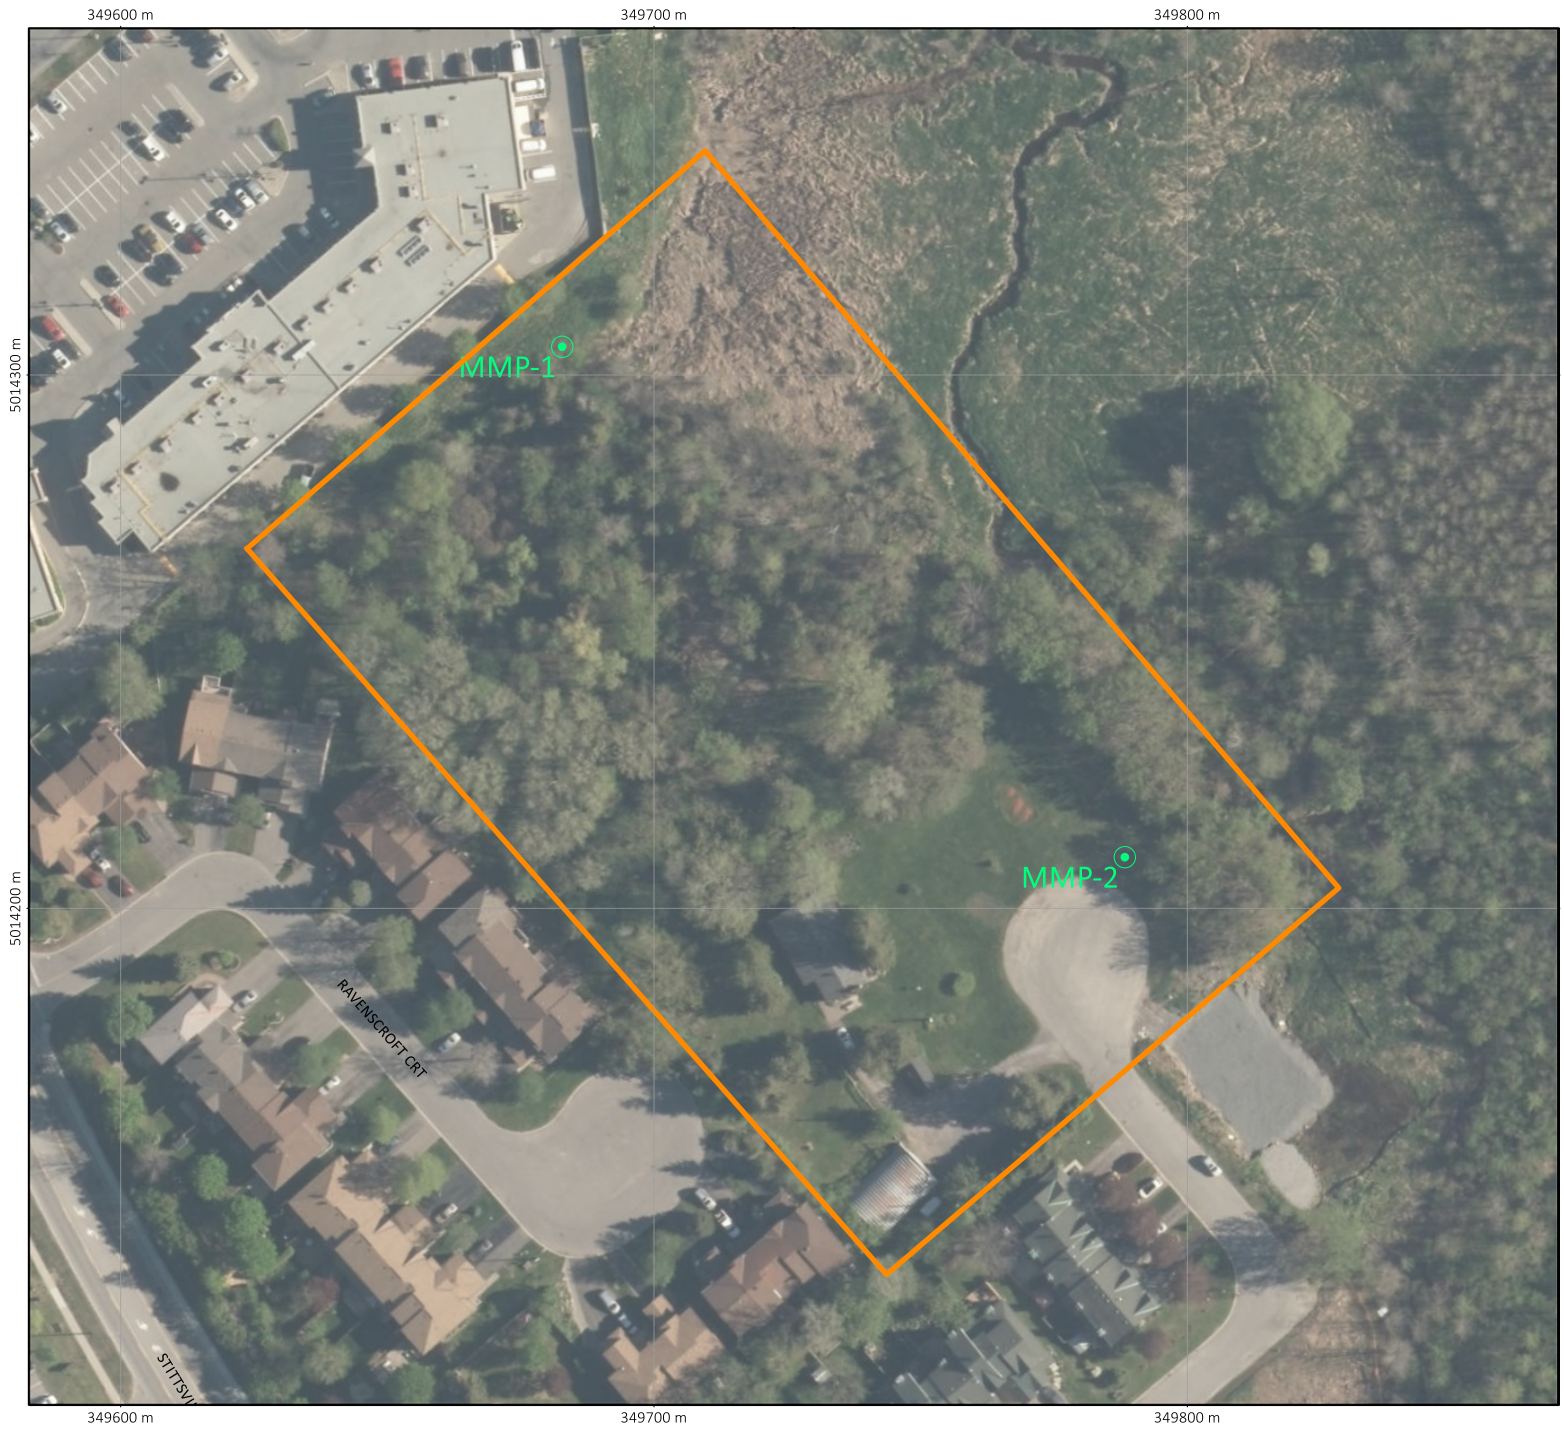
**Figure 2** Map showing the locations of anuran survey stations for the Site

Aural anuran surveys were performed following the Marsh Monitoring Program (Bird Studies Canada et al., 2008). This protocol calls for multiple survey stations at a site to capture spatial and habitat variability. Accordingly, surveys were performed from two stations (“MMP-1” and “MMP-2” on Figure 2) adjacent to the wetland on the Site. The Marsh Monitoring Program advises that each station be visited a minimum of three times at night, no less than 15 days apart, during the spring and early summer.

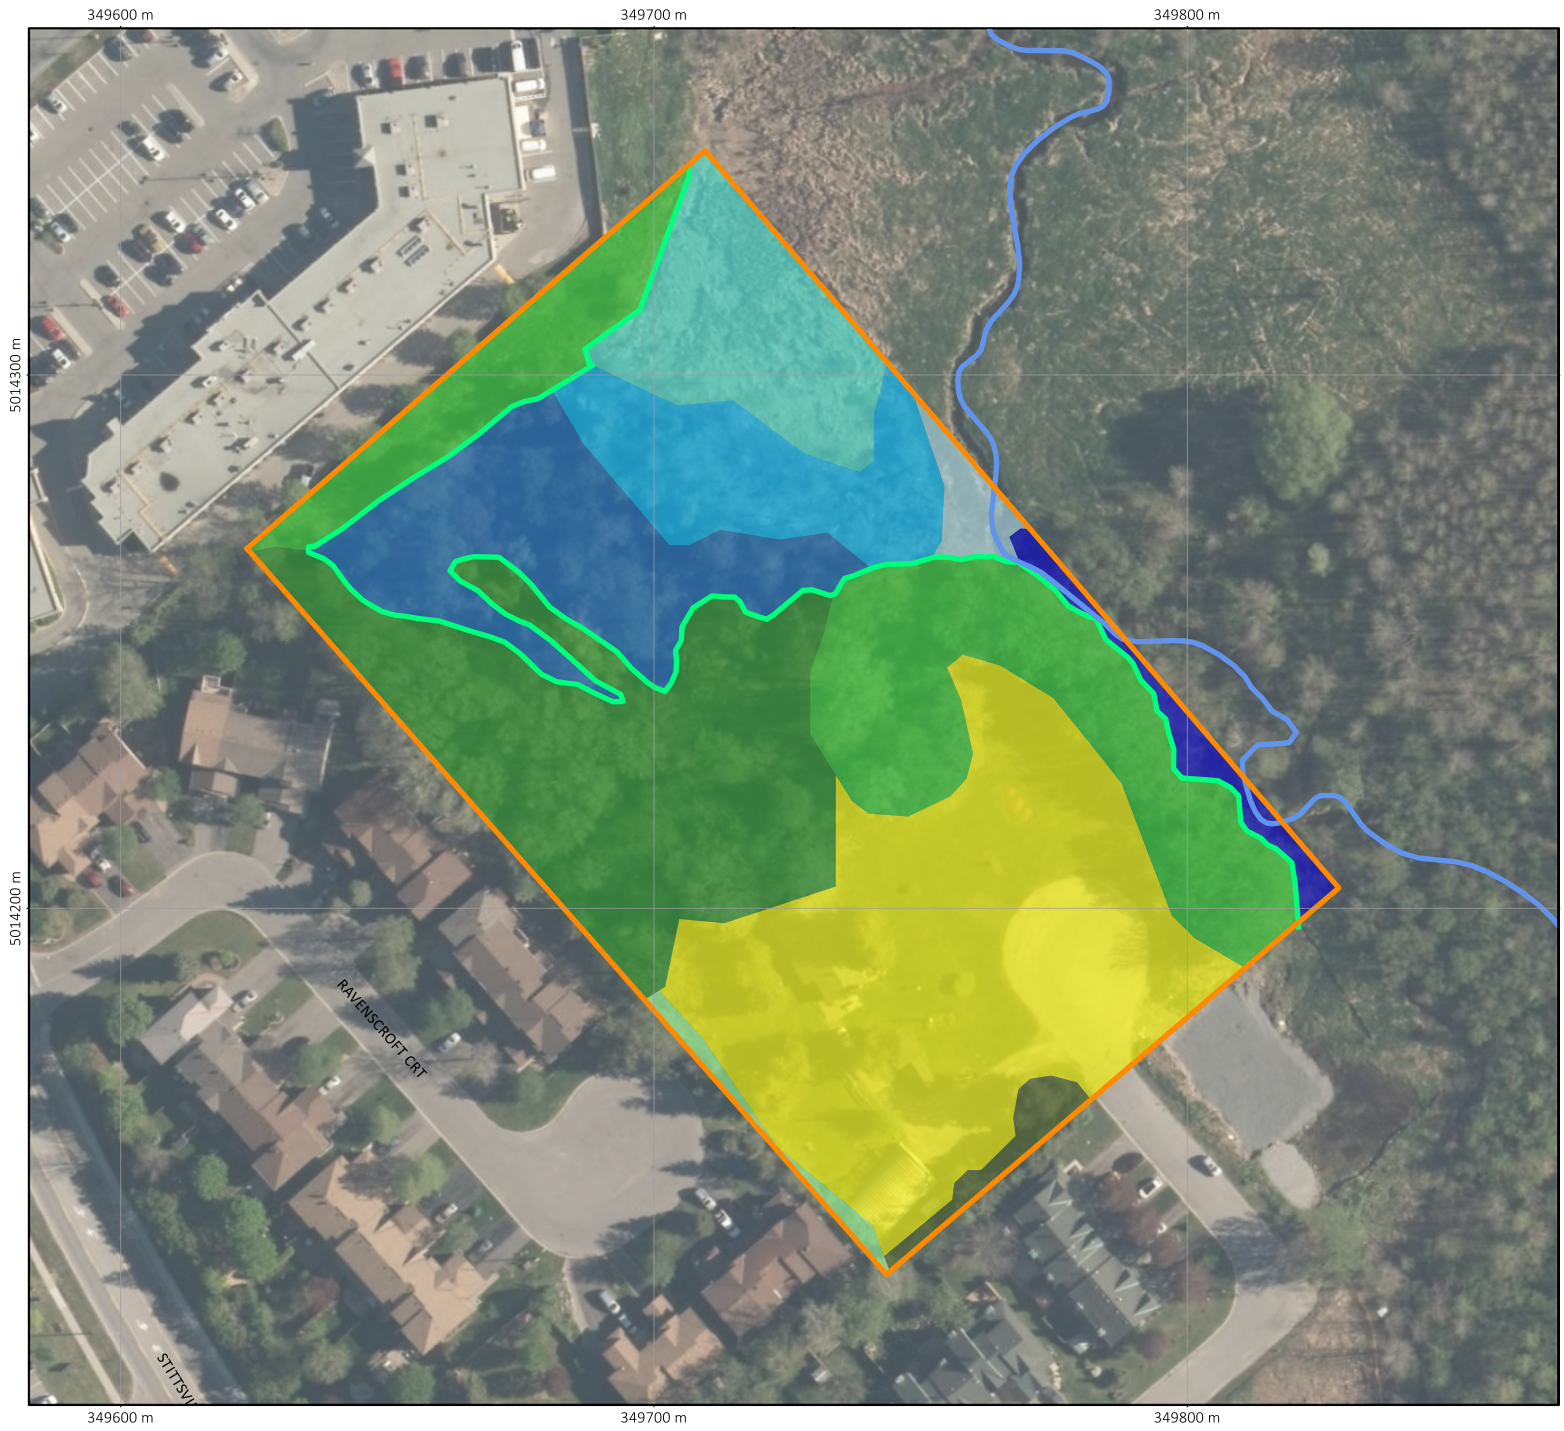
**Figure 3** Map showing the boundaries and Ecological Land Classification for the portion of the headwater wetland that falls on the Site

The boundaries of the wetland on the Site, as determined through field and desktop methods and in consultation with MVCA, are shown in Figure 3. The boundaries of the wetland were clear in the field based on the transition between wetland and upland vegetation and elevational change. The upland edge at the wetland boundary is comprised of a considerable amount of fill material that has since naturalized with vegetation. The total wetland area on the Site is approximately 0.6 ha and consists of several types

of wetland: meadow marsh, cattail marsh, deciduous thicket (low shrub) swamp, mixed swamp, and deciduous swamp.

Five distinct vegetation communities were delineated within wetland on the Site using ELC (Figure 3). Each wetland community and the dominant vegetation therein are described below. On the Site, the wetland is fully bounded by terrestrial forest ecosites including Dry – Fresh Manitoba Maple Deciduous Forest (FODM4-5) and Fresh – Moist Bitternut Hickory Deciduous Forest (FODM9-5; Figure 3).

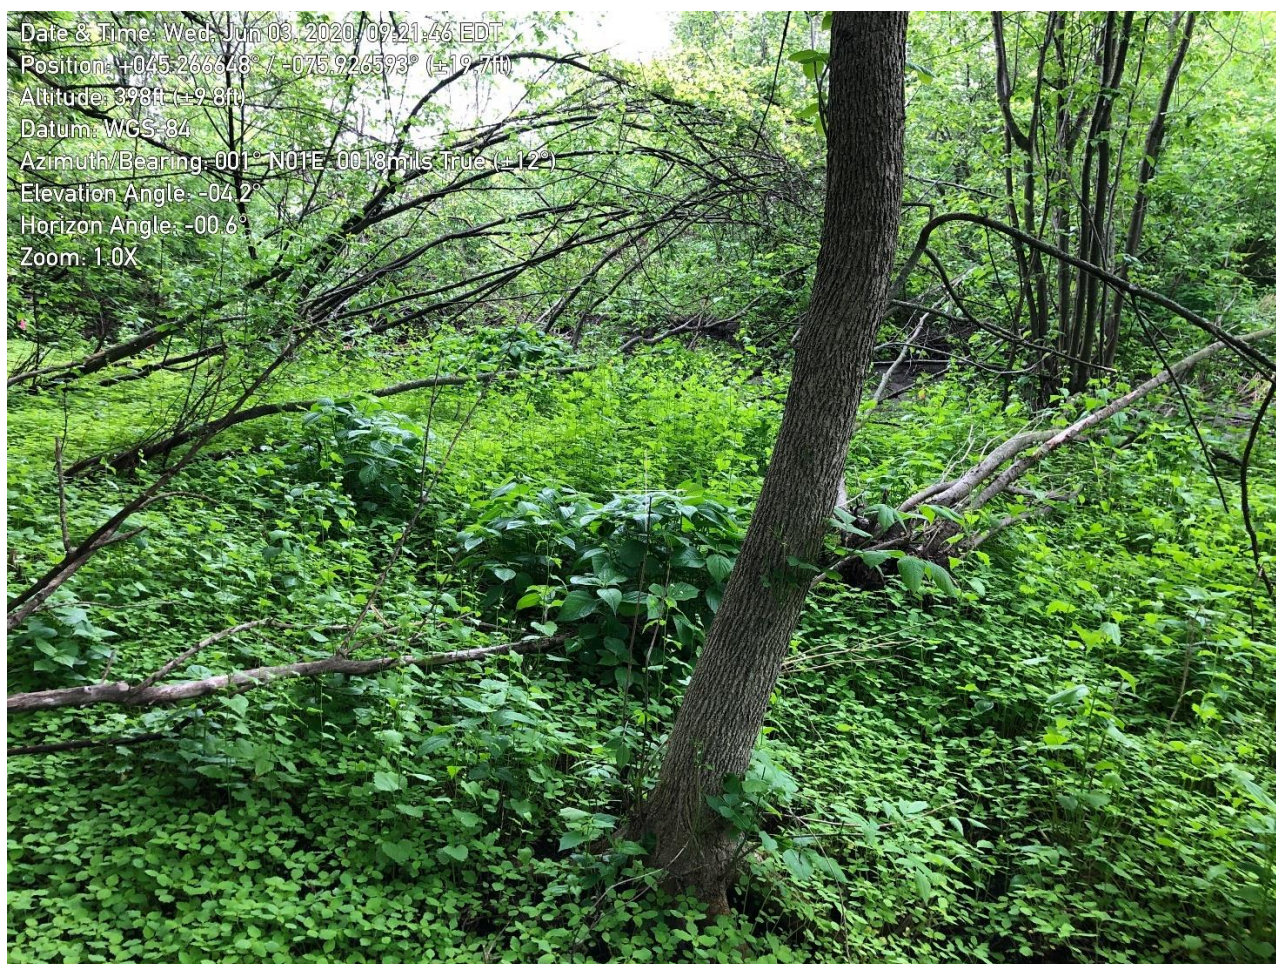
**Figure 4 Photo of the Maple Organic Deciduous Swamp Ecosite (SWD6) within the headwater wetland on the Site**

The SWD6 ecosite makes up the treed corridor of Poole Creek along the eastern edge of the Site (Figure 4). Note that SWD6 is typically used to describe organic swamps dominated by Red Maple (*Acer rubrum*), Silver Maple (*Acer saccharinum*), and/or Freeman’s Maple (*Acer freemanii*). However, this swamp is dominated by Manitoba Maple (*Acer negundo*) followed by Crack Willow (*Salix fragilis*). The dominant shrub species is Speckled Alder (*Alnus incana*) and ground cover is dominated by Spotted Jewelweed (*Impatiens capensis*).

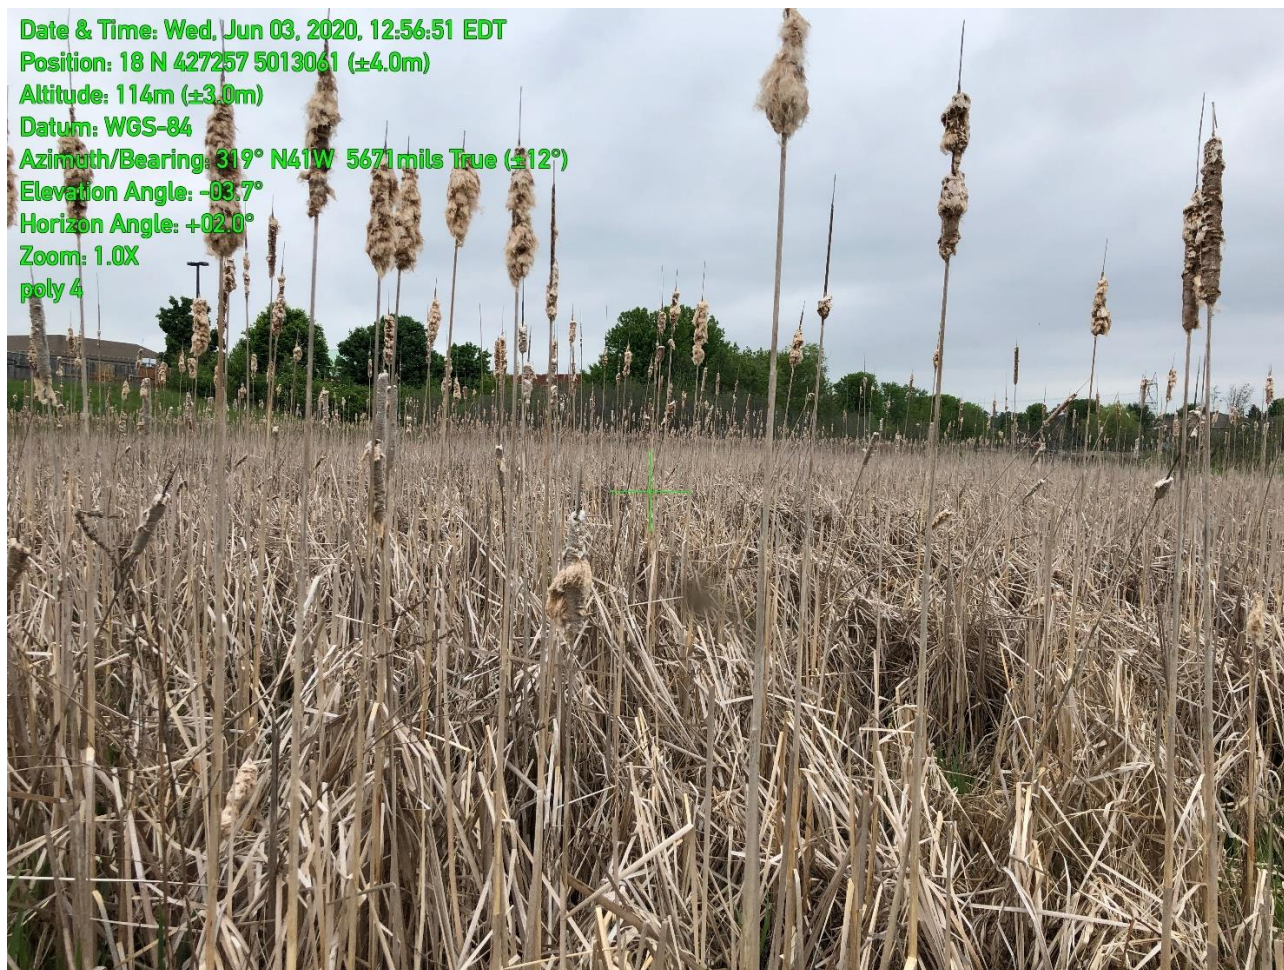
**Figure 5 Photo of the Cattail Organic Shallow Marsh Type (MAS3-1) within the headwater wetland on the Site**

The northeastern corner of the Site consists of the MAS3-1 community and is dominated by a near-homogenous cover of Broad-leaved Cattail (*Typha latifolia*; Figure 5).

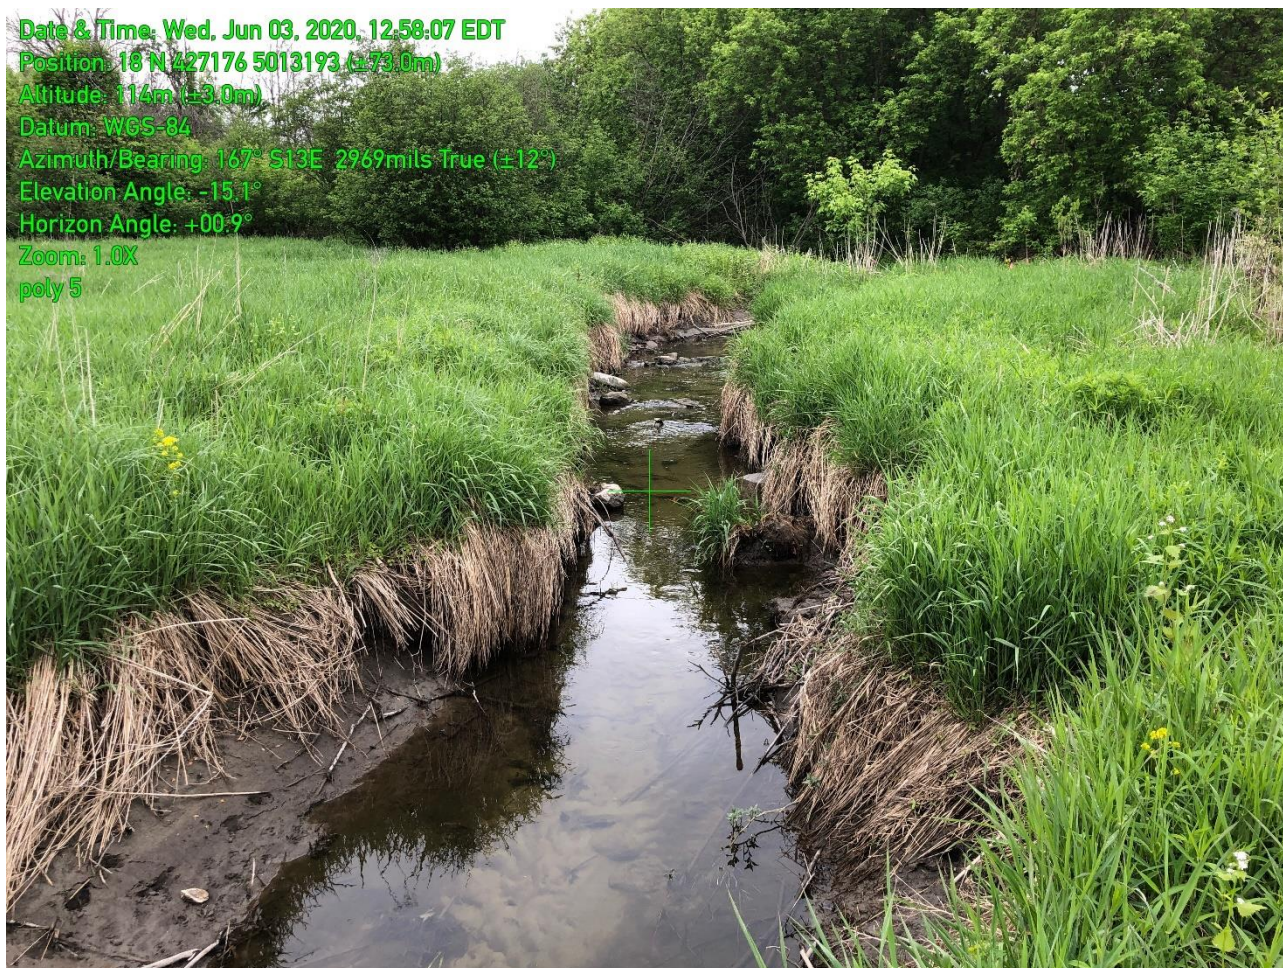
**Figure 6 Photo of the Reed Canary Grass Organic Shallow Marsh Type (MASO1-4) within the headwater wetland on the Site**

The riparian corridor of Poole Creek north of the SWD6 ecosite on the Site consists of meadow marsh dominated by Reed Canary Grass (*Phalaris arundinacea*; Figure 6).

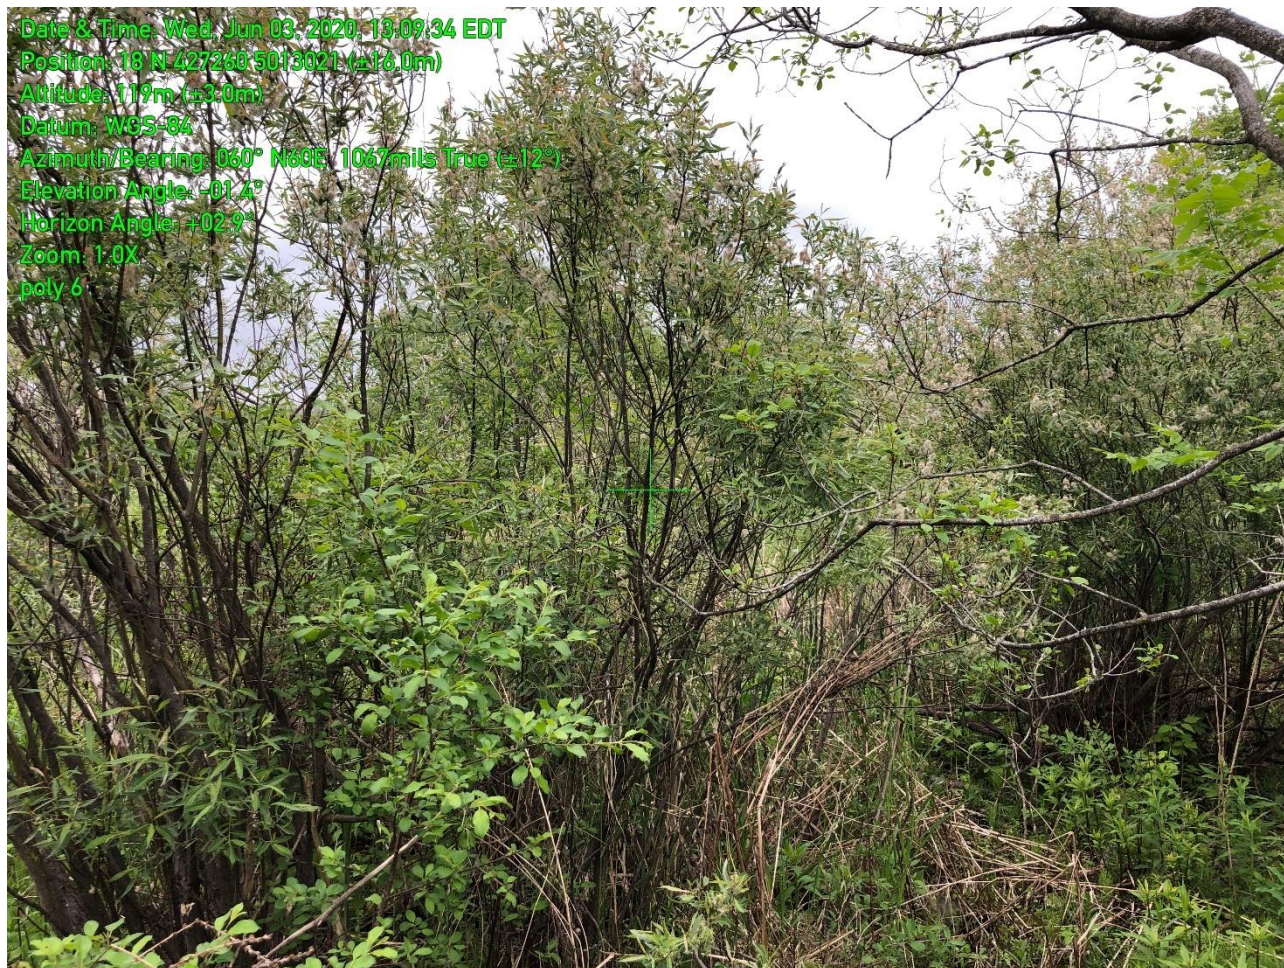
**Figure 7 Photo of the Willow Organic Thicket Swamp Type (SWT3-2) within the headwater wetland on the Site**

Southwest of the MAS3-1 community is a thicket (tall shrub) swamp dominated by Peachleaf Willow (*Salix amygdaloides*) followed by Glossy Buckthorn (*Rhamnus frangula*; Figure 7).

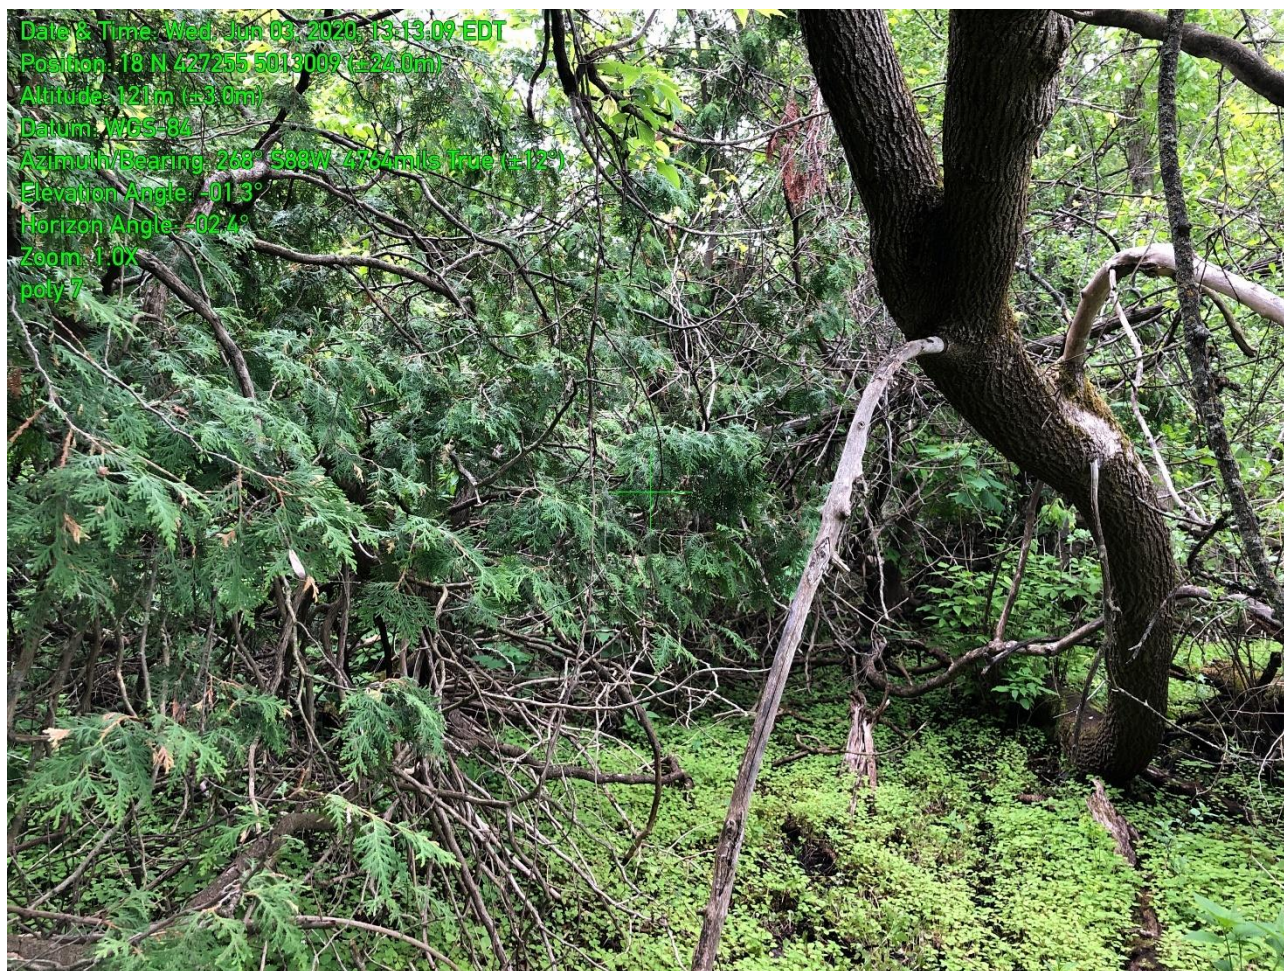
**Figure 8 Photo of the White Cedar – Hardwood Organic Mixed Swamp Type (SWM4-1) within the headwater wetland on the Site**

The northwestern to southeastern edge of the headwater wetland on the Site is a treed swamp co-dominated by Black Ash (*Fraxinus nigra*), Eastern White Cedar (*Thuja occidentalis*), and Manitoba Maple (Figure 8). The understory is dominated by Glossy Buckthorn and the ground cover is dominated by Spotted Jewelweed.

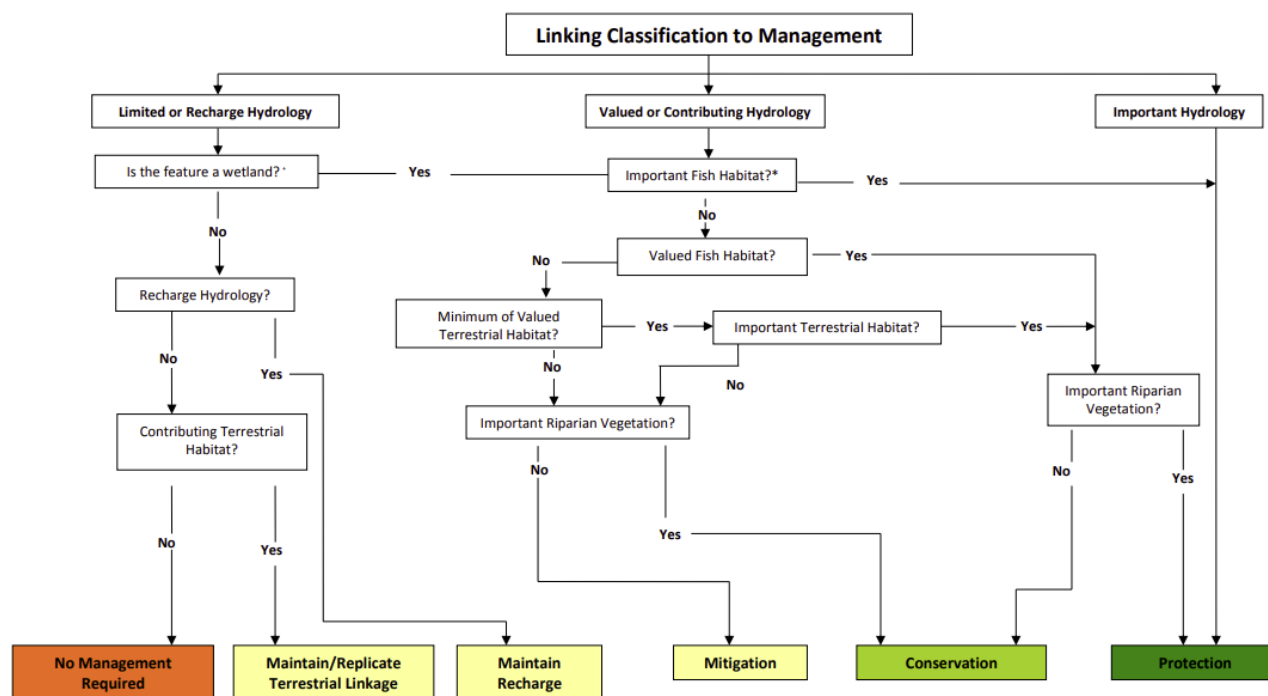
**Figure 9 Flow chart providing direction on management options based on the wetland’s classifications adapted from TRCA and CVC (2014)**

The functions rankings (classifications) identified for the hydrology, riparian conditions, fish habitat, and terrestrial habitat of the wetland form the basis of the management recommendation for the feature (Table 4; Figure 9; TRCA and CVC, 2014).

The management recommendation for the wetland on the Site is **Conservation**. Conserving the wetland includes (TRCA & CVC, 2014):

- Maintaining and/or enhancing the feature;
- Restoring hydrological and riparian and terrestrial habitat functions that may have been lost due to the historical placement of fill along the wetland’s edge, as feasible;
- Maintaining catchment flows (e.g., maintaining onsite flows through low impact development and/or natural design techniques and/or stormwater management design);
- Designing and locating the onsite stormwater management system such that impacts to the wetland (e.g., sediment loading, temperature changes) are avoided; and
- Maintaining a development setback from the wetland to prevent impacts to the feature.

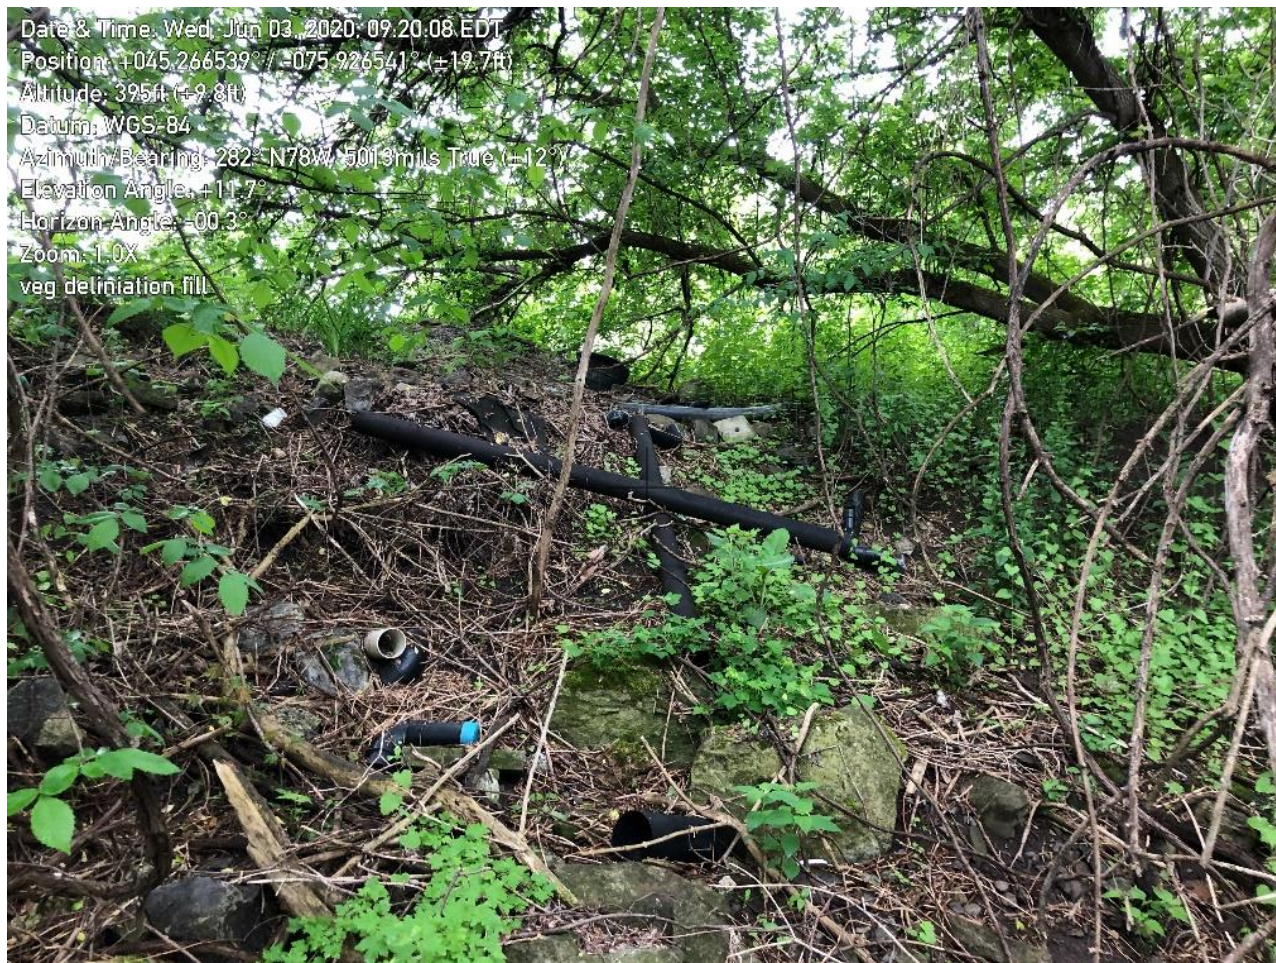
The “top edge of the fill” that had been on the Site is generally situated ≤15 m beyond the current wetland edge (Figures 10 and 11). Portions of the Site beyond 15 m from the wetland edge are located within an artificially raised tableland and are indistinct from the hydrology, riparian, or terrestrial habitat functions of areas >30 m from the wetland. The 15m buffer adjacent to the wetland encompasses the transition zone from upland to wetland and should be protected accordingly. The natural character of this area,

**Figure 10 Photo of fill and rubble on the edge of the wetland on the Site**

however, has been significantly degraded. This area should be reserved as a setback from the wetland and be subject to an enhancement program including the removal of invasive species and accumulated trash, and the planting of native species that are typical of transition areas between wetland and upland habitats.
