1009 Trim Road

Headwater Drainage Feature Assessment

November 2021

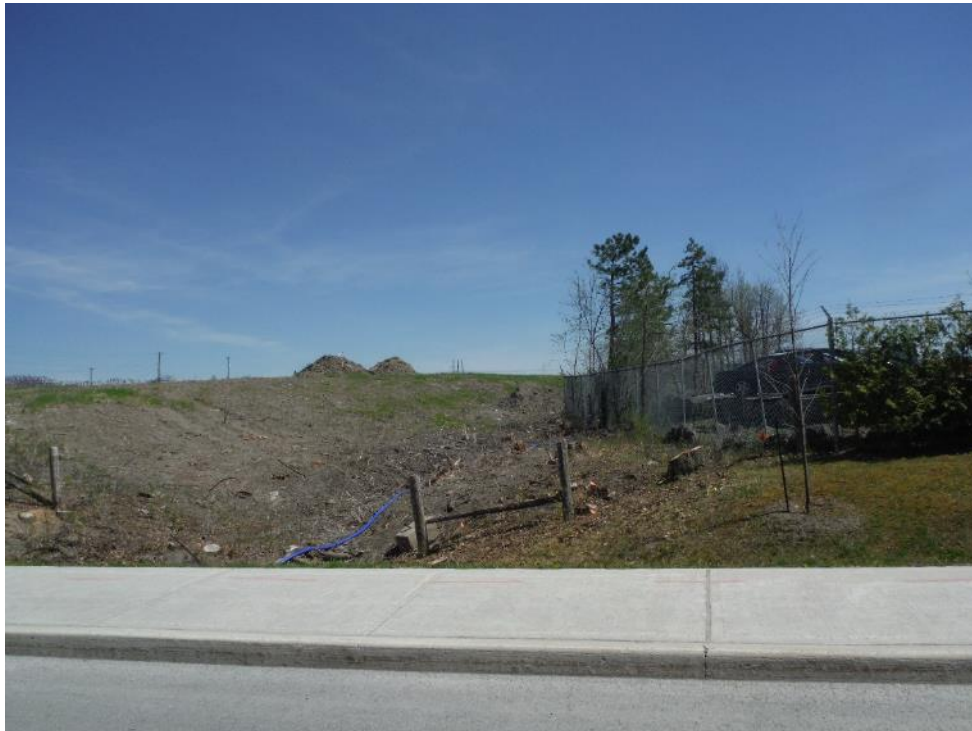
Photo 1: Headwater feature looking upstream from Jeanne D'Arc boulevard (May 21, 2020)

This potential headwater begins south of Inlet Private. However, in 2020 the City of Ottawa cleared the vegetation and left bare soil throughout and along the banks of this upstream portion. Further, a hose was present suggesting that pumping was occurring. More recently, the upstream end has been altered for the construction of the new Trim Road alignment. It is assumed that it could receive some flow from the road ditches upstream.

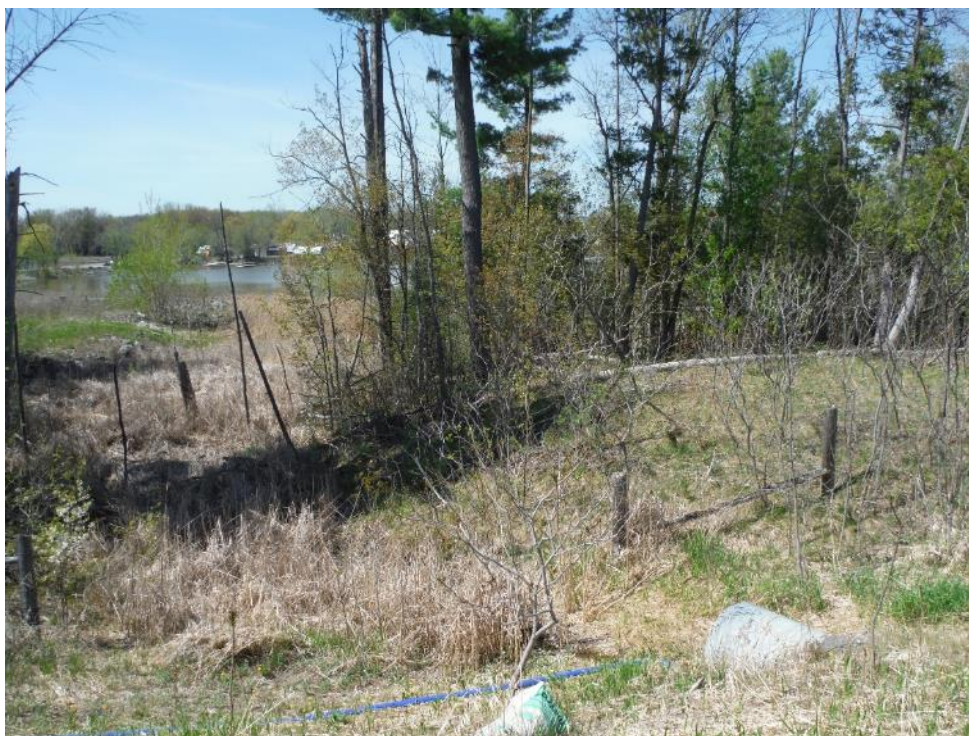
Photo 2: Headwater feature looking downstream from Jeanne D’Arc boulevard (May 21, 2020)

The habitat within the onsite feature meets the definition of wetland based on the *Ontario Wetland Evaluation System* (OWES), though it does not meet the minimum size criteria for the vegetation community to be described or assessed (minimum size requirements is 0.5 ha for description and, typically, 2 ha for assessment). The vegetation within this pocket with wetland features consisted of cattails and purple loosestrife over clay. Water depths, when present, were always less than 10-15 cm.

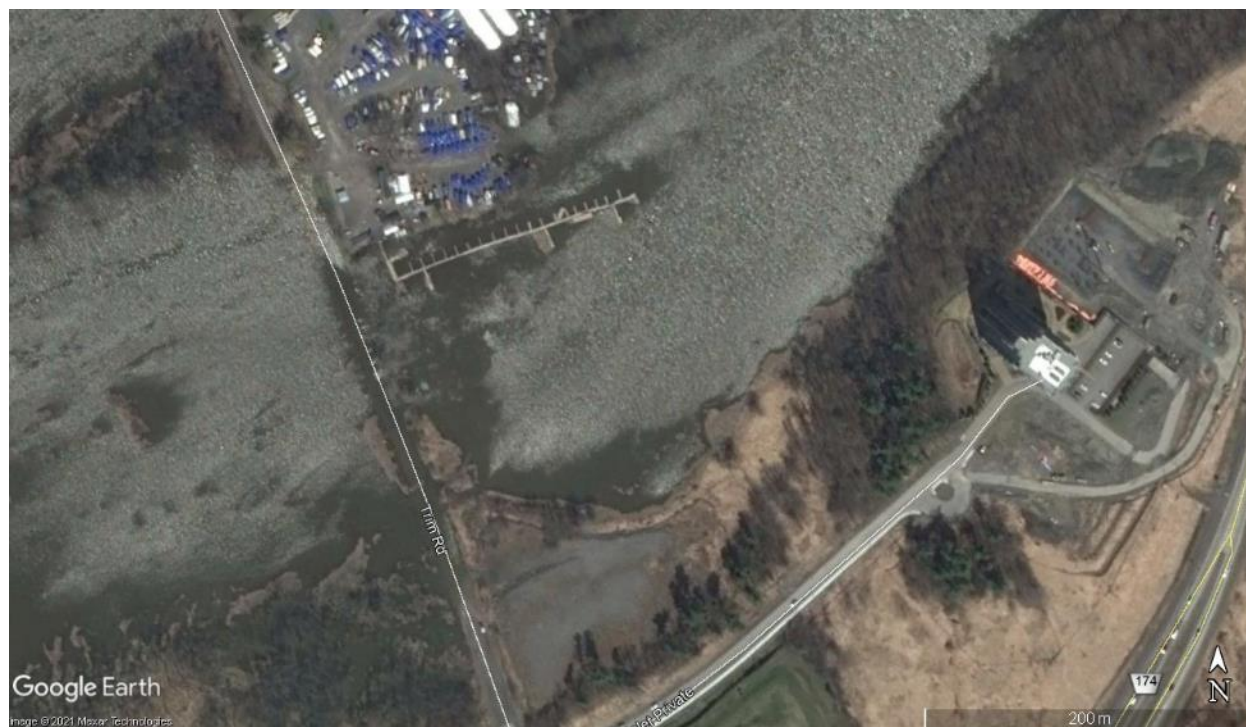
Figure 3: Satellite imagery showing water levels on April 22, 2017 (historical flood levels)

Comments from other members of the consulting team for 1009 Trim Road, indicate that the feature's catchment meets the minimum and does not exceed the maximum thresholds. However, it has characteristics of wetland feature without a downstream connection. Even during the historical flood levels of spring 2017, the Ottawa River water levels did not reach the

downstream end of the wetland pocket (Figure 3). The Ottawa River levels, remained below the reed canary on clay table lands. Because of the lack of downstream connection, it does not meet the definition of a headwater feature under the guidelines. The lack of a downstream connection could be attributed to the fill and the low volume of water exiting the Inlet Private culvert to the area in question. Any water that may have flowed through the Inlet Private culvert could have been retained by the fill (which curls around the downstream end). From there it could have percolated through the fill (the fill on the west side of the feature is gravel/rock) or been absorbed by the vegetation. However, since there was no connection noted in the background review, prior to the fill, it seems more likely that there has simply never been sufficient flow to create a headwater feature.

During the initial visit, it was confirmed that this feature is not connected to the Ottawa River during the spring or any other time of the year (Figure 3). Further, the upstream portion of this feature was severely impacted by the City influencing the habitat present on site. Finally, there was no water available for fish community sampling. No fish community sampling took place.

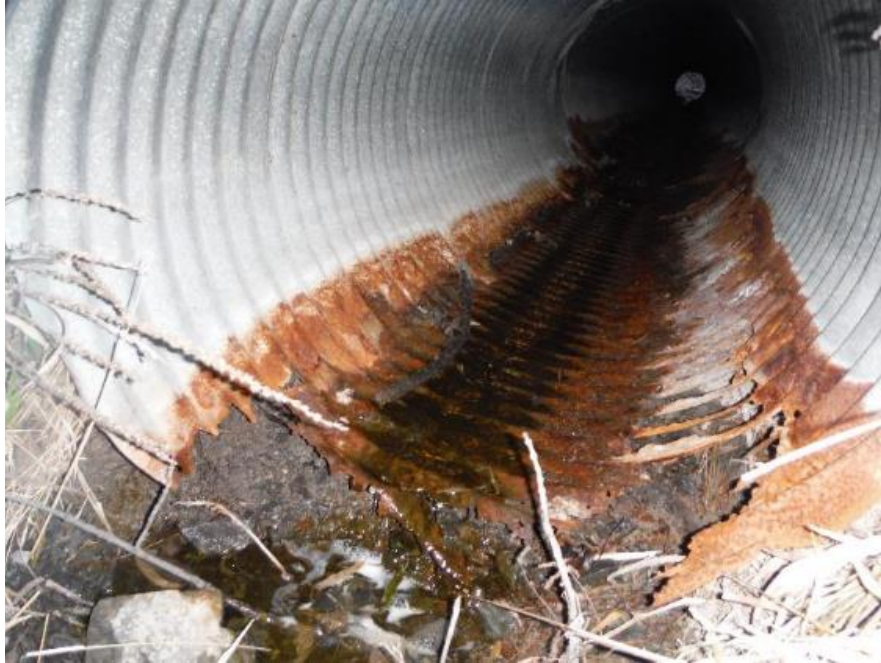
Photo 3: Headwater Drainage Feature Culvert (downstream side) (April 29, 2020)

It is noted that there was no water in the feature, where surveyed, during the second visit conducted by Bowfin in 2020. This was within roughly 45 m of the culvert and at the culvert itself. Notes from the staff from the summer visit identified water present, but they also indicated that it had been raining prior to and during the start of their visit. Soil samples (hand auger) collected in the feature indicated that the ground (outside of the rock fill) was clay. As

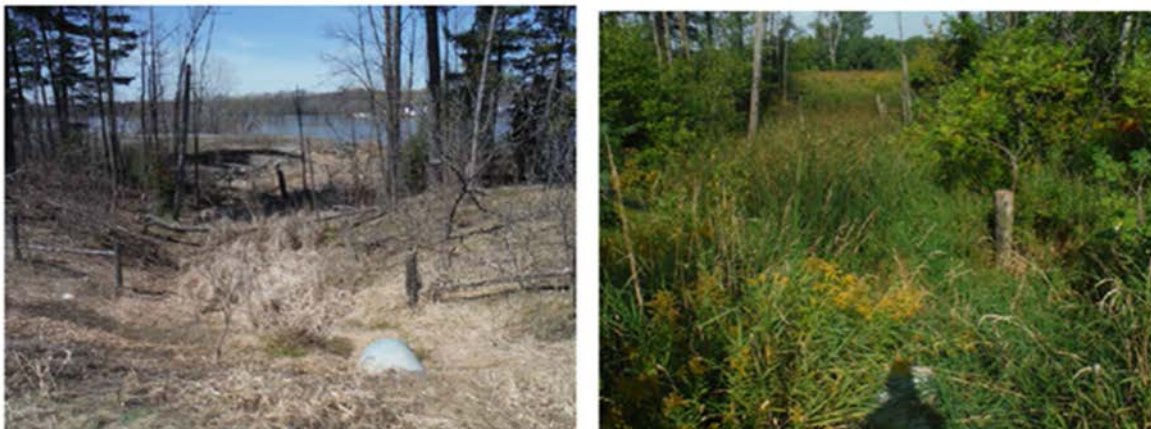
CSW423 West feature Downstream view on Inlet Private (spring vs. Summer)

The Rideau Valley Conservation Authority (RVCA) which shows that during their freshet visit, there was minimum flow in the downstream side of the feature (flow code of 4 is minimum flow).

Downstream Comments		
CULVERT DEGRADED + PERCHED

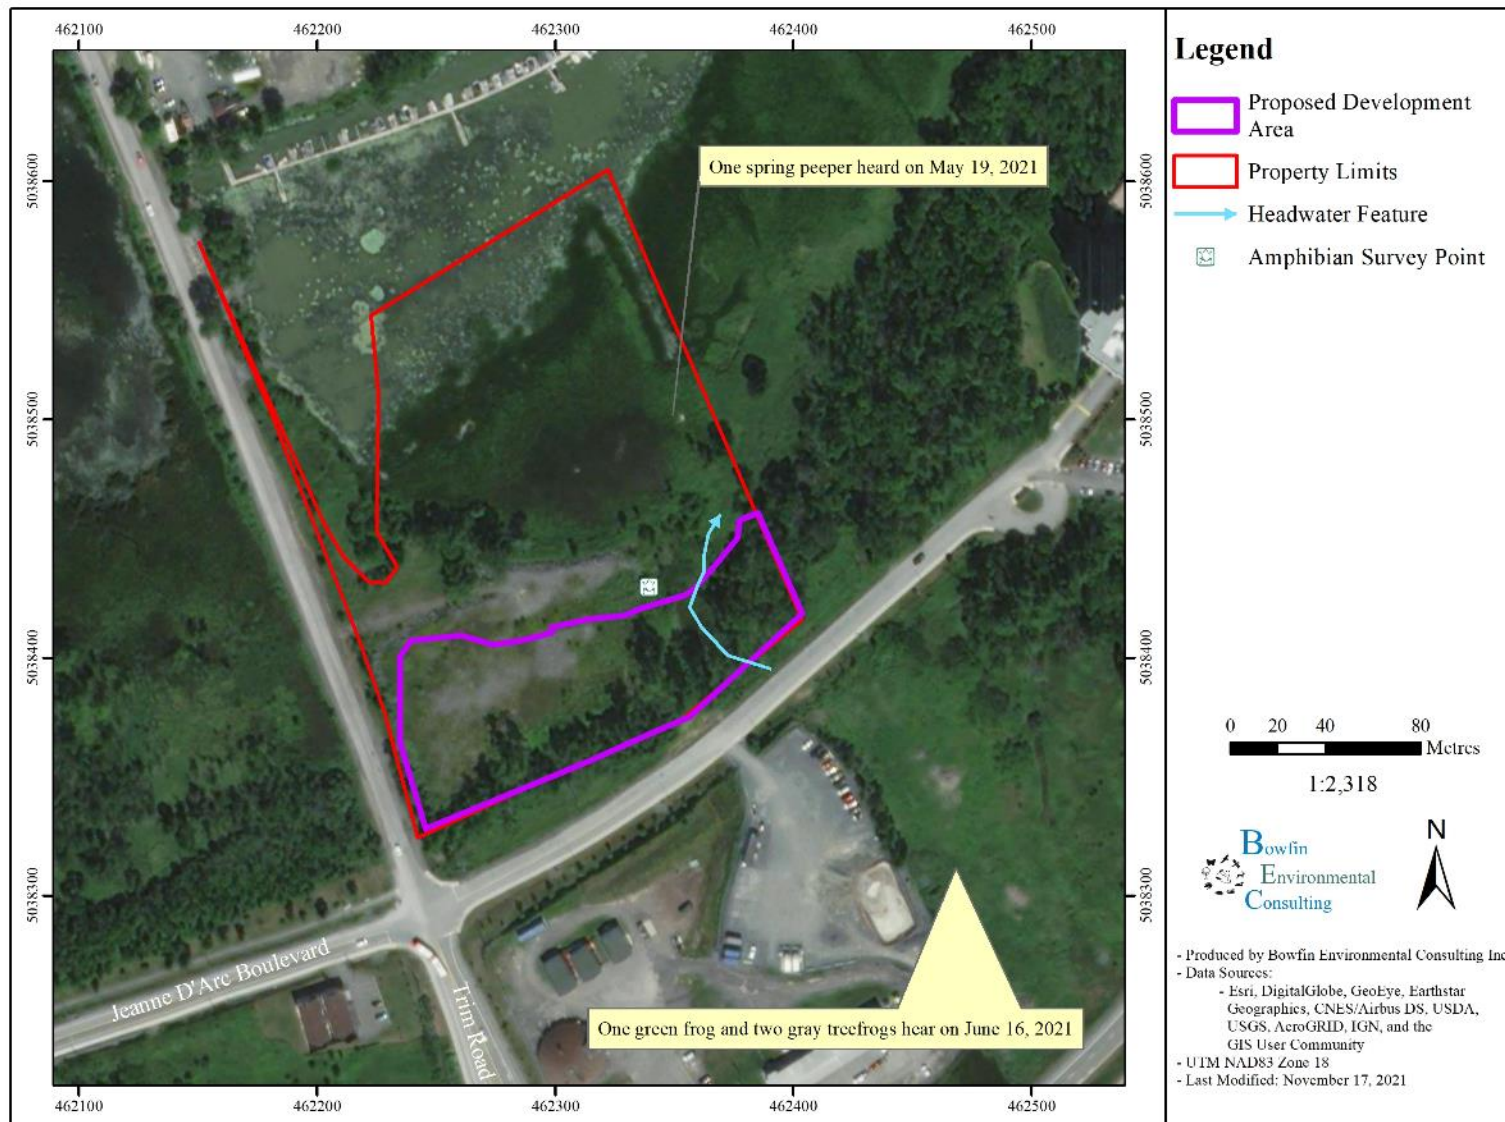
Figure 6: Amphibian Survey Results

The MMP amphibian monitoring protocol was followed with the extra step of identifying whether amphibians were calling from a specific feature or not. No amphibians were heard calling in the feature, and it does not serve as a connection (lands to the south are developed), resulting in a limited function classification. As a side note, one spring peeper was heard in the wetland near the Ottawa River on May 19, 2020. Two gray treefrogs and one green frog were heard across Inlet Private on June 16, 2020 (Appendix B).
