Phase One Environmental Site Assessment 1568 Meadowbrook Road, Ottawa, Ontario

Phase One Environmental Site Assessment

OTT-21019403-A0

2021-11-16

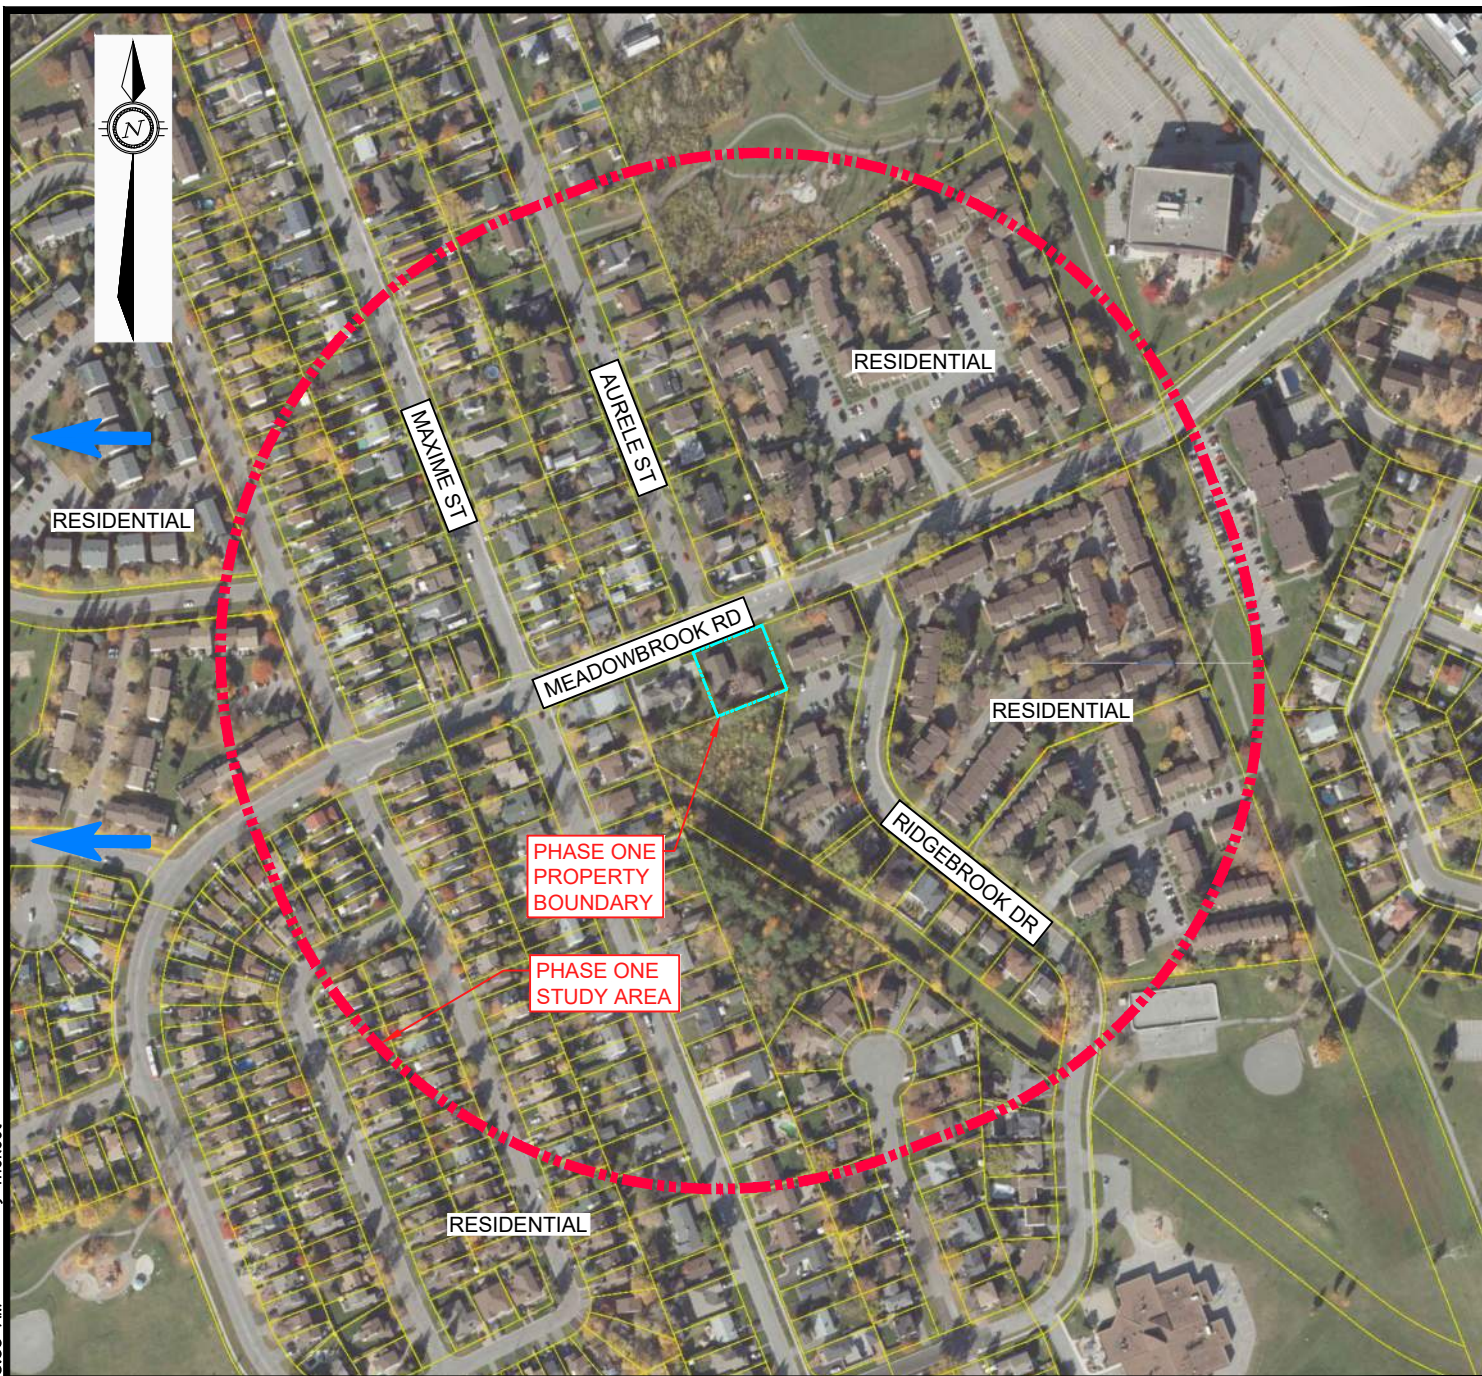
FIG 2

To develop a conceptual model for the Phase One property, the following physical characteristics and pathways were considered. A conceptual site model (CSM) showing the topography of the site, inferred groundwater flow, general site features, APEC, and PCA is shown in Figure 2.

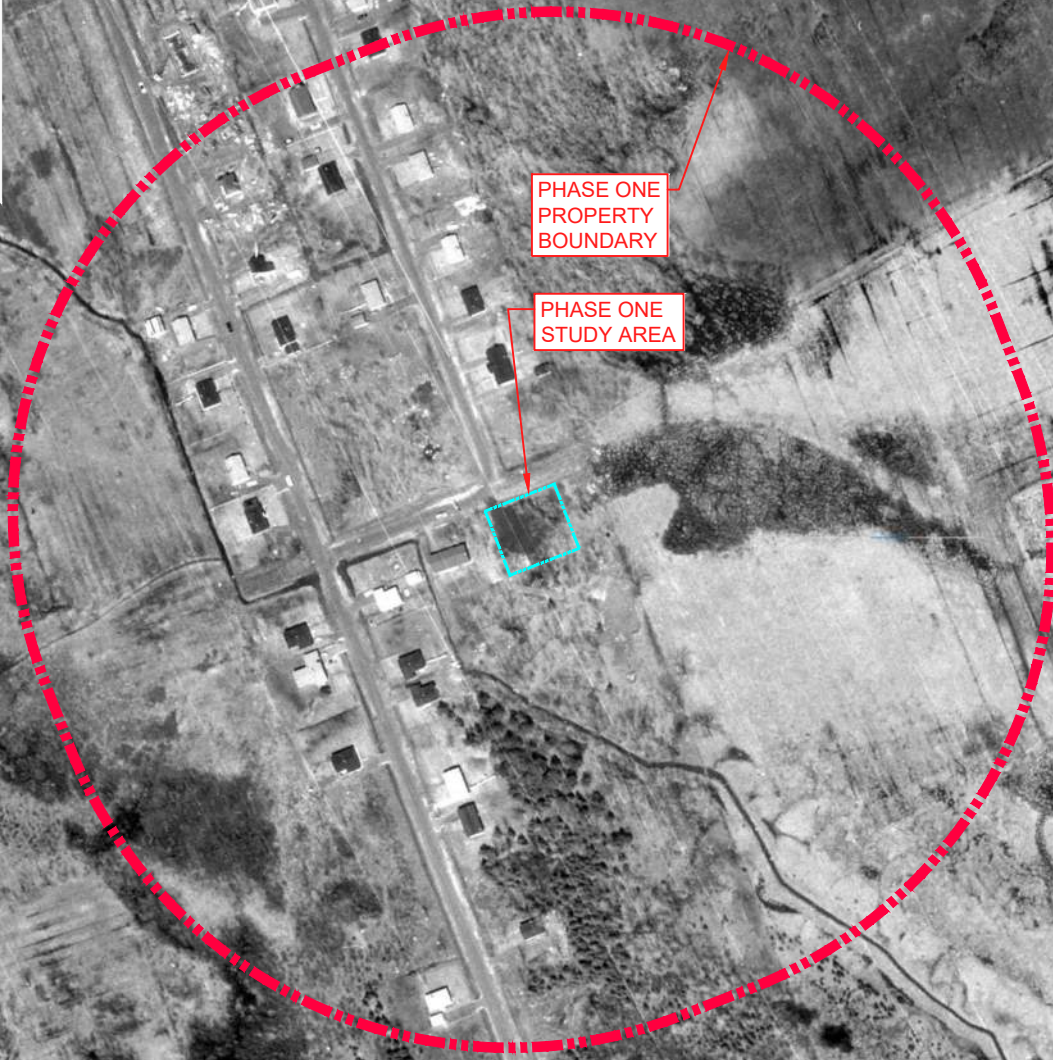
FIG F-1

1958 AERIAL PHOTOGRAPH
1568 MEADOWBROOK ROAD, OTTAWA, ONTARIO

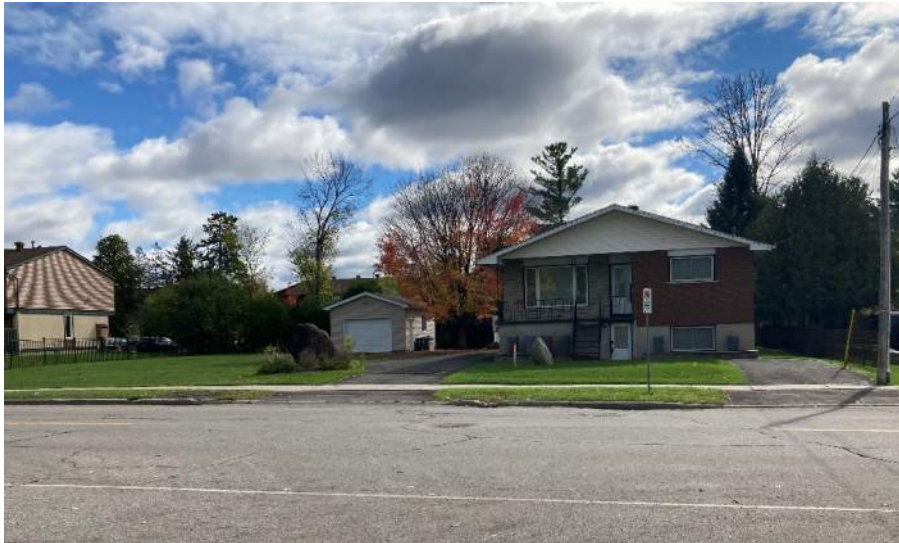
Photograph No. 1

View of the front of the property looking south.

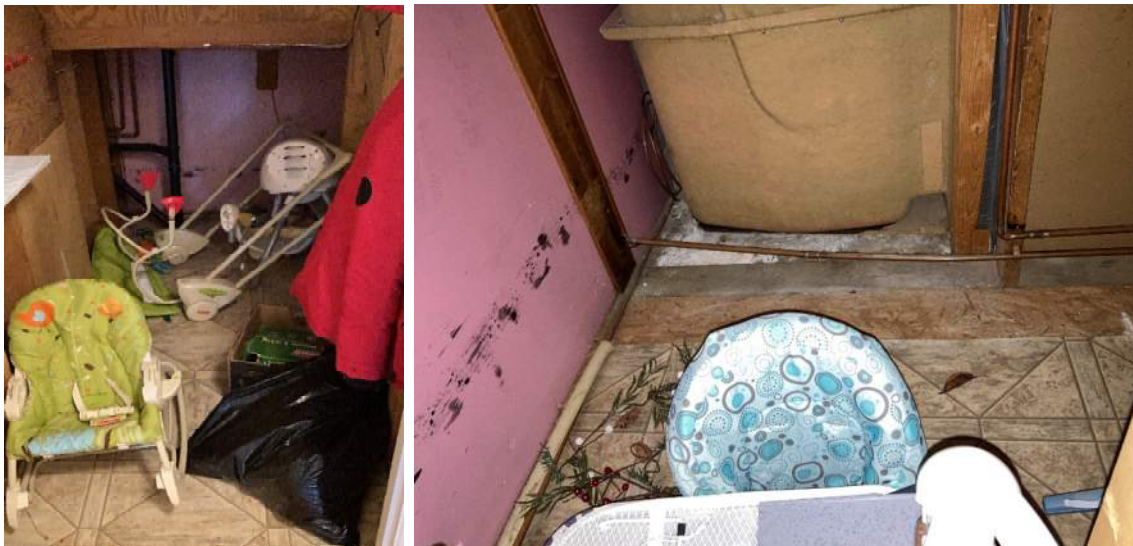
Photograph No. 2

Cut vent pipes were observed within the south side of the basement underneath the stairwell suggest that a furnace oil AST may have been formerly located there. At the time of the visit, the tank had been removed from the property and no visible sign of spills or contamination were present. As no visible signs of contamination were present in the basement, the potential former AST does not represent an APEC.

View of potential former location of furnace oil AST underneath the stairwell.

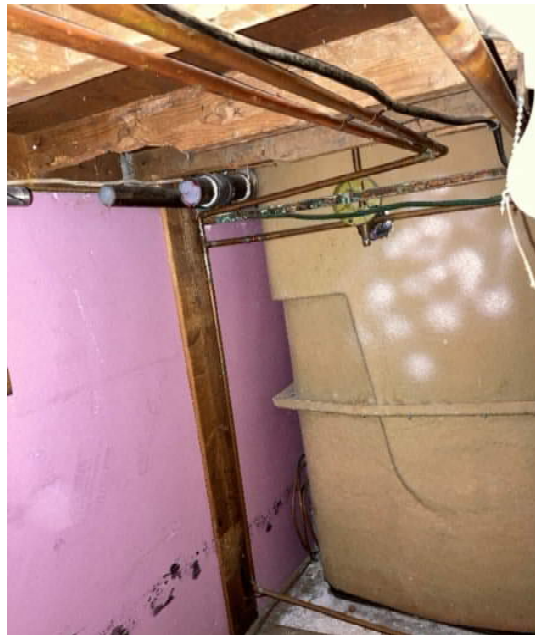
Photograph No. 3

View location of former vent/fill pipes. Vent/fill pipes have been cut and holes filled with silicone.

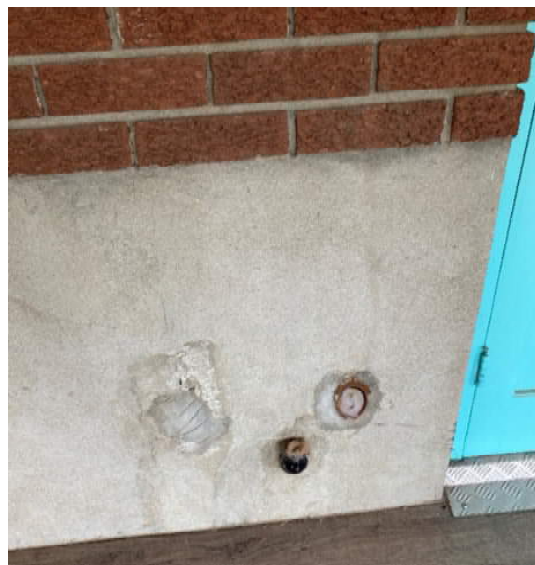
Photograph No. 4

View location of former vent/fill pipes. Vent/fill pipes holes have been filled. This area is within the solarium.
