## Phase Two Environmental Site Assessment 1568 Meadowbrook Road, Ottawa, Ontario

Phase Two Environmental Site Assessment

OTT-21019403-B0

*Nemorin Group Limited  
Phase Two Environmental Site Assessment  
1568 Meadowbrook Road, Ottawa, Ontario  
OTT-21019403-A0  
November 30, 2021*

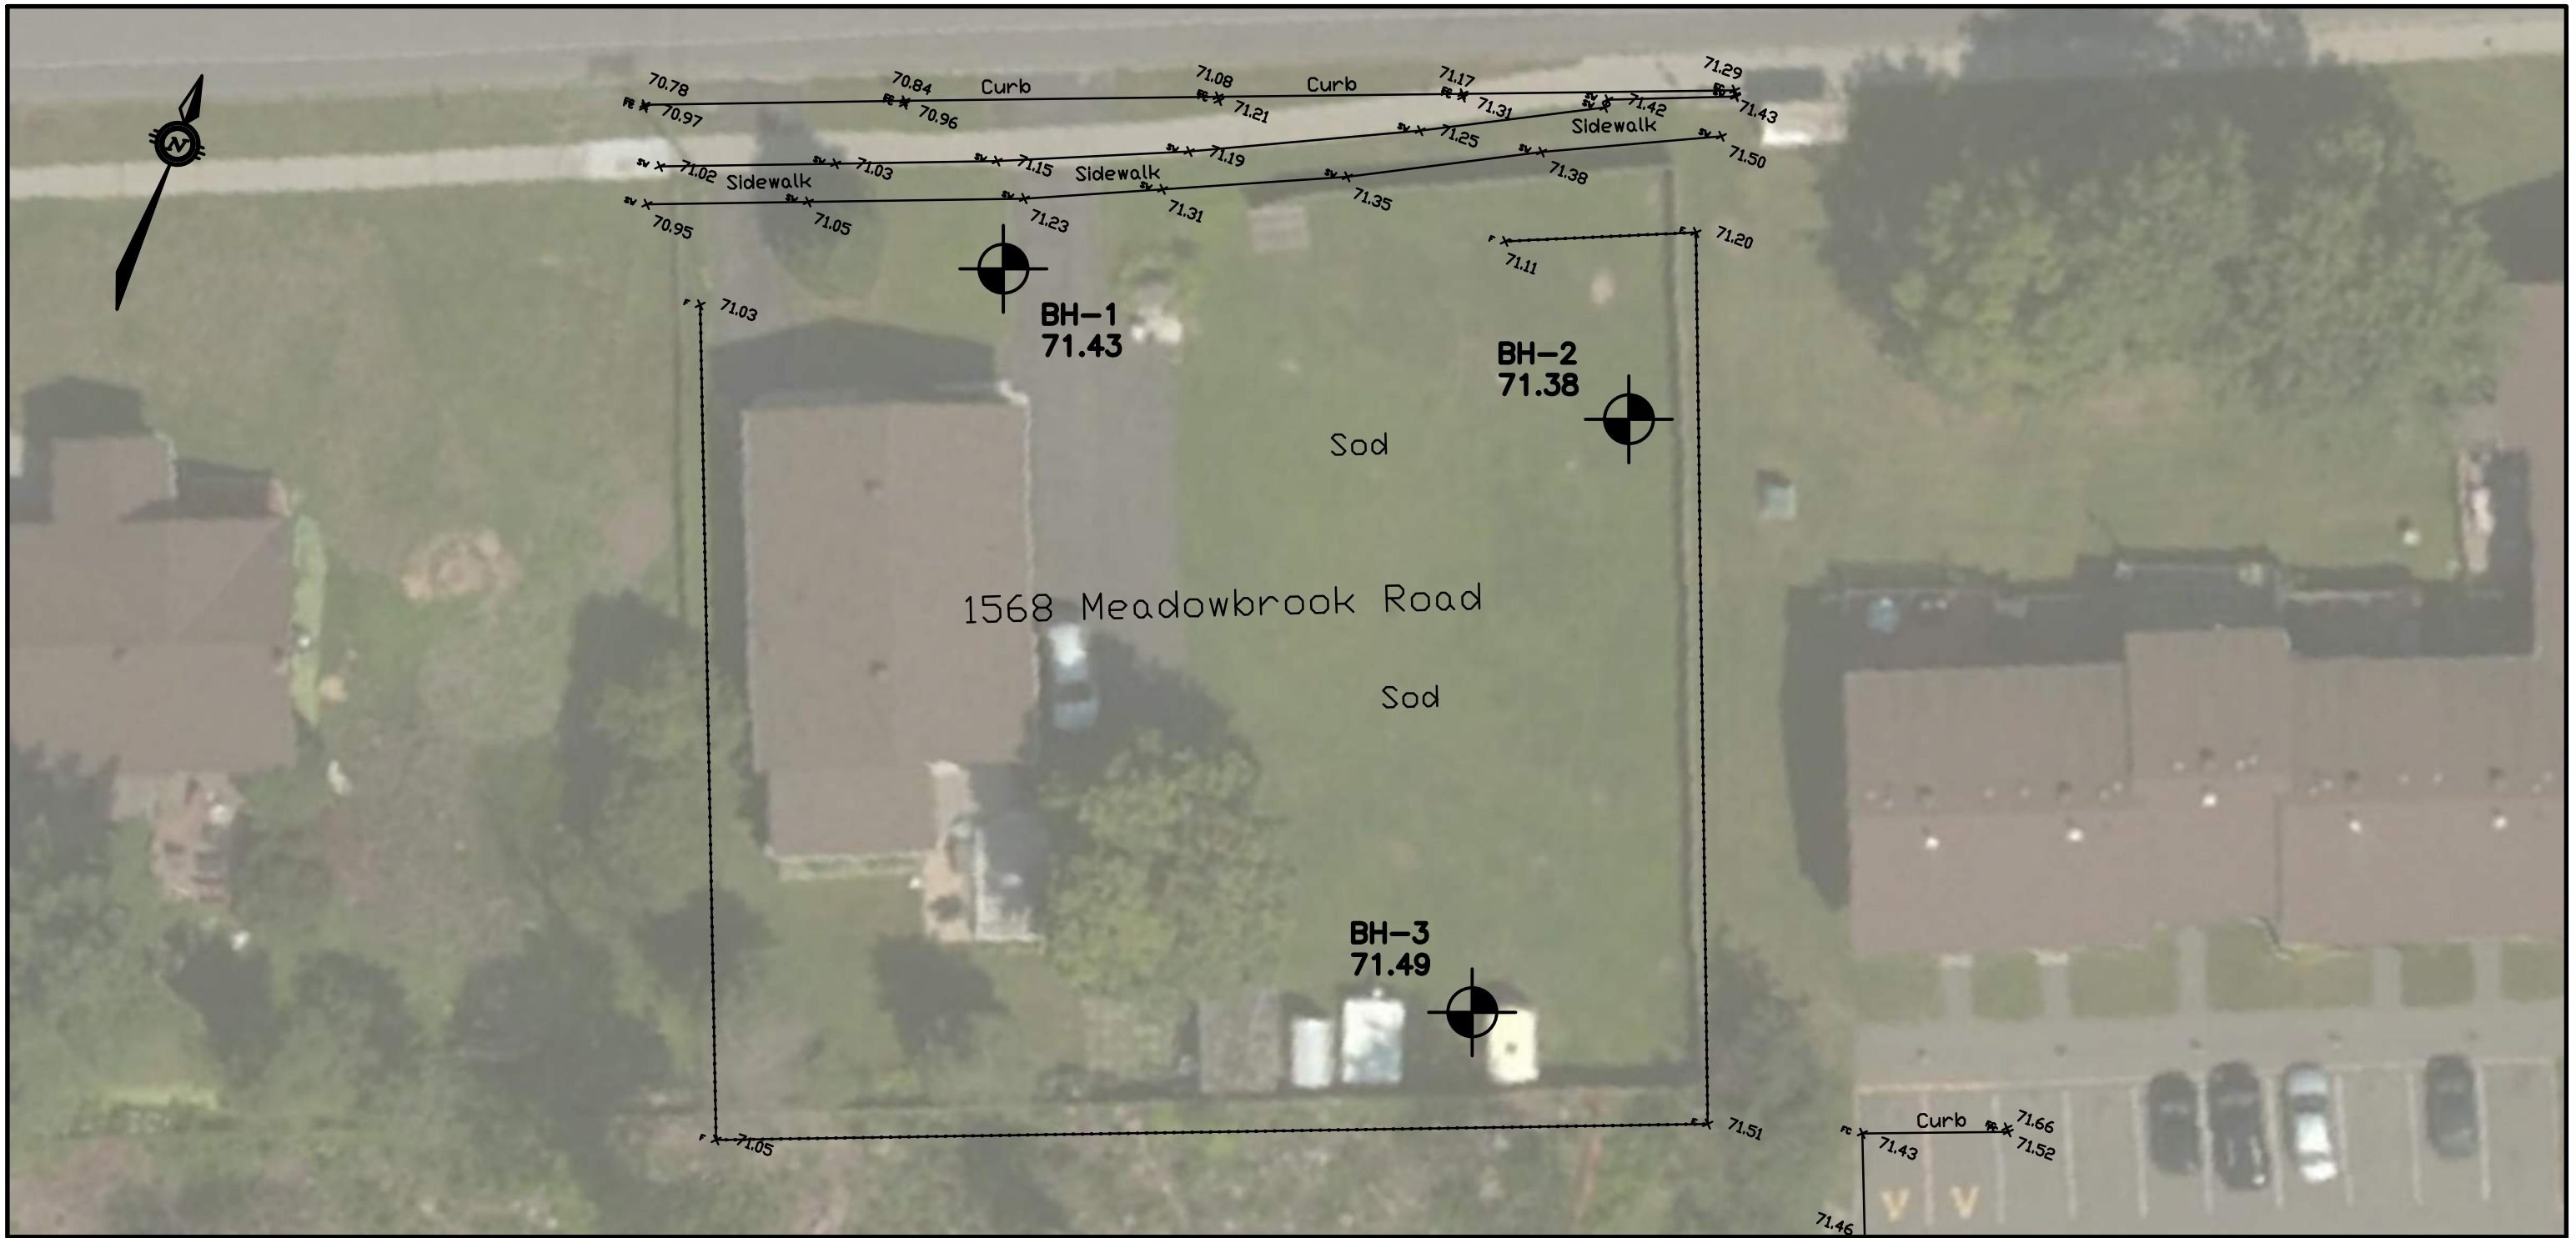
</div>	DESIGN IT	<div>GEOTECHNICAL INVESTIGATION PROPOSED RESIDENTIAL DEVELOPMENT 1568 MEADOWBROOK ROAD, OTTAWA, ON NEMOURIN GROUP LTD.</div> <div>BOREHOLE LOCATION PLAN</div>	<div>SCALE 1:250</div> <div>SKETCH NO</div> <div>FIG 2</div>
	DRAWN GC		
	DATE NOV. 2021		
	FILE NO OTT-21019403-A0

EXP staff continuously monitored the drilling activities to log the stratigraphy observed from the recovered samples, to record the depth of the samples, and to record total depths of borings. Field observations are documented on the borehole logs provided in Appendix D.

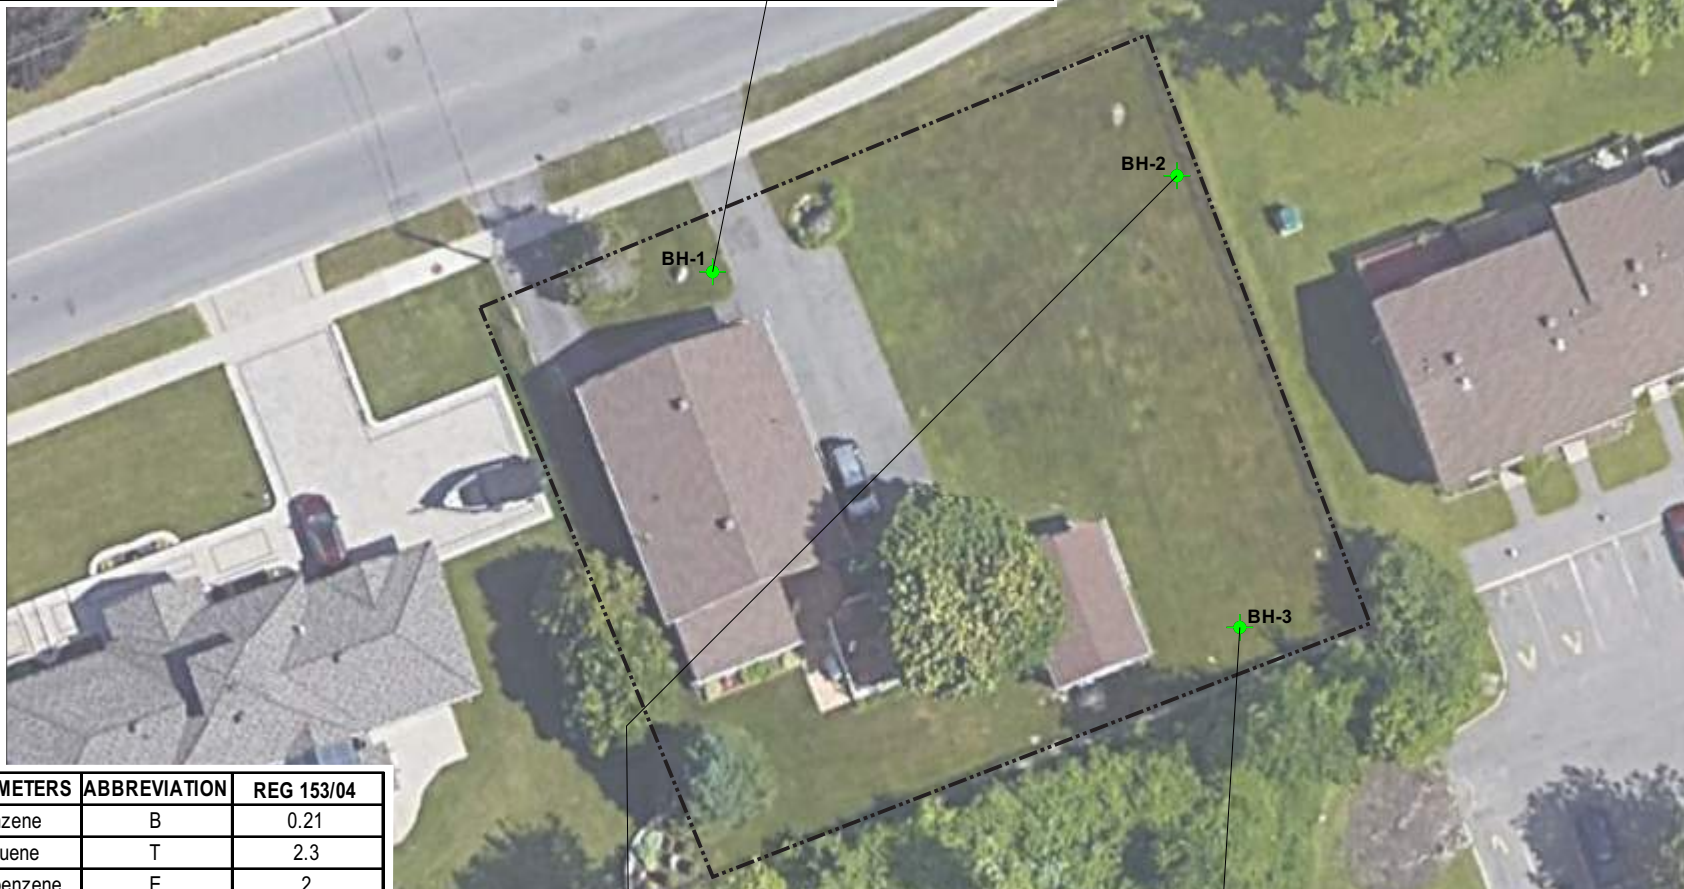
Sample ID	Date	Depth (m)	B	T	E	X	F1	F2	F3	F4
BH-1 SS2	27/10/2021	0.75 - 1.2	<0.020	<0.020	<0.020	<0.020	<10	<10	<50	<50
DUP1	27/10/2021	0.75 - 1.2	<0.020	<0.020	<0.020	<0.040	<10	<10	<50	<50

Sample ID	Date	Depth (m)	B	T	E	X	F1	F2	F3	F4
BH-3 SS1	27/10/2021	0.0 - 0.75	<0.020	<0.020	<0.020	<0.040	<10	<10	<50	<50

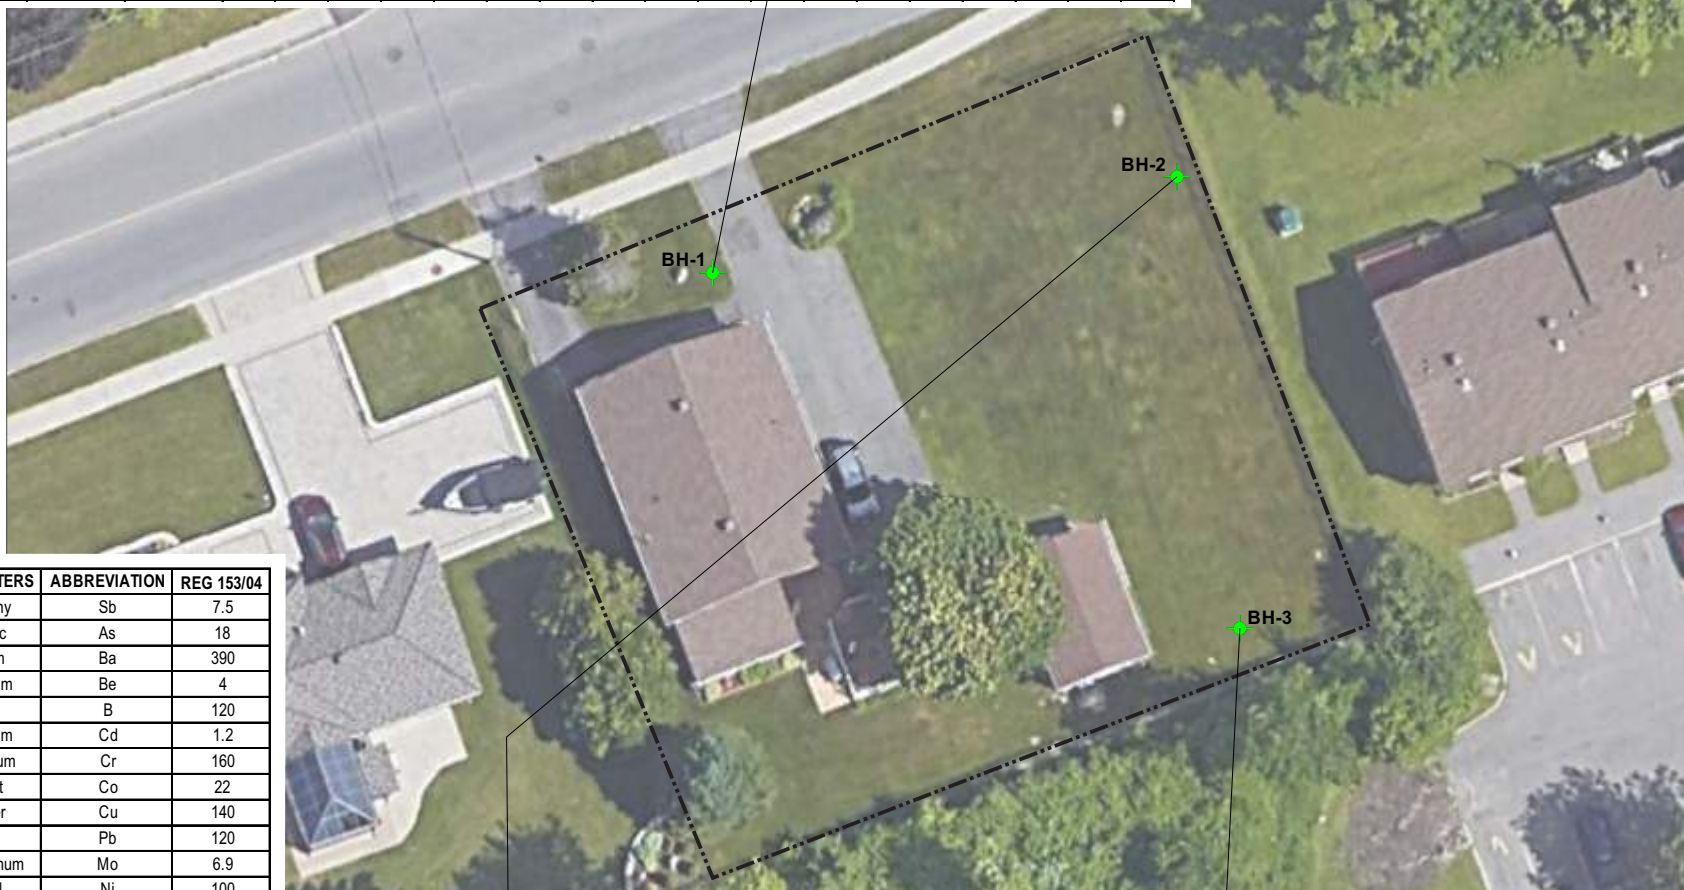
Sample ID	Date	Depth (m)	Sb	As	Ba	Be	B	Cd	Cr	Co	Cu	Pb	Mo	Ni	Se	Ag	Tl	U	V	Zn
BH-1 SS2	27/10/2021	0.75 - 1.2	<0.20	2.3	96	0.63	6.5	0.11	27	10	22	7.5	0.83	22	<0.50	<0.20	0.19	0.72	37	40
DUP1	27/10/2021	0.75 - 1.2	<0.20	2.7	100	0.64	6.4	<0.10	28	9.9	24	7.0	0.91	22	<0.50	<0.20	0.19	0.65	38	43

Sample ID	Date	Depth (m)	Sb	As	Ba	Be	B	Cd	Cr	Co	Cu	Pb	Mo	Ni	Se	Ag	Tl	U	V	Zn
BH-3 SS1	27/10/2021	0.0 - 0.75	<0.20	3.4	100	0.41	<5.0	0.12	26	6.1	14	38	0.80	16	<0.50	<0.20	0.11	0.92	28	50

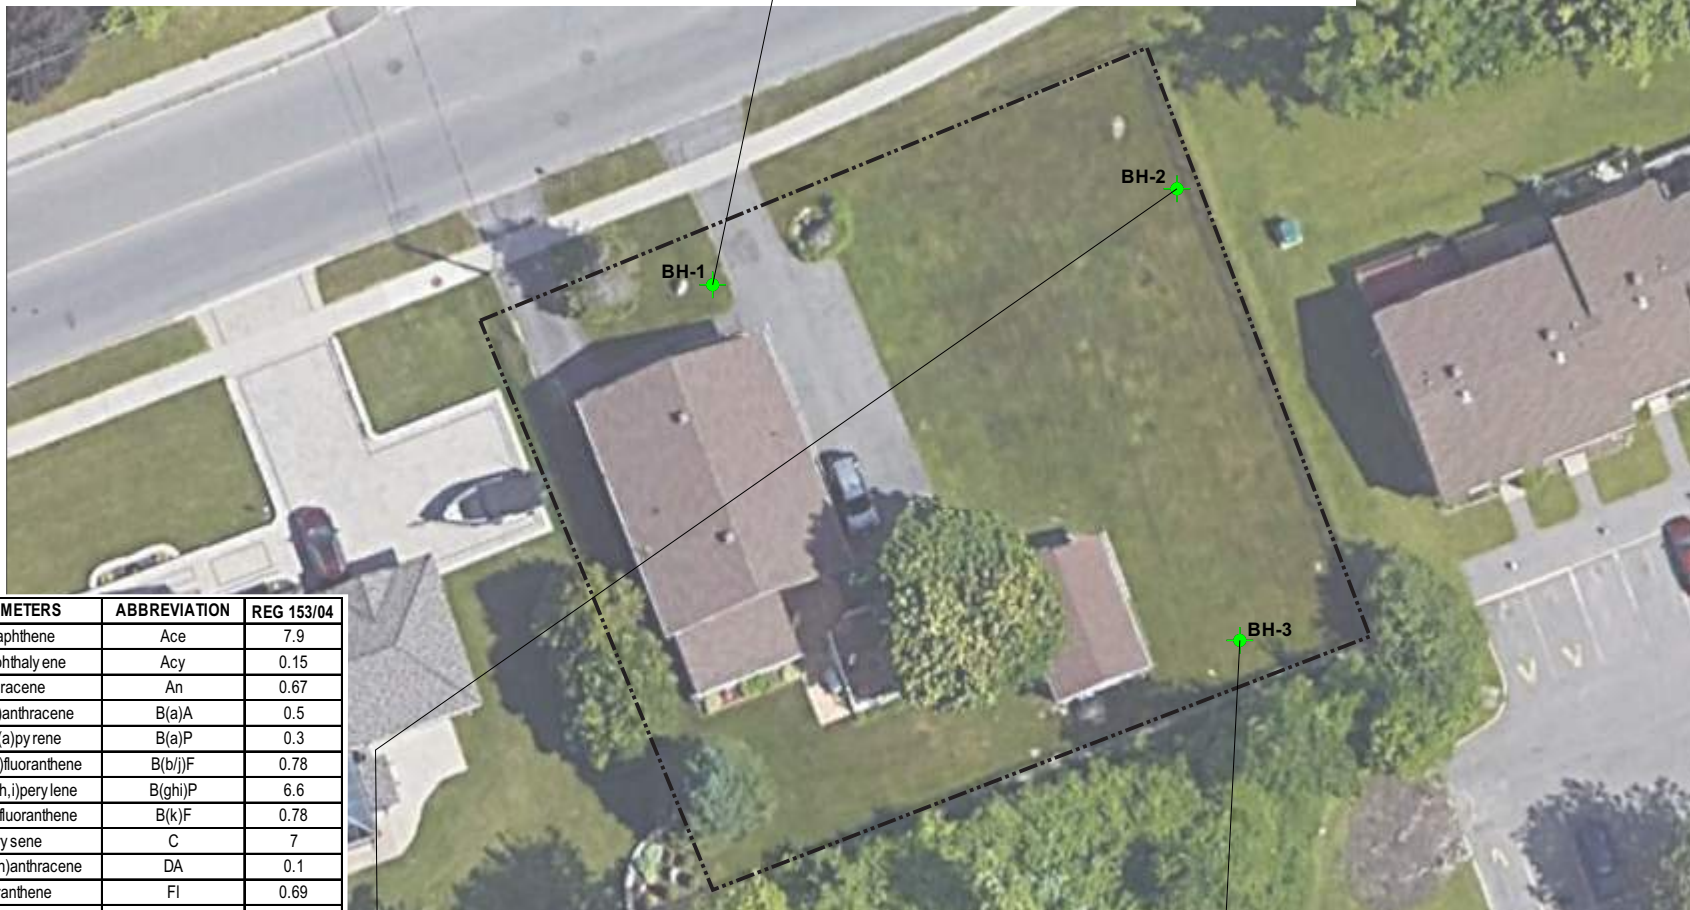
Sample ID	Date	Depth (m)	Ace	Acy	An	B(a)A	B(a)P	B(b)F	B(ghi)P	B(k)F	C	DA	Fl	F	I(123)P	T-MN	N	P	Py
BH-1 SS2	27/10/2021	0.75 - 1.2	<0.0050	<0.0050	<0.0050	<0.0050	<0.0050	<0.0050	<0.0050	<0.0050	<0.0050	<0.0050	<0.0050	<0.0050	<0.0050	<0.0071	<0.0050	<0.0050	<0.0050
DUP1	27/10/2021	0.75 - 1.2	<0.0050	<0.0050	<0.0050	<0.0050	<0.0050	<0.0050	<0.0050	<0.0050	<0.0050	<0.0050	<0.0050	<0.0050	<0.0050	<0.0071	<0.0050	<0.0050	<0.0050

Sample ID	Date	Depth (m)	Ace	Acy	An	B(a)A	B(a)P	B(b)F	B(ghi)P	B(k)F	C	DA	Fl	F	I(123)P	T-MN	N	P	Py
BH-3 SS1	27/10/2021	0.0 - 0.75	<0.0050	<0.0050	0.0058	0.016	0.016	0.026	0.012	0.0084	0.017	<0.0050	0.037	<0.0050	0.013	0.013	<0.0050	0.027	0.033

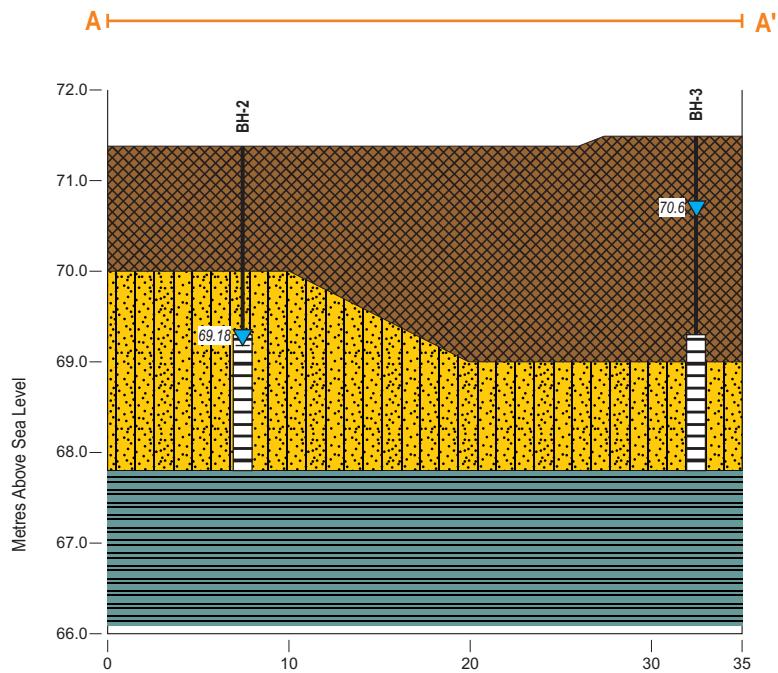
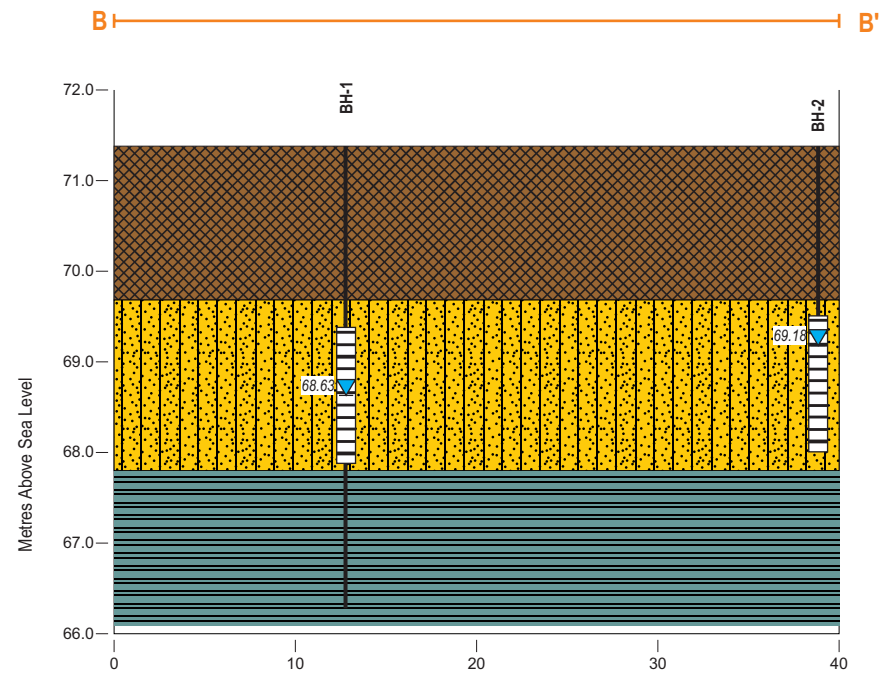
**SCALE:**  
5 X VERTICAL EXAGGERATION

**SOURCE:**  
BASED ON FIELD  
MEASUREMENTS BY EXP STAFF

The terrain at the Phase Two property consisted of silty sand and gravel fill to a maximum depth of 1.8 m. The upper 0.7 m of fill at MW21-3 had some small pieces of brick and asphalt. Underlying the fill was brown to grey clay to a maximum depth of 11.3 m and then clayey sand with gravel was observed to the maximum depth drilled of 15.8 m. Bedrock was not encountered during drilling, however cone refusal was at 22.7 m indicating bedrock may be at that depth.

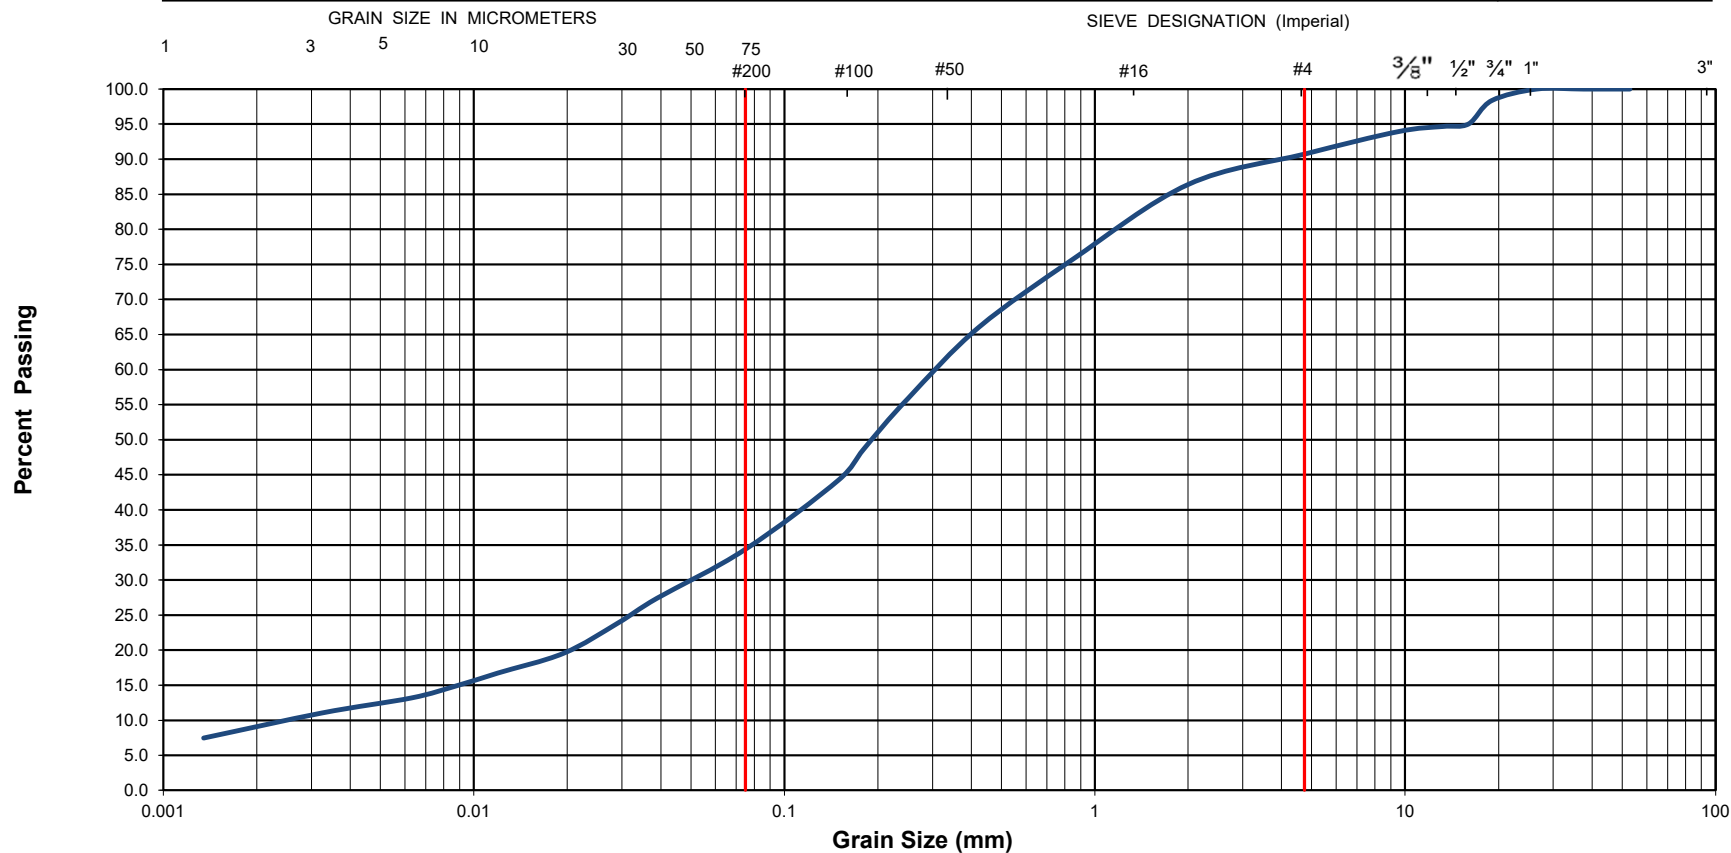
EXP Project No.:	OTT-21019403-A0	Project Name :	Geotechnical Investigation - 1568 Meadowbrook Road, Ottawa, Ontario			
Client :	Nemorin Group Limited	Project Location :	1568 Meadowbrook Road, Ottawa, ON			
Date Sampled :	October 27, 2021	Borehole No:	BH1	Sample No.:	SS3	Depth (m) : 1.5-2.1
Sample Description :	% Silt and Clay	34	% Sand	57	% Gravel	9
Sample Description :	Silty Sand (SM)					Figure : xxxx

The grain size analyses showed that the native material was fine and coarse grained. The results of the grain size analyses are found in Appendix H.

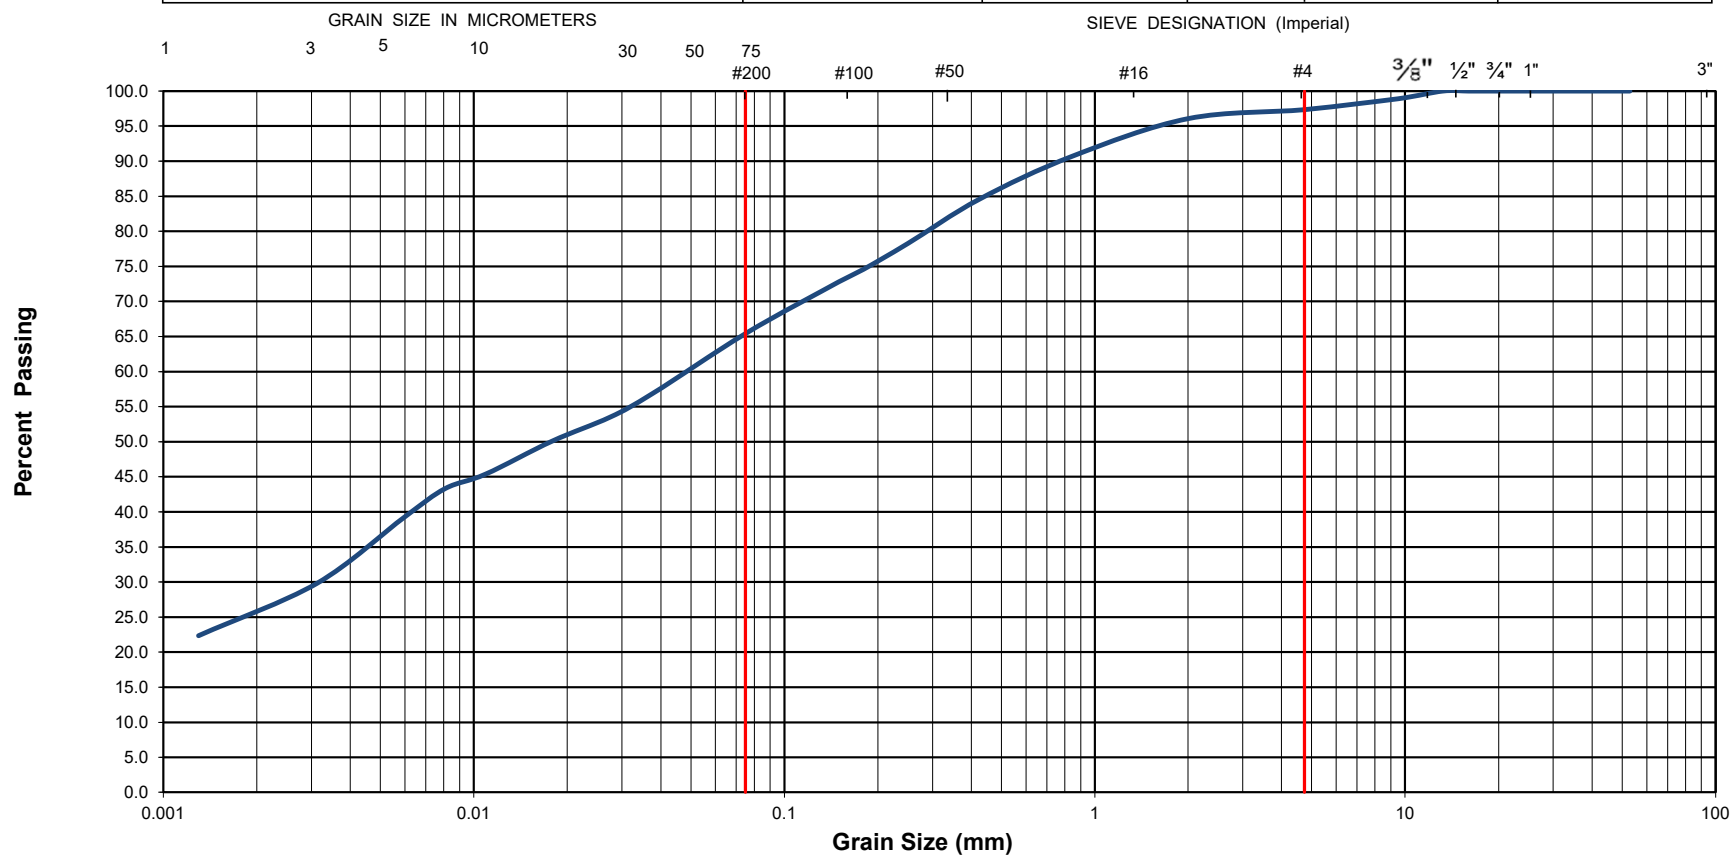
EXP Project No.:	OTT-21019403-A0	Project Name :	Geotechnical Investigation - 1568 Meadowbrook Road, Ottawa, Ontario			
Client :	Nemorin Group Limited	Project Location :	1568 Meadowbrook Road, Ottawa, ON			
Date Sampled :	October 27, 2021	Borehole No:	BH2	Sample No.:	SS2	Depth (m) : 0.8-1.4
Sample Description :	% Silt and Clay	65	% Sand	32	% Gravel	3
Sample Description :	Sandy Lean Clay (CL)					Figure : xxxx

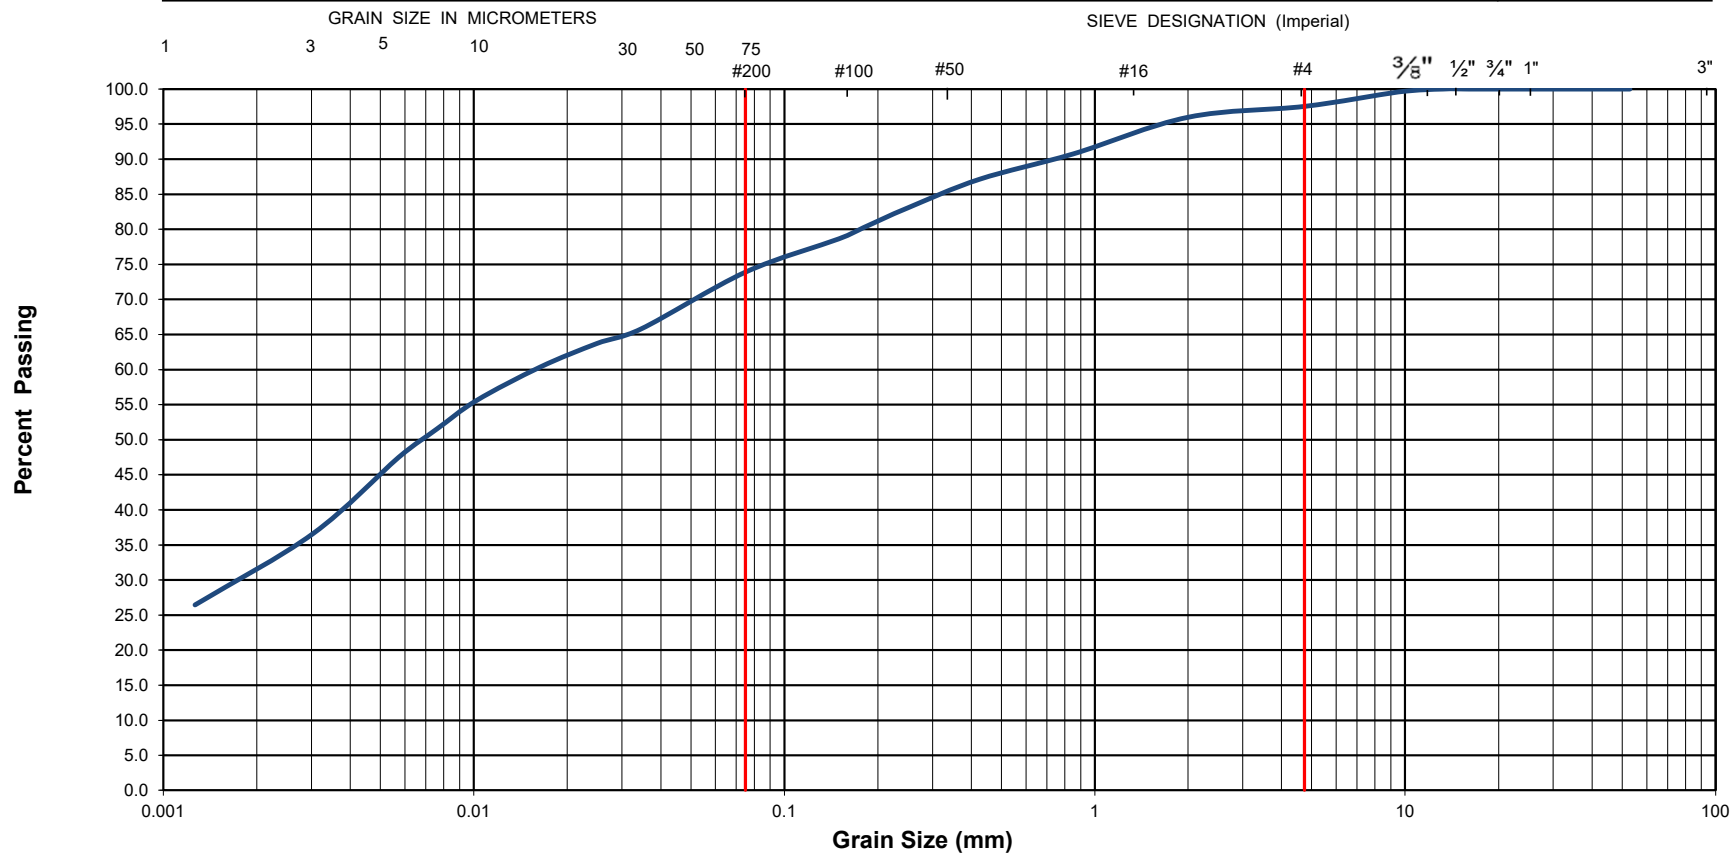
EXP Project No.:	OTT-21019403-A0	Project Name :	Geotechnical Investigation - 1568 Meadowbrook Road, Ottawa, Ontario			
Client :	Nemorin Group Limited	Project Location :	1568 Meadowbrook Road, Ottawa, ON			
Date Sampled :	October 27, 2021	Borehole No:	BH3	Sample No.:	SS4	Depth (m) : 2.3-2.9
Sample Description :	% Silt and Clay	74	% Sand	23	% Gravel	3
Sample Description :	Lean Clay with Sand (CL)					Figure : xxxx

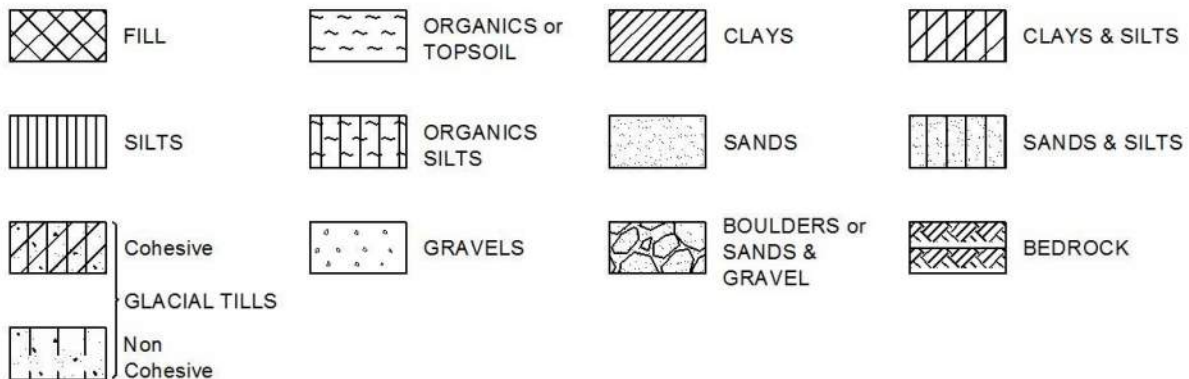
## STRATA PLOT

Strata plots symbolize the soil or bedrock description. They are combinations of the following basic symbols:

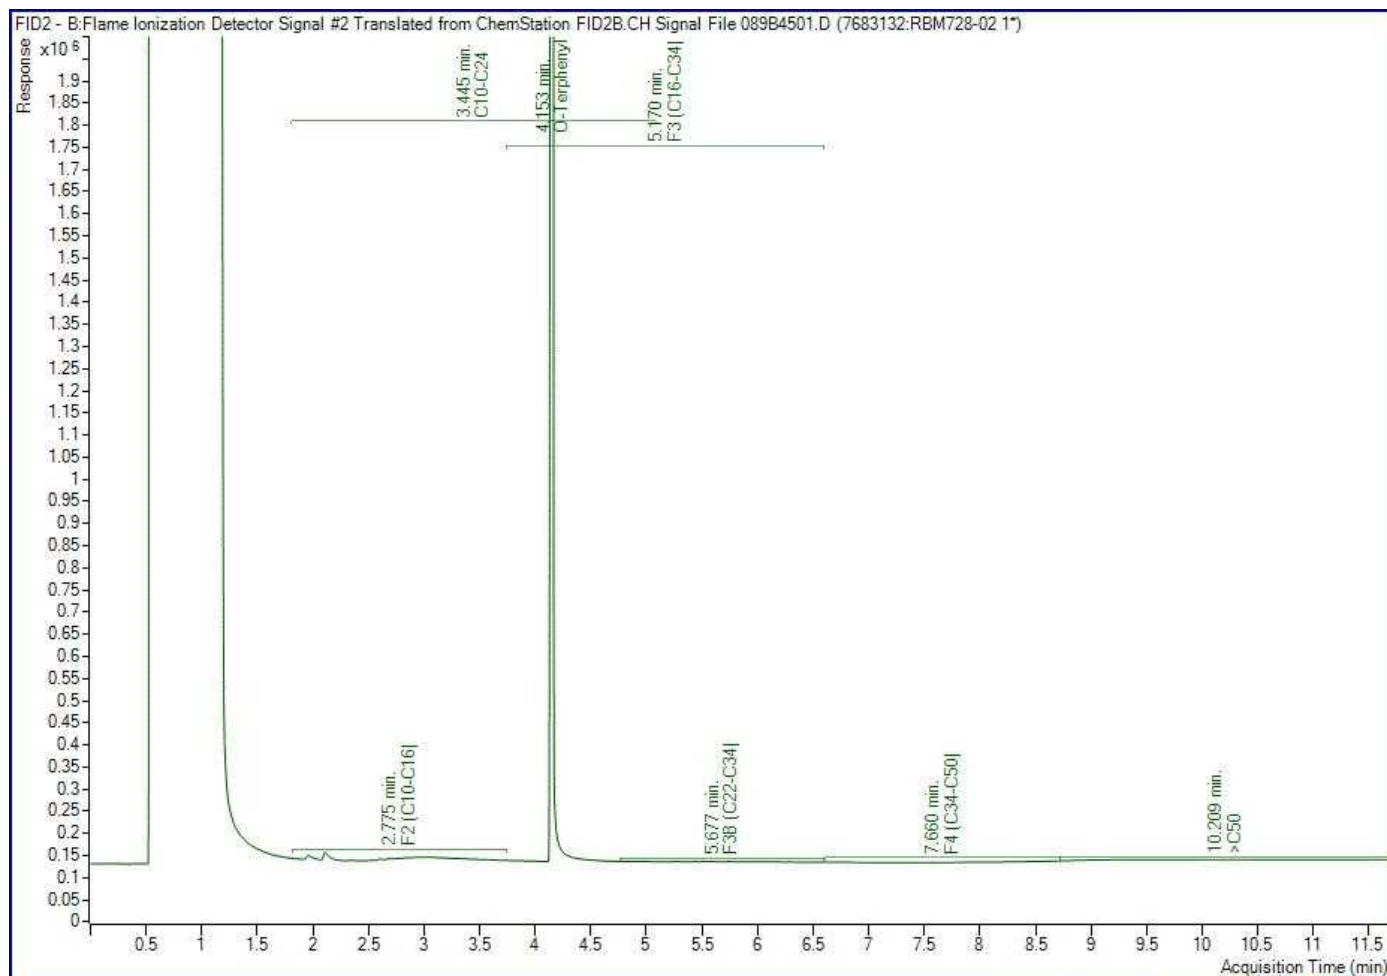
Petroleum Hydrocarbons F2-F4 in Soil Chromatogram

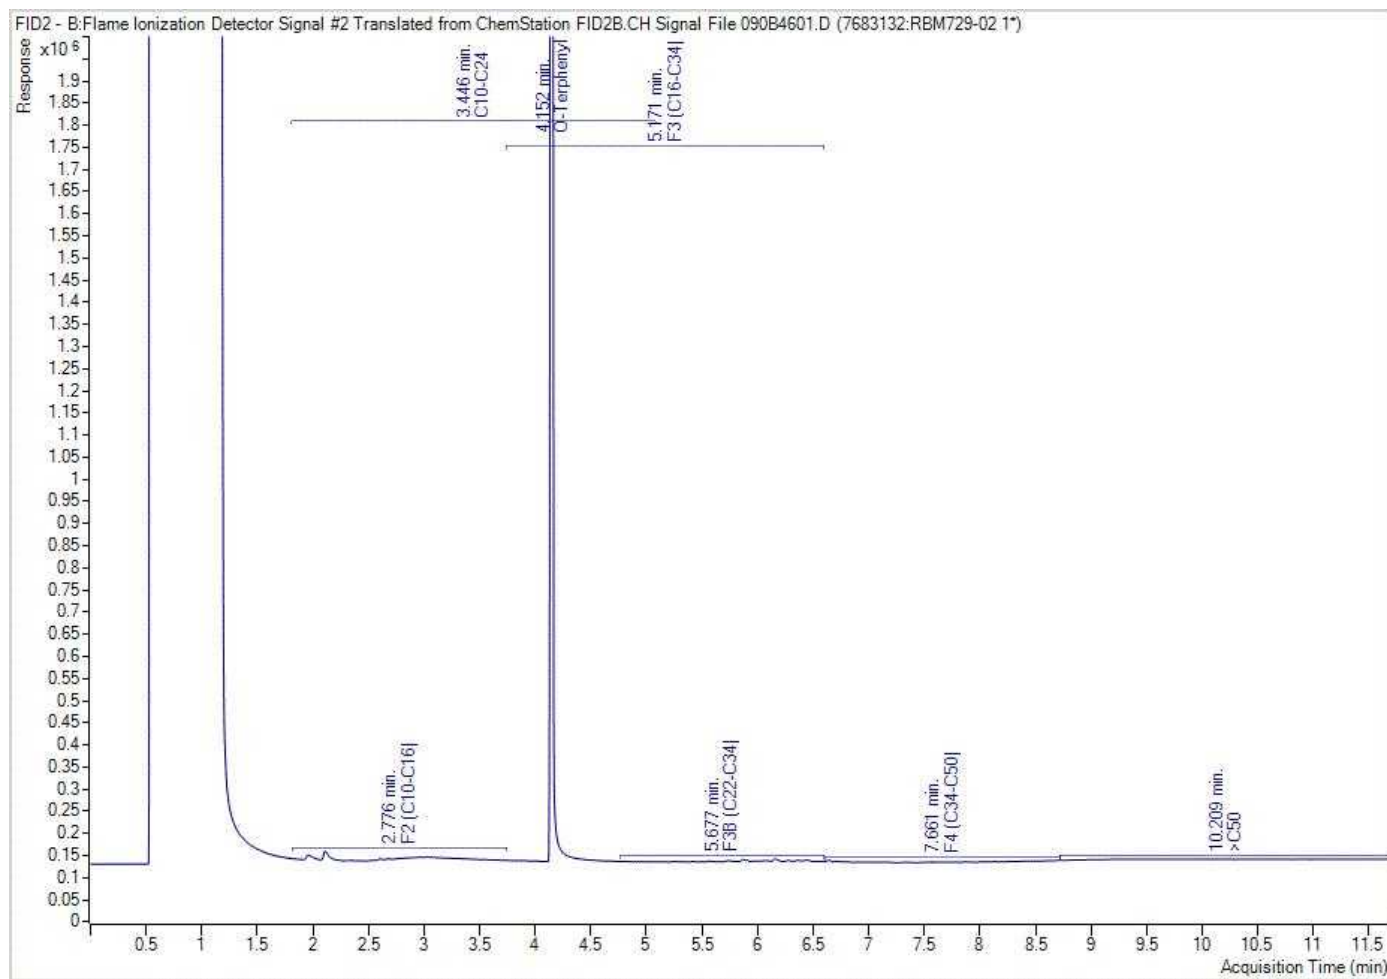
Petroleum Hydrocarbons F2-F4 in Soil Chromatogram

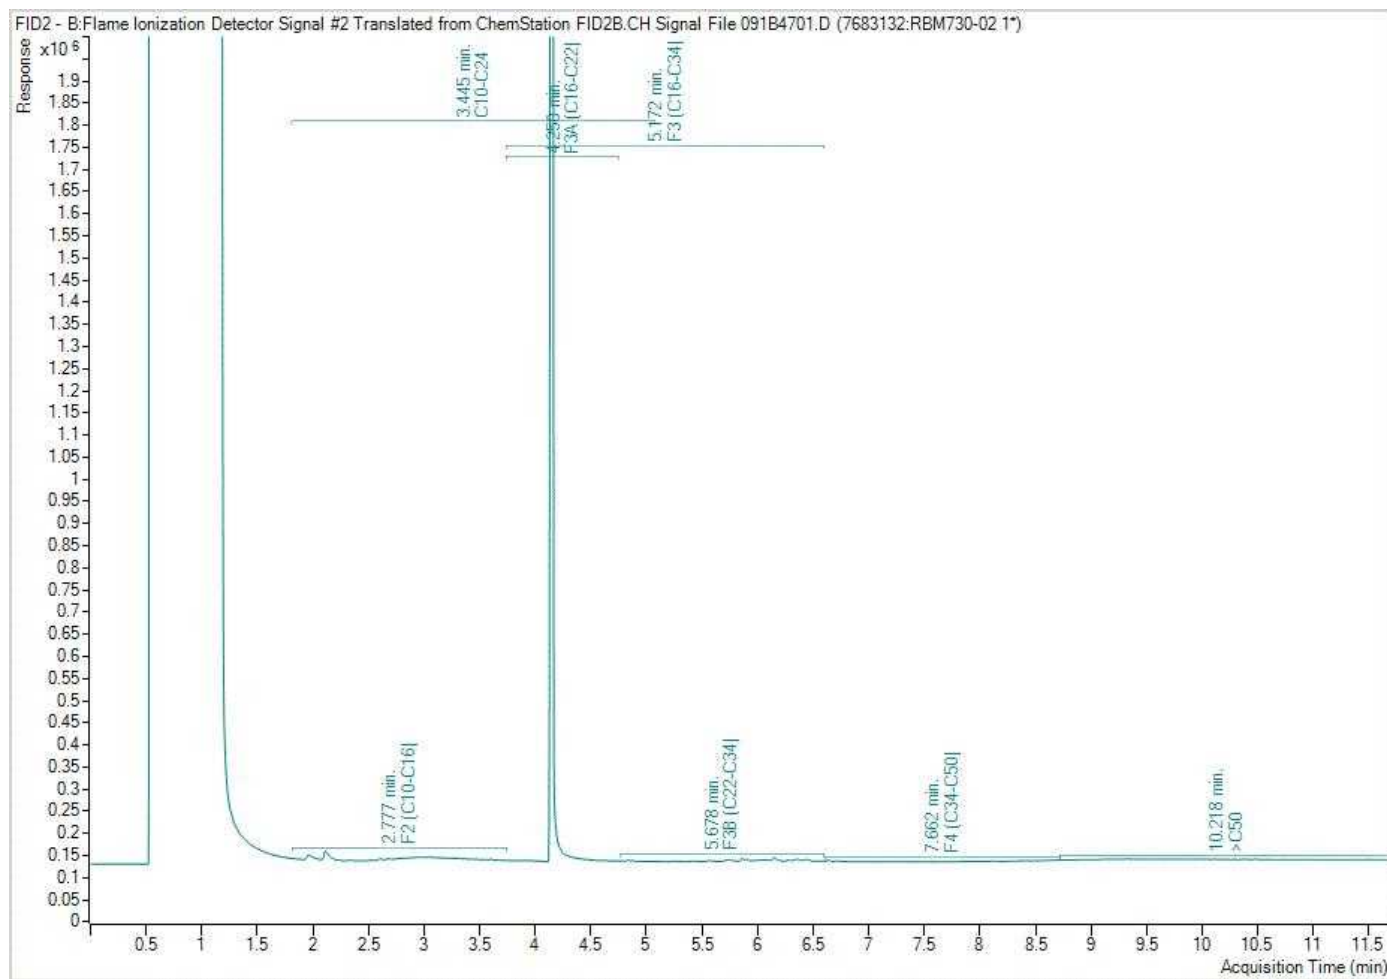
Petroleum Hydrocarbons F2-F4 in Soil Chromatogram

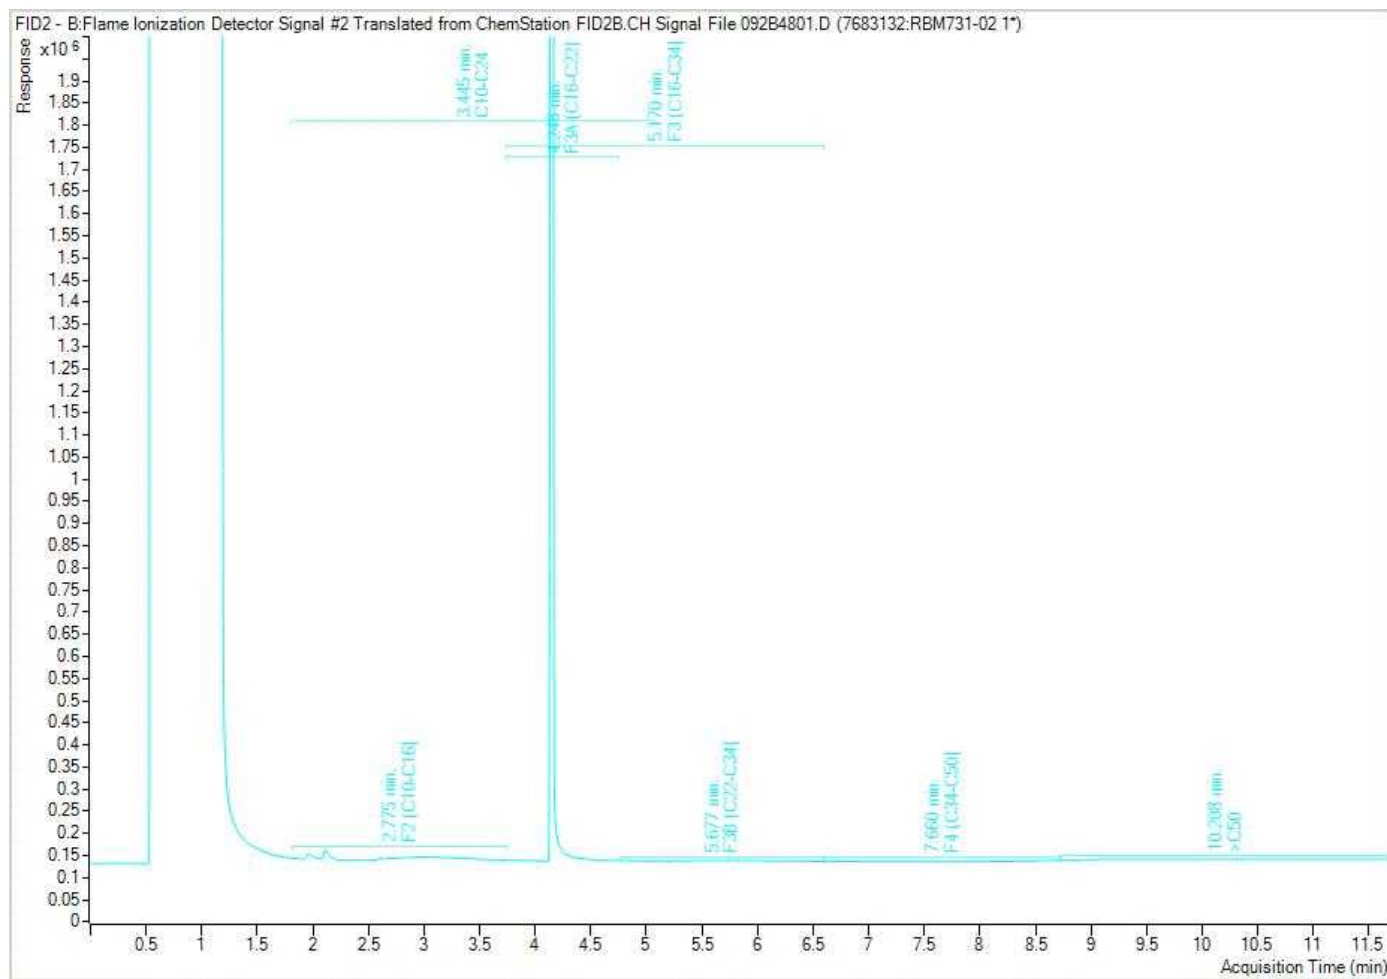
Petroleum Hydrocarbons F2-F4 in Soil Chromatogram
