ENVIRONMENTAL IMPACT STATEMENT

2050 Dunrobin Road, Kanata, Ontario
MP Project No.: CCO-21-1873

ENVIRONMENTAL IMPACT STATEMENT
2050 DUNROBIN ROAD, KANATA, ONTARIO

Version 002
November 5, 2021

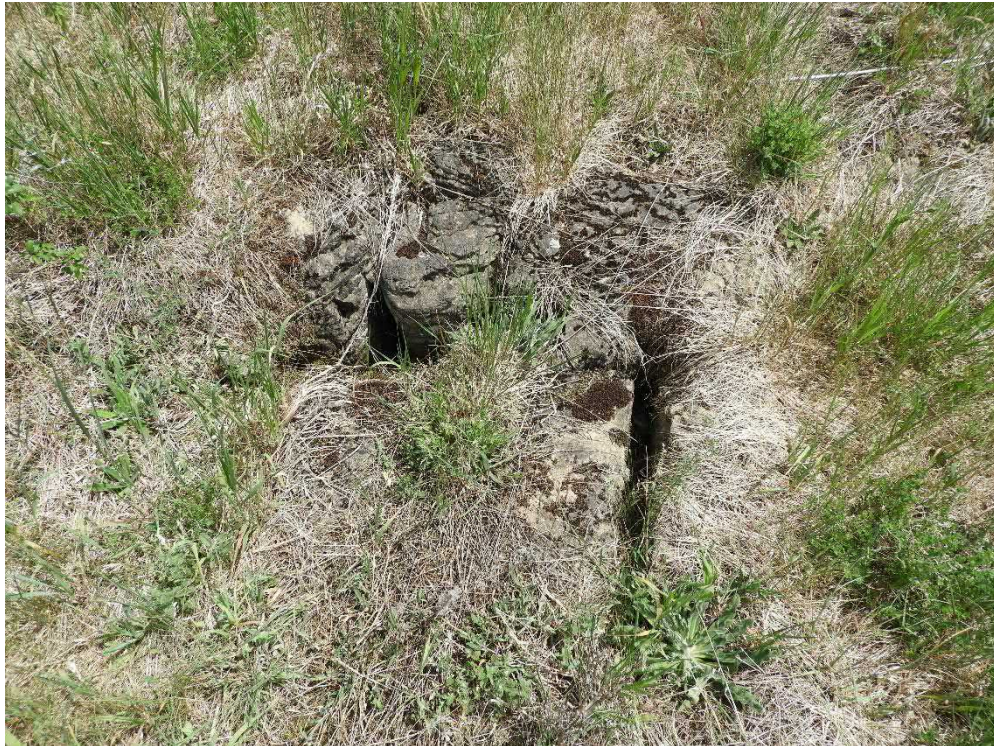
Photo 3: Potential SAR snake hibernacula habitat identified within the Dry – Fresh Non-Calcareous Bedrock Graminoid Meadow Ecosite (MEGR2) in the west end of the study area during the preliminary EIS. During the 2021 field investigations, it was determined that this area does not provide SAR snake habitat. 28 May 2021.

During the preliminary field investigation on October 30, 2020, potential SAR snake habitat was identified in the west end of the study area. This area consists of the open Dry – Fresh Non-Calcareous Bedrock Graminoid Meadow Ecosite (MEGR2) containing exposed bedrock and crevices into the ground which may provide potential habitat for Eastern Milksnakes, including areas for foraging and hibernacula. This species is a habitat generalist and may be found in a variety of habitats. The Eastern Milksnake is designated as ‘Special Concern’ under SARA and does not receive habitat protection. However, individuals of this species are protected under the FWCA (1997). Targeted surveys for SAR snakes were conducted following parameters outlined in the Ministry of Natural Resources and Forestry’s (MNRF) the Survey Protocol for Ontario’s Species at Risk Snakes (MNRF, 2016a). The surveys were conducted within potential snake habitat identified in the west portion of the study area during the preliminary field investigation. No SAR snakes or evidence of SAR snakes were observed during the 2021 targeted surveys. It was determined that the study area is not suitable for SAR snakes.

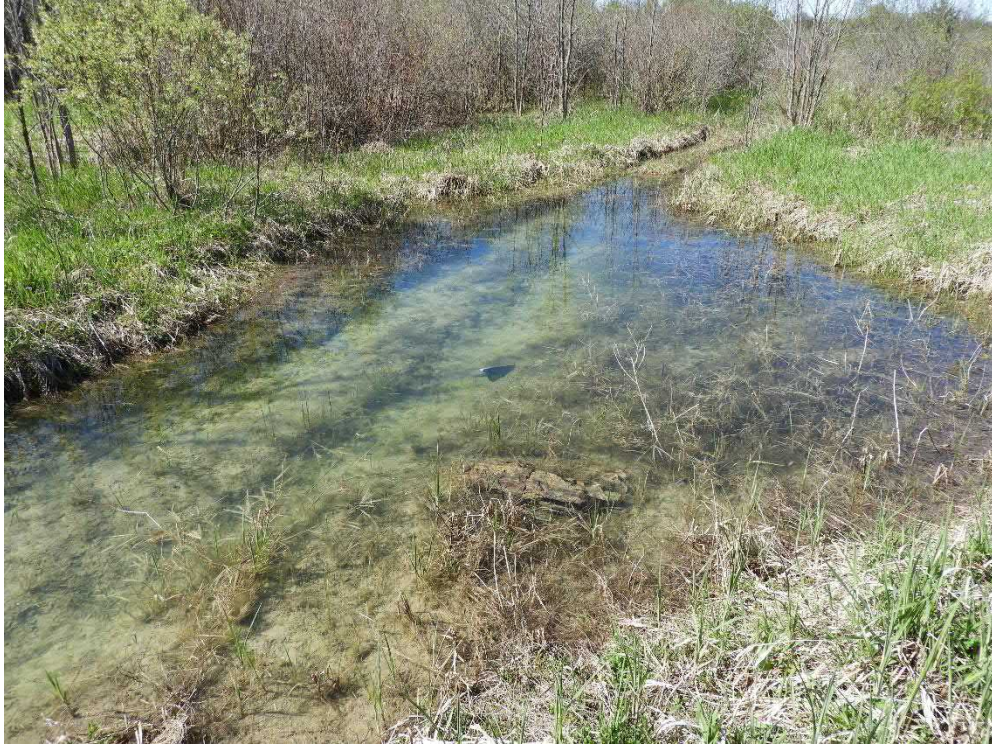
Photo 9: A flooded trail in the east end of the study area during early spring conditions. This area is part of the identified floodplain under MVCA regulation limits. 12 May 2021.

During the 2020 field investigation, standing water was observed in a depression area along the recreational vehicle trails within the east end of the property. The standing water is part of the Harwood Creek floodplain, according to the MVCA Regulation Public Mapping Browser (MVCA, 2021). The floodplain area outlined by MVCA was confirmed during the May 12, 2021 field investigation where seasonally inundated areas were observed across the northeastern portion of the study area. These areas are not considered fish-bearing. Based on the Stormwater Management Report (Kollaard Associates, 2021), the floodplain within the study area is considered a backwater area that does not contribute to the storage capacity of Harwood Creek.

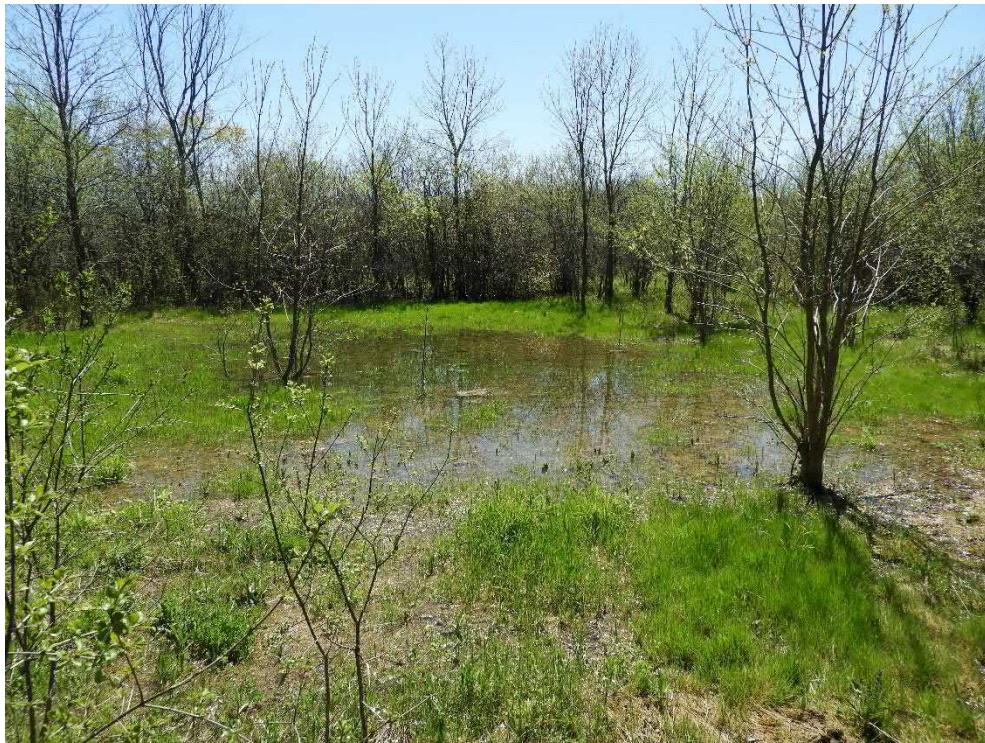
Photo 10: A flooded area in the west end of the study area during early spring conditions. This area is the western extent of the identified floodplain within the study area under MVCA regulation limits. 12 May 2021.

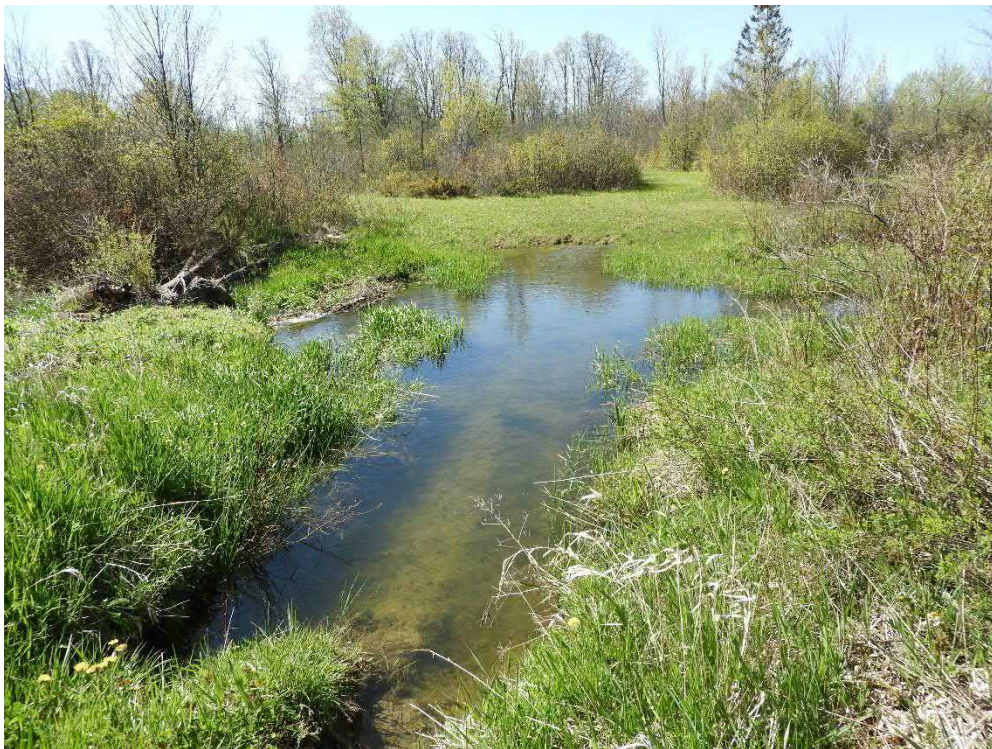
Photo 12: Harwood Creek flowing through the eastern extent of the study area. An off-road vehicle crossing is present within the watercourse located within the study area, creating a pool. 12 May 2021.

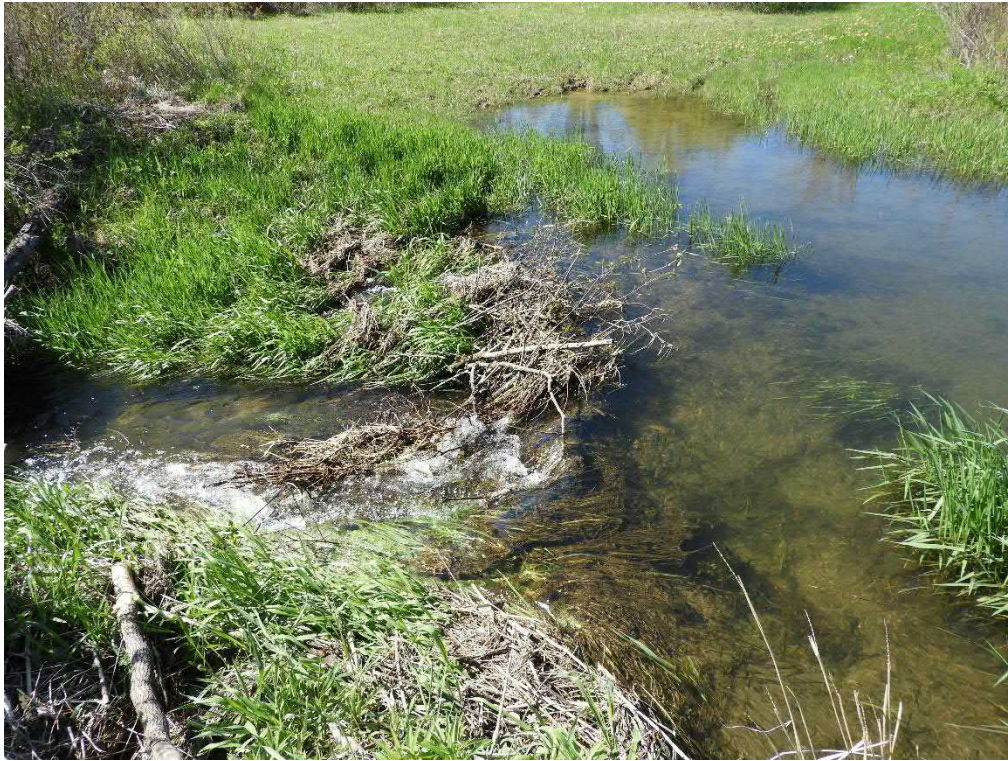
Photo 13: A beaver dam/debris within Harwood Creek directly downstream of one of the off-road vehicle crossings (right), which creates a potentially permanent barrier to fish migration. 12 May 2021.

An electrofishing survey was conducted to determine fish species present within the study area. White Sucker adults (Photo 18) and young-of-year (YOY) were caught and/or observed within Harwood Creek in the study area during the June 6, 2021 field investigation. This species and its habitat are afforded protection under the Fisheries Act (1985). Specialized baitfish spawning habitat (including White Sucker) is present within the study area within the riffles and runs with gravel substrate; however, the beaver dam/debris is a potential barrier to fish migration within the watercourse.

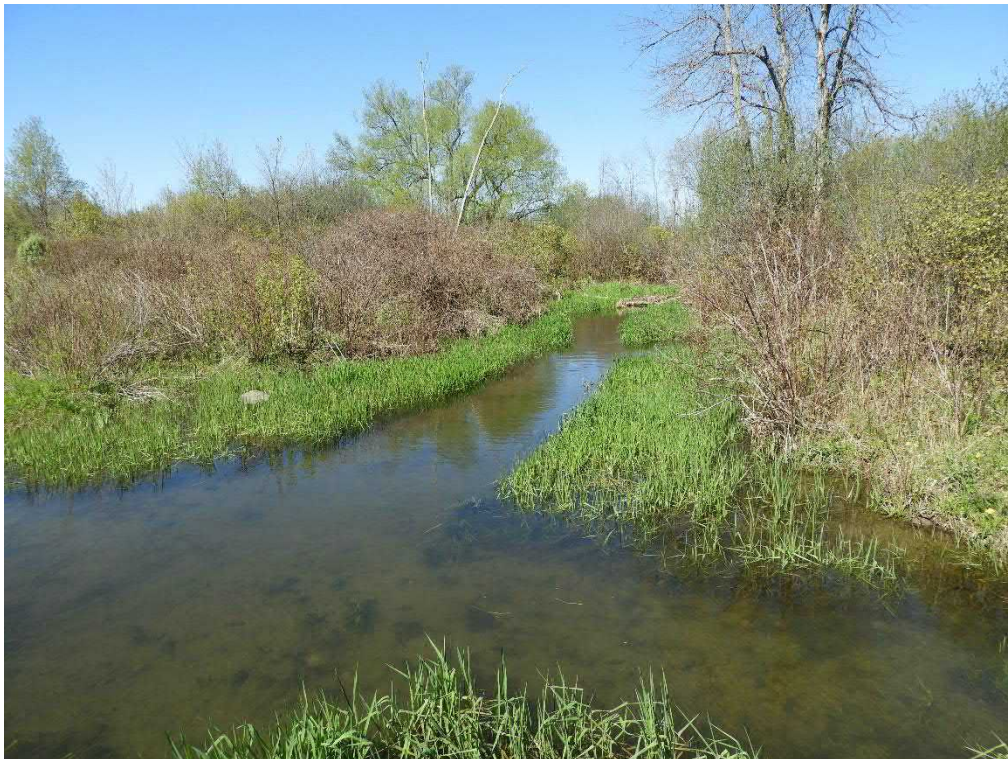
Photo 14: Harwood Creek looking upstream (west) from the off-road vehicle crossing within the study area. Another off-road vehicle crossing is present upstream at the boundary of the study area (background). 12 May 2021.

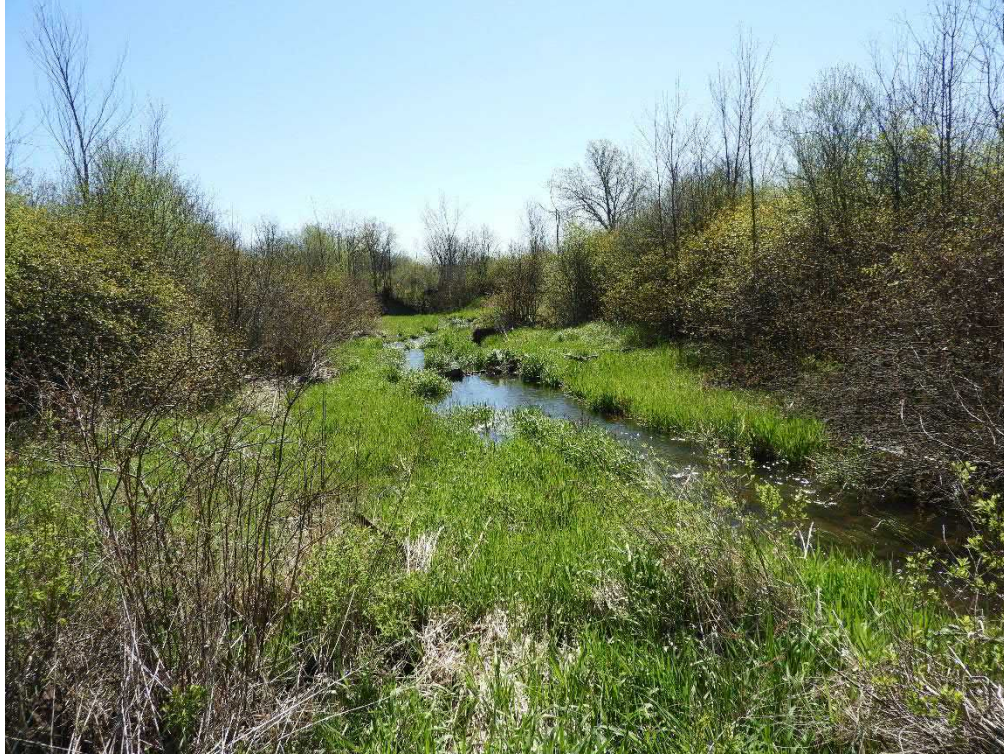
Photo 15: Harwood Creek looking downstream (east) from the beaver dam. The majority of the watercourse within the study area is downstream of the beaver dam. 12 May 2021.

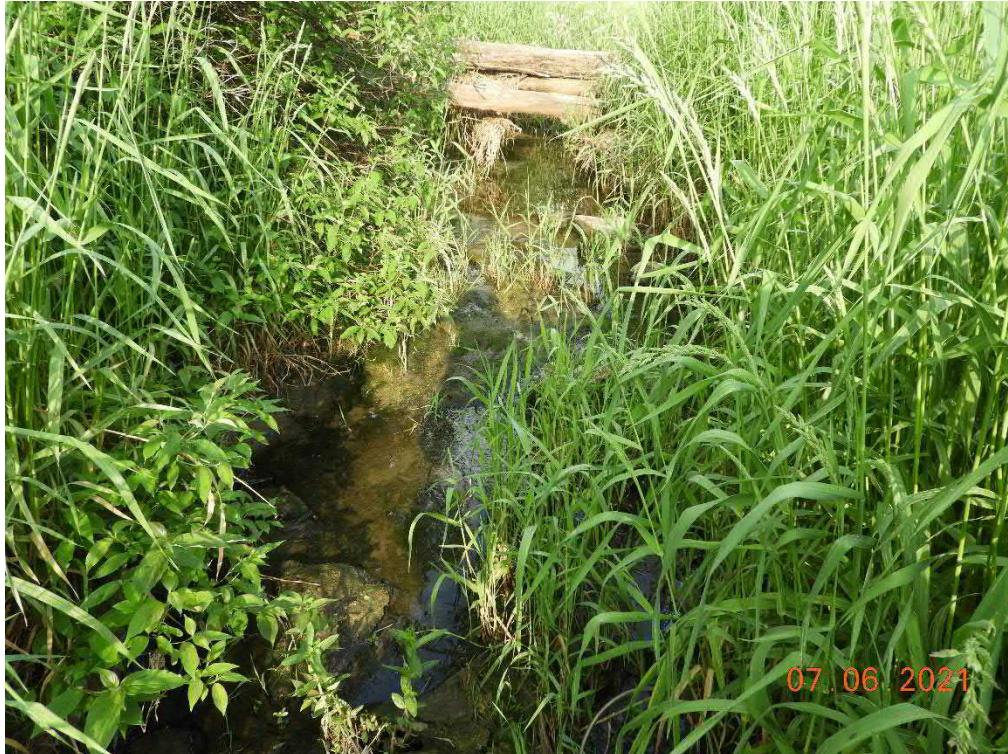
Photo 16: Upstream view (west) of Harwood Creek from downstream of the beaver dam/debris within the study area. 07 June 2021.

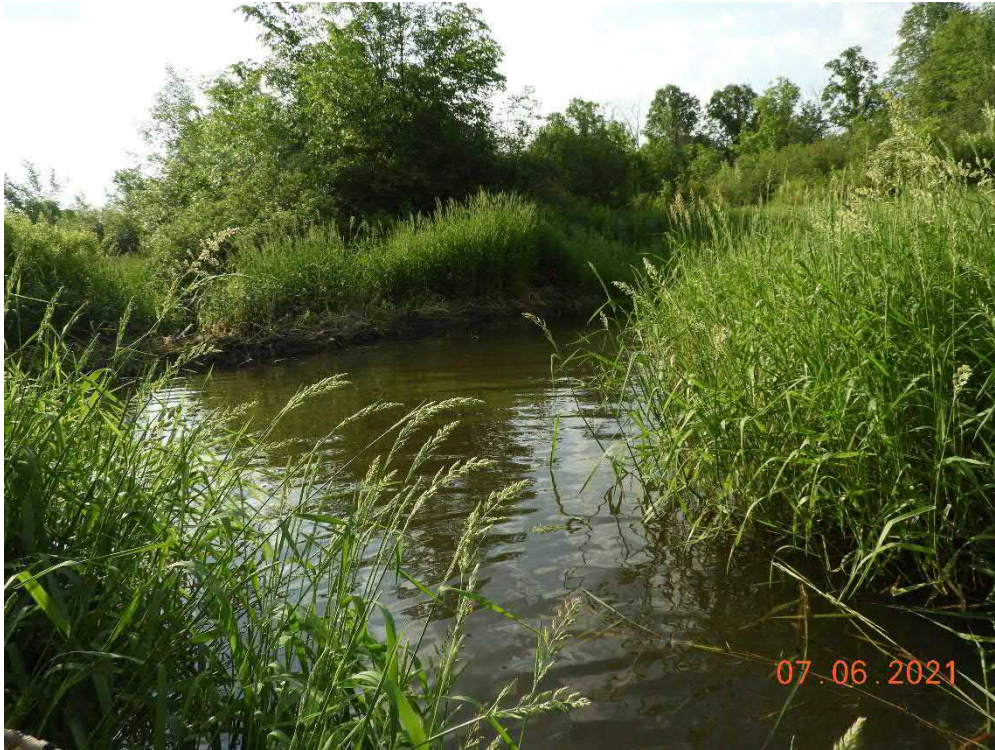
Photo 17: Upstream view (west) of Harwood Creek from upstream of the beaver dam/debris within the study area. 07 June 2021.

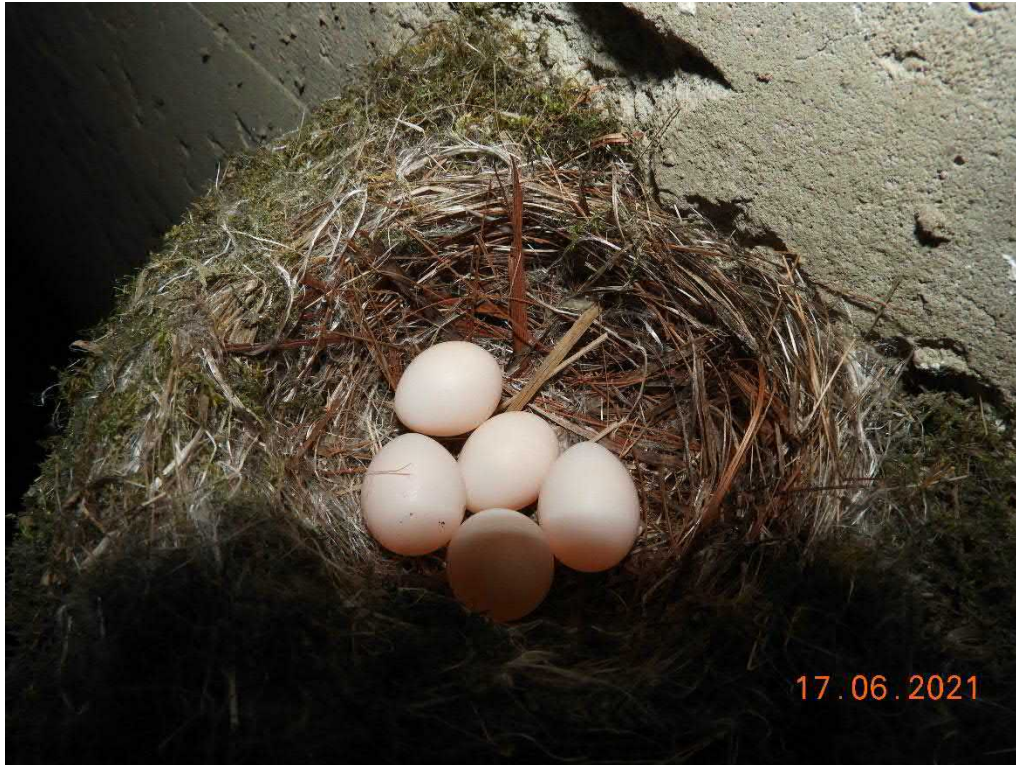
Photo 19: An active Eastern Phoebe (*Phoebe sayornis*) nest with eggs observed within the decommissioned railway culvert directly adjacent to the eastern extent of the study area. 17 June 2021.

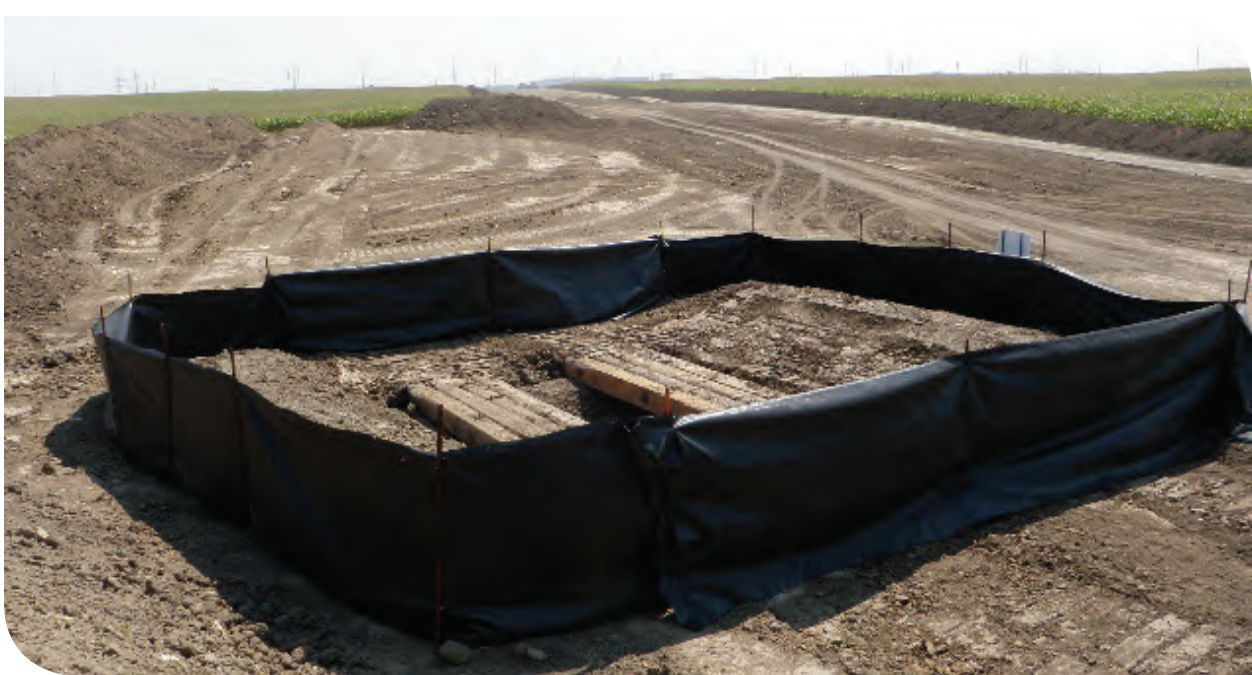
Cleaning station at construction site.

- A pump and high pressure hose OR High pressure water unit
- Minimum water pressure for vehicle cleaning should be at least 90 pounds per square inch. Water can be supplied as high volume/low pressure or low volume/high pressure (NOAA Fisheries Service).
- Air compressor and blower OR Vacuum
- Shovel
- Pry bar
- Stiff brush or broom
