**PHASE I  
ENVIRONMENTAL SITE ASSESSMENT  
2050 DUNROBIN ROAD  
CITY OF OTTAWA, ONTARIO**

Euroamber Inc.  
165 Constance Lake Road  
Kanata, Ontario  
K2K 1X7

DATE: February 18, 2022

200977

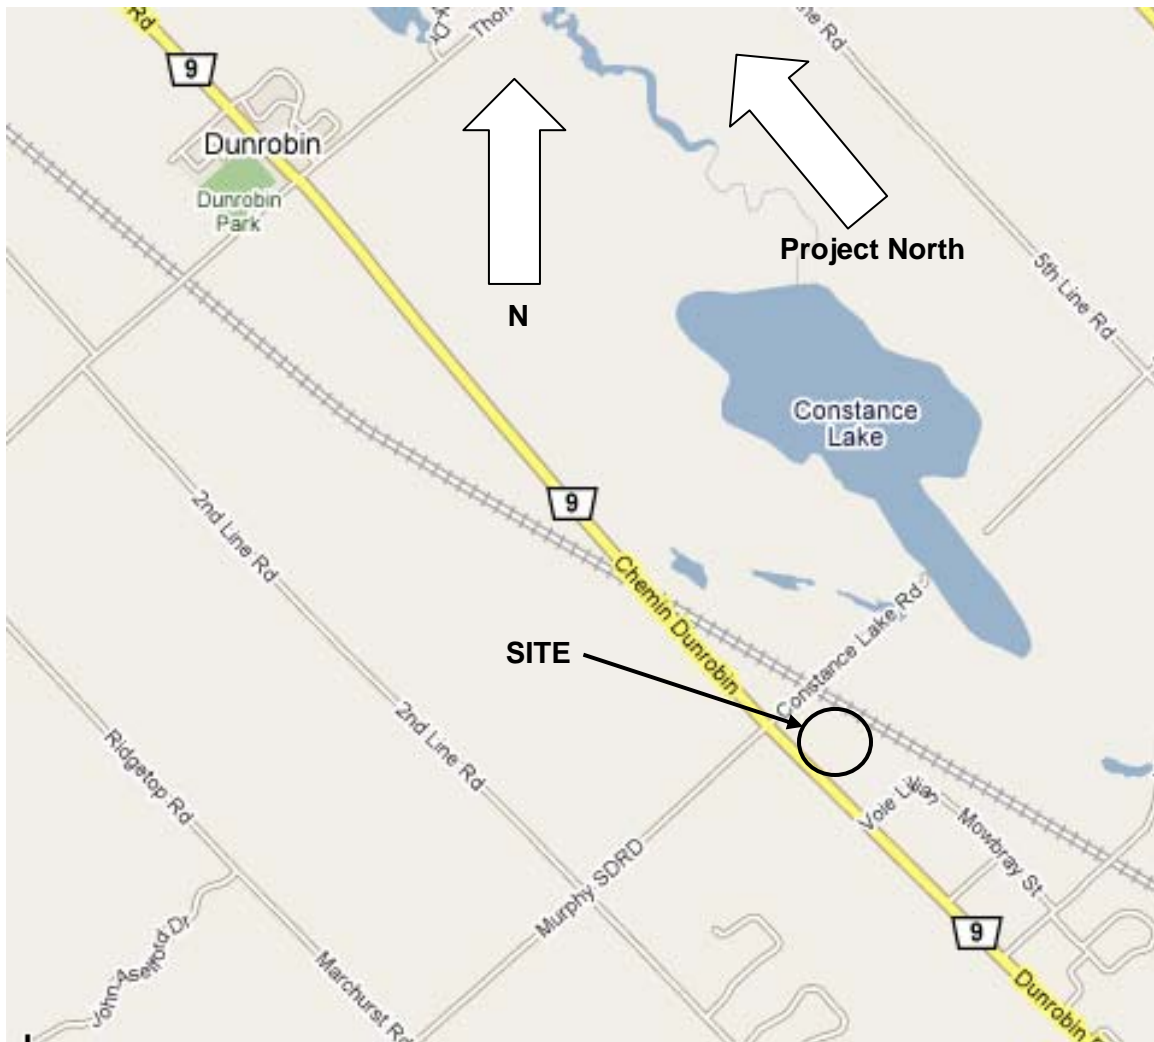
FIGURE 1

## KEY PLAN

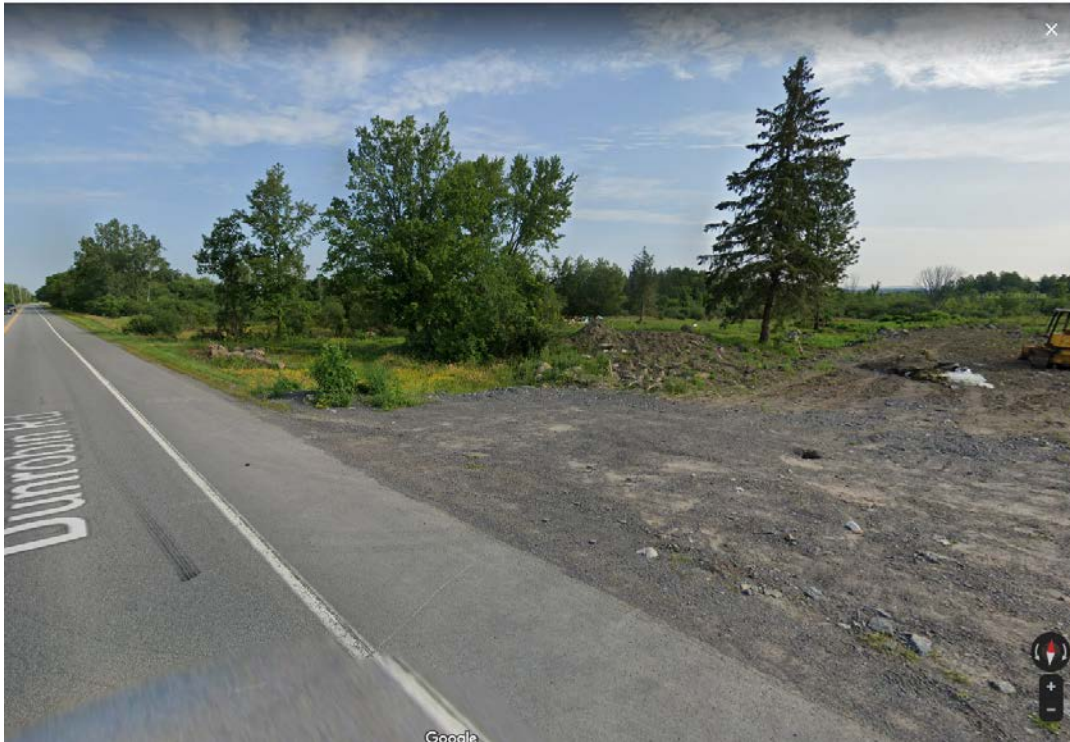
**View of Site facing northeast**

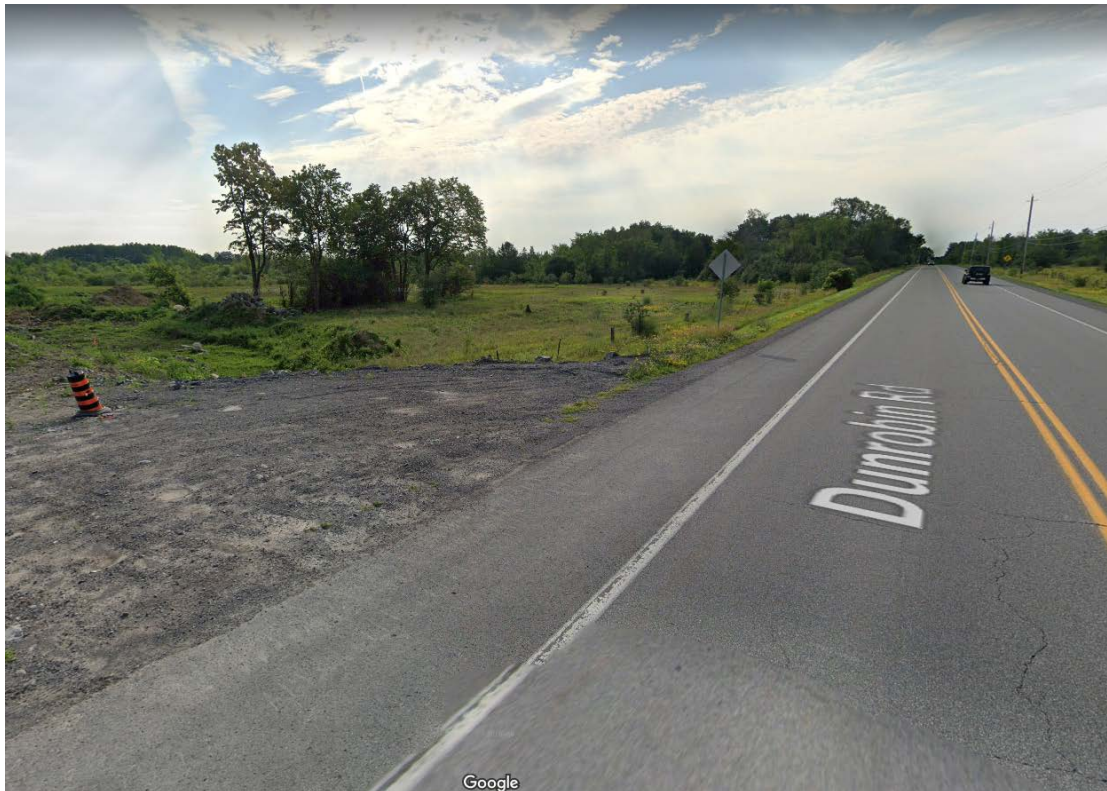
**View of Site facing southeast**

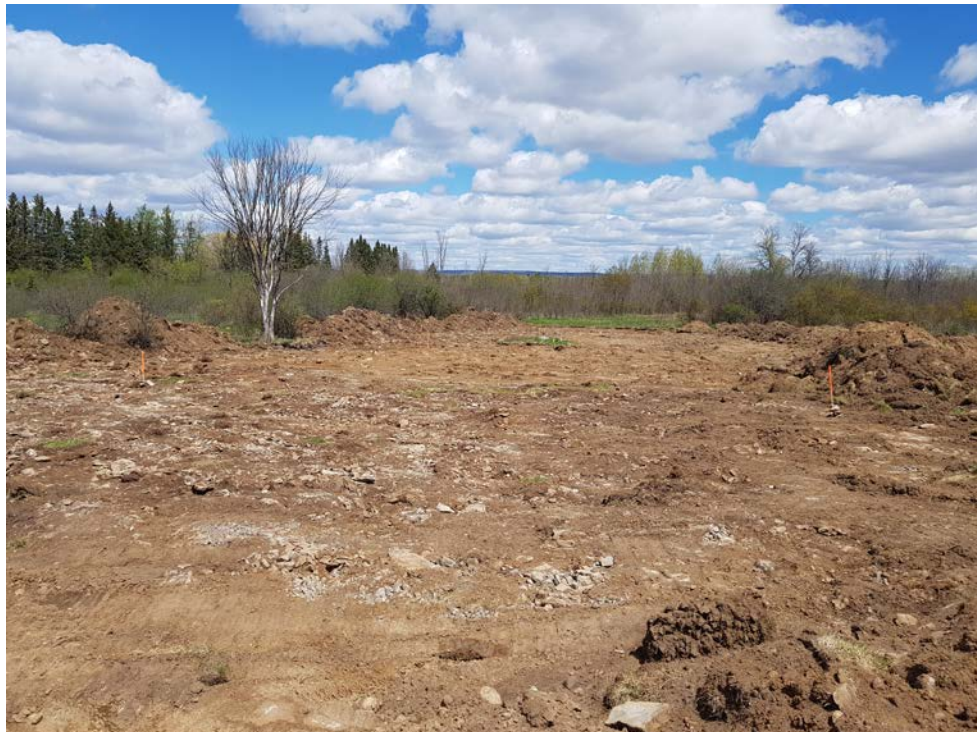
View of roadway construction after topsoil was stripped

Some fill materials were observed to have been imported to the site as part of construction of a future roadway that will service the proposed residential subdivision. The fill materials consist of a mixture of sand, gravel, cobbles, boulders, silty clay, trace to some concrete, plastic and wood debris. It is understood that the fill materials originated from properties in Almonte and Kanata. Quality testing of the fill materials was completed by Paterson Group

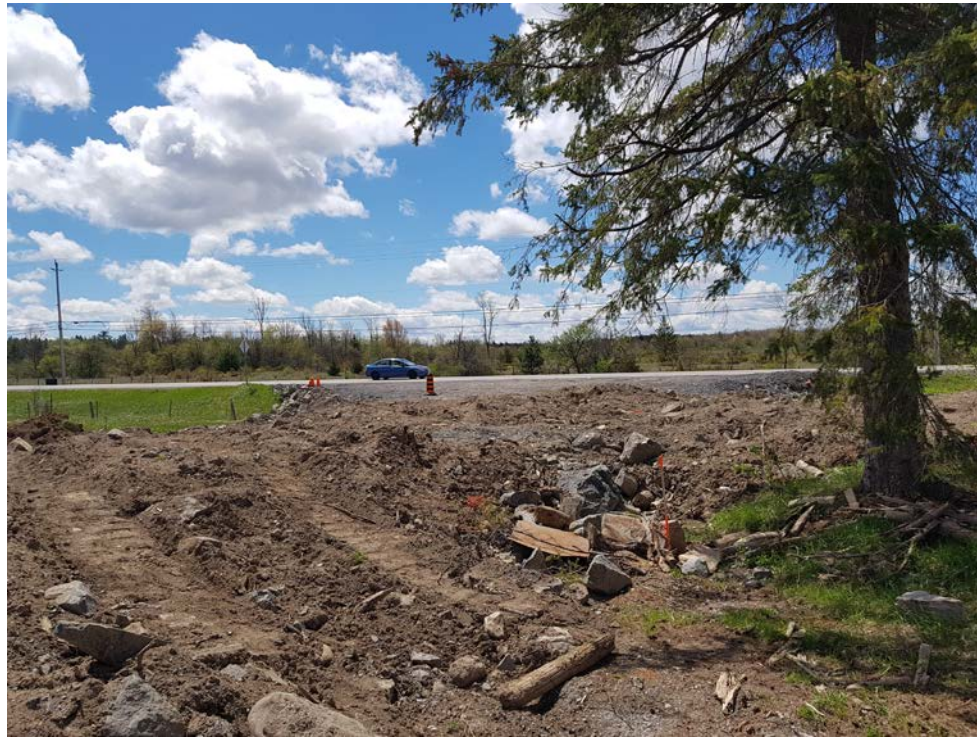
View of some fill materials used in roadway

- Fill materials was observed to have been imported to the site as part of the roadway construction for the proposed residential subdivision. The fill materials were tested as part of Excess Soil Management and are considered to be acceptable quality.

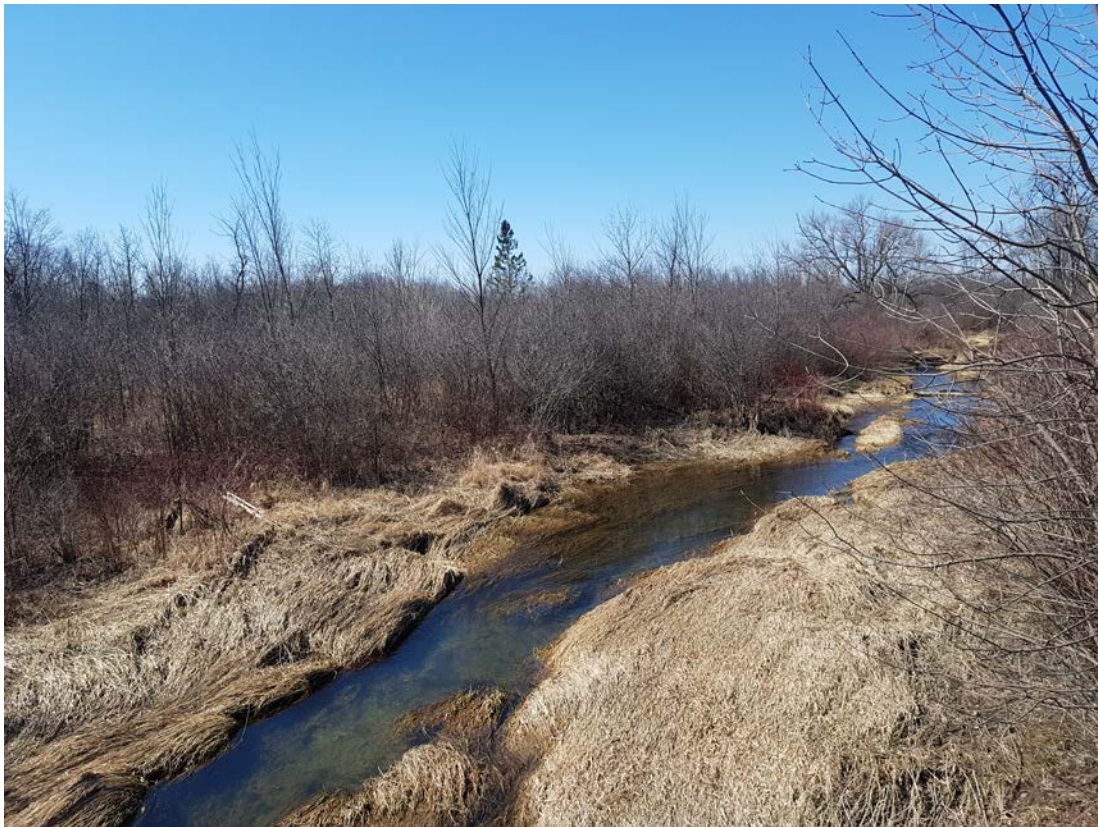
View of creek located in southeast portion of site. Creek flows east.

Roadside ditches were observed along Dunrobin Road. A ditch was also observed near the centre of the site. Water was observed in the ditch flowing north to south. Based on a review of topographical maps for the site area it is expected that the upper groundwater flow is to the northeast towards Constance Lake which exists about 1.1 kilometres east of the site.

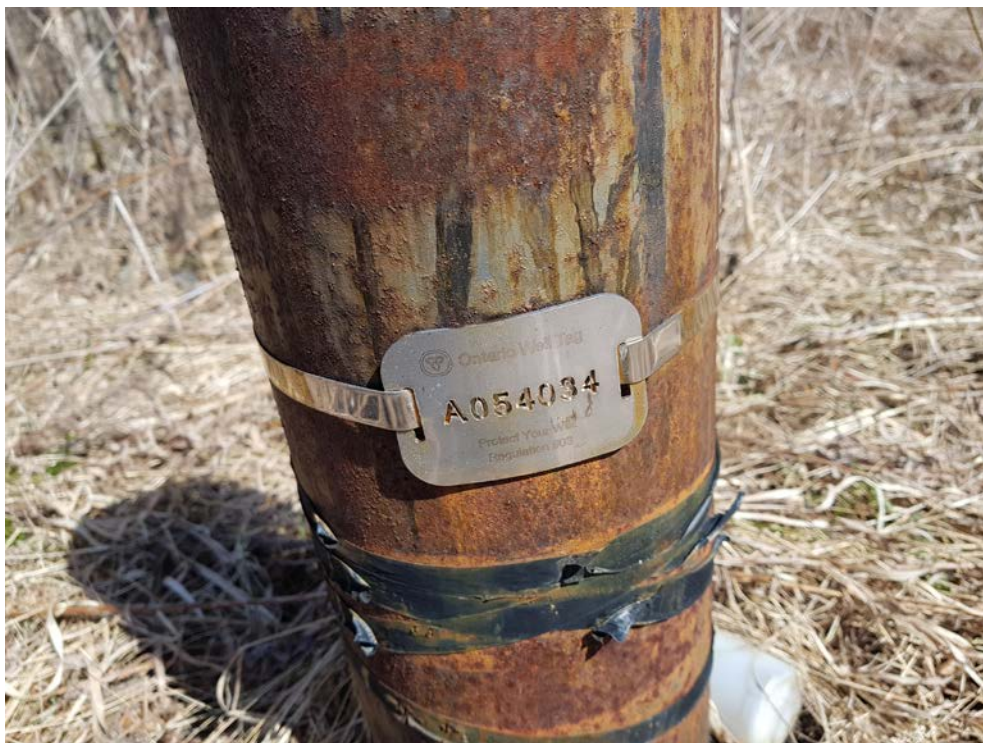
View of steel cased well at site.

Three steel cased wells were observed at the site. The three steel cased wells are test wells for the hydrogeological investigation for the proposed residential subdivision at the site. No other wells were observed at the site.

Three steel cased wells were observed at the site. The three steel cased wells are test wells for the hydrogeological investigation for the proposed residential subdivision at the site. Future dwellings for the residential subdivision will be serviced by individual steel cased wells.
