Muncaster
Environmental
Planning Inc.

RE: Creekside Phase 2 Residential Development, Richmond
Environmental Impact Statement and Tree Conservation Report

I have completed an Environmental Impact Statement (EIS) and Tree Conservation Report (TCR) for a village residential development in Richmond, to the north of Perth Street and west of Eagleson Road in Lots 26 and 27 of Concession 4, Nepean Geographic Township of the City of Ottawa (Map 2). The west portion of the approximately 24.9 hectare site has a municipal address of 2770 Eagleson Road. The site is dominated by cultivated agricultural lands, with the Flowing Creek Municipal Drain to the west of the site, flowing south to Perth Street and then the Jock River approximately 75 metres south of Perth Street.

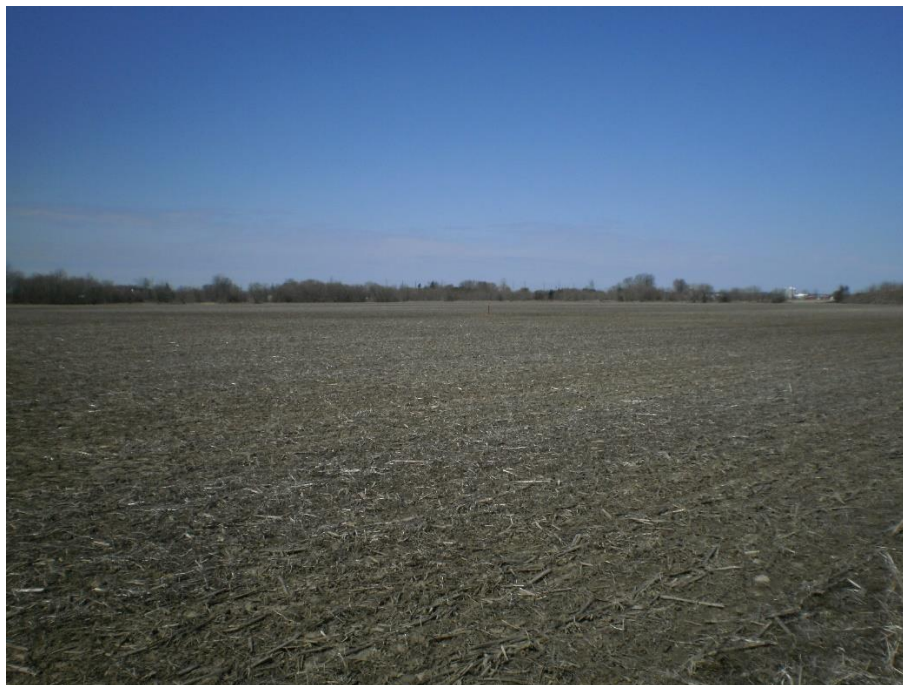
*Photo 2 – Cultivated fields in the northwest portion of the site.
View looking northwest from the middle of the site*

The topography of the site is generally level, with a very gentle slope to the south. The soils on the site are mapped as poorly drained silty clay (Schut and Wilson, 1987). The site is dominated by active cultivated fields, planted in soybeans and corn in 2019 (Photos 1 and 2). No swales with aquatic habitat potential were observed on the site.
