Phase One Environmental Site Assessment 90 Woodridge Crescent, Ottawa, Ontario

Ferguslea Properties Ltd.

Phase One Environmental Site Assessment

OTT-00201554-G0

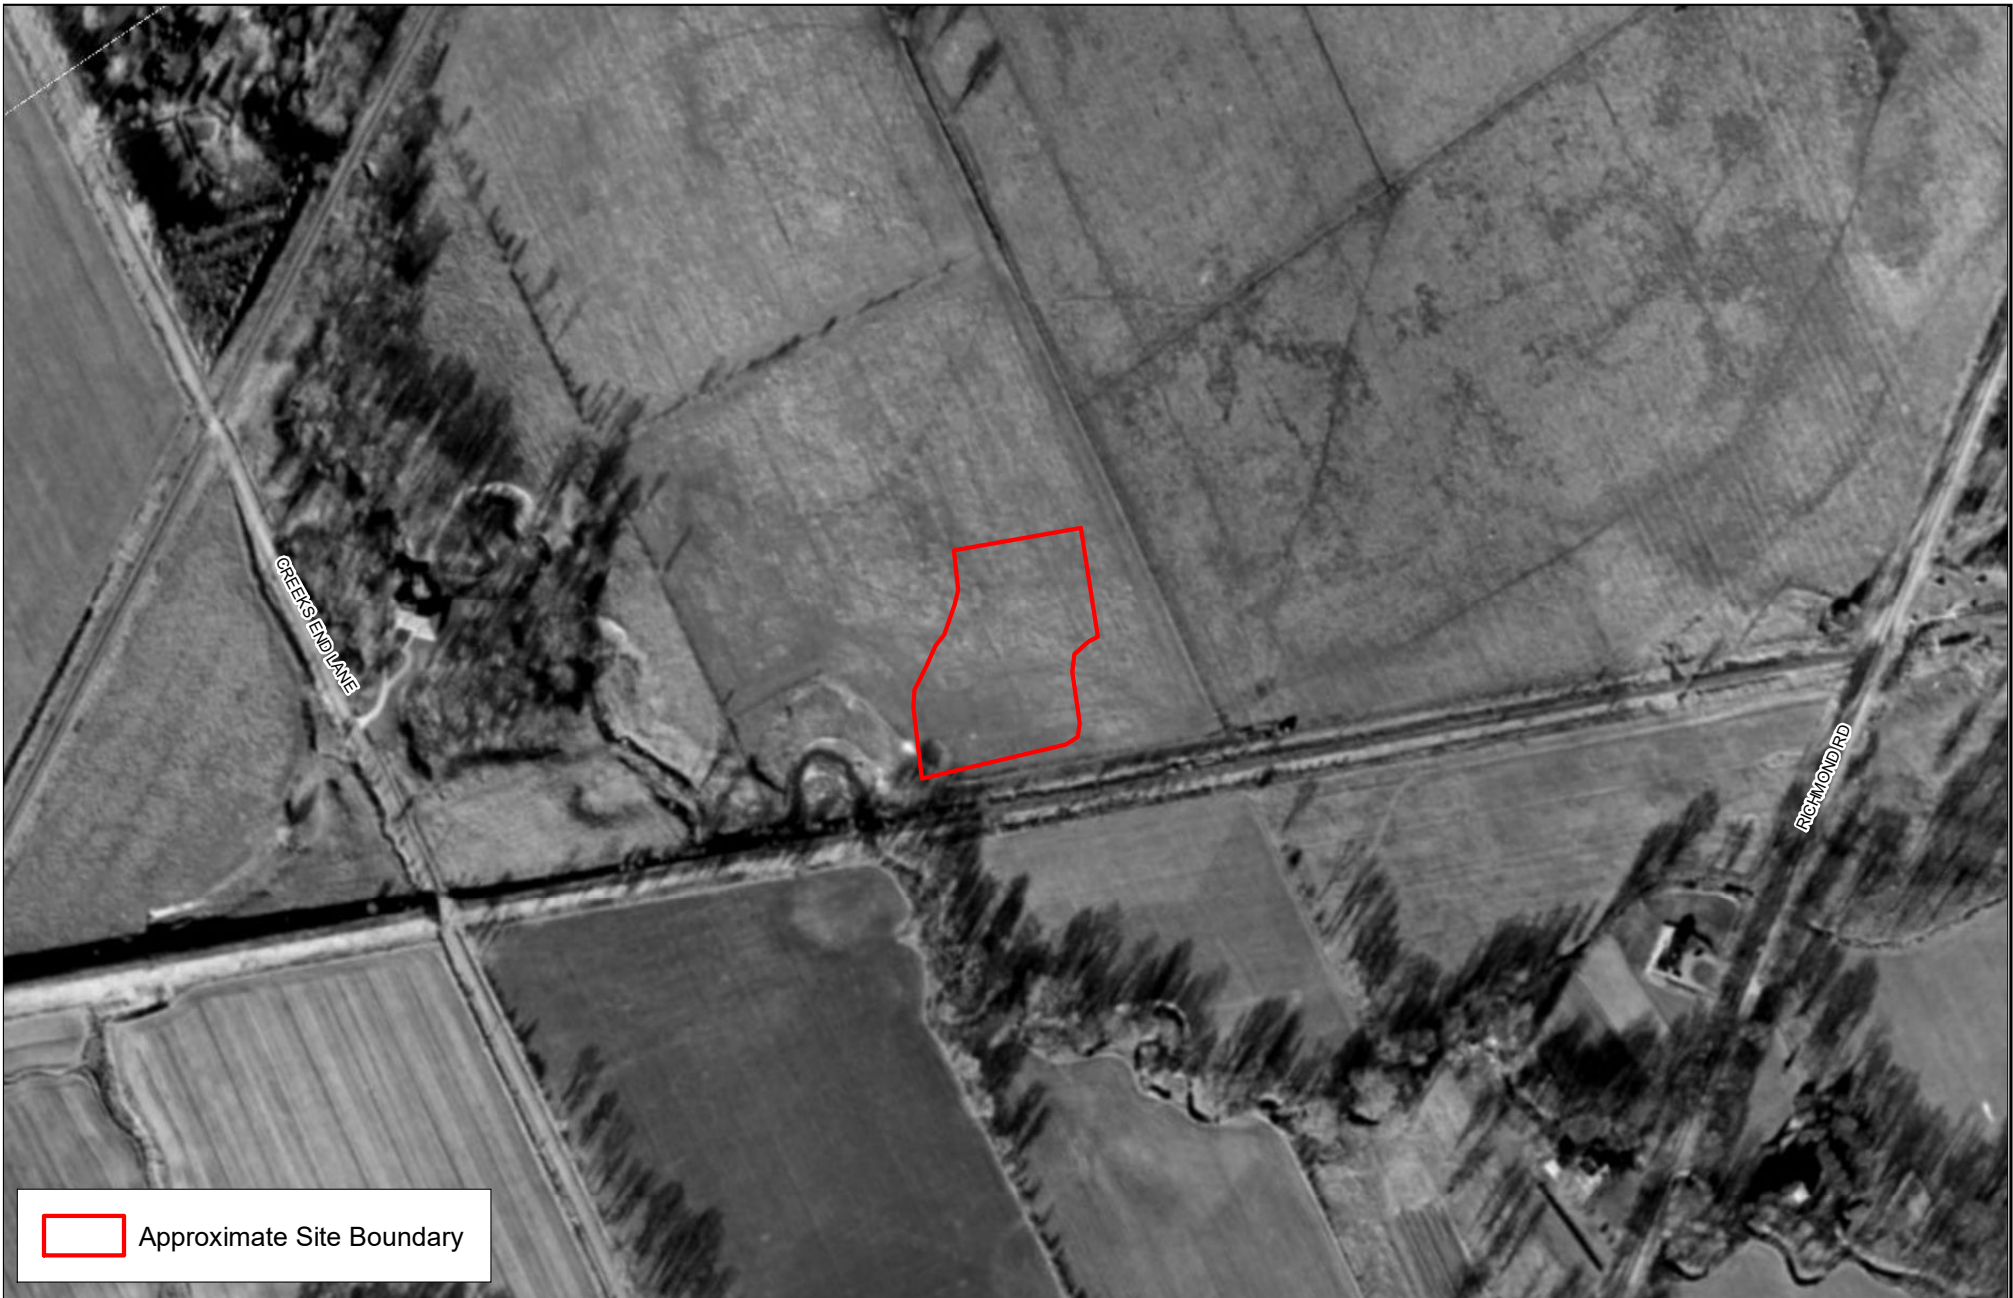
PROJECT No:	OTT-00201554-G0	DWN:	HY
SCALE:	AS NOTED	CHKD:	MM
DATE:	FEBRUARY 2022	FIG. No.:	F1

Approximate Site Boundary

1958 AERIAL PHOTOGRAPH
 Phase One Environmental Site Assessment
 90 Woodridge Crescent
 Ottawa, Ontario

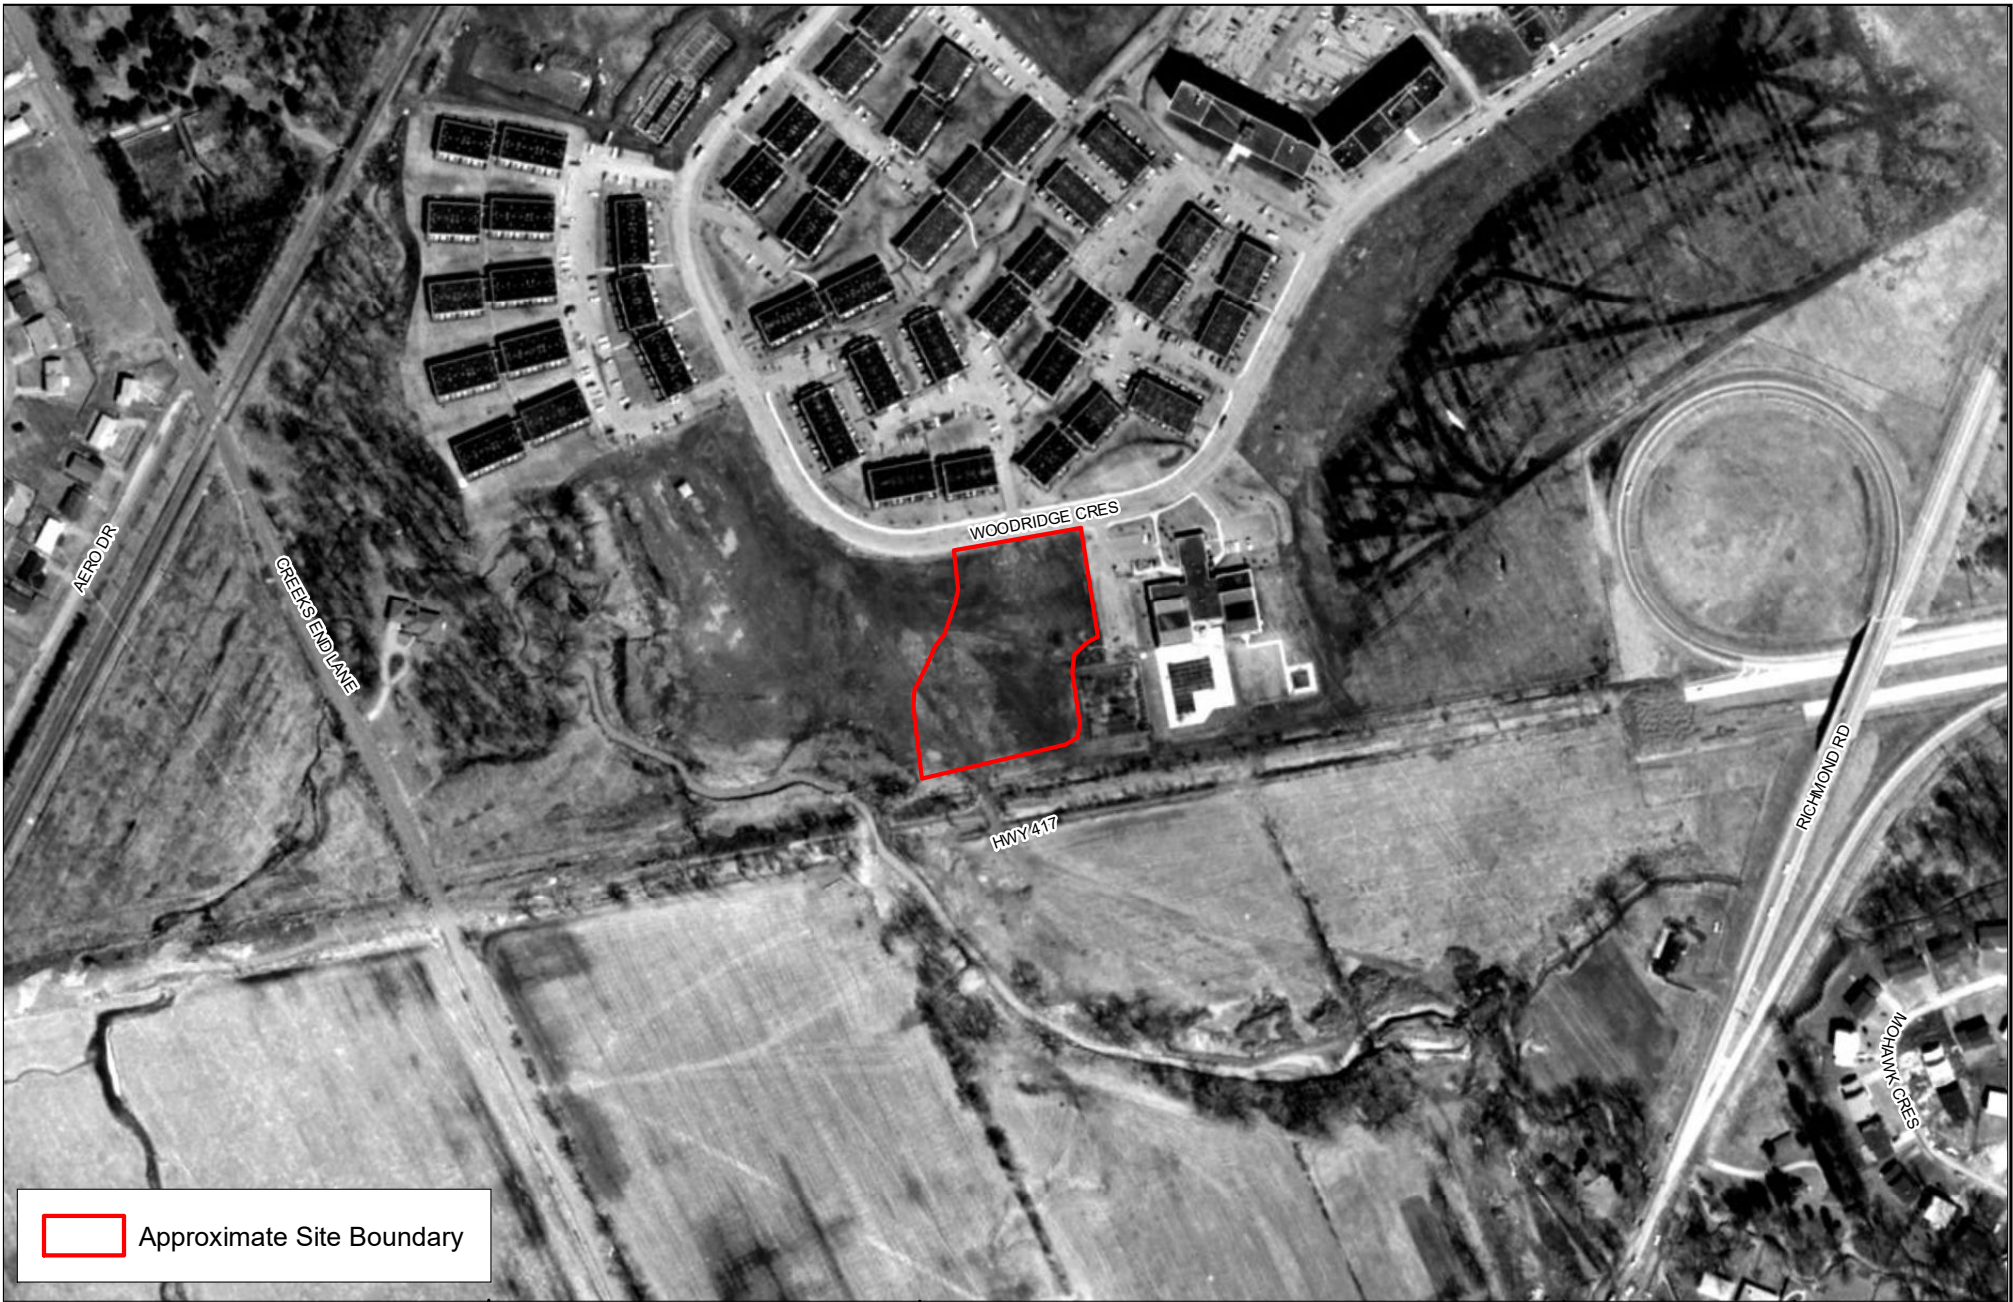
PROJECT No:	OTT-00201554-G0	DWN:	HY
SCALE:	AS NOTED	CHKD:	MM
DATE:	FEBRUARY 2022	FIG. No.:	F3

Approximate Site Boundary

1976 AERIAL PHOTOGRAPH
 Phase One Environmental Site Assessment
 90 Woodridge Crescent
 Ottawa, Ontario

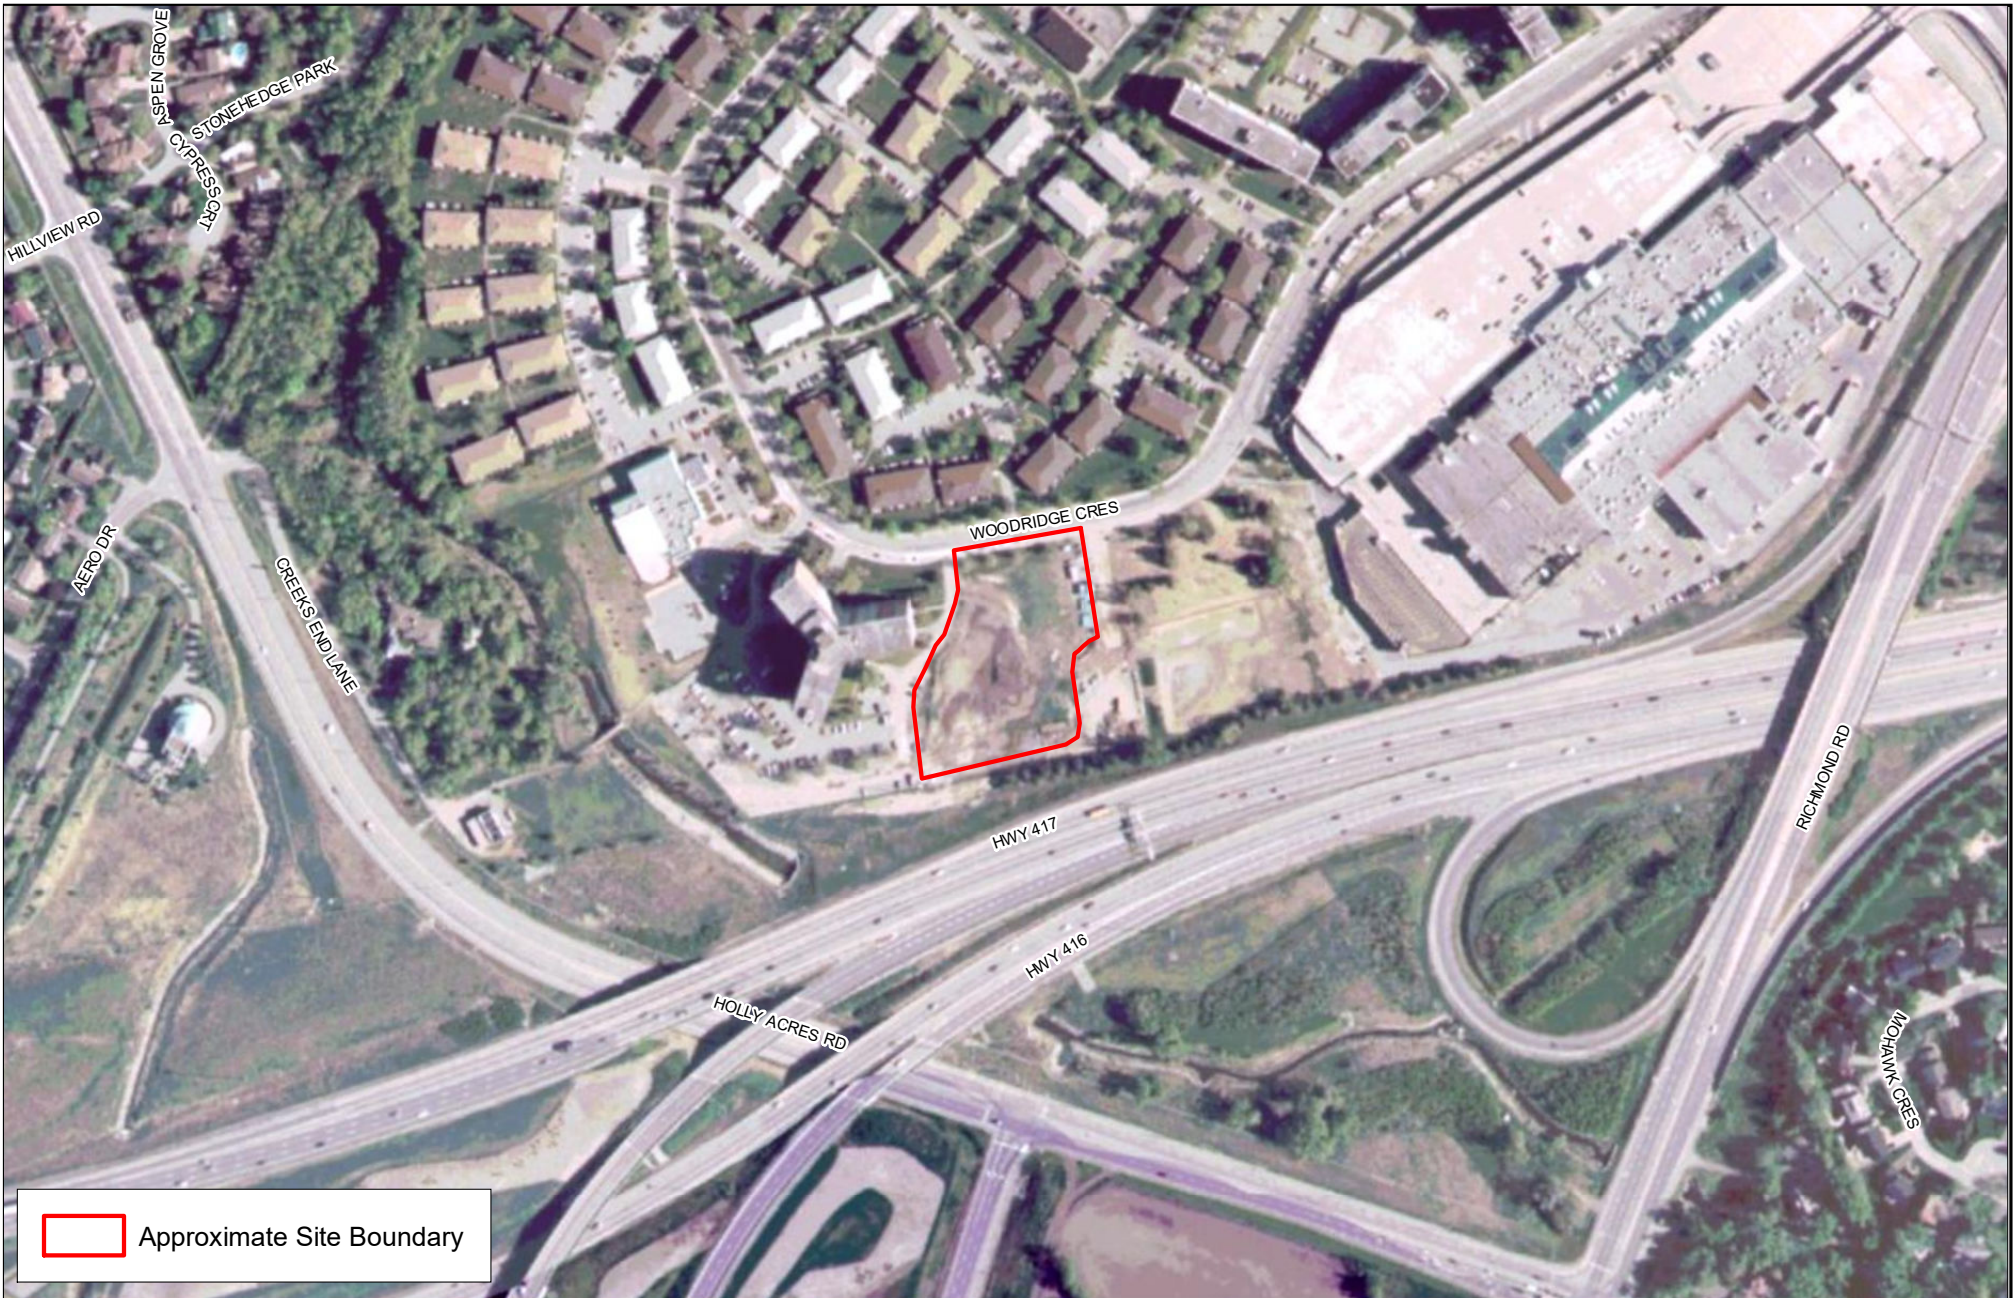
PROJECT No:	OTT-00201554-G0	DWN:	HY
SCALE:	AS NOTED	CHKD:	MM
DATE:	FEBRUARY 2022	FIG. No.:	F4

TITLE AND LOCATION:
 1999 AERIAL PHOTOGRAPH
 Phase One Environmental Site Assessment
 90 Woodridge Crescent
 Ottawa, Ontario

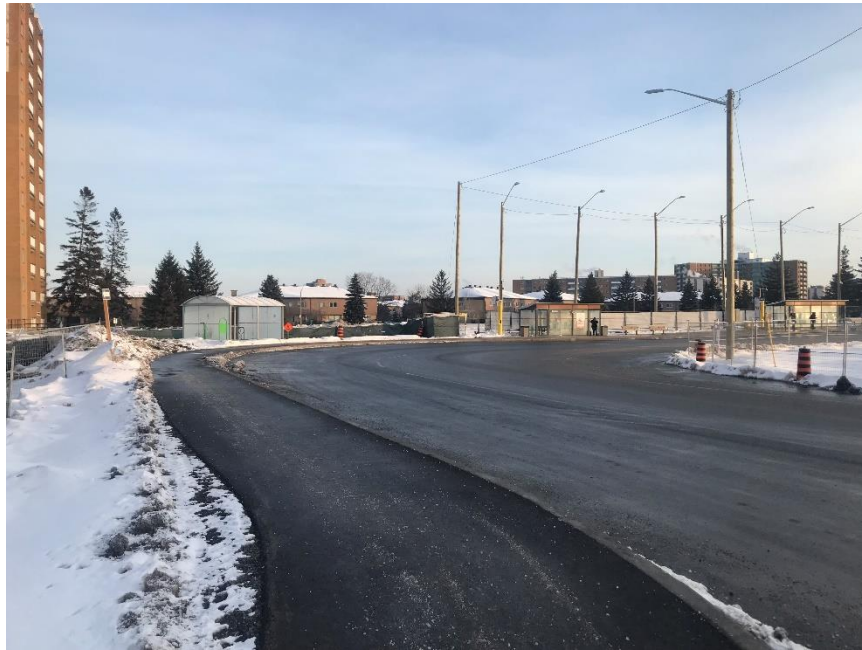
Photograph No. 1

West part of the south hal of the Phase One property.

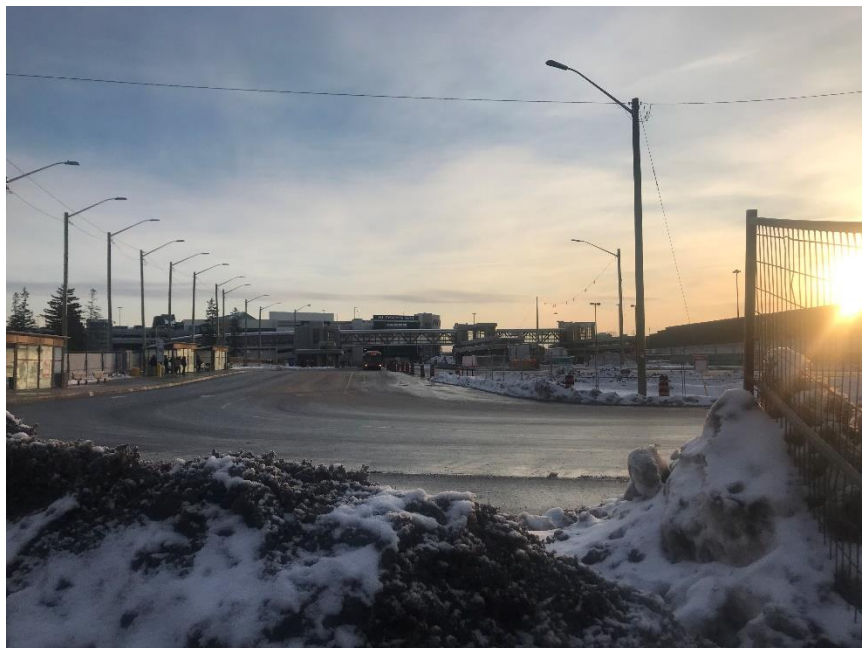
Photograph No. 2

South half of the Phase One property looking east.

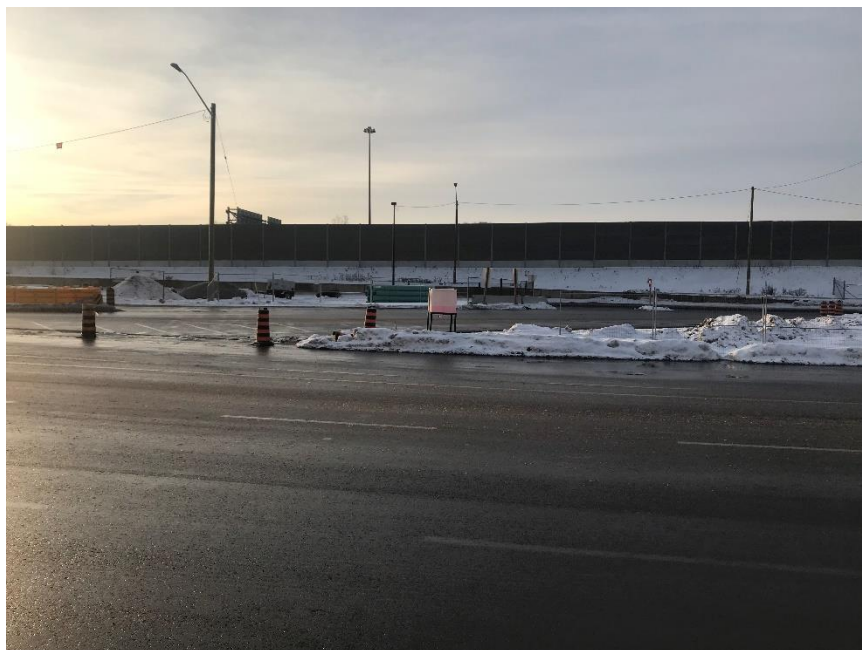
Photograph No. 3

A small plastic tote containing windshield washer fluid was present for OC Transpo bus use. The tote is raised off the ground and no staining was observed in the snow in the vicinity of the tote (Photo 3).

View of the windshield washer fluid tote.

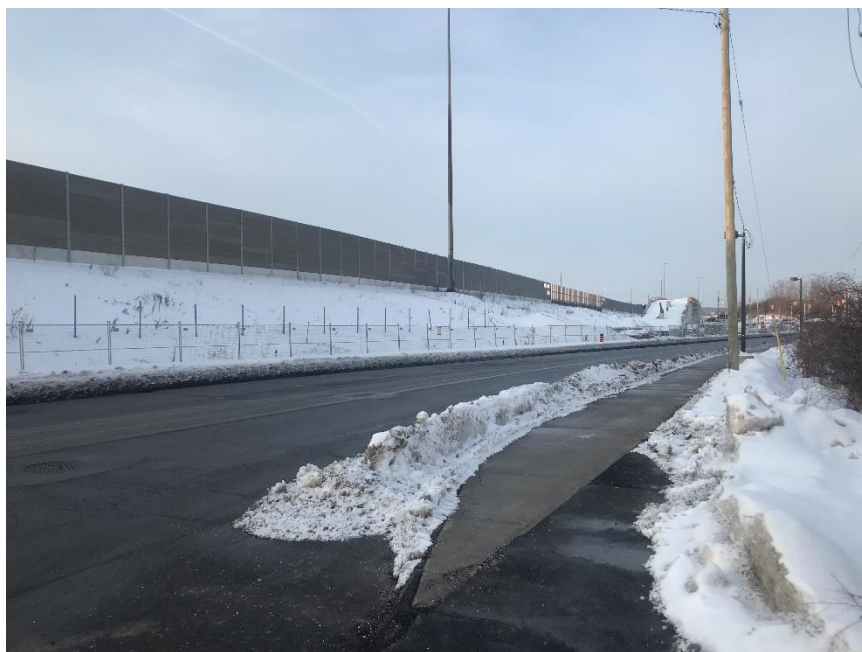
Photograph No. 4

Highway 417 divider and on-ramp south of the Phase One property.

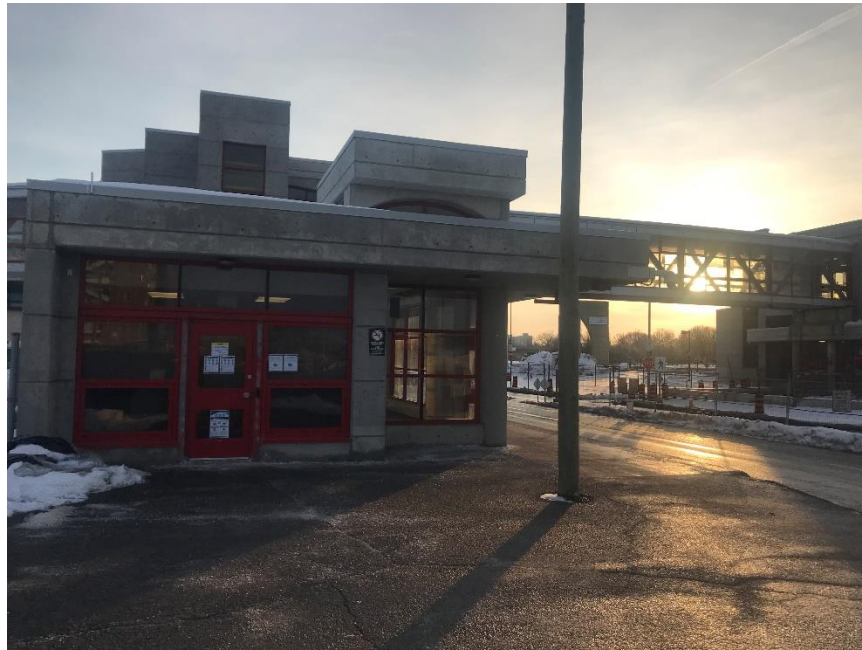
Photograph No. 5

OC Transpo bus station east of the Phase One property.

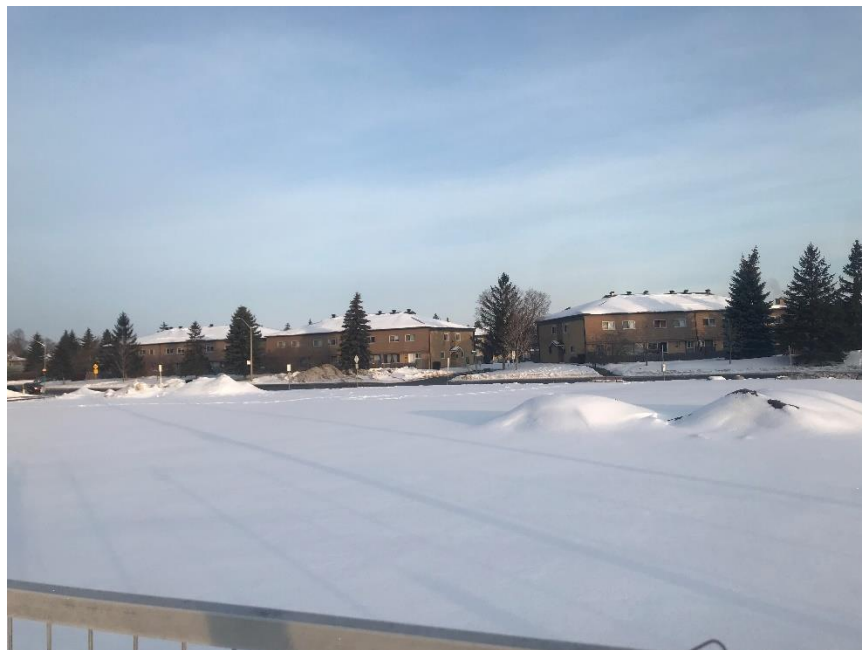
Photograph No. 6

North part of the Phase One property which remains vacant.

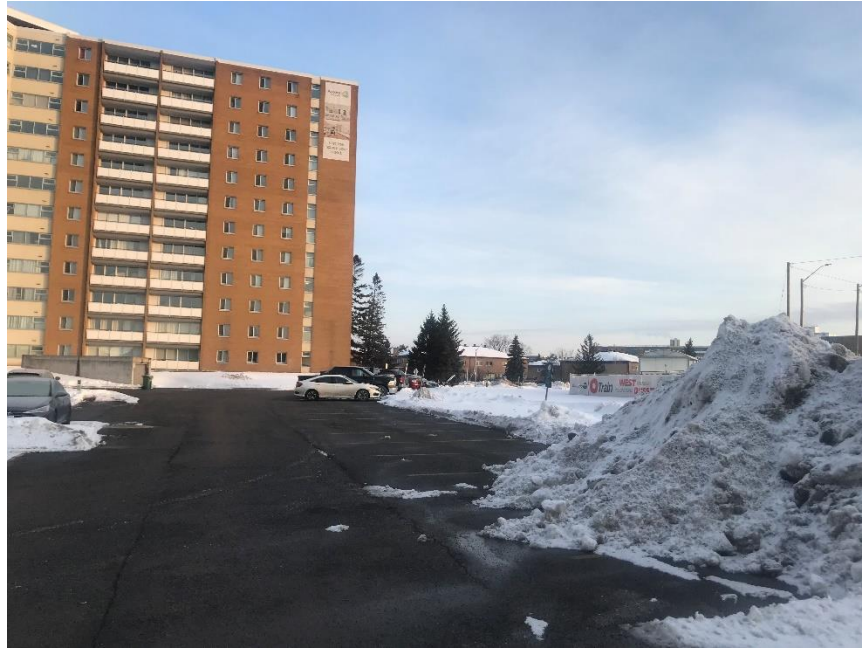
Photograph No. 7

Parking lot and the Fairview building west of the Phase One property.
