# Phase One Environmental Site Assessment

970 and 974 Silver Street and  
1271 and 1275 Shillington Avenue  
Ottawa, Ontario

December 1, 2021

Pinchin File: 299319

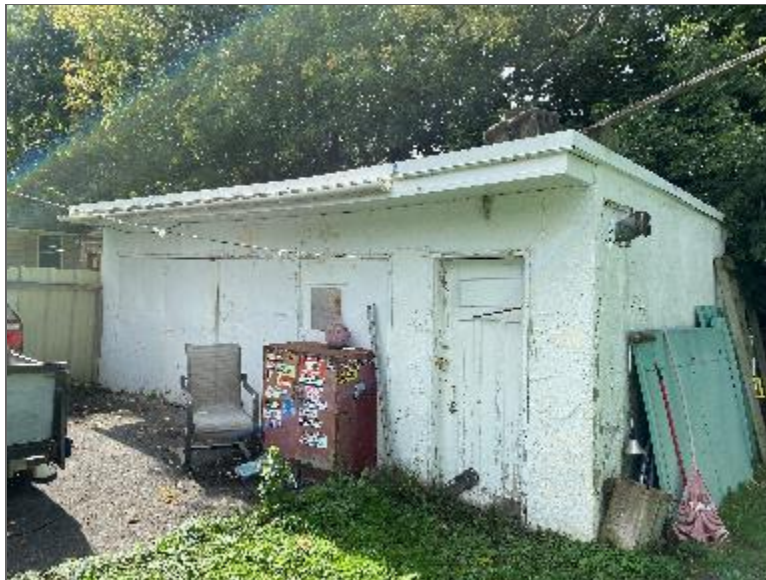
Photo 4 – Storage shed located southwest of Site Building B.

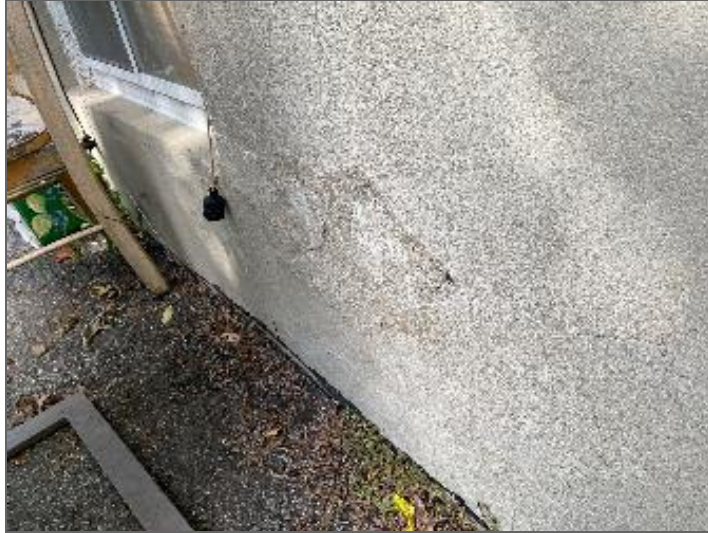
Photo 9 – Patching, inferred to be for a former heating oil AST, observed along the exterior elevation of Site Building B.

- Pinchin observed patching along the foundation wall of Site Building B, indicating the inferred former presence of a heating oil AST in the basement level of Site Building B. In addition, the Site Representative indicated that the heating sources for each Site Building have undergone the same evolution, suggesting former heating oil ASTs in the basement levels of each Site Building. However, no spills or evidence of historical spills (i.e., staining) was observed in the basement levels of Site Buildings B and C (Site Buildings A and D were not accessed), and no spill records were reported for the Phase One Property. As such, it is Pinchin's opinion that these PCAs do not represent APECs for the Phase One Property; and

- PCA #1 (Item 28: Gasoline and Associated Products Storage in Fixed Tanks – Pinchin observed patching along the foundation wall of Site Building B, indicating the inferred former presence of a heating oil AST in the basement level of Site Building B. In addition, the Site Representative indicated that the heating sources for each Site Building have undergone the same evolution, suggesting former heating oil ASTs in the basement levels of each Site Building). However, no spills or evidence of historical spills (i.e., staining) was observed in the basement levels of Site Buildings B and C (Site Buildings A and D were not accessed), and no spill records were reported for the Phase One Property. As such, it is Pinchin's opinion that these PCAs do not represent APECs for the Phase One Property; and

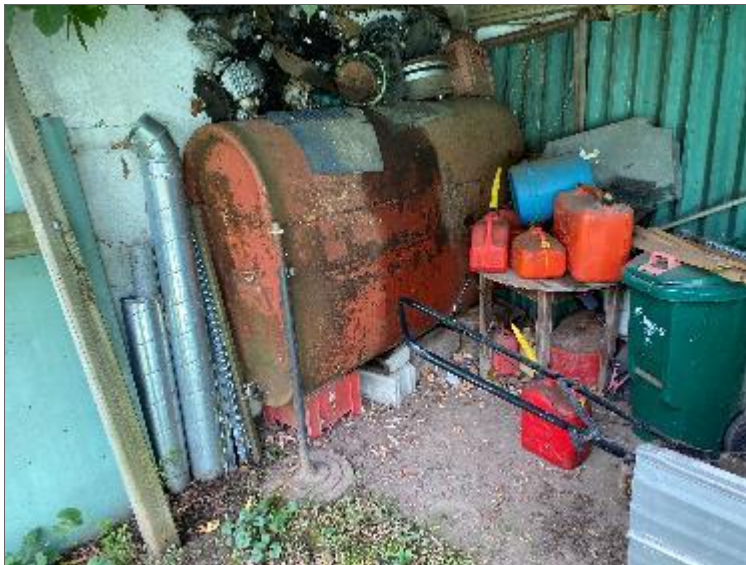
Photo 10 – AST observed beneath a covered storage area adjacent to the garage west of Site Building B.

- One out-of-use heating oil AST with a capacity of 910-L is located beneath a covered storage area adjacent to the shed southwest of Site Building B. The AST has reportedly been empty and unused since removal from the basement of Site Building B. No secondary containment was observed around the AST; however, no spills or evidence of historical spills (i.e., staining) was observed on the ground surface in the vicinity of the AST. In addition, no spill records were reported for the Phase One Property. As such, it is Pinchin's opinion that this PCA does not represent an APEC for the Phase One Property.

- PCA #2 (Item 28: Gasoline and Associated Products Storage in Fixed Tanks – One out-of-use AST with a capacity of 910-L is located beneath a covered storage area adjacent to the shed southwest of Site Building B). The AST has reportedly been empty and unused since removal from the basement level of Site Building B. No secondary containment was observed around the AST; however, no spills or evidence of historical spills (i.e., staining) was observed on the ground surface in the vicinity of the AST. In addition, no spill records were reported for the Phase One Property. As such, it is Pinchin's opinion that this PCA does not represent an APEC for the Phase One Property.
