Phase Two Environmental Site Assessment 1568 Meadowbrook Road, Ottawa, Ontario

Phase Two Environmental Site Assessment

OTT-21019403-B0

2021-11-30

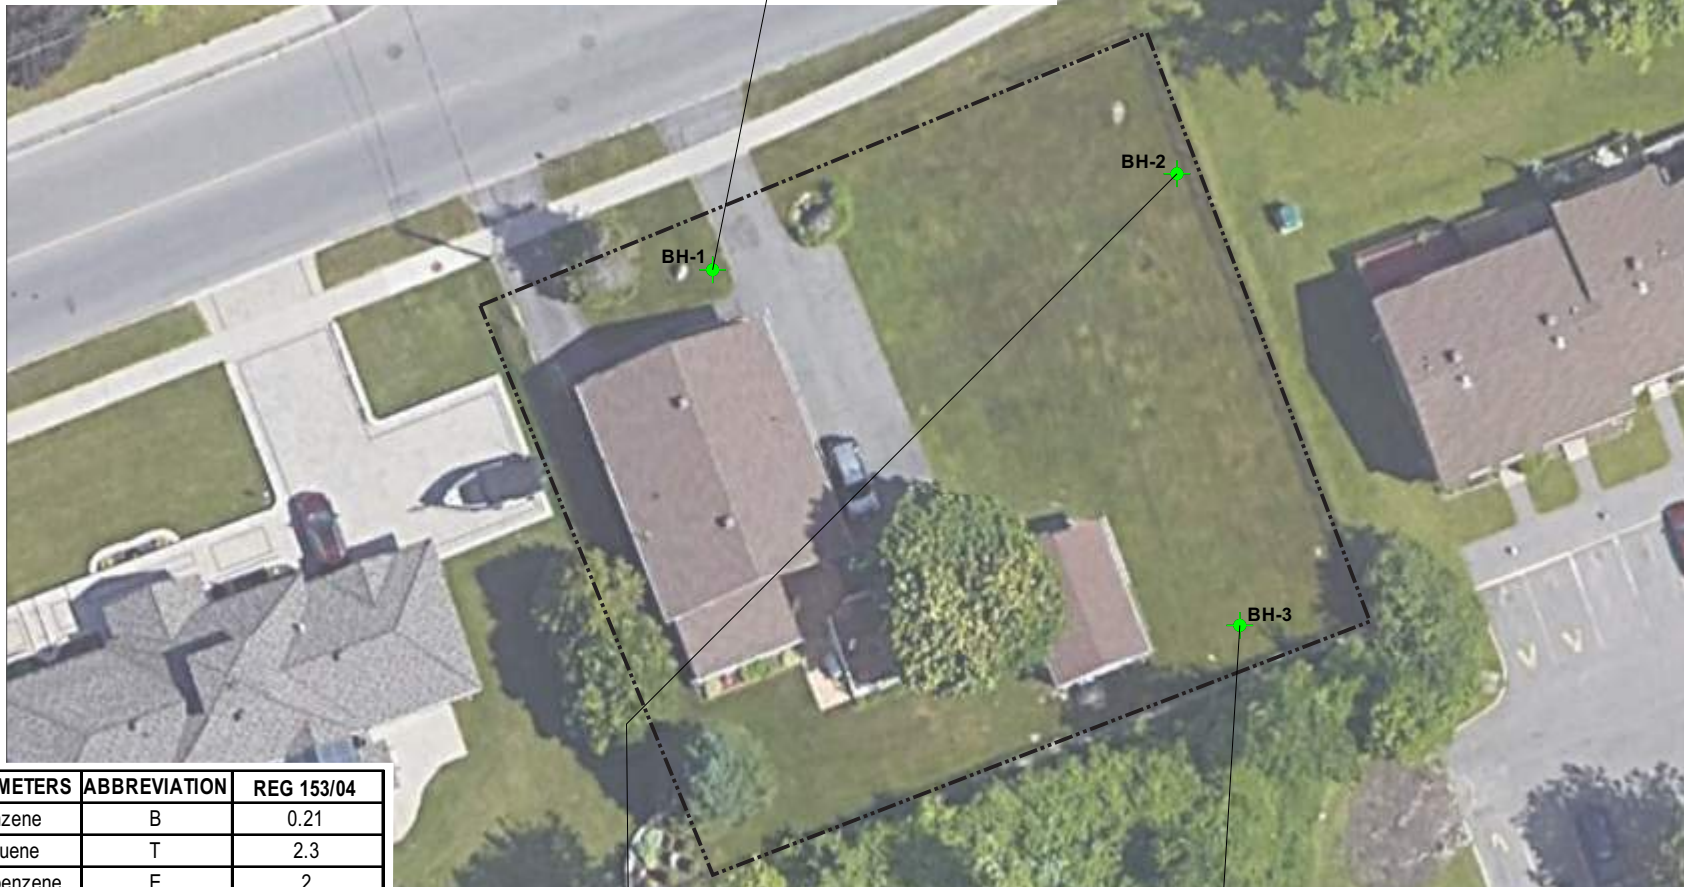
PARAMETERS	ABBREVIATION	REG 153/04
Benzene	B	0.21
Toluene	T	2.3
Ethylbenzene	E	2
Total Xylenes	X	3.1
F1 (C6-C10)	F1	55
F2 (C10-C16)	F2	98
F3 (C16-C34)	F3	300
F4 (C34-C50)	F4	2800

Sample ID	Date	Depth (m)	B	T	E	X	F1	F2	F3	F4
BH-3 SS1	27/10/2021	0.0 - 0.75	<0.020	<0.020	<0.020	<0.040	<10	<10	<50	<50

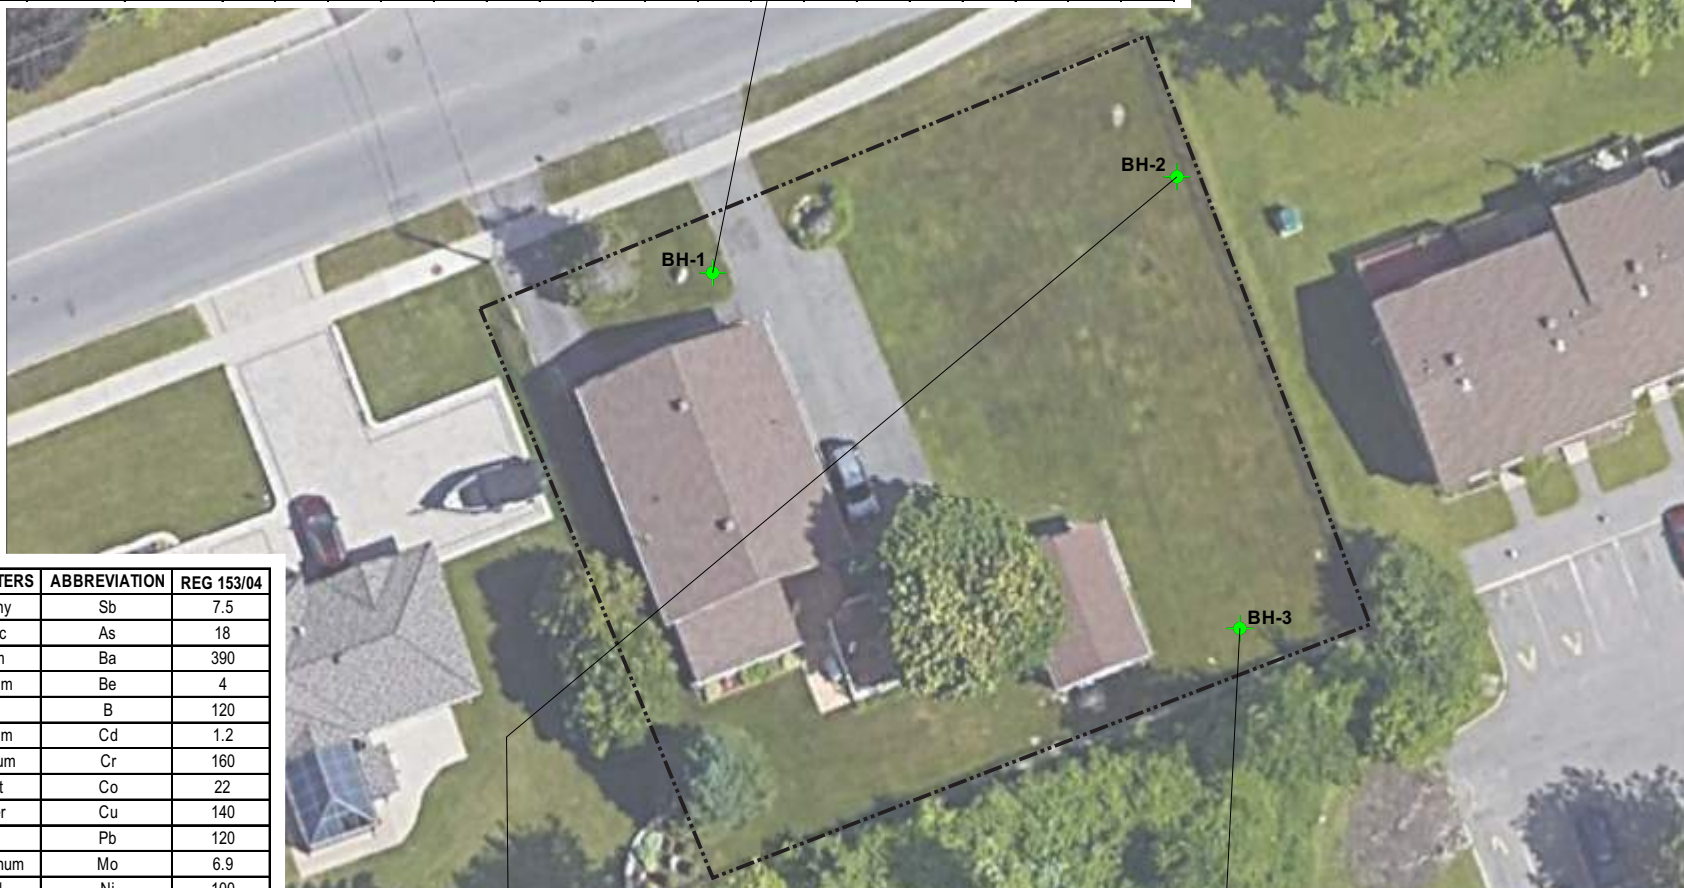
PARAMETERS	ABBREVIATION	REG 153/04
Antimony	Sb	7.5
Arsenic	As	18
Barium	Ba	390
Beryllium	Be	4
Boron	B	120
Cadmium	Cd	1.2
Chromium	Cr	160
Cobalt	Co	22
Copper	Cu	140
Lead	Pb	120
Molybdenum	Mo	6.9
Nickel	Ni	100
Selenium	Se	2.4
Silver	Ag	20
Thallium	Tl	1
Uranium	U	23
Vanadium	V	86
Zinc	Zn	340

Sample ID	Date	Depth (m)	Sb	As	Ba	Be	B	Cd	Cr	Co	Cu	Pb	Mo	Ni	Se	Ag	Tl	U	V	Zn
BH-3 SS1	27/10/2021	0.0 - 0.75	<0.20	3.4	100	0.41	<5.0	0.12	26	6.1	14	38	0.80	16	<0.50	<0.20	0.11	0.92	28	50

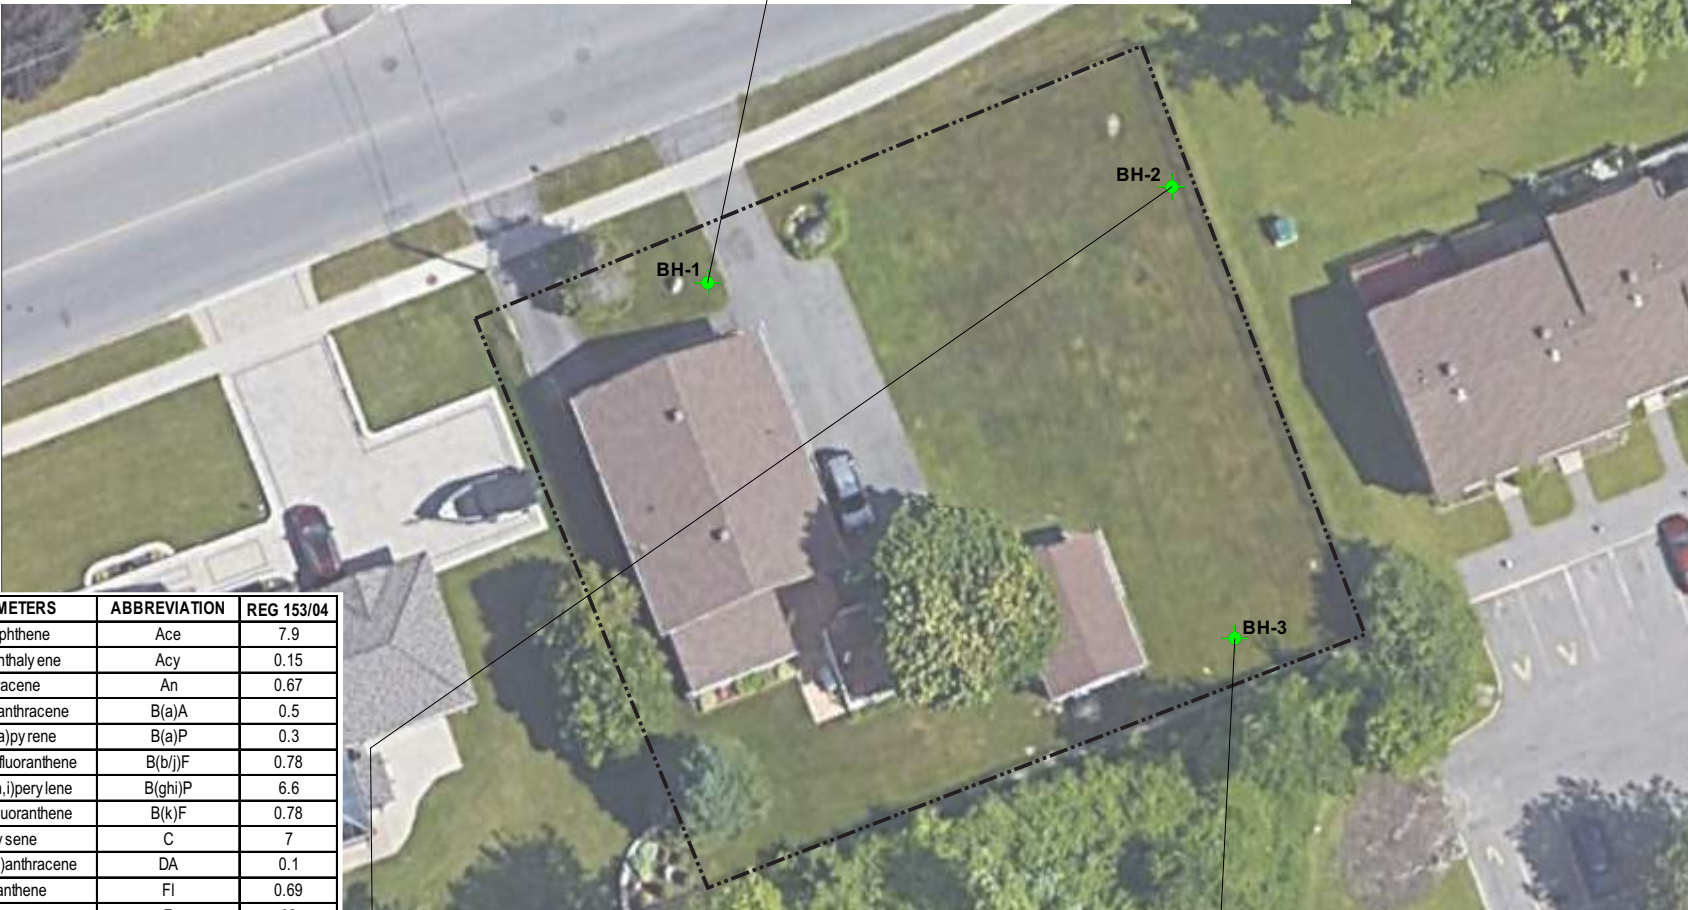
PARAMETERS	ABBREVIATION	REG 153/04
Acenaphthene	Ace	7.9
Acenaphthylene	Acy	0.15
Anthracene	An	0.67
Benzo(a)anthracene	B(a)A	0.5
Benzo(a)pyrene	B(a)P	0.3
Benzo(b)fluoranthene	B(b)F	0.78
Benzo(g,h,i)perylene	B(ghi)P	6.6
Benzo(k)fluoranthene	B(k)F	0.78
Chrysene	C	7
Dibenz(a,h)anthracene	DA	0.1
Fluoranthene	Fl	0.69
Fluorene	F	62
Indeno(1,2,3-cd)pyrene	I(123)P	0.38
Total Methylnaphthalene	T-MN	0.99
Naphthalene	N	0.6
Phenanthrene	P	6.2
Pyrene	Py	78

Sample ID	Date	Depth (m)	Ace	Acy	An	B(a)A	B(a)P	B(b)F	B(ghi)P	B(k)F	C	DA	Fl	F	I(123)P	T-MN	N	P	Py
BH-3 SS1	27/10/2021	0.0 - 0.75	<0.0050	<0.0050	0.0058	0.016	0.016	0.026	0.012	0.0084	0.017	<0.0050	0.037	<0.0050	0.013	0.013	<0.0050	0.027	0.033
