**Functional Site Servicing and
Stormwater Management
Report – 1987 Robertson Road
(Stillwater Station)**

Job #160401686

Prepared for:
The Properties Group
Management Ltd.

Prepared by:
Stantec Consulting Ltd.
1331 Clyde Avenue
Ottawa, Ontario
K2C 3G4

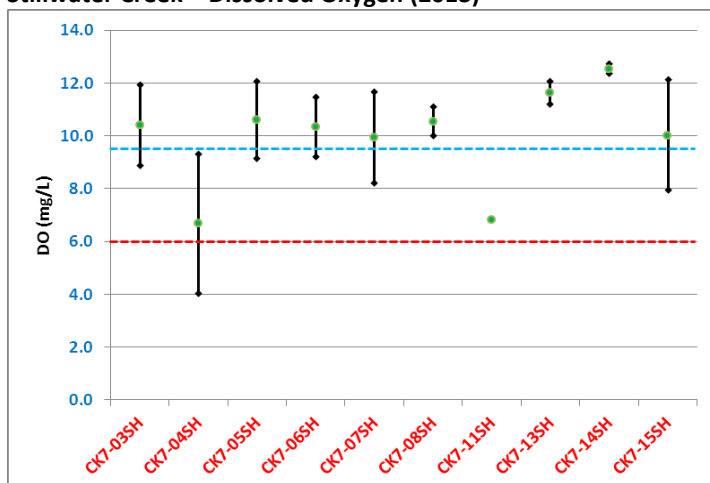
Figure 5. Dissolved oxygen ranges recorded at each sampling site along Stillwater Creek (CEQG: Red-Warmwater biota minimum tolerance – Blue: Coldwater biota minimum tolerance)

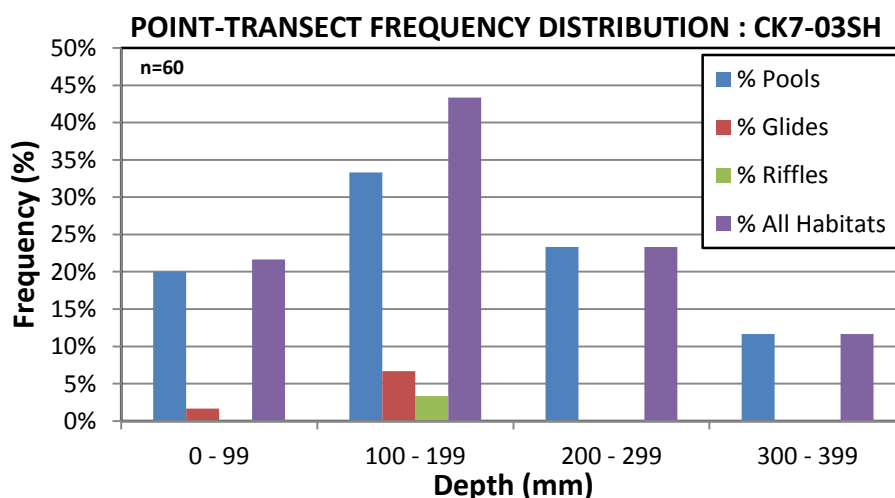
Figure 6. Frequency distribution of habitat types/stream velocities at 100mm intervals for site CK7-03SH

The results of the habitat assessment for site CK7-03SH are summarized in Figure 6. The analysis revealed a total habitat area of approximately 170.3m², consisting of 89% pool habitat, 8% glides and 3% riffles. Embedded cover was observed over approximately 30% of the site, and consisted primarily of rocks and macrophytes. Unembedded cover included rocks, macrophytes and wood, and was observed over approximately 70% of the site (Appendix IV).

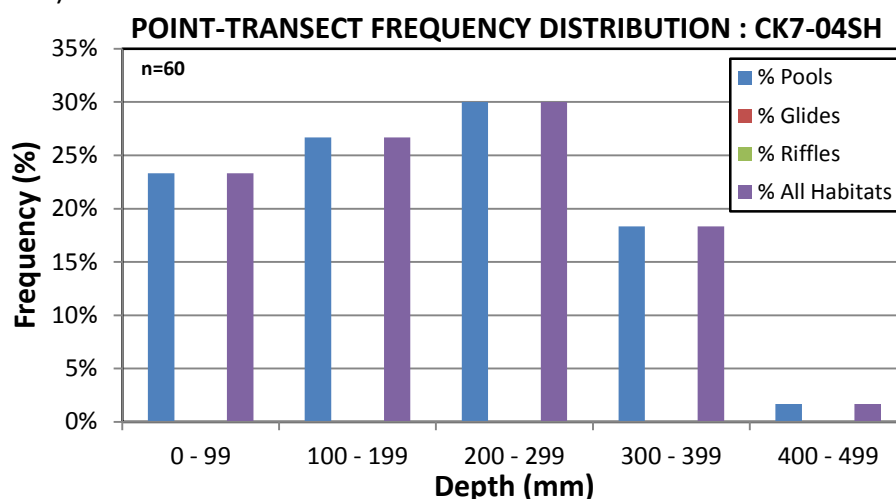
Figure 7. Frequency distribution of habitat types/stream velocities at 100mm intervals for site CK7-04SH

The results of the habitat assessment for site CK7-04SH are summarized in Figure 7. The analysis revealed a total habitat area of approximately 298.6m², consisting of 100% pool habitat. Embedded cover was observed over approximately 13% of the site, and consisted primarily of rocks, wood and macrophytes. Unembedded cover included rocks and wood, with the majority being macrophytes (66%); and was observed over approximately 86% of the site (Appendix IV).

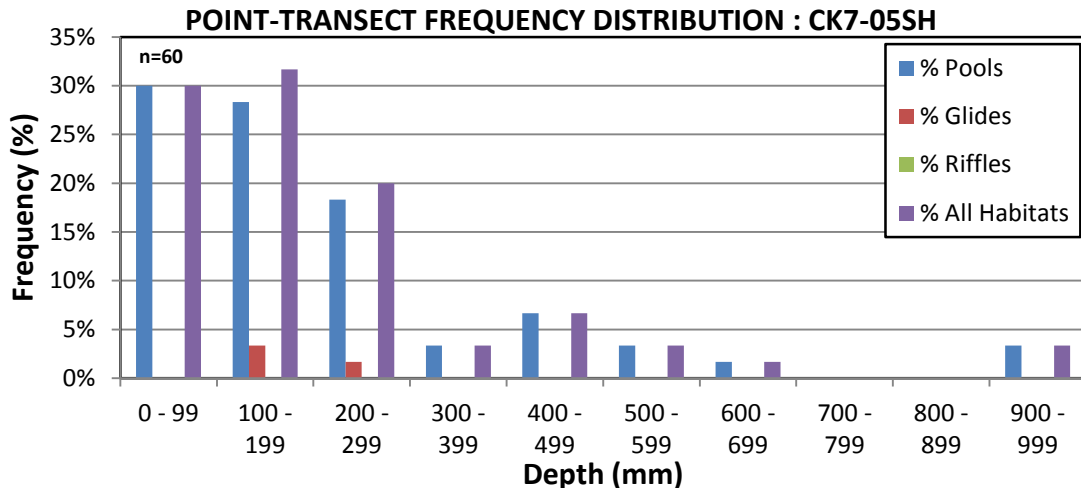
Figure 8. Frequency distribution of habitat types/stream velocities at 100mm intervals for site CK7-05SH

The results of the habitat assessment for site CK7-05SH are summarized in Figure 8. The analysis revealed a total habitat area of approximately 154.3m², consisting of 95% pool habitat, and 5% glides. Embedded cover was observed over approximately 17% of the site, and consisted primarily of wood, rocks and macrophytes. Unembedded cover included rocks, macrophytes and wood, and was observed over approximately 77% of the site (Appendix IV).

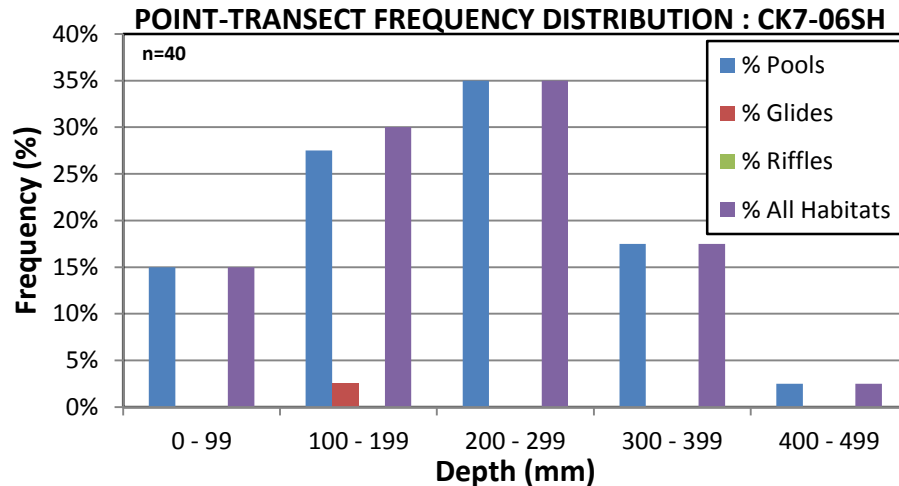
Figure 9. Frequency distribution of habitat types/stream velocities at 100mm intervals for site CK7-06SH

The results of the habitat assessment for site CK7-06SH are summarized in Figure 9. The analysis revealed a total habitat area of approximately 56.9m², consisting of 97% pool habitat, and 3% glides. Embedded cover was observed over approximately 5% of the site, and consisted solely of macrophytes. Unembedded cover included primarily macrophytes and wood, and was observed over approximately 68% of the site (Appendix IV).

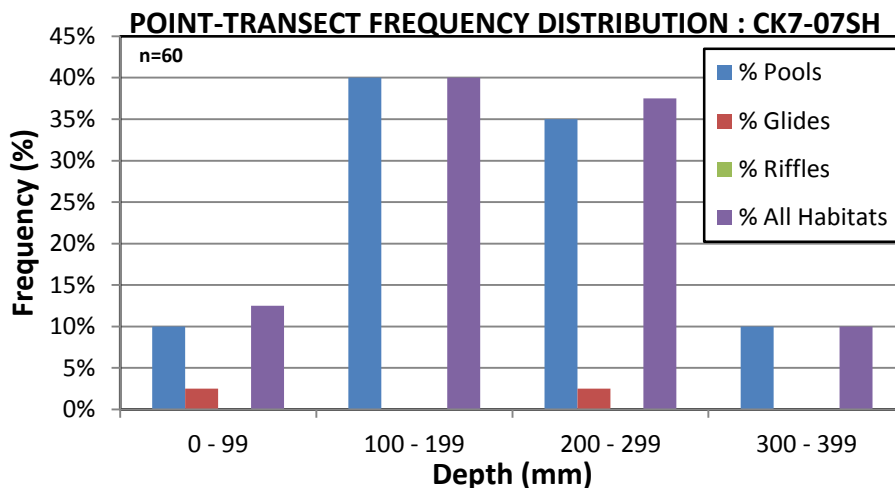
Figure 10. Frequency distribution of habitat types/stream velocities at 100mm intervals for site CK7-07SH

The results of the habitat assessment for site CK7-07SH are summarized in Figure 10.

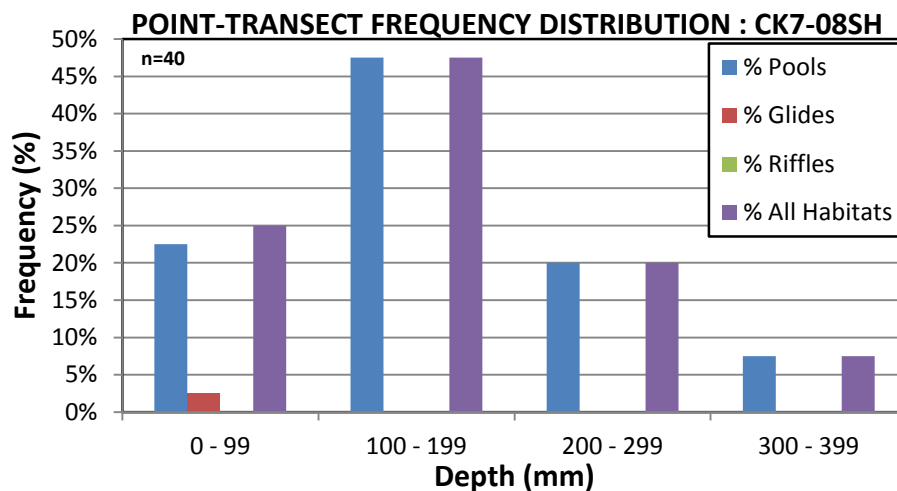
Figure 11. Frequency distribution of habitat types/stream velocities at 100mm intervals for site CK7-08SH

The results of the habitat assessment for site CK7-08SH are summarized in Figure 11. The analysis revealed a total habitat area of approximately 48.2m², consisting of 97% pool habitat, and 3% glides. Embedded cover was observed over approximately 15% of the site, and consisted primarily of rocks and macrophytes. Unembedded cover included rock, macrophytes and wood, and was observed over approximately 10% of the site (Appendix IV).

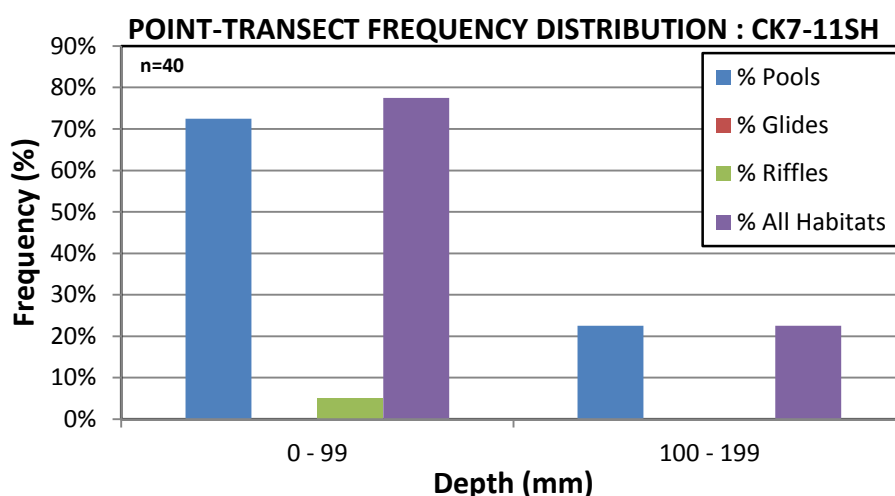
Figure 12. Frequency distribution of habitat types/stream velocities at 100mm intervals for site CK7-11SH

The results of the habitat assessment for site CK7-11SH are summarized in Figure 12. The analysis revealed a total habitat area of approximately 94.6m², consisting of 95% pool habitat, and 5% riffles. Embedded cover was observed over approximately 30% of the site, and consisted solely of wood materials. Unembedded cover included rock, macrophytes and wood, and was observed over approximately 10% of the site (Appendix IV).

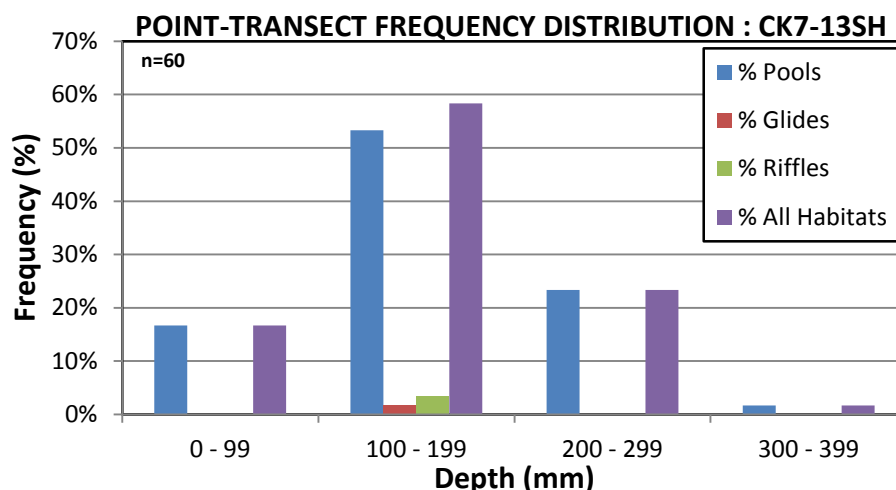
Figure 13. Frequency distribution of habitat types/stream velocities at 100mm intervals for site CK7-13SH

The results of the habitat assessment for site CK7-13SH are summarized in Figure 13. The analysis revealed a total habitat area of approximately 131.6m², consisting of 95% pool habitat, 2% glides and 3% riffles. Embedded cover was observed over approximately 12% of the site, and consisted solely of rock materials. Unembedded cover included flat and round rock, and was observed over approximately 57% of the site (Appendix IV).

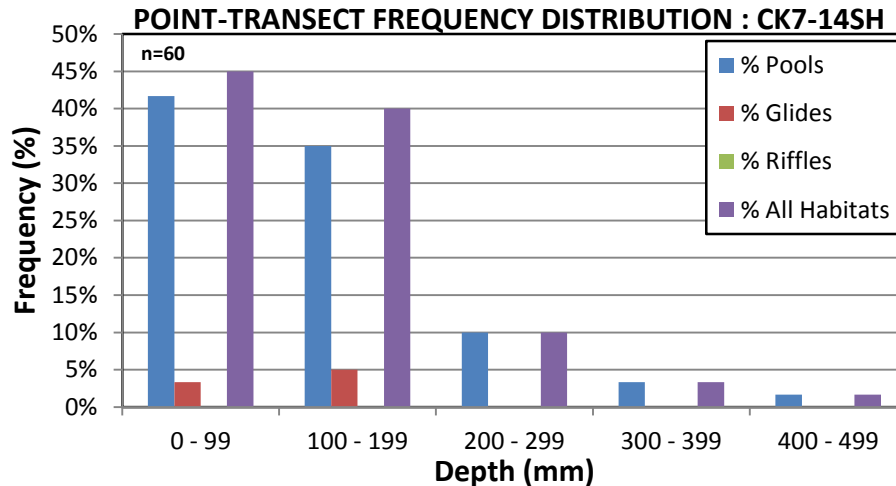
Figure 14. Frequency distribution of habitat types/stream velocities at 100mm intervals for site CK7-14SH

The results of the habitat assessment for site CK7-14SH are summarized in Figure 14. The analysis revealed a total habitat area of approximately 93.6m², consisting of 92% pool habitat, and 8% glides. Embedded cover was observed over approximately 23% of the site, and consisted of rock and woody materials. Unembedded cover included the same base materials, and was observed over approximately 30% of the site (Appendix IV).

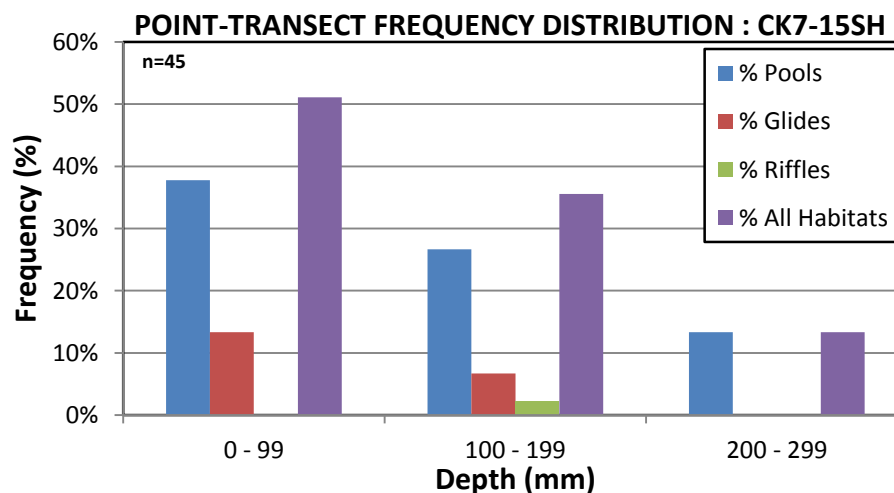
Figure 15. Frequency distribution of habitat types/stream velocities at 100mm intervals for site CK7-15SH

The results of the habitat assessment for site CK7-15SH are summarized in Figure 15. The analysis revealed a total habitat area of approximately 84.3m², consisting of 78% pool habitat, 20% glides and 2% riffles. Embedded cover was observed over approximately 9% of the site, and consisted solely of rock materials.

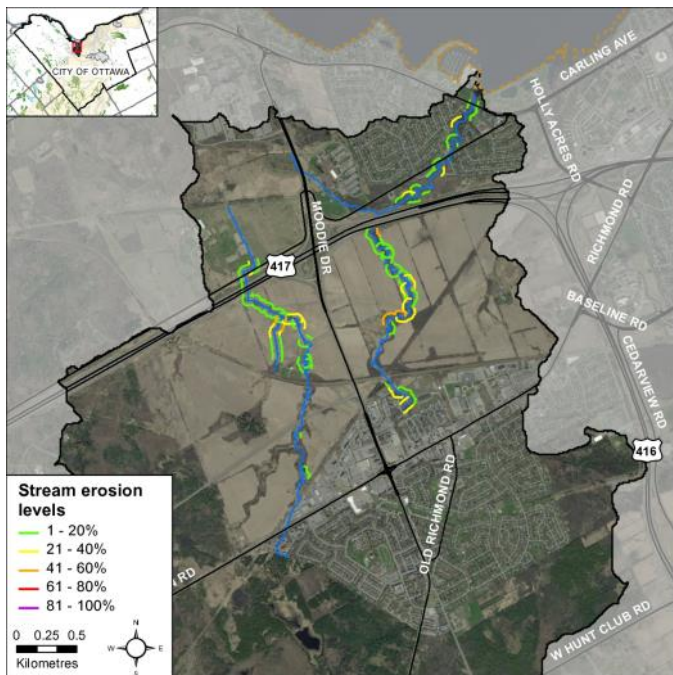
Erosion is a normal, important stream process and may not affect actual bank stability; however, excessive erosion and deposition of sediment within a stream can have a detrimental effect on important fish and wildlife habitat. Poor bank stability can greatly contribute to the amount of sediment carried in a waterbody as well as loss of bank vegetation due to bank failure, resulting in trees falling into the stream and the potential to impact instream migration. Figure 4 shows low to moderate levels of bank erosion were observed along many sections of Stillwater Creek. Most of the areas where erosion was observed were in the agricultural lands south of Highway 417 on the main channel of the creek and its tributary. Shoreline stability in this area could be improved by increasing the vegetated buffer width along the creek.

Figure 4 Erosion along Stillwater Creek

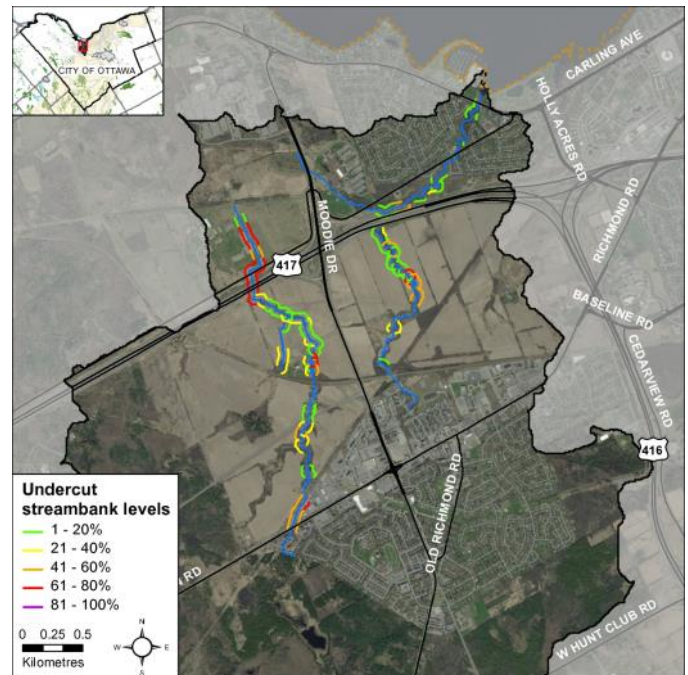
Undercut banks are a normal and natural part of stream function and can provide excellent refuge areas for fish. Figure 5 shows that the bank undercutting on Stillwater Creek varied considerably. Much of the creek had low levels of bank undercutting but these were interspersed with areas of moderate to high level undercutting. The highest levels of undercutting were observed where highway 417 crosses Stillwater Creek. The bank and substrate composition in this area is dominated by clay and the riparian vegetation is predominantly grasses so there is a possibility that the bank undercutting in section of the creek may lead to bank failure over time.

Figure 5 Undercut stream banks along Stillwater Creek

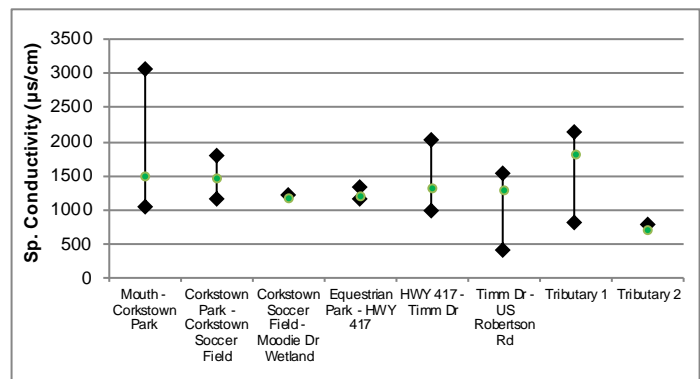
Conductivity in streams is primarily influenced by the geology of the surrounding environment, but can vary drastically as a function of surface water runoff. Currently there are no CCME guideline standards for stream conductivity, however readings which are outside the normal range observed within the system are often an indication of unmitigated discharge and/or stormwater input. The average specific conductivity observed within Stillwater Creek was 1309 $\mu\text{S}/\text{cm}$. Figure 23 shows that the conductivity readings varied moderately along the course of the creek. The lowest average specific conductivity reading at 717 $\mu\text{S}/\text{cm}$, was observed on the tributary of Stillwater Creek surveyed to the west of Moodie Drive. There is a significant spike in conductivity in the tributary east of Moodie Drive where the average recorded conductivity was 1813 $\mu\text{S}/\text{cm}$. The tributary east of Moodie Drive conveys flow from the highly developed area of Bells Corners around Robertson Road. As a result, the water chemistry of the tributary is significantly influenced by stormwater runoff.

Figure 23 Conductivity ranges in Stillwater Creek

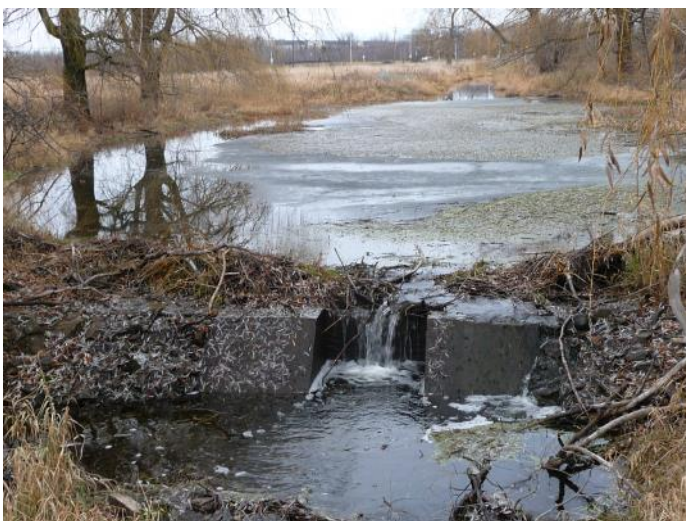
A weir constructed along Stillwater Creek downstream of Moodie Drive that was observed in 2009 and 2015
