Phase I - Environmental Site Assessment

2006, 2020, & 2026 Scott Street
and 314 & 318 Athlone Avenue
Ottawa, Ontario

May 21, 2021

Report: PE5303-1

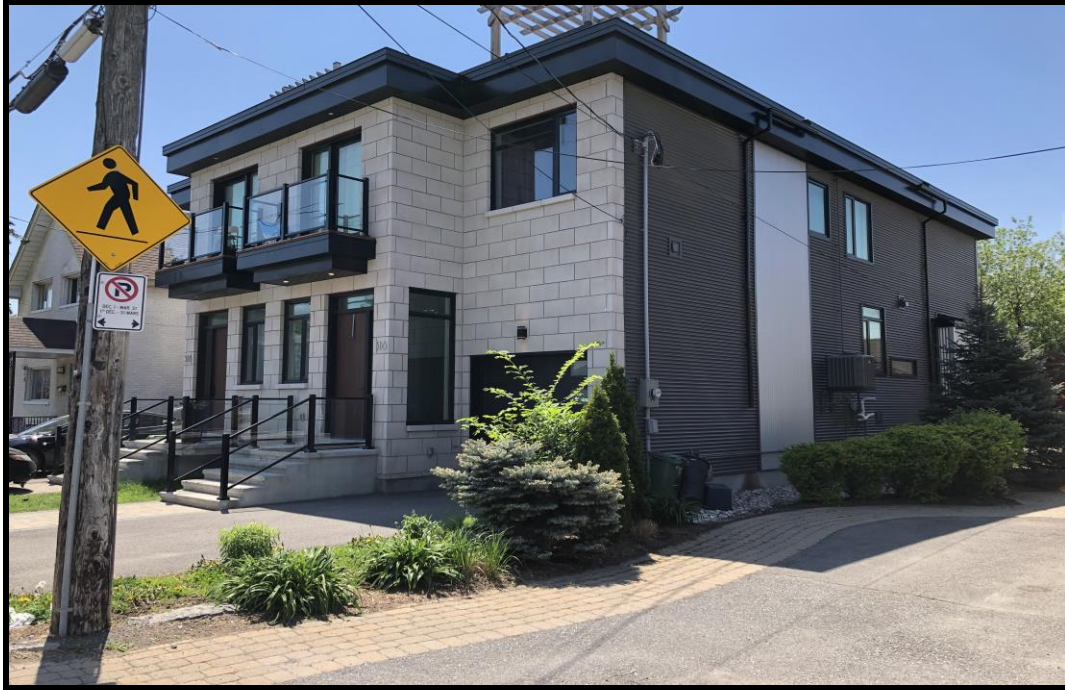
This property is currently occupied with a two storey semi-detached residential dwelling, with one basement level. Built in 2017, the subject building is constructed with a poured concrete foundation and is finished on the exterior with concrete block in addition to a flat rolled membrane roof. The subject building is currently heated via a natural gas-fired furnace.

Photograph 1: View of the semi-detached residential dwelling at 318 Athlone Avenue, facing southwest from Athlone Avenue.

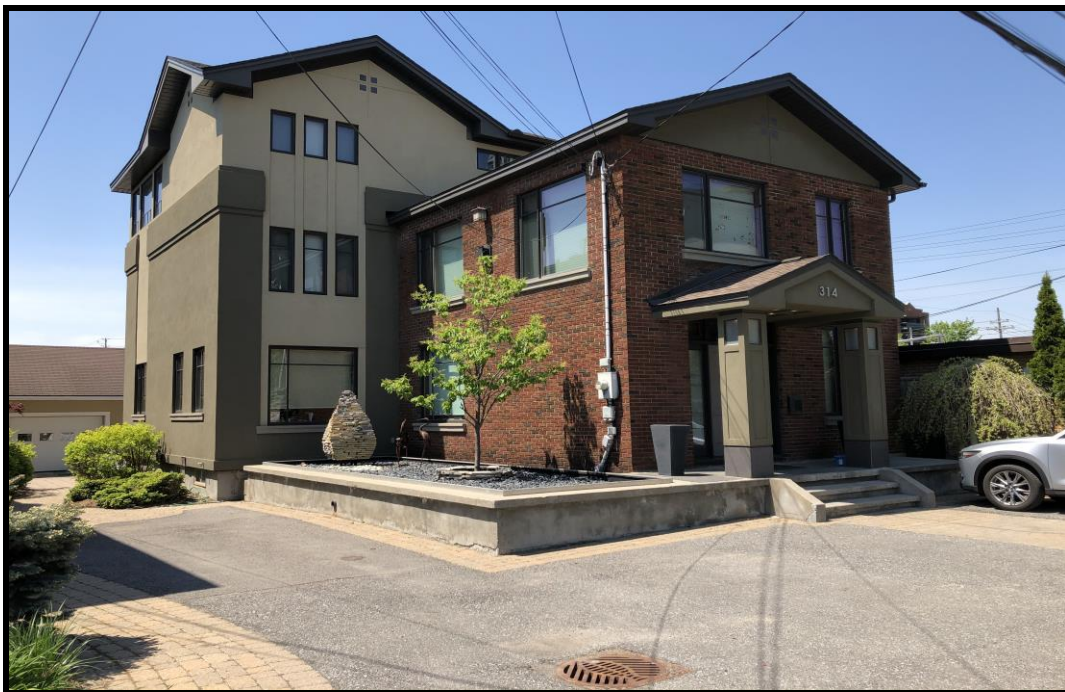
This property is currently occupied with a three storey mixed-use building, with one basement level. The original two storey structure, initially constructed as a residential dwelling, was built sometime circa 1910. A rear addition, as well as a third storey, were later constructed in 2006. The subject building is constructed with a stone (original structure) and poured concrete (rear addition) foundation, and is finished on the exterior with brick and stucco siding in addition to a sloped-shingled roof. The subject building is currently heated via a natural gas-fired furnace.

A one storey, slab-on-grade style detached garage building is also located at the rear of this property. Built sometime in the 1960's, (and later renovated in 2006) the subject building is constructed with a poured concrete slab foundation and is finished on the exterior with stucco siding in addition to a sloped-shingled roof. The subject building is currently heated via a natural gas-fired furnace.

Photograph 2: View of the mixed-use building at 314 Athlone Avenue, facing west from Athlone Avenue.

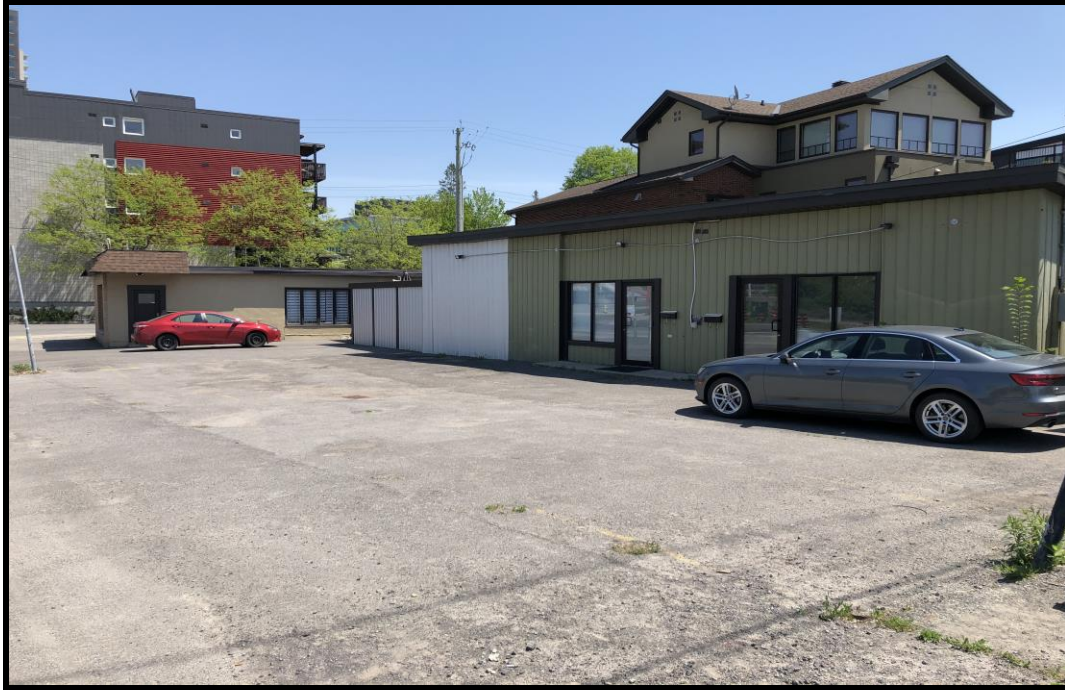
This property is currently occupied with a one storey, slab-on-grade style commercial office building. Built sometime in the 1960's (later renovated in 2019), the subject building is constructed with a poured concrete slab foundation, and is finished on the exterior with brick and vinyl siding in addition to a flat tar-and-gravel style roof. The subject building is currently heated via a natural gas-fired furnace.

Photograph 3: View of the two commercial office buildings at 2006 Scott Street (background) and 2020 Scott Street (foreground), facing east from Scott Street.

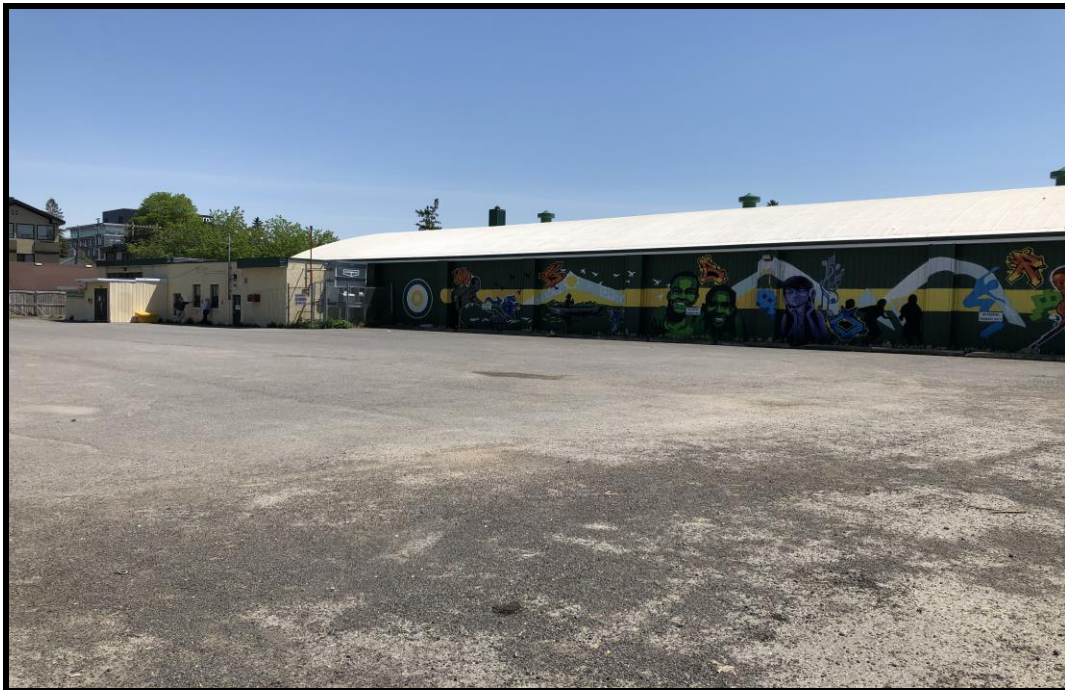
This property is currently occupied with a one storey community curling arena, with a partial basement located under the eastern wing of the building. Built in 1953 (with an addition later constructed on to the eastern wing in 1961), the subject building is constructed with a poured concrete foundation and is finished on the exterior with metal, concrete block, and stucco siding, in addition to a rolled membrane roof. The subject building is currently heated via a natural gas-fired furnace.

Photograph 4: View of the curling arena at 2026 Scott Street, facing southeast from Scott Street.

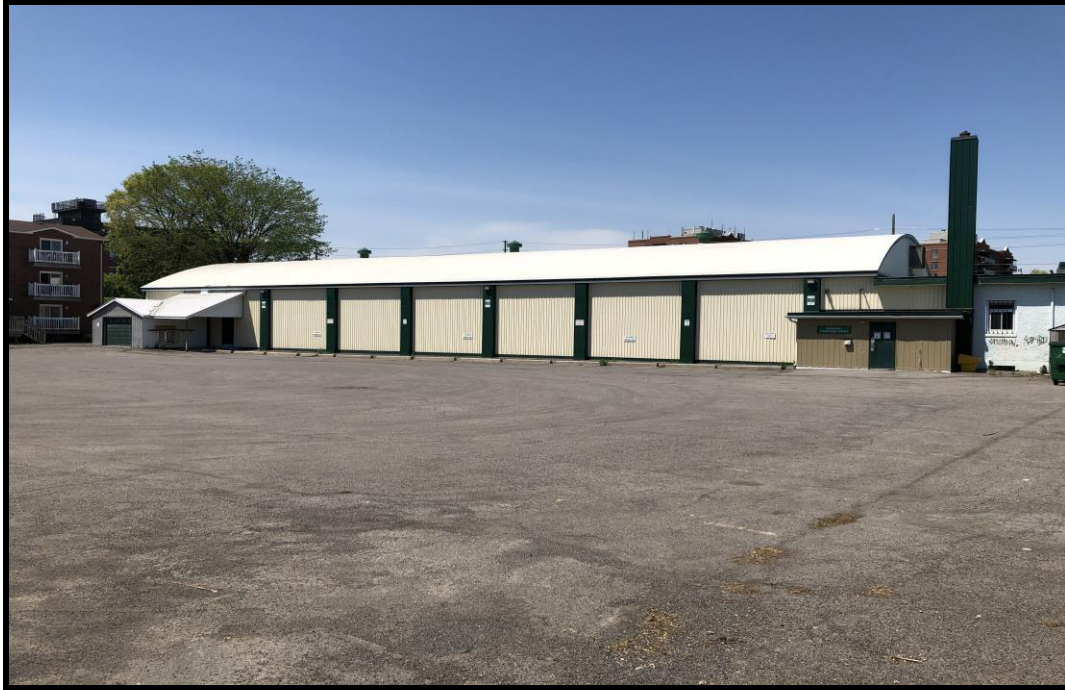
Photograph 5: View of the curling arena at 2026 Scott Street, facing north from Ashton Avenue.

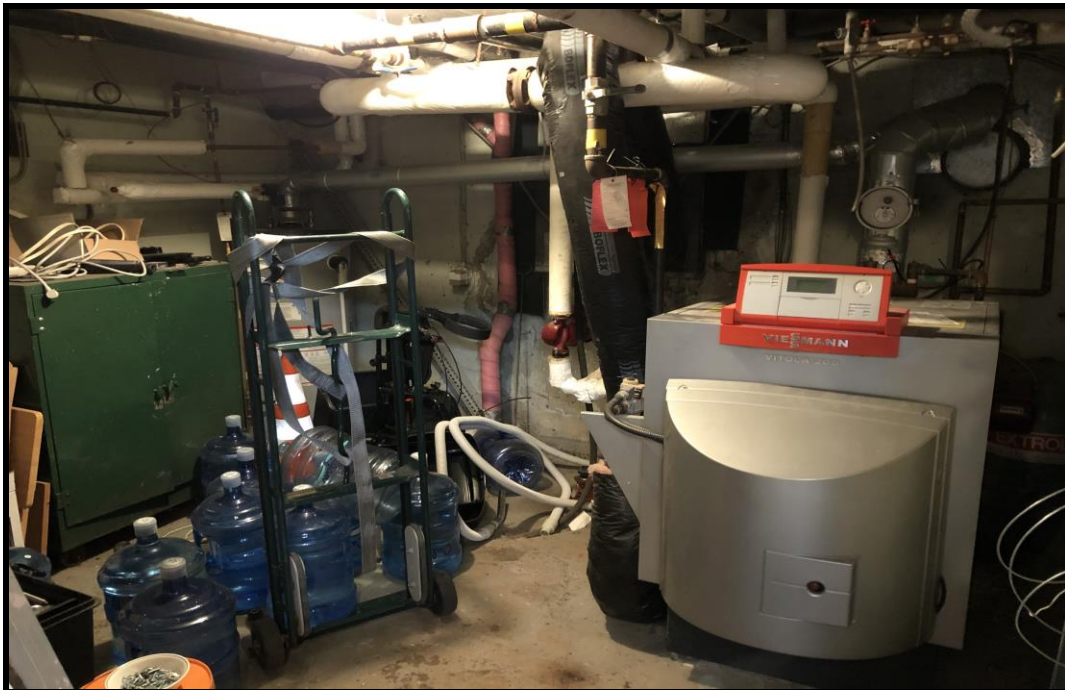
Photograph 6: View of the natural gas-fired boiler heating system, located in the basement of the curling arena at 2026 Scott Street.
