McKINLEY
ENVIRONMENTAL
SOLUTIONS

Combined Environmental Impact Statement &
Tree Conservation Report (Revised)
Kennedy Lands
3432 Greenbank Road, Ottawa, ON

April 2022
Prepared for Minto Communities

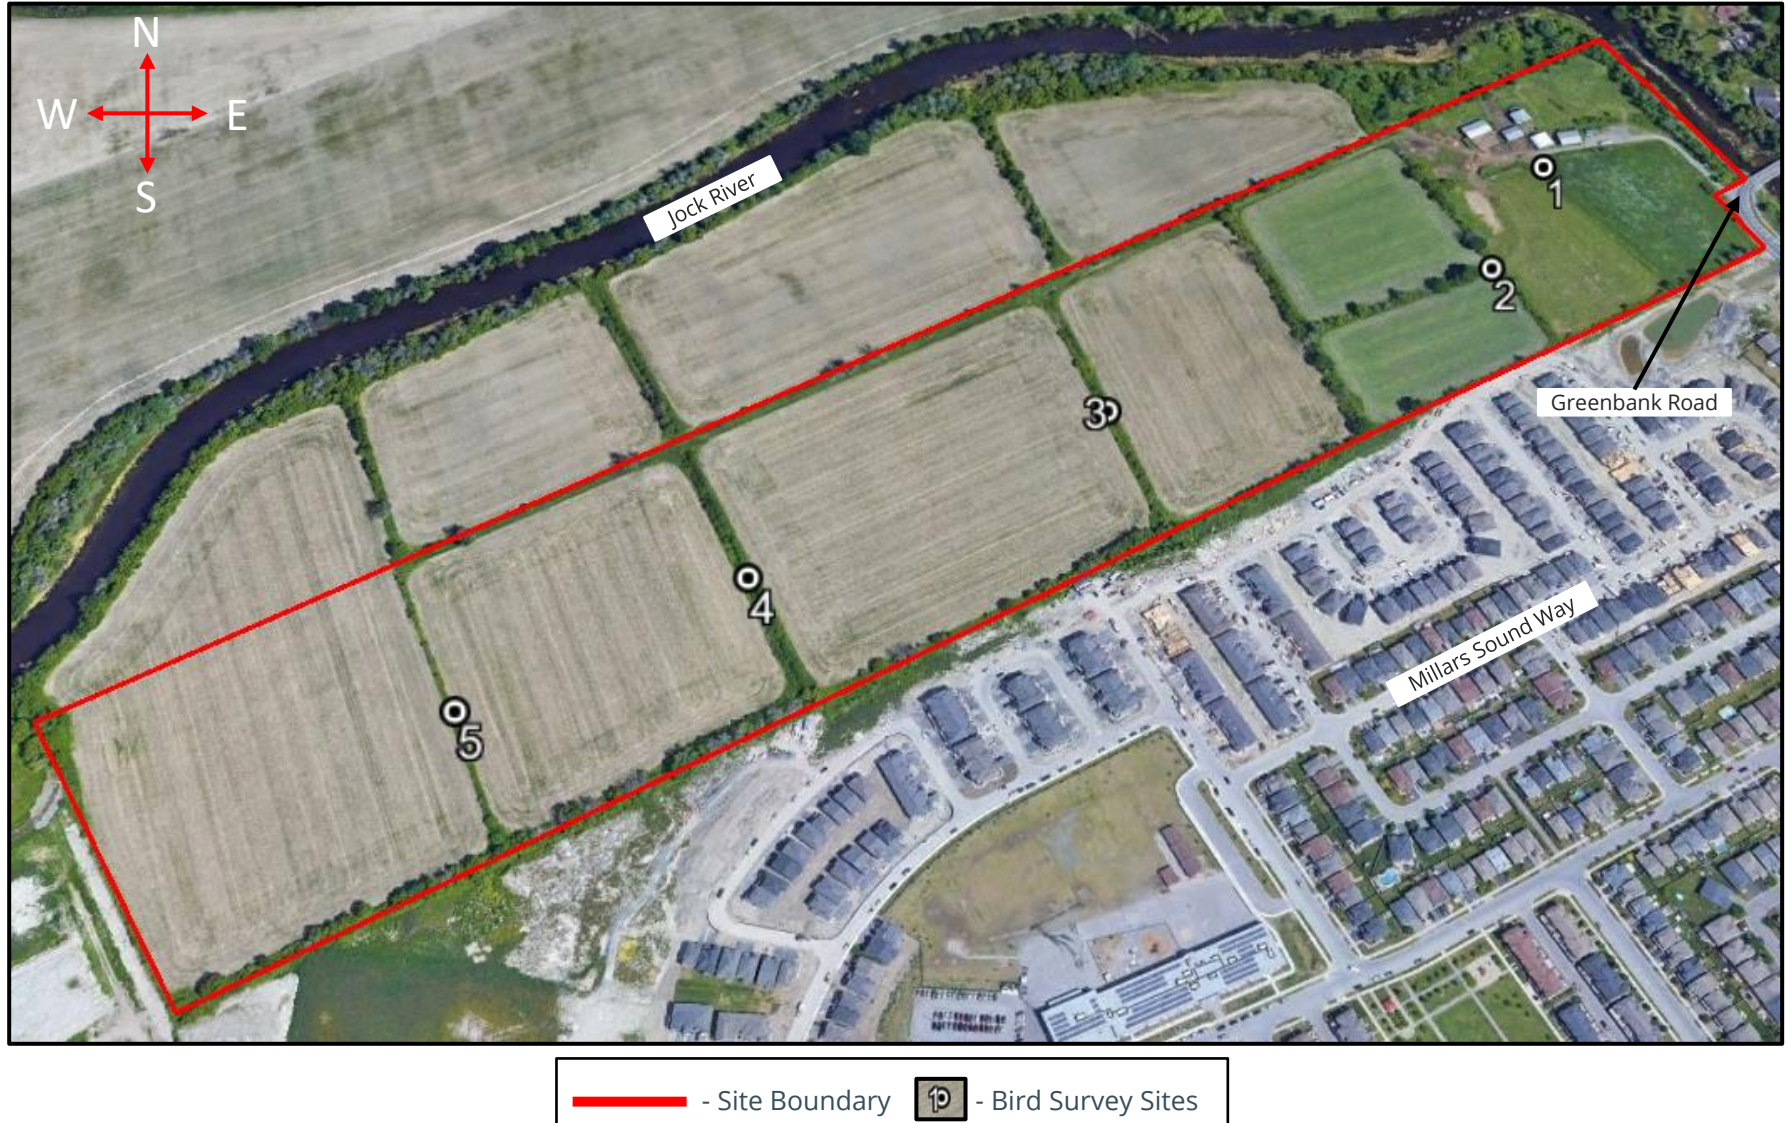
FIGURE 2: BIRD SURVEY SITES

the Breeding Bird Surveys was completed in the early morning between 6 am and 9 am. Weather conditions during the May 26th Site visit included temperatures of 22 °C and partly cloudy skies. Weather conditions during the June 2nd Site visit included temperatures of 17 °C and sunny skies. Weather conditions during the June 10th Site visit included temperatures of 18 °C and sunny skies. The surveys were undertaken following the Ontario Ministry of Natural Resources and Forestry (OMNRF) *Wildlife Monitoring Programs and Inventory Techniques - Technical Manual* (Konze & McLaren 1998) Breeding Bird Survey (BBS) method. The timing and methodology of the surveys followed the requirements outlined in the OMNRF *Survey Methodology under the Endangered Species Act: Dolichonyx oryzivorus (Bobolink)* (OMNRF 2011b). The bird survey points are shown below in Figure 2.

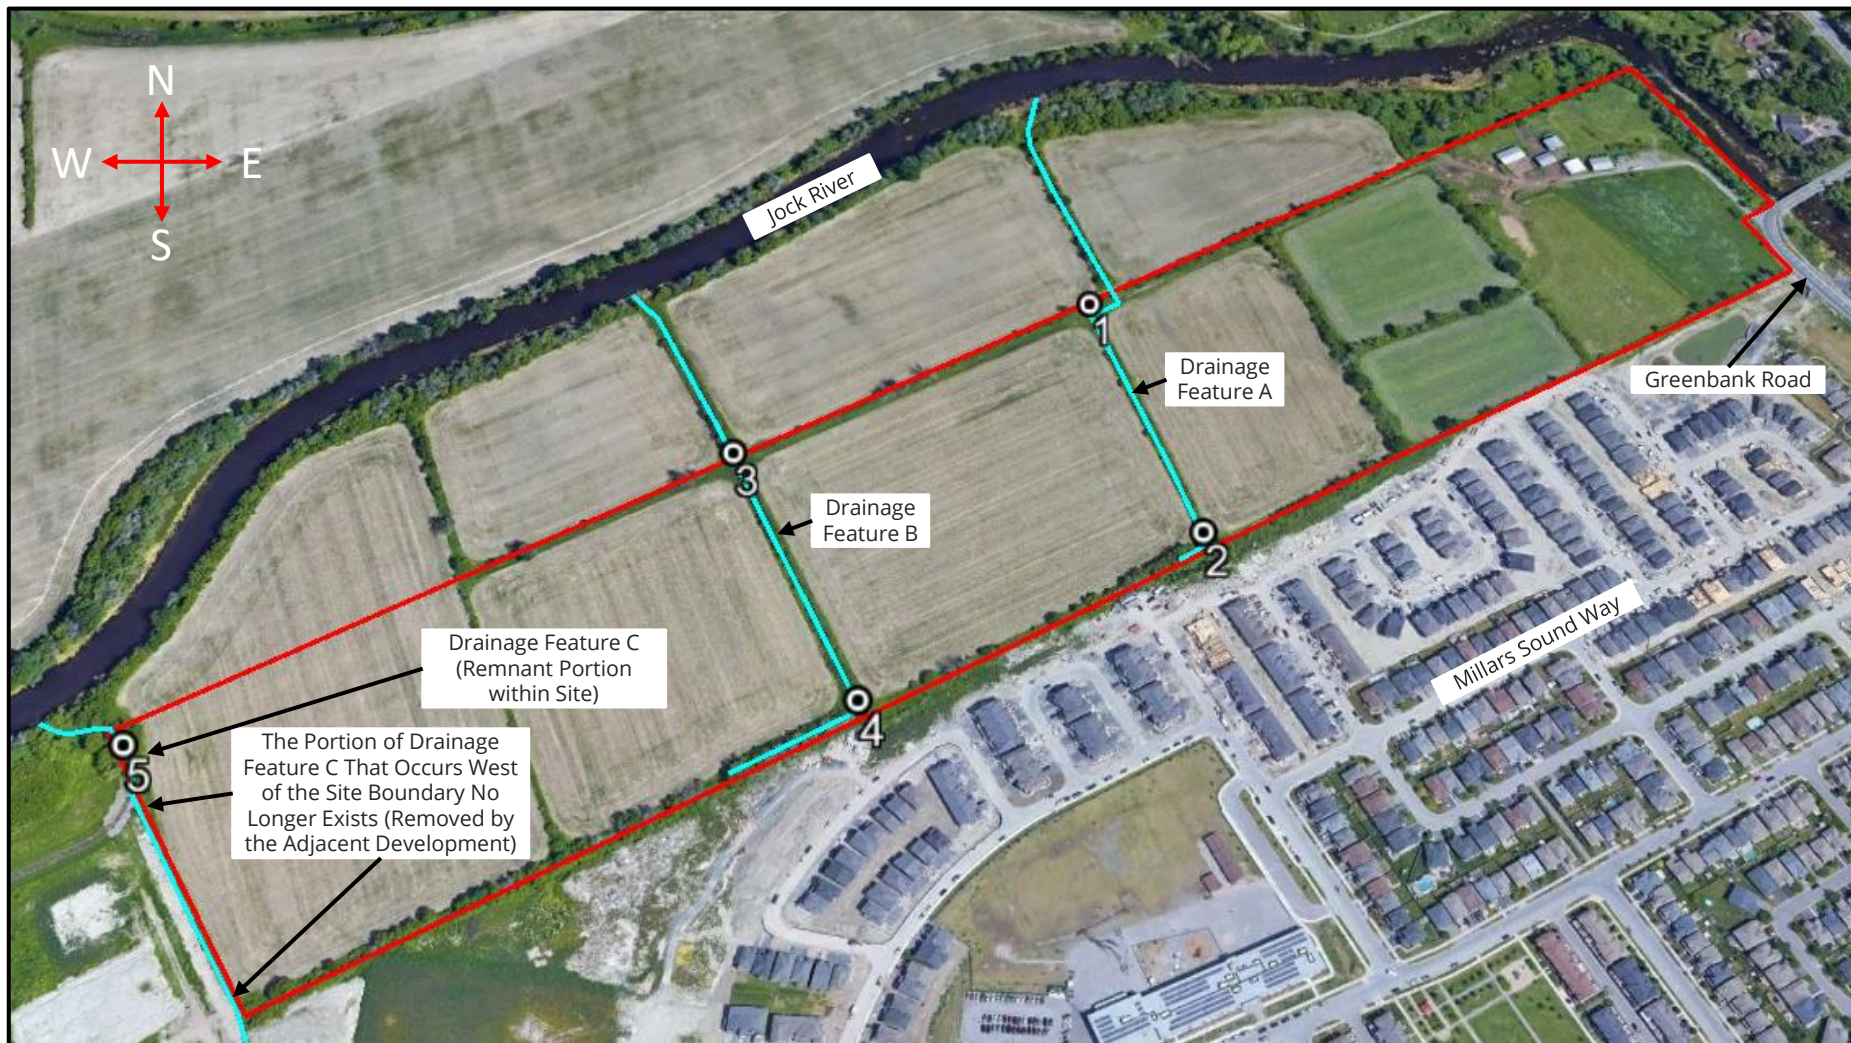
FIGURE 3: HDA SURVEY SITES

Site visits to preliminarily assess the ecological functions of the three (3) minor drainage features (minor tributaries of the Clarke Drain) were completed on July 29th, 2020 and September 17th, 2020. Weather conditions during the July 29th, 2020 Site visit included temperatures of 22 °C and partly cloudy skies. Weather conditions during the September 17th, 2020 Site visit included temperatures of 14 °C and sunny skies. Following the preliminary assessment of the three (3) minor drainage features in 2020, a full Headwaters Drainage Assessment (HDA) was undertaken in 2021. The Headwaters Drainage Assessment has been prepared under separate cover (Refer to MES 2022).

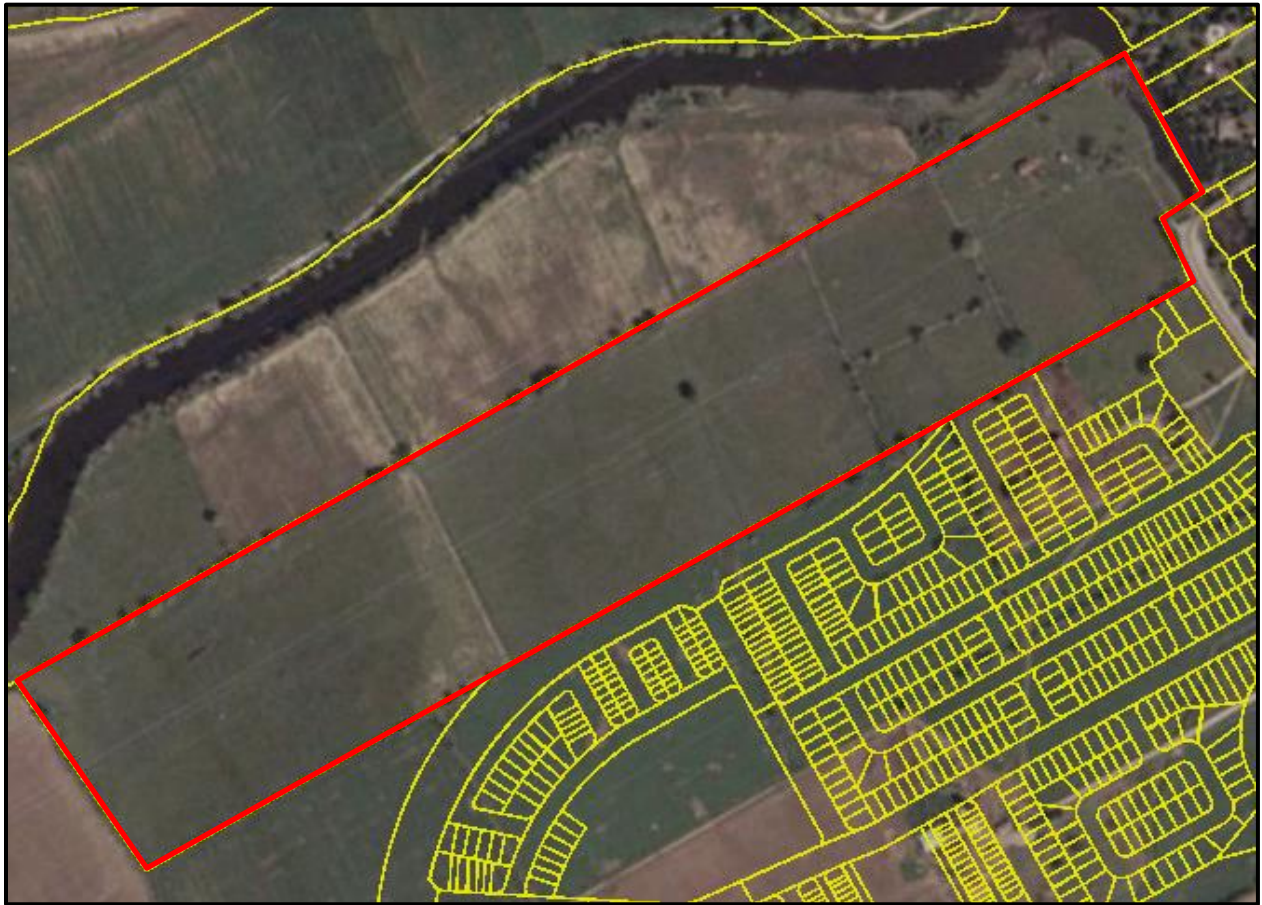
Historic Air Photograph 1: Historic Air Photo from 1976 (Site limits shown in red). Note that the overall composition of the Site was similar to current conditions in 1976, with most of the Site intensively farmed. Relatively few trees are visible within the Site in 1976, suggesting that the Deciduous Hedgerows began growing at a later date (Photos from City of Ottawa 2021).

Air photos from 1976 and 1991 are included below (Photos from City of Ottawa 2021). Recent air photos are included in the report figures. The overall composition of the Site was similar to current conditions in 1976, with most of the Site intensively farmed. Relatively few trees are visible within the Site in 1976, suggesting that the Deciduous Hedgerows began growing at a later date. In 1991, again the overall composition of the Site was similar to current conditions, with most of the Site intensively farmed. Tree cover at the Site edges and within the Deciduous Hedgerows increased by 1991 (compared to 1976). However, tree cover within the Deciduous Hedgerows remains sparse in 1991. This suggests that while some trees that currently occur within the Deciduous Hedgerows are approximately 30 years of age, the majority of stems began growing after 1991, and hence are <30 years of age.

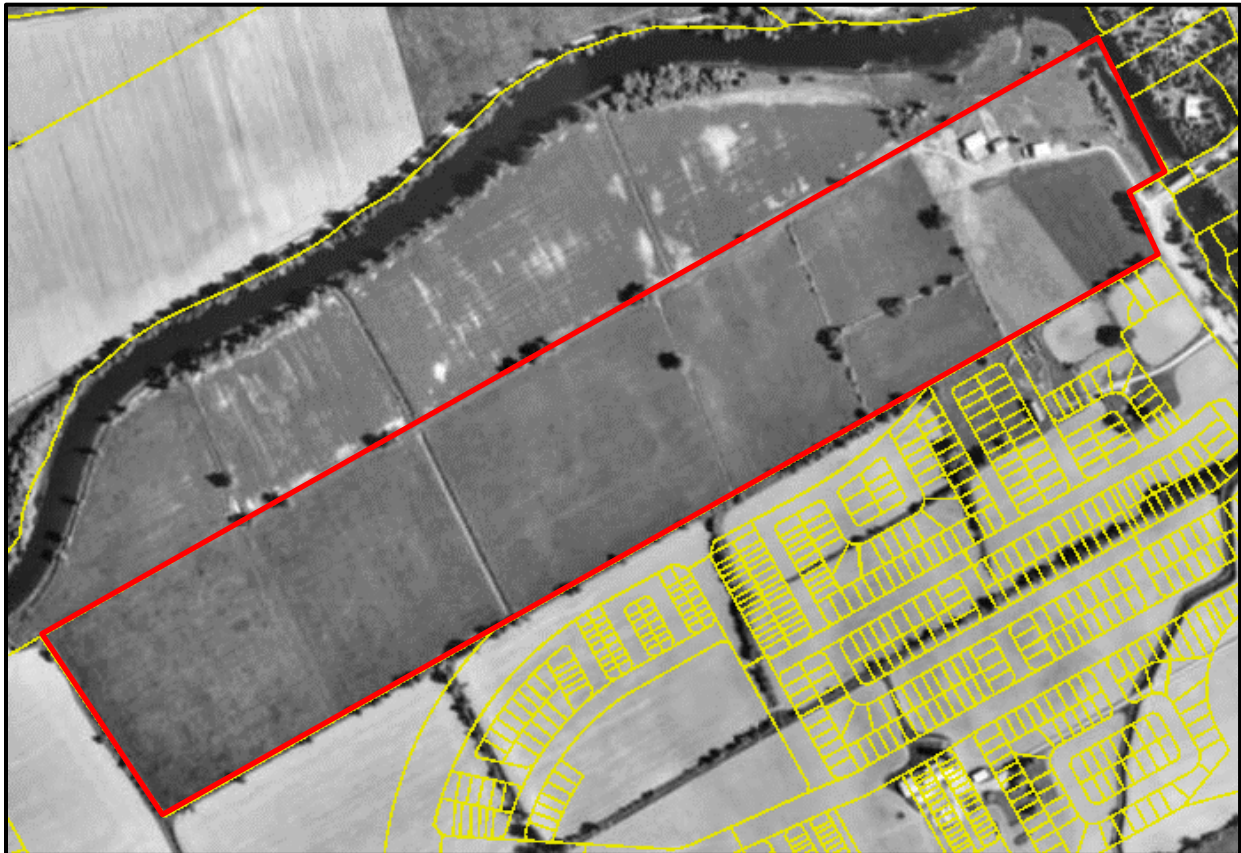
Historic Air Photograph 2: Historic Air Photo from 1991 (Site limits shown in red). Note that the overall composition of the Site was similar to current conditions in 1991, with most of the Site intensively farmed. Tree cover at the Site edges and within the Deciduous Hedgerows increased by 1991 (compared to 1976). However, tree cover within the Deciduous Hedgerows remains sparse in 1991 (Photos from City of Ottawa 2021).

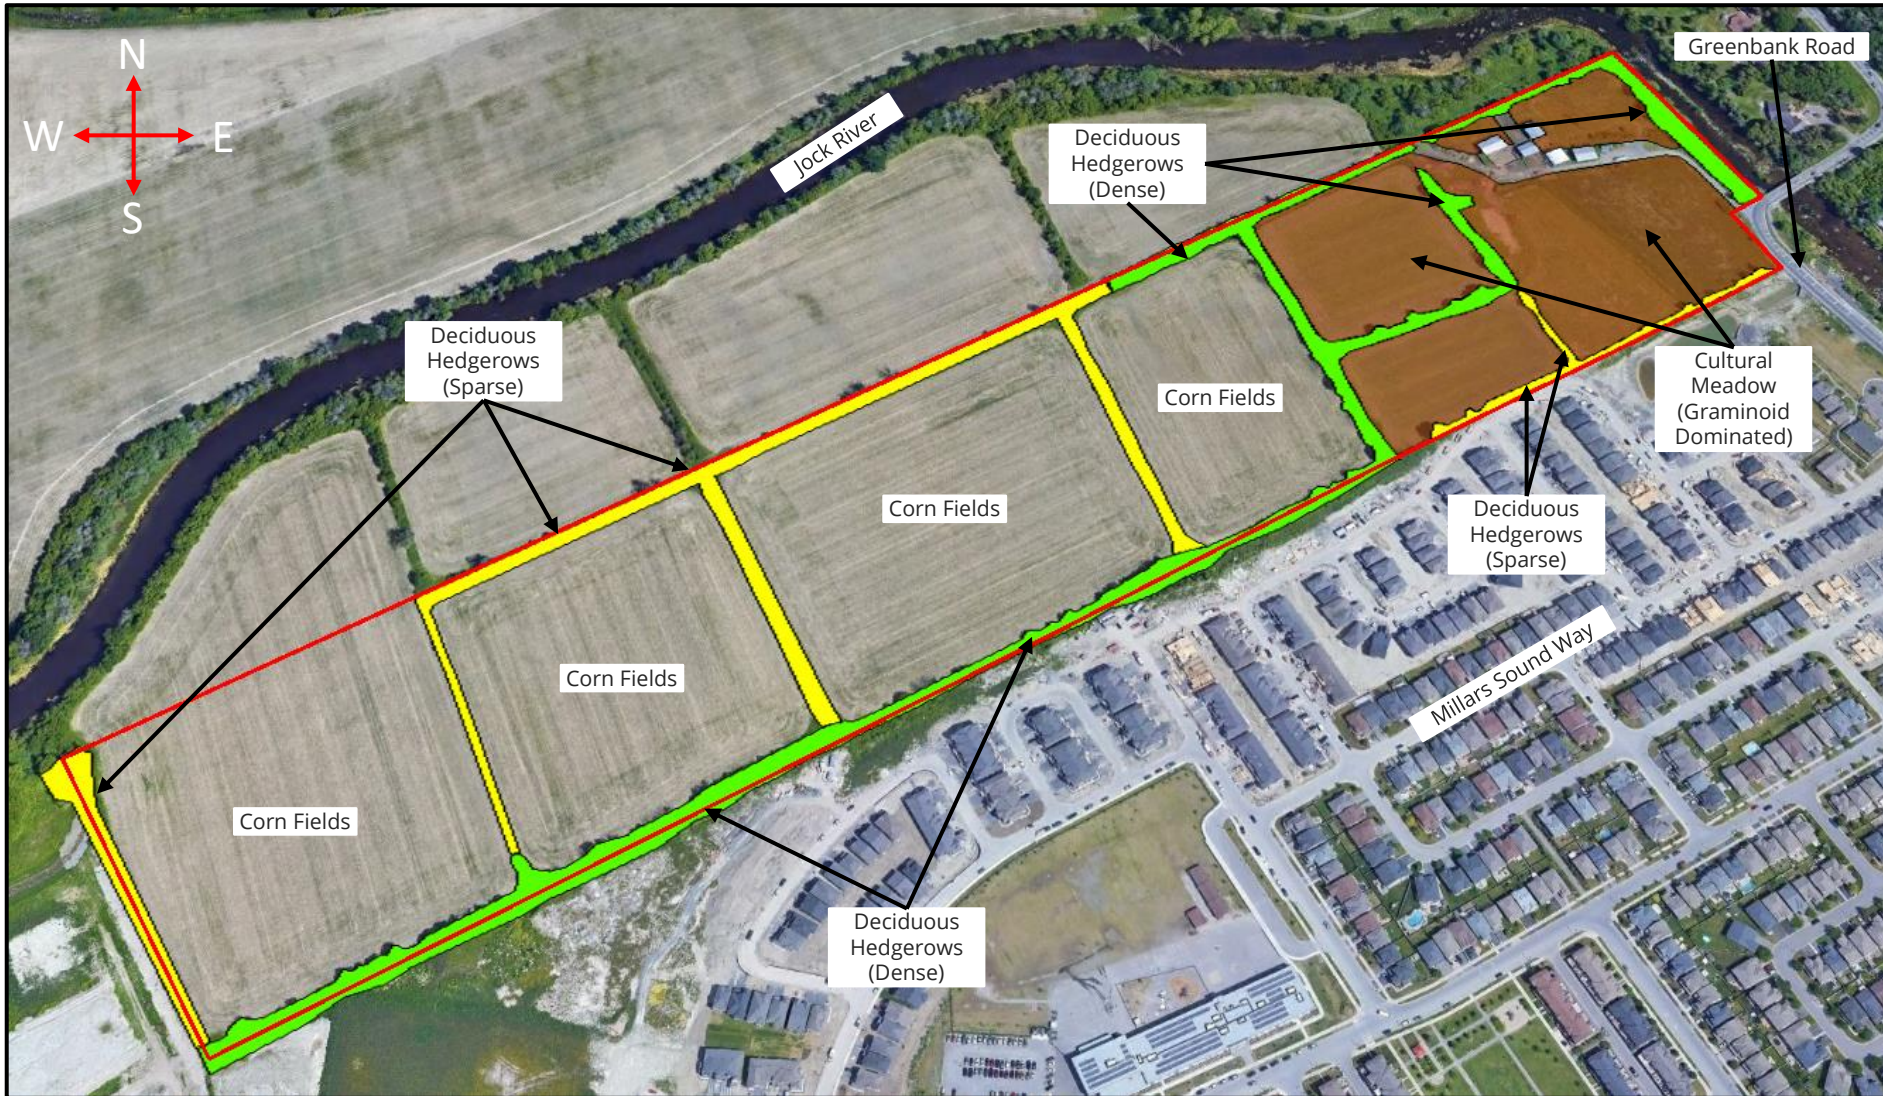
Vegetation communities found within the Site are shown below in Figure 4. Refer to the Plant List (Appendix A) for a complete list of plants found within the Site. The Site includes the following terrestrial vegetation communities:

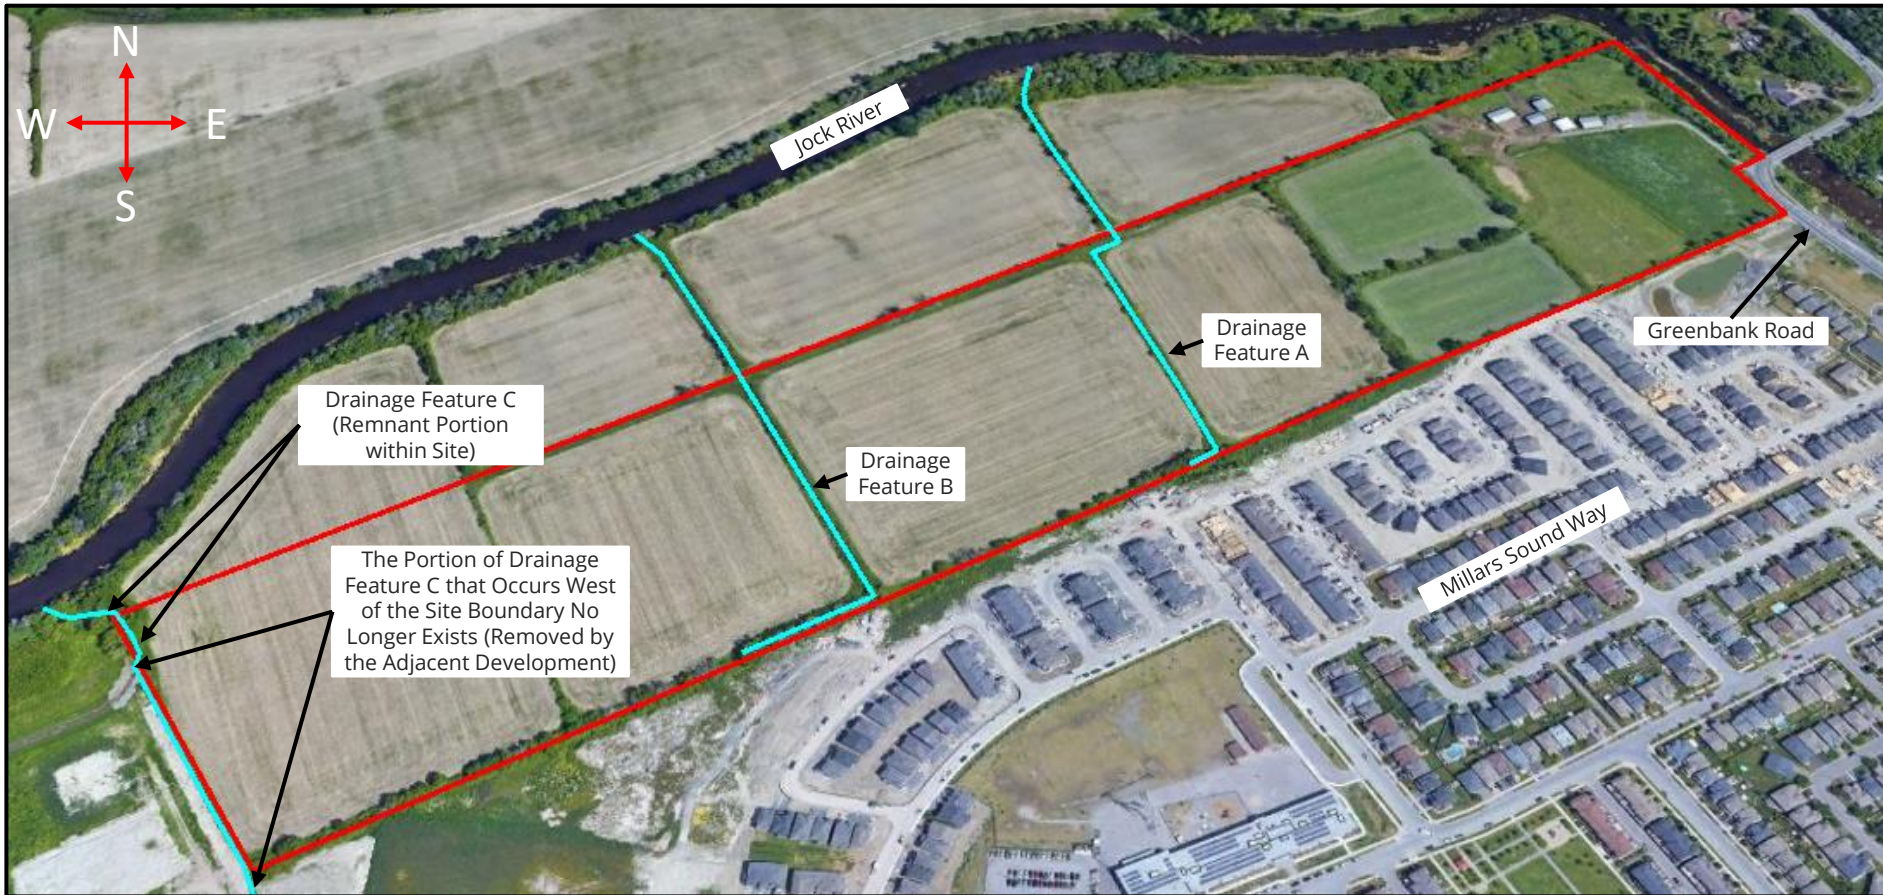
FIGURE 5: MINOR DRAINAGE FEATURES

MES (2022) identifies that all three (3) of the minor drainage features are highly degraded channelized drains which provide negligible ecological functions. Drainage Feature A and Drainage Feature B both displayed extremely limited hydrological functions. Both Drainage Feature A and Drainage Feature B occur within narrow deciduous hedgerows, beyond which the riparian zone consists of corn fields and/or the adjacent residential subdivision (located to the south). Drainage Feature C was hydrated by water backed up from the Jock River in the early spring, but displayed very limited hydrological functions throughout the remainder of the survey period. The riparian vegetation surrounding Drainage Feature C consists of a mix of meadow, a narrow hedgerow, and corn fields. No evidence of amphibian breeding habitat was observed in relation to any of the three (3) minor drainage features. No evidence of fish habitat functions was observed in relation to Drainage Feature A and Drainage Feature B. Drainage Feature C may provide minor fish habitat functions during the spring freshet, at which time fish could potentially migrate into the feature from the adjacent Jock River. However, no fish were observed within Drainage Feature C throughout the survey period.

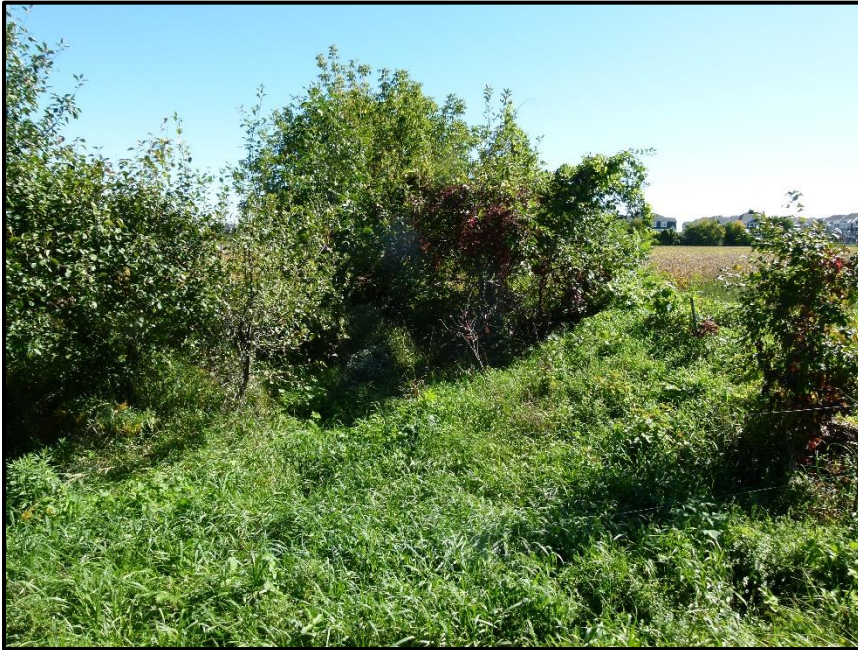
Photograph 8: Looking south at the northern end of Drainage Feature A (September 17th, 2020).

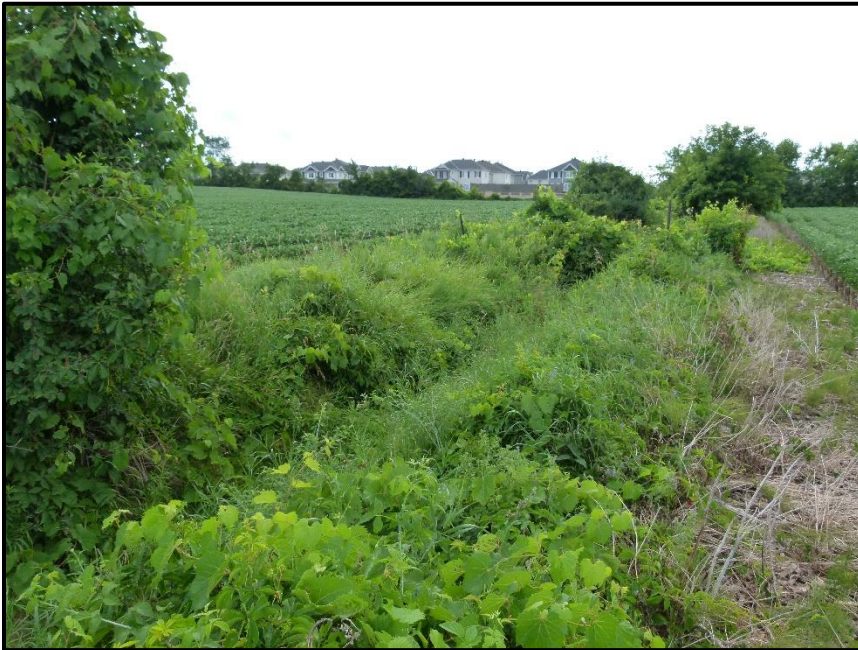
Photograph 9: Looking south at the central part of Drainage Feature A (July 29th, 2020).

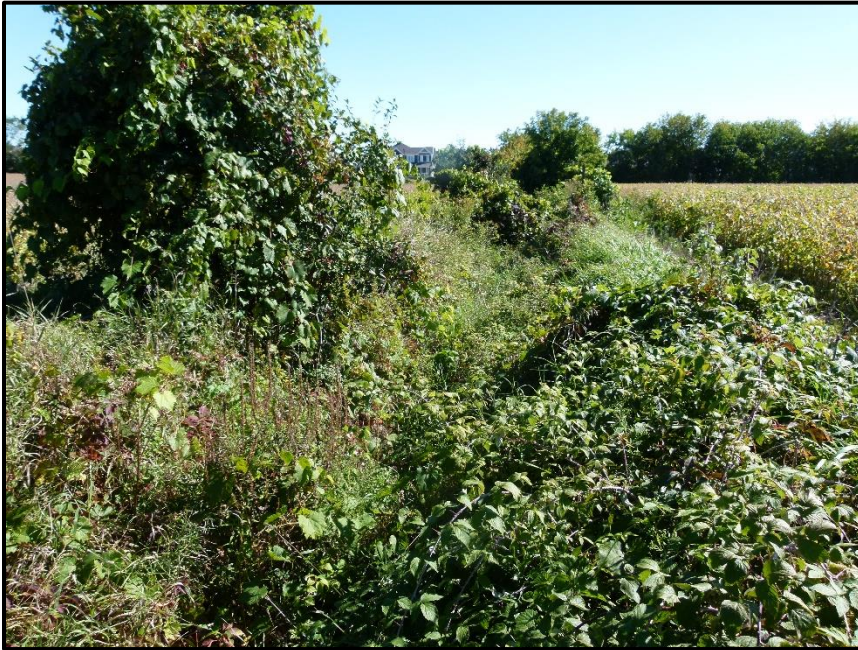
Photograph 10: Looking south at the southern end of Drainage Feature A (September 17th, 2020).

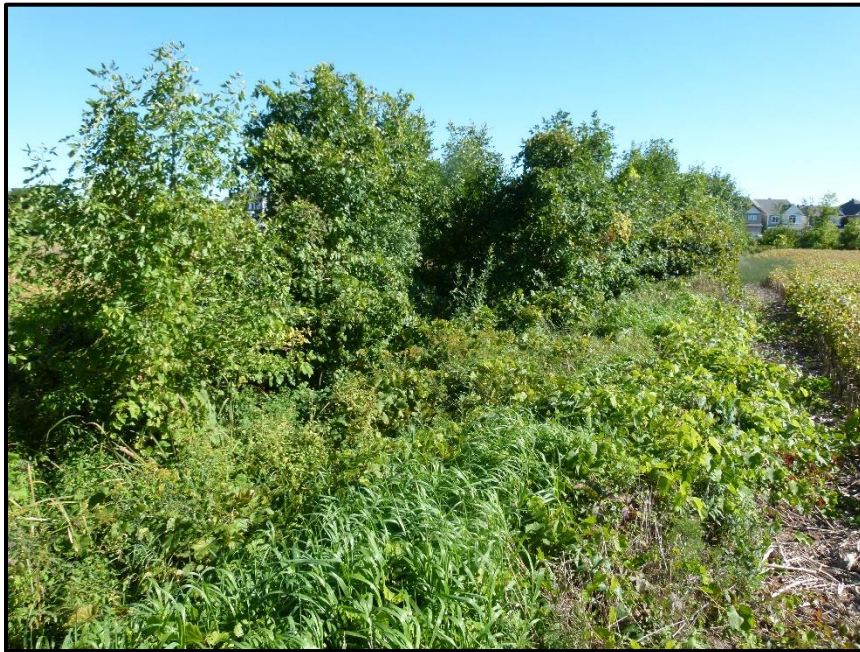
Photograph 12: Looking south at the northern end of Drainage Feature B (September 17th, 2020).

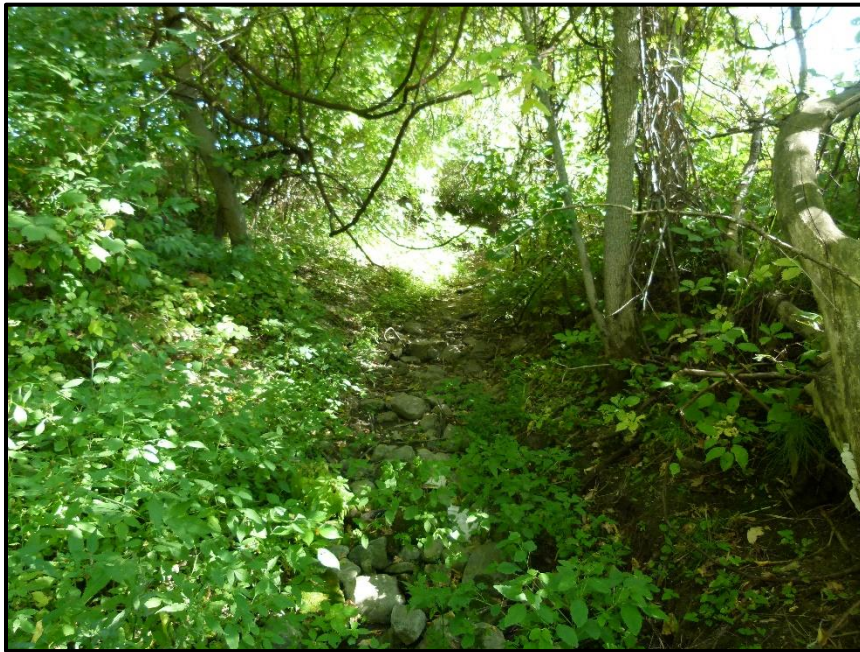
Photograph 14: Looking south at the northern end of the remnant portion of Drainage Feature C (September 17th, 2020).

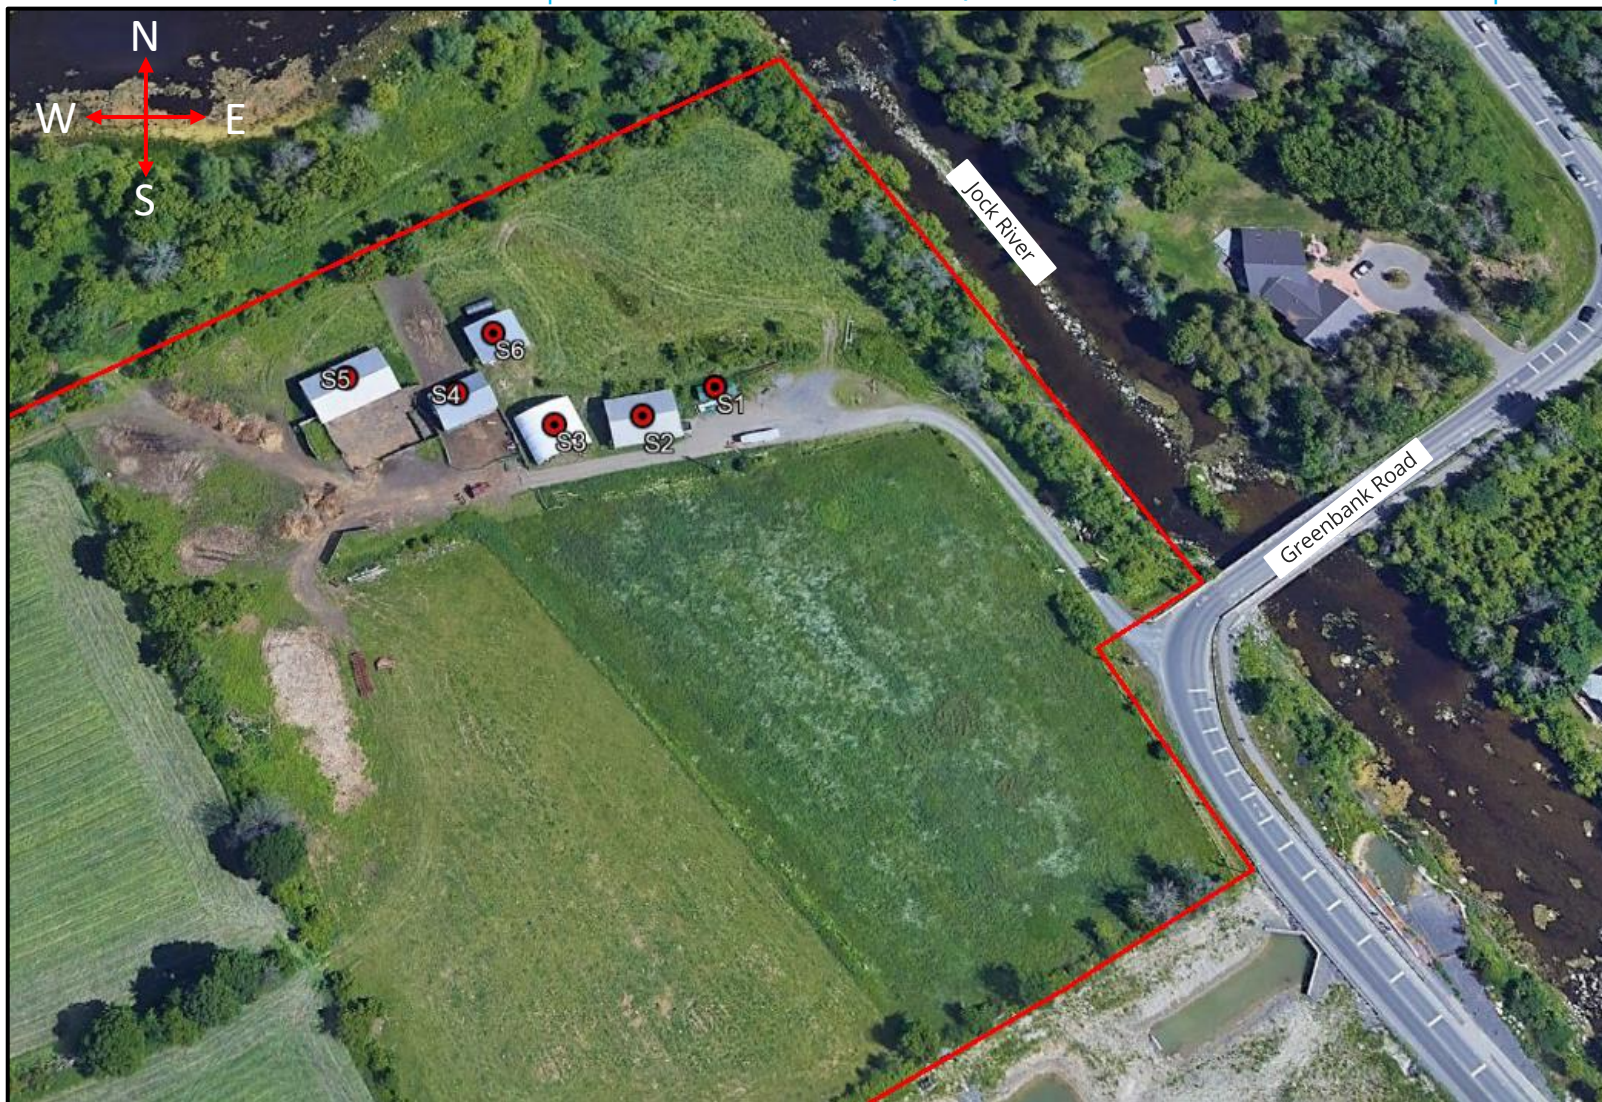
FIGURE 6: STRUCTURE LOCATIONS

Barn Swallows (threatened) may be found nesting in many anthropogenic structures including old barns and sheds, culverts, and under bridges (SARO 2021). There are currently six (6) agricultural structures within the Site (Refer to Figure 6). Photographs of the six (6) agricultural structures are included below. All accessible interior and exterior surfaces of the six (6) agricultural structures were searched for evidence of Barn Swallow nesting during the July 29th, 2020 Site visit. The July 29th, 2020 Site visit occurred during the Barn Swallow nesting season. The following is a summary of the Barn Swallow survey results:

In summary, evidence of Barn Swallow nesting was observed in Structure #2 and Structure #5. Barn Swallow regulatory requirements are discussed below in Section 4.4.1. Chimney Swifts (threatened)

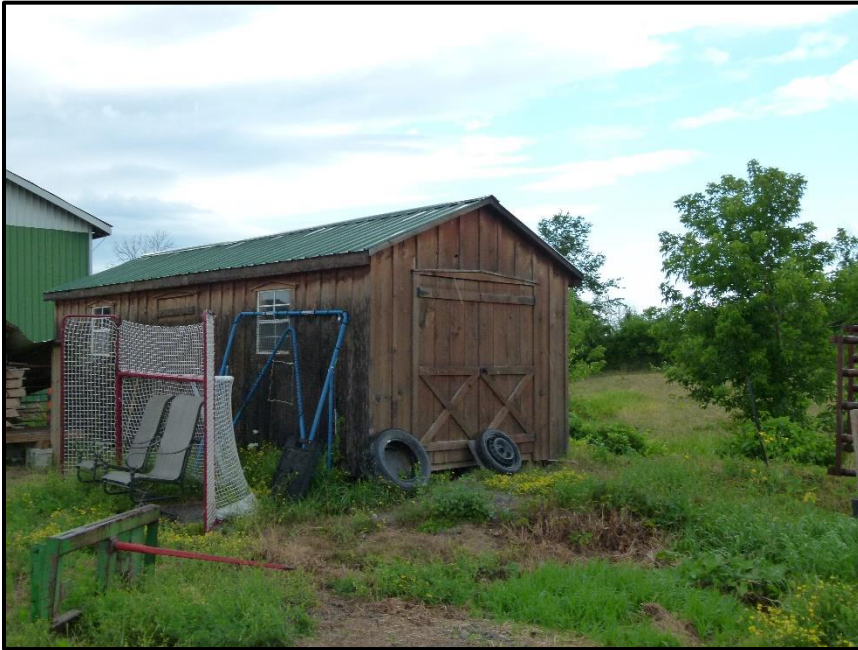
Photograph 17: Structure #1 (Sealed Wood Shed). No Barn Swallow nests were observed within Structure #1 (July 29th, 2020).

- **Structure #1 (Sealed Wood Shed):** Structure #1 is a sealed wood shed with a tin roof. The structure does not include any significant openings. The exterior surfaces of Structure #1 were examined, and no evidence of Barn Swallow nesting was observed.

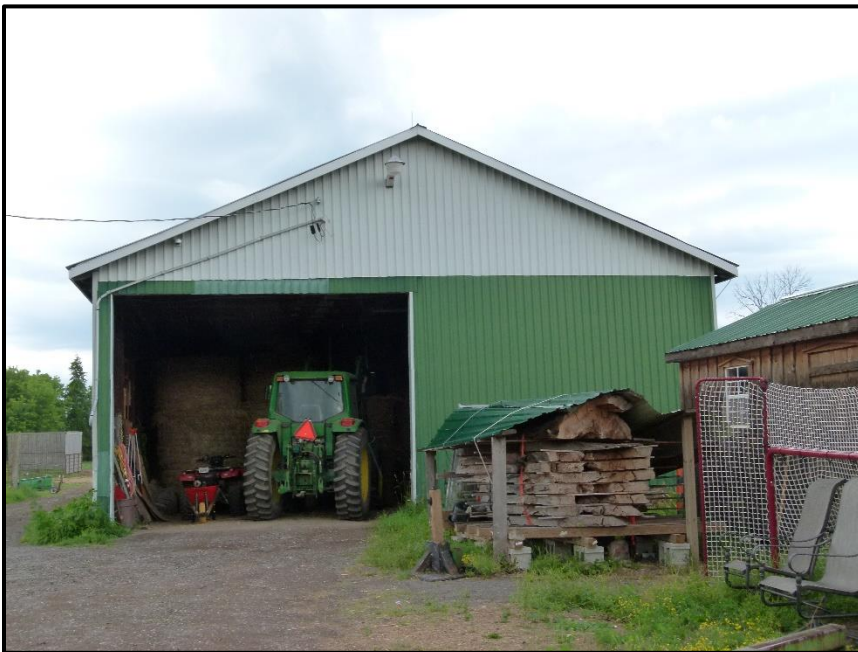
Photograph 18: Structure #2 (Tractor Garage). Two (2) active Barn Swallow nests were observed within Structure #2 (July 29th, 2020).

- **Structure #2 (Tractor Garage):** Structure #2 is a tractor garage with tin walls and a tin roof. A large door provides access to the interior of Structure #2. The interior and exterior surfaces of Structure #2 were examined, and two (2) active Barn Swallow nests were found. Three (3) adult Barn Swallows were observed foraging in the vicinity of Structure #2, indicating that the nests were likely being utilized by Barn Swallows in July 2020.

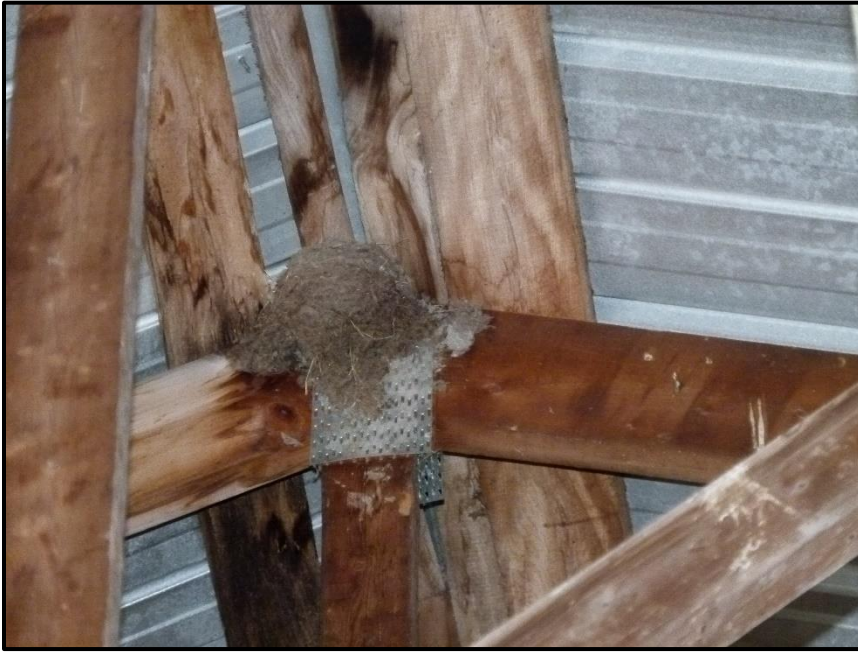
Photograph 19: Active Barn Swallow nest within Structure #2 (July 29th, 2020).

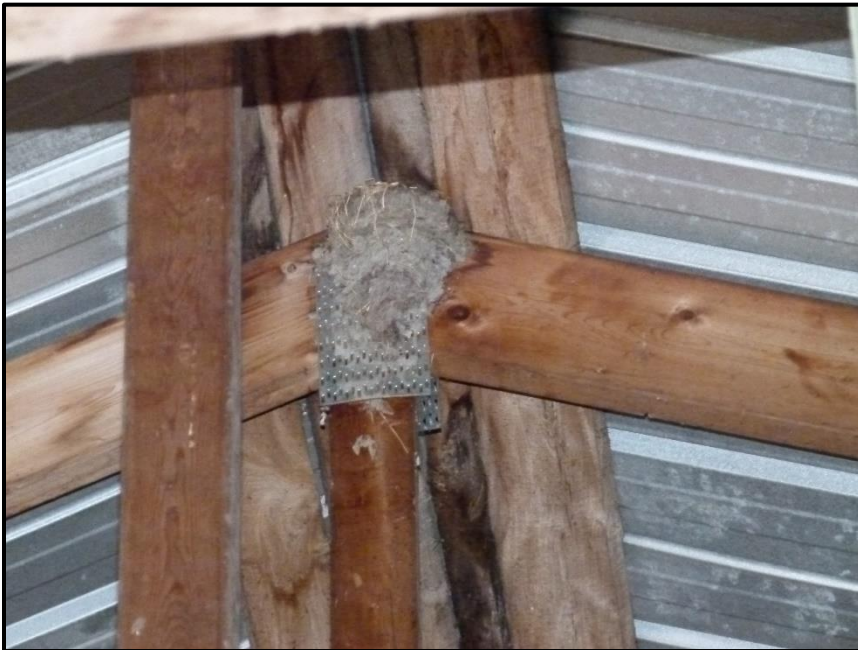
Photograph 20: Active Barn Swallow nest within Structure #2 (July 29th, 2020).

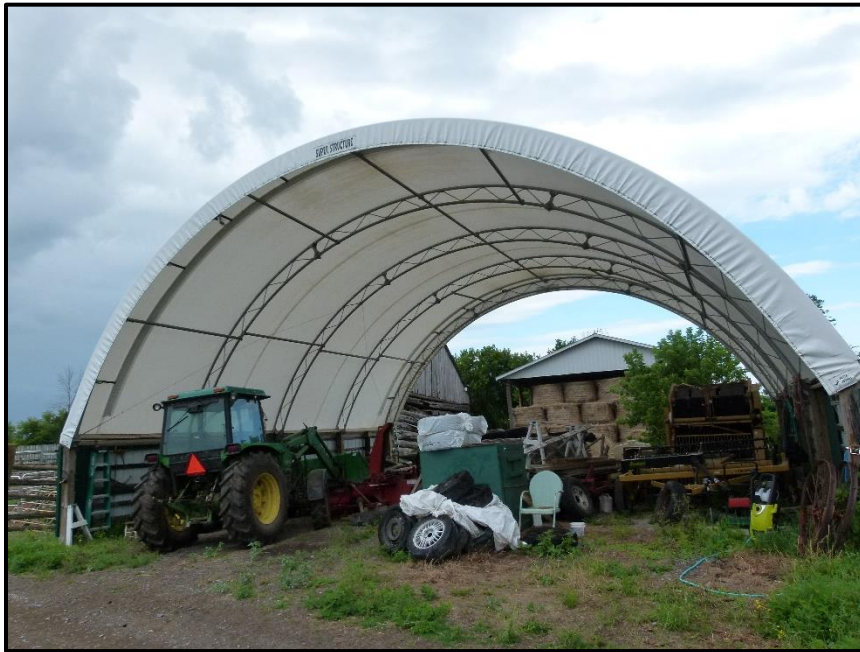
Photograph 21: Structure #3 (Plastic Coverall). No Barn Swallow nests were observed within Structure #3 (July 29th, 2020).

- **Structure #3 (Plastic Coverall):** Structure #3 is a plastic coverall with a metal frame and open sides. The interior and exterior surfaces of Structure #3 were examined, and no evidence of Barn Swallow nesting was observed.

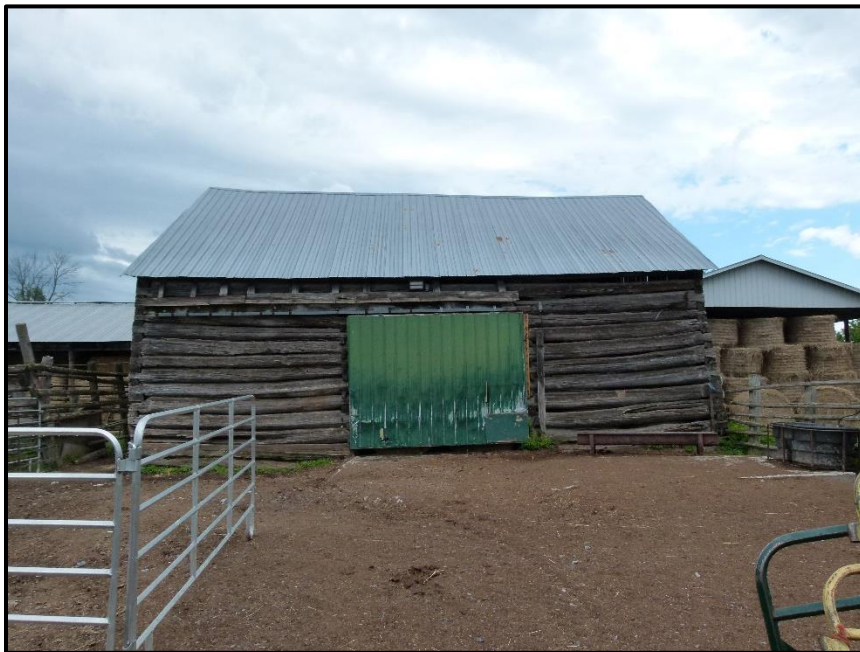
Photograph 22: Structure #4 (Wooden Barn). No Barn Swallow nests were observed within Structure #4 (July 29th, 2020).

- **Structure #4 (Wooden Barn):** Structure #4 is a wooden barn with a tin roof. The wooden barn is sealed, although many small gaps are present within the walls of the structure. The gaps do not appear large enough to allow Barn Swallows to enter, and no evidence of Barn Swallow nesting was observed.

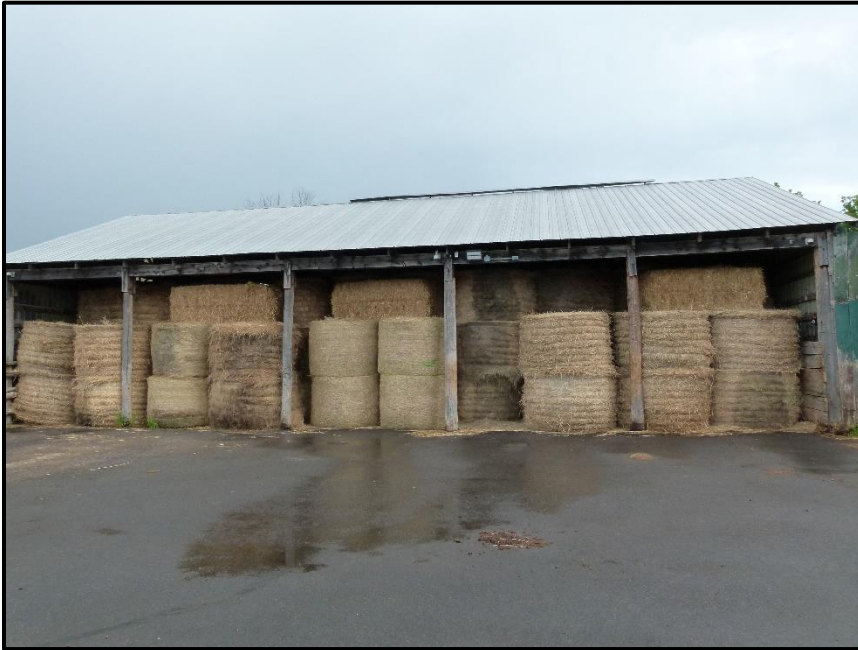
Photograph 23: Structure #5 (Hay Storage Area). One (1) Barn Swallow nest was observed within Structure #5 (July 29th, 2020).

- **Structure #5 (Hay Storage Area):** Structure #5 is a hay storage area with wood walls and a tin roof. The structure is permanently open on one side, and hence is accessible to nesting birds. One (1) Barn Swallow nest was observed within the interior of Structure #5. The Barn Swallow nest appeared partially degraded and no adult birds were observed to be in attendance. As such, the nest may not have been used in July 2020.

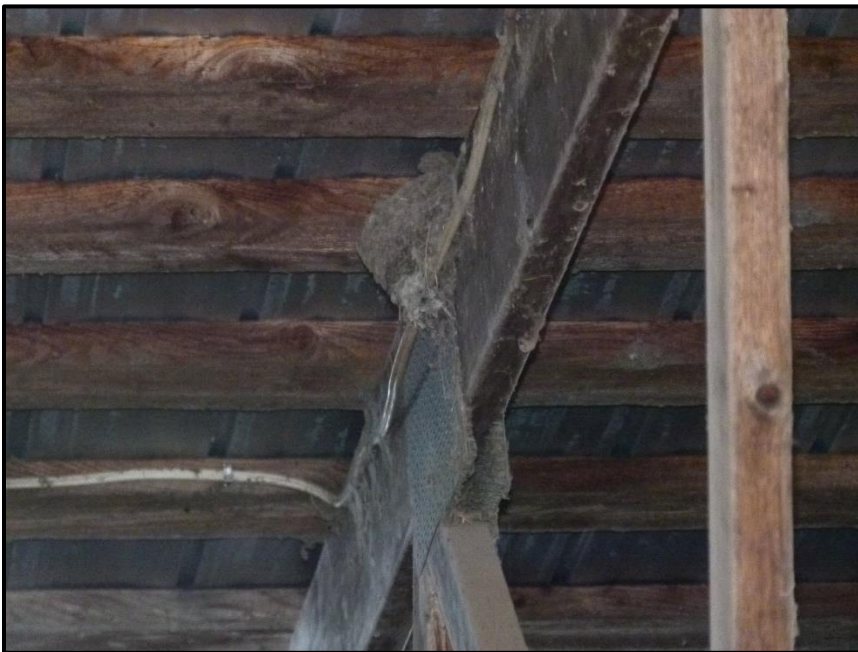
Photograph 24: Barn Swallow nest within Structure #5 (July 29th, 2020).

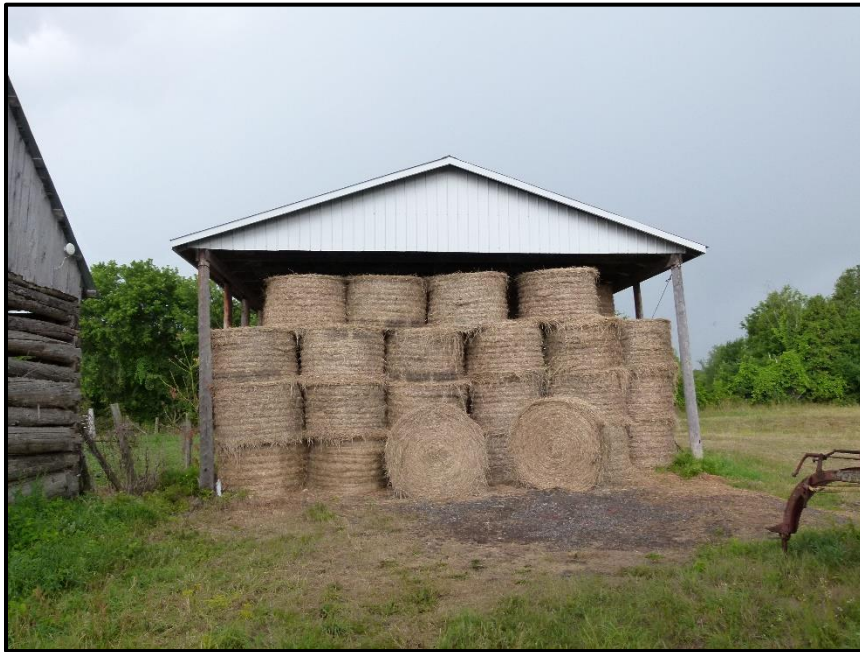
Photograph 25: Structure #6 (Open Hay Storage Area). No Barn Swallow nests were observed within Structure #6 (July 29th, 2020).

- **Structure #6 (Open Hay Storage Area):** Structure #6 is an open hay storage area which includes a tin roof suspended on top of four (4) wooden pillars. The structure does not include any exterior walls. The interior and exterior surfaces of Structure #6 were examined, and no evidence of Barn Swallow nesting was observed.
