McKINLEY
ENVIRONMENTAL
SOLUTIONS

Combined Environmental Impact Statement &
Tree Conservation Report (Revised)
Kennedy Lands
3432 Greenbank Road, Ottawa, ON

April 2022
Prepared for Minto Communities

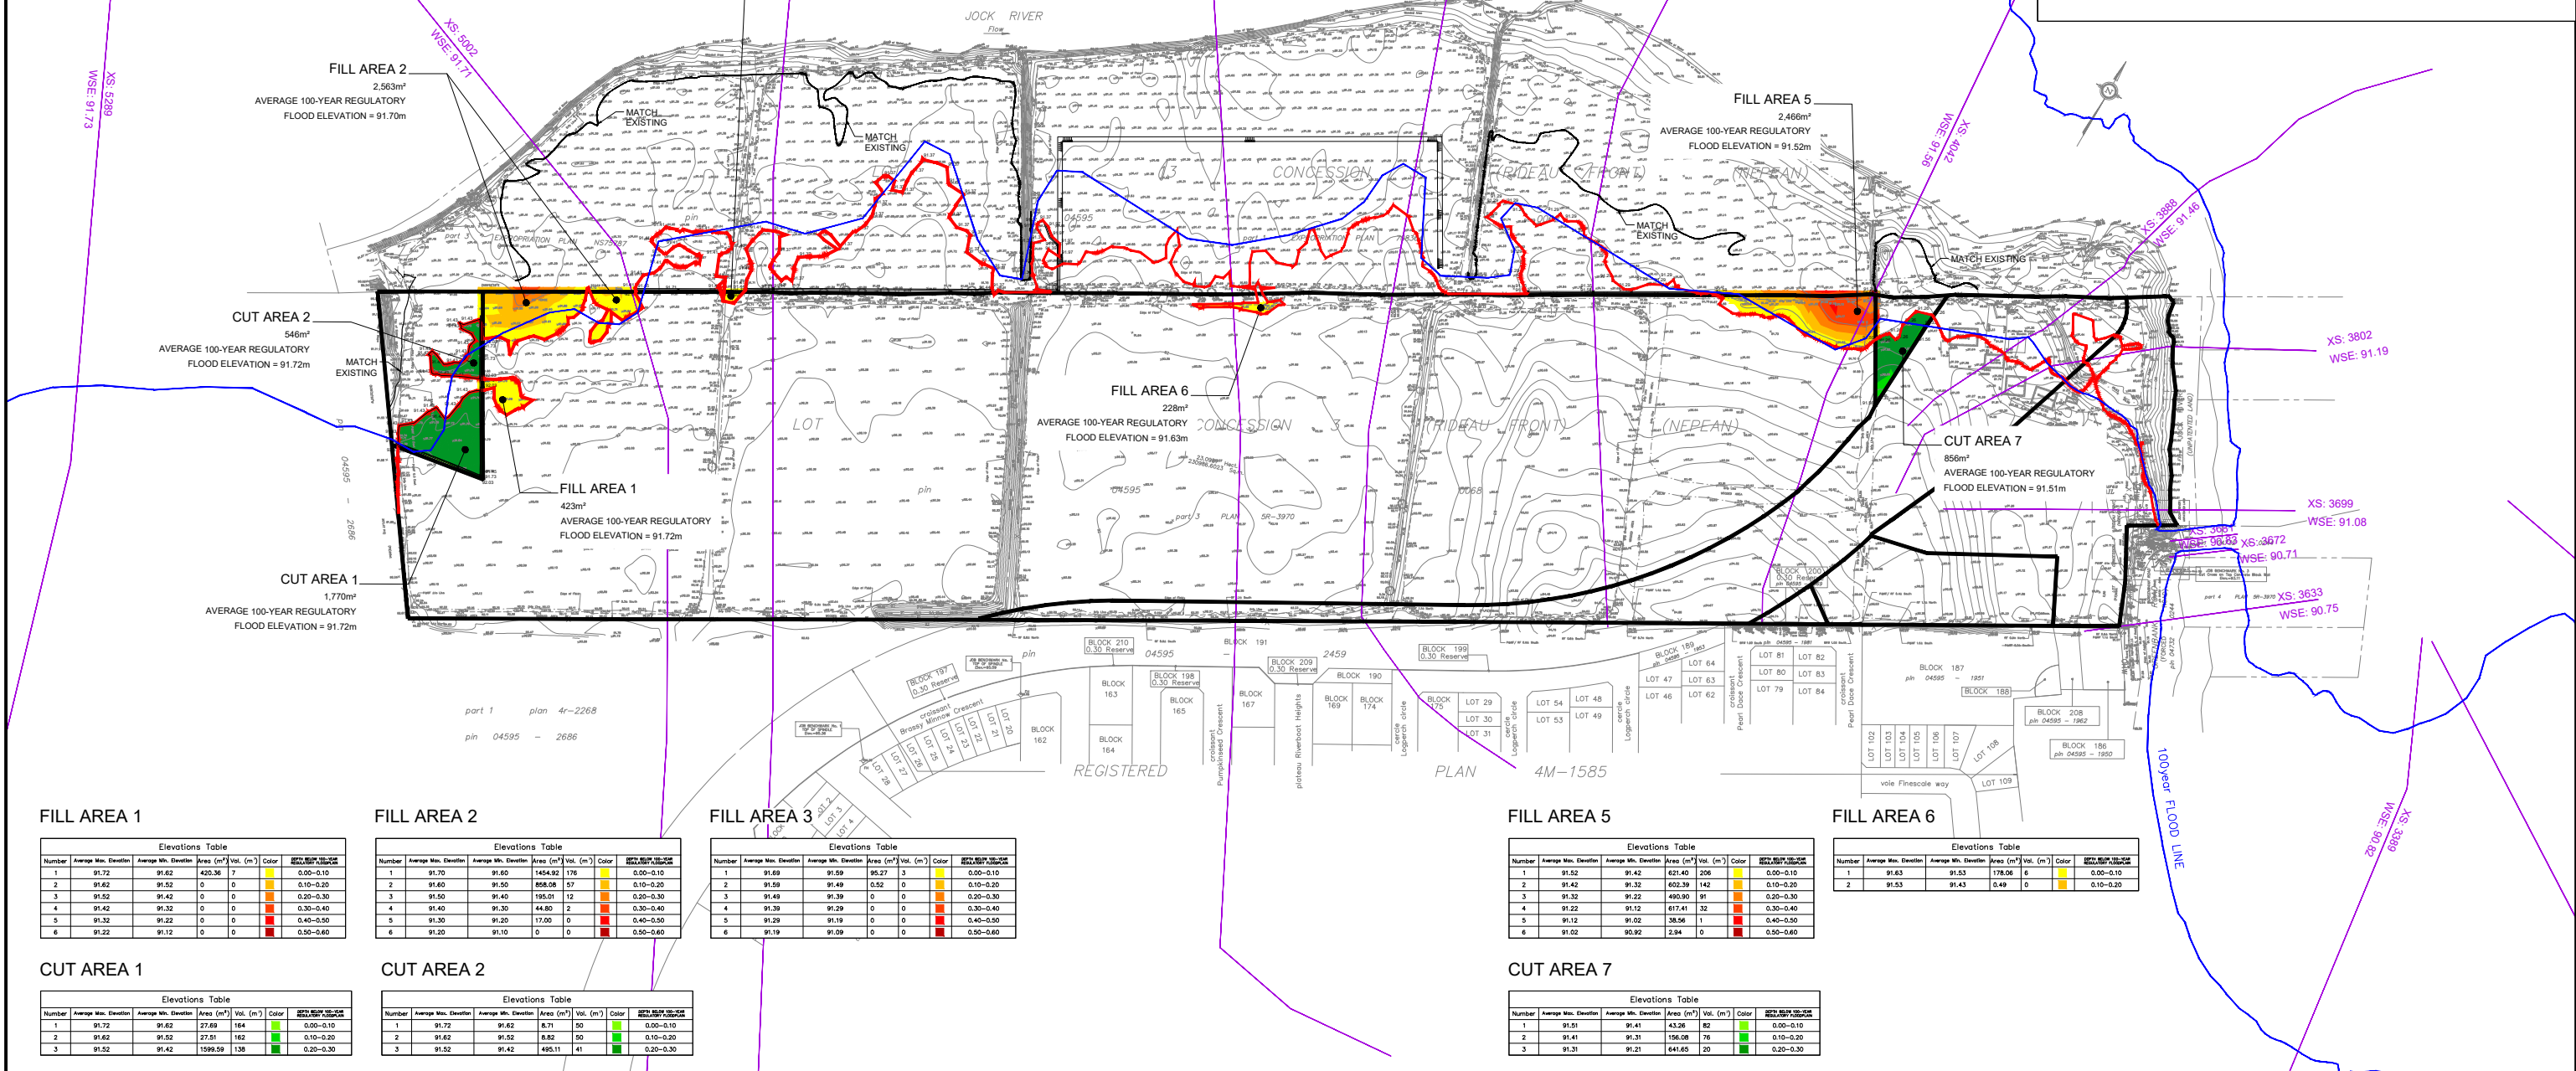
FILL AREA 1
