PHASE ONE ENVIRONMENTAL SITE ASSESSMENT 2504 WHITE STREET, NAVAN, ONTARIO

Project No.: CCO-22-2100

March 31, 2022

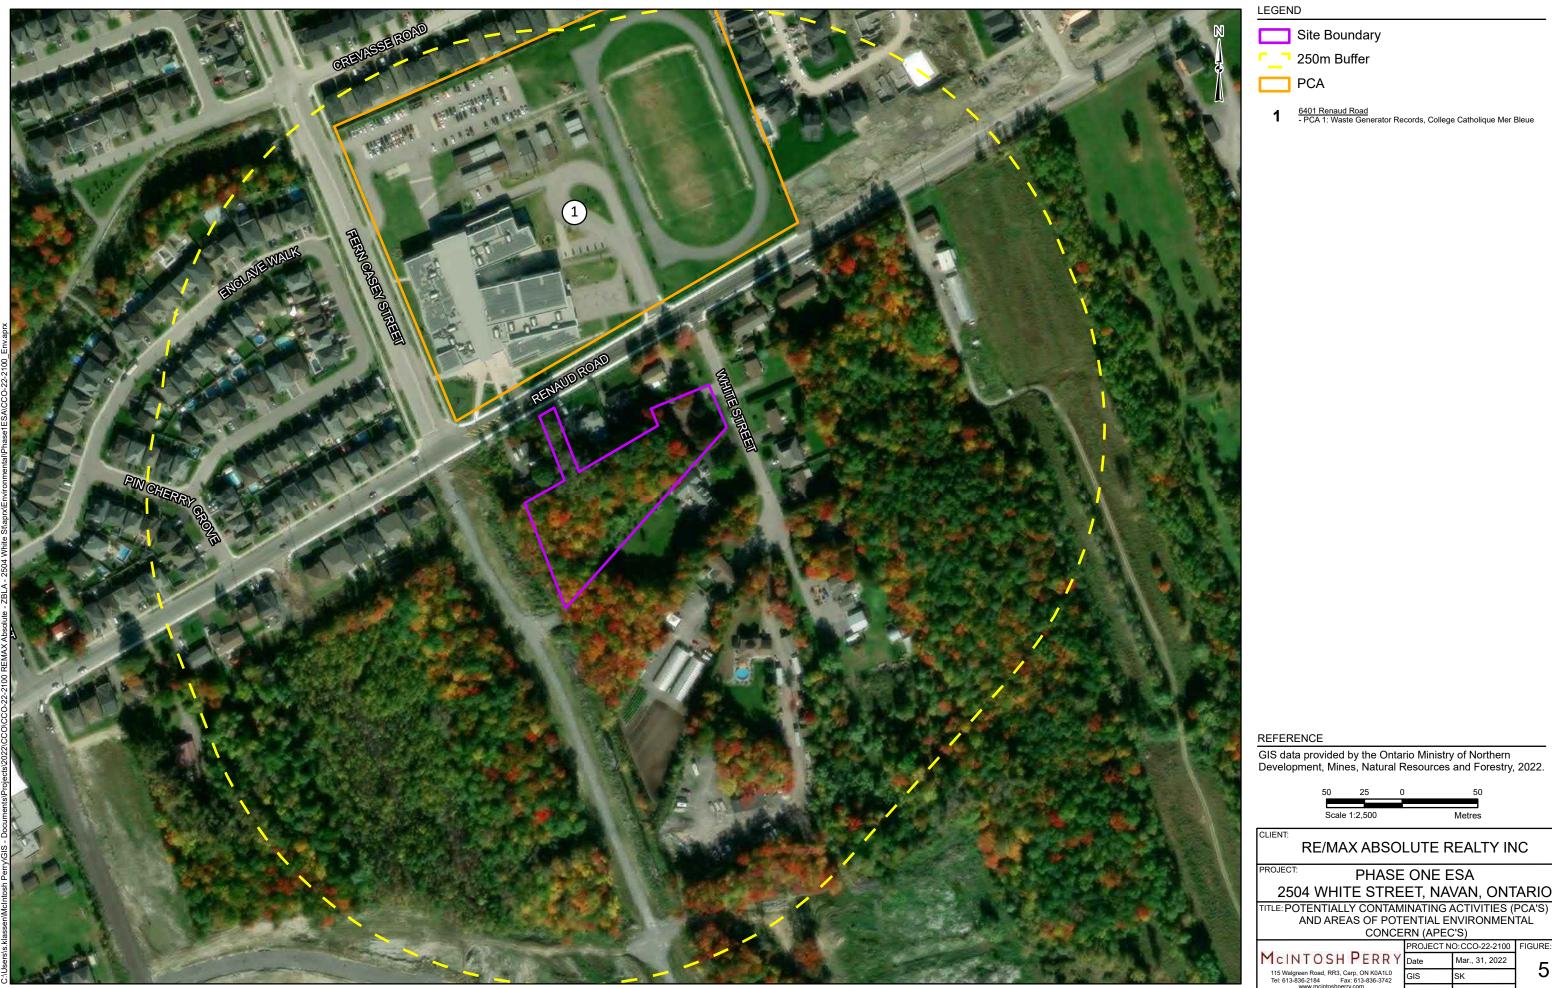
Scale 1:2,500		Metres	
RE/MAX ABSO	LUTE R	EALTY IN	IC
PROJECT: PHASE 2504 WHITE STRE	••••		ARIO
TITLE: POTENTIALLY CONTAMINATING ACTIVITIES (PCA'S) AND AREAS OF POTENTIAL ENVIRONMENTAL CONCERN (APEC'S)			
McINTOSH PERRY		O:CCO-22-2100 Mar., 31, 2022	
115 Walgreen Road, RR3, Carp, ON K0A1L0 Tel: 613-836-2184 Fax: 613-836-3742 www.mcintoshperry.com	GIS Checked By	SK DA	5

Potentially Contaminating Activities within the Phase One Study Area include the waste generated at 6401 Renaud Road, located approximately 60 metres northwest of the Site, from 2018-2021. Based on separation distance, this PCA does not represent an Area of Potential Environmental Concern to the Site.

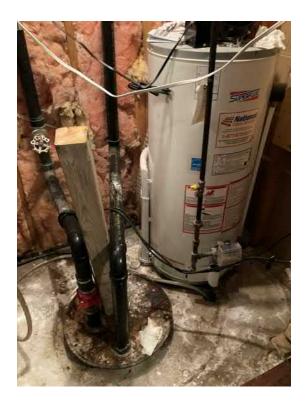
Photo 1: Sewage collection pit and water heater located in basement furnace room

In the furnace room in the basement of the house, a sewage pit was present. Based on information provided by the tenant, sewage from the pit was pumped via electric pump to the septic bed in the front of the house. No other drains, pits or sumps were observed at the Site.

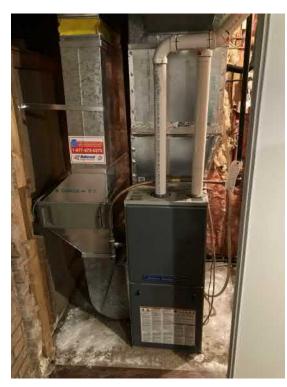
Photo 2: Gas-fired furnace located in basement furnace room

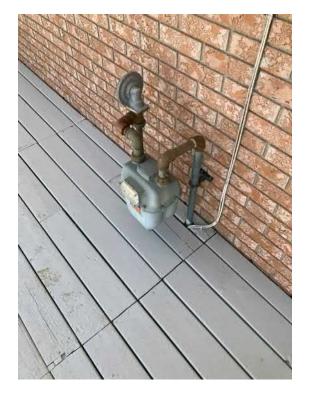
Photo 3: Gas connection on east side (front) of house

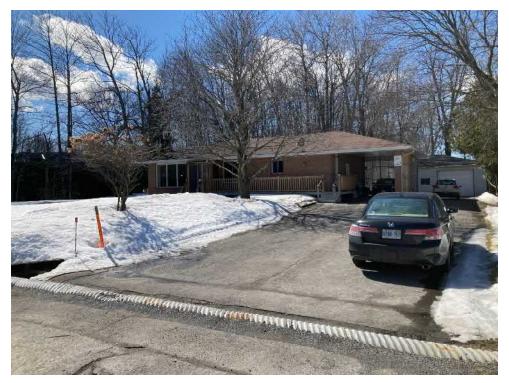
Photo 4: House and driveway, facing east from White Street, showing ditch and corrugated steel pipe culvert along White Street in foreground

The Site is currently occupied by a single-storey wood-frame brick-clad house with a poured concrete foundation and one basement level A single-storey slab-on-grade wood-frame garage building is present to the northwest of the house. No other structures or improvements are present on the Site.

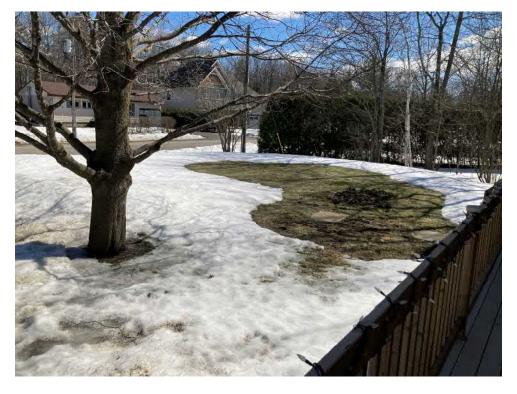
Photo 5: Facing southeast from front of house, showing location of septic bed

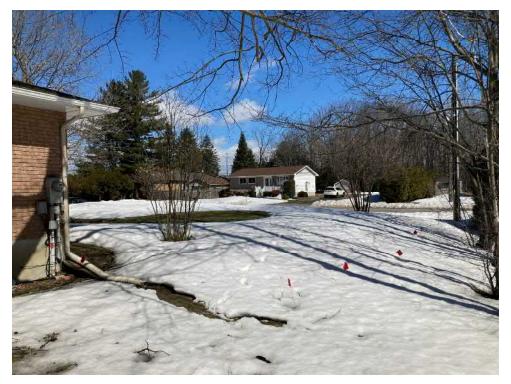
Photo 6: Facing northeast from south property boundary, showing utility pole along White Street and location of underground electrical service (flagged) to house

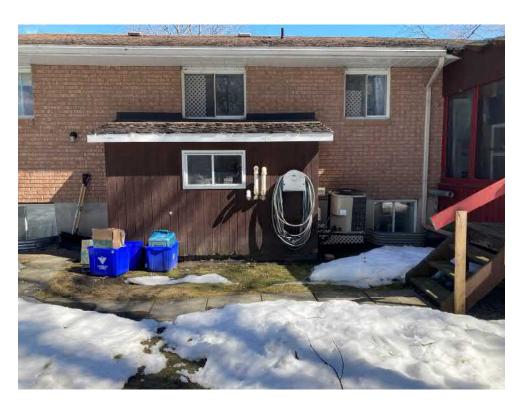
Photo 7: West side (rear) of house, facing east, showing central air conditioning unit and gas furnace exhaust

A central air conditioner was present on the west wall of the house.

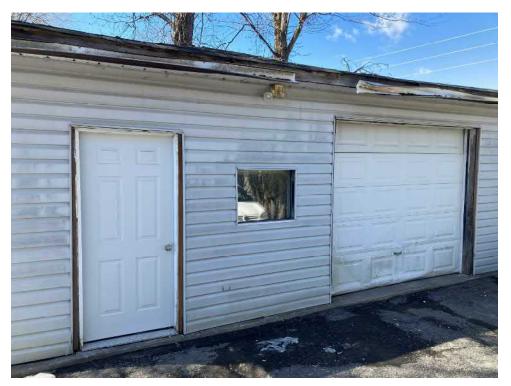
Photo 8: Detached garage, facing west
