**Claridge Homes
2559 Mer Bleue Road
Subdivision**

Headwaters Report

November 2020

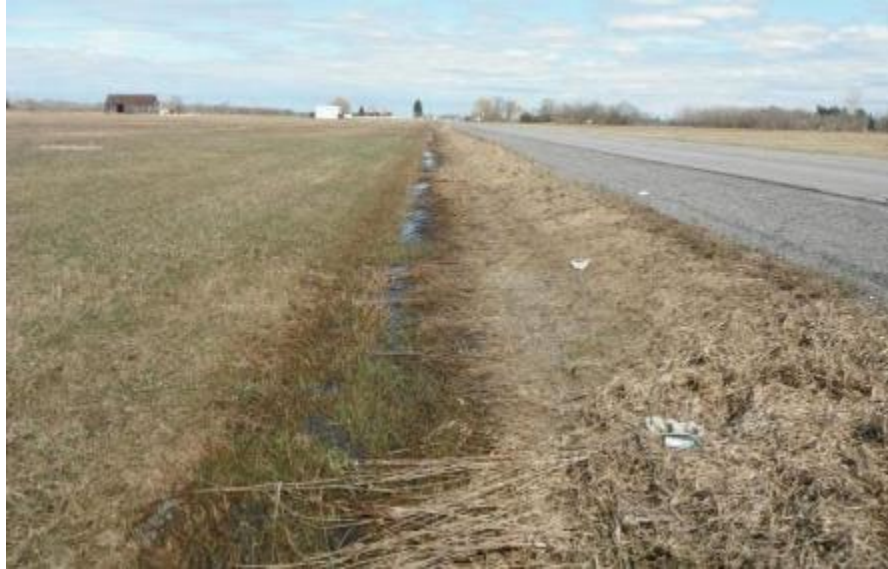
Photo 1: Drain 6 (Station 8) looking upstream from the downstream end (April 28, 2014)

Station 8 was situated 460 m west of Tenth Line Road. The station length was 40 m. The entire station was dry. The average channel and bankfull depth were 1.2 m and 12 cm in spring 2013.

The substrate was composed of fines. The entire channel was choked with vegetation (reed canary grass, and purple loosestrife). There were no signs of erosion.

The banks were fully vegetated with herbaceous vegetation. Herbaceous vegetation consisted of grass species, common sow-thistle and purple loosestrife. There was no canopy cover.

During the spring visit in April 2014, the site was dipped 60 times as it was too shallow to shock. The average wetted width and water depth obtained in April were 1.3 m and 5 cm (range 3-12 cm), respectively. No fish were captured.

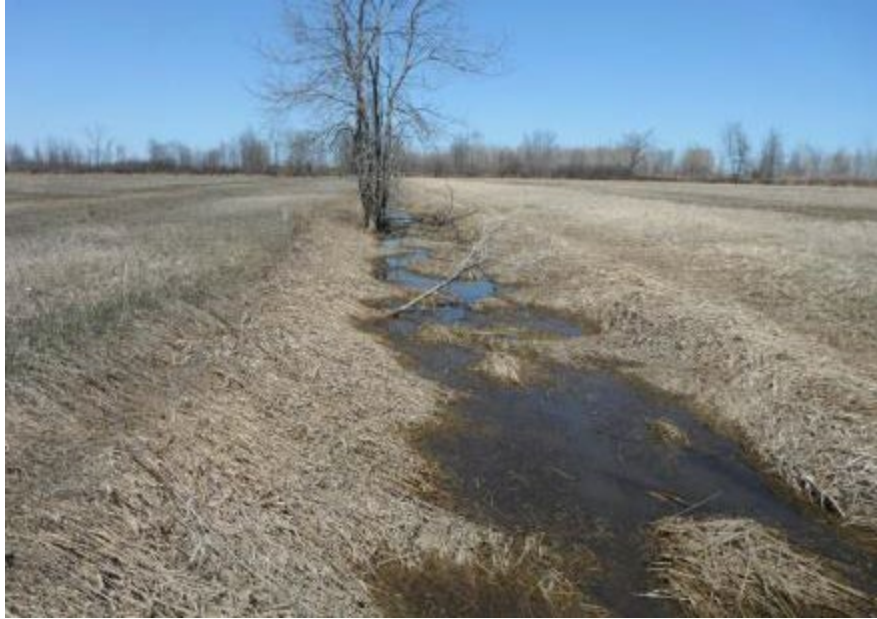
Photo 3: Drain 7 (Station 9) looking upstream from the downstream end (April 28, 2014)

Station 9 was 360 m upstream of the confluence with McKinnon's Creek. The surrounding land consisted of an agricultural field. The station length was 40 m. The entire station was dry in spring 2013. The average channel and bankfull depth were 3.0 m and 22 cm.

The substrate was composed of fines. The in-stream cover consisted of aquatic vegetation (reed canary grass, narrow-leaved cattail, and purple loosestrife). There were no signs of erosion.

During the spring visit in April 2014, the site was shocked for 328 seconds over an area of approximately 80 m². The average wetted width and water depth obtained in April were 2.0 m and 10 cm (range 7-22 cm), respectively. No fish were captured.

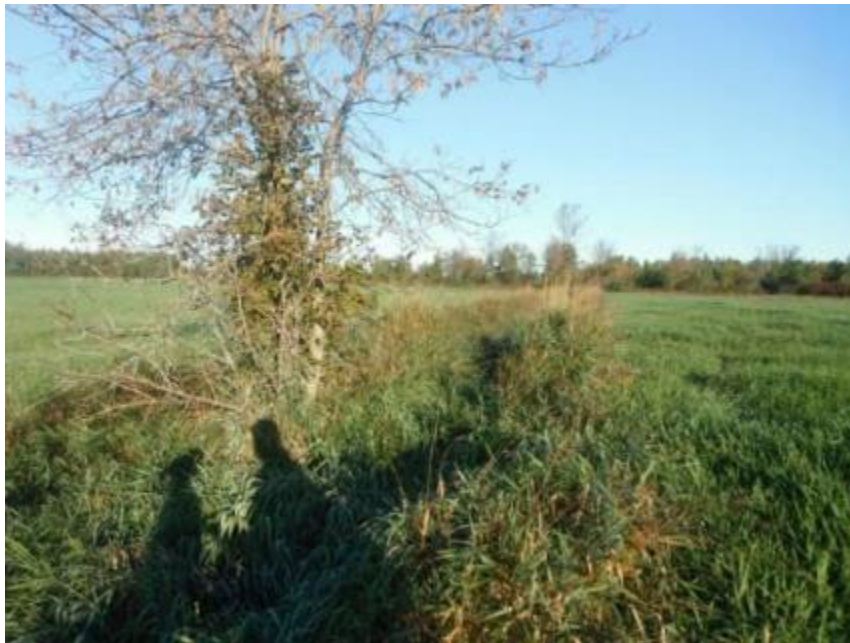
Photo 4: Drain 7 (Station 9) looking upstream from the downstream end (September 17, 2013)

The banks were fully vegetated with herbaceous vegetation, and very poorly with woody species. Herbaceous vegetation consisted of reed canary grass, timothy and common sow-thistle. Woody vegetation included green ash. There was no canopy cover.

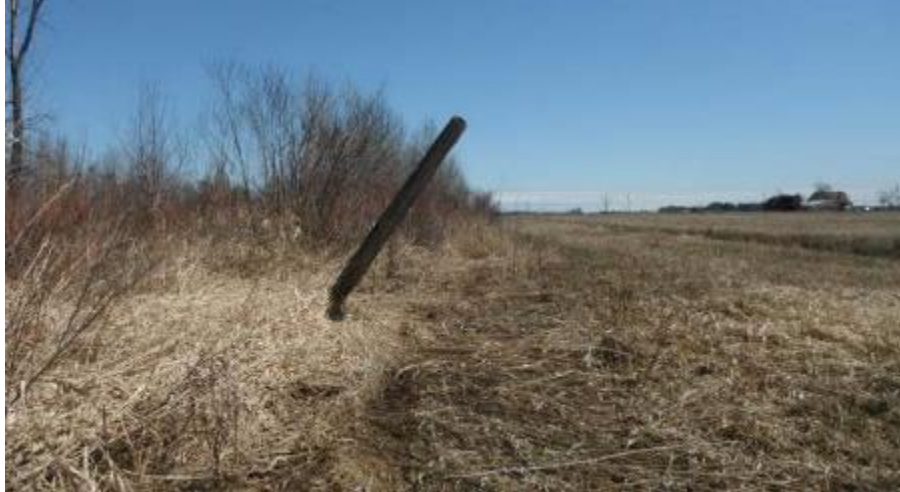
Photo 6: Drain 8 (Station 10) looking upstream from the downstream end (April 28, 2014)

Station 10 was situated approximately 185 m east of its confluence with Drain 8. The station length was 40 m. The entire station was dry. The average channel and bankfull depth were 1.3 m and 19 cm in spring 2013.

The substrate was composed of fines. The channel was heavily choked with vegetation (purple loosestrife, narrow-leaved cattail, and reed canary grass). There were no signs of erosion.

During the spring visit in April 2014, the site was dipped 10 times as it was too shallow to shock and was choked with vegetation. The average wetted width and water depth obtained in April were 0.7 m and 2 cm (range 1-6 cm), respectively. No fish were captured.

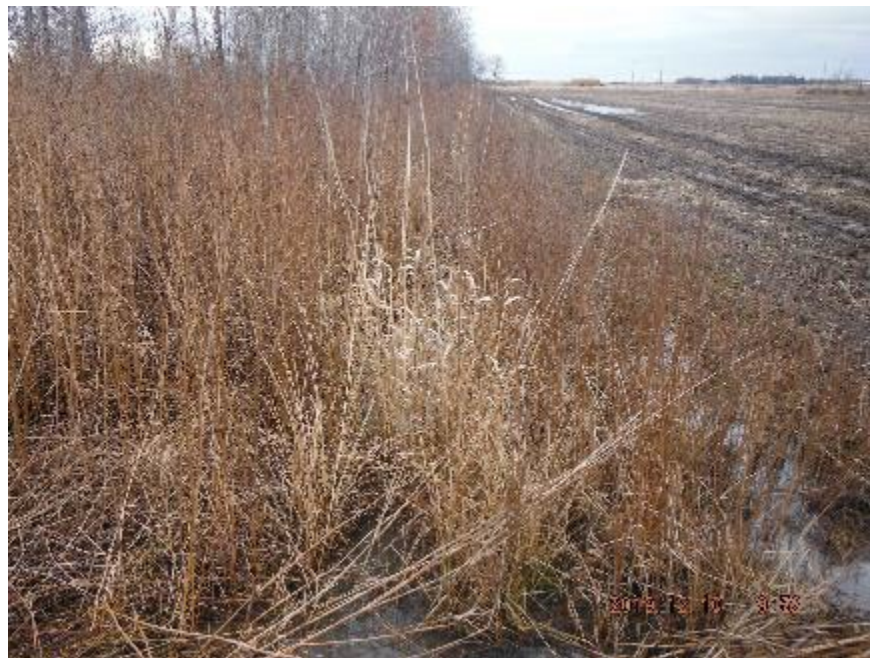
Photo 7: Drain 8 (Station 10) looking upstream from the downstream end (December 10, 2019)

The banks were fully vegetated herbaceous vegetation and very poorly vegetated with woody species. Herbaceous vegetation consisted of New England aster, timothy and brome species. Woody species included slender willow, grey birch and trembling aspen. There was scarce canopy cover.

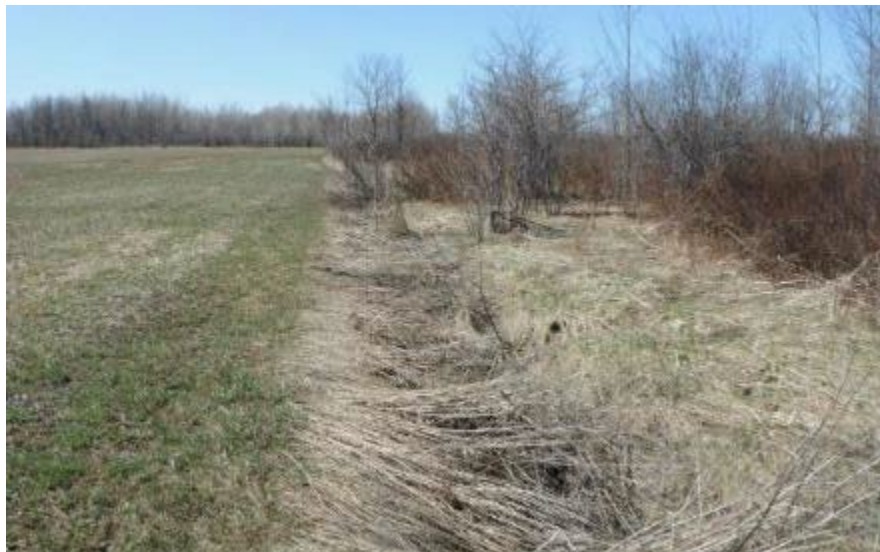
Photo 8: Drain 9 (Station 11) looking upstream from the downstream end (April 28, 2014)

Station 11 was situated approximately 60 m west of the confluence with Drain 7. The surrounding land consisted of an agricultural field and a wooded area. The station length was 40 m. The entire station was dry. The average channel and bankfull depth were 1.3 m and 18 cm in spring 2013.

The substrate was composed of fines. The channel was entirely choked with aquatic vegetation (reed canary grass, black bulrush, and purple loosestrife). There were no signs of erosion.

During the spring visit in April 2014, the site was dipped 10 times as it was too shallow to shock and was choked with vegetation. The average wetted width and water depth obtained in April were 0.9 m and 4 cm (range 2-8 cm), respectively. No fish were captured.

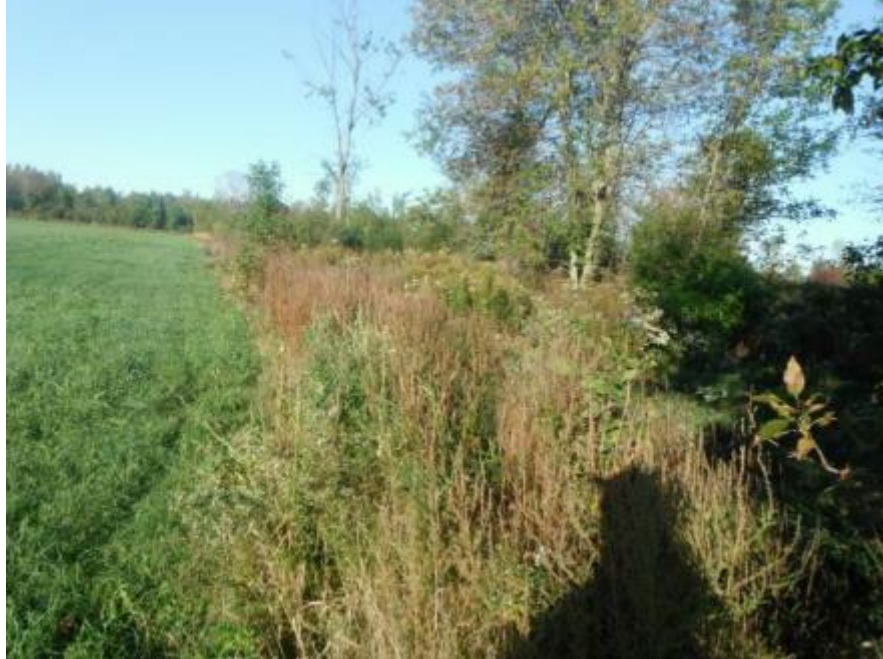
Photo 9: Drain 9 (Station 11) looking upstream from the downstream end (September 17, 2013)

The banks were fully vegetated with herbaceous vegetation and very poorly vegetated with woody species. Herbaceous vegetation consisted of common ragweed, reed canary grass and timothy. Woody species included green ash and American elm. There was no canopy cover.

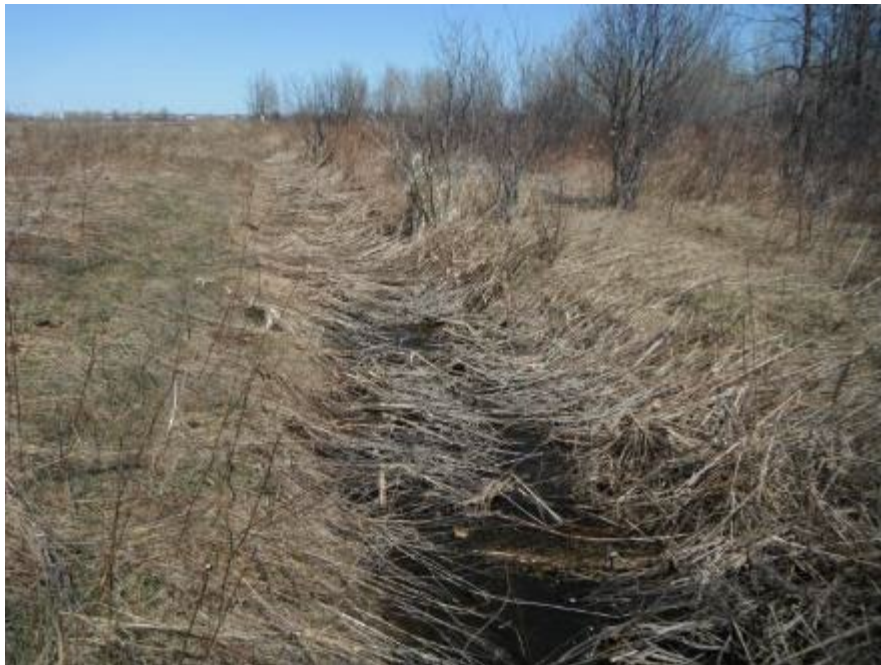
Photo 11: Drain 10 (Station 12) looking upstream from the downstream end (April 28, 2014)

Station 12 was situated approximately 95 m south of the confluence with Drain 7. The station length was 40 m. The entire station was dry. The average channel and bankfull depth were 2.9 m and 23 cm in spring 2013.

The substrate was composed of fines. The channel was entirely vegetated with purple loosestrife, reed canary grass, and narrow-leaved cattail. There were no signs of erosion.

During the spring visit in April 2014, the site was shocked for 416 seconds over an area of approximately 84 m². The average wetted width and water depth obtained in April were 2.1 m and 11 cm (range 4-20 cm), respectively. No fish were captured.

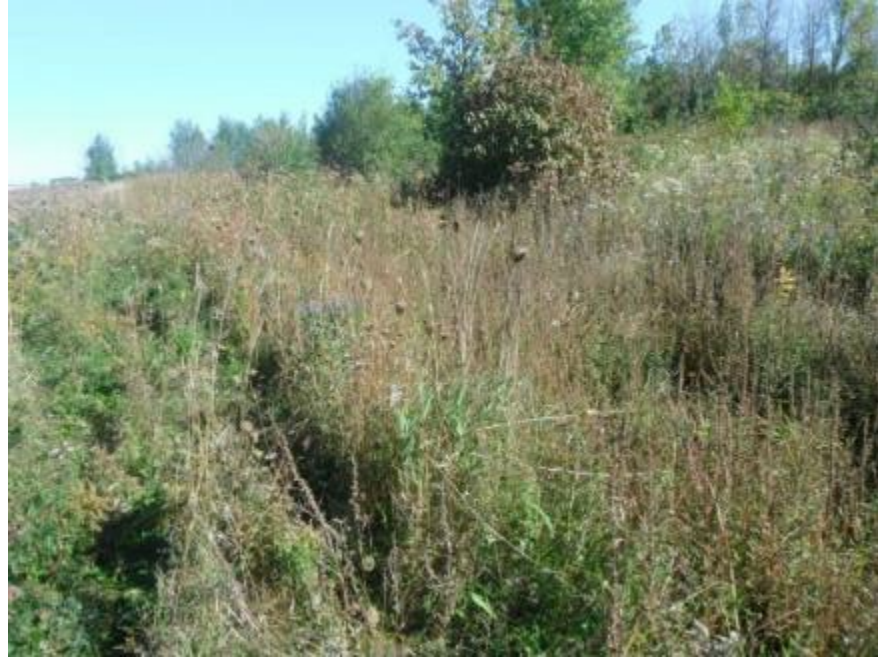
Photo 12: Drain 10 (Station 12) looking upstream from the downstream end (September 17, 2013)

The banks were fully vegetated with herbaceous vegetation and very poorly vegetated with woody species. Herbaceous vegetation consisted of Canada goldenrod, wild carrot and timothy. Woody species included common buckthorn. There was no canopy cover.

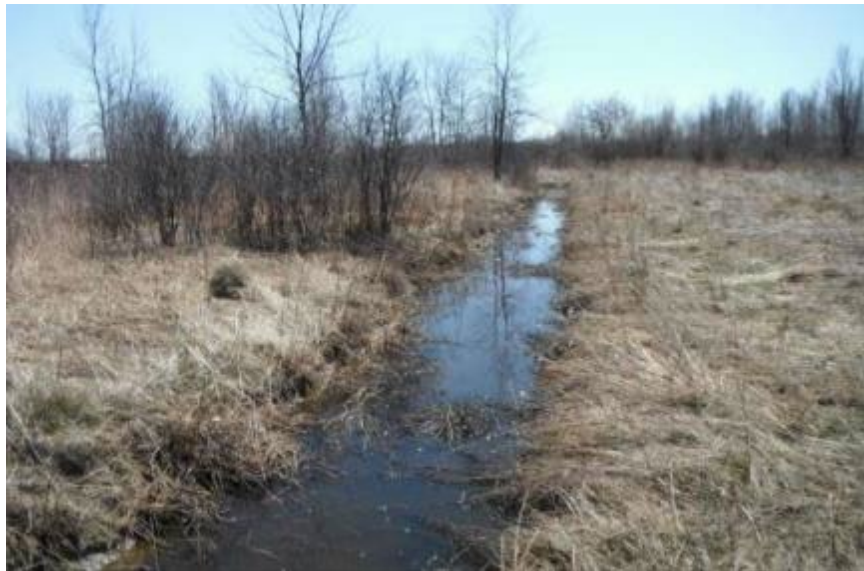
Photo 14: Drain 11 (Station 13) looking upstream from the downstream end (April 28, 2014)

Station 13 was situated approximately 155 m south of the confluence with Drain 10. The station length was 40 m. The entire station was dry. The average channel and bankfull depth were 2.1 m and 23 cm in spring 2013.

The substrate was composed of fines. The channel was choked by aquatic vegetation (purple loosestrife, narrow-leaved cattail, and reed canary grass). There were no signs of erosion.

During the spring visit in April 2014, the site was dipped 50 times as it was too shallow to shock and was choked with vegetation. The average wetted width and water depth obtained in April were 1.2 m and 6 cm (range 2-15 cm), respectively. No fish were captured.

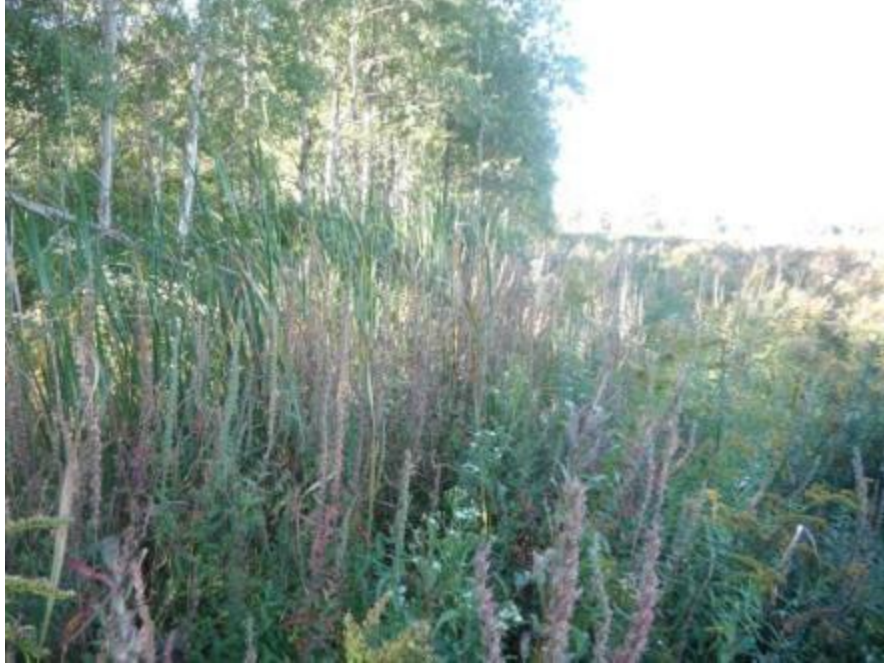
Photo 15: Drain 11 (Station 13) looking upstream from the downstream end (September 17, 2013)

The banks were fully vegetated with herbaceous vegetation and moderately vegetated with woody species. Herbaceous vegetation consisted of purple loosestrife, late goldenrod and black bulrush. Woody species included pussy willow, common buckthorn and slender willow. There was poor canopy cover.

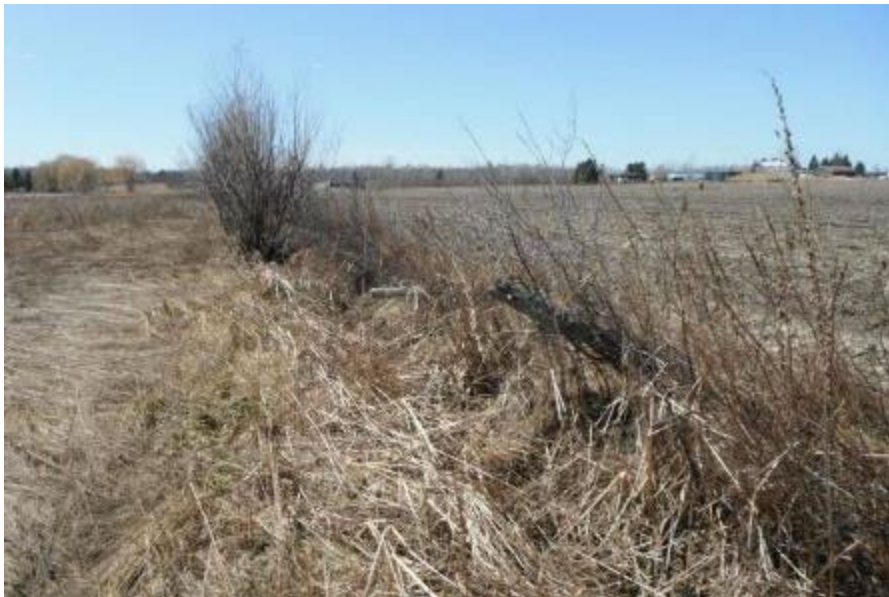
Photo 17: Drain 12 (Station 14) looking upstream from the downstream end (April 28, 2014)

The substrate was composed of fines. The channel was entirely choked by aquatic vegetation (purple loosestrife, broad-leaved cattail, and reed canary grass). There were no signs of erosion.

The site was dry during the visit in spring 2014; therefore no fish sampling was completed.

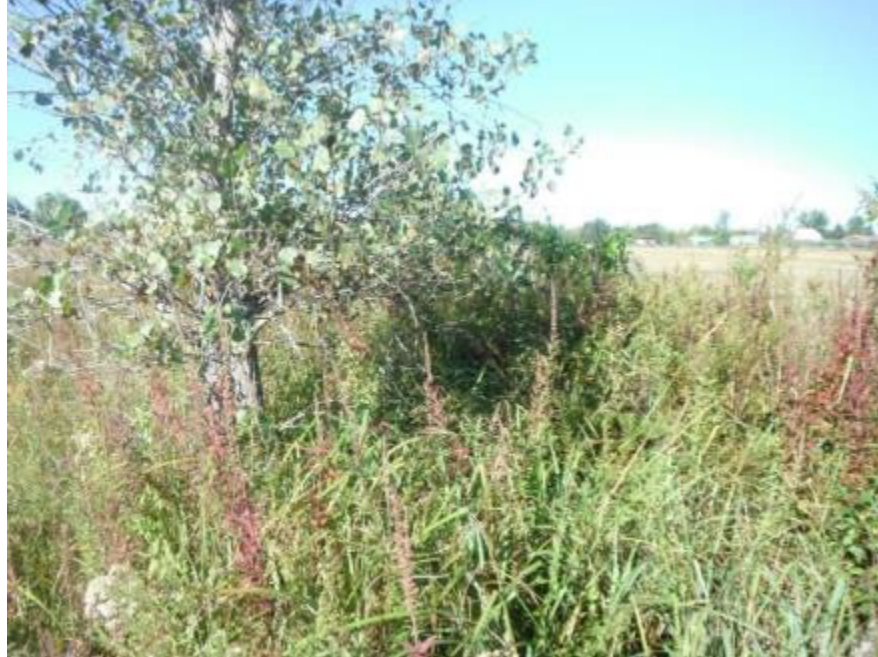
Photo 18: Drain 12 (Station 14) looking upstream from the downstream end (September 17, 2013)

The banks were fully vegetated herbaceous vegetation and poorly vegetated with woody species. Herbaceous vegetation consisted of purple loosestrife, Canada goldenrod and wild carrot. Woody species included pussy willow and common buckthorn. There was no canopy cover.
