**Phase I Environmental Site
Assessment – 3713 Navan Road,
Navan, Ontario**

Final Report

June 20, 2022

Project No.: 122170502

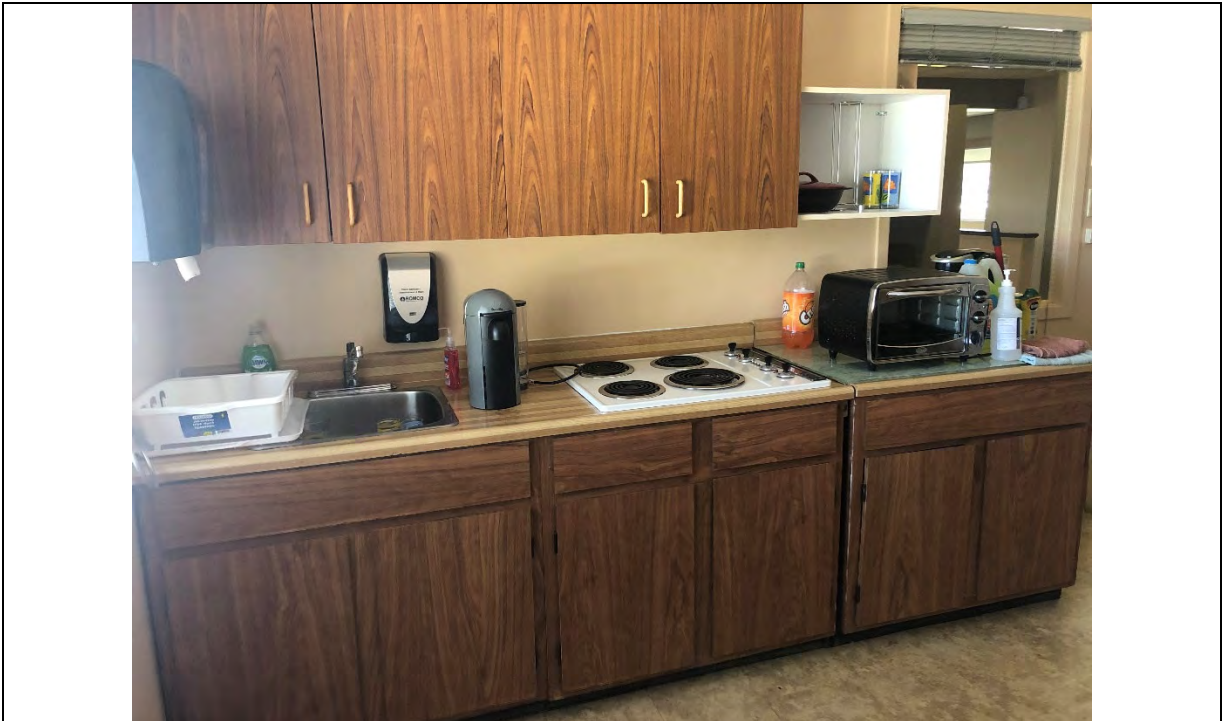
Photo 001 View of kitchenette including electric range, kitchen sink and other small appliances on the main floor in the building on the Site (facing west).

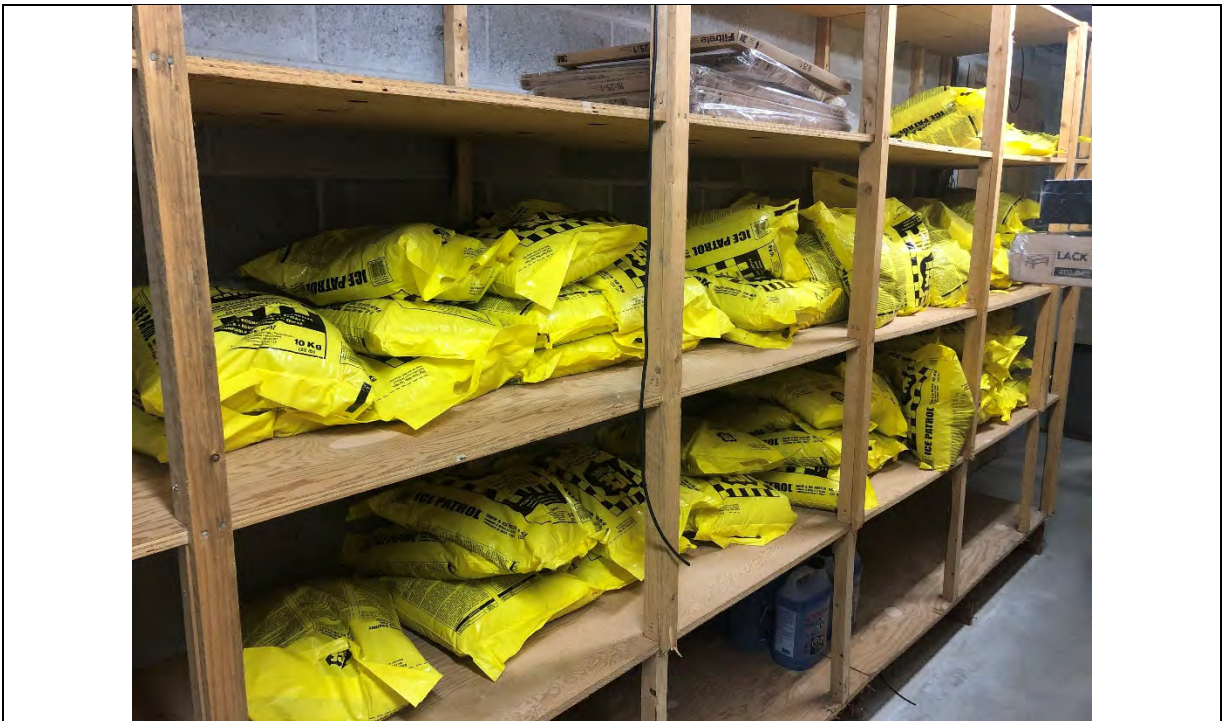
No other chemical storage was observed in the accessible areas of the Site. Household cleaners such as dish soap and laundry detergent were observed, as well as packages of de-icing salt. Based on the limited quantities of these products, these are not considered to represent a potential environmental concern on the Site.

Photo 002 View of road salt stored in basement of the building on Site (facing west).

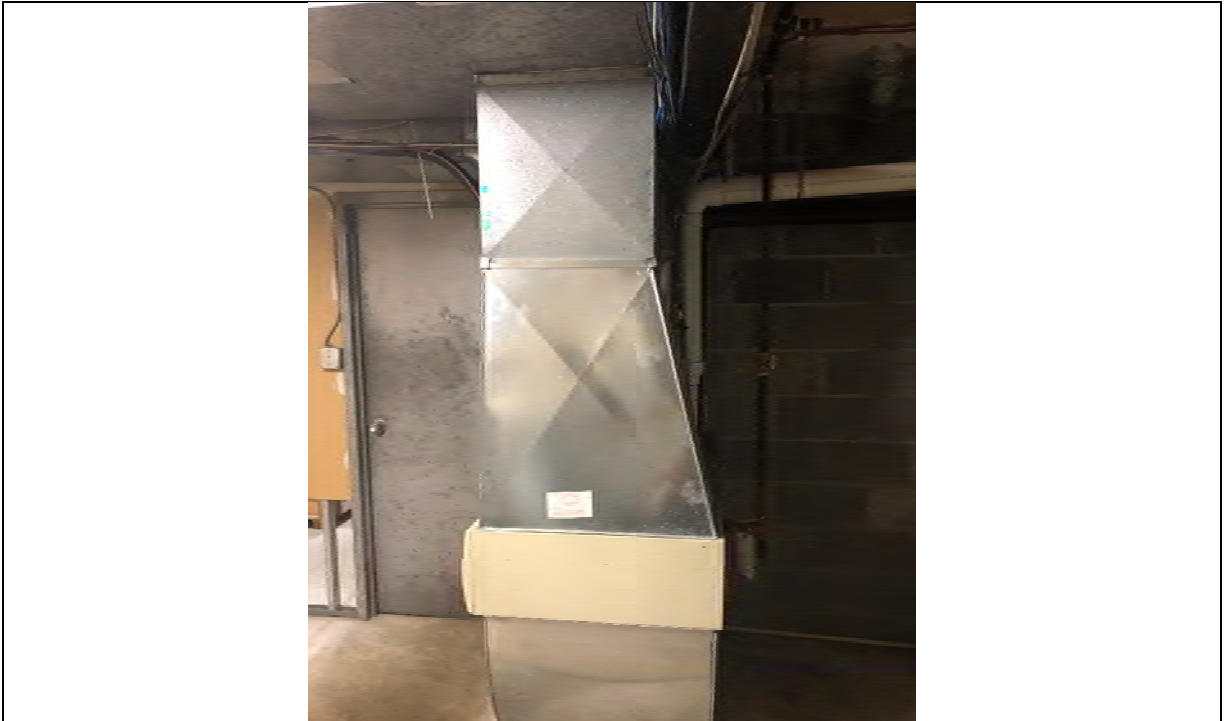
Photo 003 View of HVAC system in the basement of the building on the Site (facing north).

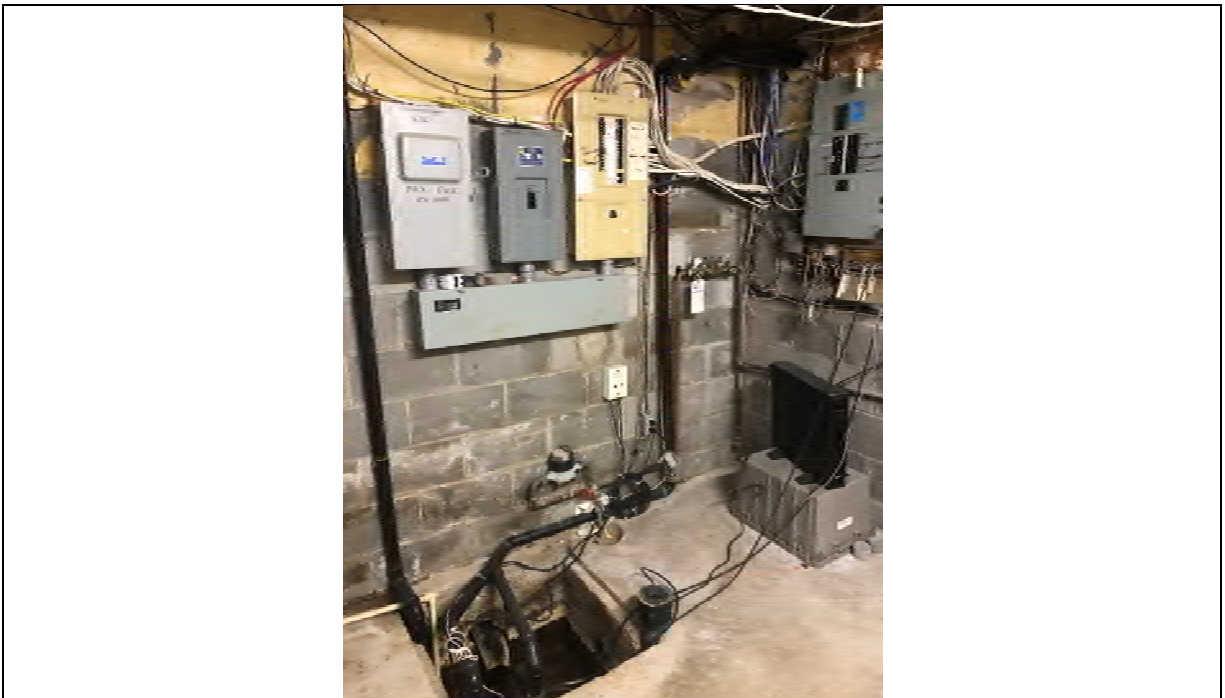
No floor drains were observed in the building; however, one storm drain was noted in the parking lot. A sump was located in the basement of the building; however, the property owner was not aware where the sump drained. Reportedly, the Site has a septic system and possible holding tank located within the southern landscaped area.

Photo 004 View of sump in the basement of the building on the Site (facing southwest).

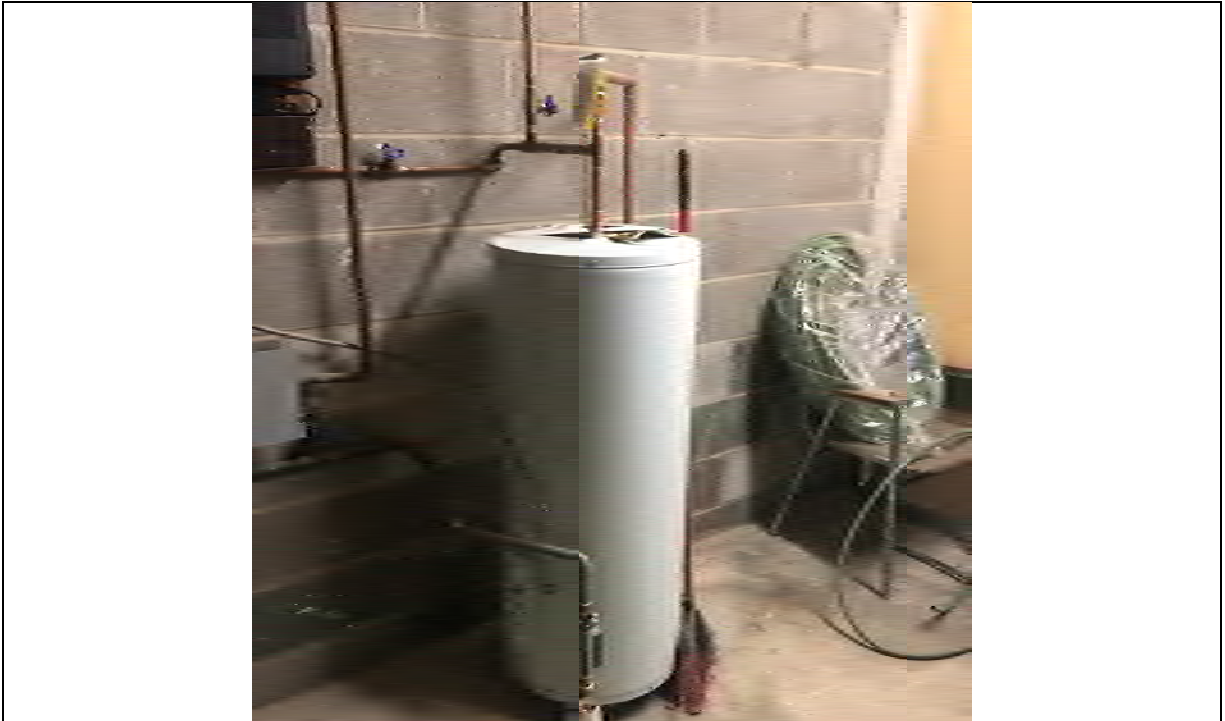
Photo 005 View of hot water tank in the basement of the building on the Site (facing southeast).

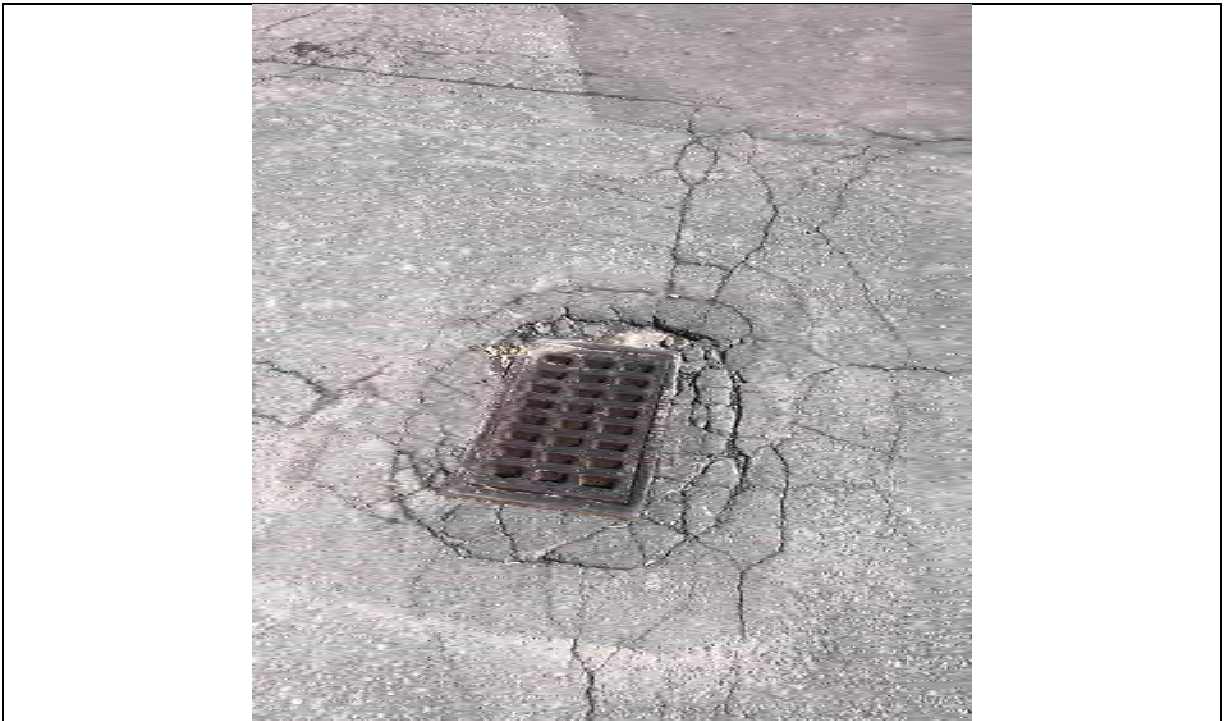
Photo 006 View storm drain in the parking lot on the Site.

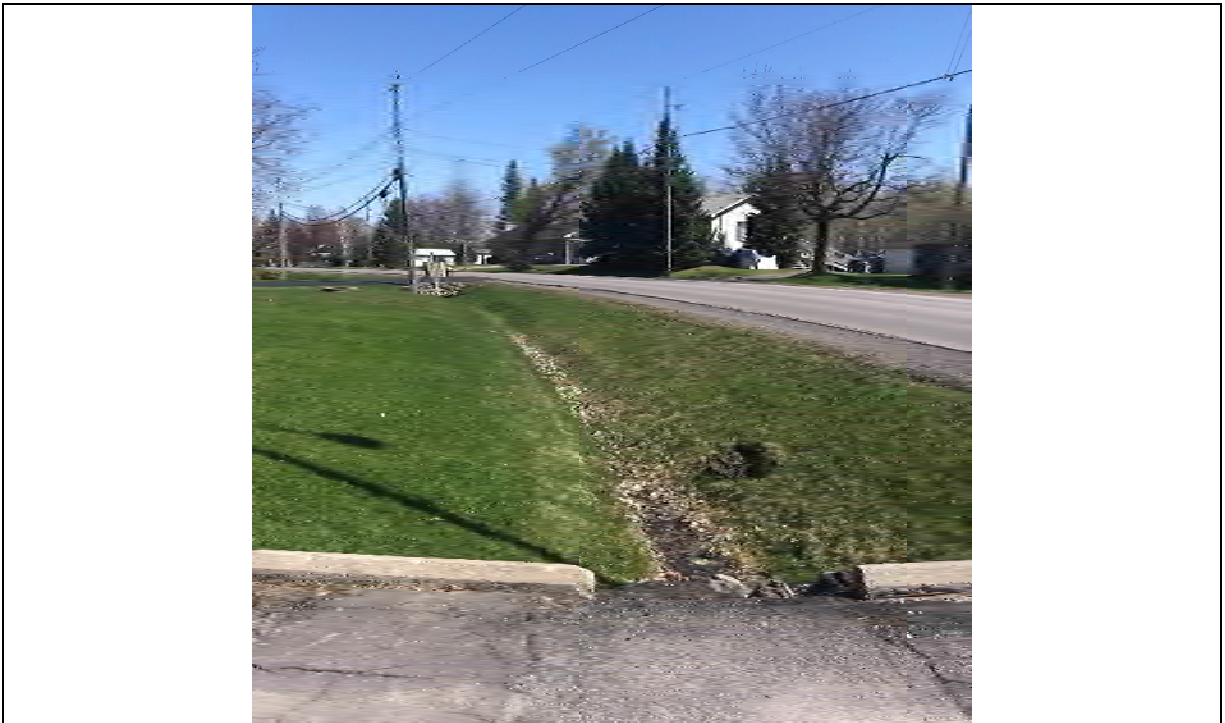
The Site is occupied by one building, a paved parking lot and a grassed landscaped area south of the site building. A drainage ditch separating the property from the nearby roadways was observed along the eastern and southern Site boundaries. No natural waterbodies, pits, or lagoons, were identified at the Site during the site visit. At the time of the Site visit, standing water was observed within the drainage ditch.

Photo 007 View of the storm ditch along the eastern portion of the Site separating the Site from Mer Bleue Road (facing north).

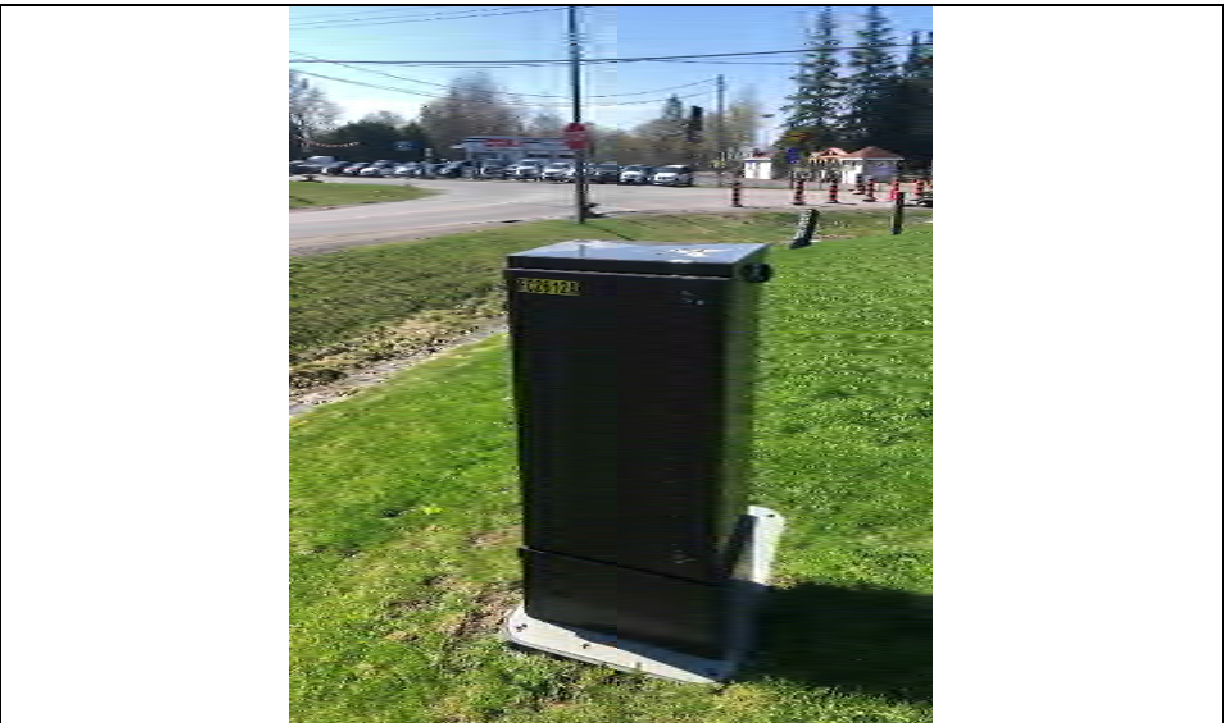
Photo 008 View of a transformer on the Site, with the intersection of Navan Road and Mer Bleue Road in the background (facing southeast).

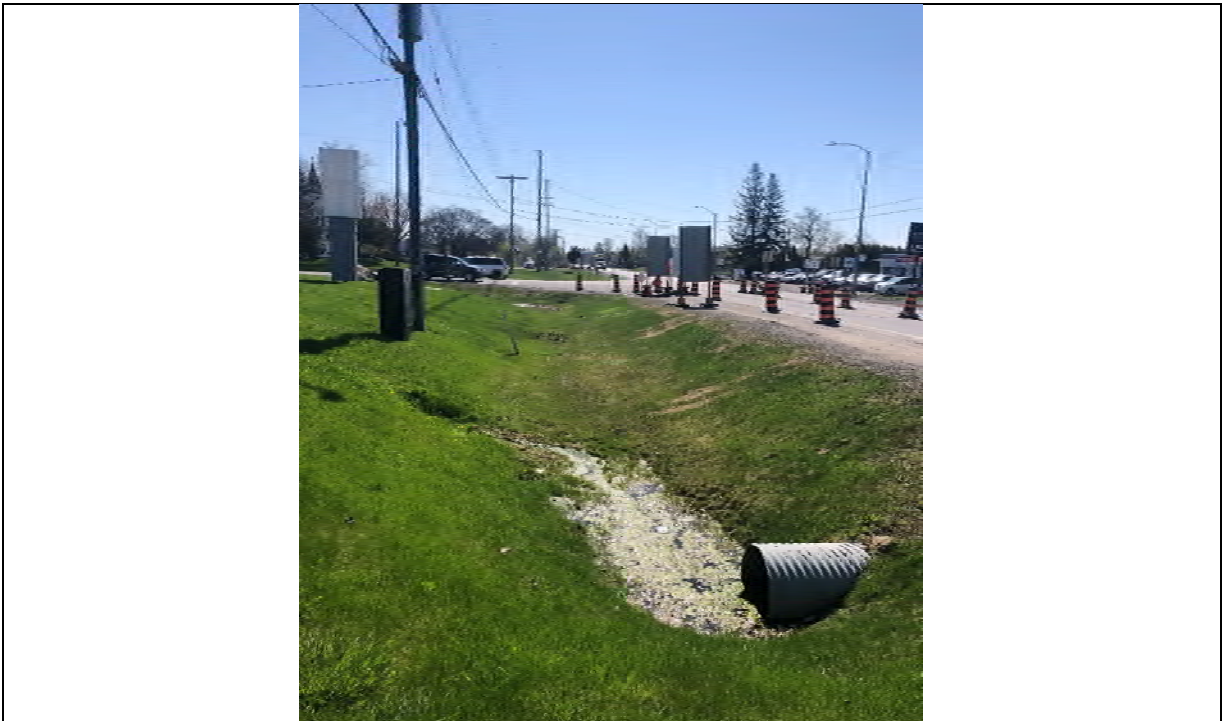
No liquid waste was observed at the Site during the site visit; however, stormwater discharge was observed coming from a culvert in the field south of the building on the Site. It is anticipated that the stormwater was runoff and drainage originated from nearby. No sheen or odour was observed in the stormwater discharge. The observed stormwater is not anticipated to pose an environmental concern to the Site.

Photo 010 View of ditch along the southern Site boundary including a culvert under Navan Road (facing east).

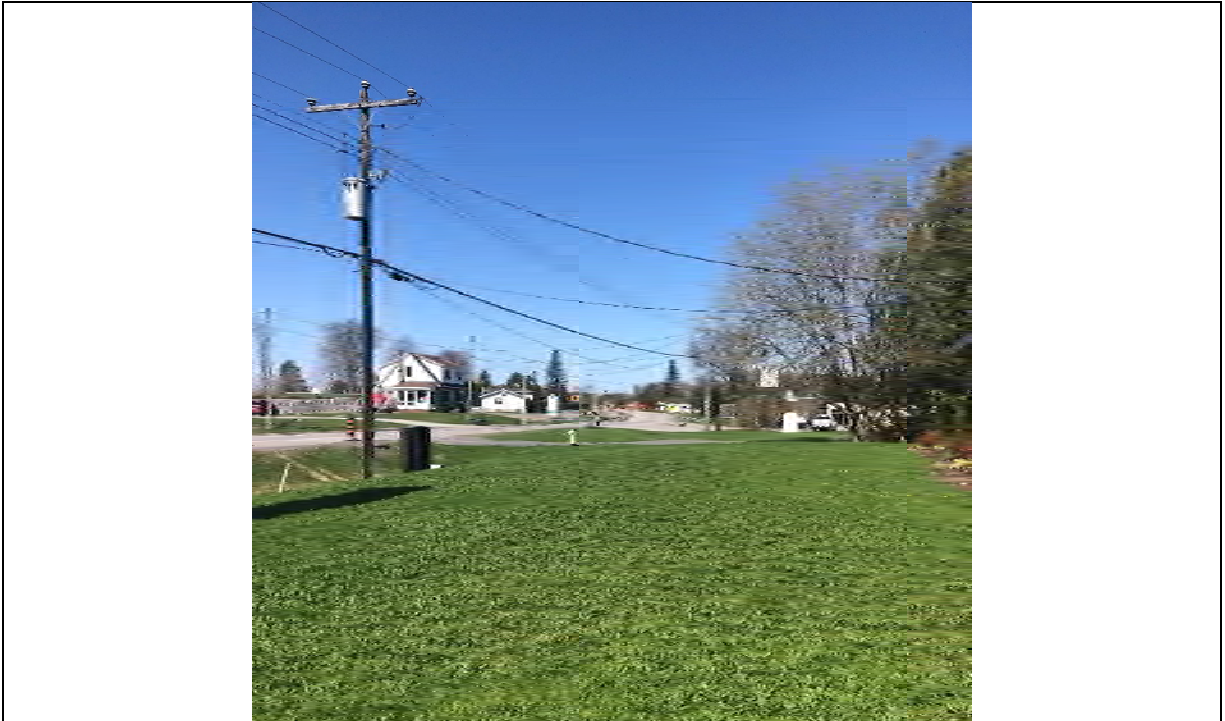
Photo 011 View of pole-mounted transformer and grassy area on the southern portion of the Site where reportedly the septic field or septic holding tank is anticipated to be located (facing west).

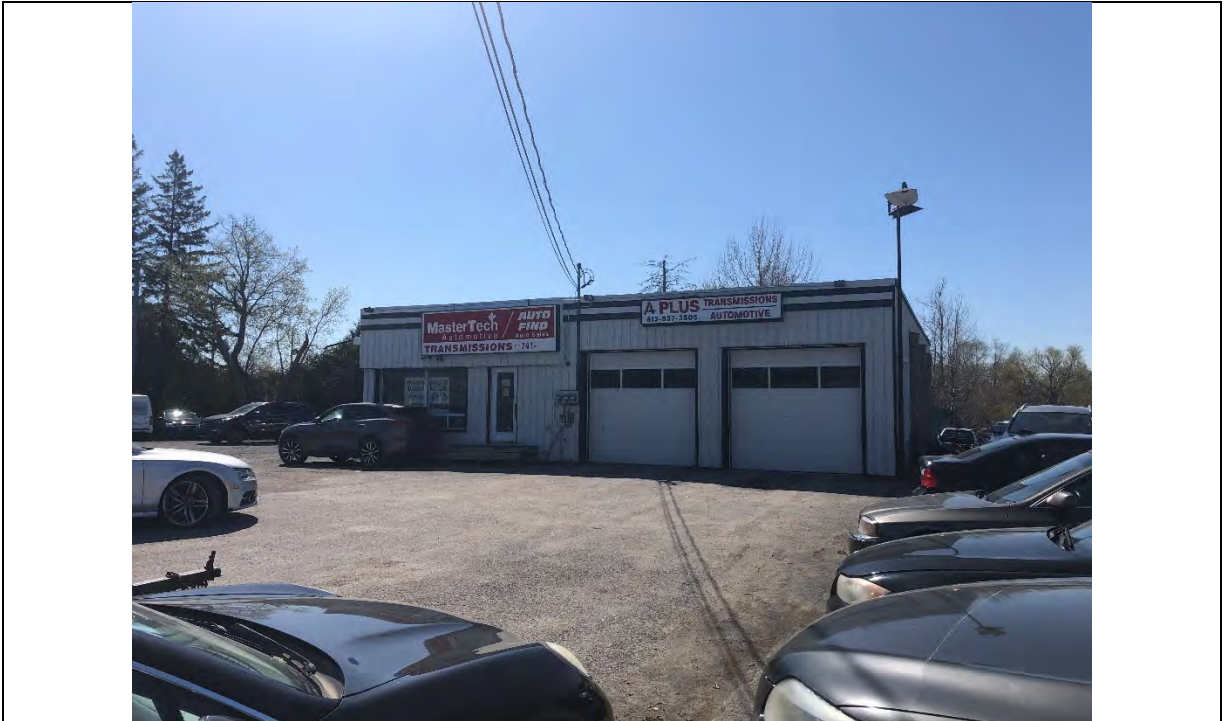
Photo 013 View of MasterTech automotive services located at 3714 Navan Road, south of the Site across Navan Road (facing south).

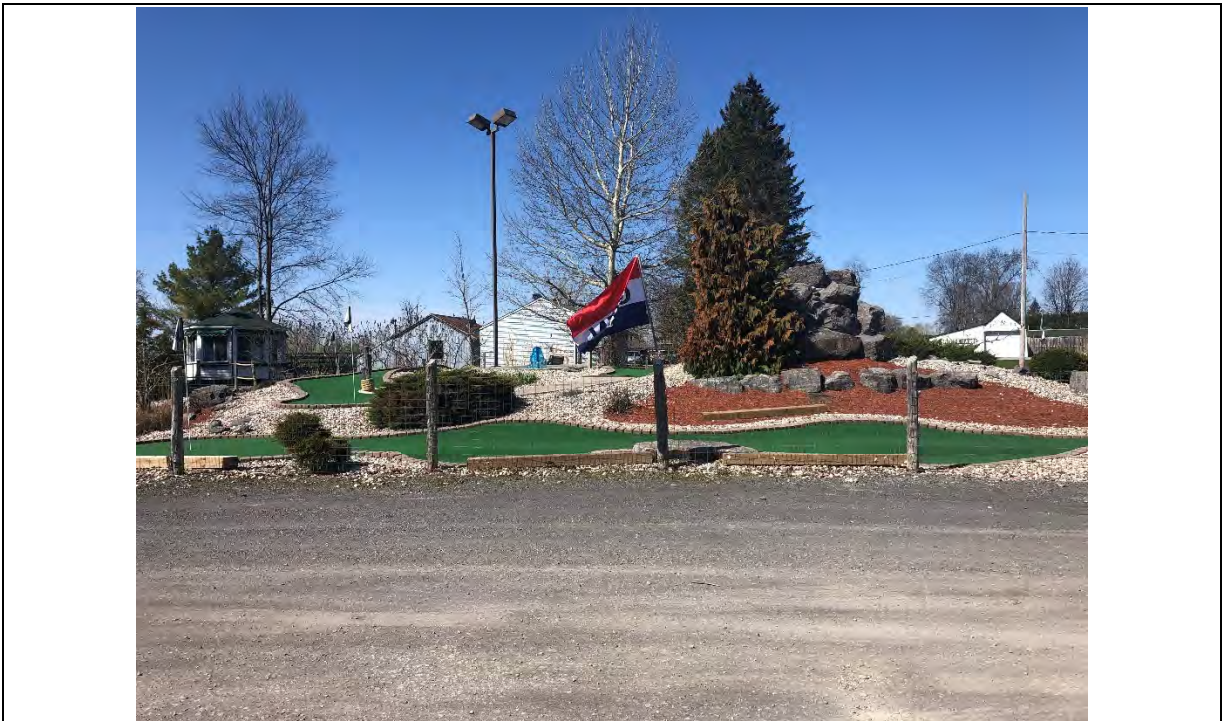
Photo 014 View of the Mer Bleue driving range, 9-hole golf course, and mini-putt golf course located at 3708 Navan Road south of the Site, across Navan Road (facing south).
