Phase I - Environmental Site Assessment

Vacant Property
Palladium Drive and Campeau Drive
Ottawa, Ontario

November 16, 2018

Report: PE3146-2

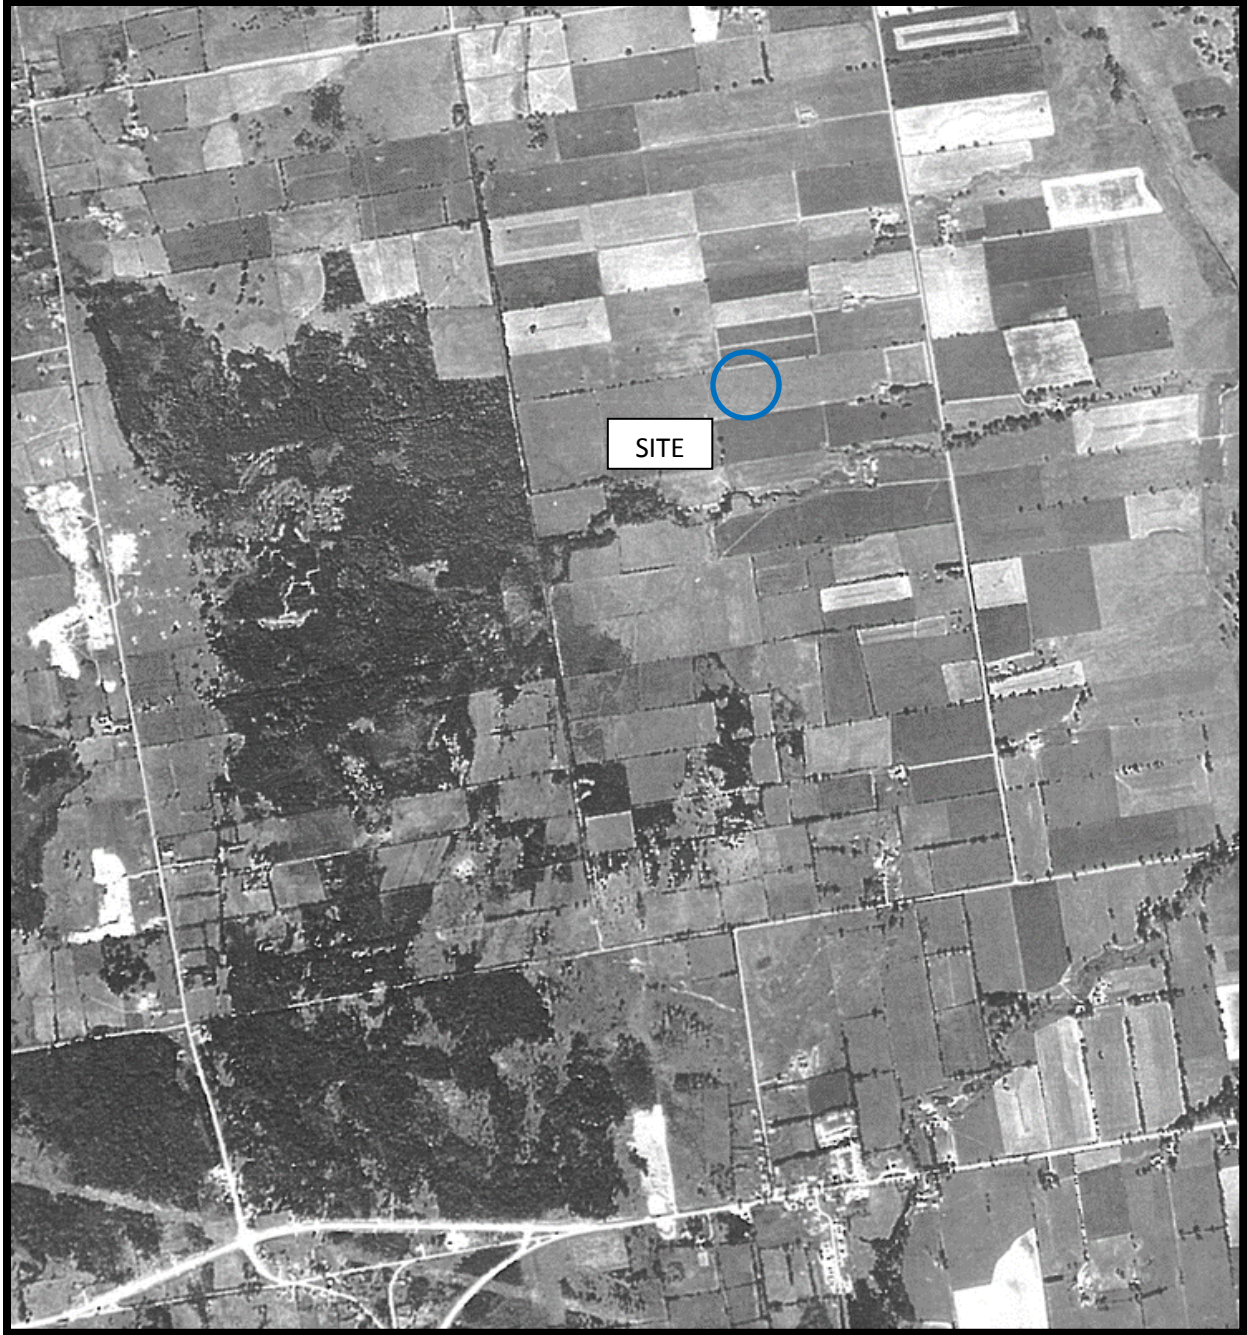
AERIAL PHOTOGRAPH
1959

| 1959 | No apparent changes have been made to the subject site or surrounding properties. |

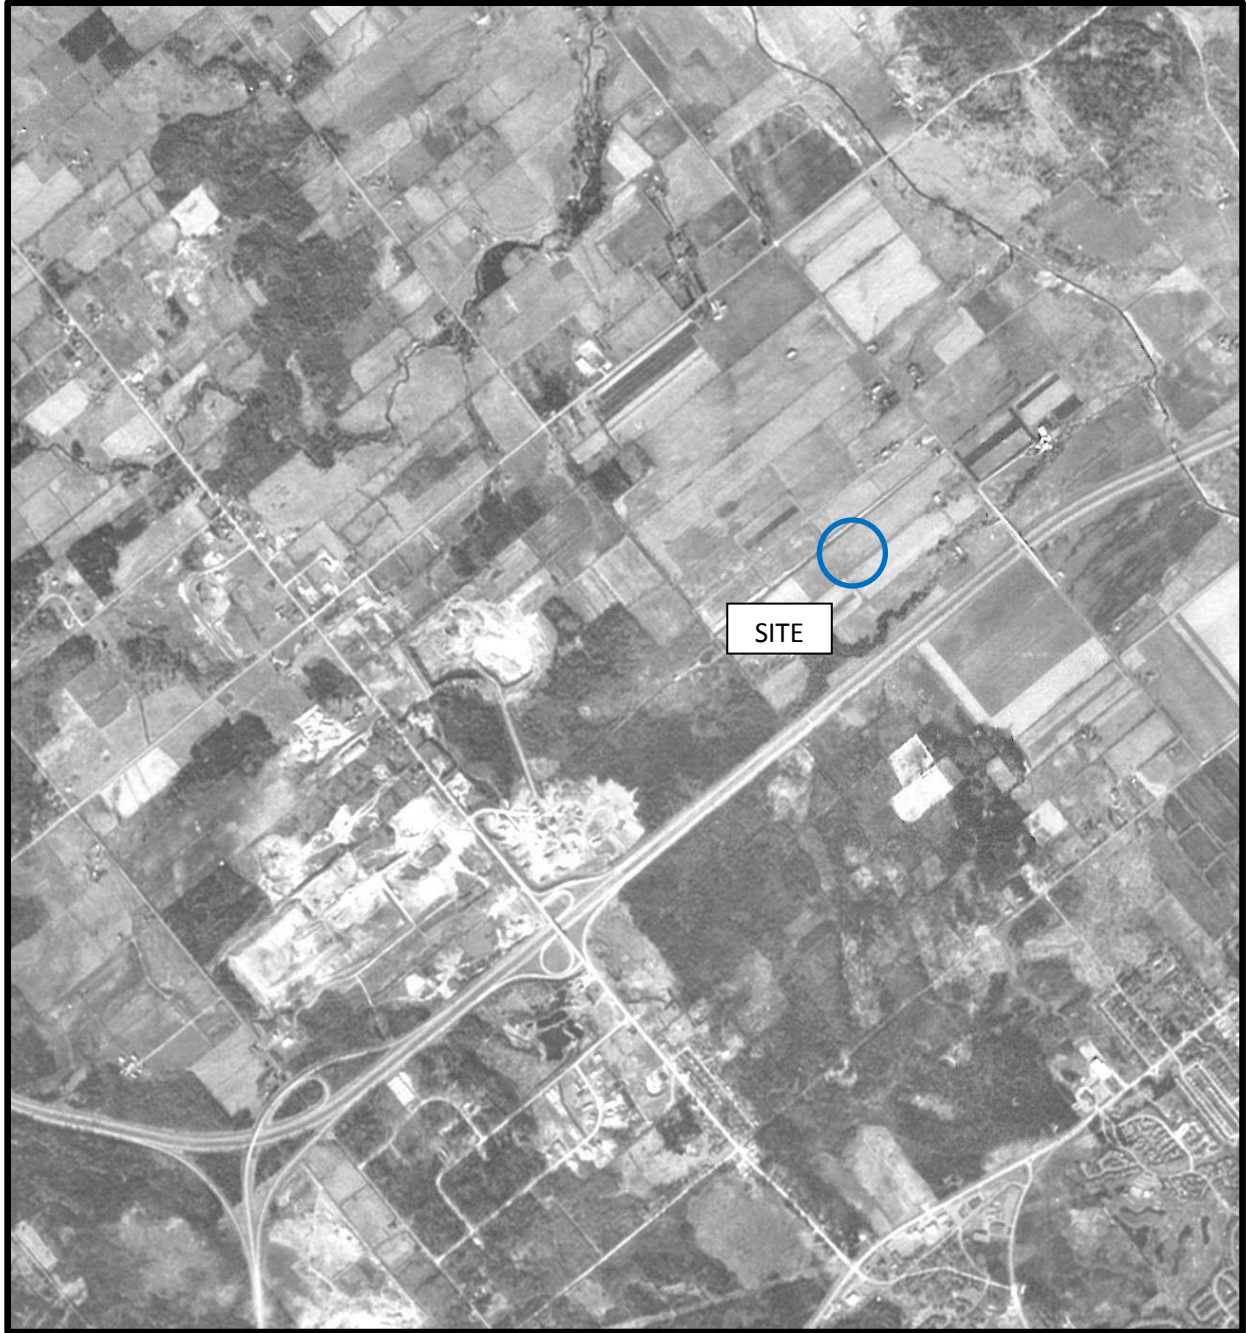
AERIAL PHOTOGRAPH
1988

| 1988 | No apparent changes have been made to the subject site or surrounding properties. Highway 417 can be seen at this time. |

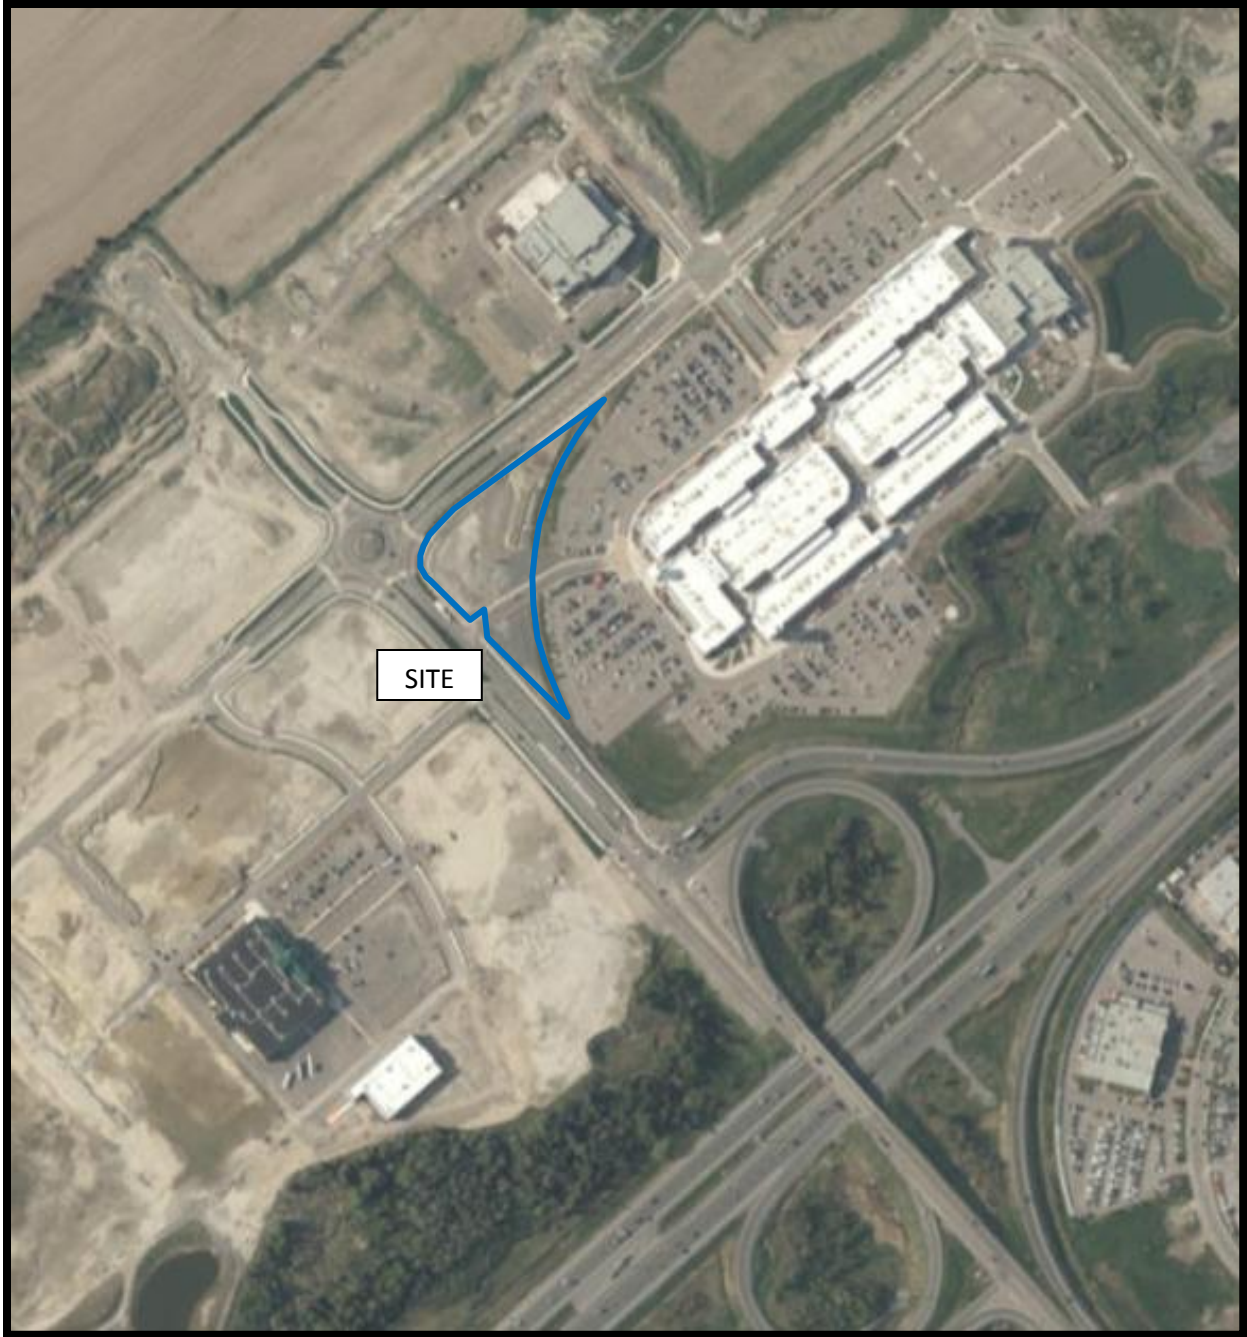
AERIAL PHOTOGRAPH
2017

| 2017 | (City of Ottawa website) The subject site appears to be vacant and cleared of vegetation. A drainage ditch can be seen under construction on the northeastern portion of the property. An asphaltic concrete paved access road can be seen on the southern portion of the subject property. A retail outlet mall and parking lot can be seen east of the subject site (Tanger Outlets), as well as a Carpenters Training Centre building north of the subject site (Carpenters' Union 93). Additionally, an outdoor recreation retail store (Cabela's), and an auto parts retail store (Princess Auto) can be seen approximately 270 m south of the subject site. Palladium Drive and Campeau Drive are visible in their current configuration. |

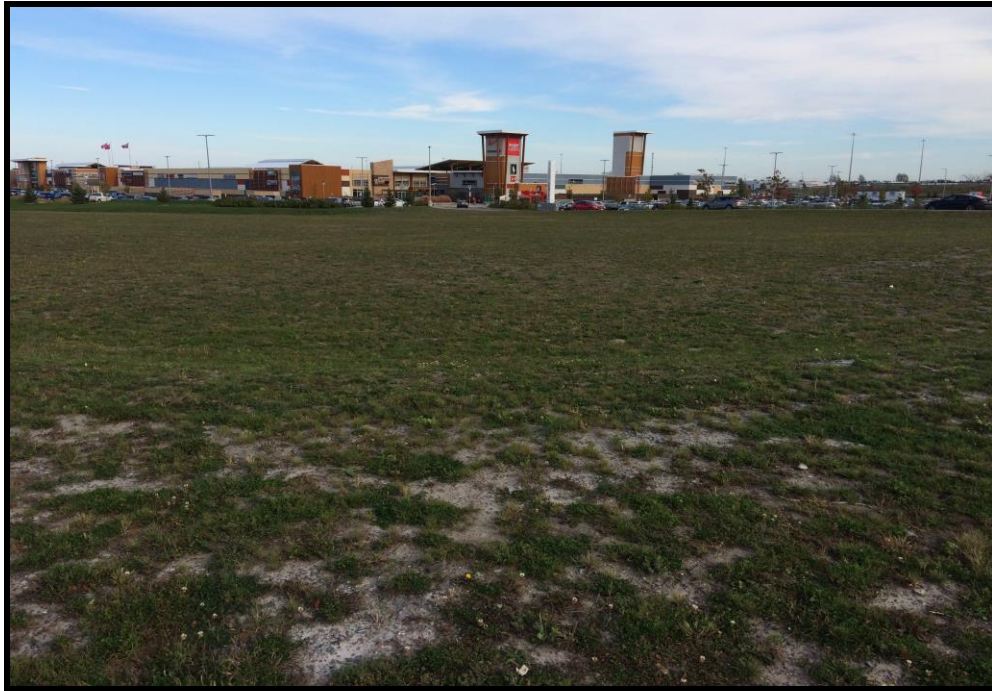
Photograph 1: View of the west portion of the property, facing east from the intersection of Palladium Drive and Campeau Drive.

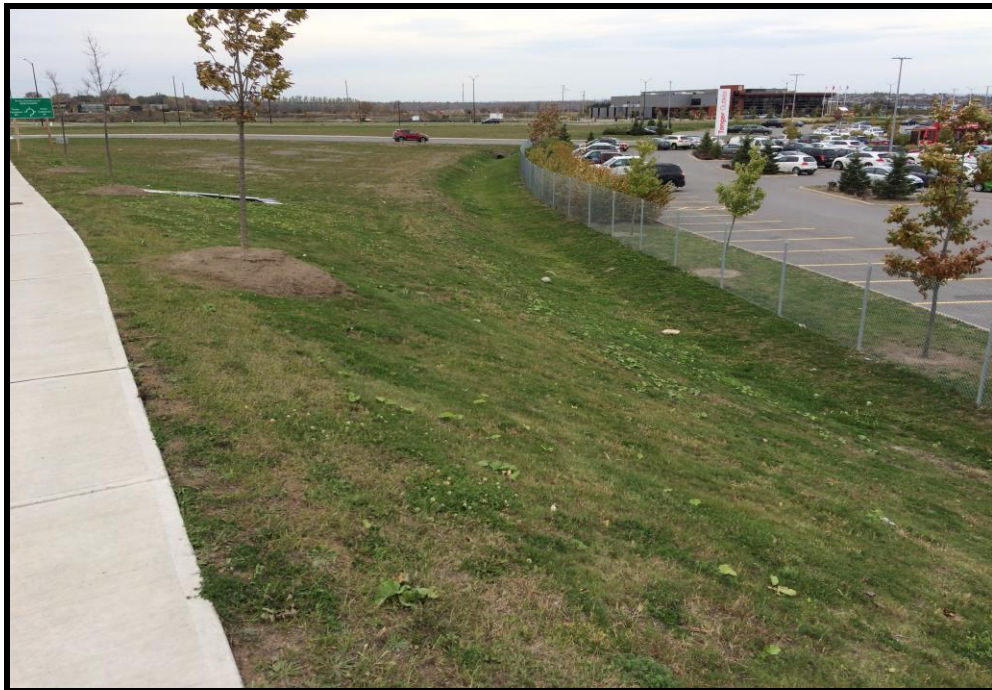
Photograph 2: View of the south portion of the property, facing north from Palladium Drive.

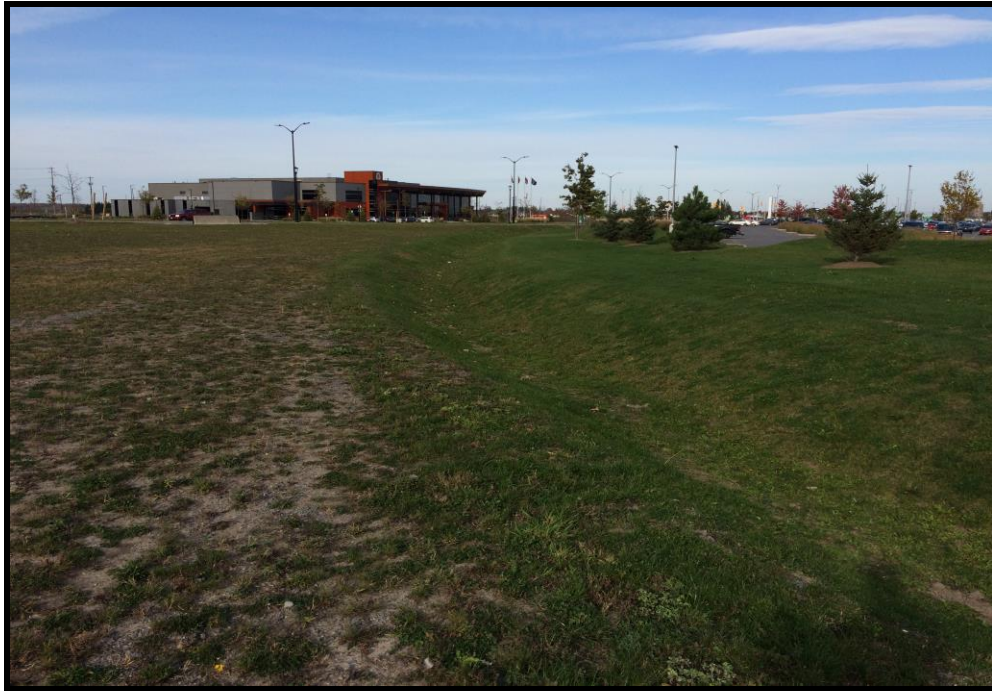
The subject site is not developed with any buildings and currently exists as a vacant lot of grassed land with a paved access road running through the southern portion of the property. A drainage ditch is currently present on the east side of the subject property and runs in a north-south direction along the eastern property boundary. Site drainage consists primarily of infiltration and sheet flow towards the drainage ditch. The drainage ditch is connected to the City of Ottawa stormwater system. No hazardous materials were observed on the subject site.

Photograph 3: View of a drainage ditch located in the eastern portion of the property, facing north.

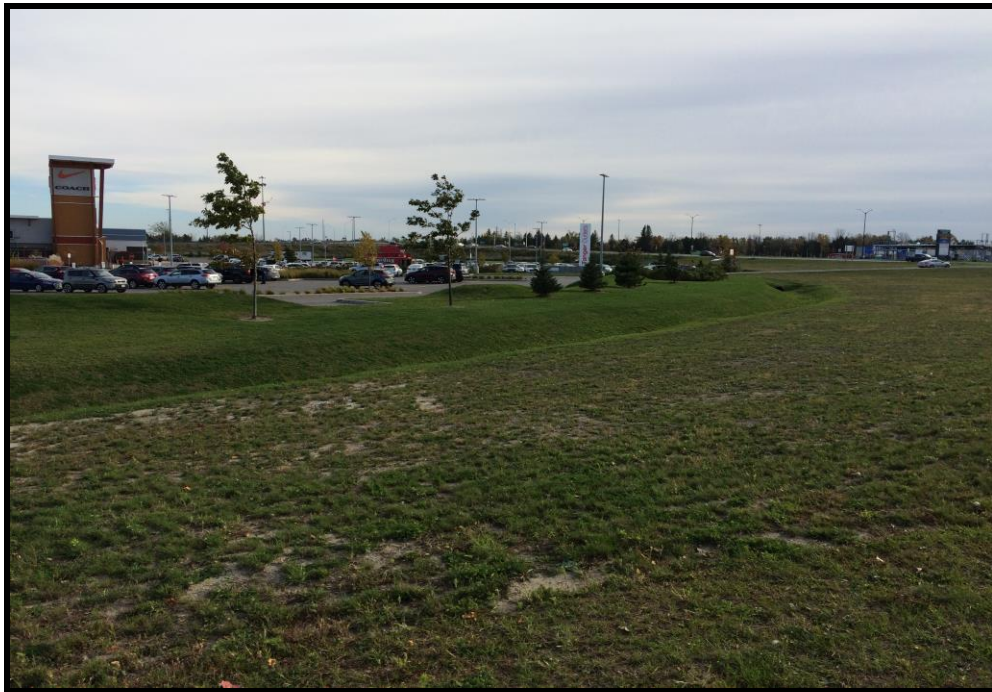
Photograph 4: View of the north portion of the property, as well as an alternate view of a drainage ditch located on the eastern portion of the property, facing south.

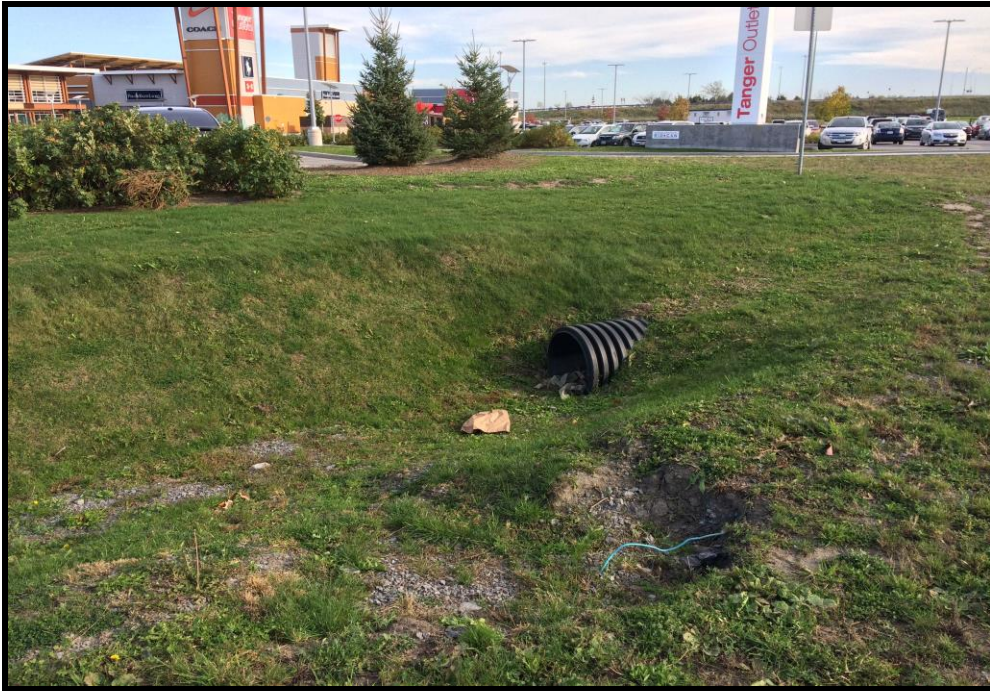
Photograph 5: View of a drainage culvert located in the eastern portion of the property, facing southeast.

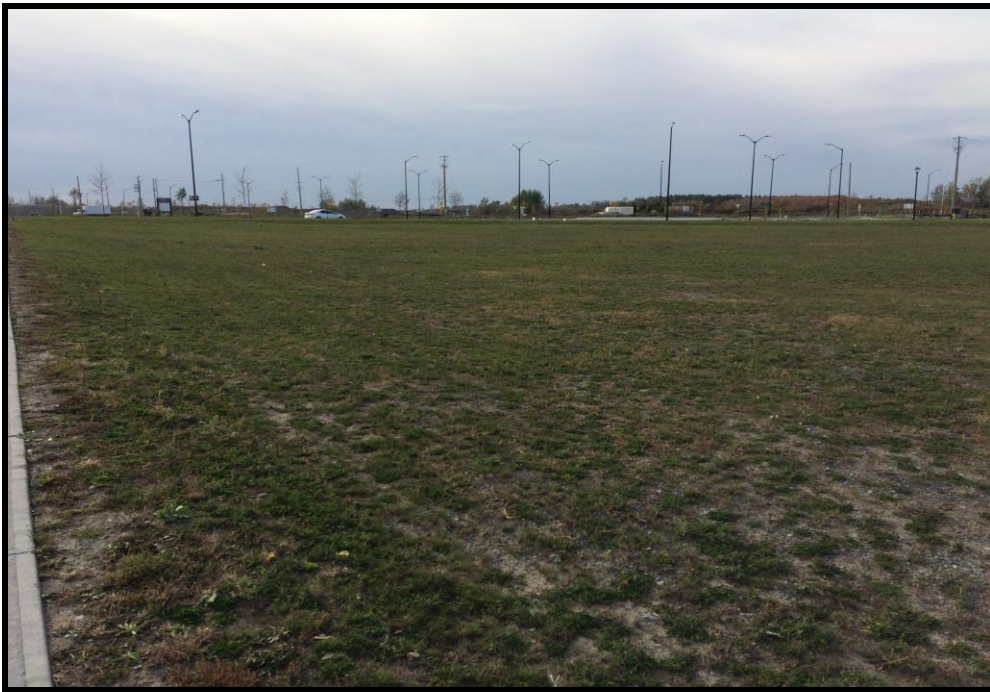
Photograph 6: View of the east portion of the property, facing west from the Tanger Outlet Mall access road.
