JBPA Developments Inc.

**Phase I Environmental Site Assessment
12-24 Hawthorne Avenue
Ottawa, Ontario**

CM3 Project SDC1007

June 30, 2022

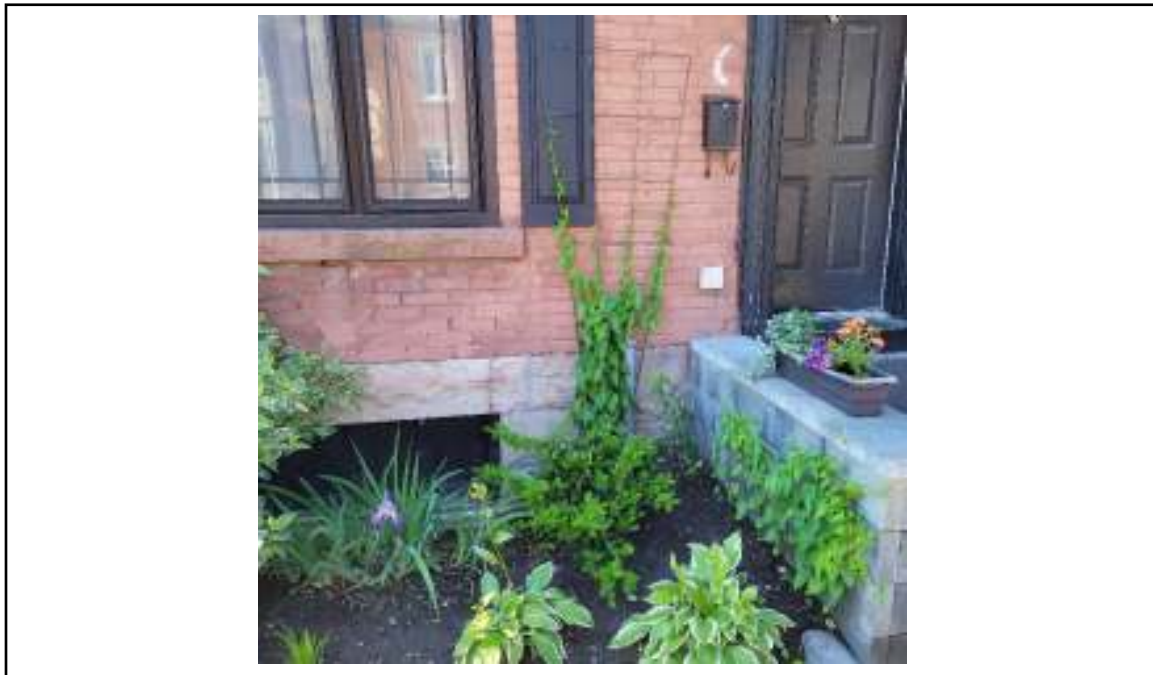
Photograph 5: Looking south at north front wall of 18 Hawthorne, note fill and vent pipes for AST in basement of unit.

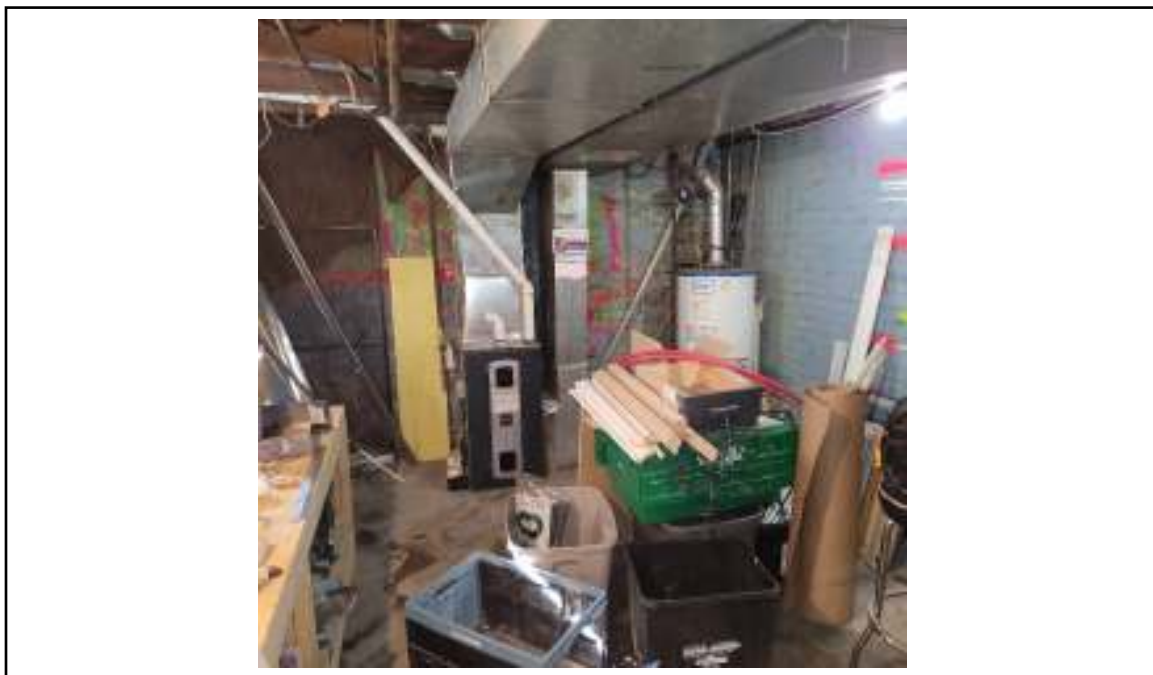
Photograph 6: Natural gas furnace and hot water tank in basement of 14 Hawthorne.

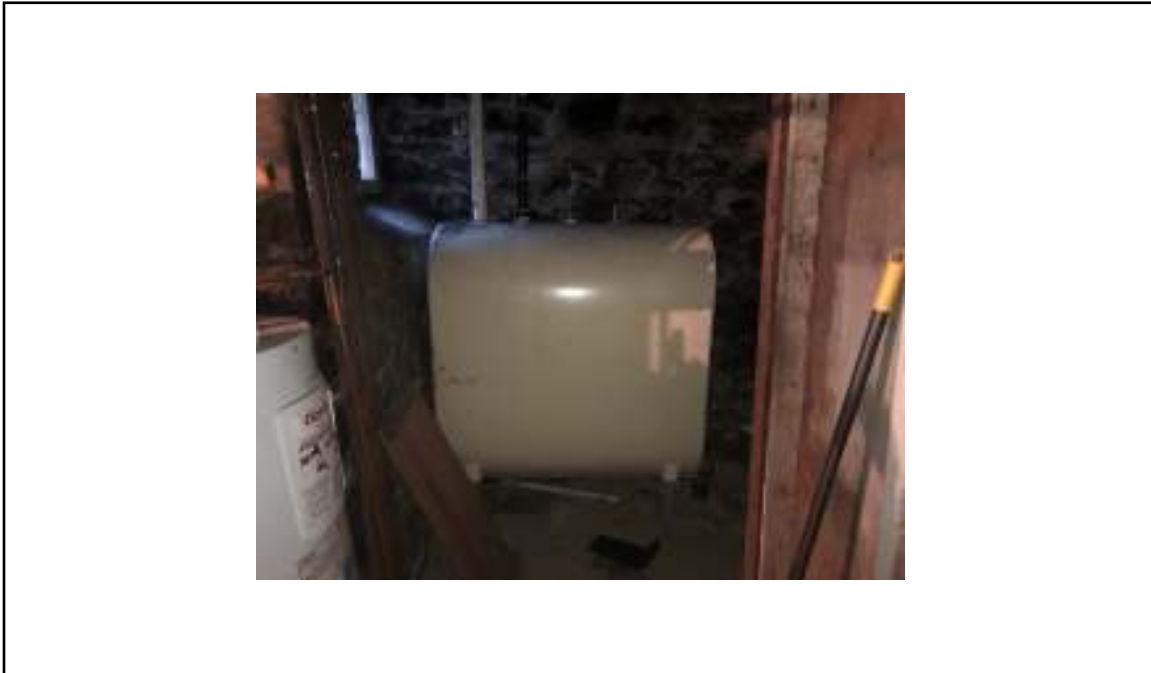
Above ground storage tanks (ASTs), containing fuel oil, were observed in the basement of 12 Hawthorne mid-way along the west wall and in the basement of 18 Hawthorne at the north wall adjacent to the basement window. Based on information provided during the interview, all units were likely heated by fuel oil at one time. Documentation regarding the removal of the tanks from the units 14 and 16 was not available.

Photograph 13: 680 liter fuel oil above ground storage tank in basement of 12 Hawthorne.

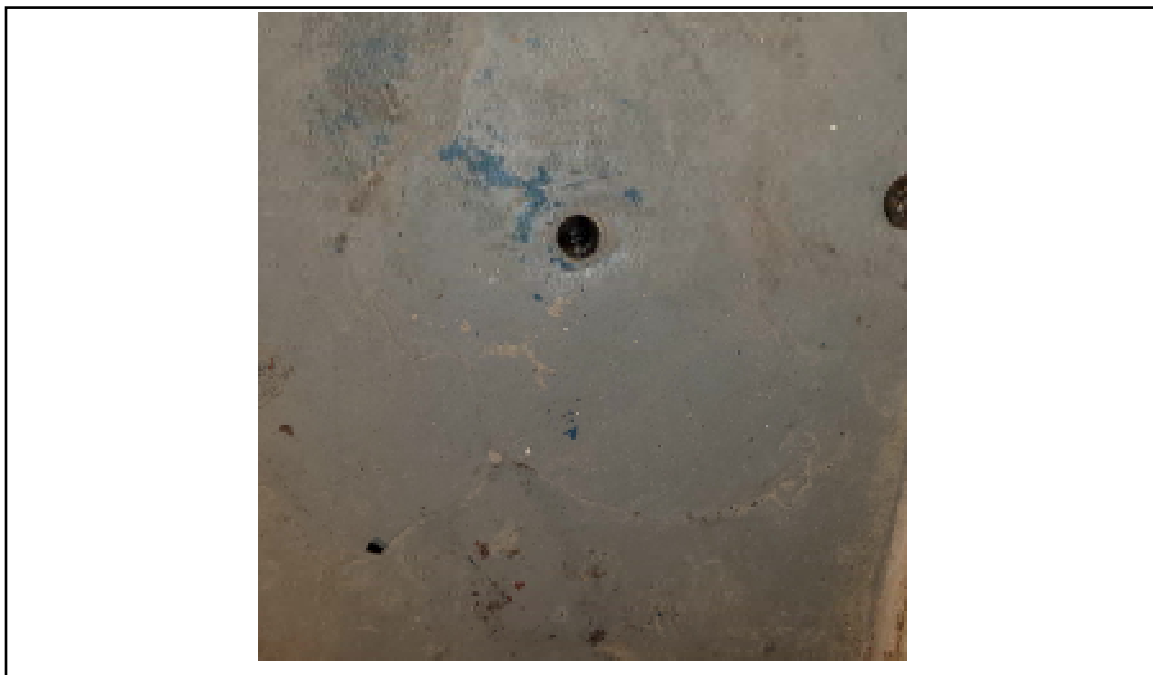
Photograph 16: Floor drain in floor of basement of 16 Hawthorne.

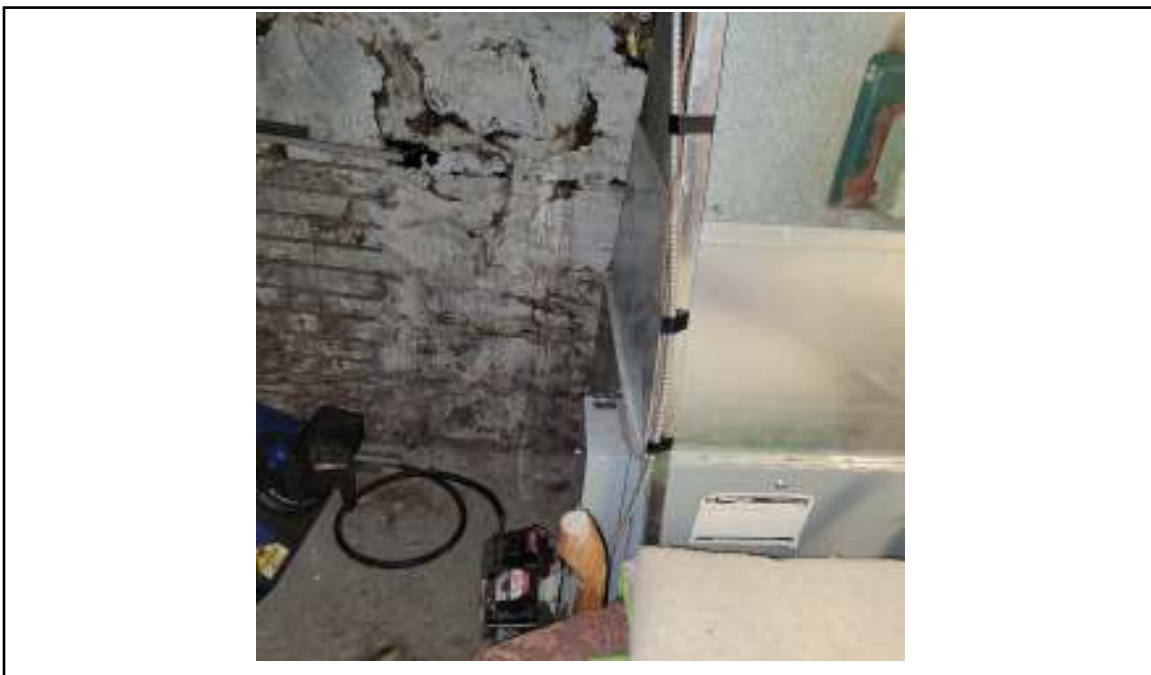
Photograph 22: Oil fired furnace in south end of basement of 18 Hawthorne.

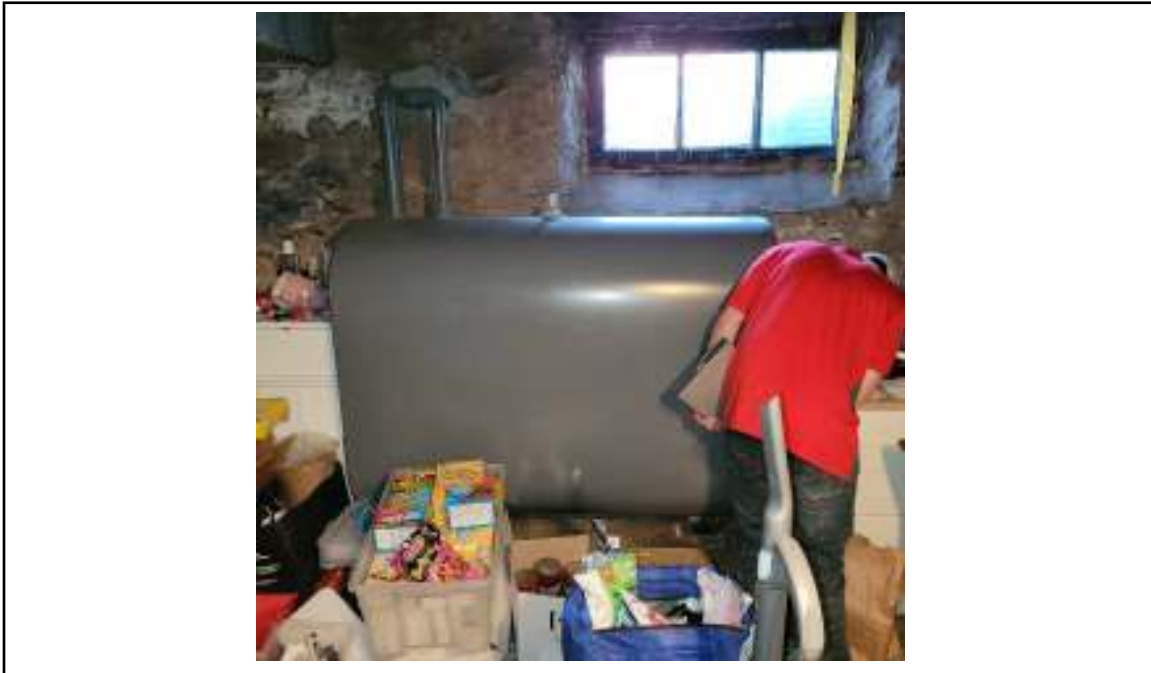
Photograph 23: 900 liter fuel oil aboveground storage tank in basement of 18 Hawthorne.

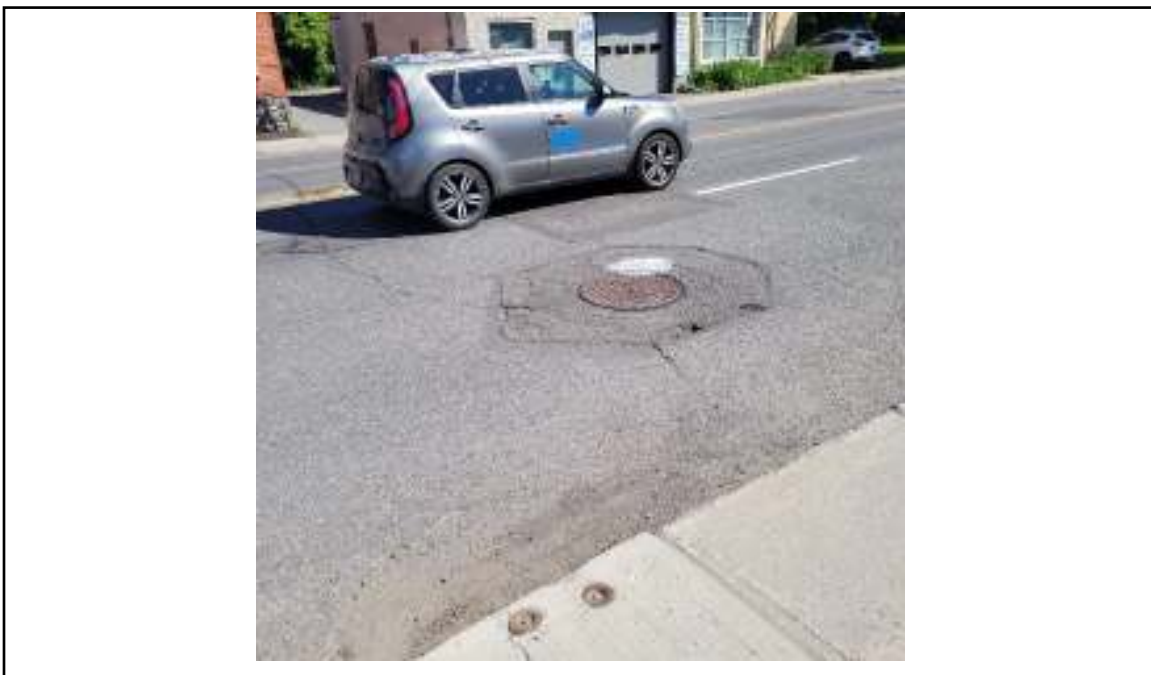
Photograph 26: Storm water manhole on Hawthorne Avenue, water service valves in sidewalk in front of 20 Hawthorne with former automotive service center across street at 25 Hawthorne.

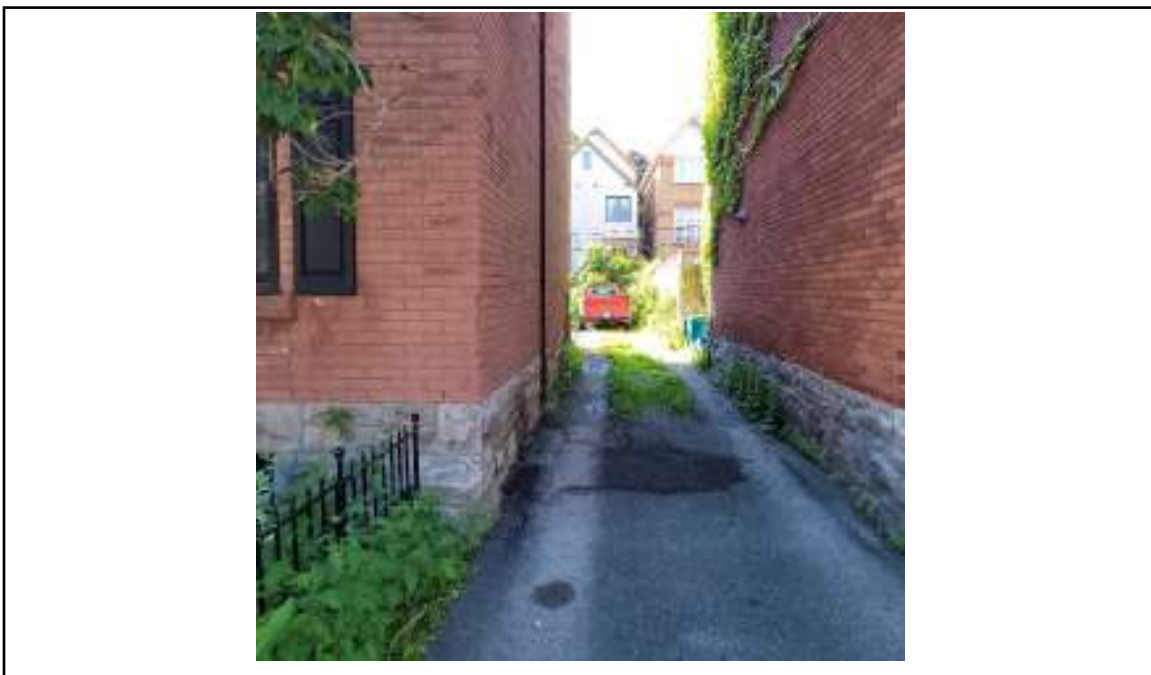
Photograph 30: Looking south from asphalt laneway of 12. Note fill and vent pipes for AST in basement of 12 Hawthorne on brick wall, center of photograph. Off-site property 10 Hawthorne is on left.
