**Tree Conservation Report
Proposed Re-Zoning Application
555, 591, 595 and 603 March Road
Ottawa, Ontario**

October 24, 2022
Project: 102220.001 - V01

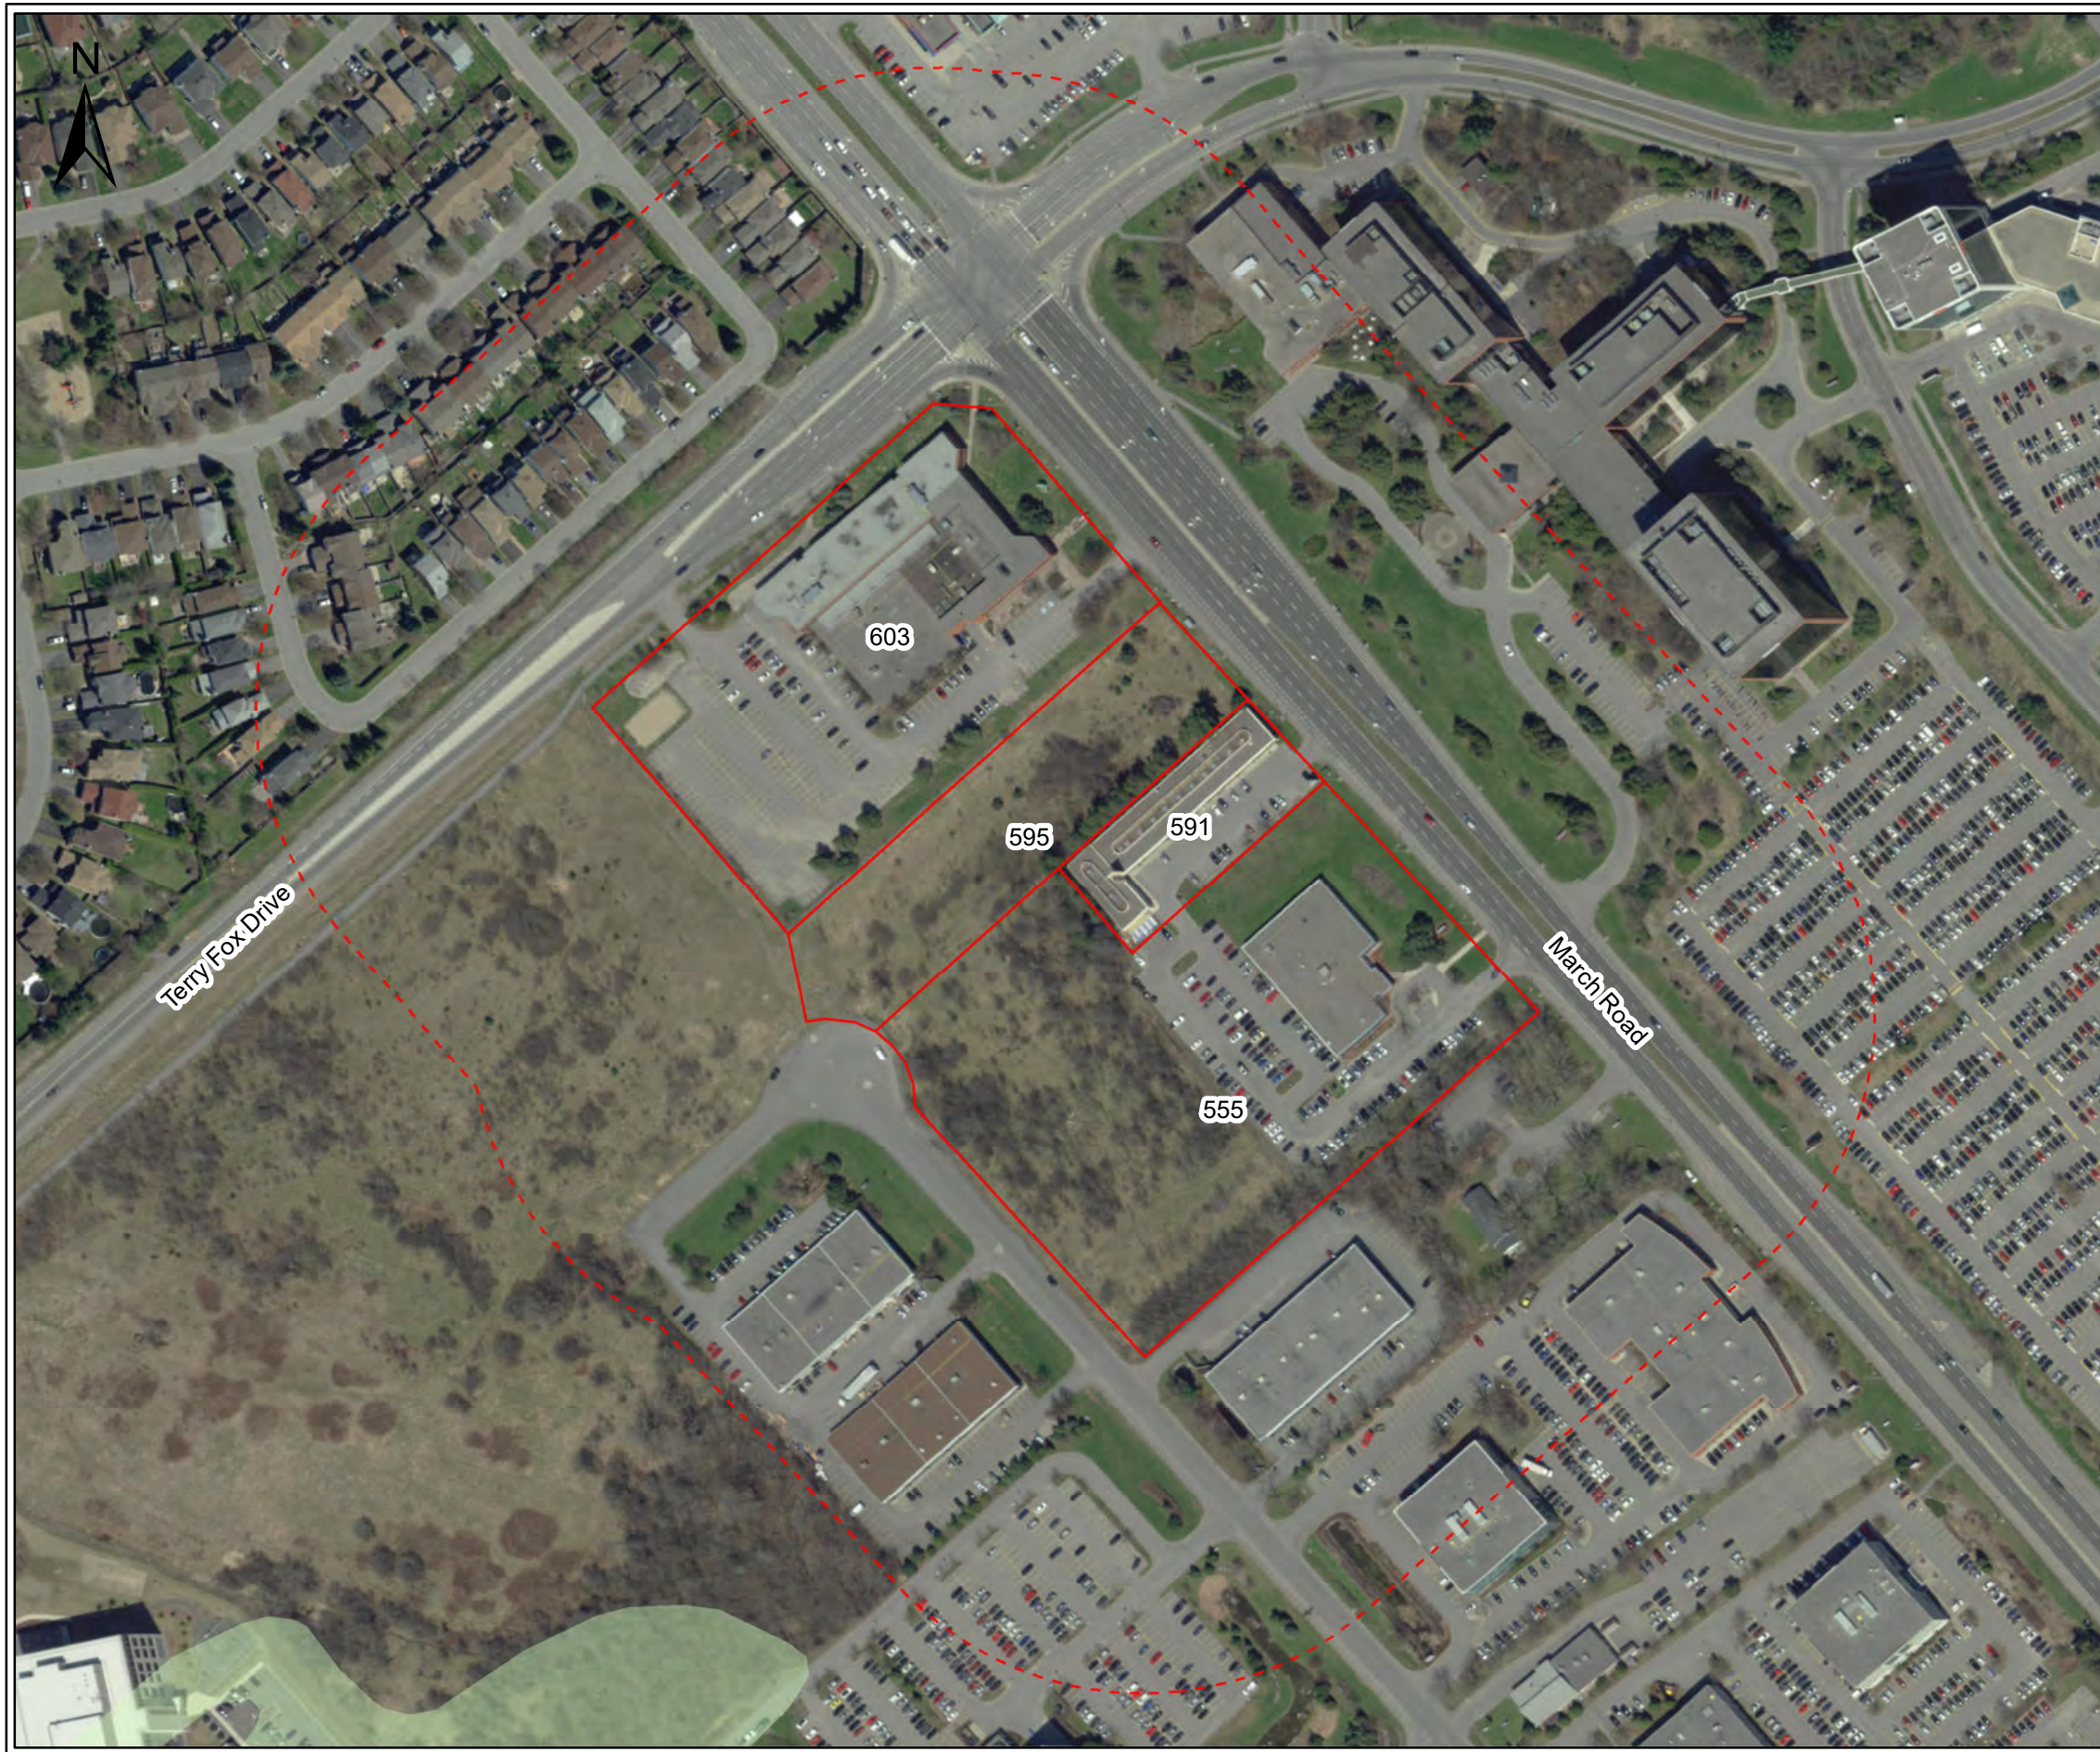
Figure A.2 – Site Layout

The existing site layout is provided in Figure A.2 with the proposed development provided in Figure A.3, Appendix A.

Existing commercial developments are present on 555, 591 and 603 March Road, whereas 595 March Road is currently vacant. Developments on 555 and 591 March Road are single story buildings fronting to March Road, while 603 is occupied by a two-story building, fronting to March Road and Terry Fox Drive. Including the existing structures and associated parking areas on the subject site have a combined approximate area of 2.5 ha. Impermeable surfaces account for 45% of the total property area.

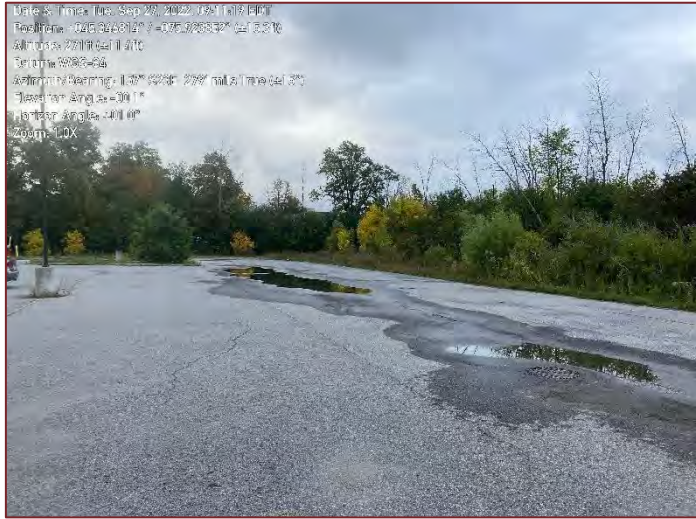
Site Photograph 1 – Dense vegetation adjacent to commercial area of property.

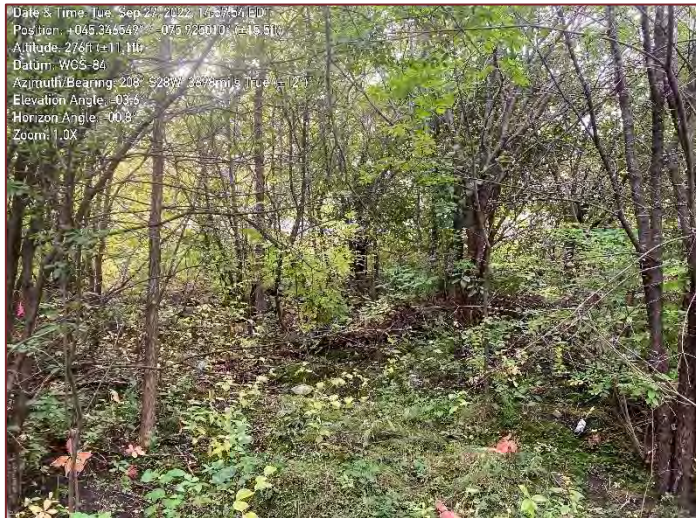
Site Photograph 3 – Example of dense shrub vegetation, common throughout the site.

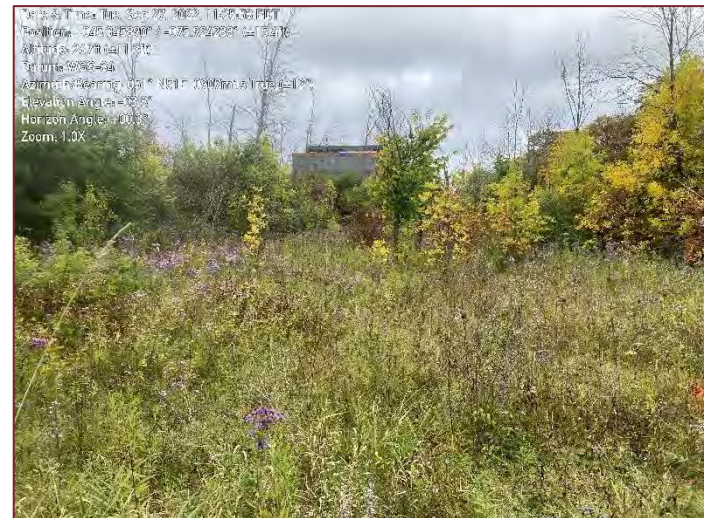
Site Photograph 4 – Example of meadow area on-site.
