# **Phase I Environmental Site Assessment**

210 Clearview Avenue  
Ottawa, Ontario

Prepared for Homestead Land Holdings Inc.

Report: PE5751-1  
July 15, 2022

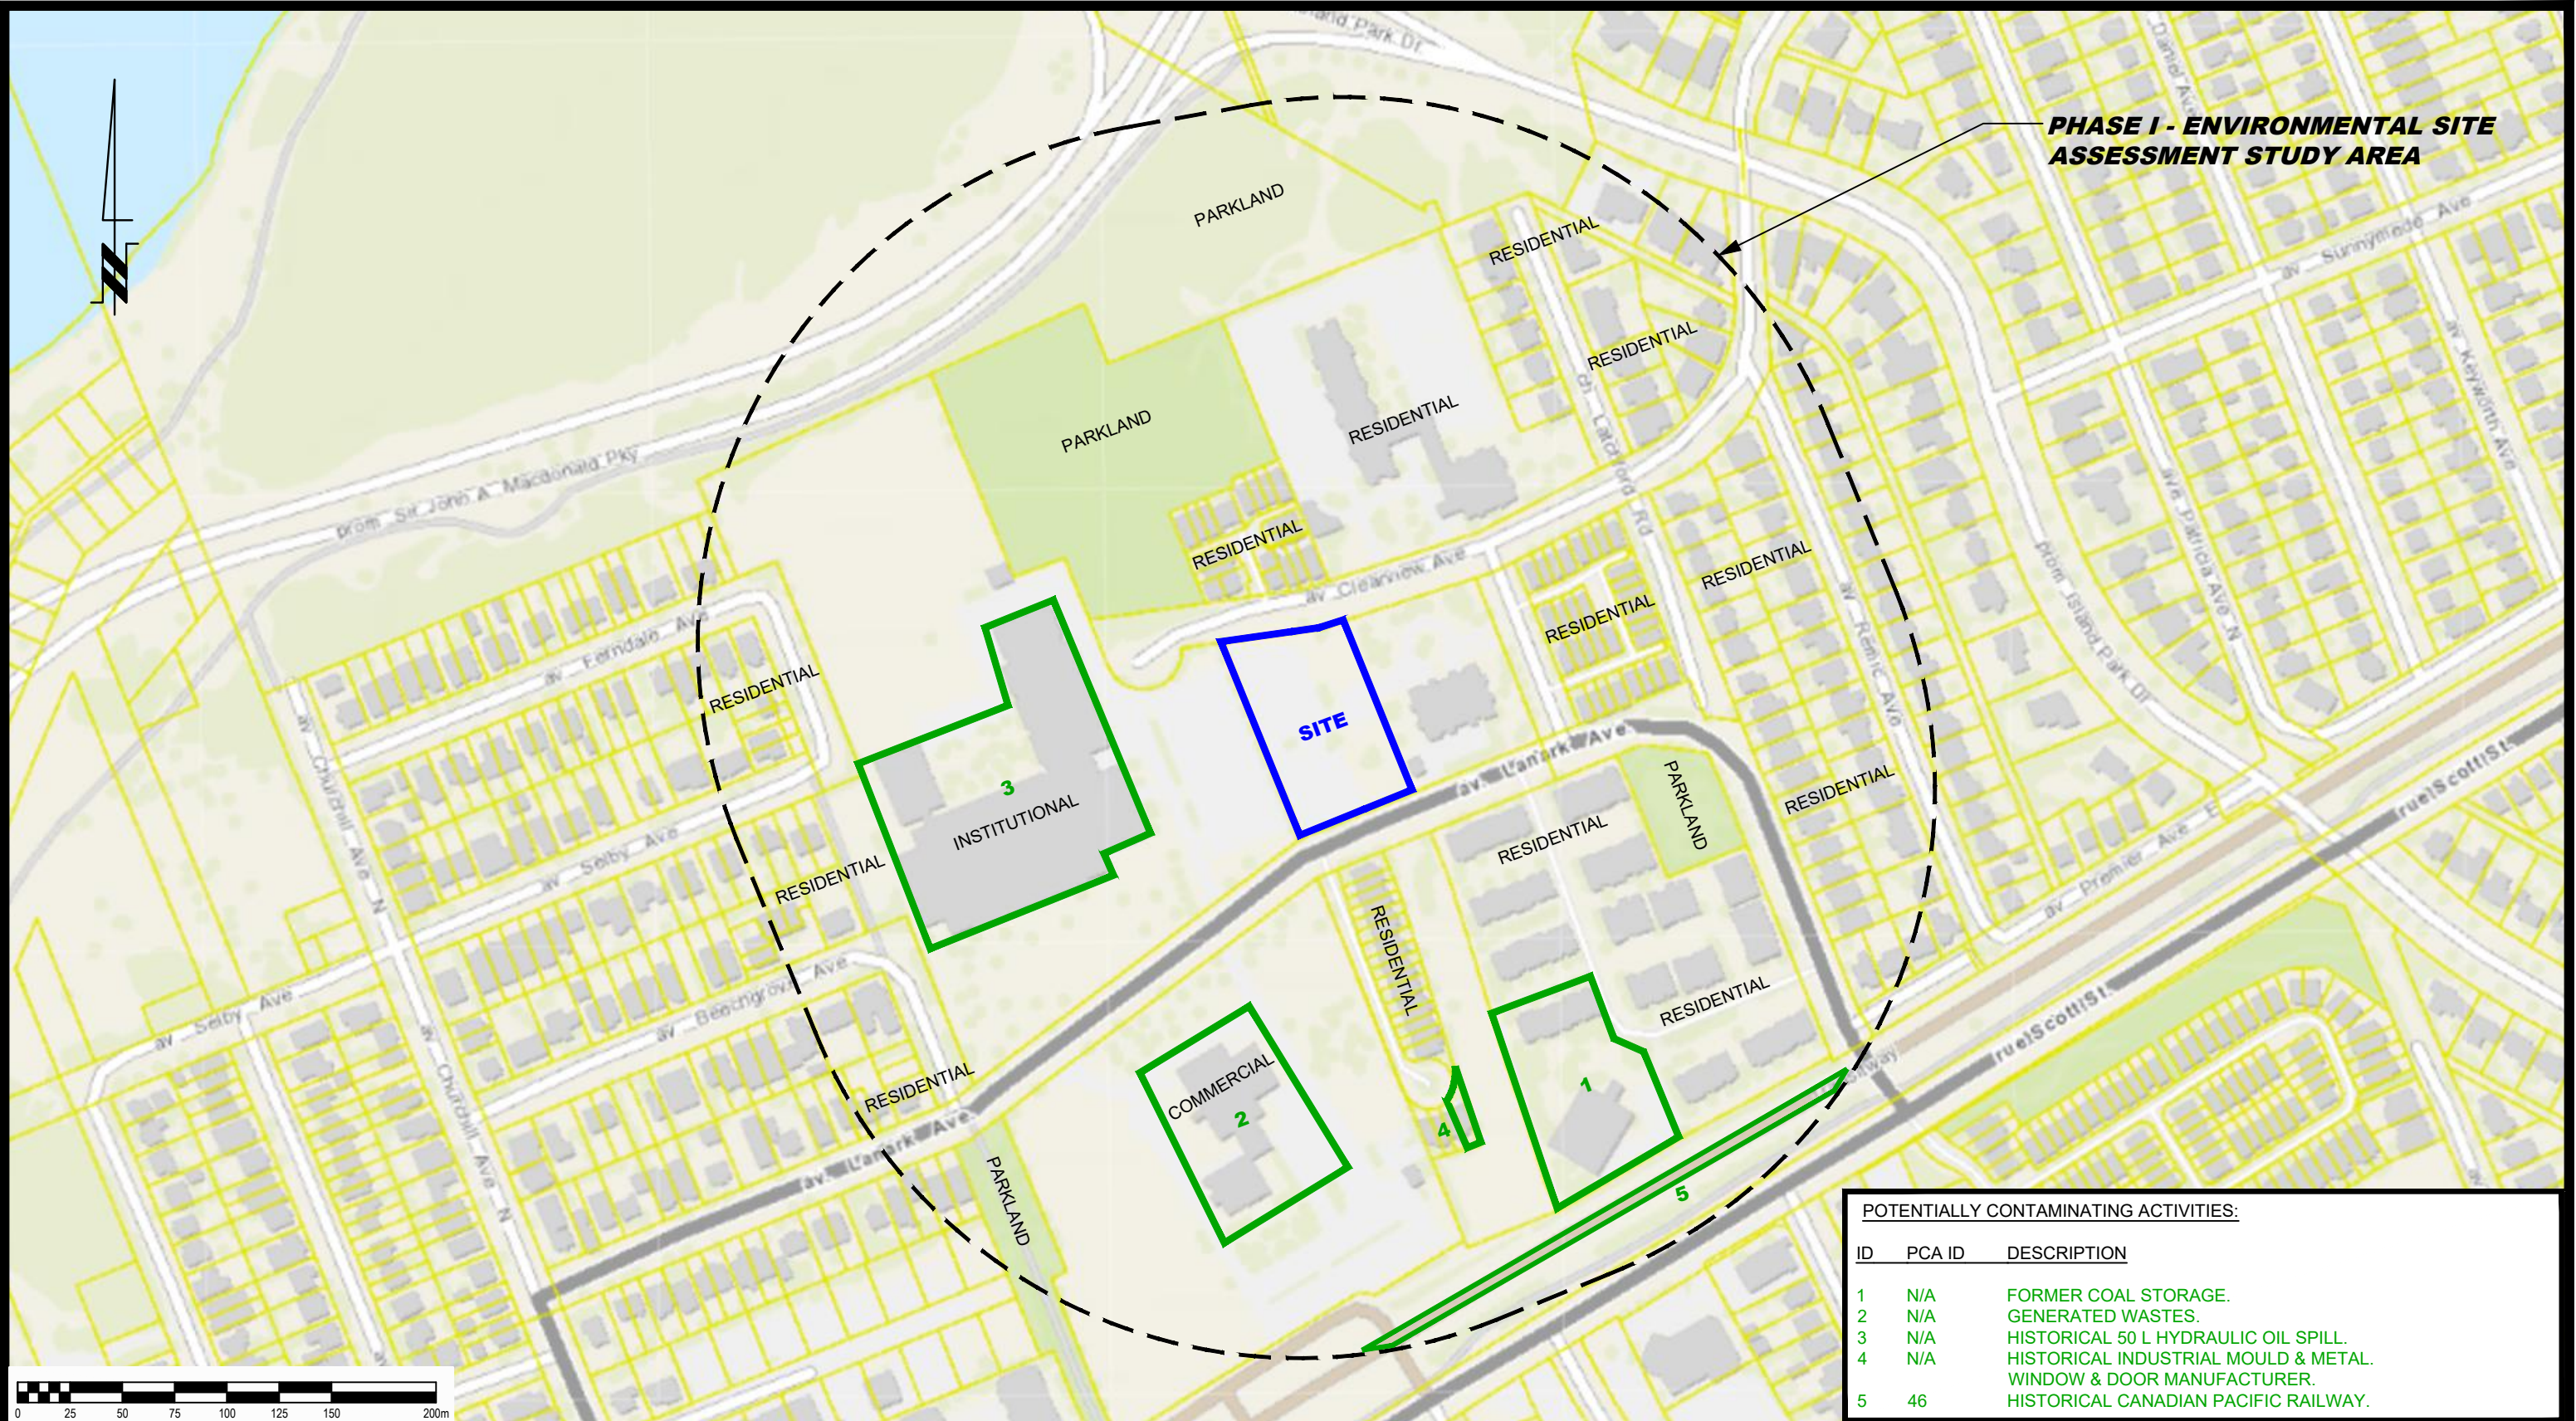
**PHASE I - ENVIRONMENTAL SITE ASSESSMENT STUDY AREA**

POTENTIALLY CONTAMINATING ACTIVITIES:

Five PCAs were identified within the Phase I – Study Area and are listed in Table 1. Based on their separation distances and cross or down gradient orientation with respect to the Phase I Property, the above noted PCAs are not considered to result in APECs on the Phase I Property.
