Phase Two Environmental Site Assessment 266 and 268 Carruthers Avenue, Ottawa, Ontario

McCormick Park Developments Incorporated

OTT-22009213-C0

2022-10-03

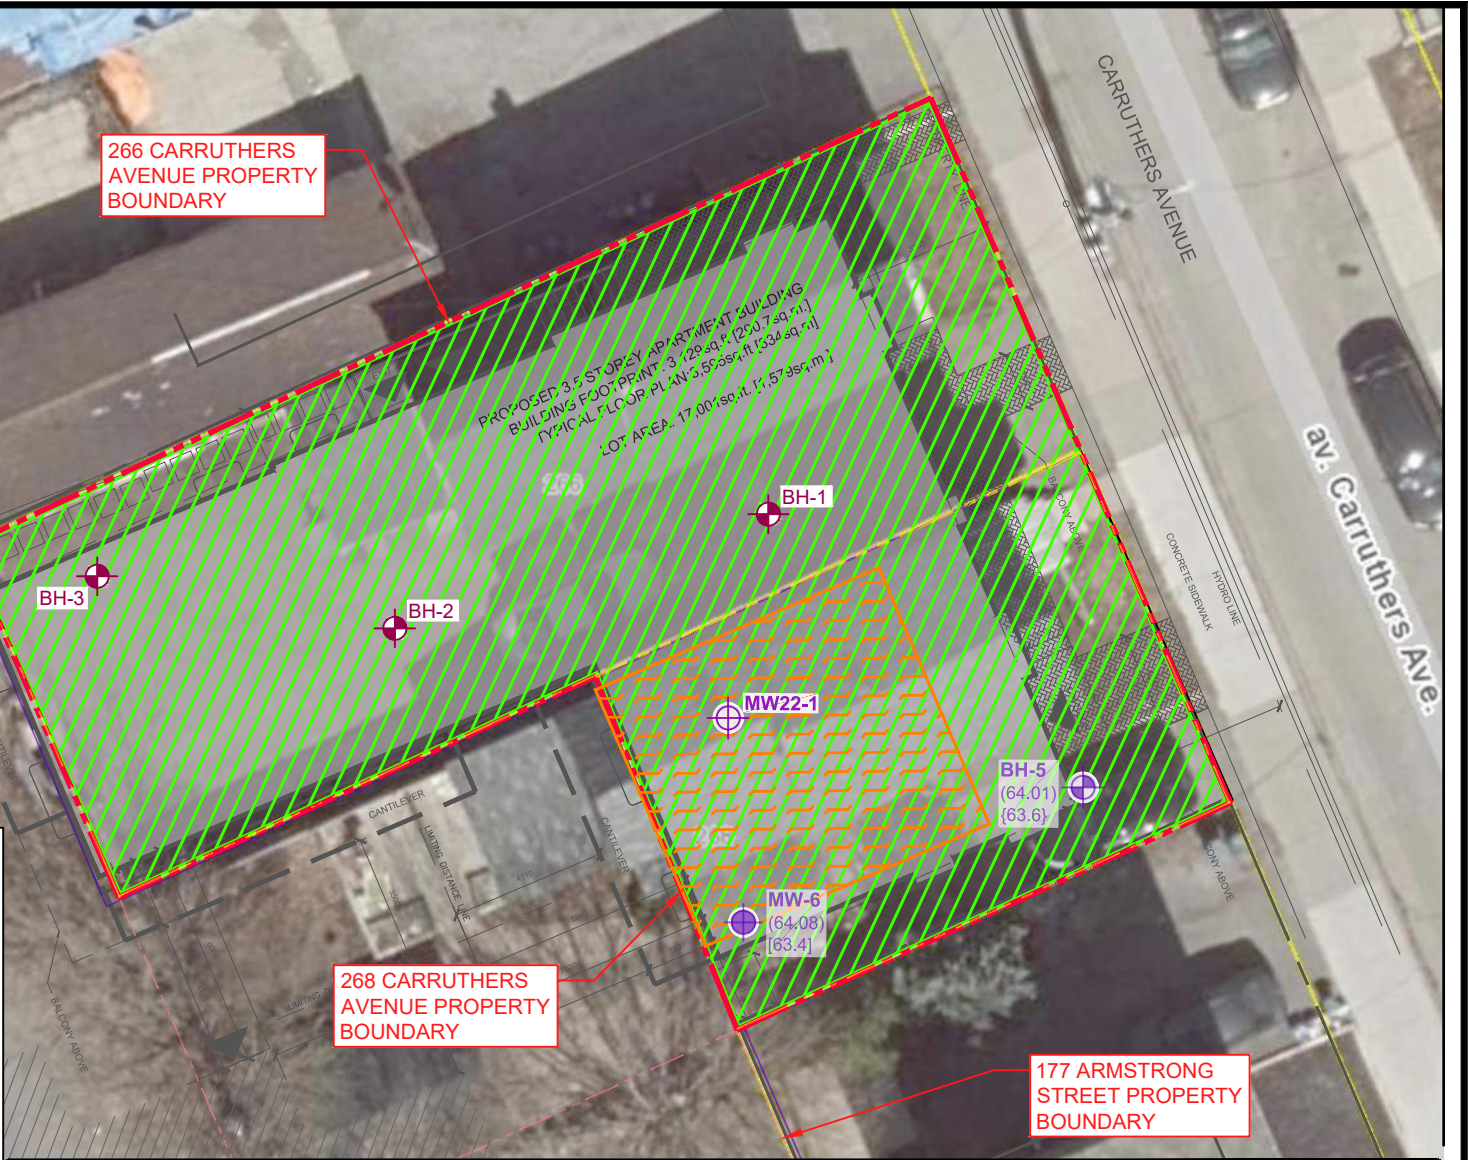
DATE SEPTEMBER 2022		PHASE TWO ENVIRONMENTAL SITE ASSESSMENT (ESA) 266 AND 268 CARRUTHERS AVENUE, OTTAWA, ONTARIO		project no. OTT-22009213-C0
DESIGN MM	CHECKED CH			scale 1:200
DRAWN BY AS		TITLE: AREAS OF POTENTIAL ENVIRONMENTAL CONCERN		FIG 3

- PROPERTY(IES) BOUNDARIES
- BH-1 BOREHOLE NUMBER AND LOCATION (EXP, 2022)
- MW22-1 POST-REMEDATION MONITORING WELL NUMBER AND LOCATION (EXP, 2022)
- BH-5 PRE-REMEDATION BOREHOLE NUMBER AND LOCATION (EXP, 2019)
- MW-6 PRE-REMEDATION MONITORING WELL / STANDPIPE NUMBER AND LOCATION (EXP, 2019)
- (64.01) GROUND ELEVATION
- (63.46) BEDROCK ELEVATION
- (63.55) AUGER REFUSAL ELEVATION
- APEC 1 - PCA #30 - IMPORTATION OF FILL MATERIAL OF UNKNOWN QUALITY
- APEC 2 - PCA #28 - GASOLINE AND ASSOCIATED PRODUCTS STORAGE IN FIXED TANKS

The purpose of the Phase Two ESA was to investigate the soil quality at the Phase Two property and to characterize conditions in the fill material related to the PCA described above within the APEC shown on Figure 3 in Appendix A.

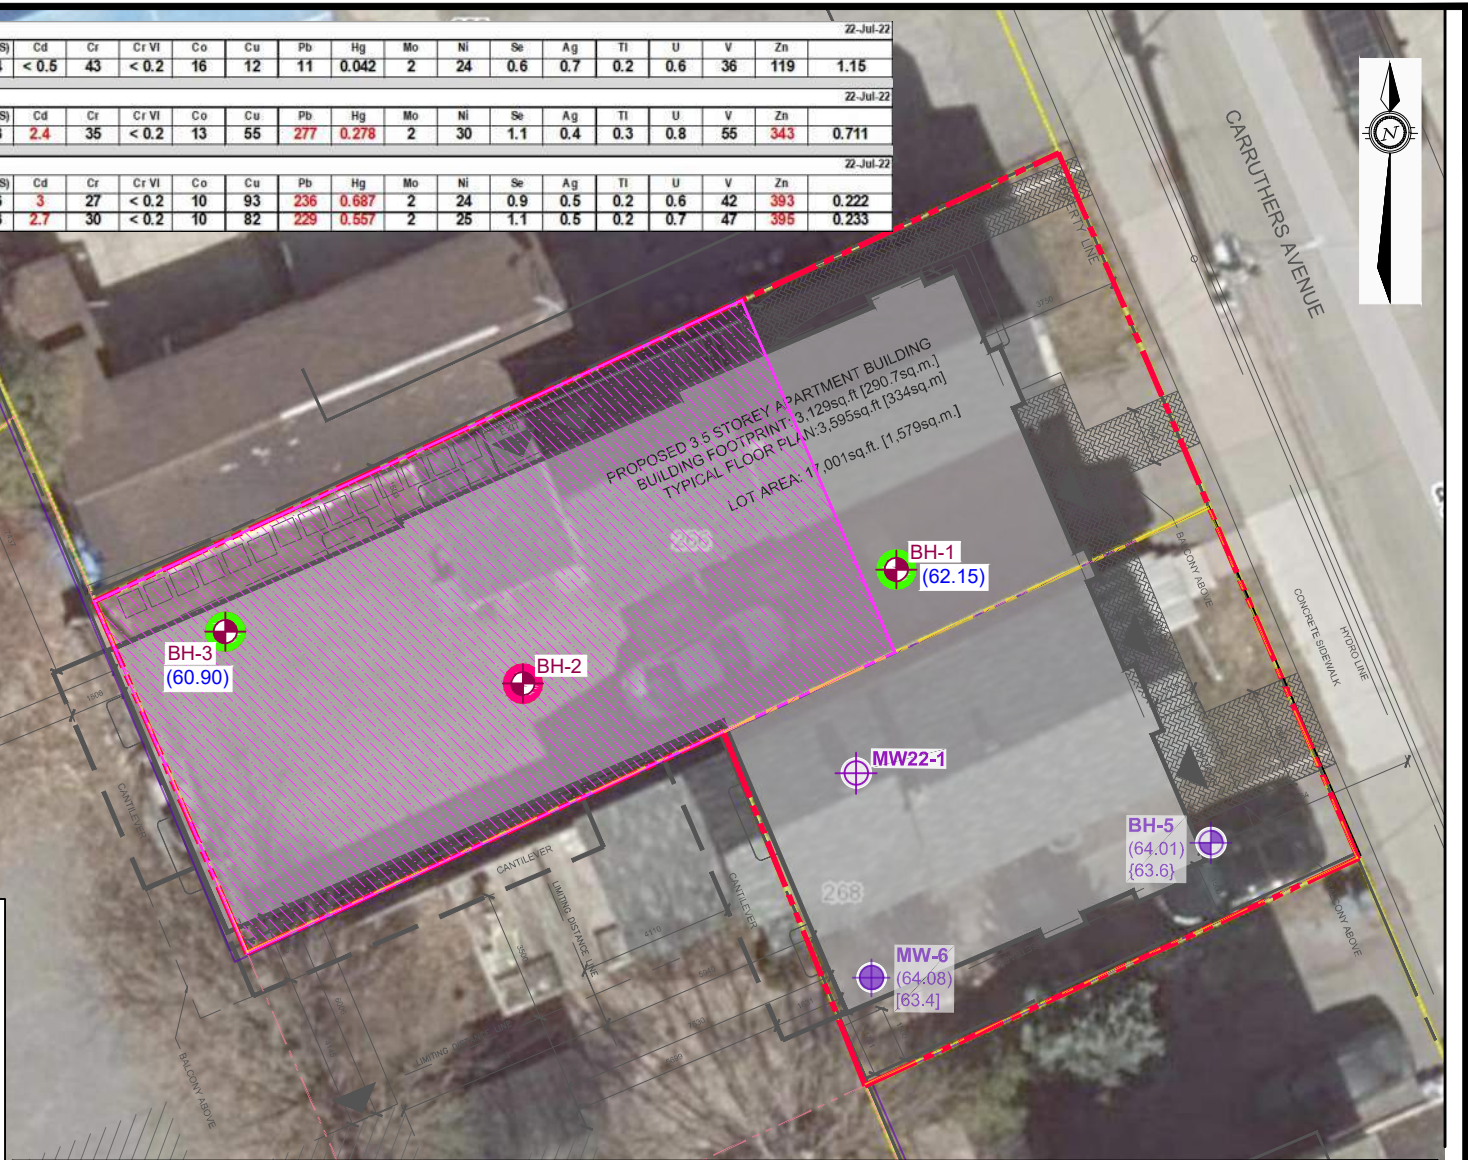
DATE SEPTEMBER 2022	PHASE TWO ENVIRONMENTAL SITE ASSESSMENT (ESA) 266 AND 268 CARRUTHERS AVENUE, OTTAWA, ONTARIO		project no. OTT-22009213-C0
DESIGN MM	CHECKED CH	TITLE: SOIL ANALYTICAL RESULTS - METALS	scale 1:200
DRAWN BY AS			FIG 7

- PROPERTY (IES) BOUNDARIES
- BH-1 BOREHOLE NUMBER AND LOCATION (EXP, 2022)
- MW22-1 POST-REMEDATION MONITORING WELL NUMBER AND LOCATION (EXP, 2022)
- BH-5 PRE-REMEDATION BOREHOLE NUMBER AND LOCATION (EXP, 2019)
- MW-6 PRE-REMEDATION MONITORING WELL / STANDPIPE NUMBER AND LOCATION (EXP, 2019)
- SOIL QUALITY MEETS MECP TABLE 7 SCS
- SOIL QUALITY EXCEEDS MECP TABLE 7 SCS
- ESTIMATED AREA OF IMPACTED SOIL

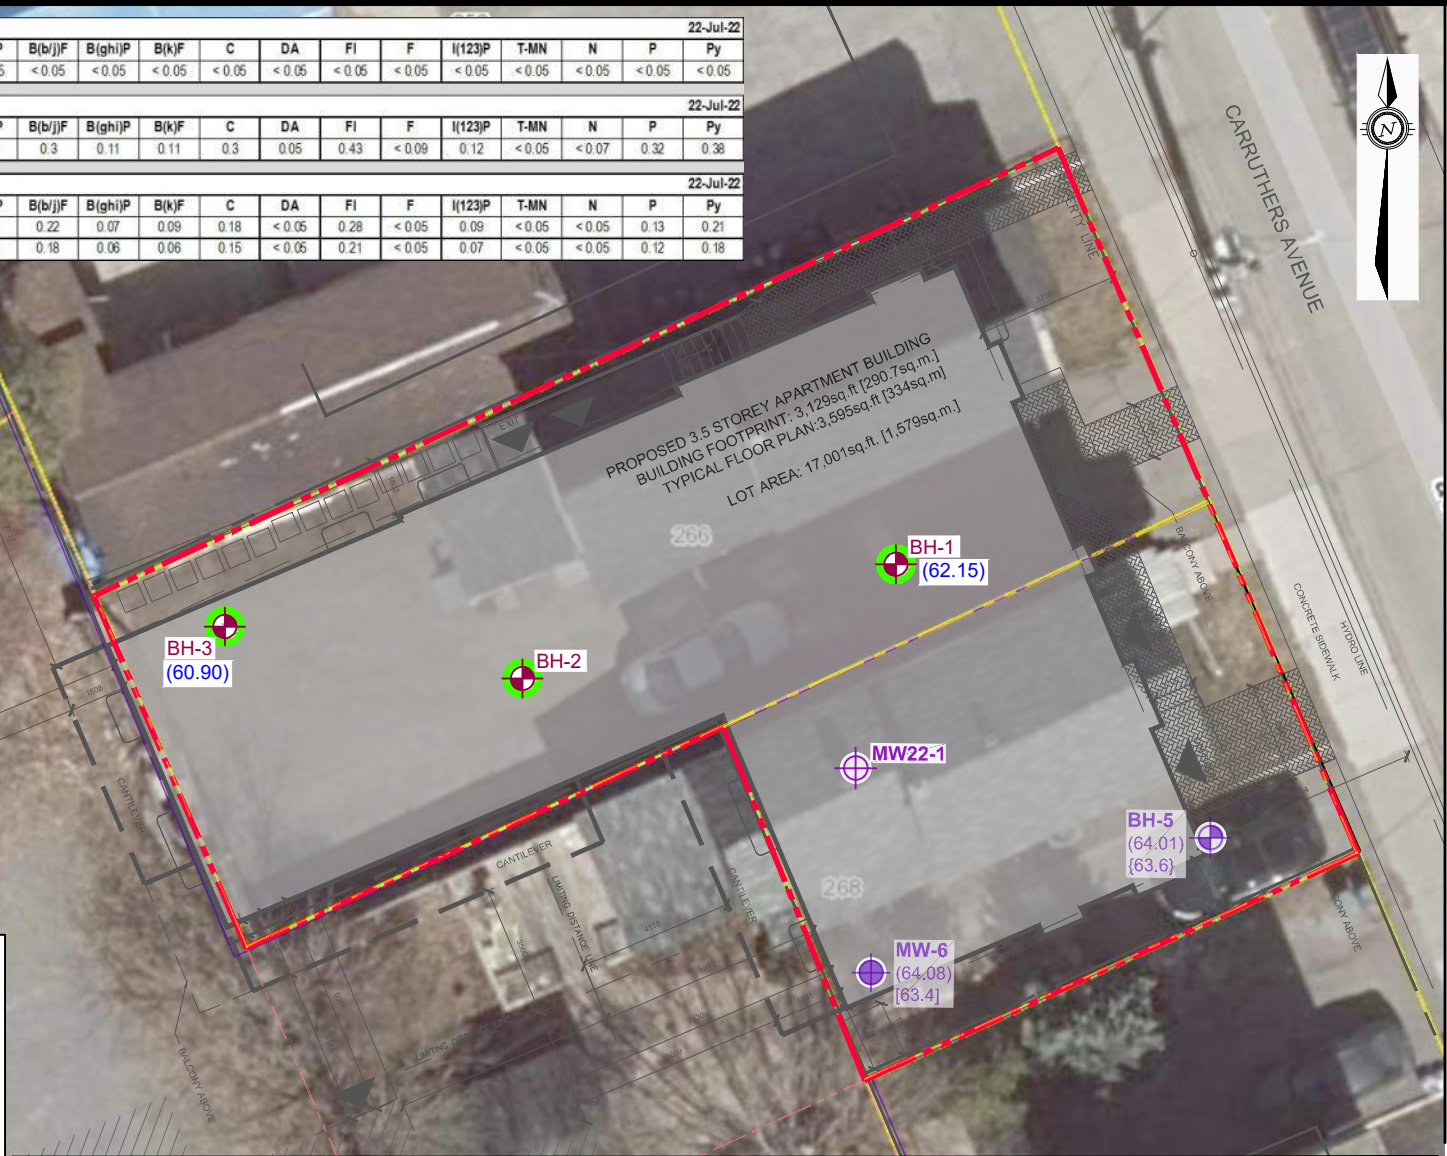
DATE SEPTEMBER 2022	PHASE TWO ENVIRONMENTAL SITE ASSESSMENT (ESA) 266 AND 268 CARRUTHERS AVENUE, OTTAWA, ONTARIO		project no. OTT-22009213-CO
DESIGN MM	CHECKED CH	TITLE: SOIL ANALYTICAL RESULTS - PAH	scale 1:200
DRAWN BY AS			FIG 8

- PROPERTY(IES) BOUNDARIES
- BH-1** BOREHOLE NUMBER AND LOCATION (EXP, 2022)
- MW22-1** POST-REMEDATION MONITORING WELL NUMBER AND LOCATION (EXP, 2022)
- BH-5** PRE-REMEDATION BOREHOLE NUMBER AND LOCATION (EXP, 2019)
- MW-6** PRE-REMEDATION MONITORING WELL / STANDPIPE NUMBER AND LOCATION (EXP, 2019)
- SOIL QUALITY MEETS MECP TABLE 7 SCS
- SOIL QUALITY EXCEEDS MECP TABLE 7 SCS

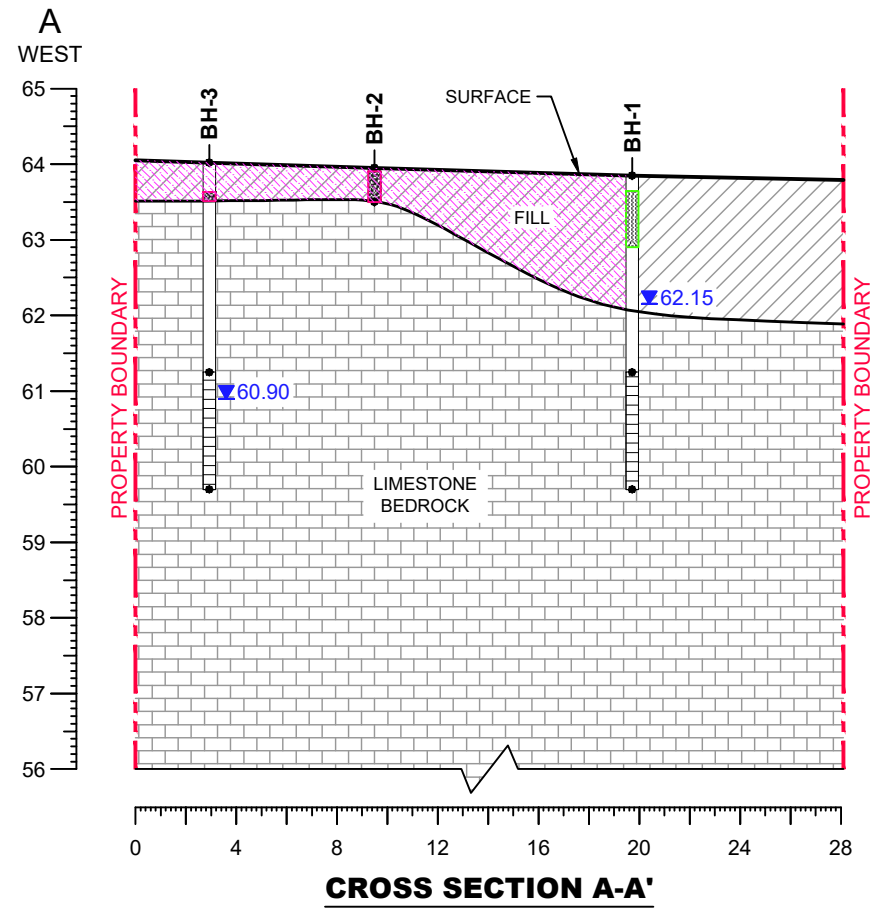
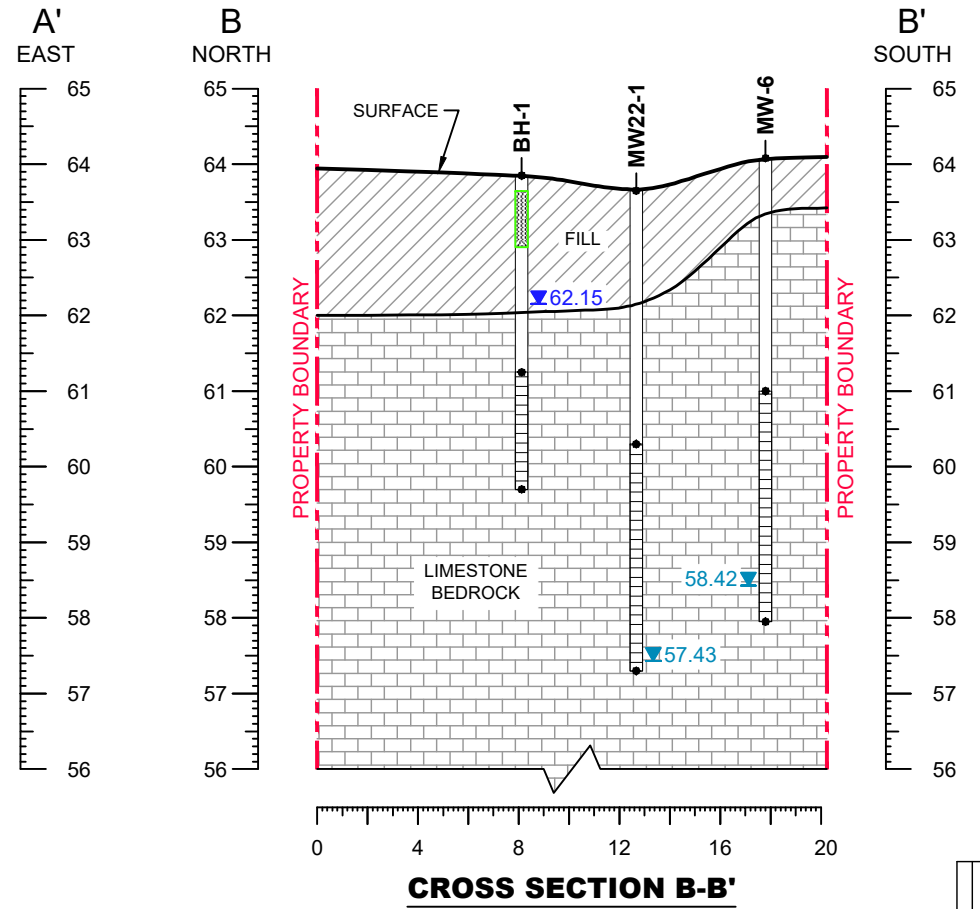
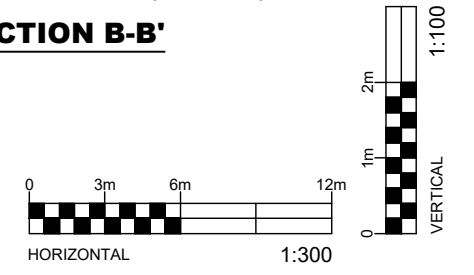
DATE SEPTEMBER 2022	PHASE TWO ENVIRONMENTAL SITE ASSESSMENT (ESA) 266 AND 268 CARRUTHERS AVENUE, OTTAWA, ONTARIO	project no. OTT-22009213-CO
DESIGN MM	CHECKED CH	scale HORZ. 1:300 / VERT. 1:100
DRAWN BY AS		TITLE: CROSS SECTION A-A' & B-B' ANALYTICAL RESULTS - METALS
		FIG 10

PARAMETERS	ABBREVIATION	REG
Antimony	Sb	7.5
Arsenic	As	18
Barium	Ba	390
Beryllium	Be	4
Boron	B	120
Cadmium	Cd	1.2
Chromium	Cr	160
Chromium VI	Cr VI	8
Cobalt	Co	22
Copper	Cu	140
Lead	Pb	120
Mercury	Hg	0.27
Molybdenum	Mo	6.9
Nickel	Ni	100
Selenium	Se	2.4
Silver	Ag	20

BH-1	Depth (mbgs)	22-Jul-22																					
		Sb	As	Ba	Be	B	B (HWS)	Cd	Cr	Cr VI	Co	Cu	Pb	Hg	Mo	Ni	Se	Ag	Tl	U	V	Zn	
Run1	0.15 - 0.75	< 0.5	1.2	259	0.5	6.2	0.14	< 0.5	43	< 0.2	16	12	11	0.042	2	24	0.6	0.7	0.2	0.6	36	119	1.15
BH-2	Depth (mbgs)	22-Jul-22																					
		Sb	As	Ba	Be	B	B (HWS)	Cd	Cr	Cr VI	Co	Cu	Pb	Hg	Mo	Ni	Se	Ag	Tl	U	V	Zn	
SS2	0.15 - 0.5	2.9	7.7	343	0.6	9.9	0.13	2.4	35	< 0.2	13	55	277	0.278	2	30	1.1	0.4	0.3	0.8	55	343	0.711
BH3	Depth (mbgs)	22-Jul-22																					
		Sb	As	Ba	Be	B	B (HWS)	Cd	Cr	Cr VI	Co	Cu	Pb	Hg	Mo	Ni	Se	Ag	Tl	U	V	Zn	
GS3	0.35 - 0.45	1.6	9.4	267	0.6	9.5	0.16	3	27	< 0.2	10	93	236	0.687	2	24	0.9	0.5	0.2	0.6	42	393	0.222
Dup1	0.35 - 0.45	1.8	9.8	283	0.7	7.9	0.13	2.7	30	< 0.2	10	82	229	0.557	2	25	1.1	0.5	0.2	0.7	47	395	0.233

- LEGEND**
- PROPERTY(IES) BOUNDARIES
 - ESTIMATED AREA OF IMPACTED SOIL
 - GROUNDWATER LEVEL SEPTEMBER 19, 2019
 - GROUNDWATER LEVEL (2022)
 - SOIL QUALITY MEETS MECP TABLE 7 SCS
 - SOIL QUALITY EXCEEDS MECP TABLE 7 SCS

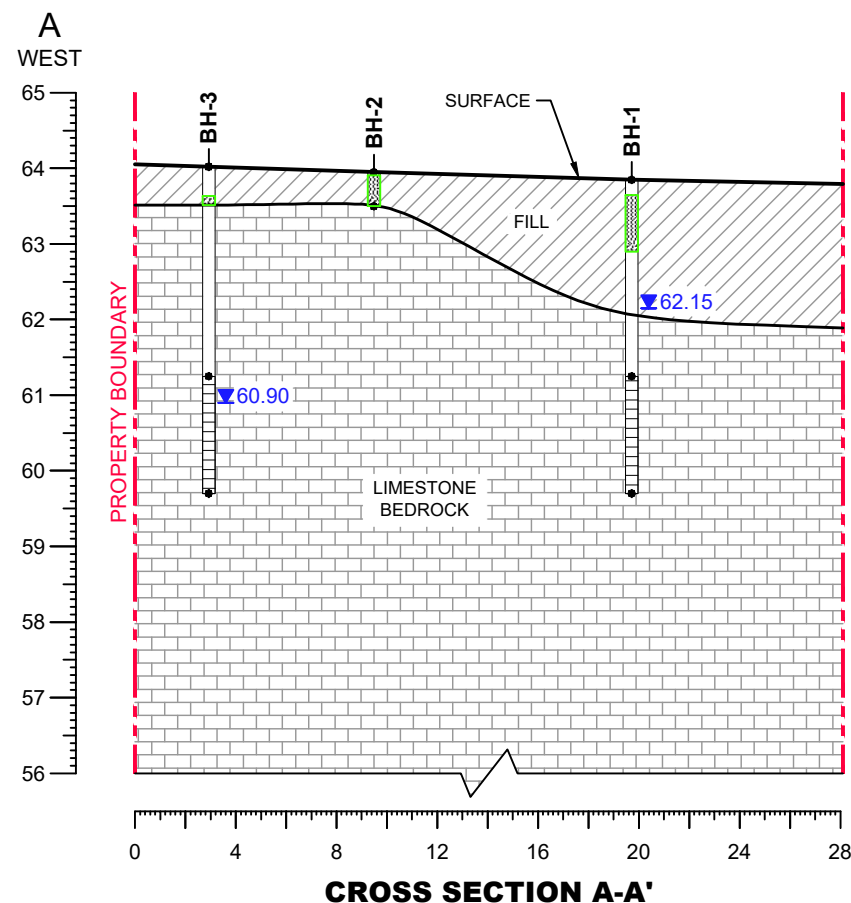
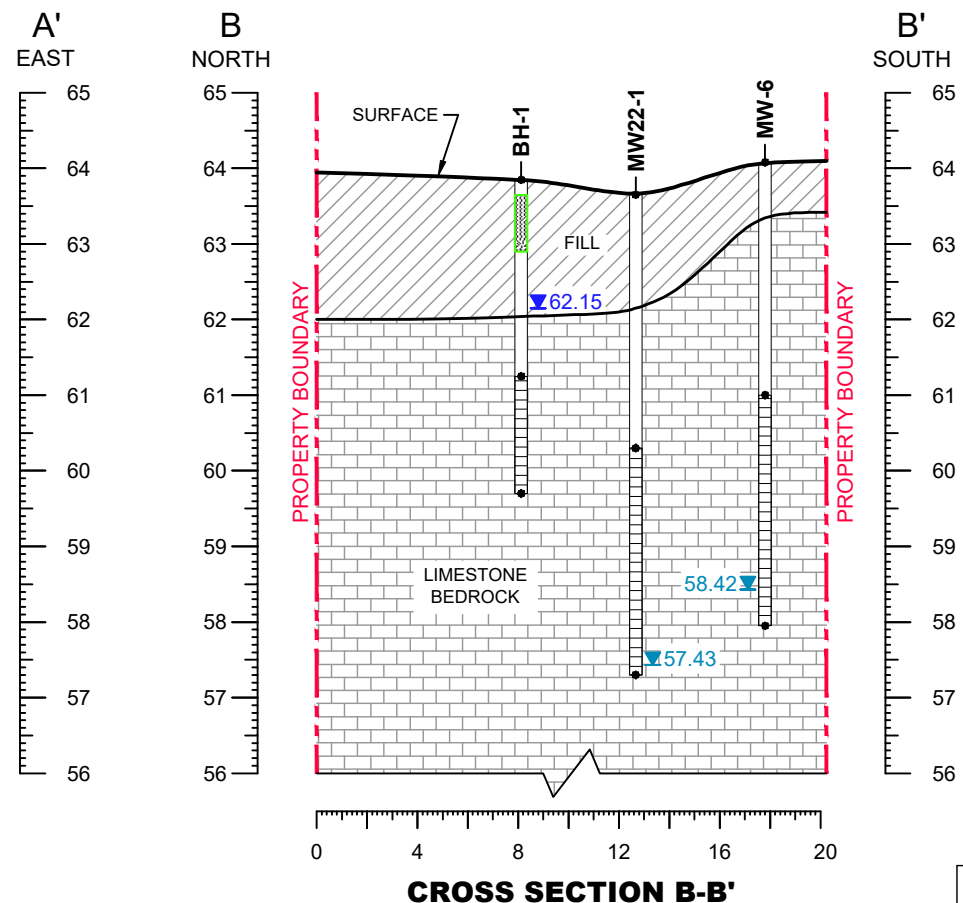
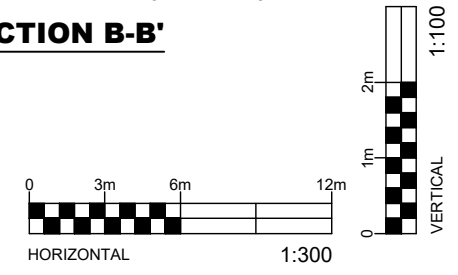
DATE SEPTEMBER 2022	PHASE TWO ENVIRONMENTAL SITE ASSESSMENT (ESA) 266 AND 268 CARRUTHERS AVENUE, OTTAWA, ONTARIO	project no. OTT-22009213-CO
DESIGN MM	CHECKED CH	scale HORZ. 1:300 / VERT. 1:100
DRAWN BY AS		TITLE: CROSS SECTION A-A' & B-B' ANALYTICAL RESULTS - PAH
		FIG 11

PARAMETERS	ABBREVIATION	REG 153/04 TABLE 7
Acenaphthene	Ace	7.9
Acenaphthylene	AcI	0.15
Anthracene	An	0.67
benzo(a)anthracene	B(a)A	0.5
Benzo(a)pyrene	B(a)P	0.3
benzo(b)fluoranthene	B(b)F	0.78
benzo(g,h,i)perylene	B(ghi)P	6.6
benzo(k)fluoranthene	B(k)F	0.78
Chrysene	C	7
benz(a,h)anthracene	DA	0.1
Fluoranthene	Fl	0.69
Fluorene	F	62
benzo(1,2,3-cd)pyrene	I(123)P	0.38
1-Methyl naphthalene	T-MN	0.99
Naphthalene	N	0.6
Phenanthrene	P	6.2
Pyrene	Py	78
Total PCBs	PCB	0.35

Borehole	Depth (mbgs)	22-Jul-22																	
		Ace	AcI	An	B(a)A	B(a)P	B(b)F	B(ghi)P	B(k)F	C	DA	Fl	F	I(123)P	T-MN	N	P	Py	
BH-1	Run1	0.15 - 0.75	< 0.05	< 0.05	< 0.05	< 0.05	< 0.05	< 0.05	< 0.05	< 0.05	< 0.05	< 0.05	< 0.05	< 0.05	< 0.05	< 0.05	< 0.05	< 0.05	
BH-2	SS2	0.15 - 0.5	< 0.05	< 0.07	0.08	0.26	0.23	0.3	0.11	0.11	0.3	0.05	0.43	< 0.09	0.12	< 0.05	< 0.07	0.32	0.38
BH3	GS3	0.35 - 0.45	< 0.05	< 0.05	< 0.05	0.17	0.15	0.22	0.07	0.09	0.18	< 0.05	0.28	< 0.05	0.09	< 0.05	< 0.05	0.13	0.21
BH3	Dup1	0.35 - 0.45	< 0.05	< 0.05	< 0.05	0.12	0.13	0.18	0.06	0.06	0.15	< 0.05	0.21	< 0.05	0.07	< 0.05	< 0.05	0.12	0.18

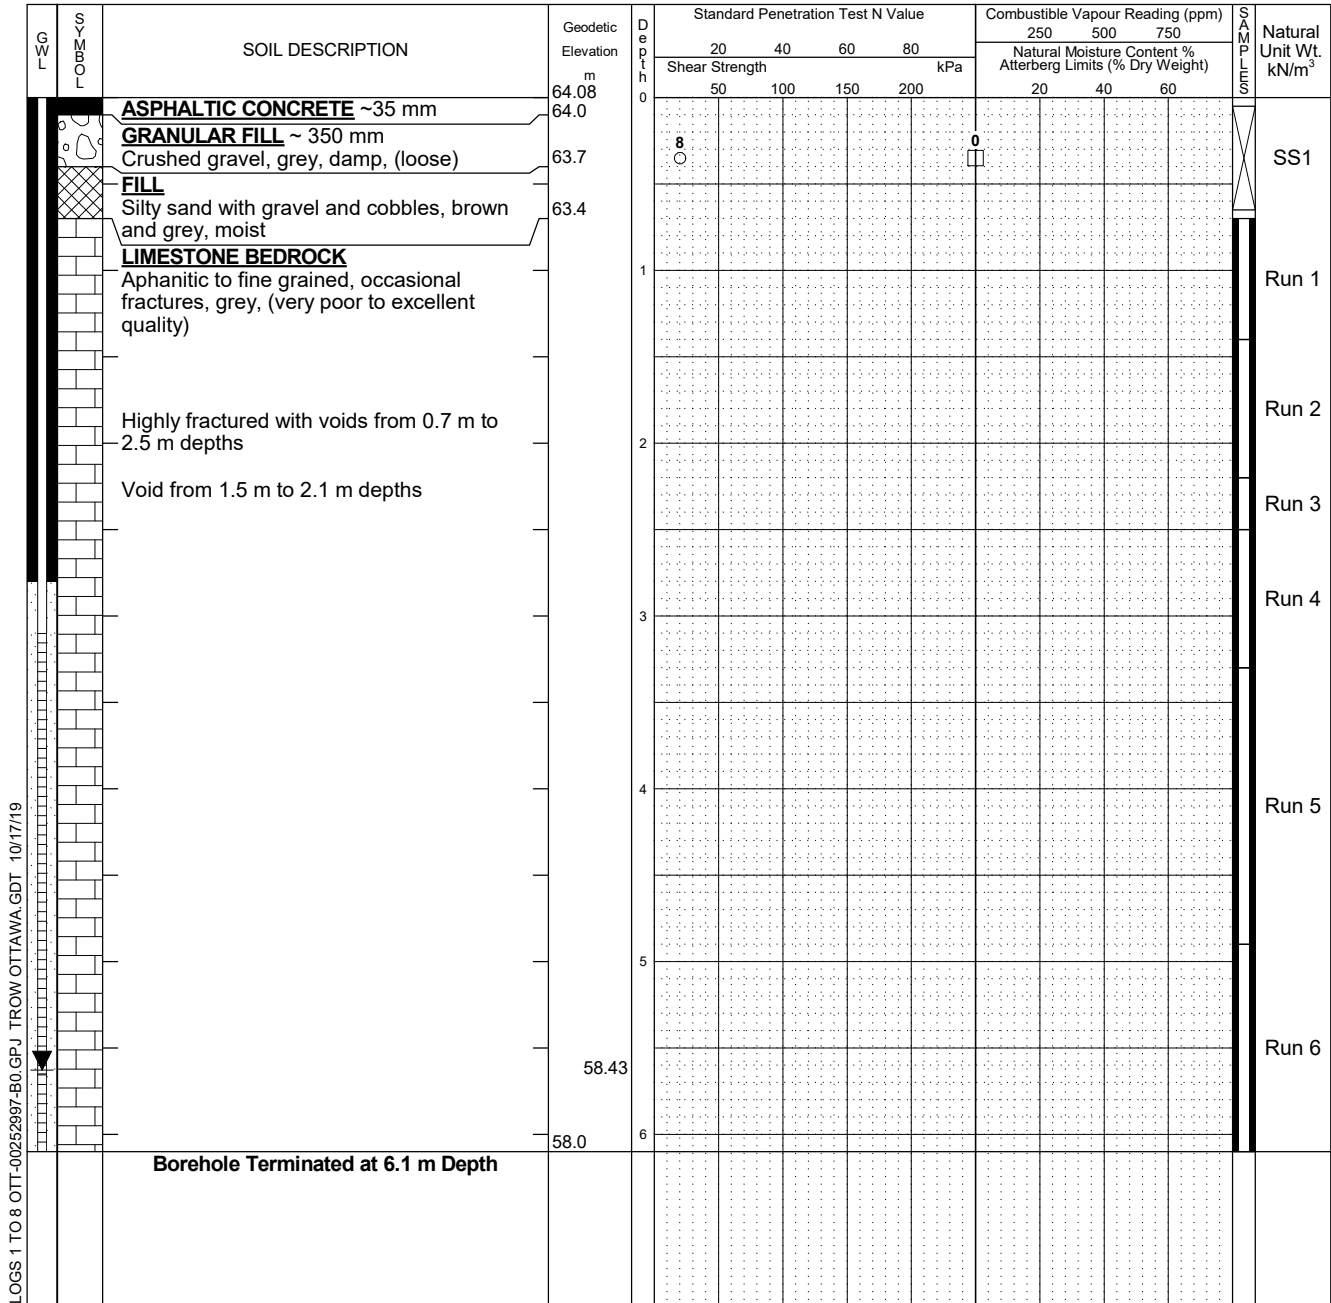
LOG OF BOREHOLE BOREHOLE LOGS 1 TO 8 OTT-00252997-B0.GPJ TROW/OTTAWA.GDT 10/17/19

- NOTES:
- Borehole data requires interpretation by EXP before use by others
 - A 32 mm diameter monitoring well with screened section installed as shown.
 - Field work supervised by an EXP representative.
 - See Notes on Sample Descriptions
 - Log to be read with EXP Report OTT-00252997-B0

EXP staff continuously monitored the drilling activities to log the stratigraphy observed from the recovered samples, to record the depth of the samples, and to record total depths of borings. Field observations are documented on the borehole logs provided in Appendix D.
