Phase I Environmental Site Assessment

230 and 232 Lisgar Street
Ottawa, Ontario

Prepared for 230 Lisgar Street Inc.

Report: PE5905-1
November 11, 2022

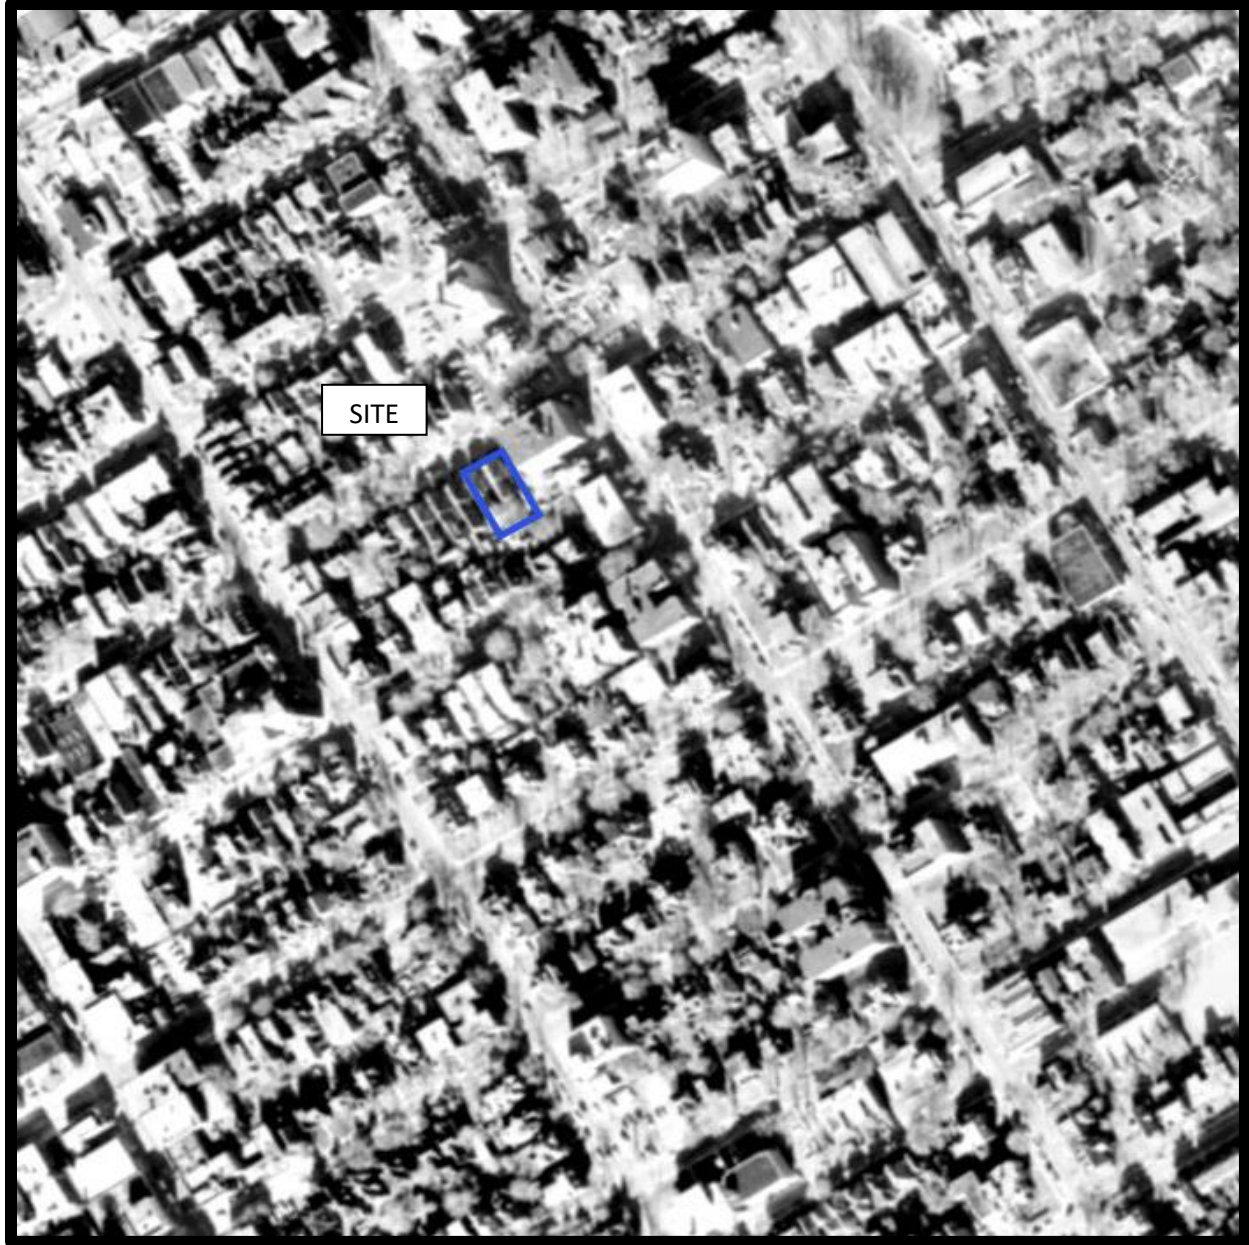
AERIAL PHOTOGRAPH
1958

1958	No significant changes are apparent on the Phase I Property or properties within the Phase I Study Area.
1965	The Phase I Property and surrounding lands appear unchanged from the previous image.
1976	The Phase I Property and surrounding lands to the east, west and south appear unchanged at this time. Lands further to the north appear to have been redeveloped with the present-day commercial office building.
1991	No significant changes are apparent on the Phase I Property or properties within the Phase I Study Area.
2005	The Phase I Property and surrounding lands appear unchanged from the previous image.
2011	The Phase I Property and surrounding lands to the north, east, west and south appear unchanged at this time, with the exception of a former parking lot situated on the northeast corner of the Metcalfe and Nepean Street intersection, which now appears to be under construction.
2021	The Phase I Property and the surrounding lands appear unchanged from the previous image, with the exception that the property that was formerly under construction, is now occupied by a residential high-rise building.

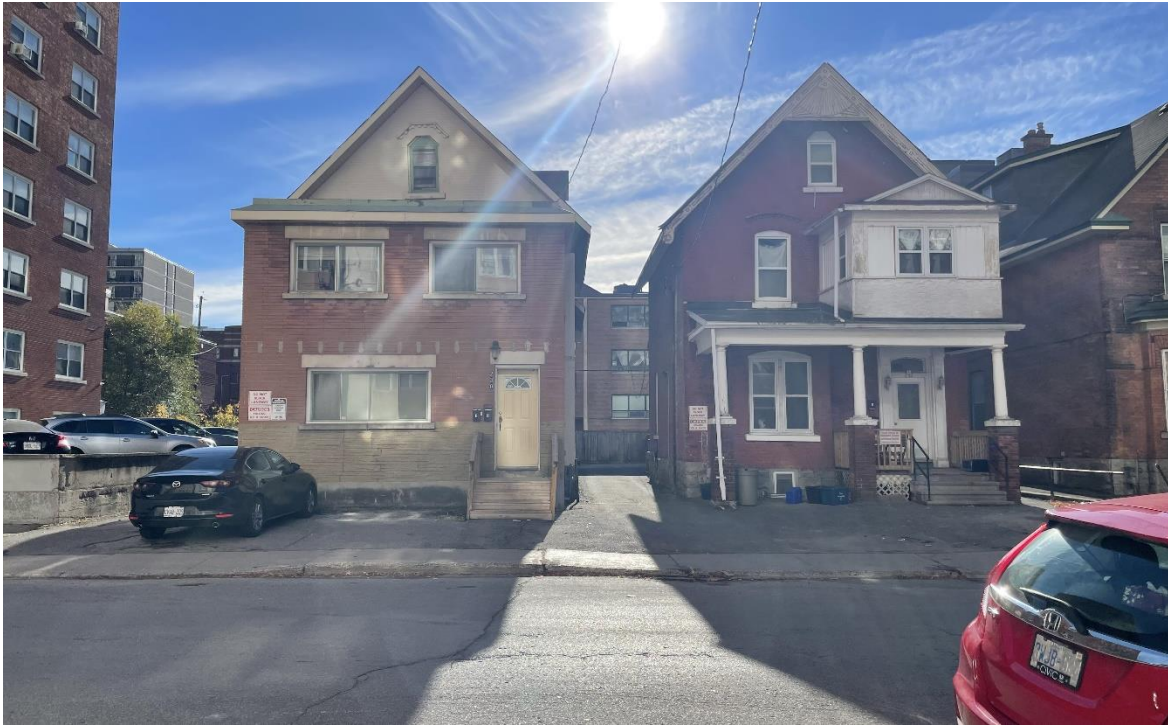
Photograph 1: View of the northern side of the Phase I Property, fronting Lisgar Street.

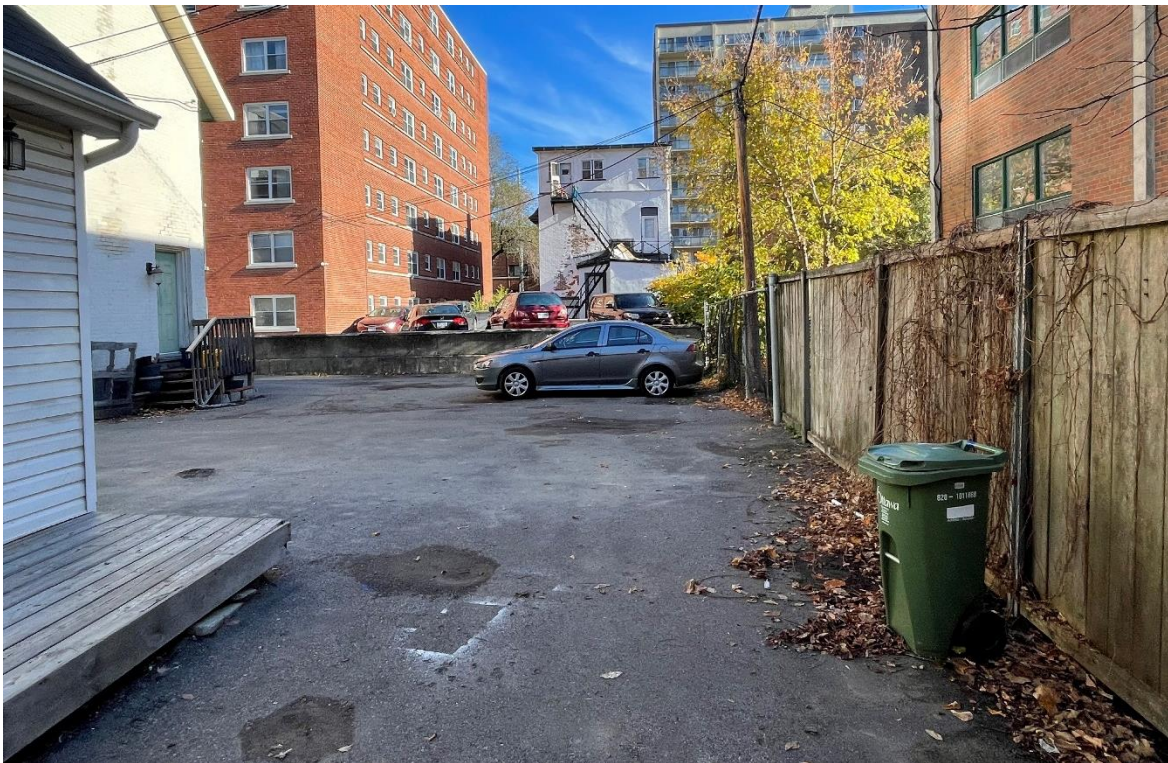
Photograph 2: View of the southern side of the of the Phase I Property, looking north.

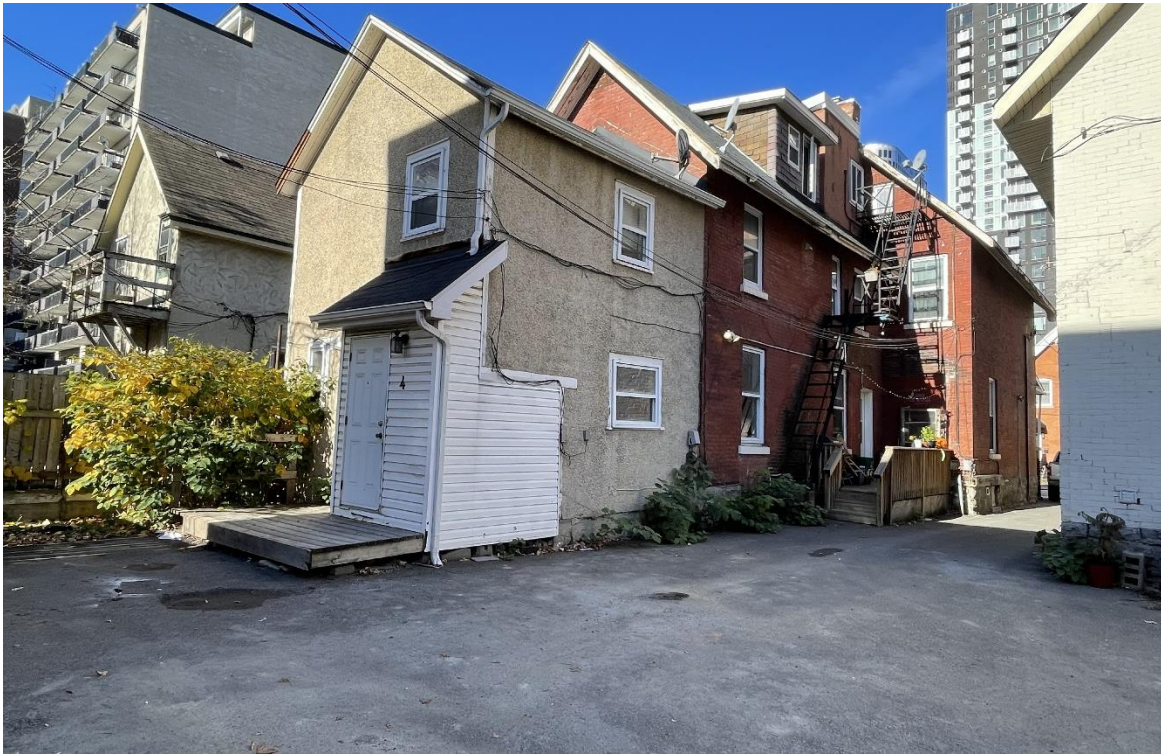
232 Lisgar Street is occupied by a 2-storey, multi-tenant residence with a basement level. The present-day residence was constructed circa 1888 with a limestone foundation with large areas covered in exterior parging. The exterior façade of the building is finished in brick, while the rear extension is finished in a mixed aggregate stucco and vinyl siding with a sloped shingle style roof.

Photograph 3: View of the 232 Lisgar Street, looking northwest.

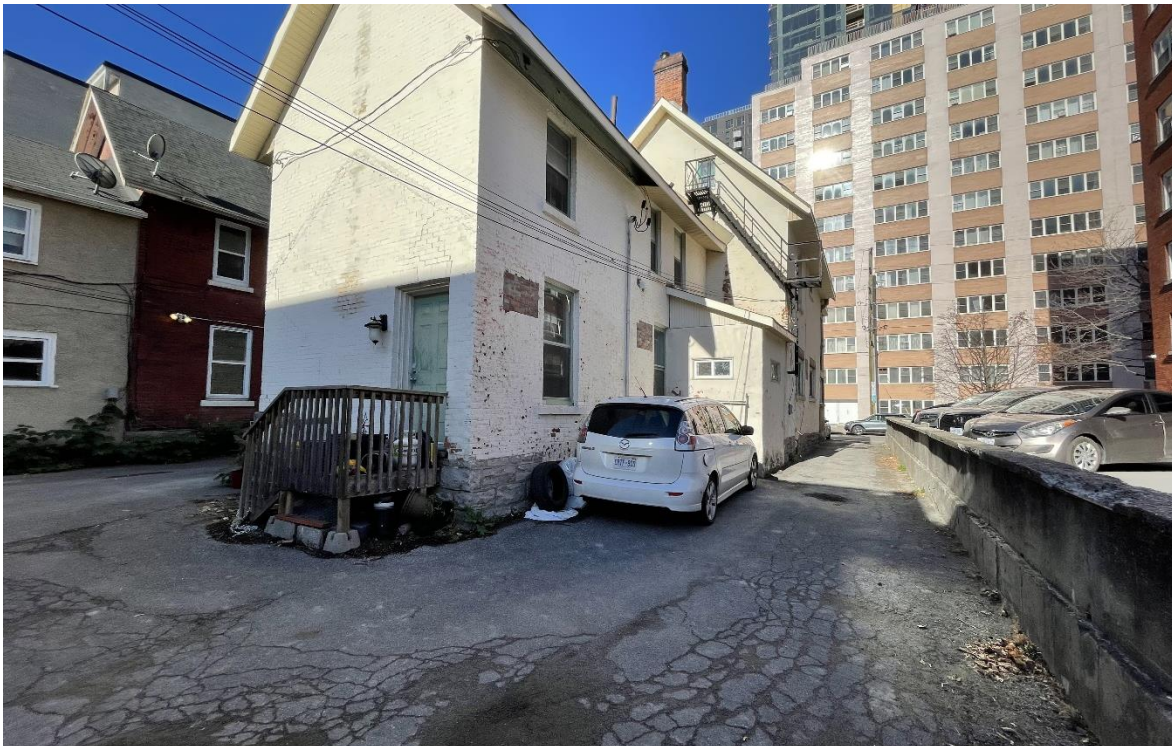
230 Lisgar Street is occupied by a 2-storey, multi-tenant residence with a basement level. The present-day residence was constructed circa 1888 with a limestone foundation with large areas covered in exterior parging. The exterior façade of the building is finished in brick with a sloped shingle style roof.

Photograph 4: View of the 230 Lisgar Street, looking northwest
