**LANDRIC HOMES  
LOW RISE APARTMENTS**  
1765 MONTREAL ROAD E, OTTAWA  
CANADA

DRAWING TITLE:  
**PRE-DEVELOPMENT  
VEGETATION**

**LTP-1**

**LTP-2**

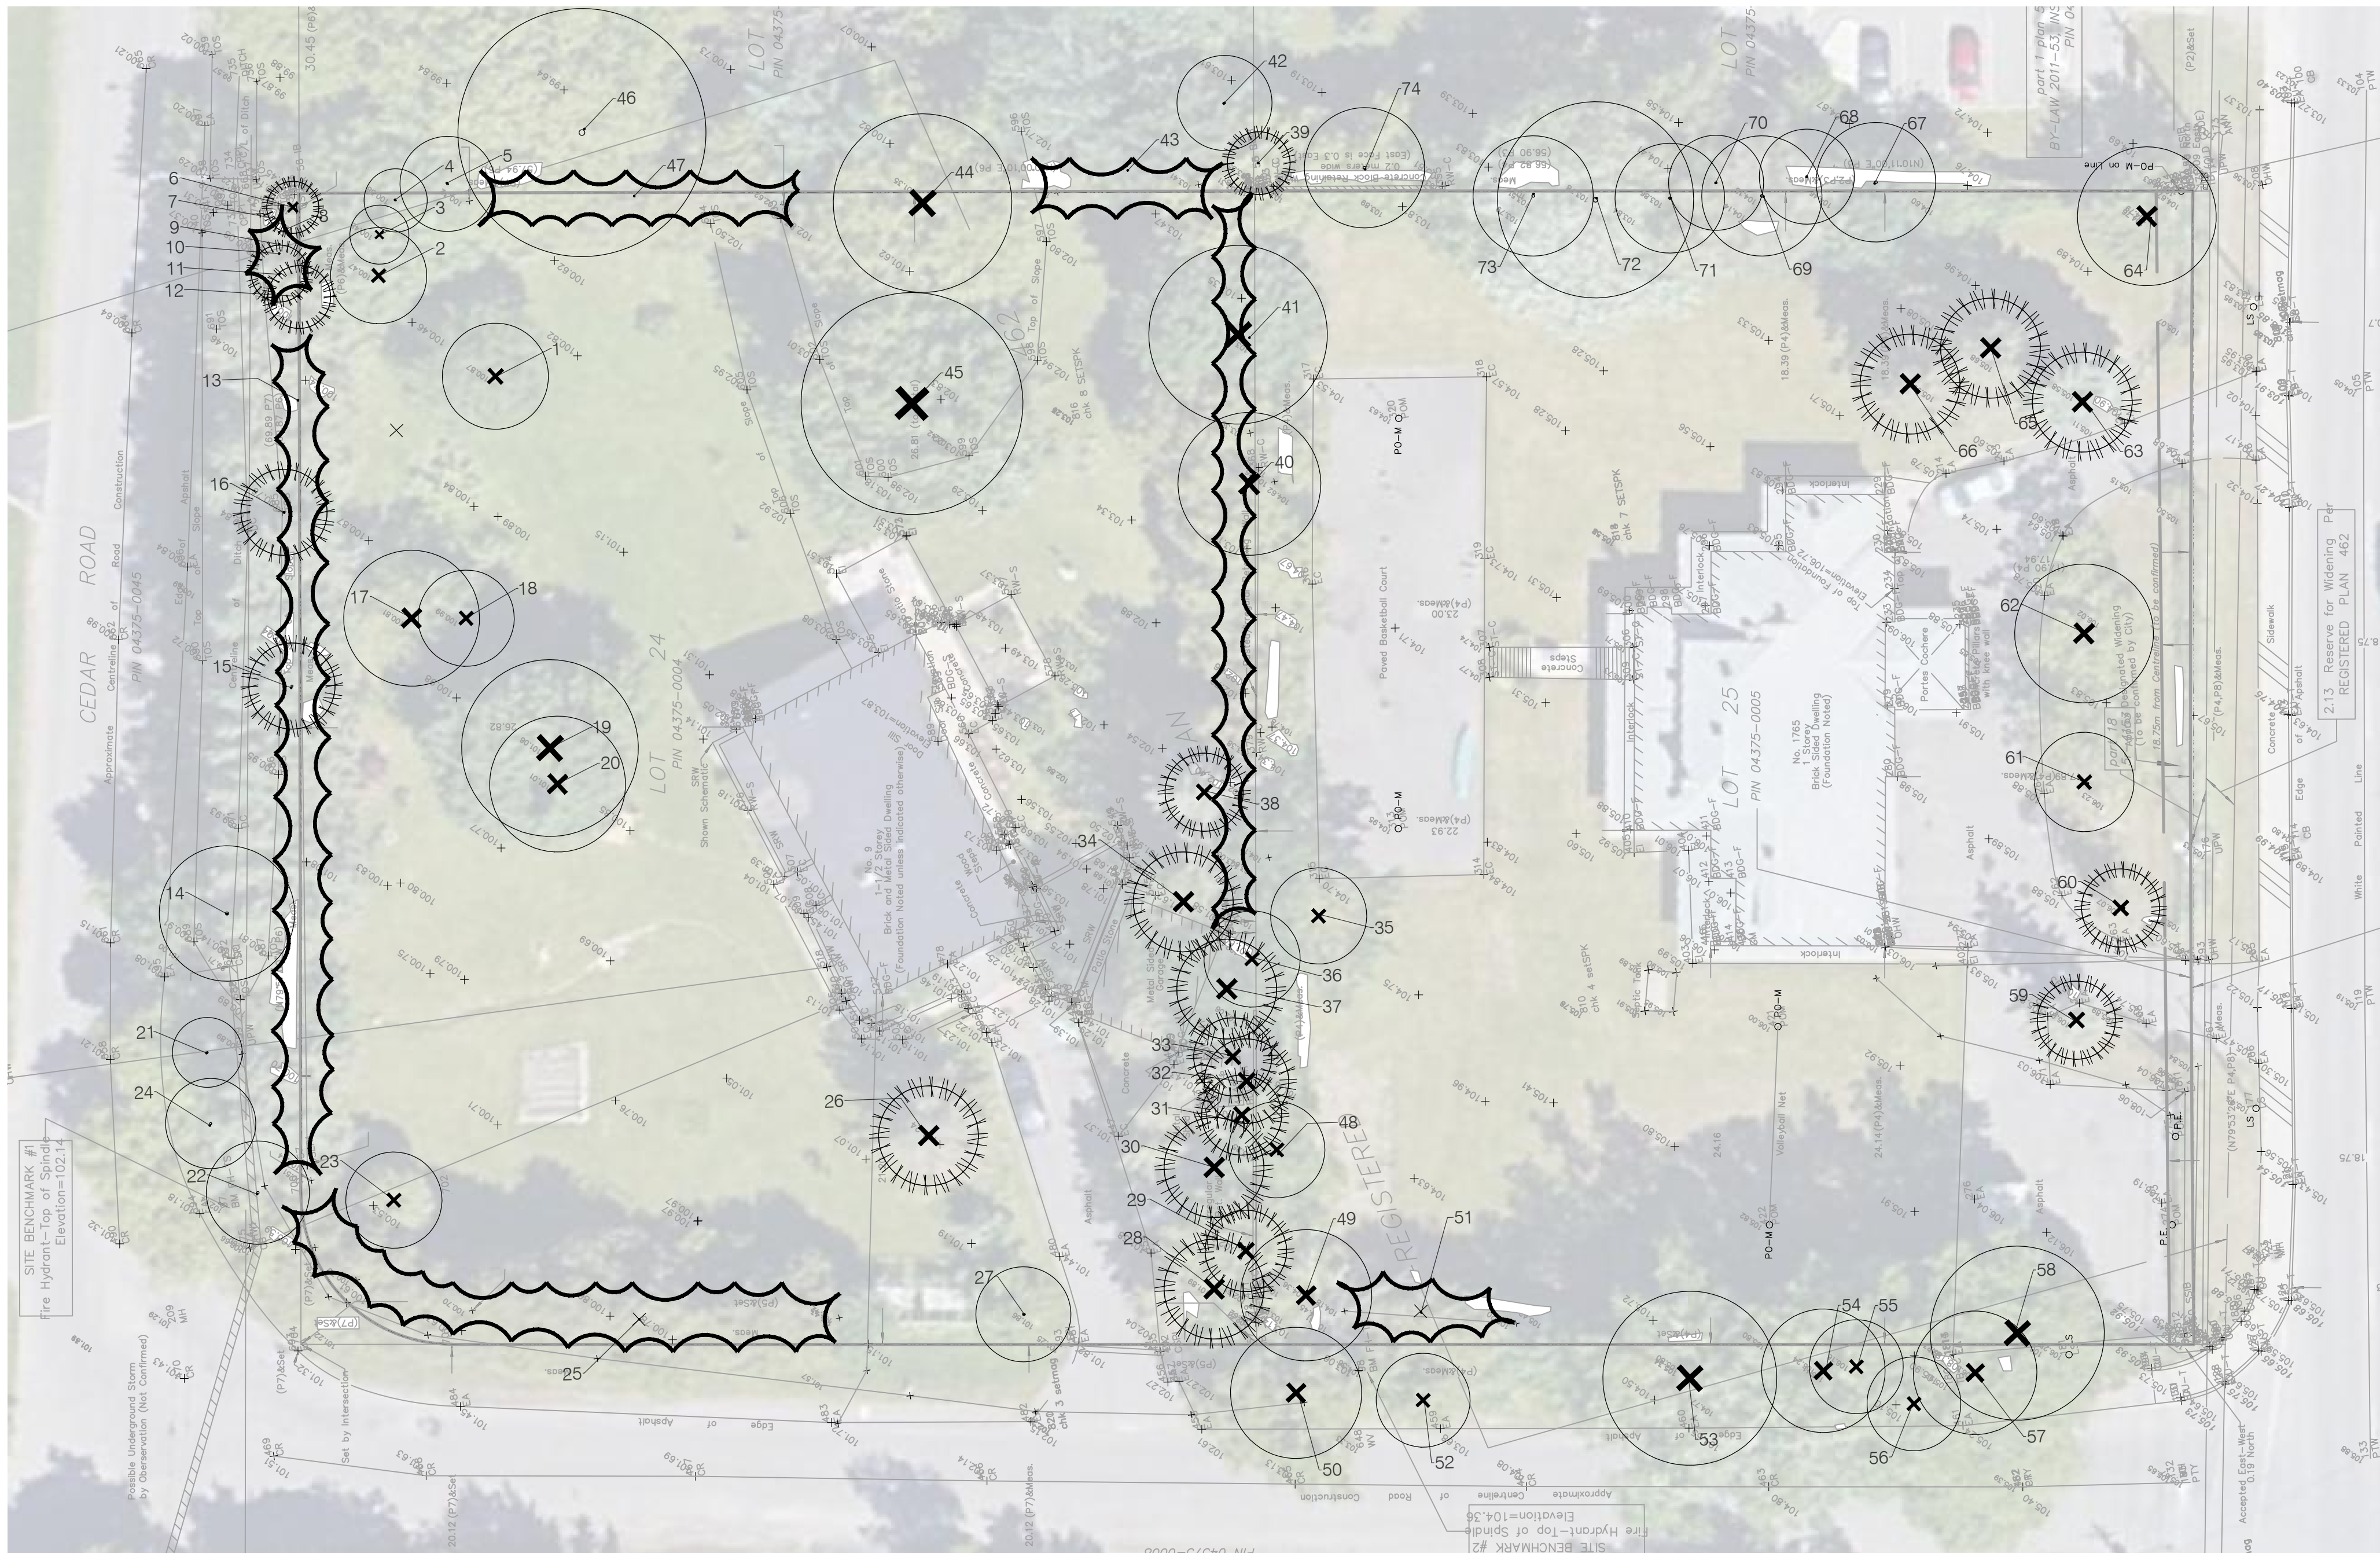
1 PRE-DEVELOPMENT VEGETATION  
L-TP-1

NO.	SPECIES	DBH (CM)	HEALTH	COMMENTS
4	Norway Maple / Acer platanoides	23	Good	
27	Hackberry / Celtis occidentalis	18	Good	
69	Norway Maple / Acer platanoides	23	Fair	
71	Siberian Elm / Ulmus pumila	22	Fair	
72	Silver Maple / Acer saccharinum	68, 31	Fair	
73	Red Oak / Quercus rubra	25, 22	Fair

NO.	SPECIES	DBH (CM)	HEALTH	COMMENTS
1	Apple / Malus spp.	67, 23	Fair	
2	Norway Maple / Acer platanoides	19	Good	
3	Norway Maple / Acer platanoides	27	Good	
12	White Spruce / Picea glauca	30	Good	
13	White Spruce / Picea glauca	15 - 35	Fair - Good	37 trees
17	Butternut / Juglans cinerea	17	Poor	
18	Apple / Malus spp.	15, 14	Poor	Black rot present
19	Norway Maple / Acer platanoides	39	Good	
20	Norway Maple / Acer platanoides	29	Good	
23	Norway Maple / Acer platanoides	12, 10, 8	Poor	
25	Eastern White Cedar / Thuja occidentalis	15 - 25	Fair - Good	44 Trees

26	White Spruce / Picea glauca	15	Good	
28	White Spruce / Picea glauca	38	Good	
29	Eastern White Cedar / Thuja occidentalis	17	Good	
30	White Spruce / Picea glauca	13	Fair	
31	White Spruce / Picea glauca	22	Fair	
32	White Spruce / Picea glauca	21	Good	
33	White Spruce / Picea glauca	18	Good	
34	White Pine / Pinus strobus	36	Good	
35	Siberian Elm / Ulmus pumila	51, 26	Good	
36	Manitoba Maple / Acer negundo	33	Poor	
37	Eastern White Cedar / Thuja occidentalis	20 - 23	Good	3 Trees
38	Balsam Fir / Abies balsamea	35	Good	
40	Manitoba Maple / Acer negundo	49	Poor	Heavy Lean

41	Norway Maple / Acer platanoides	38	Good	
44	Manitoba Maple / Acer negundo	52, 29	Poor	
45	Silver Maple / Acer saccharinum	55, 46	Fair	
48	American Elm / Ulmus americana	23	Fair	
49	Manitoba Maple / Acer negundo	30	Poor	
51	Eastern White Cedar / Thuja occidentalis	10 - 16	Fair	4 Trees
58	Siberian Elm / Ulmus pumila	91	Fair	3 Stems joined at 1.6m
59	Colorado Blue Spruce / Picea pungens	33	Fair	
60	Colorado Blue Spruce / Picea pungens	28	Poor	
61	Northern Catalpa / Catalpa speciosa	62	Poor	
62	Northern Catalpa / Catalpa speciosa	49, 35, 29	Poor	
63	Colorado Blue Spruce / Picea pungens	40	Fair	
64	Siberian Elm / Ulmus pumila	20, 19, 18	Fair	
65	White Spruce / Picea glauca	44	Good	
66	White Spruce / Picea glauca	42	Good

NO.	SPECIES	DBH (CM)	HEALTH	COMMENTS
5	Norway Spruce / Picea abies	18	Good	
39	Eastern White Cedar / Thuja occidentalis	15, 25	Fair - Good	39 Trees
42	American Elm / Ulmus americana	23	Fair	
43	Eastern White Cedar / Thuja occidentalis	16 - 23	Fair - Good	5 Trees
46	European White Poplar / Populus alba	26, 26	Poor	
47	Eastern White Cedar / Thuja occidentalis	15, 25	Fair - Good	17 Trees
67	Norway Maple / Acer platanoides	28	Fair	
68	Norway Maple / Acer platanoides	18	Fair	
70	Siberian Elm / Ulmus pumila	16	Poor	
74	Manitoba Maple / Acer negundo	25	Poor

NO.	SPECIES	DBH (CM)	HEALTH	COMMENTS
7	Eastern White Cedar / Thuja occidentalis	24	Poor	Woodpecker damage
8	Eastern White Cedar / Thuja occidentalis	17	Poor	Woodpecker damage
9	Eastern White Cedar / Thuja occidentalis	14	Poor	Woodpecker damage
10	Eastern White Cedar / Thuja occidentalis	15	Poor	Woodpecker damage
11	Eastern White Cedar / Thuja occidentalis	15	Poor	Woodpecker damage
14	Norway Maple / Acer platanoides	23	Fair	
15	White Pine / Pinus strobus	21	Good	
16	White Pine / Pinus strobus	23	Good	
21	Manitoba Maple / Acer negundo	17	Poor	
22	Manitoba Maple / Acer negundo	21	Poor	
24	Manitoba Maple / Acer negundo	14	Poor

NO.	SPECIES	DBH (CM)	HEALTH	COMMENTS
6	Eastern White Cedar / Thuja occidentalis	25	Poor	Woodpecker damage
50	Manitoba Maple / Acer negundo	36, 34	Poor	
52	Manitoba Maple / Acer negundo	100	Poor	Heavy Lean
53	Siberian Elm / Ulmus pumila	51, 26	Fair	2 Stems joined at base
54	Siberian Elm / Ulmus pumila	42, 28	Fair	
55	Siberian Elm / Ulmus pumila	24, 14	Fair	
56	Siberian Elm / Ulmus pumila	18	Good	
57	Siberian Elm / Ulmus pumila	13	Good
