Phase I Environmental Site Assessment

1185 Beaverwood Road
Manotick, Ontario

Prepared for ARK Construction Ltd.

Report: PE5615-1R
January 18, 2023

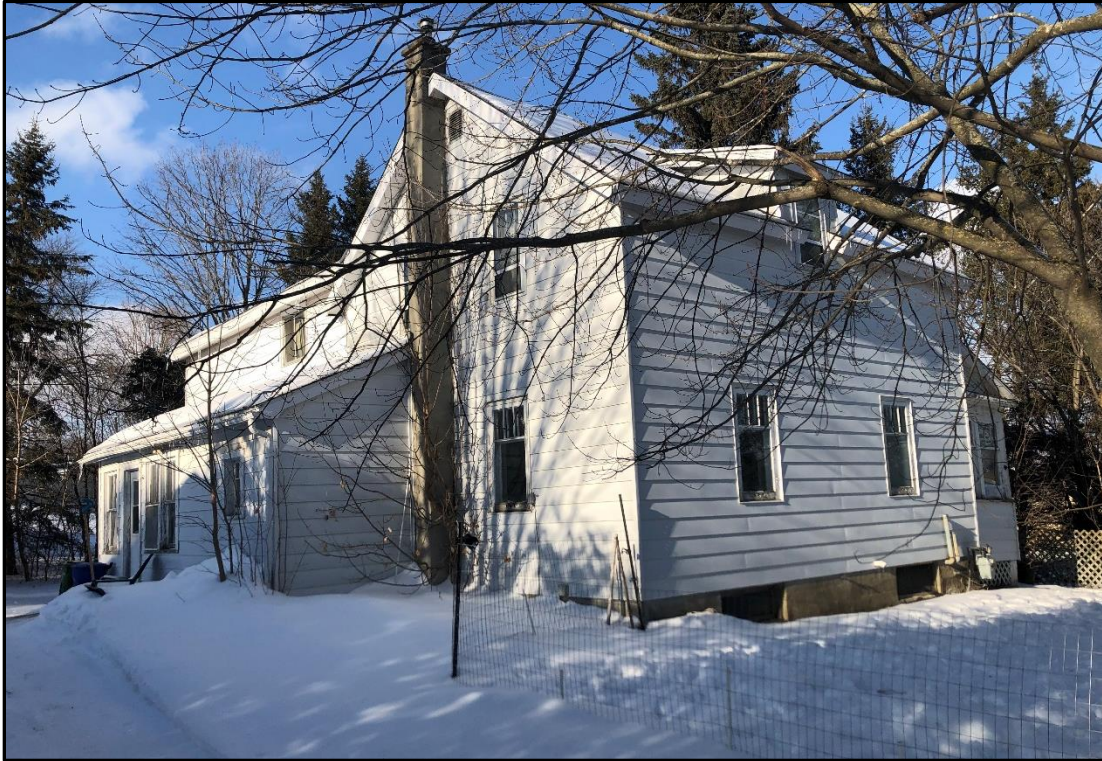
Photo 1: On the western portion of the gravel driveway, facing north towards the residential dwelling.

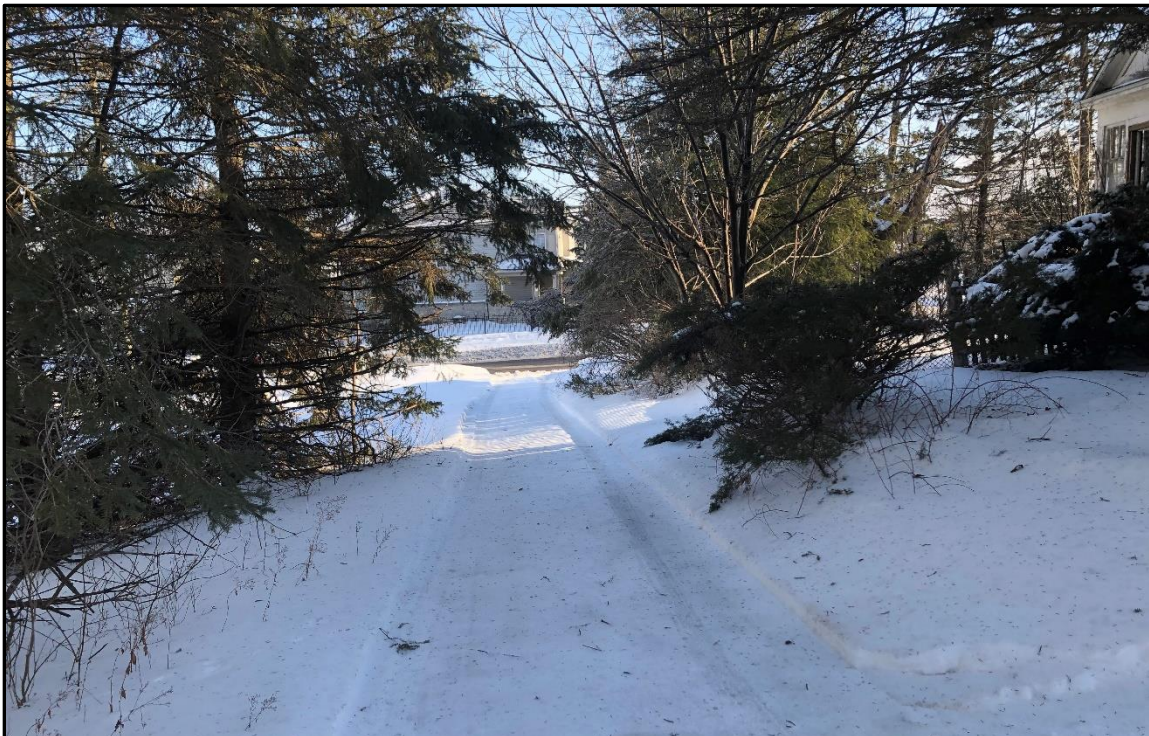
Photo 2: East of the residential dwelling, on the eastern portion of the gravel driveway, facing southeast towards Beaverwood Road.

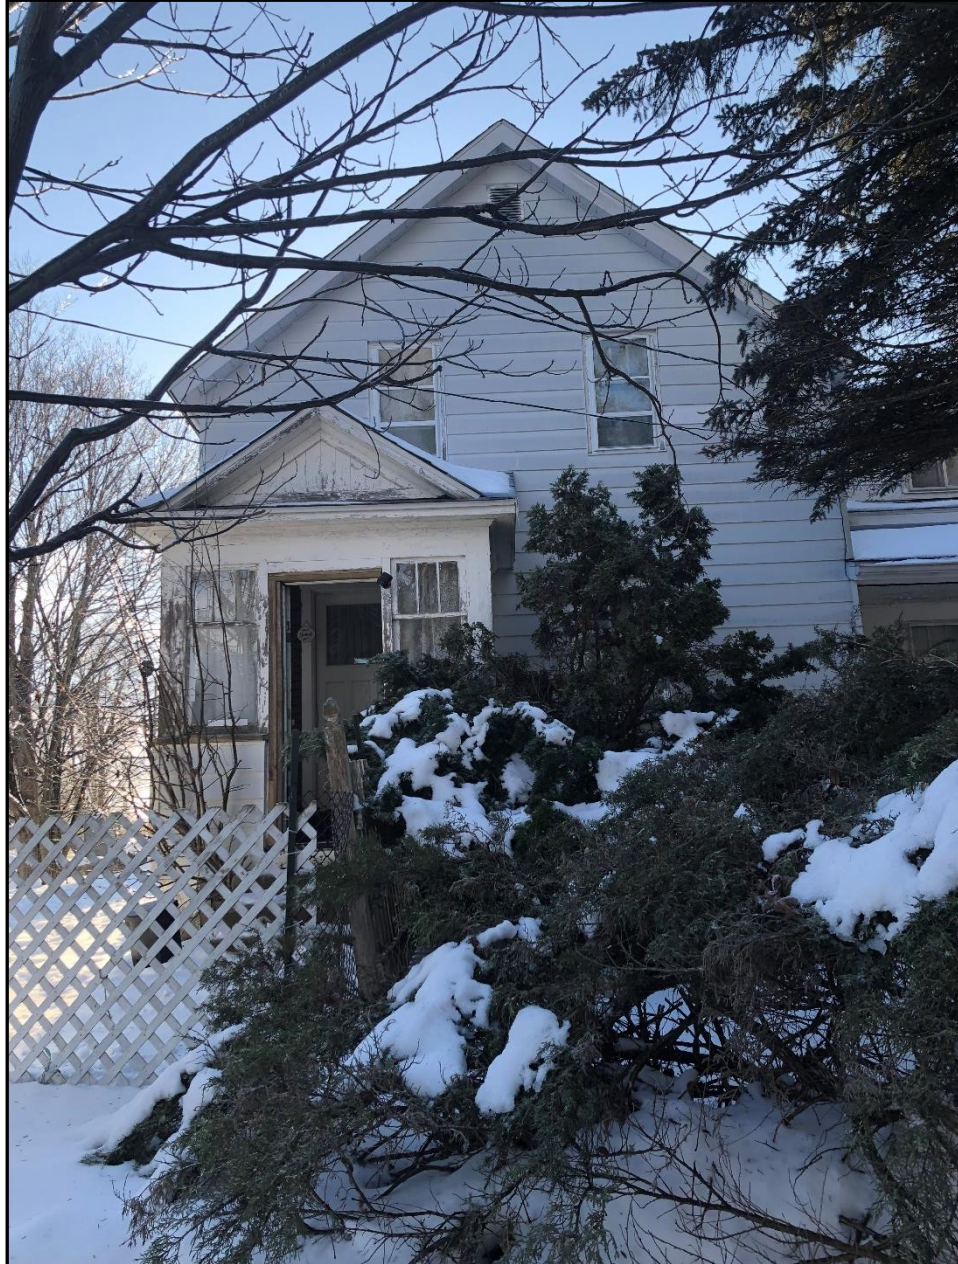
Photo 3: East of the residential dwelling, facing towards the west building face.

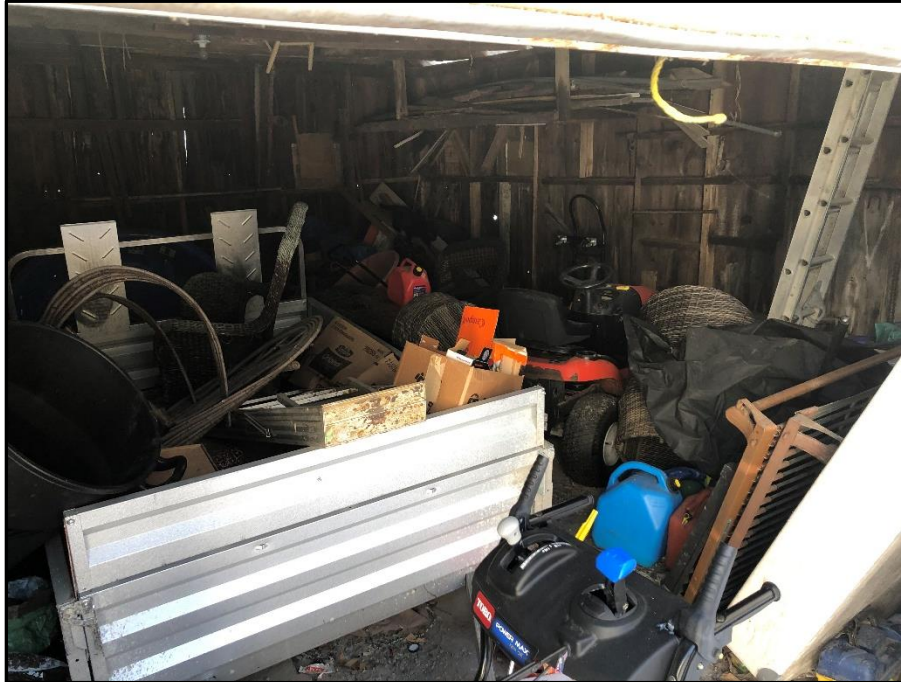
Photo 4: Inside of the detached garage, used for general storage.

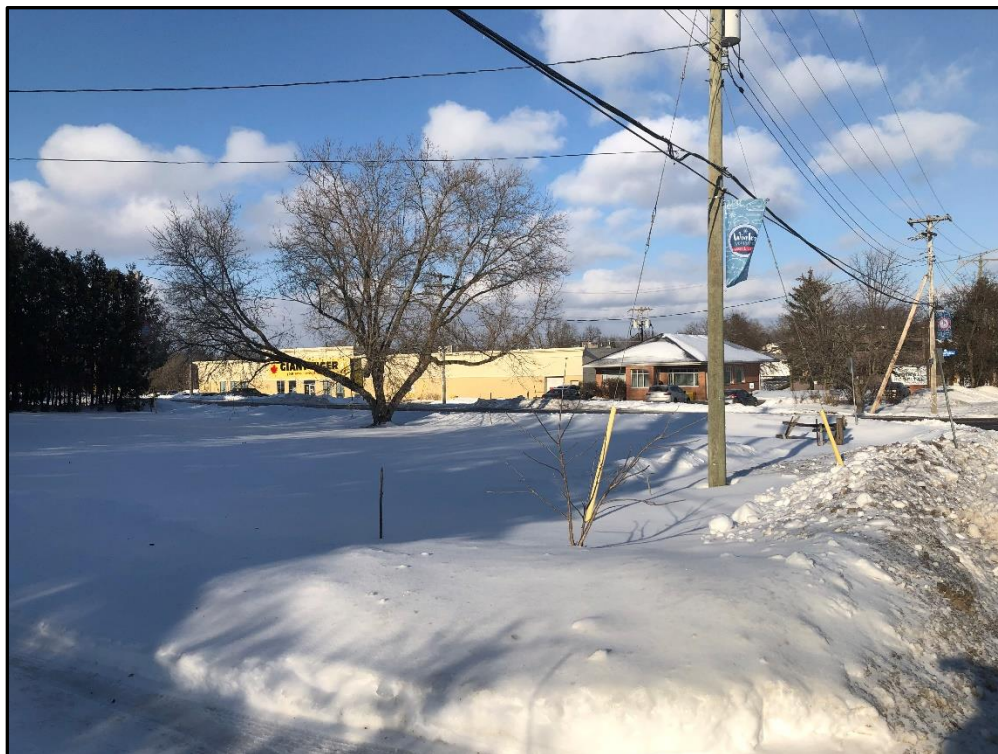
Photo 5: At Beaverwood Road and the eastern gravel entrance, facing towards the eastern portion of the Phase I Property.
