**PHASE ONE ENVIRONMENTAL SITE ASSESSMENT
3493, 3497, AND 3499 INNES ROAD, OTTAWA, ONTARIO**

Gestion FRAMI
6587712 Canada Inc.
1085 Boulevard de la Carrière
Gatineau, QC J8Y 6V4

BluMetric Environmental Inc.
1682 Woodward Drive
Ottawa, ON K2C 3R8

Project Number: 230028-00
January 19, 2023

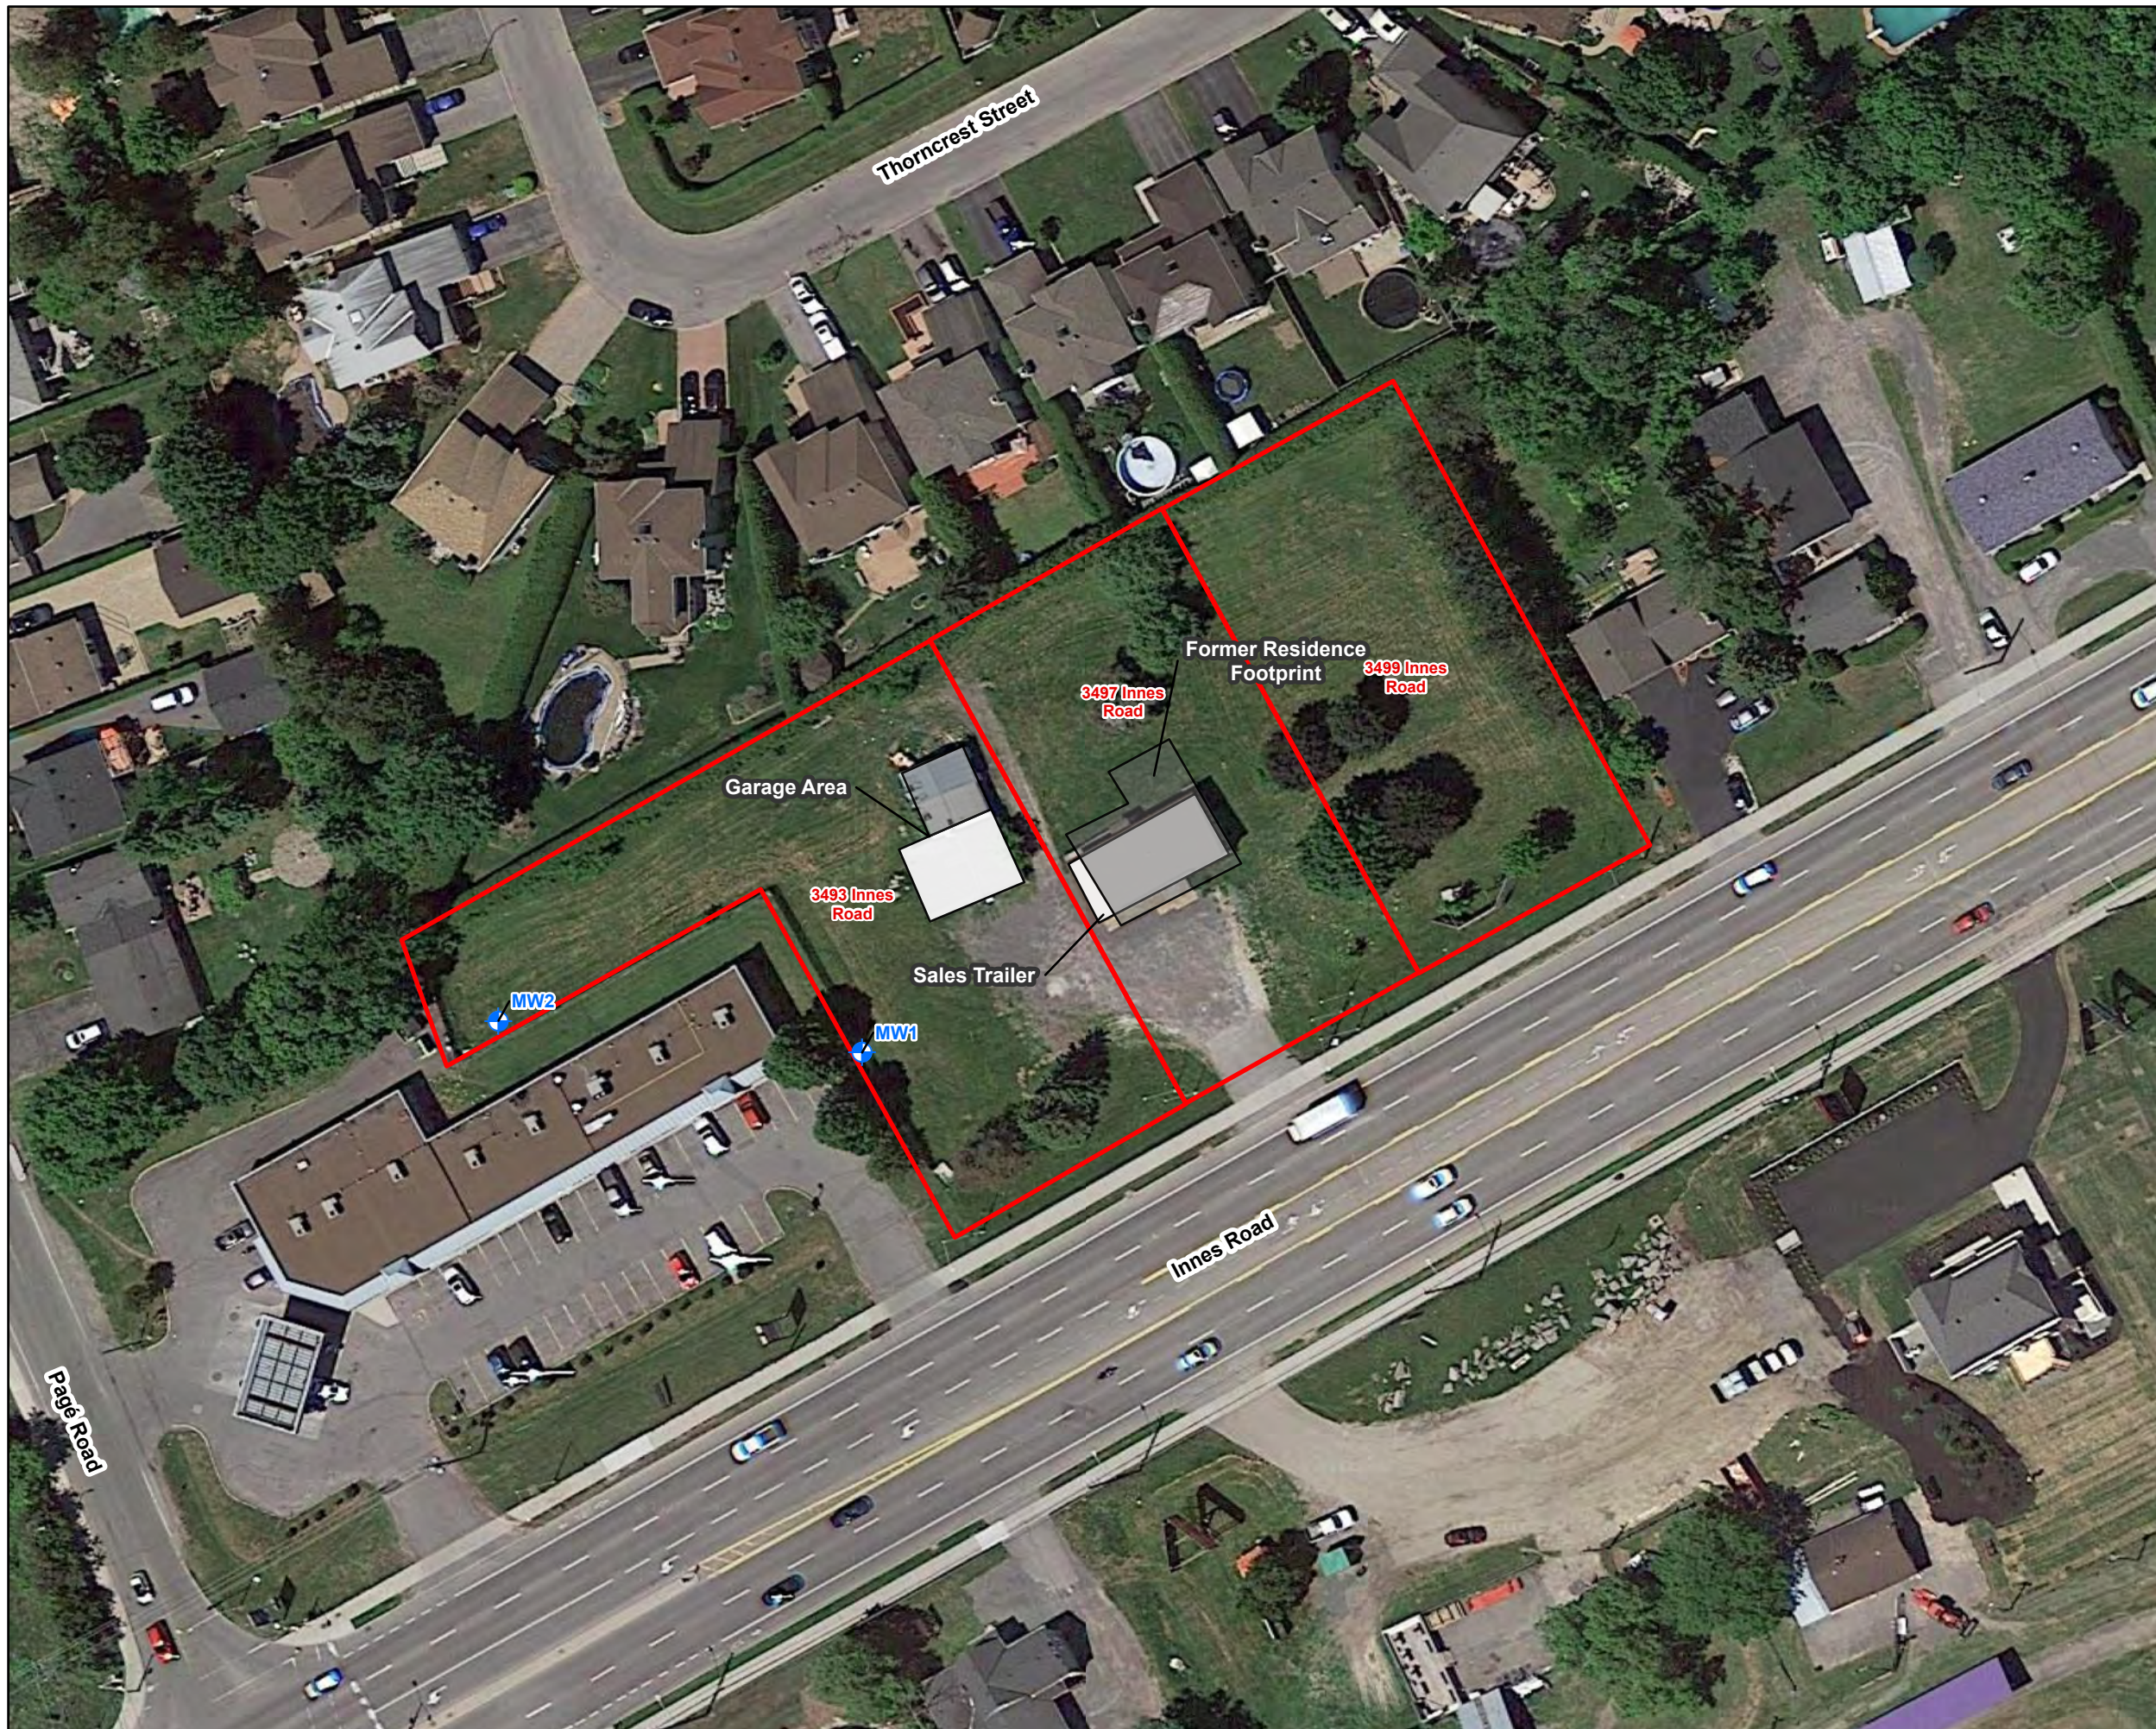
PROJECT # 230028	DATE January 23, 2023
DRAWN MB	CHECKED RH
FIG NO. 01	REV 2

- Property Outline
- Existing Structure
- Former Structure Footprint
- + Monitoring Well Location

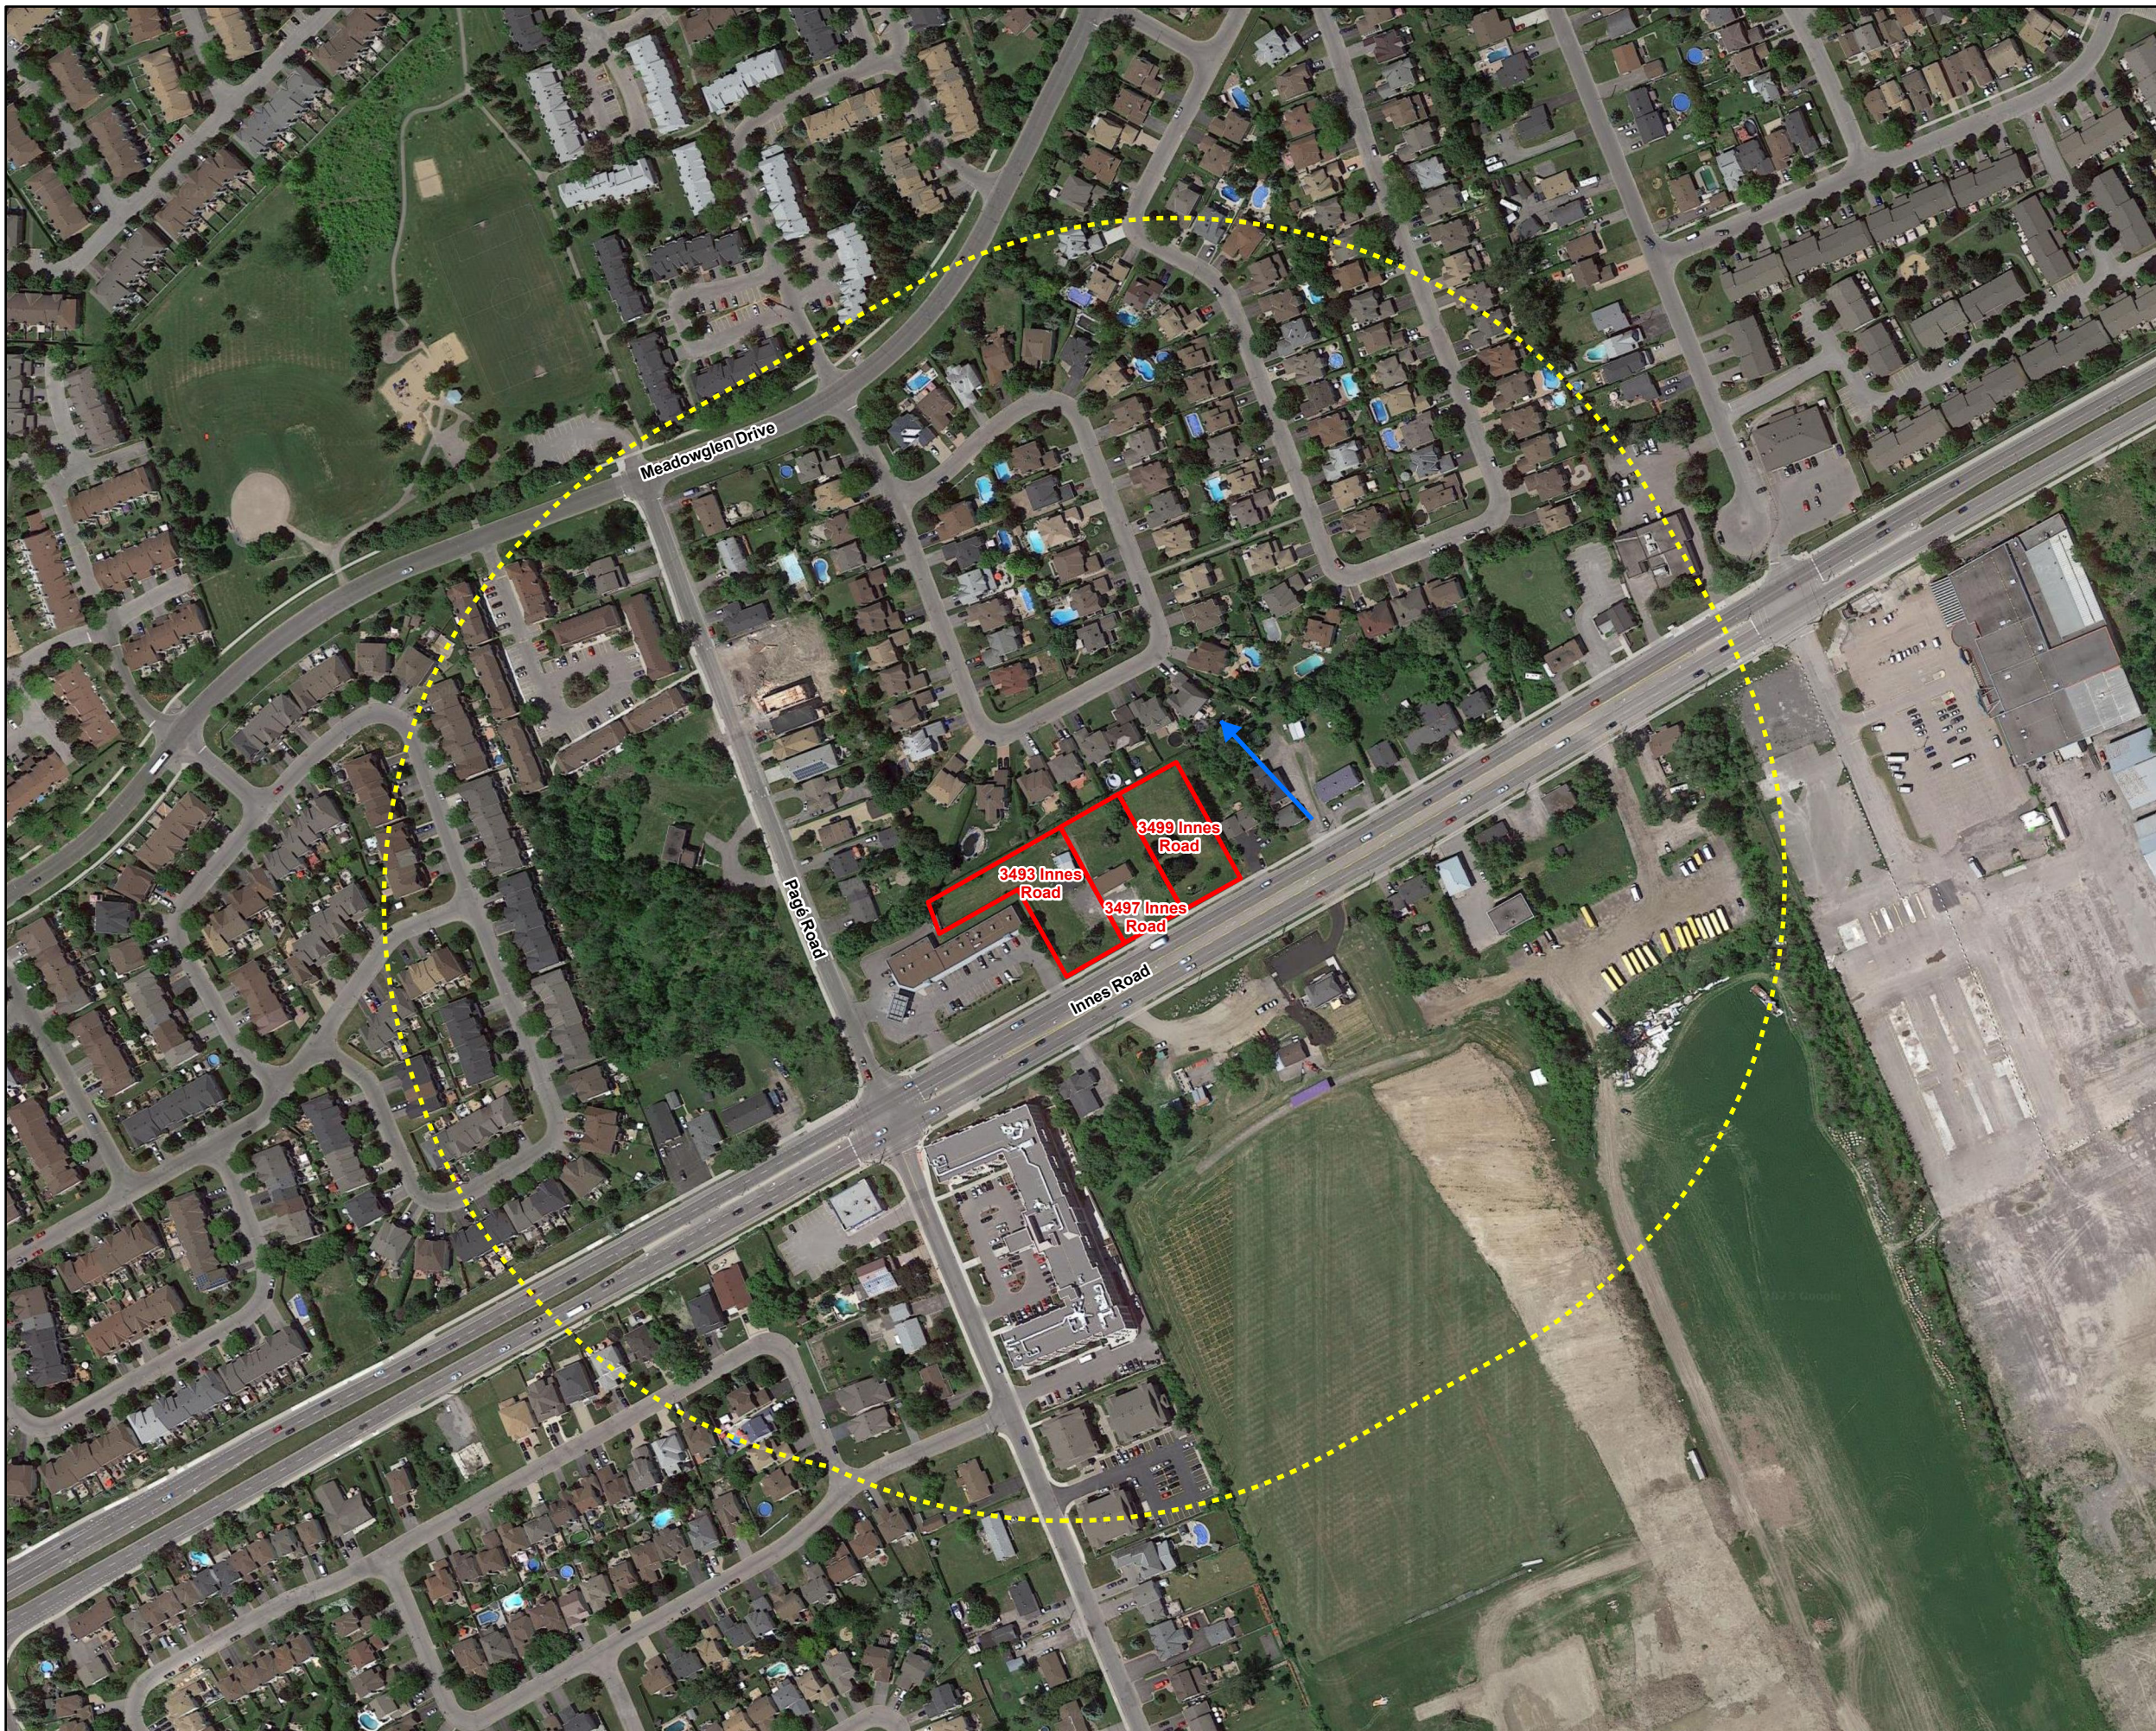
PROJECT # 230028	DATE January 23, 2023
DRAWN MB	CHECKED RH
FIG NO. 03	REV 2

The qualified person (QP) determined that the conventional distance of 250 m from the Phase One Property boundary was adequate for defining the Phase One Study Area for all records reviewed, with the exception that a distance of 2 km was appropriate for reviewing records that pertain to active or former waste disposal sites, coal gasification plants, and coal tar sites, given that such sources can cause impacts that extend for distances of more than 250 m. The Phase One Property and Phase One Study Area are illustrated in Figure 3.

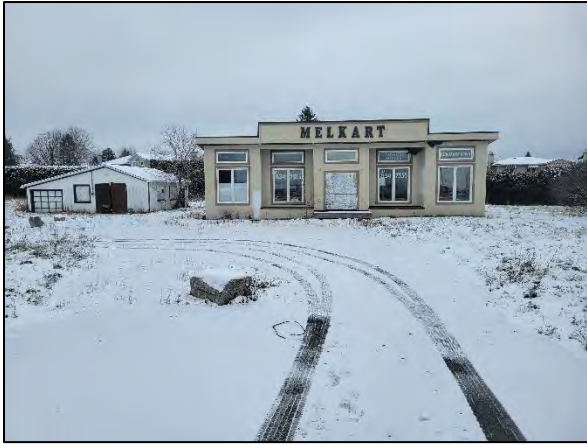
1. Photo is taken facing north from the south boundary along Innes Road, looking at 3497 Innes Road and the structures on the Phase One Property.

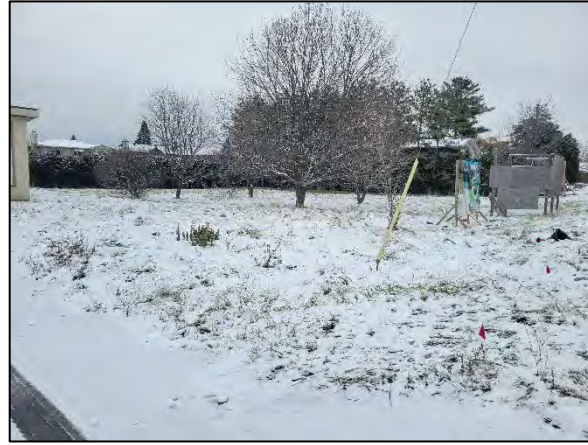
2. Photo is taken facing northeast from the south boundary of the property along Innes Road, looking at 3499 Innes Road property.

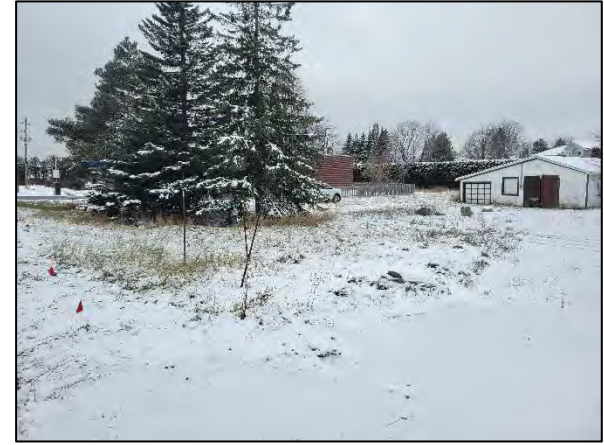
3. Photo is taken facing northwest from the south boundary, looking at the 3493 Innes Road property.

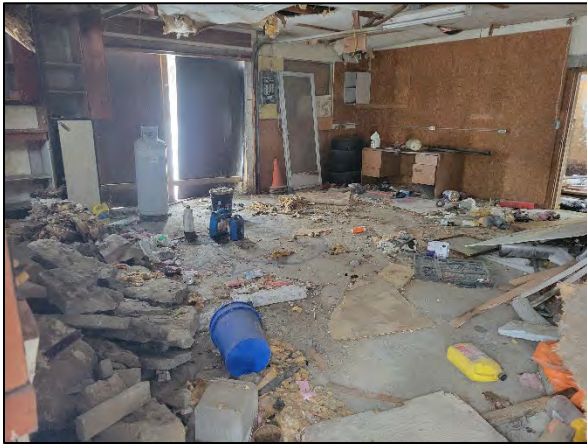
4. Photo is taken inside the garage structure at 3493 Innes Road.

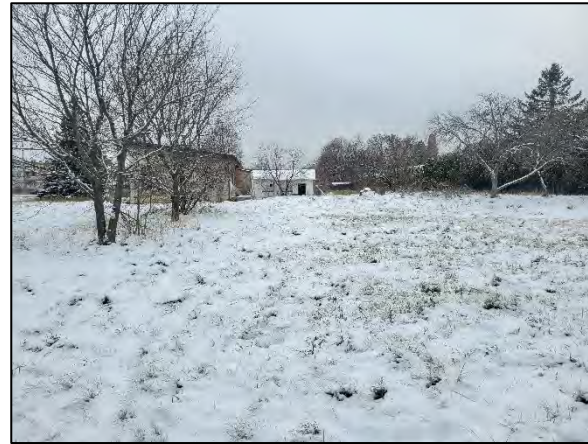
5. Photo is taken facing west from the central-east part of the Phase One Property.

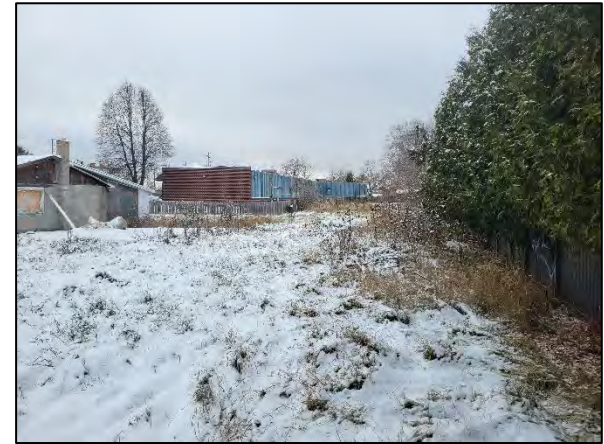
6. Photo is taken facing west from the north side of the 3493 Innes Road property.

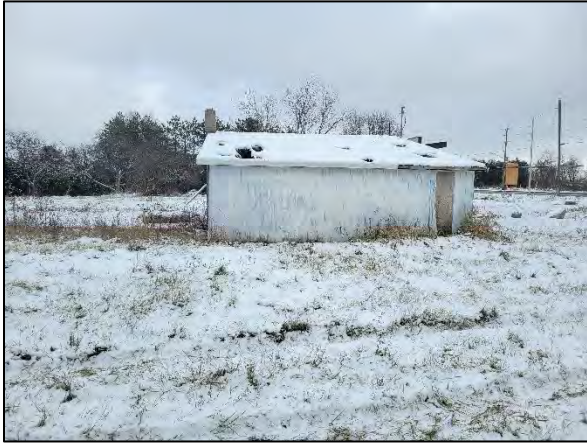
7. Photo is taken facing east from the west side of the garage building on 3493 Innes Road.

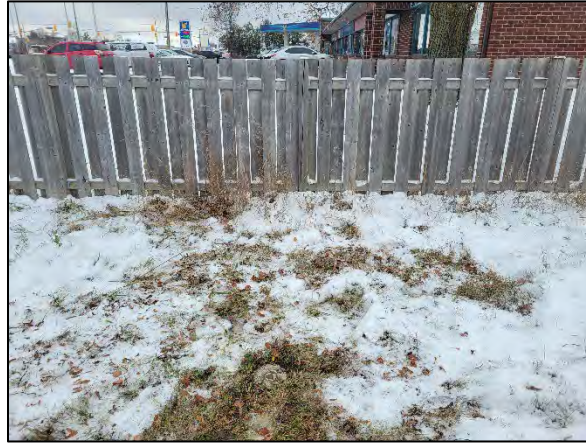
8. Photo is taken along the western boundary of the Phase One Property, showing the location of MW1.

No catch basins were observed on the Phase One Property. Two monitoring wells were present along the west side of the Phase One Property, installed by BluMetric in 2020.

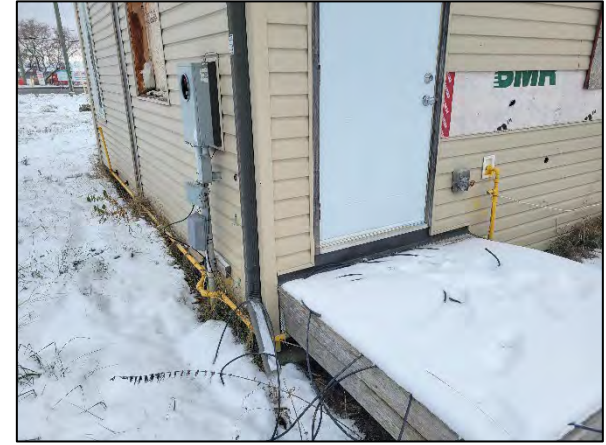
9. Photo is taken of the southwest corner of the trailer structure at 3497 Innes Road, showing the location of the utility connections, which were shut off at the time of the site visit.

A trailer previously used as a real-estate sales office was noted on the central part of the Phase One Property (3497 Innes Road) and a garage outbuilding was noted on the western part of the Phase One Property (3493 Innes Road). Both structures are planned for demolition/removal, prior to the proposed commercial redevelopment. Aerial photographs discussed further in Section 3.1 indicate that a two-storey stone house was present in the current location of the trailer prior to 2011 and has been removed from the site. The remainder of the property area is primarily grass-covered, with a gravel driveway and parking area accessed from Innes Road. Several mature trees were noted across the property.

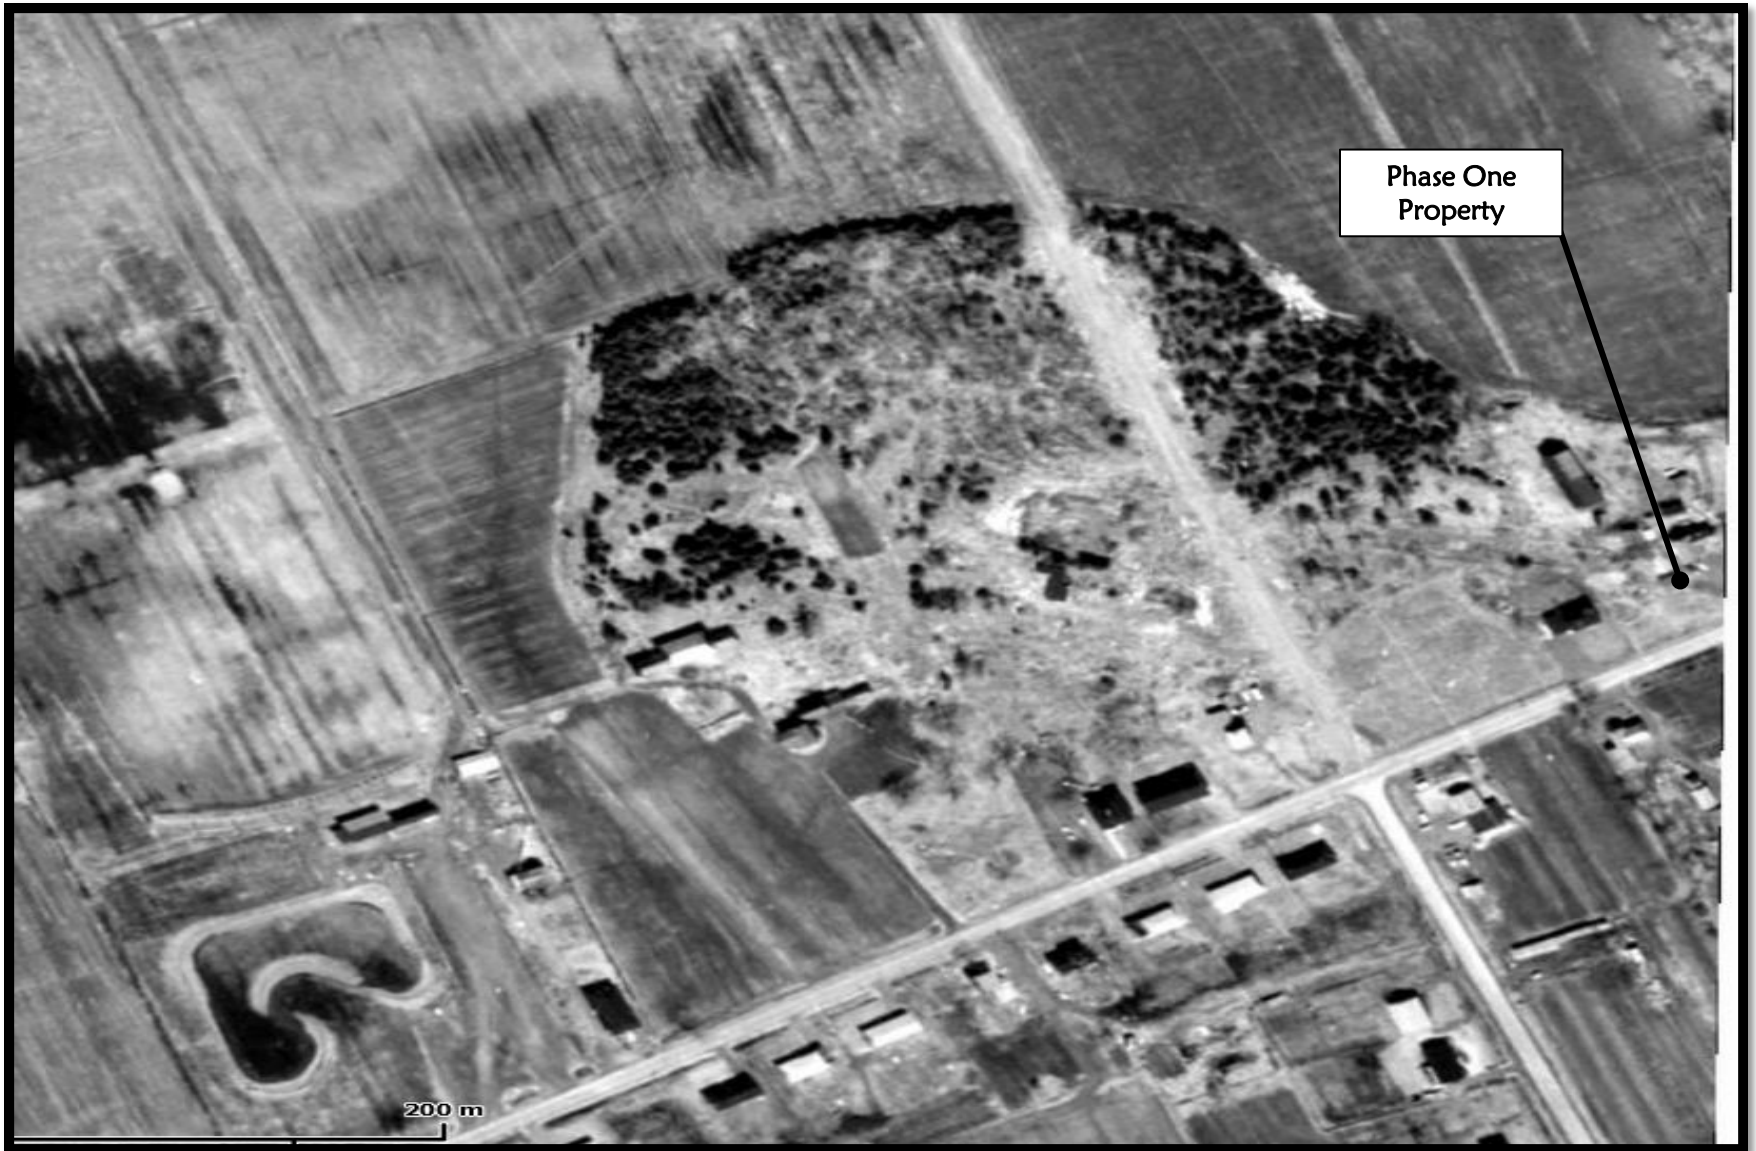
Historical Aerial Photography of the Site
3493, 3497, and 3499 Innes Road, Ottawa, Ontario
1965
230028 – January 2023

1965 (GeoOttawa Website)	There is no significant visible change to the use of the Phase One Property. The residence and several small structures/ sheds remain on the centre and east sides of the Phase One Property. The east side of the Phase One Property is not shown in the air photo coverage.	A residence is visible on the property to the west of the Phase One Property followed by Page Road. Residential properties are noted southwest of the Phase One Property, southwest of Innes and Page Road. Other farming type operations appear to be in operation along the south side of Innes Road, south of the Phase One Property. East of the Phase One Property is not covered by the air photo.

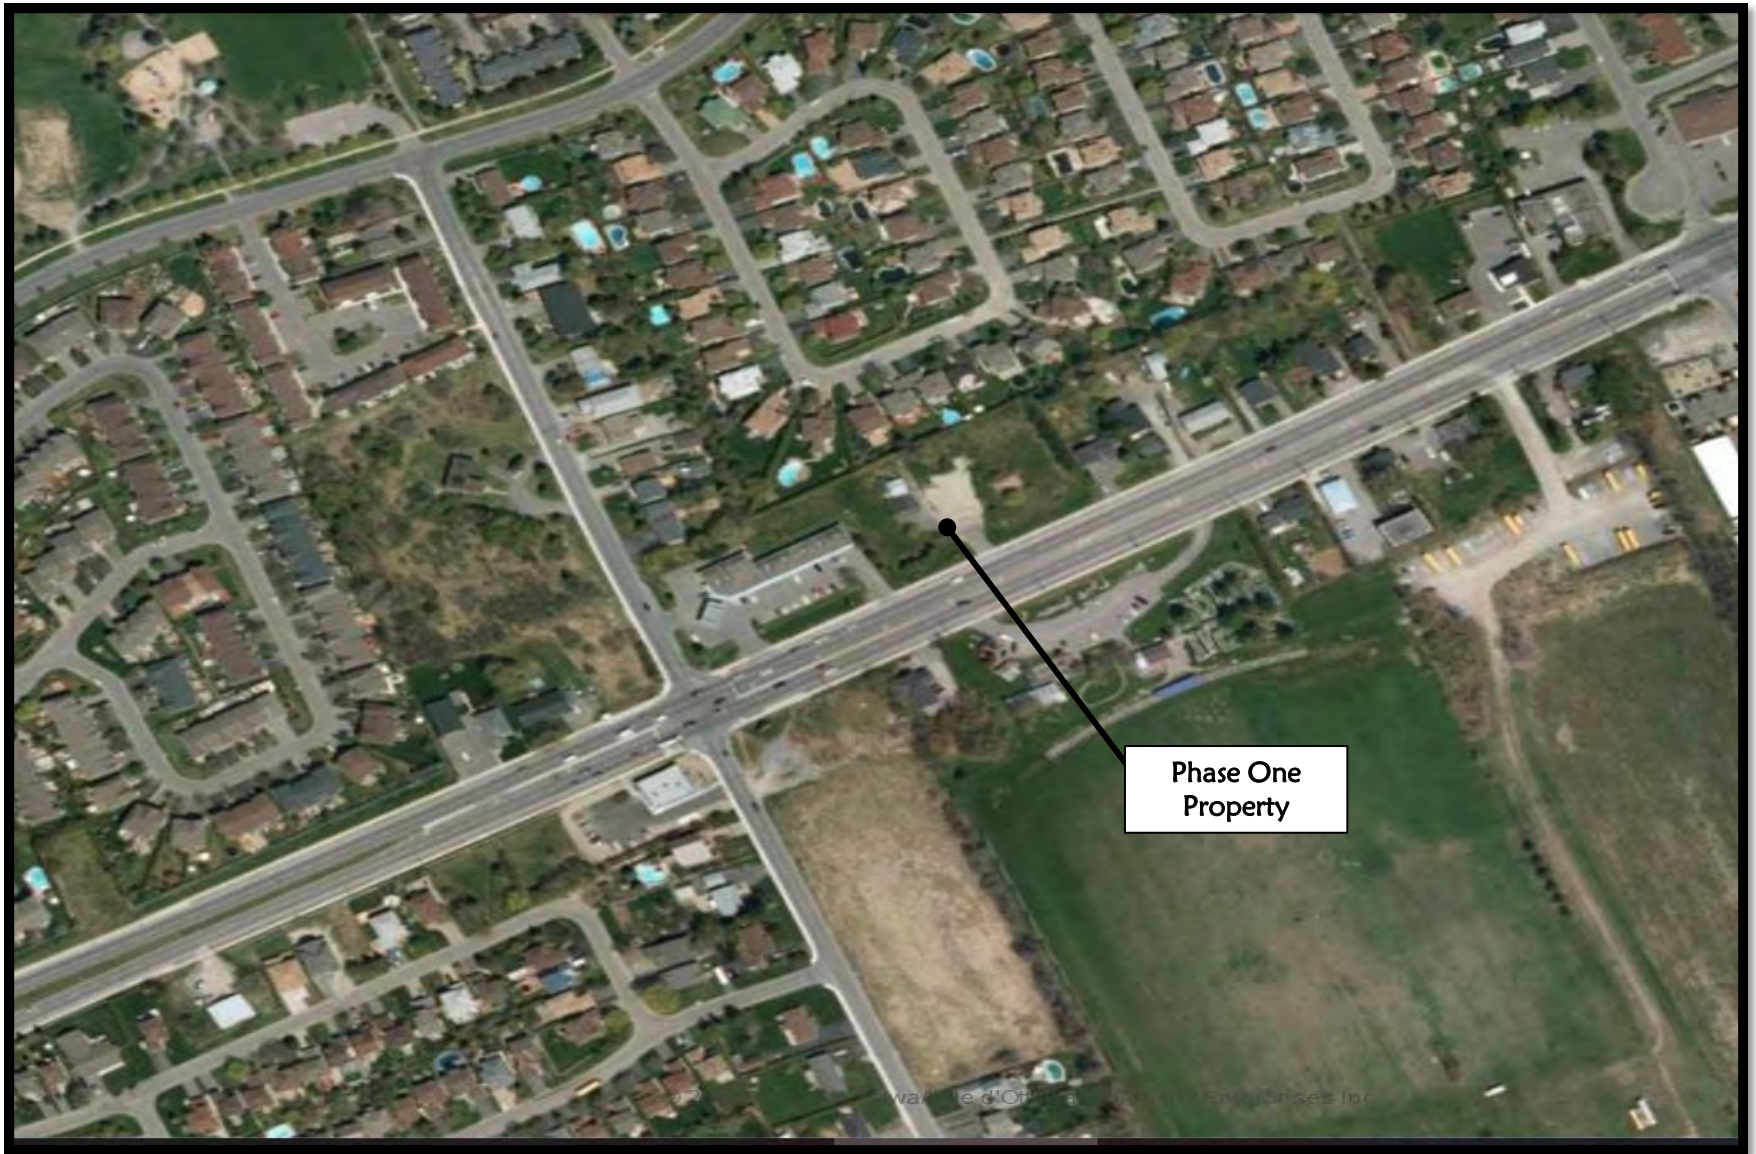
Historical Aerial Photography of the Site
3493, 3497, and 3499 Innes Road, Ottawa, Ontario
2011
230028 – January 2023

2011 (GeoOttawa Website)	The residence has been demolished. The garage structure remains intact. No other significant changes in the use of the Phase One Property were noted since the 2008 aerial photograph.	The property at the southwest corner of Innes and Page Road has been redeveloped for commercial use. No other significant changes were noted since the 2008 aerial photograph.
2014 (GeoOttawa Website)	A rectangular structure, likely the existing trailer, is visible on the centre of the Phase One Property. The garage structure remains on the property. A small billboard is also visible on the southeast side of the property.	The vacant property at the southeast corner of Innes and Page Road is under construction with a multi-storey building. Further south of the building are several other smaller residential structures.

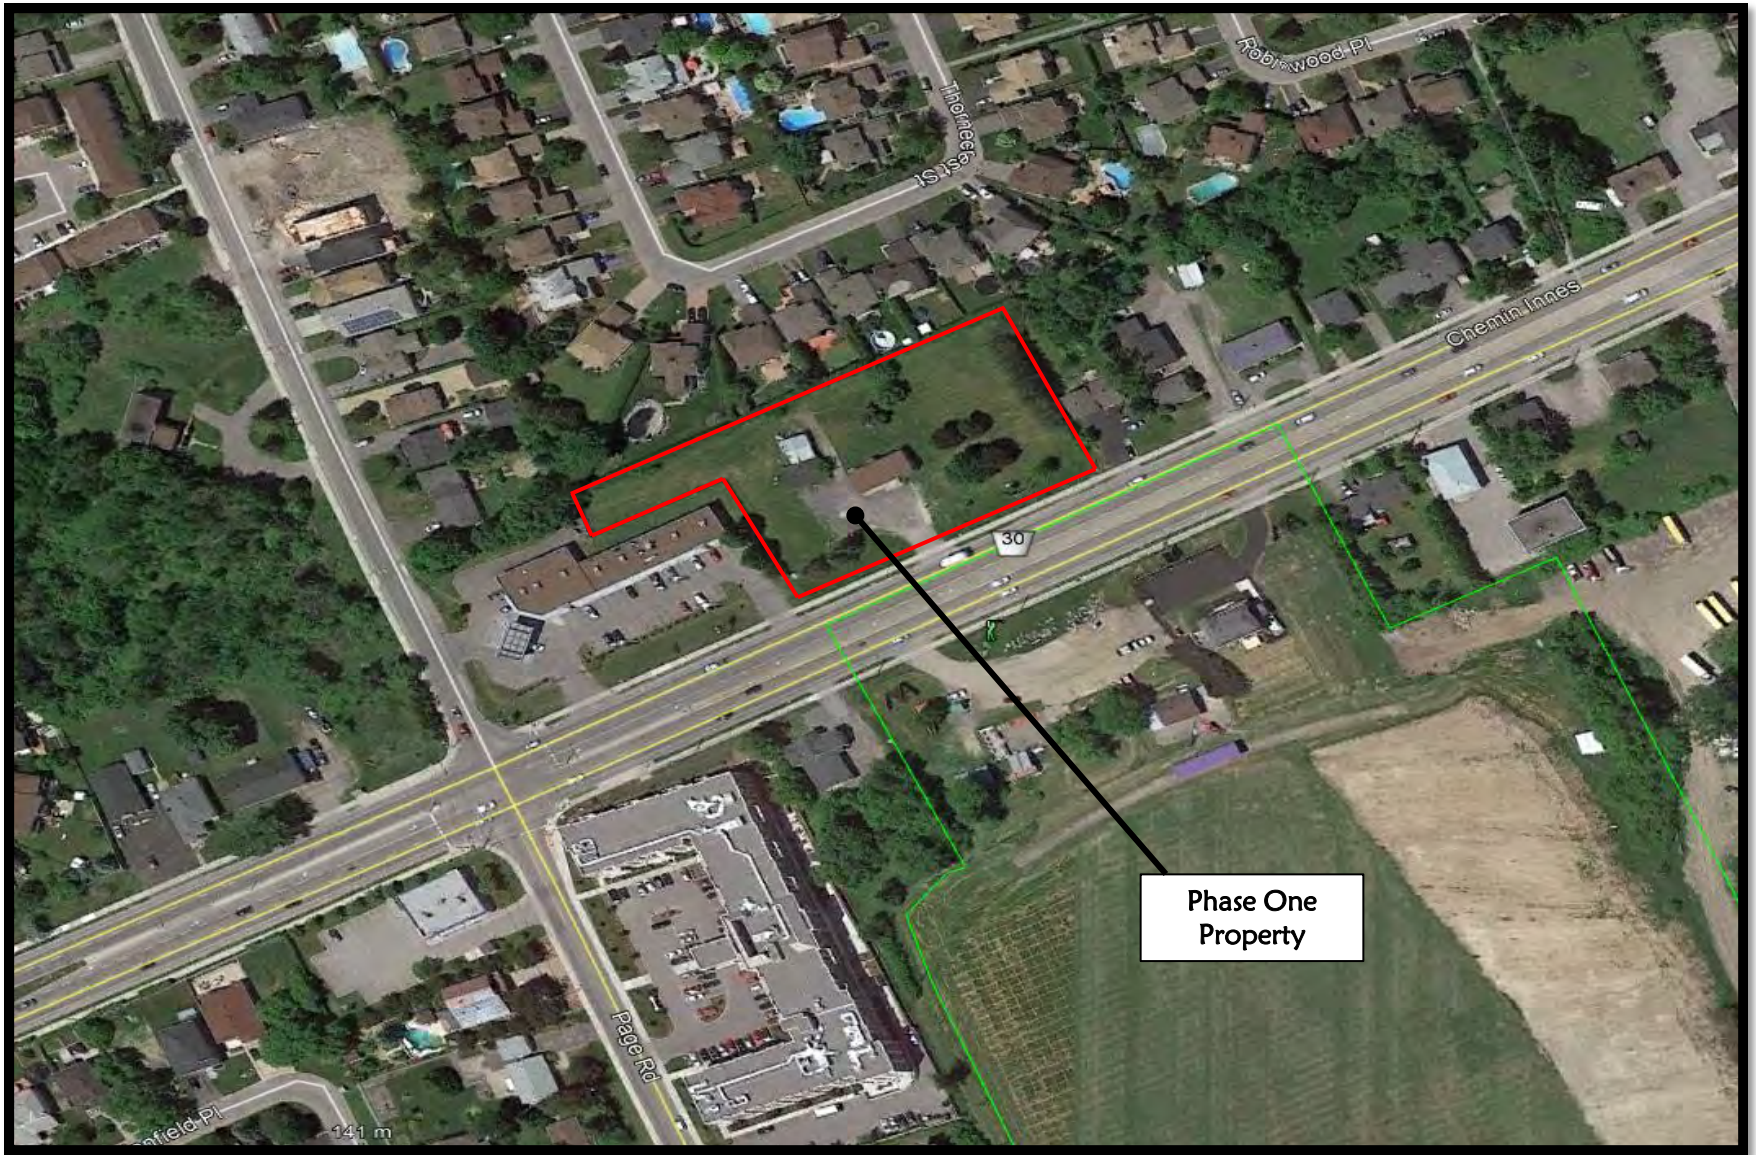
Historical Aerial Photography of the Site
3493, 3497, and 3499 Innes Road, Ottawa, Ontario
2018
230028 – January 2023

Year (source)	Description	
	Phase One Property	Phase One Study Area
2018 (GeoOttawa Website)	No significant visible changes are noted since the 2014 aerial photograph.	A multi-storey building to the southwest of the Phase One Property (retirement residence) has been constructed on the southeast corner of Page Road and Innes Road.
2021 (GeoOttawa Website)	The rear portion of the garage building has been removed leaving only the front portion of the structure intact. The trailer remains on the centre of the Phase One Property.	A roadway was developed through the golf range property south of the Phase One Property. A property to the southeast of the site appears to be used for the storage and stockpiling of fill and aggregate material, likely related to development further south of the study area.
