Tree Information Report

Submitted as part of Building Permit Application for the City of Ottawa

Address: 1568 Meadowbrook

Date: August 13, 2021

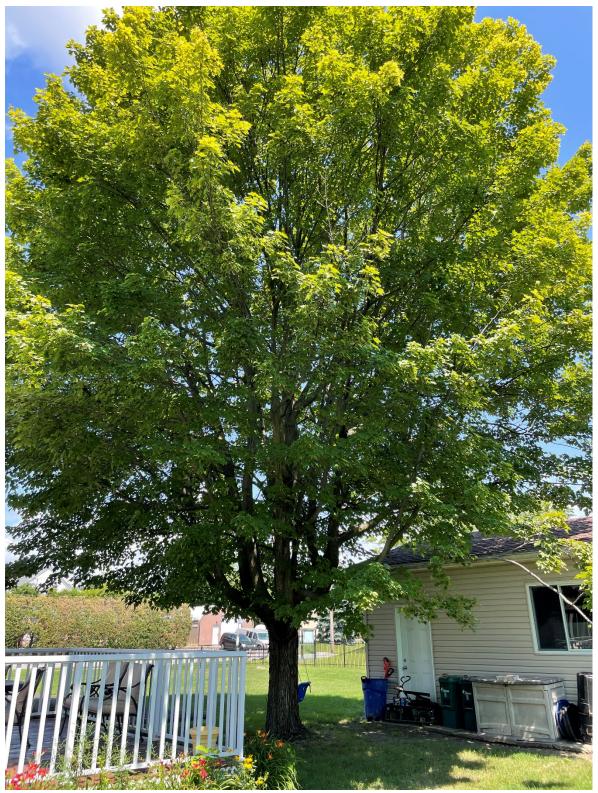
Figure 1: Tree 1, Freeman maple to be removed

Tree ¹	Species	Diameter at breast height (cm)	Ownership ^{2,3}	Condition	Action	Recommendations
1	Freeman maple (Acer freemanii)	47 cm	Private	Good	Remove	Remove based on plans – in the zone of excavation; Tree Permit required
2	Balsam fir (Abies balsamea)	35 cm	Private	Good	Retain and protect	Techno posts to be used for porch to avoid excavation; follow City of Ottawa Tree Protection Specifications (March 2021)
3	Eastern white cedar (Thuja occidentalis)	32, 28 cm (est.)	1560 Meadowbrook – 88 cm from property line	Good	Retain and protect	Excavation to be reduced from 88 cm to approximately 1.2 m from the tree

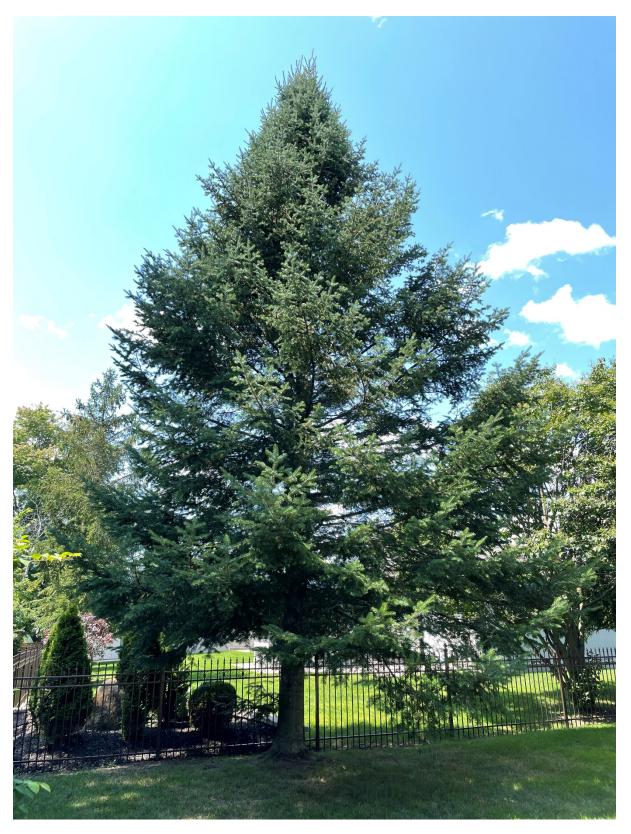
Figure 2: Tre 2, Balsam fir
