# **Phase II – Environmental Site Investigation**

84 and 100 Gloucester Street

Prepared for Claridge Homes

Report PE5571-2 dated June 28, 2022

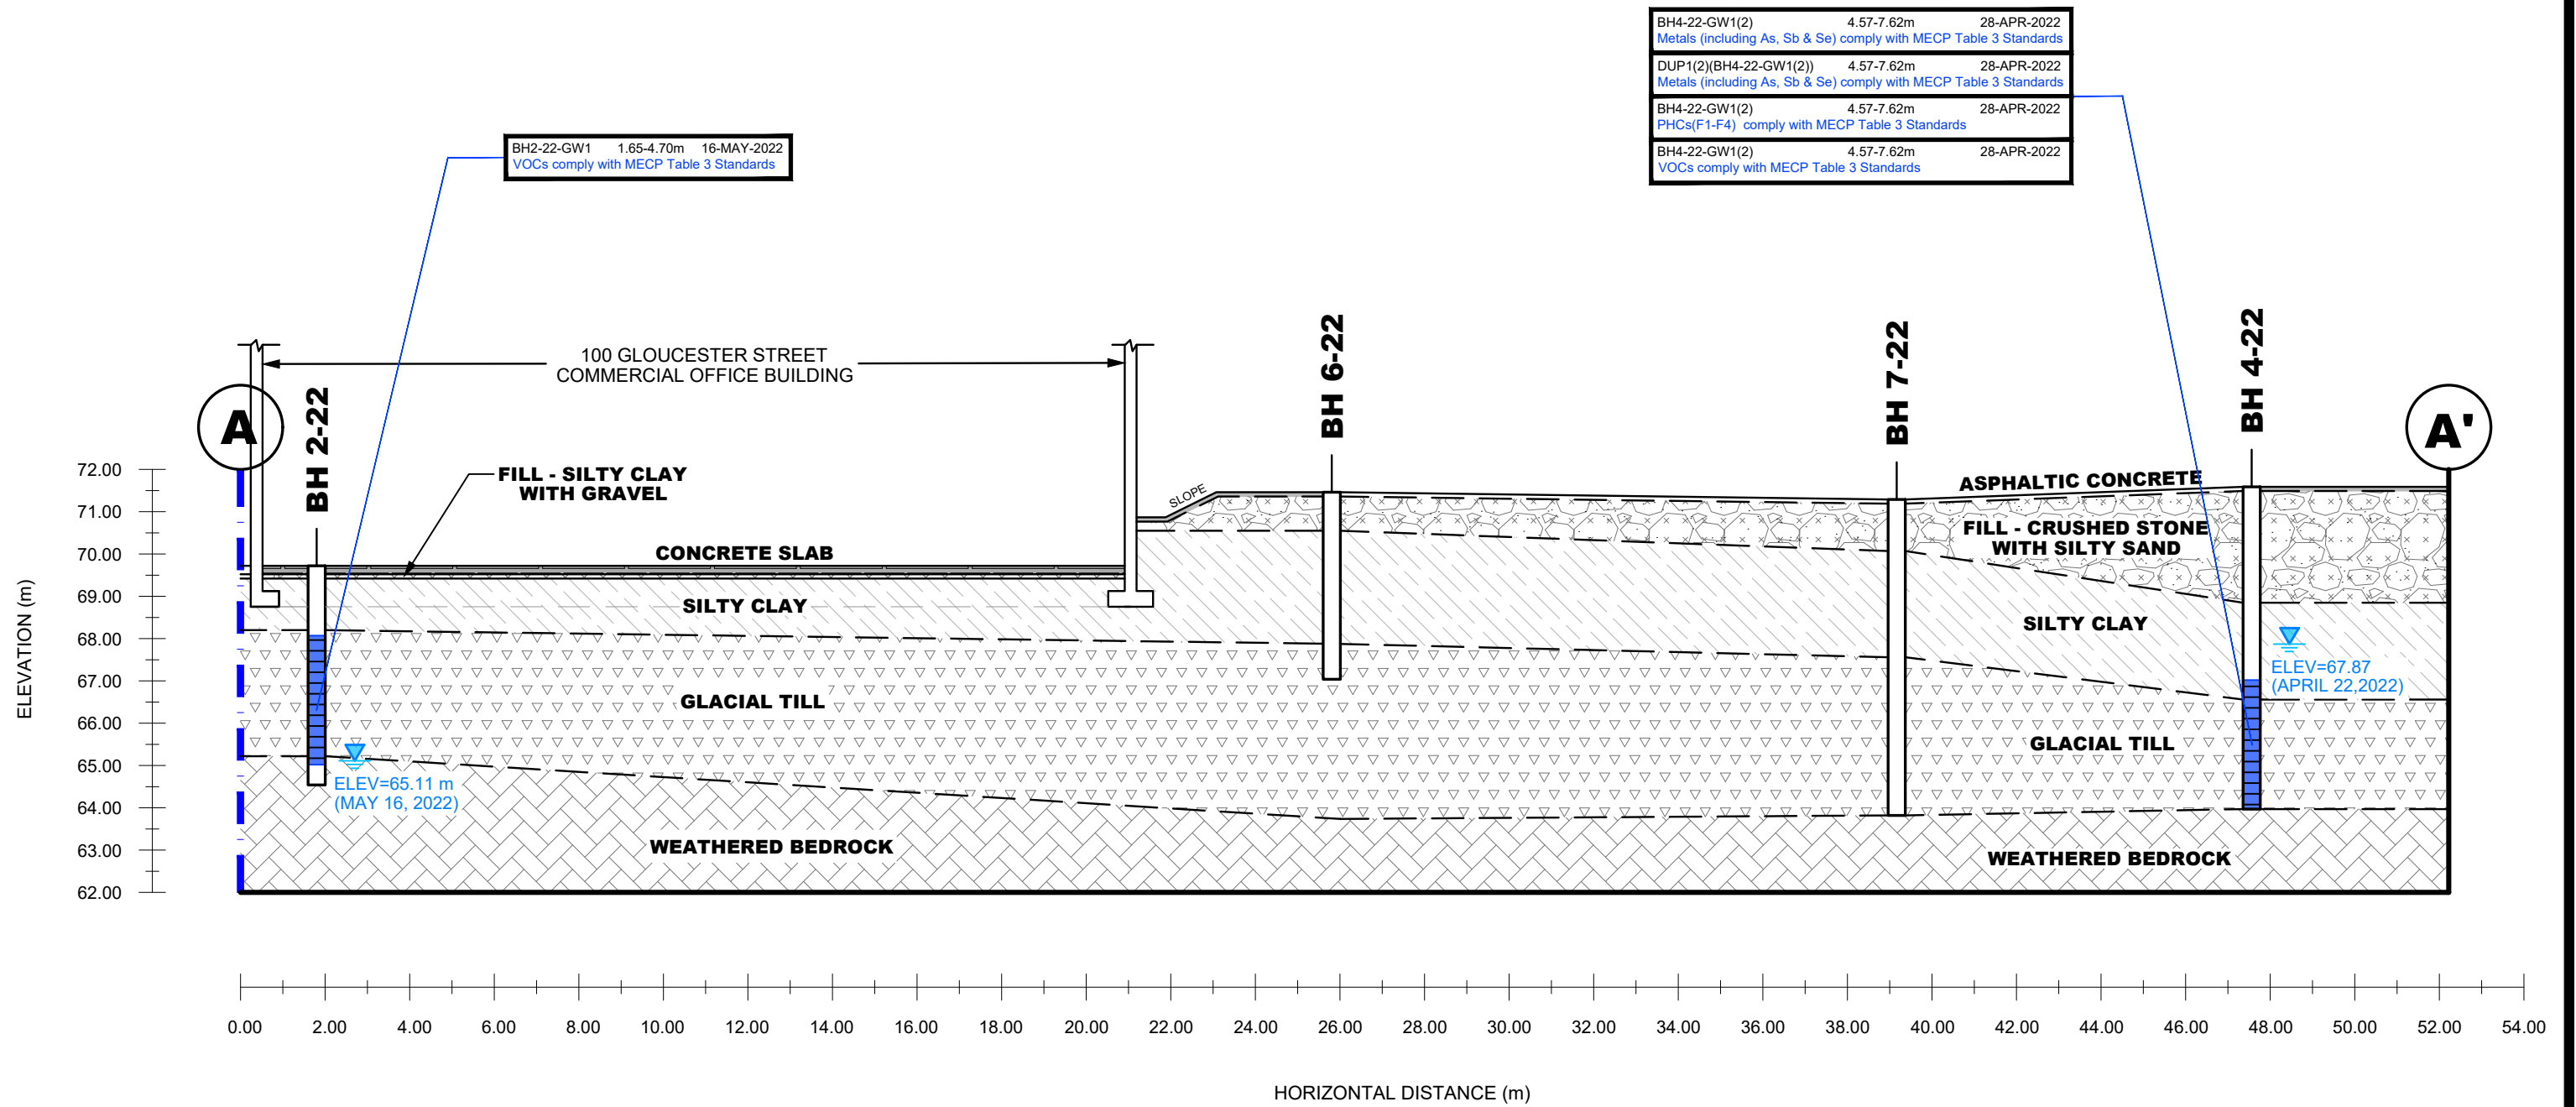
**DRAWING PE5571-5A – CROSS-SECTION A – A' – GROUNDWATER**

**GROUNDWATER RESULT COMPLIES WITH MECP TABLE 3 STANDARDS**

**GROUNDWATER RESULT EXCEEDS MECP TABLE 3 STANDARDS**

**METALS INCLUDE : As, Sb , Se**
