RE: TREE CONSERVATION REPORT FOR 381 KENT STREET, OTTAWA

S.E.C 381 KENT LP 9 STOREY APARTMENT BUILDING/COMMERCIAL MIXED USE

381 KENT STREET

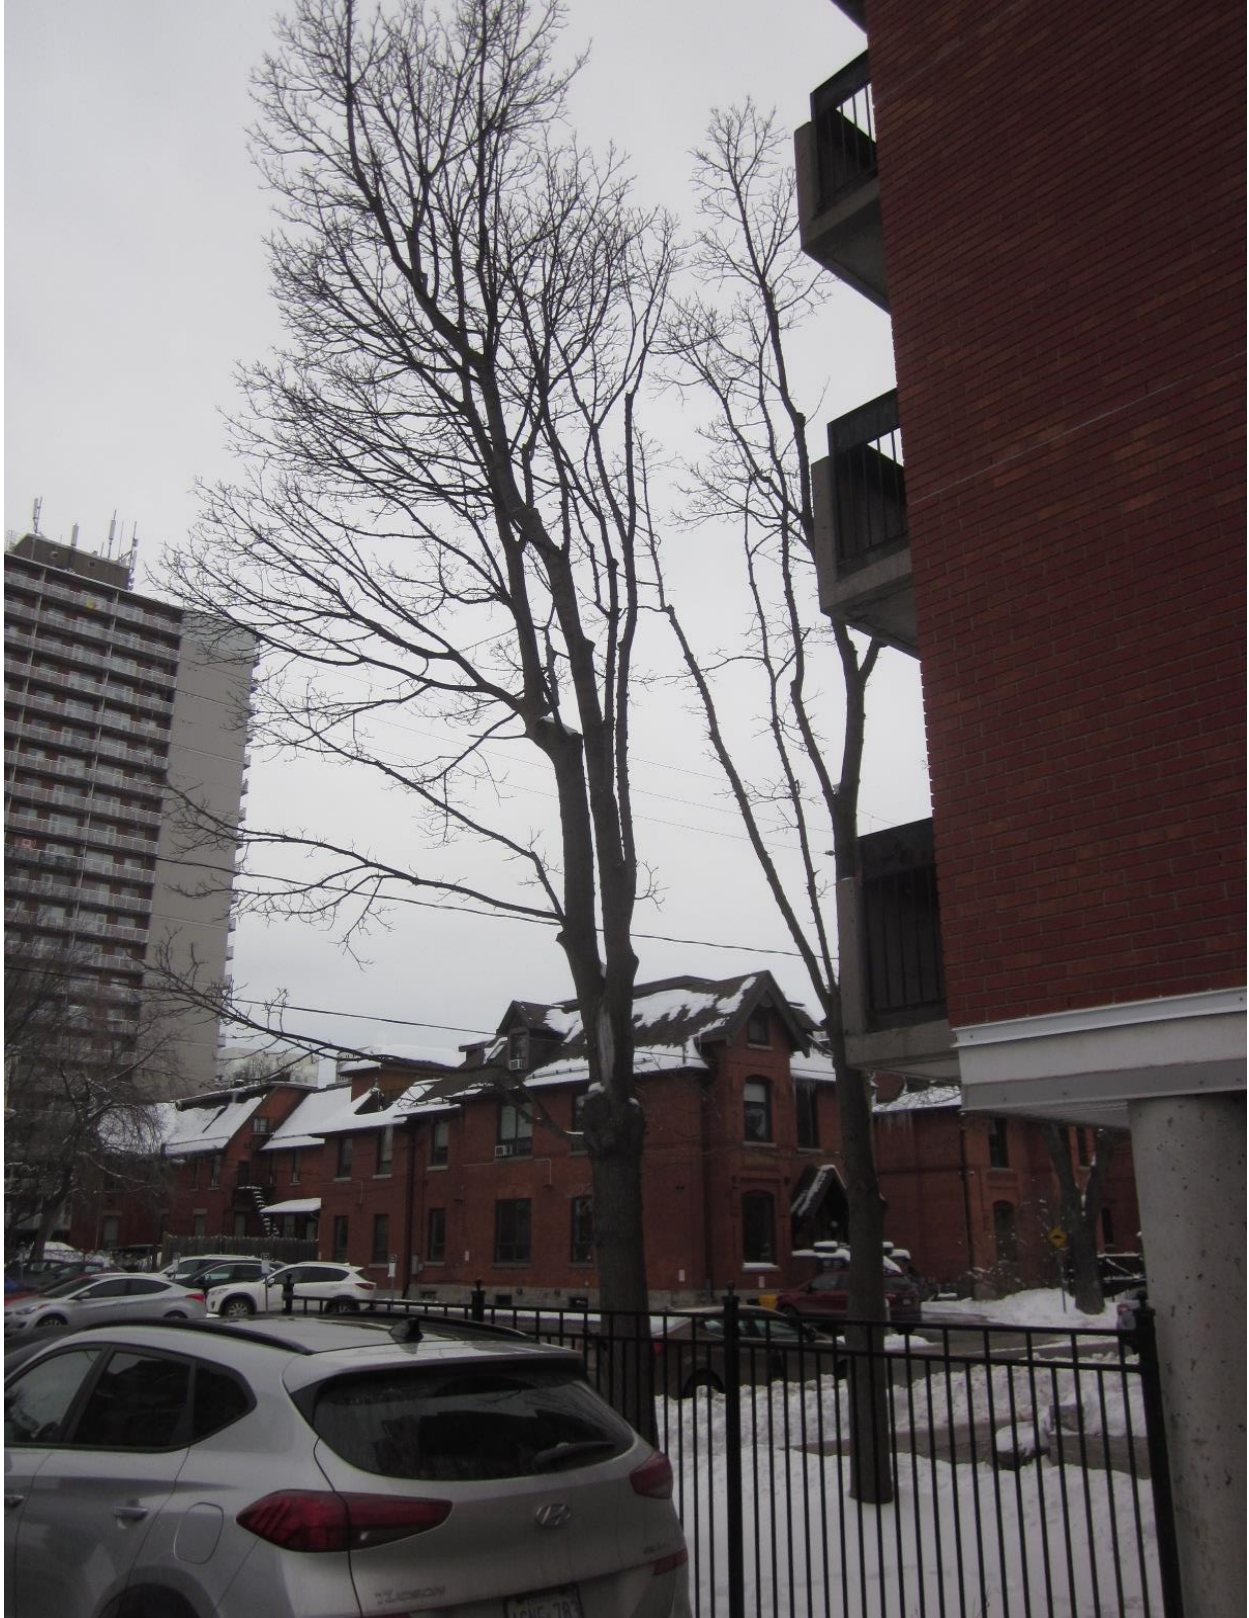
Picture 3. Tree(s) #3, neighbouring Norway maples adjacent to 381 Kent Street
