**ENVIRONMENTAL IMPACT STATEMENT
and
TREE CONSERVATION REPORT**

**PROPOSED RESIDENTIAL DEVELOPMENT
CARDINAL CREEK VILLAGE PHASE
OLD MONTREAL ROAD to SOUTH TRIBUTARY
CITY of OTTAWA**

Tamarack Homes

by *Muncaster Environmental Planning Inc.*

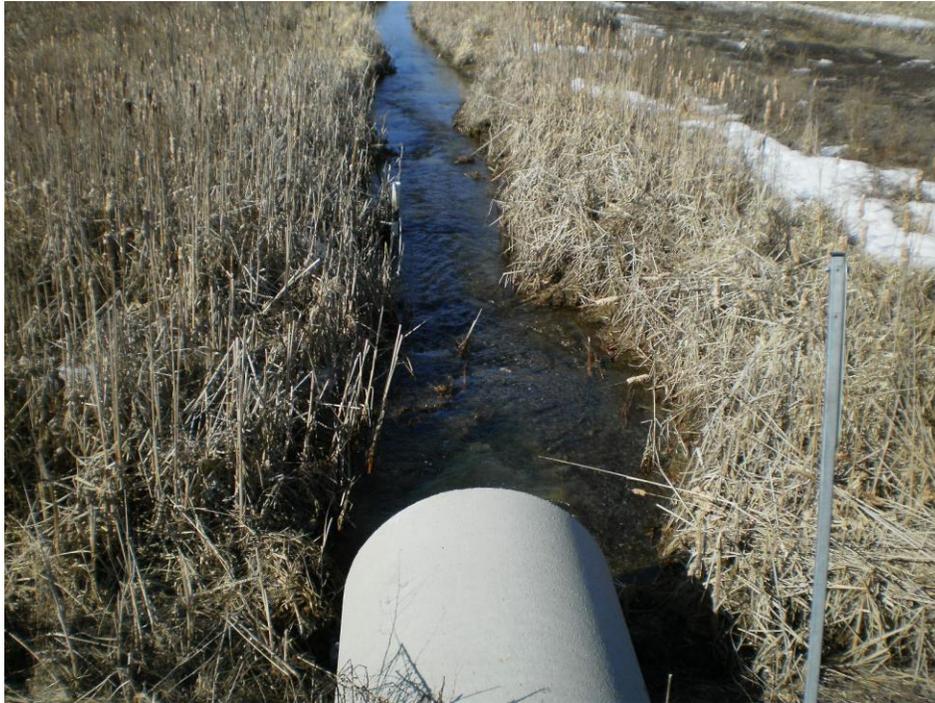
*Photo 1 - South tributary looking west from culvert under Cox Country Road
(March 17th, 2020)*

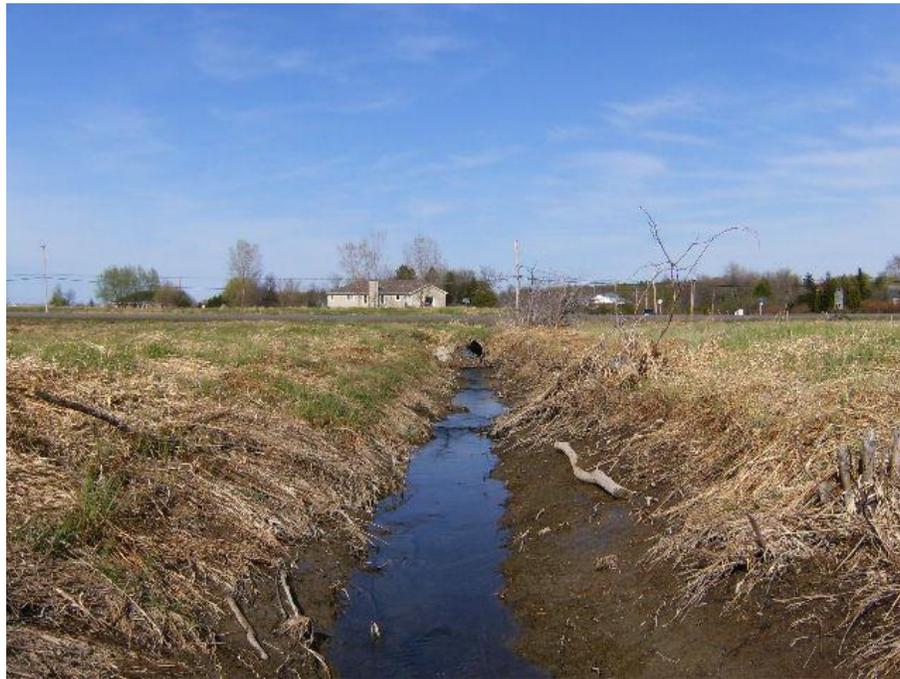
Photo 2 – The South Tributary looking upstream, east, to Cox Country Road (May 4th, 2009)

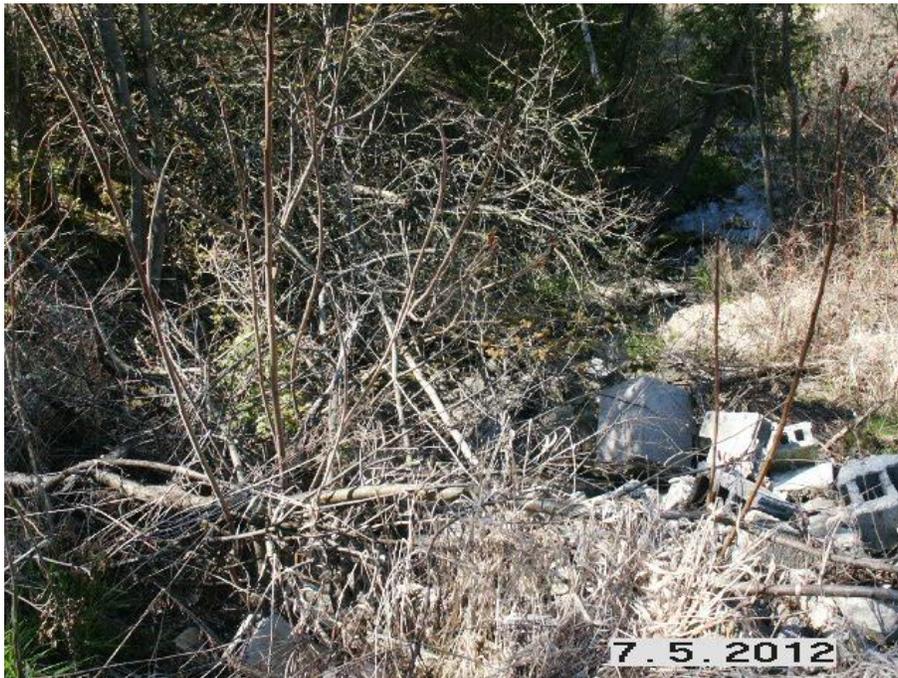
Photo 4 – Culverts and other debris impact the connectivity of the south tributary downstream (west) of the site. View looking west

To the west of the site, culverts in poor condition and debris associated with an access lane create a barrier to fish movement between Cardinal Creek and the site (Photo 4). Also in this area PECG (2013) noted that the gradient of the South Tributary flattened out and much of the stream flow was interpreted to be lost to subsurface flow in thick sediments in this area, with an associated loss of defined channel.

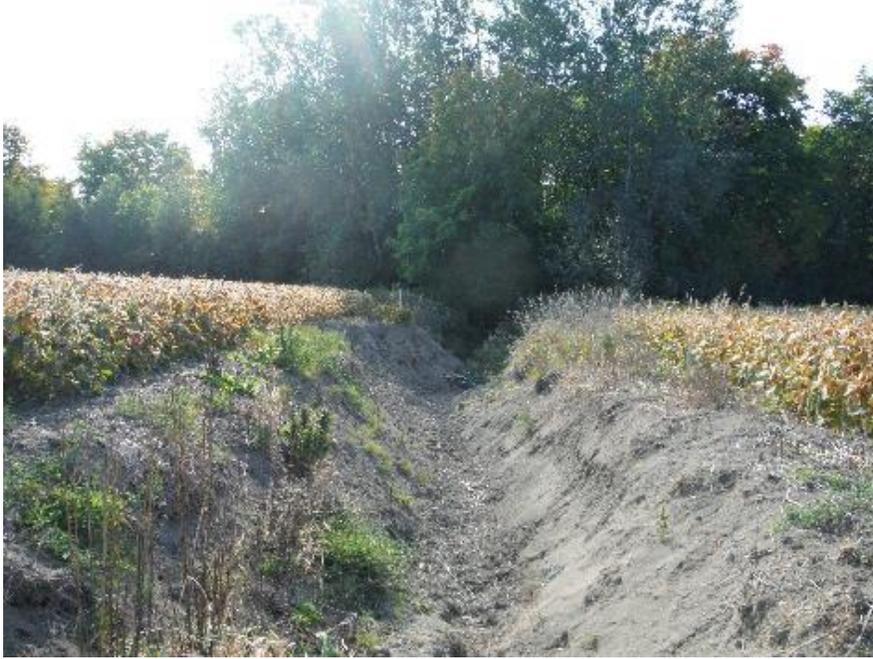
*Photo 5 - North Channel, approaching the forested corridor along the South Tributary.
View looking south (September 21, 2020)*

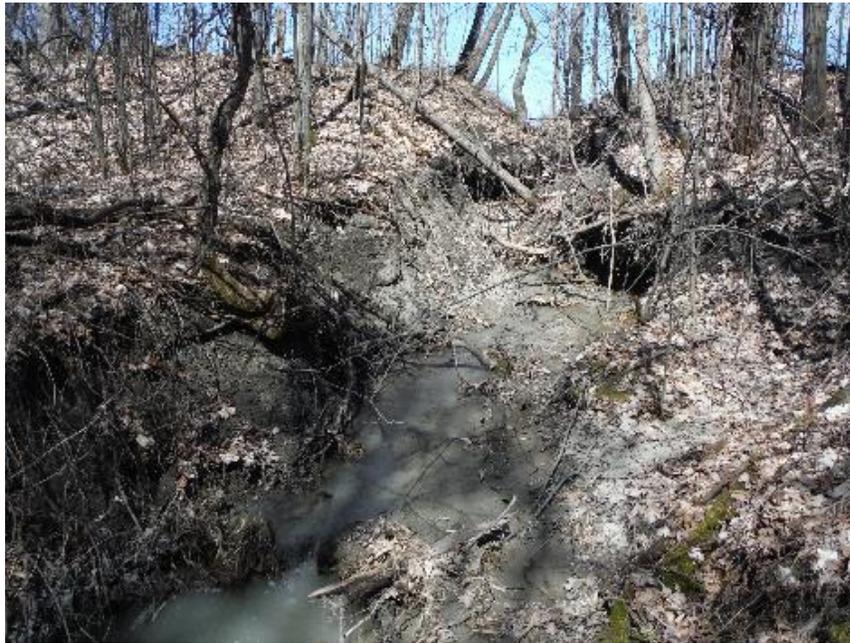
*Photo 6 - Downstream portion of the North Channel showing the physical barrier within the
South Tributary corridor. View looking north (April 6, 2020)*

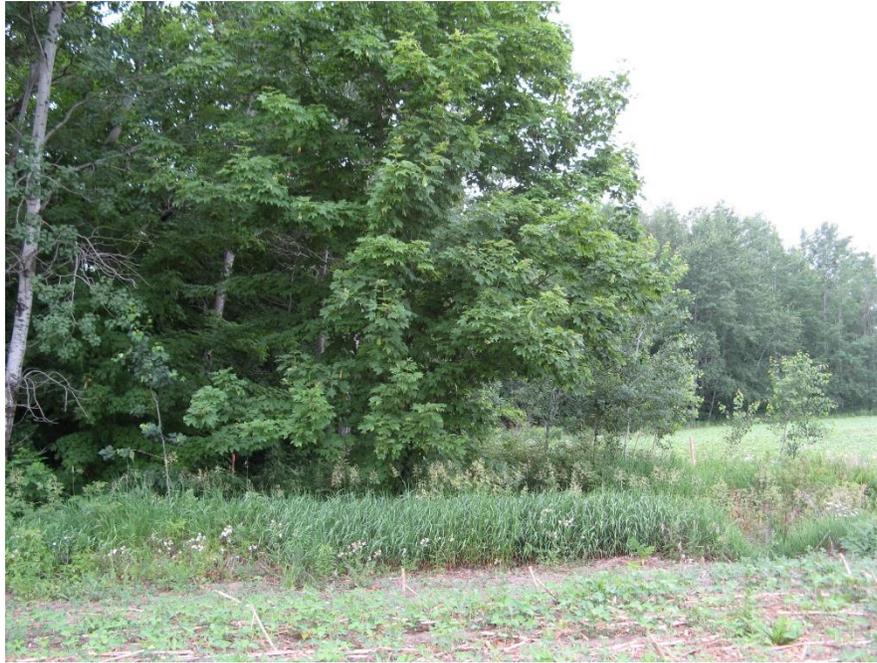
Photo 9 – Trees along the north edge of the South Tributary forest are smaller. View looking west (June 28th, 2020)

The forest conditions along the north edge of the maple forest, closest to the proposed site disturbances, are generally dominated by trembling aspen, white ash, green ash, white elm, and bur oak, with the largest of the trees white ash up to 40cm dbh (Photo 9). Common buckthorn and tartarian honeysuckle shrubs are common along the outer forest edges. The maple trees become dominant beginning in the range of ten metres into the forest cover.

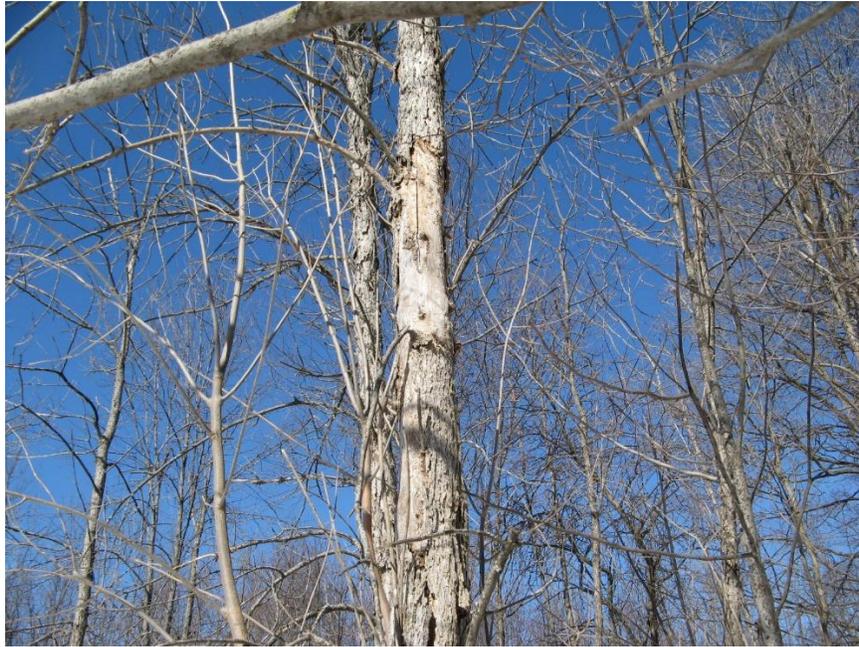
Photo 13 - Impact of emerald ash borer is extensive in the ash deciduous forest (March 20th, 2021)

In 2012 an upland ash forest north of the South Tributary in the southeast portion of the site was included in the Natural Heritage System for the Cardinal Creek Area, as well as the Subwatershed Study (AECOM, 2014). Surveys in 2020 and 2021 indicate that the condition of the ash trees have declined dramatically since these observations, with impacts of emerald ash borer extensive (Photos 10, 11, 13, and 16). In addition to the dominant white ash in poor

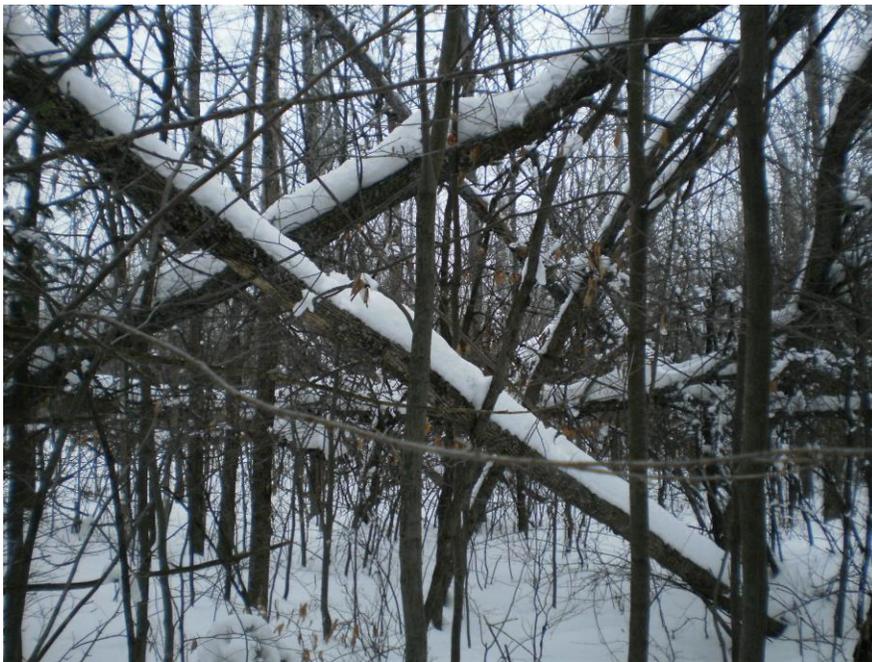
Photo 14 - Windthrow is extensive in the ash deciduous forest. View looking south in the north-central portion of the ash deciduous forest (February 11th, 2020)

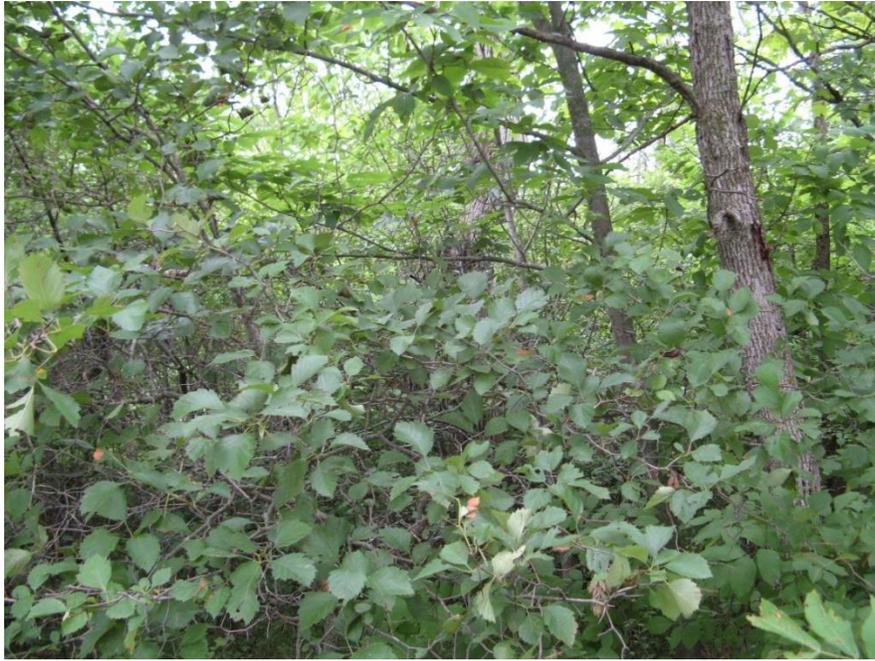
*Photo 15 - Understory is very thick in the ash deciduous forest in the southeast portion of the site
View looking south (June 28th, 2020)*

The understory of the ash deciduous forest is very thick (Photo 15), with regenerating stems of ash and buckthorn shrubs abundant, along with extensive hawthorn shrubs around the periphery. Other regenerating stems include basswood, balsam fir, maple, Manitoba maple, poplar, bitternut hickory, ironwood, white spruce, and bur oak. In addition to the common hawthorn, red raspberry, beaked hazel, common buckthorn, glossy buckthorn, red-osier dogwood, and prickly ash shrubs are present. Pennsylvania sedge, June meadow grass, common strawberry, small enchanter's nightshade, common burdock, heart-leaved aster, calico aster, early goldenrod, Canada goldenrod, thicket creeper, wild grape, white avens, blue violet, yellow violet, purple flowering raspberry, and poison ivy (dominant in areas) indicate past disturbances in the forest with lady fern, ostrich fern, white snakeroot, Canada mayflower, white baneberry, starflower, sweet cicely, and false Solomon's seal also present.

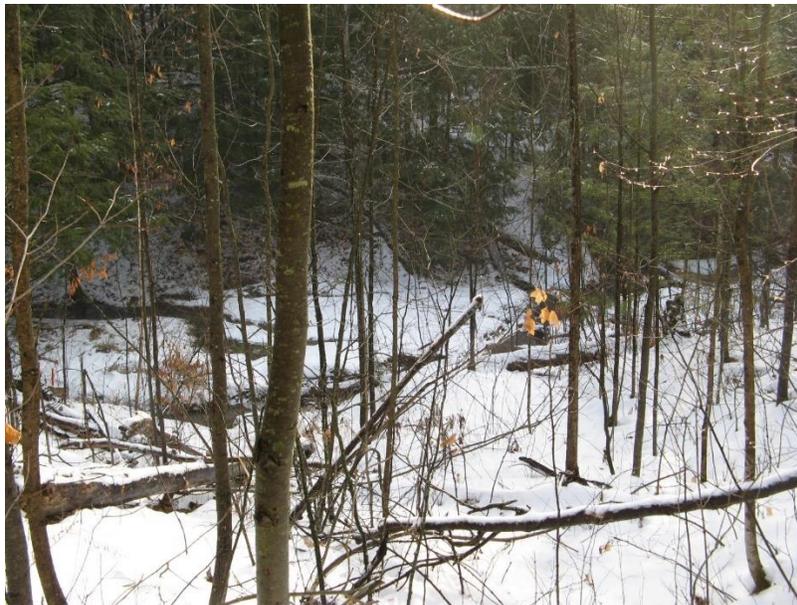
*Photo 25 – Location of outfall (west) spillway approaching the South Tributary.
View looking southwest (December 16, 2021)*

Sections 6.2 and 6.3 provide mitigation measures to protect the downstream aquatic habitat, including the South Tributary, Cardinal Creek, and ultimately the Ottawa River. These potential impacts *could* include increase erosion in the channel from quicker and stronger runoff inputs during storm events, additional nutrient and contaminant inputs from residential activities such as automobile use and maintenance, application of fertilizers, pesticides and herbicides and improper disposal of solvents and other wastes. No work is proposed within the high water mark of the South Tributary. It is anticipated that closure of the on-site agricultural channels will reduce the extent of sedimentation into the South Tributary.

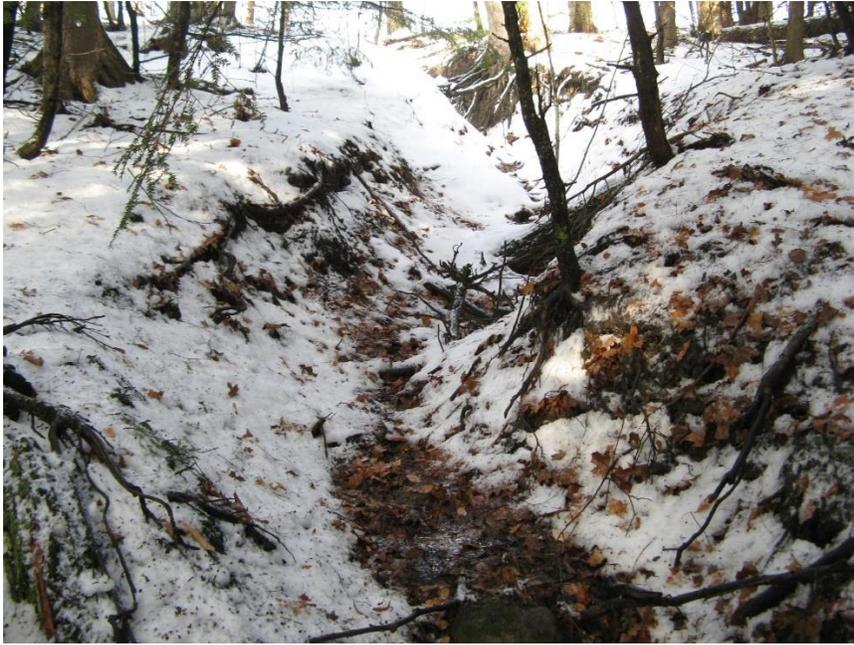
Photo 26 – Location of emergency spillway looking north towards top of valley slope from north of the South Tributary (December 16, 2021)
