Phase I - Environmental Site Assessment

201 Friel Street
Ottawa, Ontario

Ottawa Community Housing Corporation

Report: PE4033-1

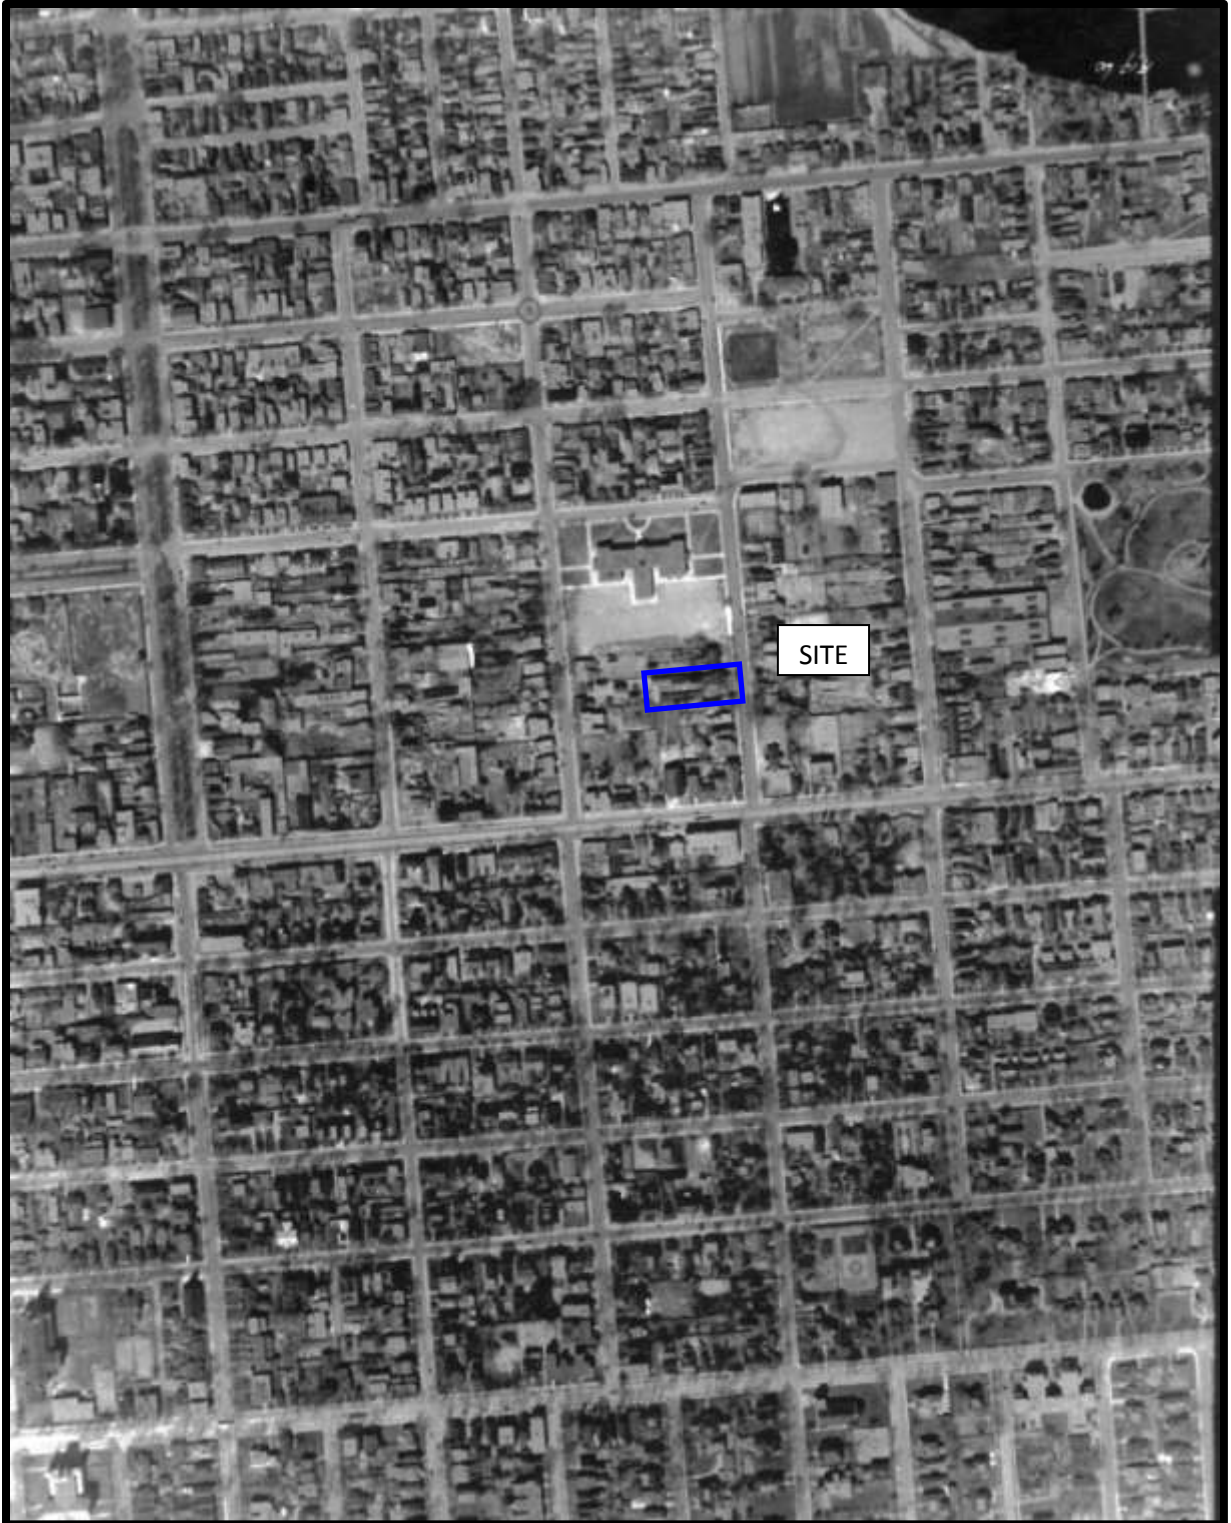
AERIAL PHOTOGRAPH
1922

The subject property was observed in the 1922 aerial photographs as utilized for residential purposes, with a single residential dwelling. Based on the directories, the previous site address (134 Chapel Street) was listed as early as 1891 as a residential dwelling. No earlier data is available for the subject site. The use of the subject site as a residential dwelling is considered to be the first developed use of the subject property.

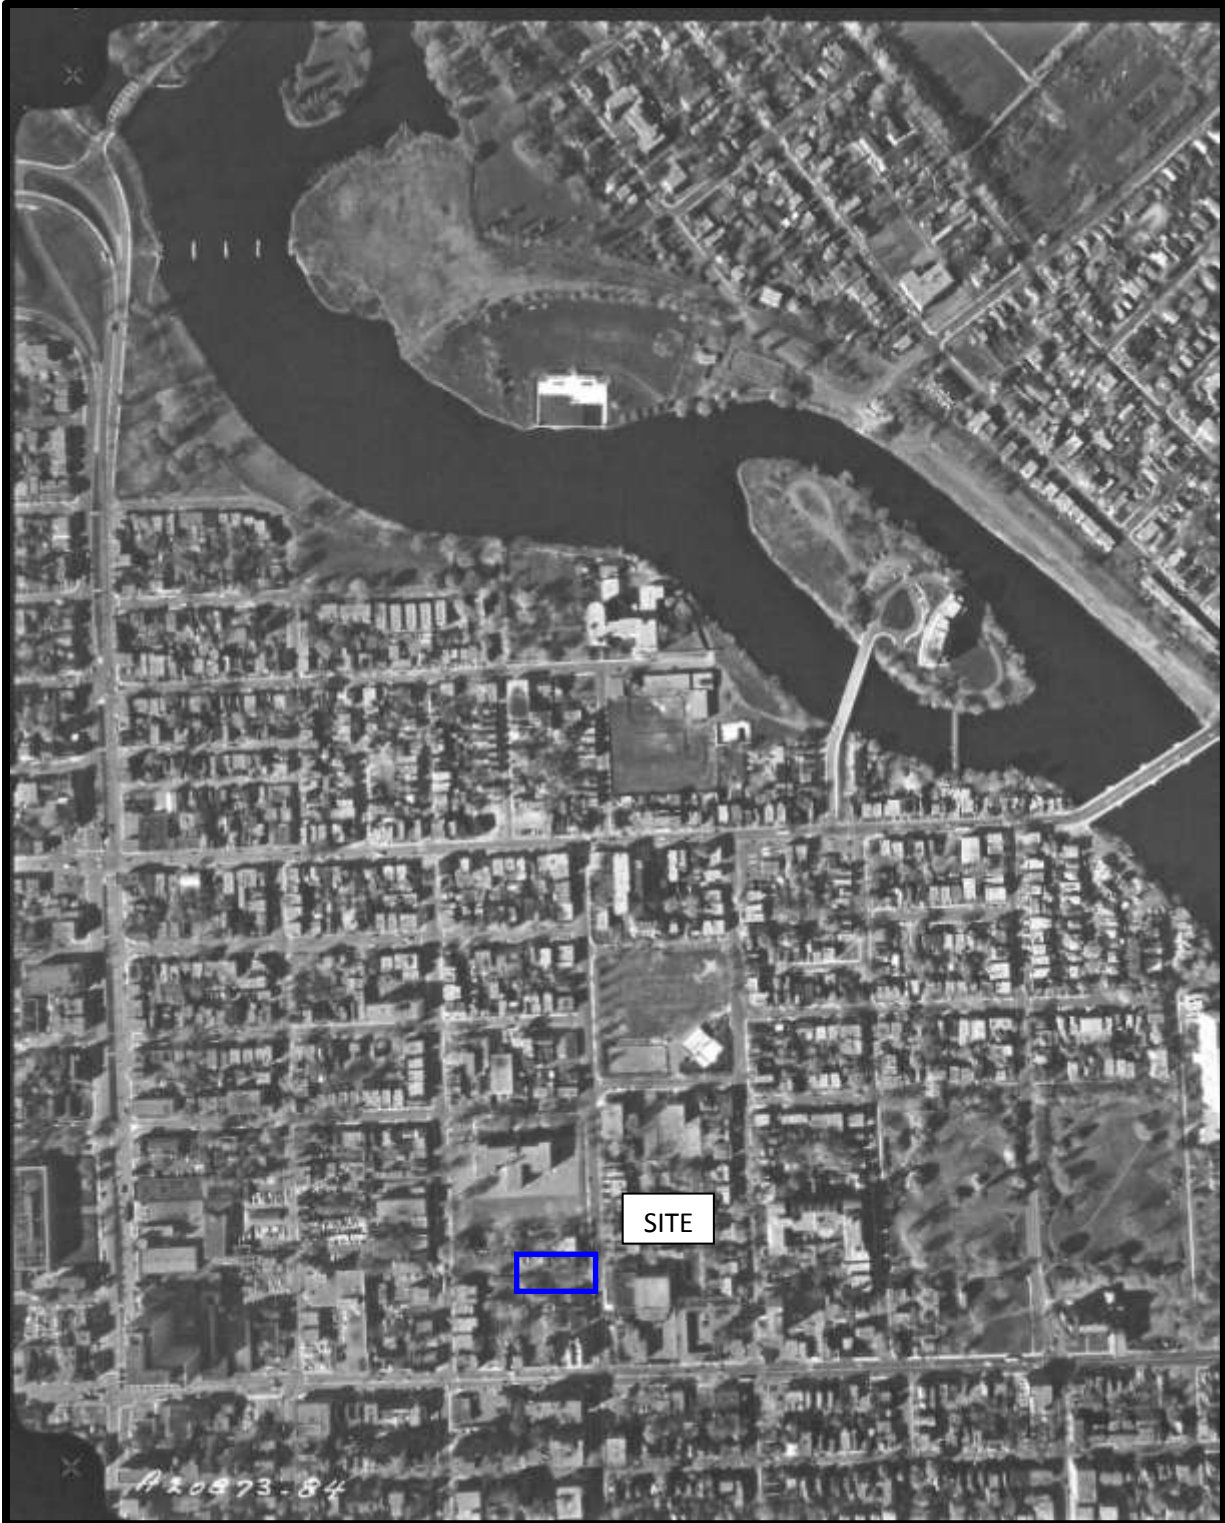
AERIAL PHOTOGRAPH
1968

- 1968 The subject site appears to be occupied by the same residential dwellings, however, tree coverage obstructs the view of the residence and the southern portion of the property. The garages/sheds located on the northwestern portion of the property appear to have been removed and a few vehicles are parking in this area. The synagogue to the east has increased in size and properties along Rideau Street appear to be more commercial than previously noted, particularly to the west of the subject site.

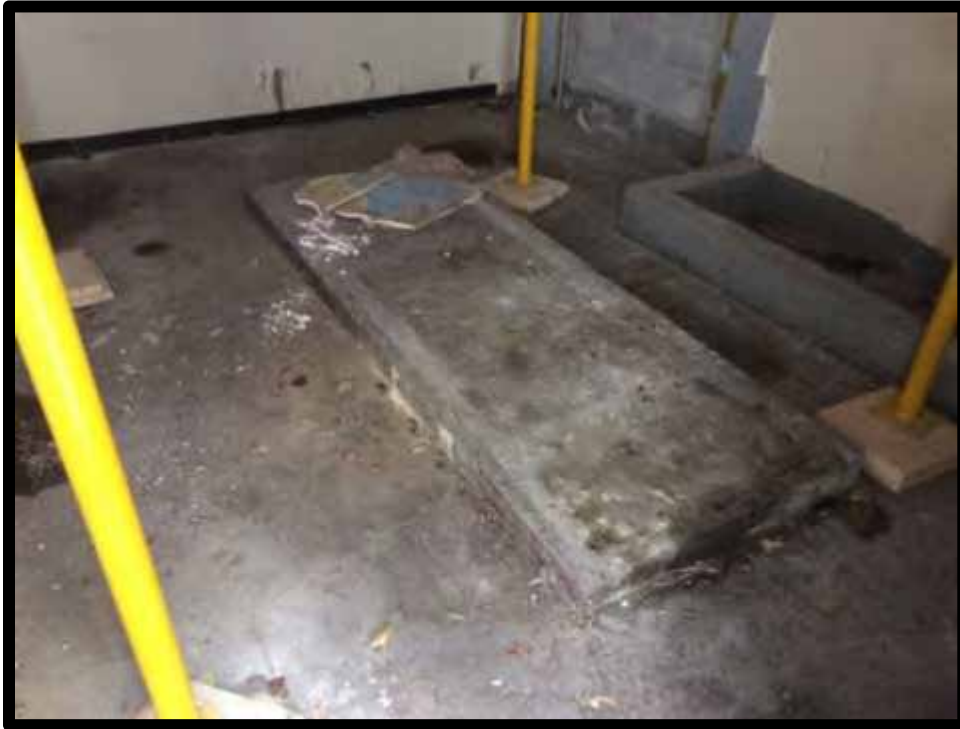
Photograph 1: View of former generator room. The concrete slab and berm are evidence of the former generator and tank locations. Concrete was observed to be in good condition with minimal staining.

Patched holes (evidence of vent/fill lines) were noted on the western wall of the garage, at the former generator room. No staining was observed around the exterior of the former generator room. The former generator room contained a concrete lip, considered to formerly house an interior aboveground storage tank (AST) and an elevated concrete pad, considered to be the former location of the

diesel generator. The concrete floor in the former generator room appeared to be in good condition with very little staining. No concerns were identified with regard to the former use of the former standby diesel generator system at the subject property.

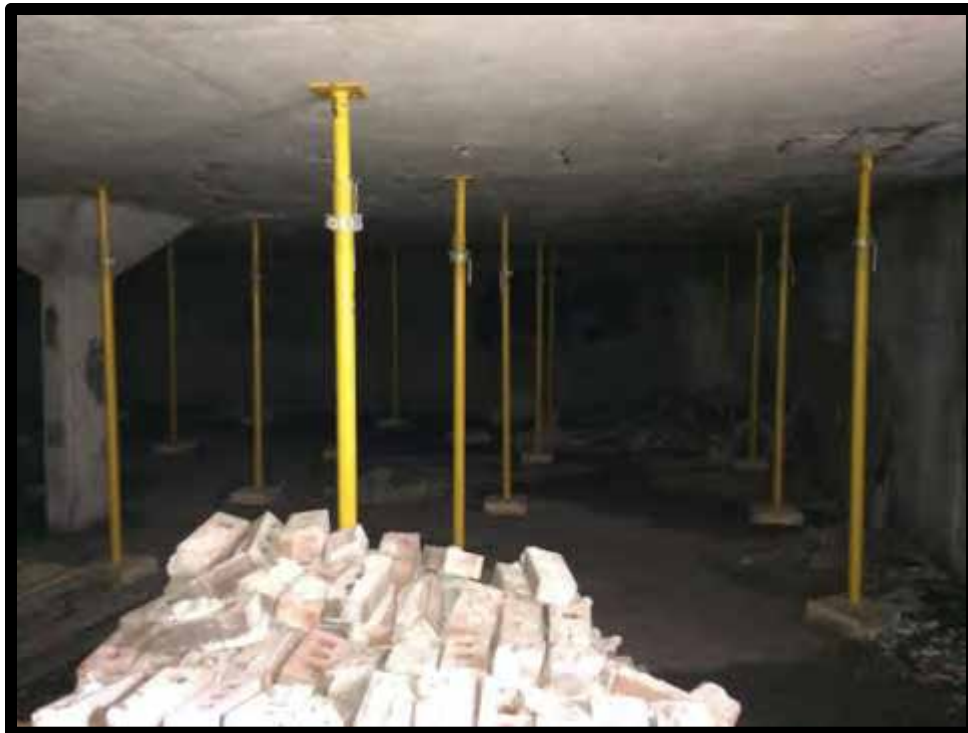
Photograph 2: View of interior of lower portion of the parking structure, facing east from the western portion of the structure. Some debris and bricks are present in the foreground.

At the time of the site visit, the garage was condemned and slated for demolition. Supplemental support of the upper level was provided by an array of jackposts in the lower level. Piles of brick and some building materials were observed in the stored in lower level.

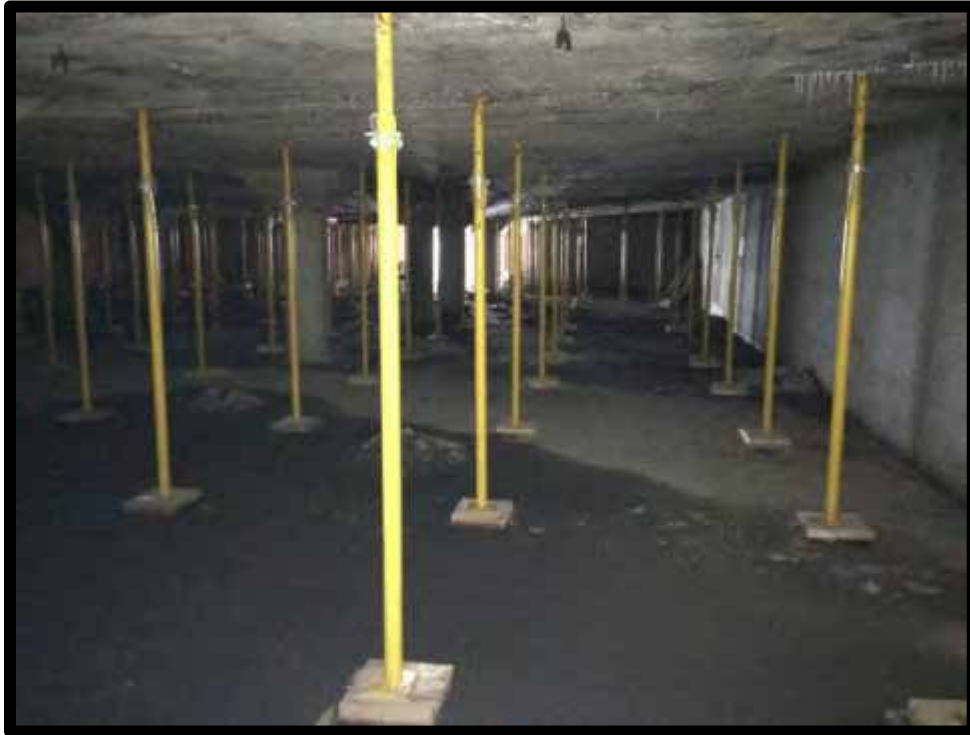
Photograph 3: View of the interior of the lower level of the parking structure. Facing west from the eastern end of the structure.

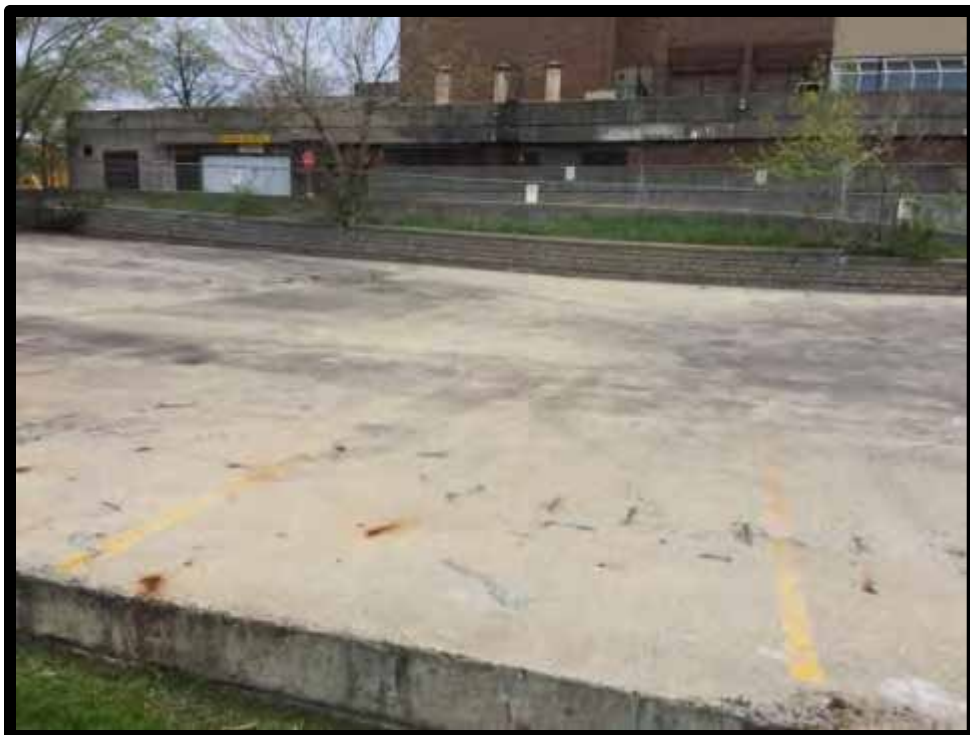
Photograph 4: View of upper level of the parking structure, facing south from the north side of the property.
