Phase One Environmental Site Assessment

265 Catherine Street
Ottawa, Ontario

Prepared for:
11034936 Canada Inc.

LOP21-018A

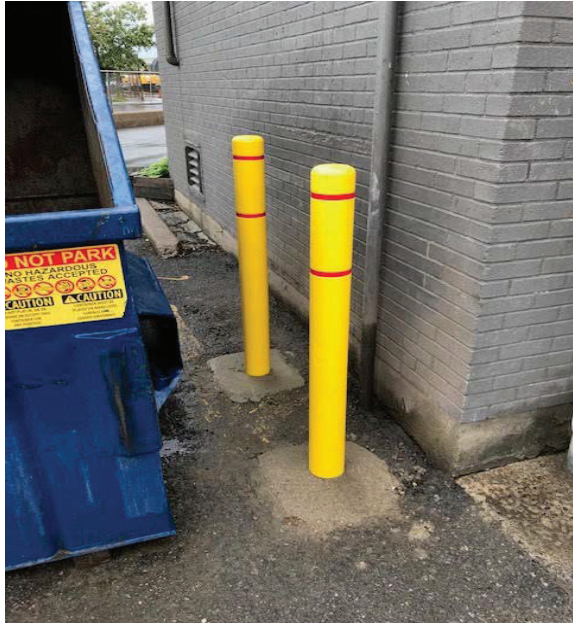
VENT AREA AFTER INSTALLATION OF BOLLARDS

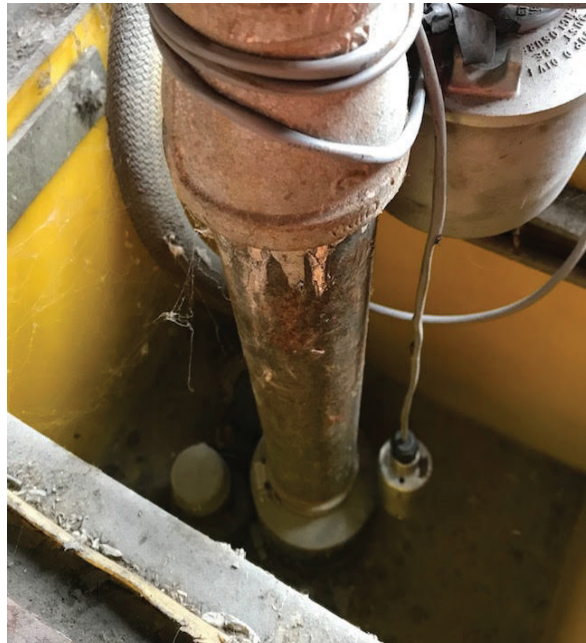
SENSOR LOCATED BENEATH DISPENSER

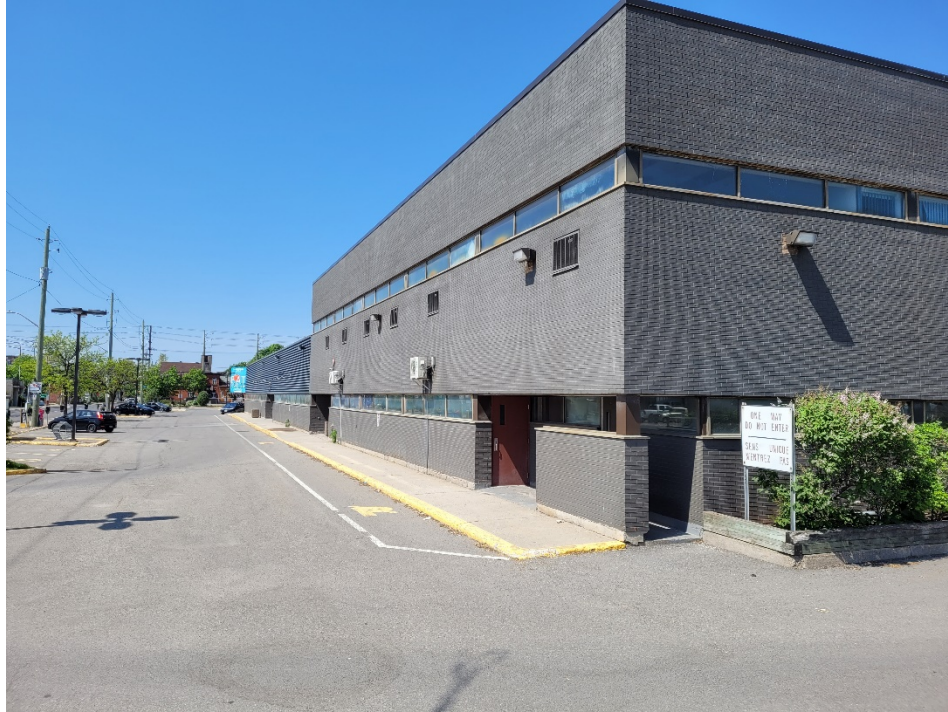
Photograph 1: View of Phase One Property looking west on the southeast portion of the Property. View shows the south side (front) of the commercial building at the Property.

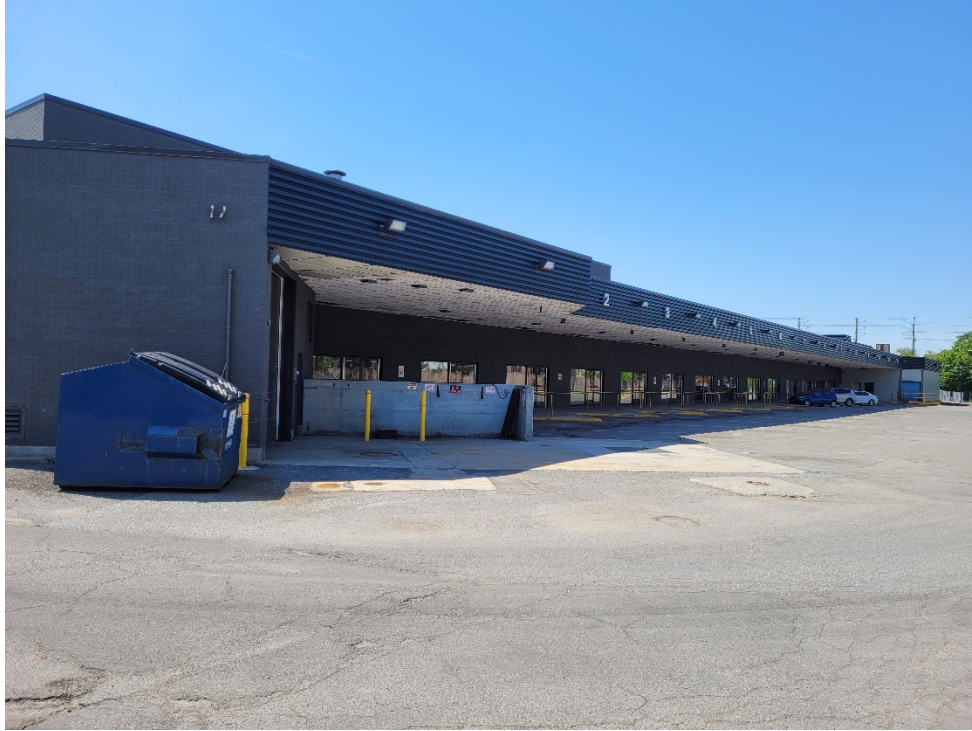
Photograph 3: View of the north side of the Phase One Property looking west. View shows the terminals for the former central bus station. The diesel underground storage tank and former fueling area is visible in this photograph.

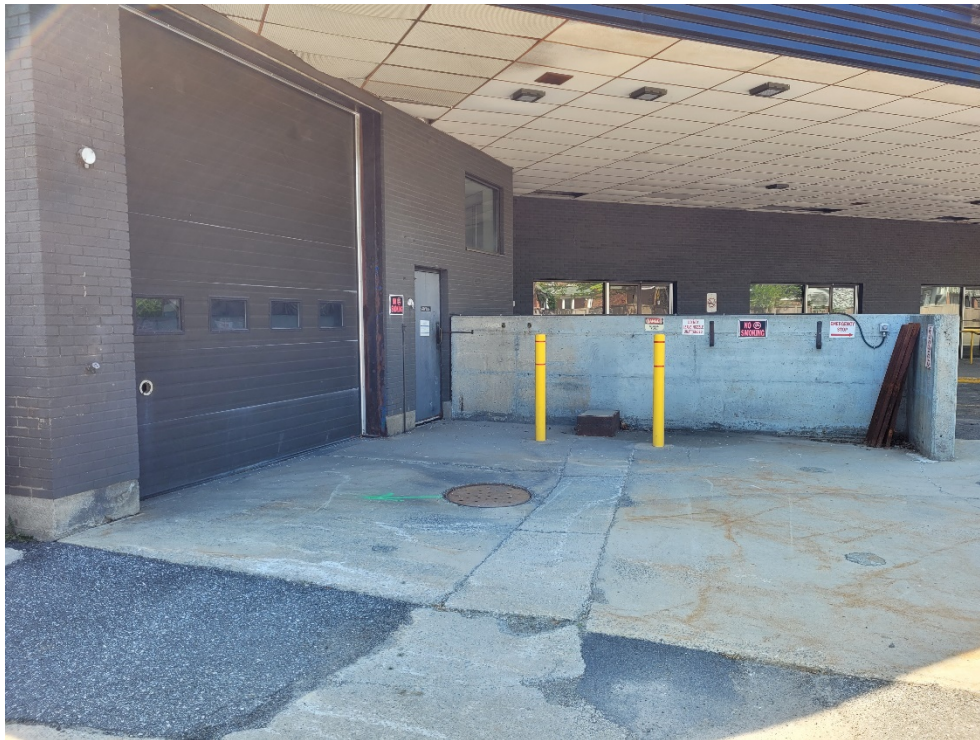
Minor staining was observed on the floors of the service bay and on the concrete surfaced area surrounding the diesel UST. The staining in the service bay is typical of mechanical service operations. There have been several historical reported fuel spills at the Property, which are expected to have contributed to the exterior staining.

Photograph 4: View of the service garage entrance and former fueling area at the Property.

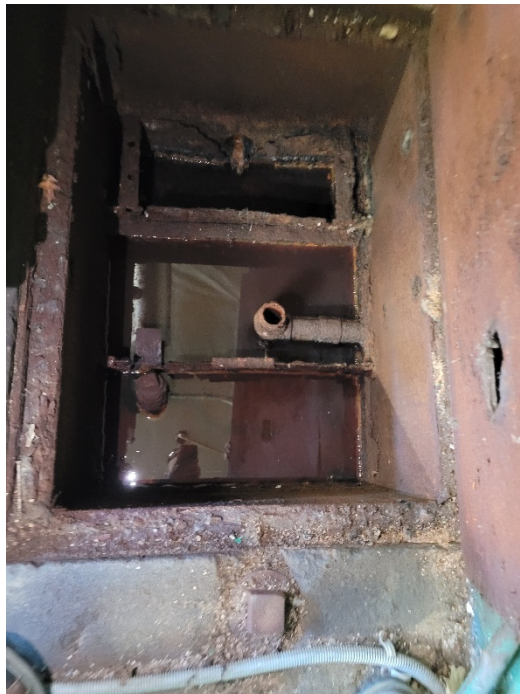
Photograph 6: View of the interior of the oil/water separator in the service bay of the building at the Property. An oily water mixture is evident within the separator.

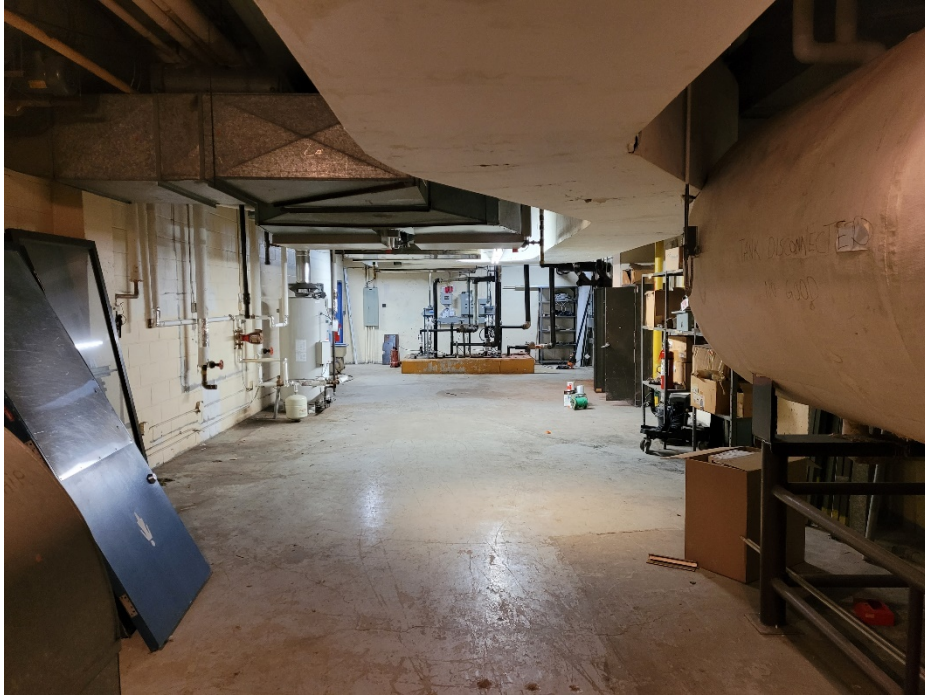
A sump was identified in the northeast portion of the basement of the building. The sump extended approximately 1.8 m below the floor slab and had some standing water at the time of the Site Investigation. There were no odours or sheen observed on the water in the sump, which discharges to the municipal sanitary sewer system.

Photograph 7: View of the basement level mechanical room in the east portion of the building. The sump is visible at the rear wall in this photograph.

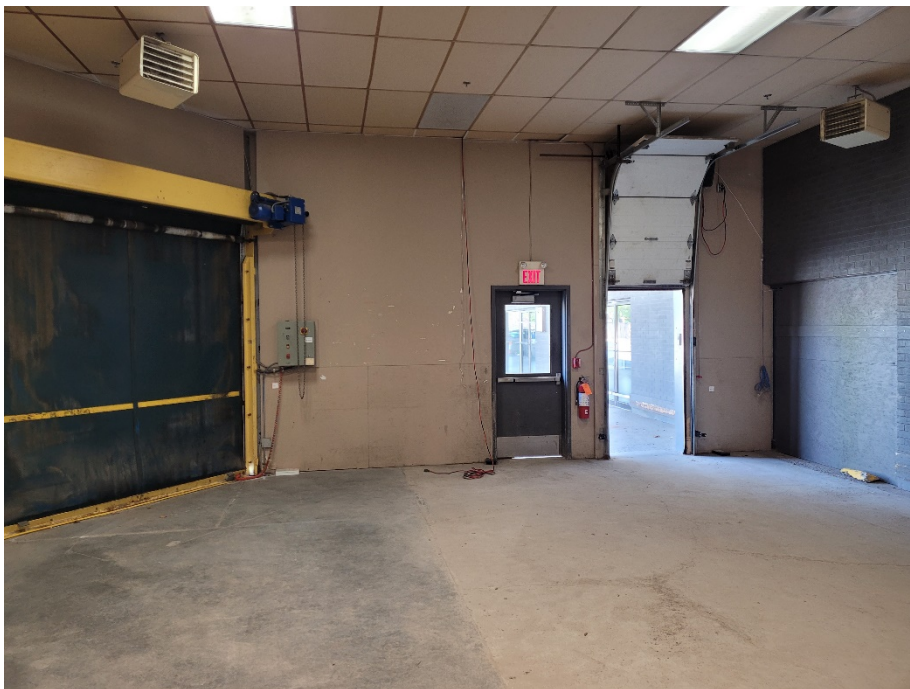
Photograph 8: View of interior of the shipping and receiving area in the northwest portion of the Site building.
