ENVIRONMENTAL IMPACT STUDY

2050 Dunrobin Road, Kanata, Ontario
MP Project No.: CCO-21-1873

**ENVIRONMENTAL IMPACT STUDY
2050 DUNROBIN ROAD, KANATA, ONTARIO**

**Version 004
June 7, 2023**

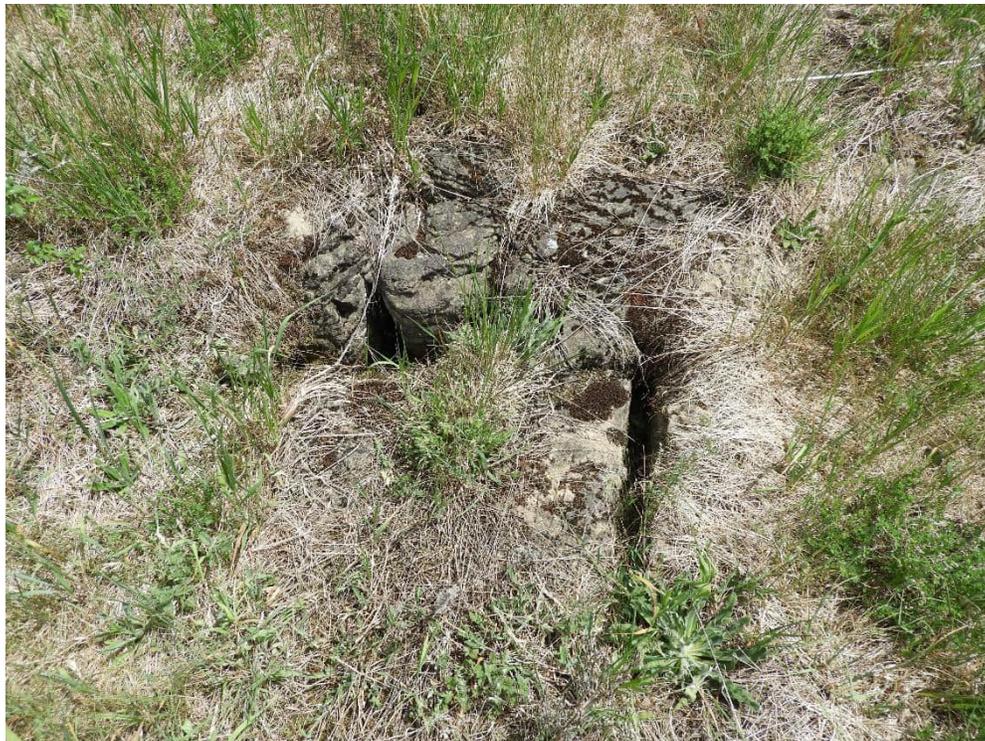
Photo 3: Potential SAR snake hibernacula habitat identified within the Dry – Fresh Non-Calcareous Bedrock Graminoid Meadow Ecosite (MEGR2) in the west end of the study area during the preliminary EIS. During the 2021 field investigations, it was determined that this area does not provide SAR snake habitat. 28 May 2021.

During the preliminary field investigation on October 30, 2020, potential SAR snake habitat was identified in the west end of the study area. This area consists of the open Dry – Fresh Non-Calcareous Bedrock Graminoid Meadow Ecosite (MEGR2) containing exposed bedrock and crevices into the ground which may provide potential habitat for Eastern Milksnakes, including areas for foraging and hibernacula. This species is a habitat generalist and may be found in a variety of habitats. The Eastern Milksnake is designated as ‘Special Concern’ under SARA and does not receive habitat protection. However, individuals of this species are protected under the FWCA (1997). Targeted surveys for SAR snakes were conducted following parameters outlined in the Ministry of Natural Resources and Forestry’s (MNRF) *the Survey Protocol for Ontario’s Species at Risk Snakes* (MNRF, 2016a). The surveys were conducted within potential snake habitat identified in the west portion of the study area during the preliminary field investigation. No SAR snakes or evidence of SAR snakes were observed during the 2021 targeted surveys. It was determined that the study area is not suitable for SAR snakes.

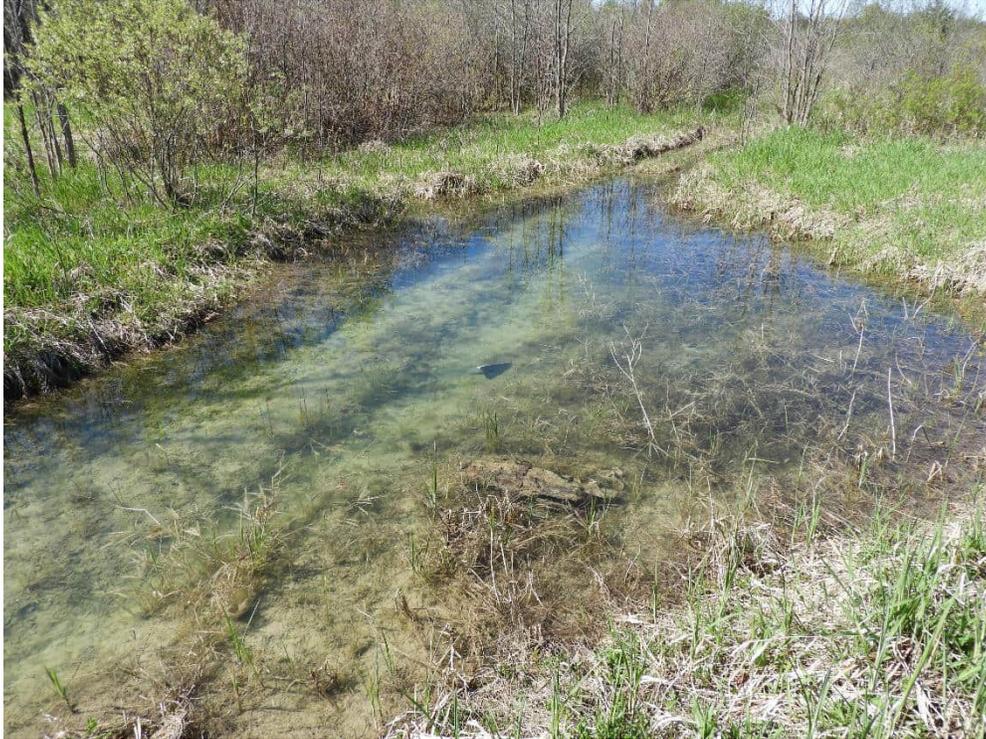
Photo 9: A flooded trail in the east end of the study area during early spring conditions. This area is part of the identified floodplain under MVCA regulation limits. 12 May 2021.

During the 2020 field investigation, standing water was observed in a depression area along the recreational vehicle trails within the east end of the property. The standing water is part of the Harwood Creek floodplain, according to the MVCA Regulation Public Mapping Browser (MVCA, 2021). The floodplain area outlined by MVCA was confirmed during the May 12, 2021 field investigation where seasonally inundated areas were observed across the northeastern portion of the study area. These areas are not considered fish-bearing. Based on the *Stormwater Management Report* (Kollaard Associates, 2021), the floodplain within the study area is considered a backwater area that does not contribute to the storage capacity of Harwood Creek.

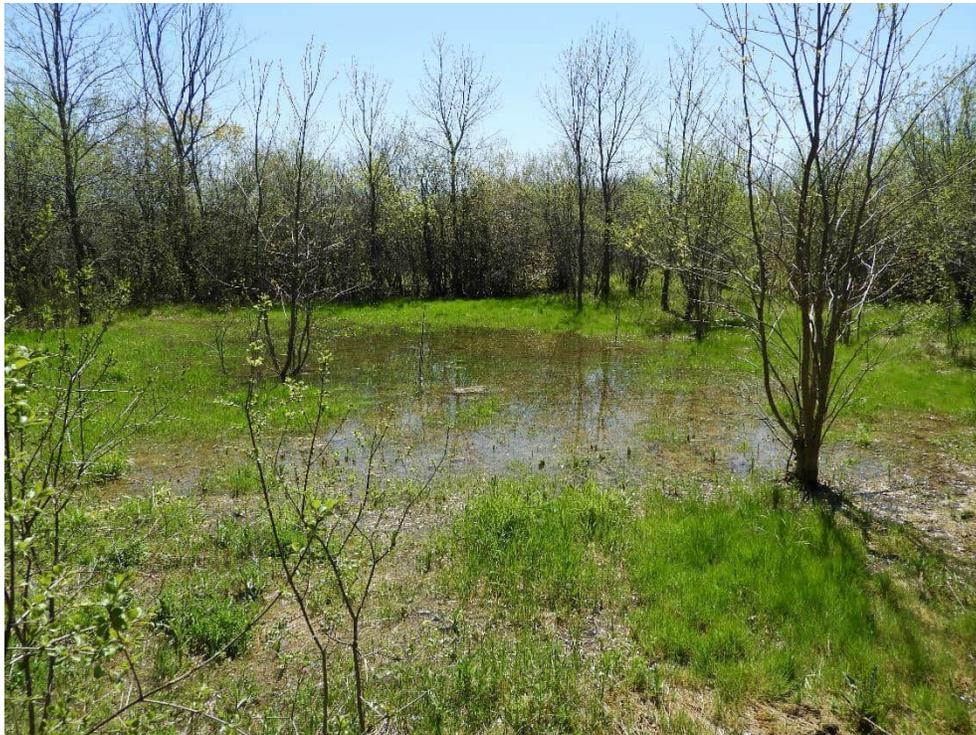
Photo 10: A flooded area in the west end of the study area during early spring conditions. This area is the western extent of the identified floodplain within the study area under MVCA regulation limits. 12 May 2021.

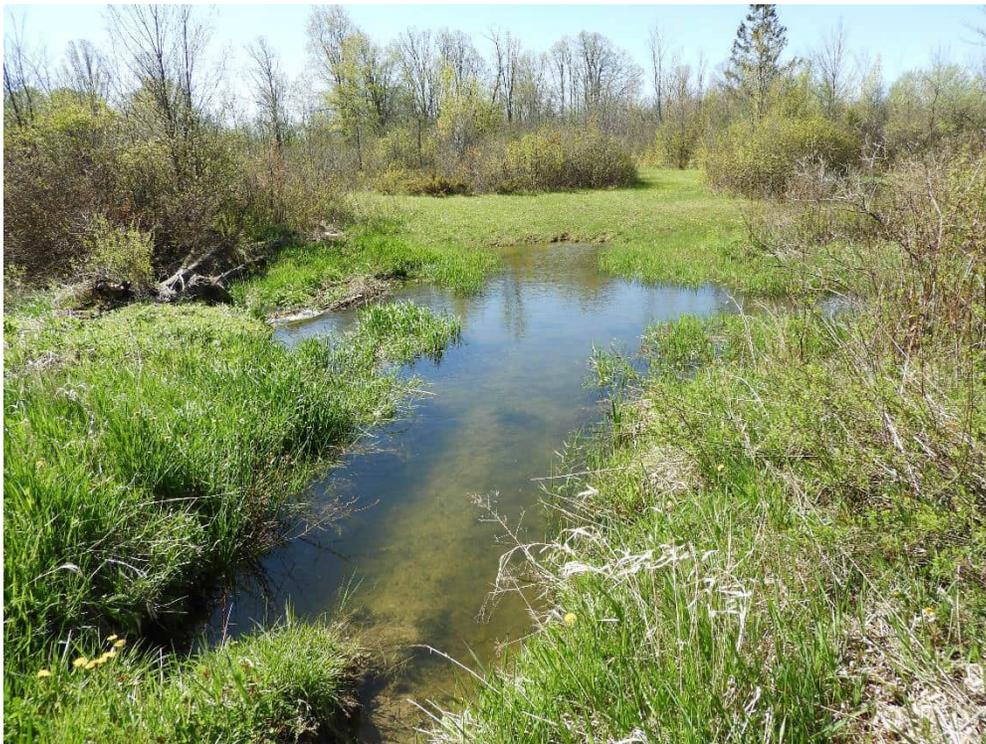
Photo 12: Harwood Creek flowing through the eastern extent of the study area. An off-road vehicle crossing is present within the watercourse located within the study area, creating a pool. 12 May 2021.

During the June 6, 2021 field investigation, a fisheries survey was conducted by McIntosh Perry staff on Harwood Creek within the study area. Harwood Creek is a permanent warm-water system within the study area consisting of a mix of runs and pools with some riffles. A wide pool is present at an access path within the study area. The pool is located directly upstream of a beaver dam/debris. Evidence of off-road vehicle access into the pool was observed (i.e., tire ruts crossing the pool). Runs with moderate depths (approximately 75 cm) are present upstream of the pool as well as another off-road vehicle crossing. The watercourse consists of shallow runs and riffles

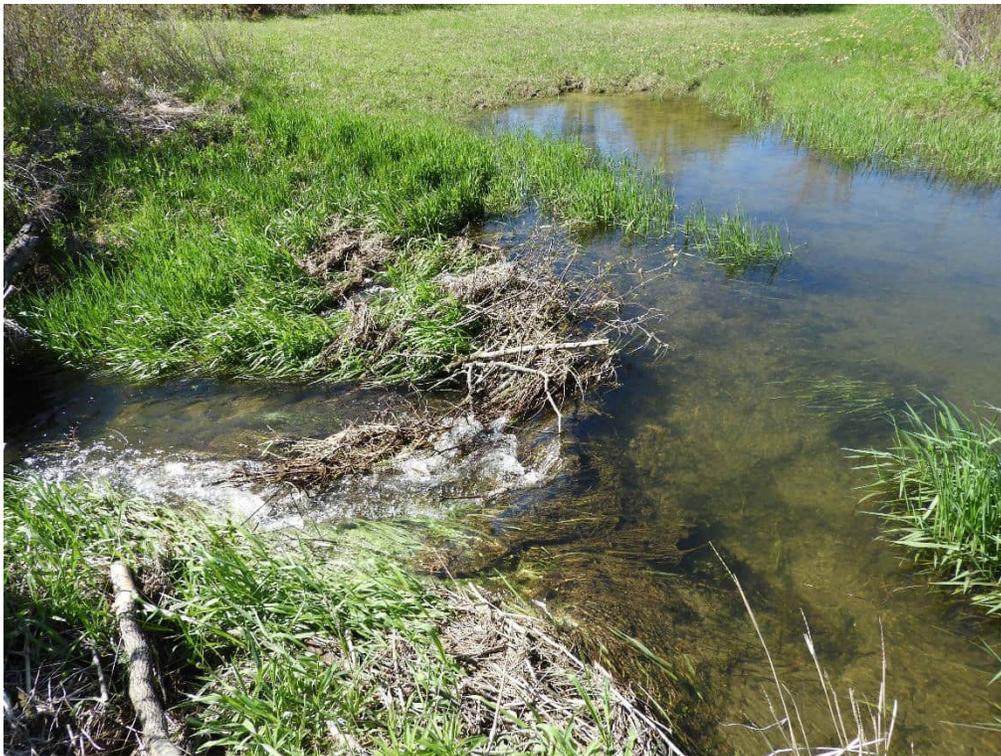
Photo 13: A beaver dam/debris within Harwood Creek directly downstream of one of the off-road vehicle crossings (right), which creates a potentially permanent barrier to fish migration. 12 May 2021.

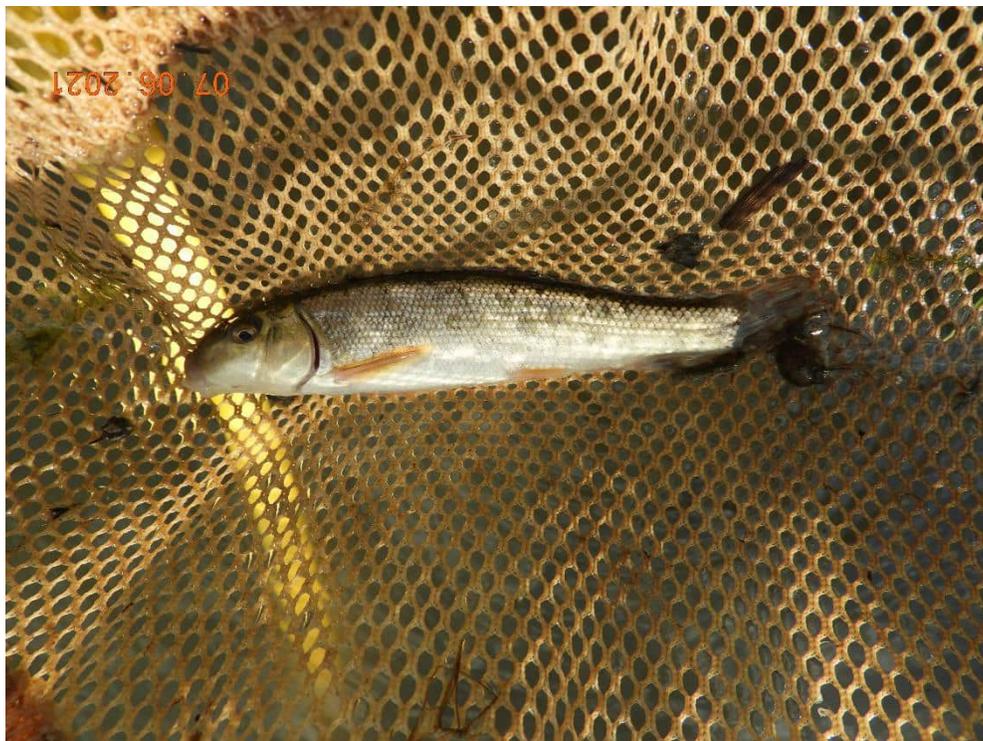
Photo 18: White Sucker (*Catostomus commersonii*) caught in Harwood Creek within the study area. The watercourse within the study area provides specialized baitfish spawning habitat. 07 June 2021.

An electrofishing survey was conducted to determine fish species present within the study area. White Sucker adults (**Photo 18**) and young-of-year (YOY) were caught and/or observed within Harwood Creek in the study area during the June 6, 2021 field investigation. This species and its habitat are afforded protection under the *Fisheries Act* (1985). Specialized baitfish spawning habitat (including White Sucker) is present within the study area within the riffles and runs with gravel substrate; however, the beaver dam/debris is a potential barrier to fish migration within the watercourse.

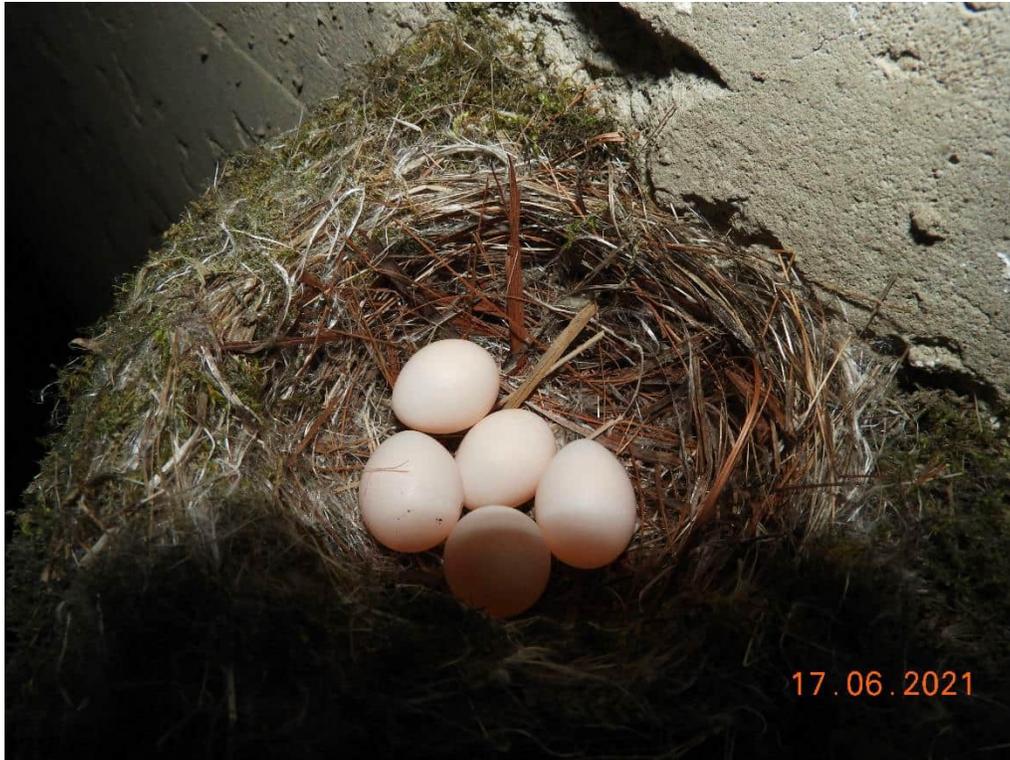
Photo 19: An active Eastern Phoebe (*Phoebe sayornis*) nest with eggs observed within the decommissioned railway culvert directly adjacent to the eastern extent of the study area. 17 June 2021.

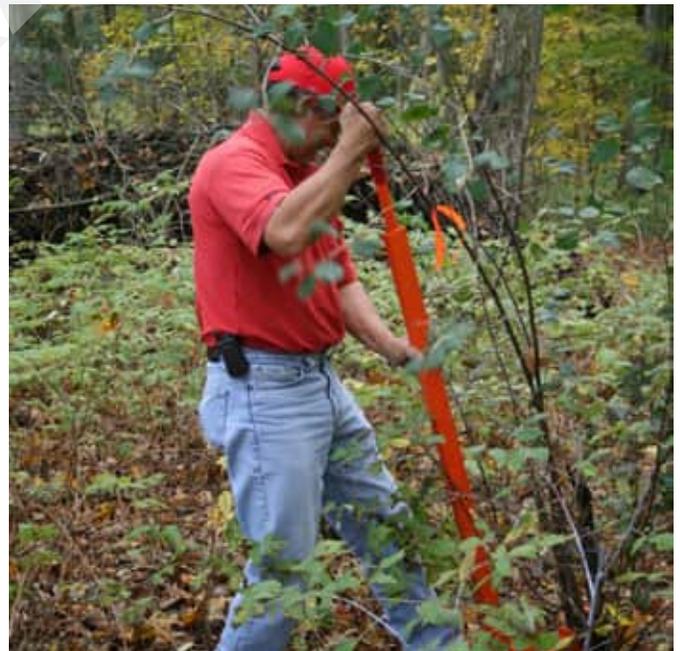
Removal using a weed wrench tool.

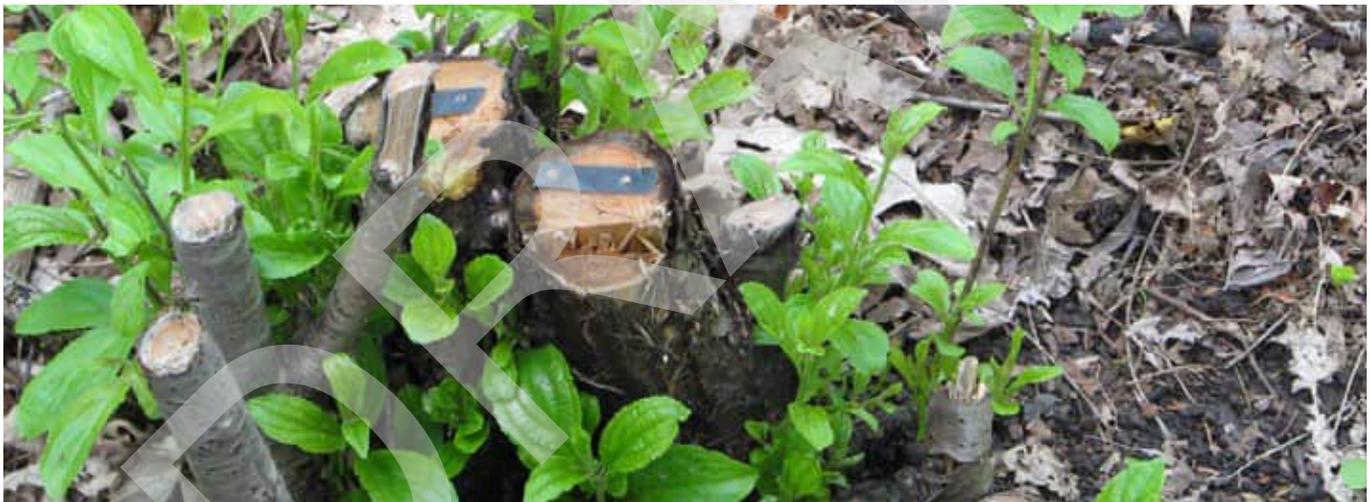
A cut buckthorn stump will re-sprout unless treated.
