**PHASE I
ENVIRONMENTAL SITE ASSESSMENT
2050 DUNROBIN ROAD
CITY OF OTTAWA, ONTARIO**

Euroamber Inc.
165 Constance Lake Road
Kanata, Ontario
K2K 1X7

REVISED DATE June 6, 2023
DATE: February 18, 2022

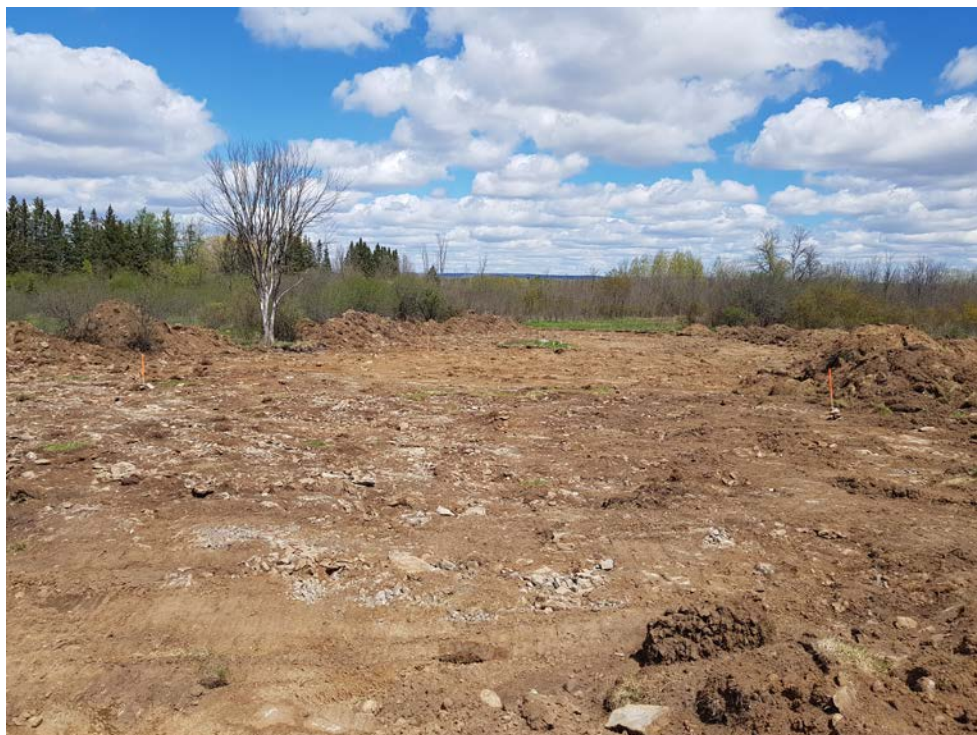
View of roadway construction after topsoil was stripped

- Fill materials was observed to have been imported to the site as part of the roadway construction for the proposed residential subdivision. The fill materials were tested as part of Excess Soil Management and are considered to be acceptable quality.

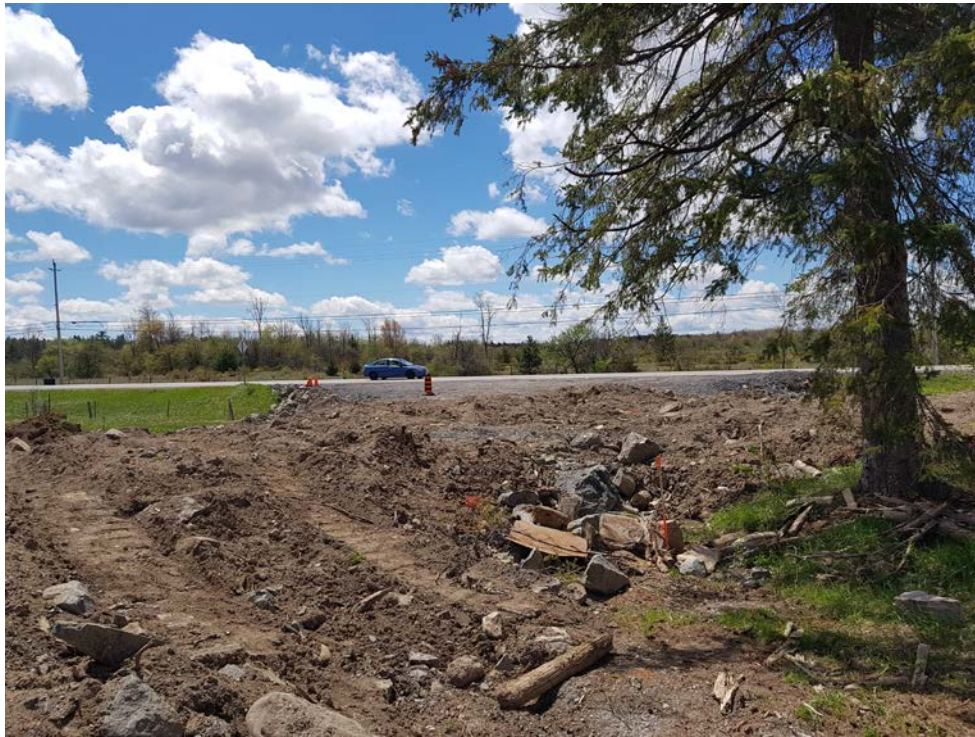
View of some fill materials used in roadway

Some fill materials were observed to have been imported to the site as part of construction of a future roadway that will service the proposed residential subdivision. The fill materials consist of a mixture of sand, gravel, cobbles, boulders, silty clay, trace to some concrete, plastic and wood debris. It is understood that the fill materials originated from properties in Almonte and Kanata. Quality testing of the fill materials was completed by Paterson Group

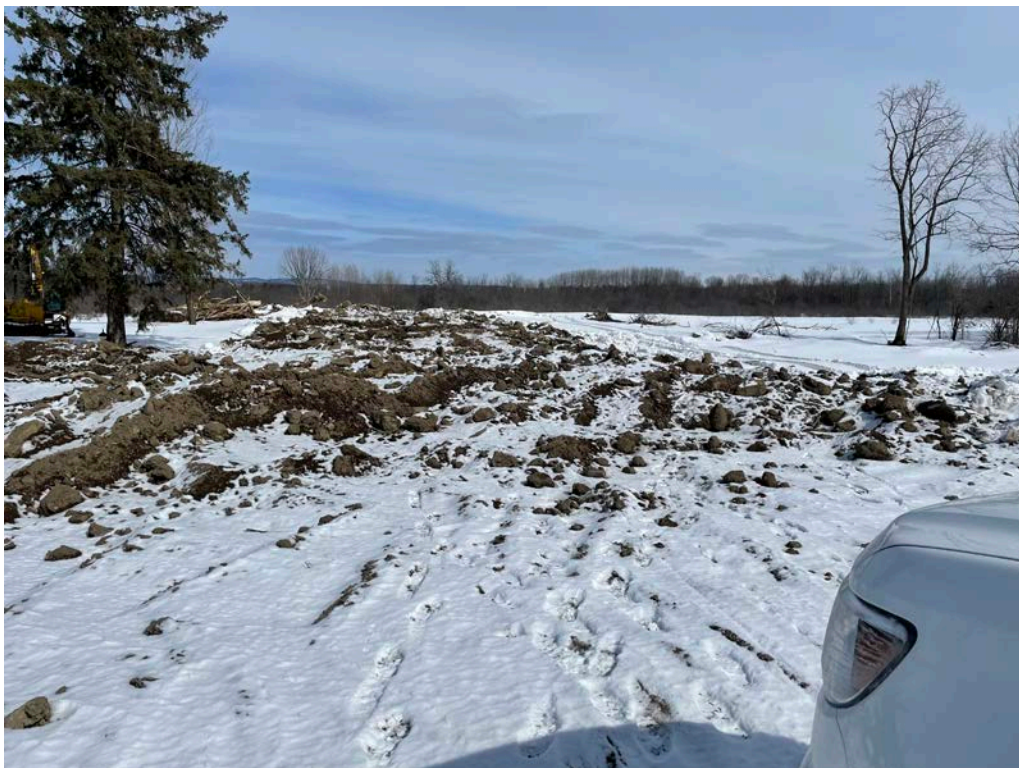
View of site facing east
