## Phase I Environmental Site Assessment

Vacant Land  
3317 Navan Road  
Ottawa, Ontario

March 15, 2018

Report: PE4245-1

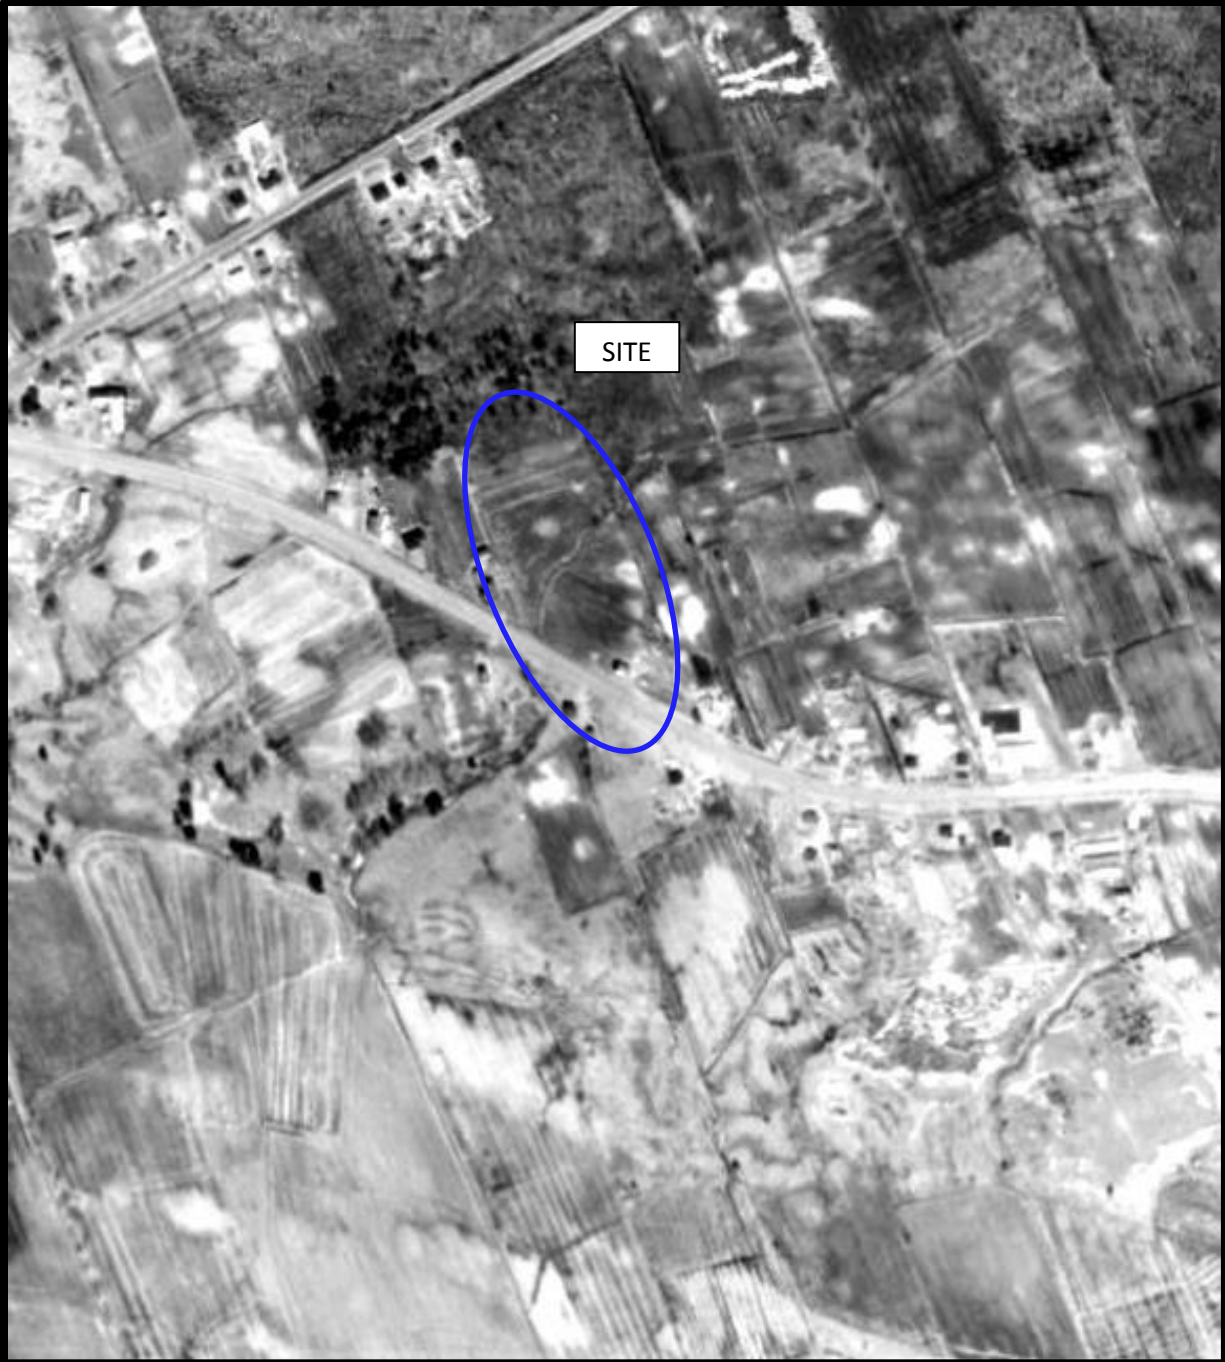
AERIAL PHOTOGRAPH  
1965

| 1965 | (City of Ottawa website) No significant changes have been made to the subject site. Residential dwellings have been developed on neighbouring properties to the north along Renaud Road. |

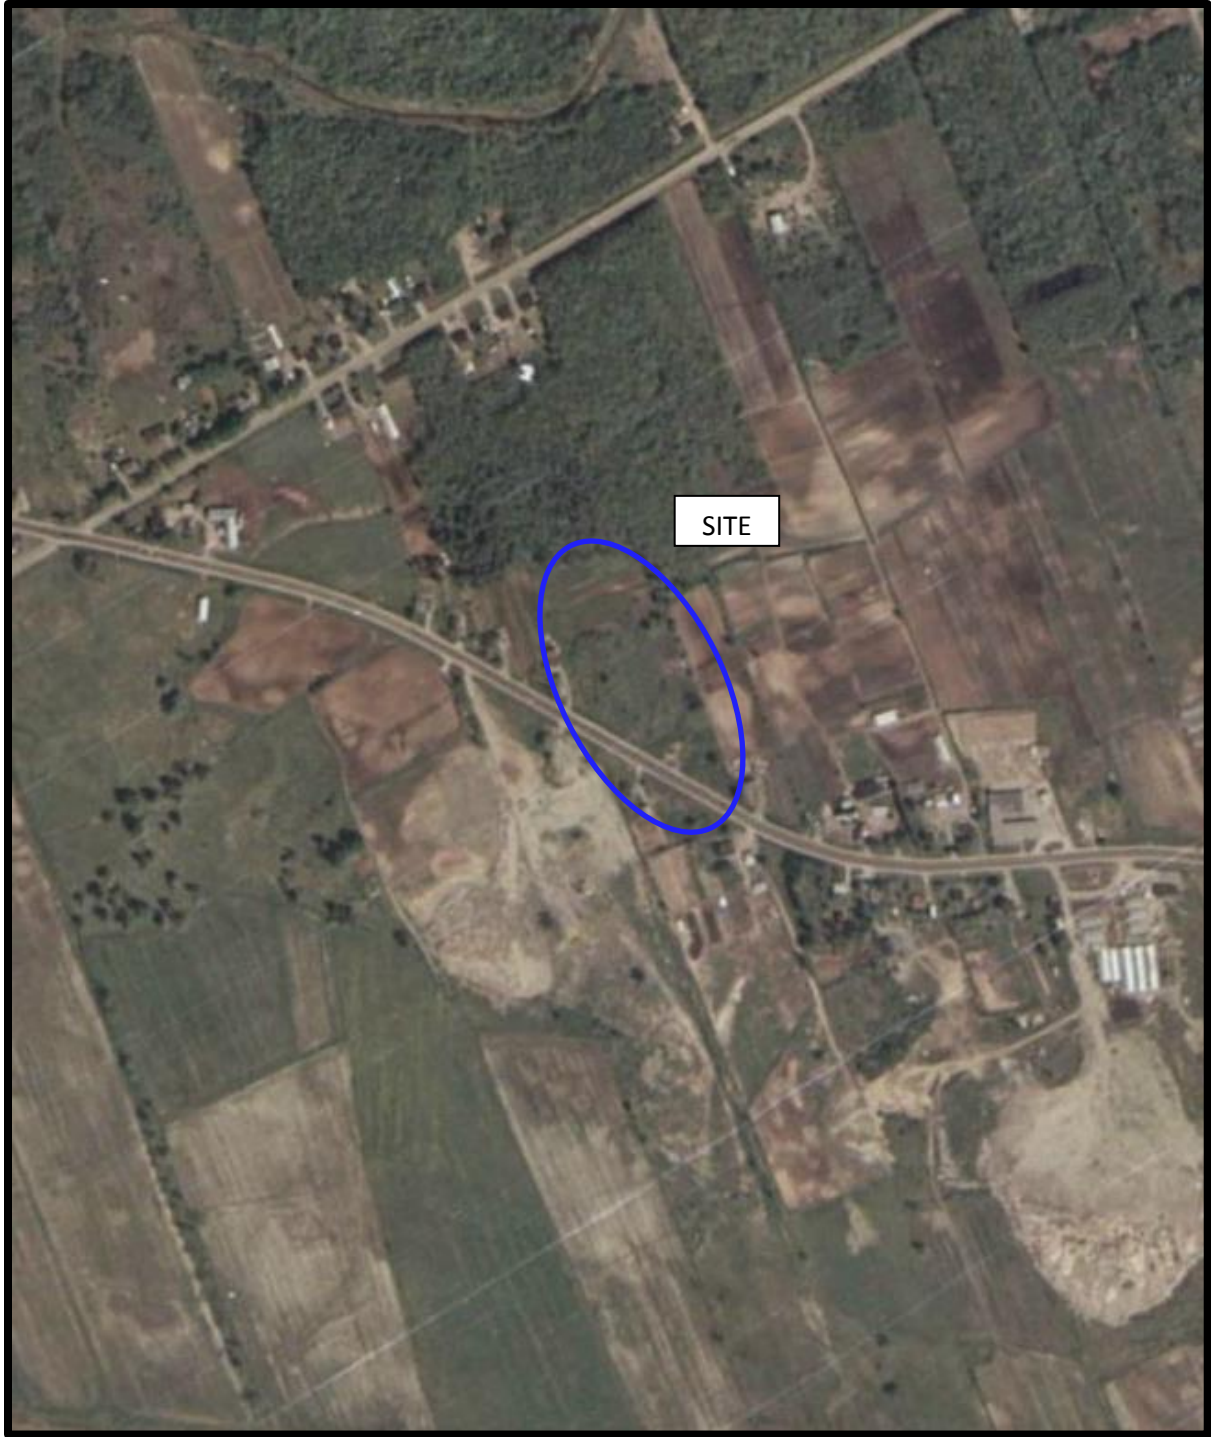
AERIAL PHOTOGRAPH  
1976

| 1976 | (City of Ottawa website) The dwelling on the subject site appears to have been demolished and the site is vacant. The Navan landfill appears to be under development southeast of the subject site. |

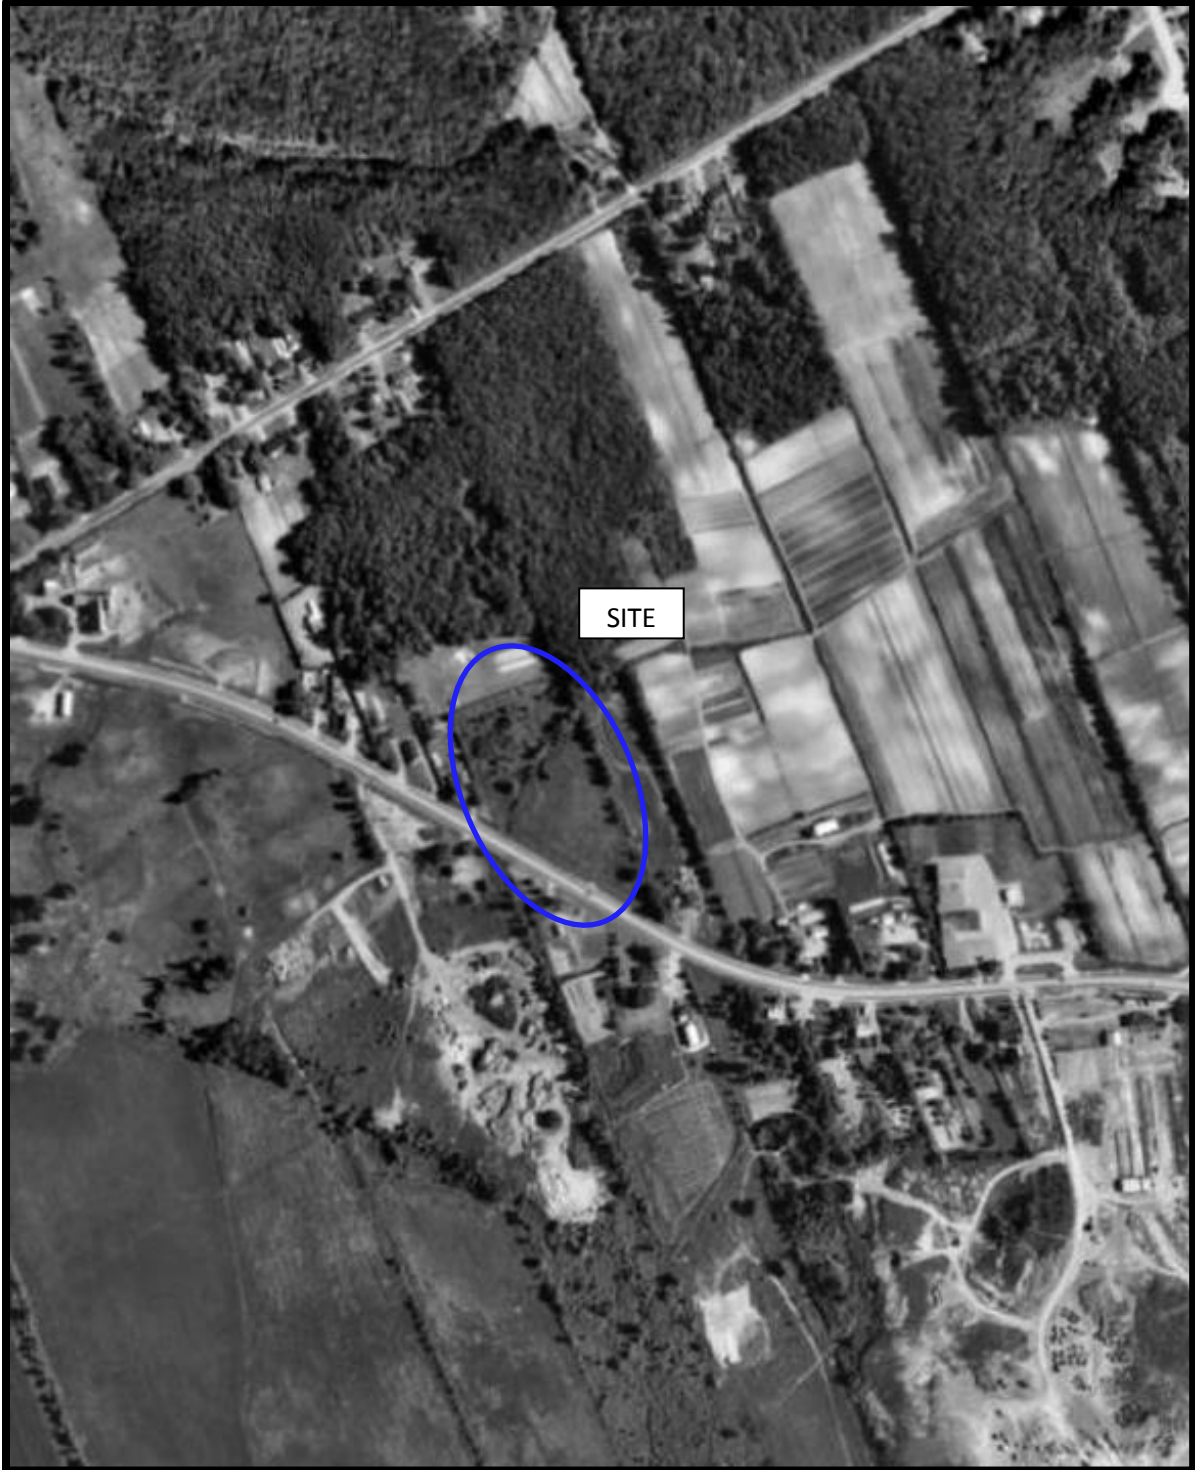
AERIAL PHOTOGRAPH  
1991

- 1991      (City of Ottawa website) No significant changes have been made to the subject site. Green house structures have been constructed on residential/farmstead properties southeast of the subject site. The Navan landfill has been expanded to the west.
- 2005      (City of Ottawa website) No significant changes have been made to the subject site. North of the subject site, trees have been cleared likely for residential development.
- 2017      (City of Ottawa website) The subject site appears as it does today. Residential dwellings have been constructed north and northwest of the subject site. A water management pond has been constructed south of the subject site on the Navan landfill property.

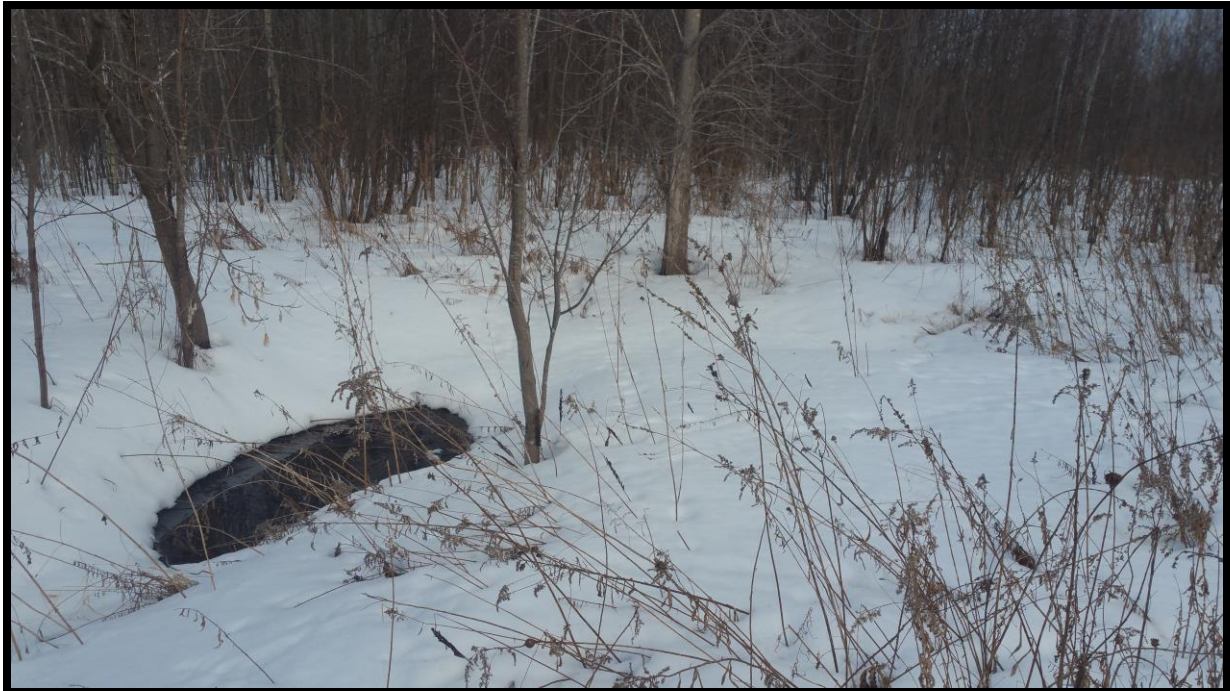
Photograph 1: View of the central portion of the site, facing north. Photograph depicts a small ditch/stream.

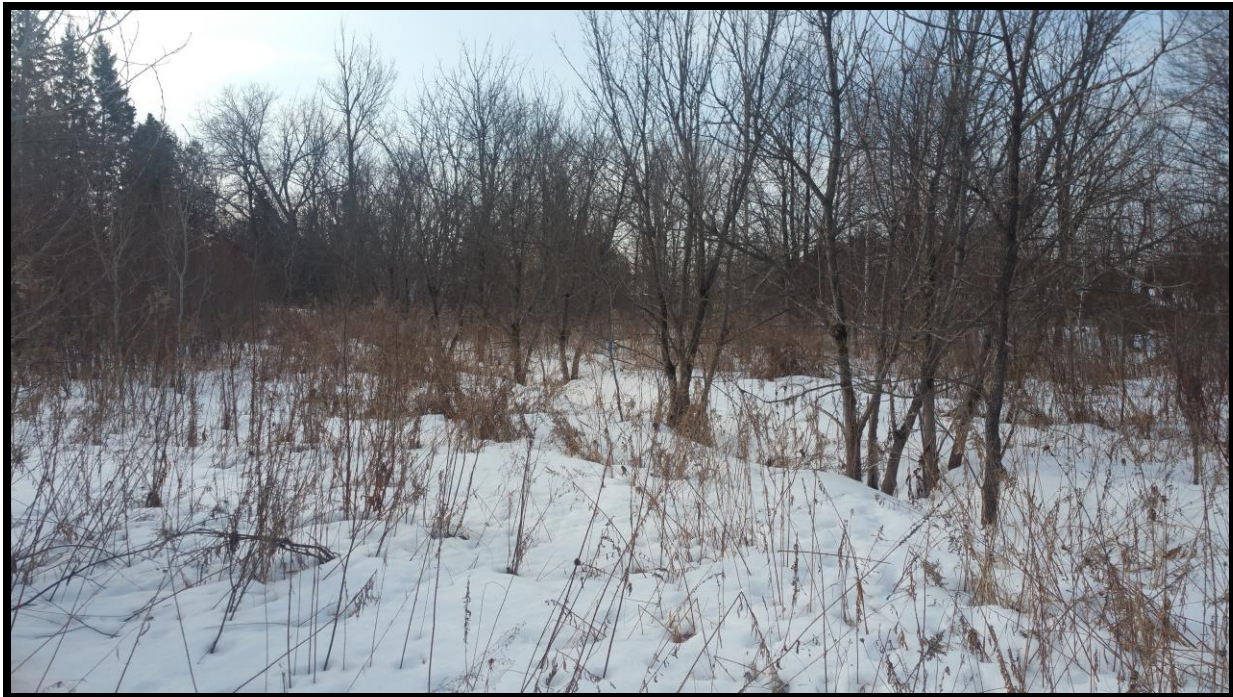
Photograph 2: View of the central portion of the site, facing west. Photograph depicts the main land cover, brush and trees.
