December 16, 2022  
CO884.00

**Re: Designated Substances Survey  
5650 Manotick Main Street, Ottawa, Ontario**

Further to your request, Terrapex Environmental Ltd. (Terrapex) completed a designated substances survey (DSS) of a residential dwelling at 5650 Manotick Main Street Ottawa, Ontario (the site). It is understood that the work program is required by 595831 Ontario Inc. (the Client) for municipal Site plan approval in anticipation of demolition of the structure for potential redevelopment of the Site.

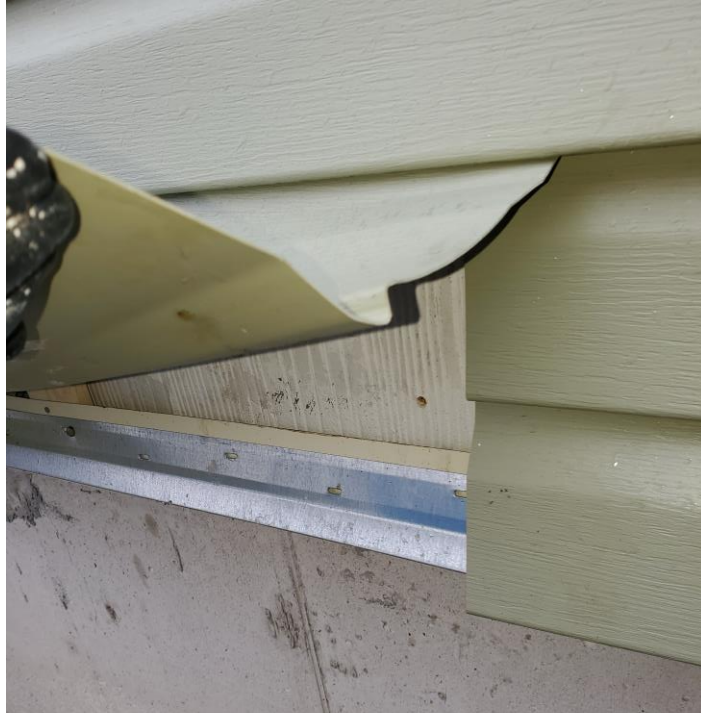
Photo No: 3

- Grey transite board located underneath the aluminum siding on the exterior of the dwelling (sample ACM-5A, non-friable, 20% Chrysotile asbestos, good condition). The entire area of the transite board could not be determined but it may represent an area of approximately 160 m<sup>2</sup>.

View of the transite cement board located underneath the tin siding. ACM-5 was collected from the white transite board.

If any demolition, alteration or repair work that may result in disturbing ACM or potential ACM areas, a qualified asbestos abatement contractor should be retained for asbestos removal prior to undertaking the work. O. Reg. 278/05 defines three types of asbestos removal operations, which require different levels of protection, isolation and decontamination. Type 1 operations involve the lowest level of risk and include the removal of non-friable materials where the material is not damaged, or can be wetted and cut without power tools. Type 3 operations involve the highest level of risk, including removal of most types of friable materials, and require full enclosure of the area and construction of a decontamination area for workers and equipment, among other things.

Disposal of hazardous materials, including asbestos, if required, should be completed in accordance with Reg. 347.

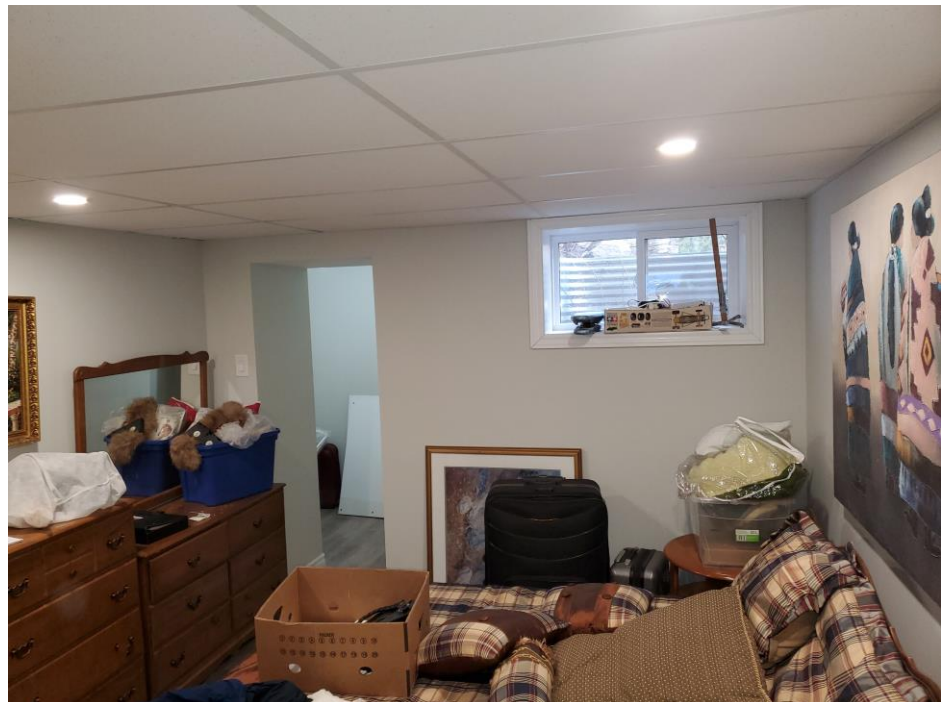
Photo No: 4

View of the finished portion of the basement.

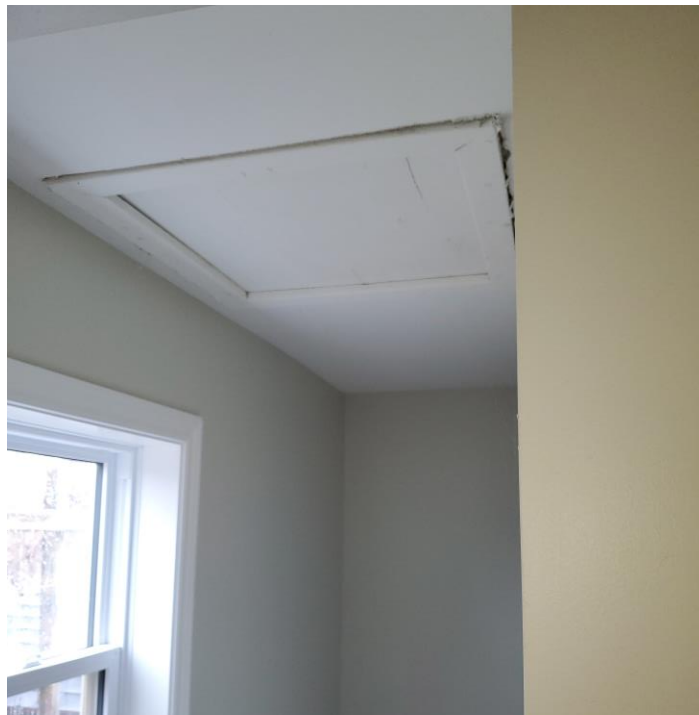
**Photo No:** 6

- Due to the location of the hatch providing access to the attic was located in a stairwell, it was not accessible due to safety reasons.
- Samples of the roofing material were not able to be collected. Based on the fact that the roofing shingles appeared to be new they are not expected to be a concern.

A view attic hatch in the stairwell of the residence.

All other samples are considered to be non-ACM. It should be noted that the attic of the building was not inspected and should be inspected before the demolition of the building to identify any potential ACM.
