**PHASE ONE
ENVIRONMENTAL SITE ASSESSMENT**

**5646 & 5650 Manotick Main Street
Ottawa, Ontario**

FINAL REPORT

December 16, 2022

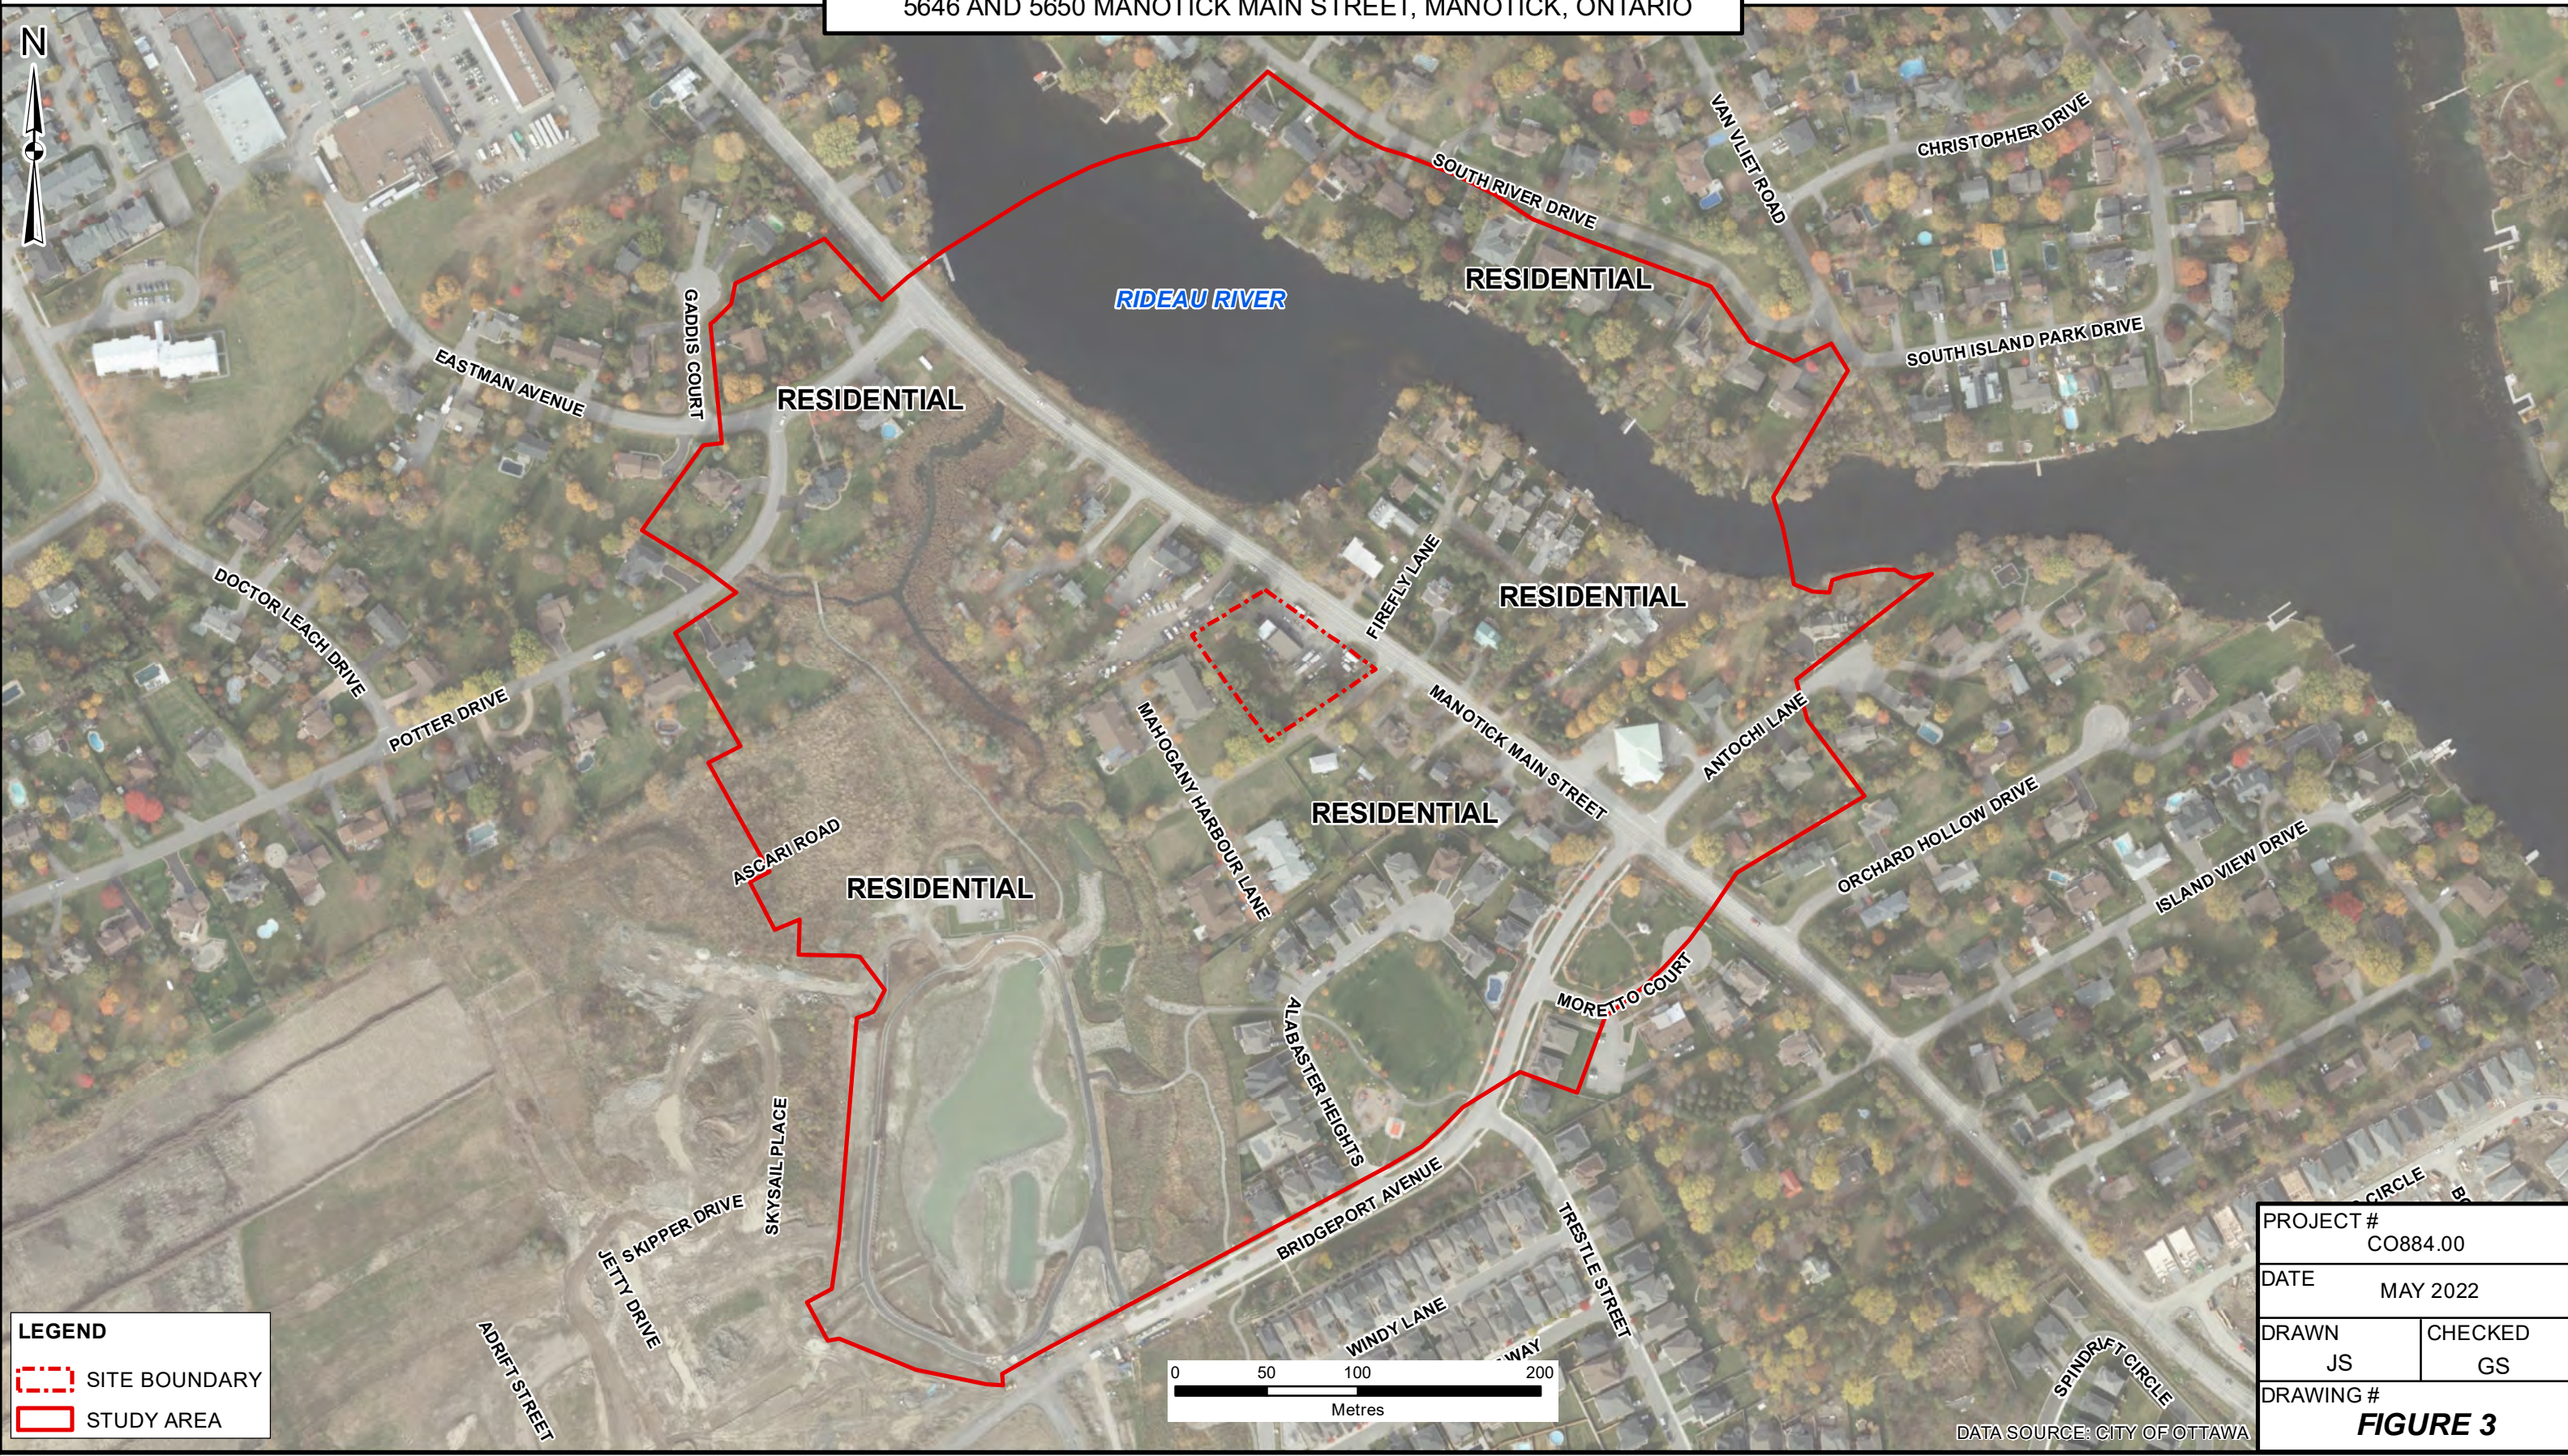
PROJECT #	CO884.00	
DATE	MAY 2022	
DRAWN	JS	CHECKED
		GS
DRAWING #	FIGURE 3

The surrounding properties are shown in Figure 3. It was observed that a backup generator with a integrated fuel storage tank was present at the fire station located 142 m south east of the Site.

The boundary of the Phase One study area is depicted in Figure 3. Documentation and interpretation of the records reviewed are provided in the sub-sections below. Note that all distances are calculated from the nearest property boundary of the Site to the nearest boundary of the feature in question and are approximate.

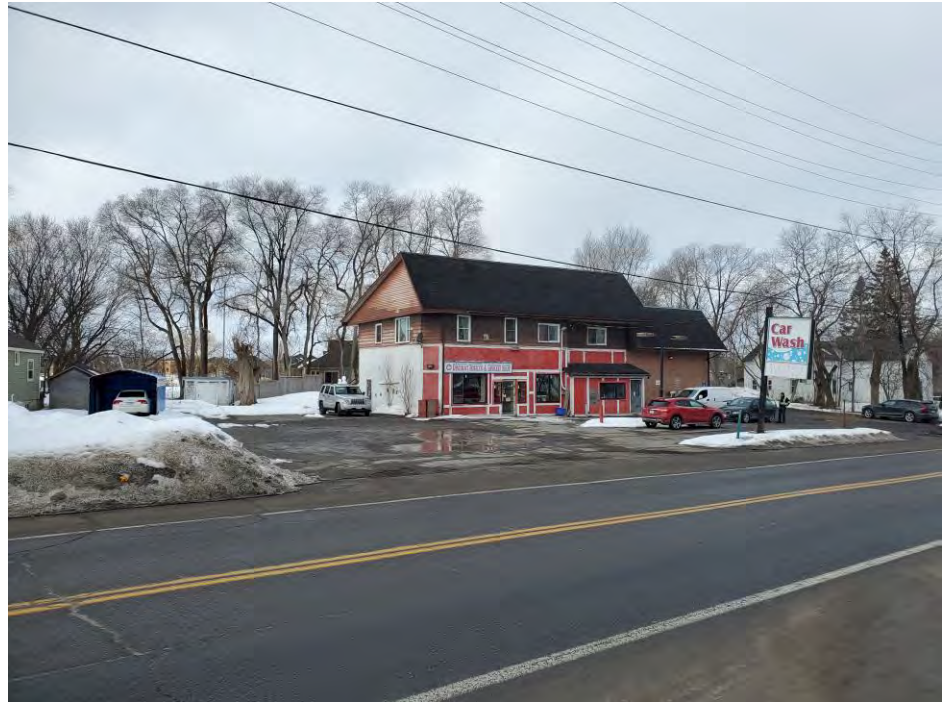
A view of the Site from the eastern side of Manotick Main Street.

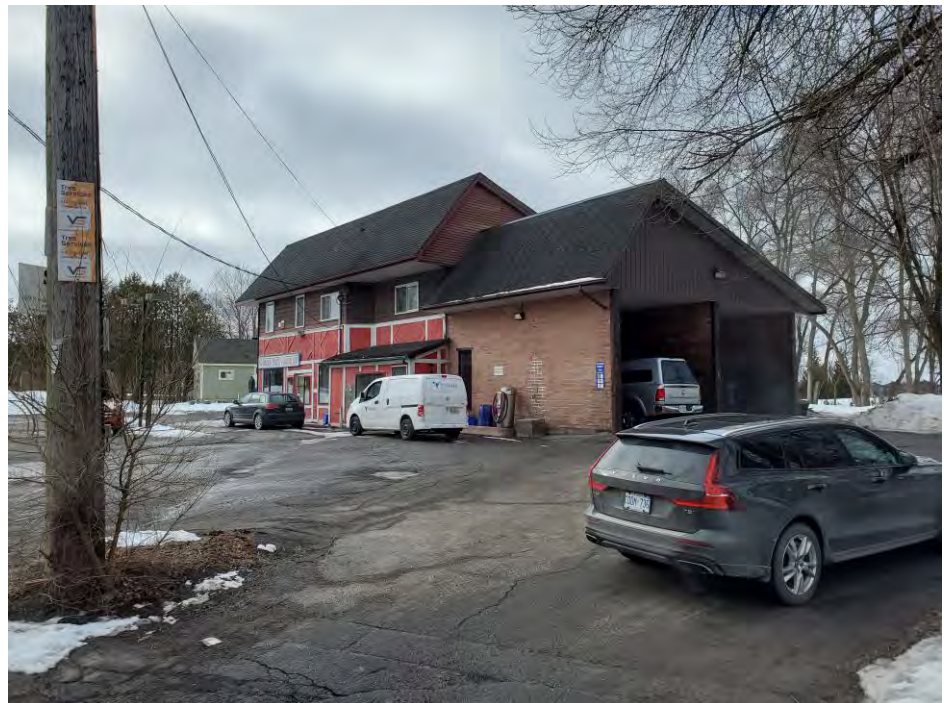
View of the Site from the northeastern portion of the Site. The two-bay car wash is visible at the north end of the building.

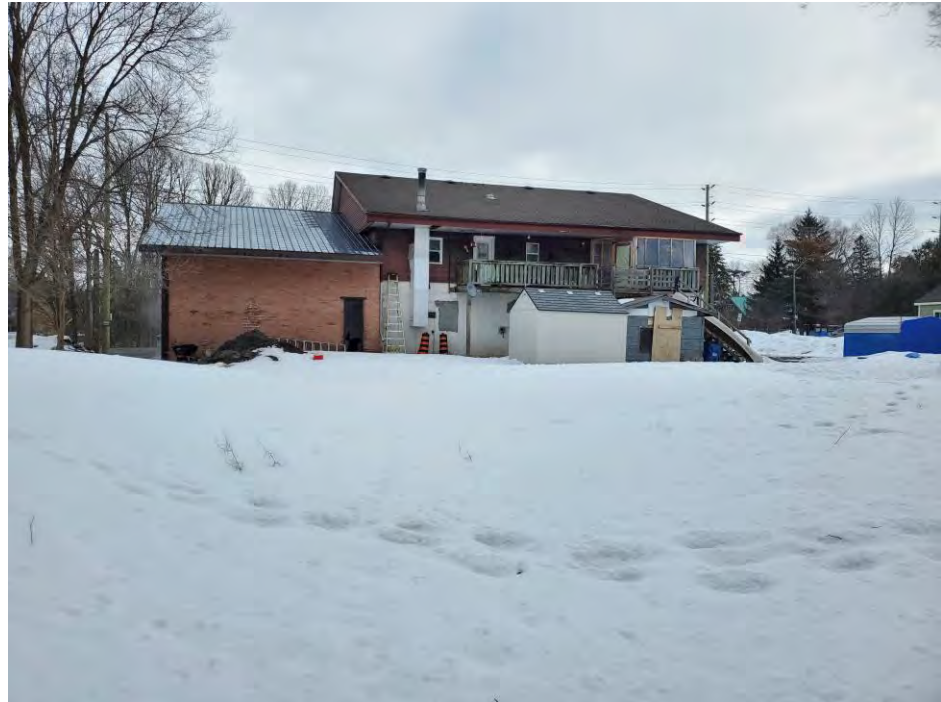
View of rear portion of the building from the southwestern portion of the Site.

The two second floor apartments are accessed from the wooden staircase at the southwest corner of the building.

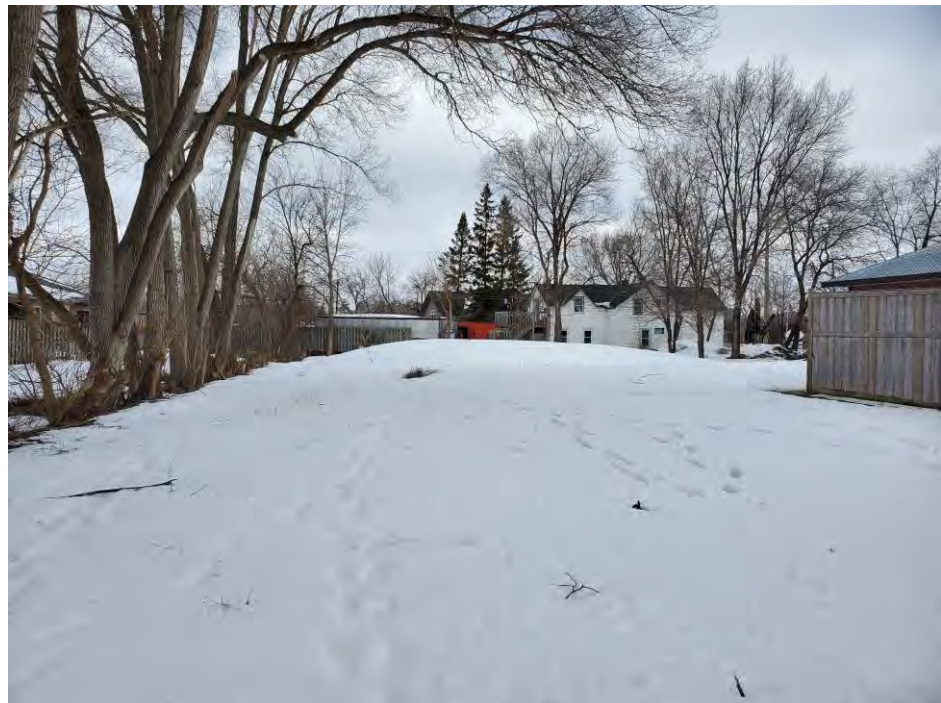
Photo No: 4

View of the septic bed located at the rear of the Site.

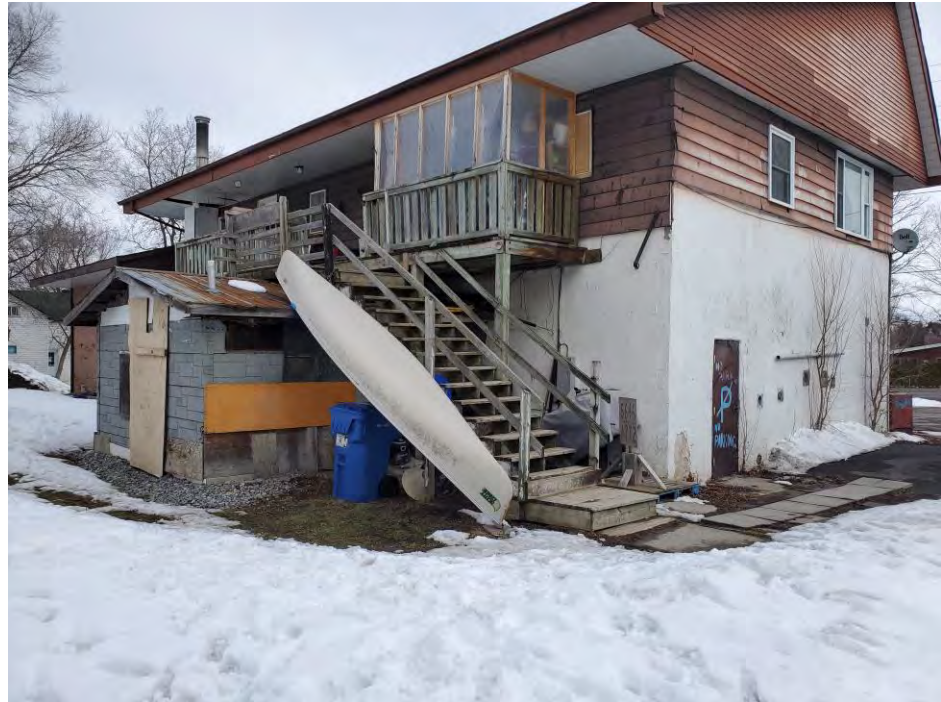
**Photo No:** 6**Date:** March 16, 2022**Viewing Direction:**
North**Description:**A view of excavated soil
located at the rear of the
building.

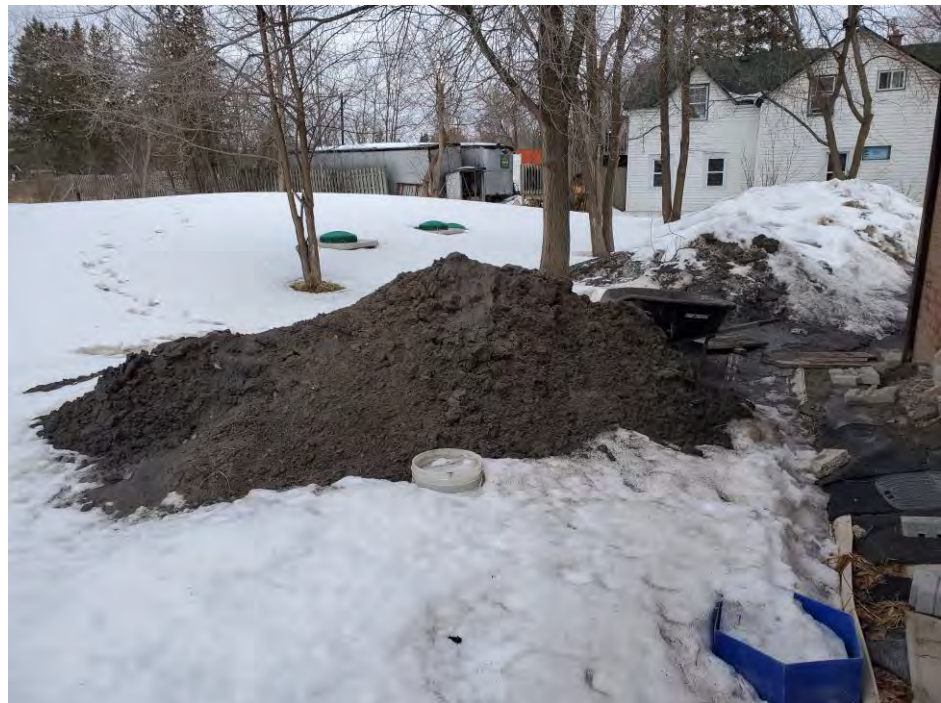
Debris and Fill Material: Debris and potential fill material were observed in the backyard of the onsite building on the 5646 Manotick Main Street property (refer to Appendix VIII, Photograph 6). Reportedly this fill was related to repairs to a foundation leak.

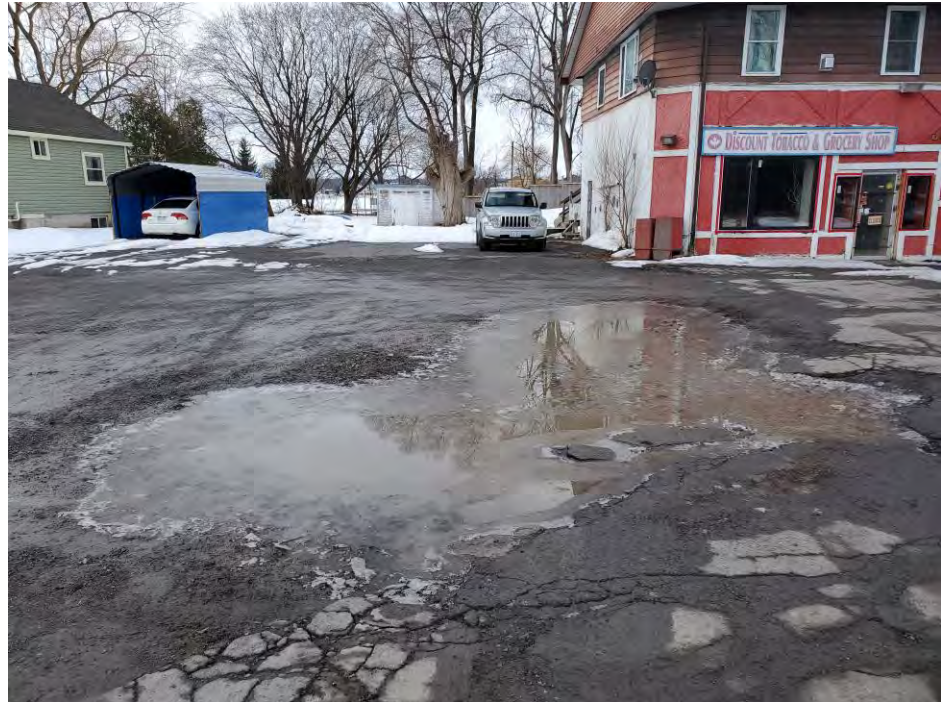
Photo No: 7
Date: March 16, 2021
Viewing Direction: East
Description: A view of the apparent location of the former underground storage tank nest.

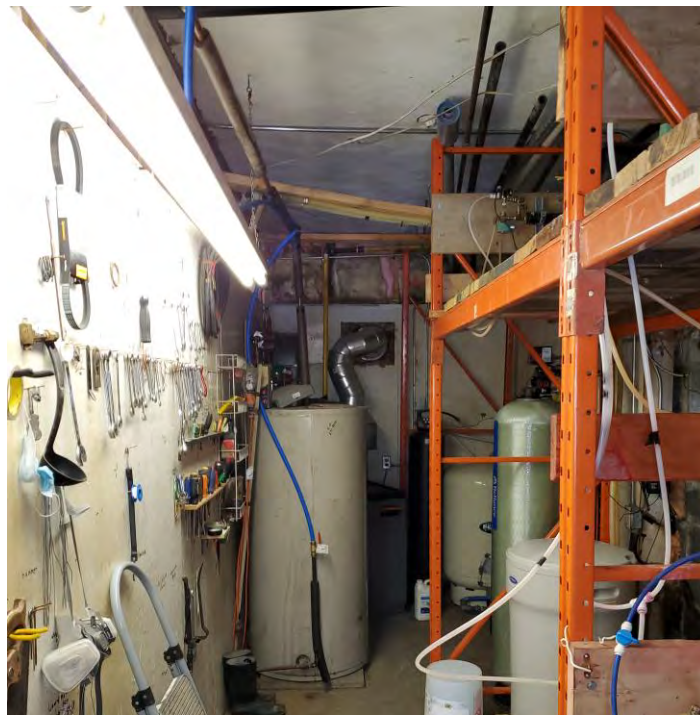
Photo No: 10

A view of car wash mechanical room located in the northern portion of the building.

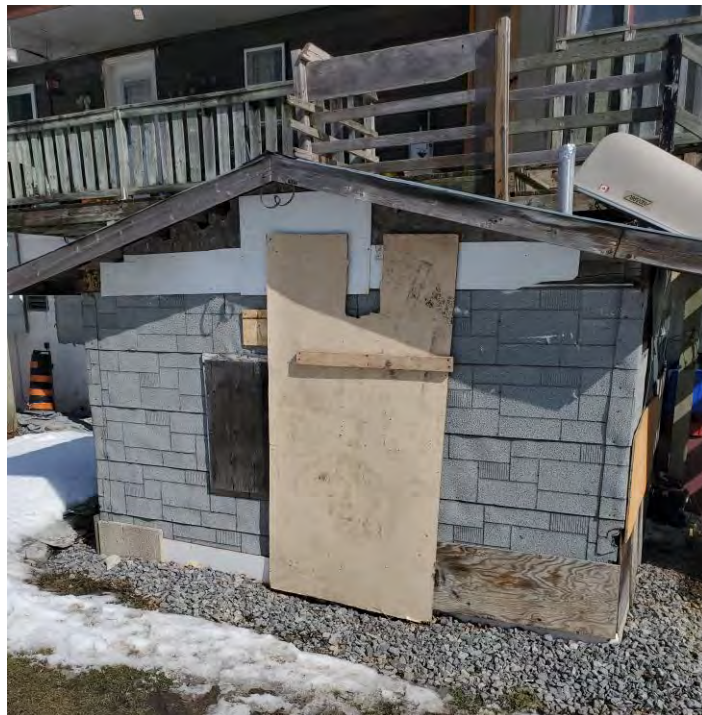
The interior of this expansion was covered in drywall and had extensive mold and water damage throughout.

**Photo No:** 12**Date:** March 16, 2022**Viewing Direction:**
East**Description:**A view of extension
located at the rear of the
building.

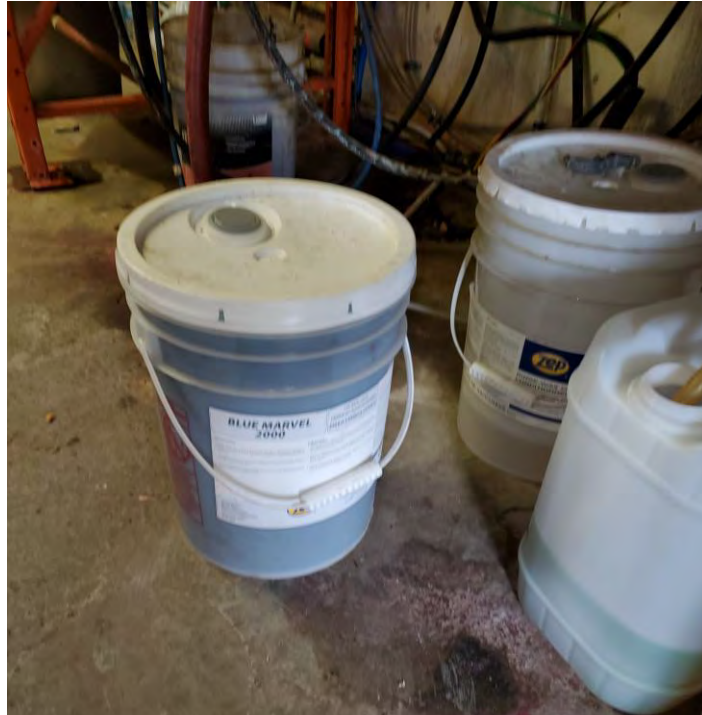
Storage Containers: Various containers of soaps and detergents were observed in the mechanical room of the car wash in the commercial building located on the 5646 Manotick Main Street property.

A view of the bulk detergents stored in the mechanical room for the car wash.

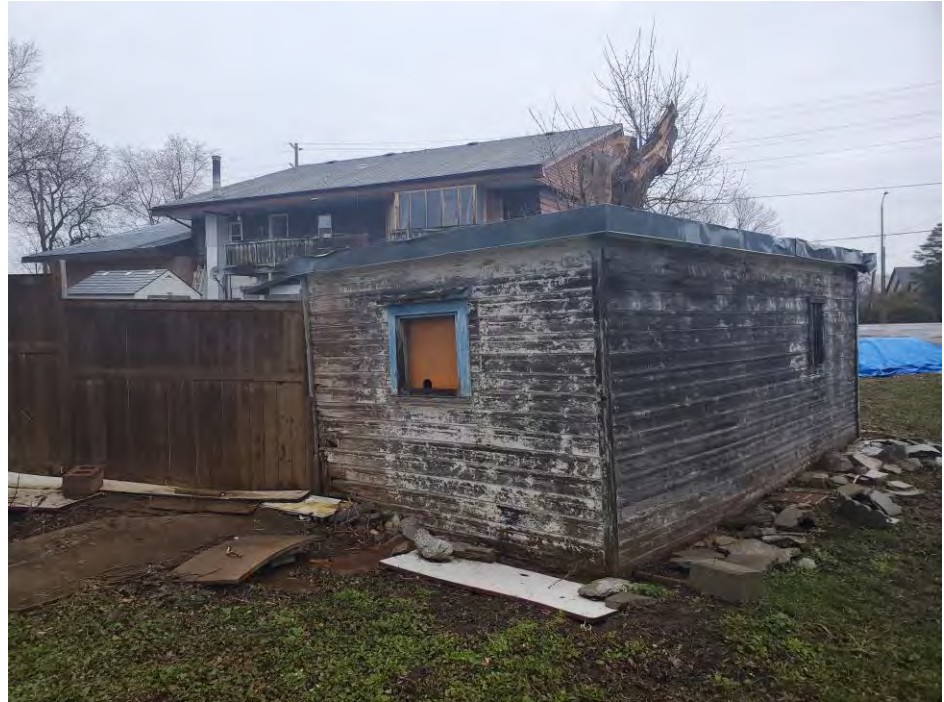
**Photo No:** 18**Date:** April 21, 2022**Viewing Direction:**
N/A**Description:**

A view of the staining located underneath the lawn mower inside the shed located on the 5650 Manotick Main Street Property.

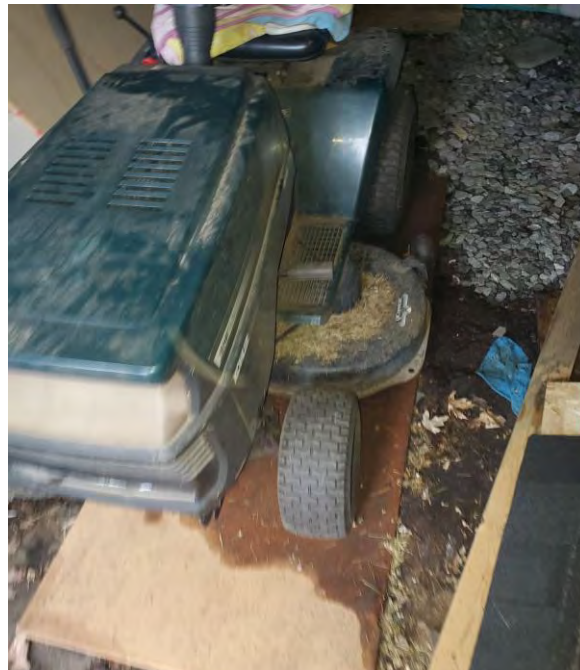
PCA 6 / APEC 4: Staining underneath the ride on lawn mower in the white shed.

Residues and Staining: Staining was observed underneath the ride-on lawn mower located in the shed on the 5650 Manotick Main Street property (refer to Appendix VIII, Photograph 18). Due to the extent of the staining this will be considered a PCA.

APEC 4	- Encompassing area of stained ground.	- Not Applicable	- PCA 6 (On-site)	- PHCs - BTEX	- Soil
APEC 5	- Encompassing area of downgradient of the weeping tile bed dedicated to the 2-bay PCA car wash	- Not applicable	- PCA 7 (On-Site)	- PHCs - BTEX - VOCs	- Groundwater
