Phase Two Environmental Site Assessment 1640-1660 Carling Avenue, Ottawa, Ontario

Phase Two Environmental Site Assessment

OTT-22015769-A0

2023-07-06

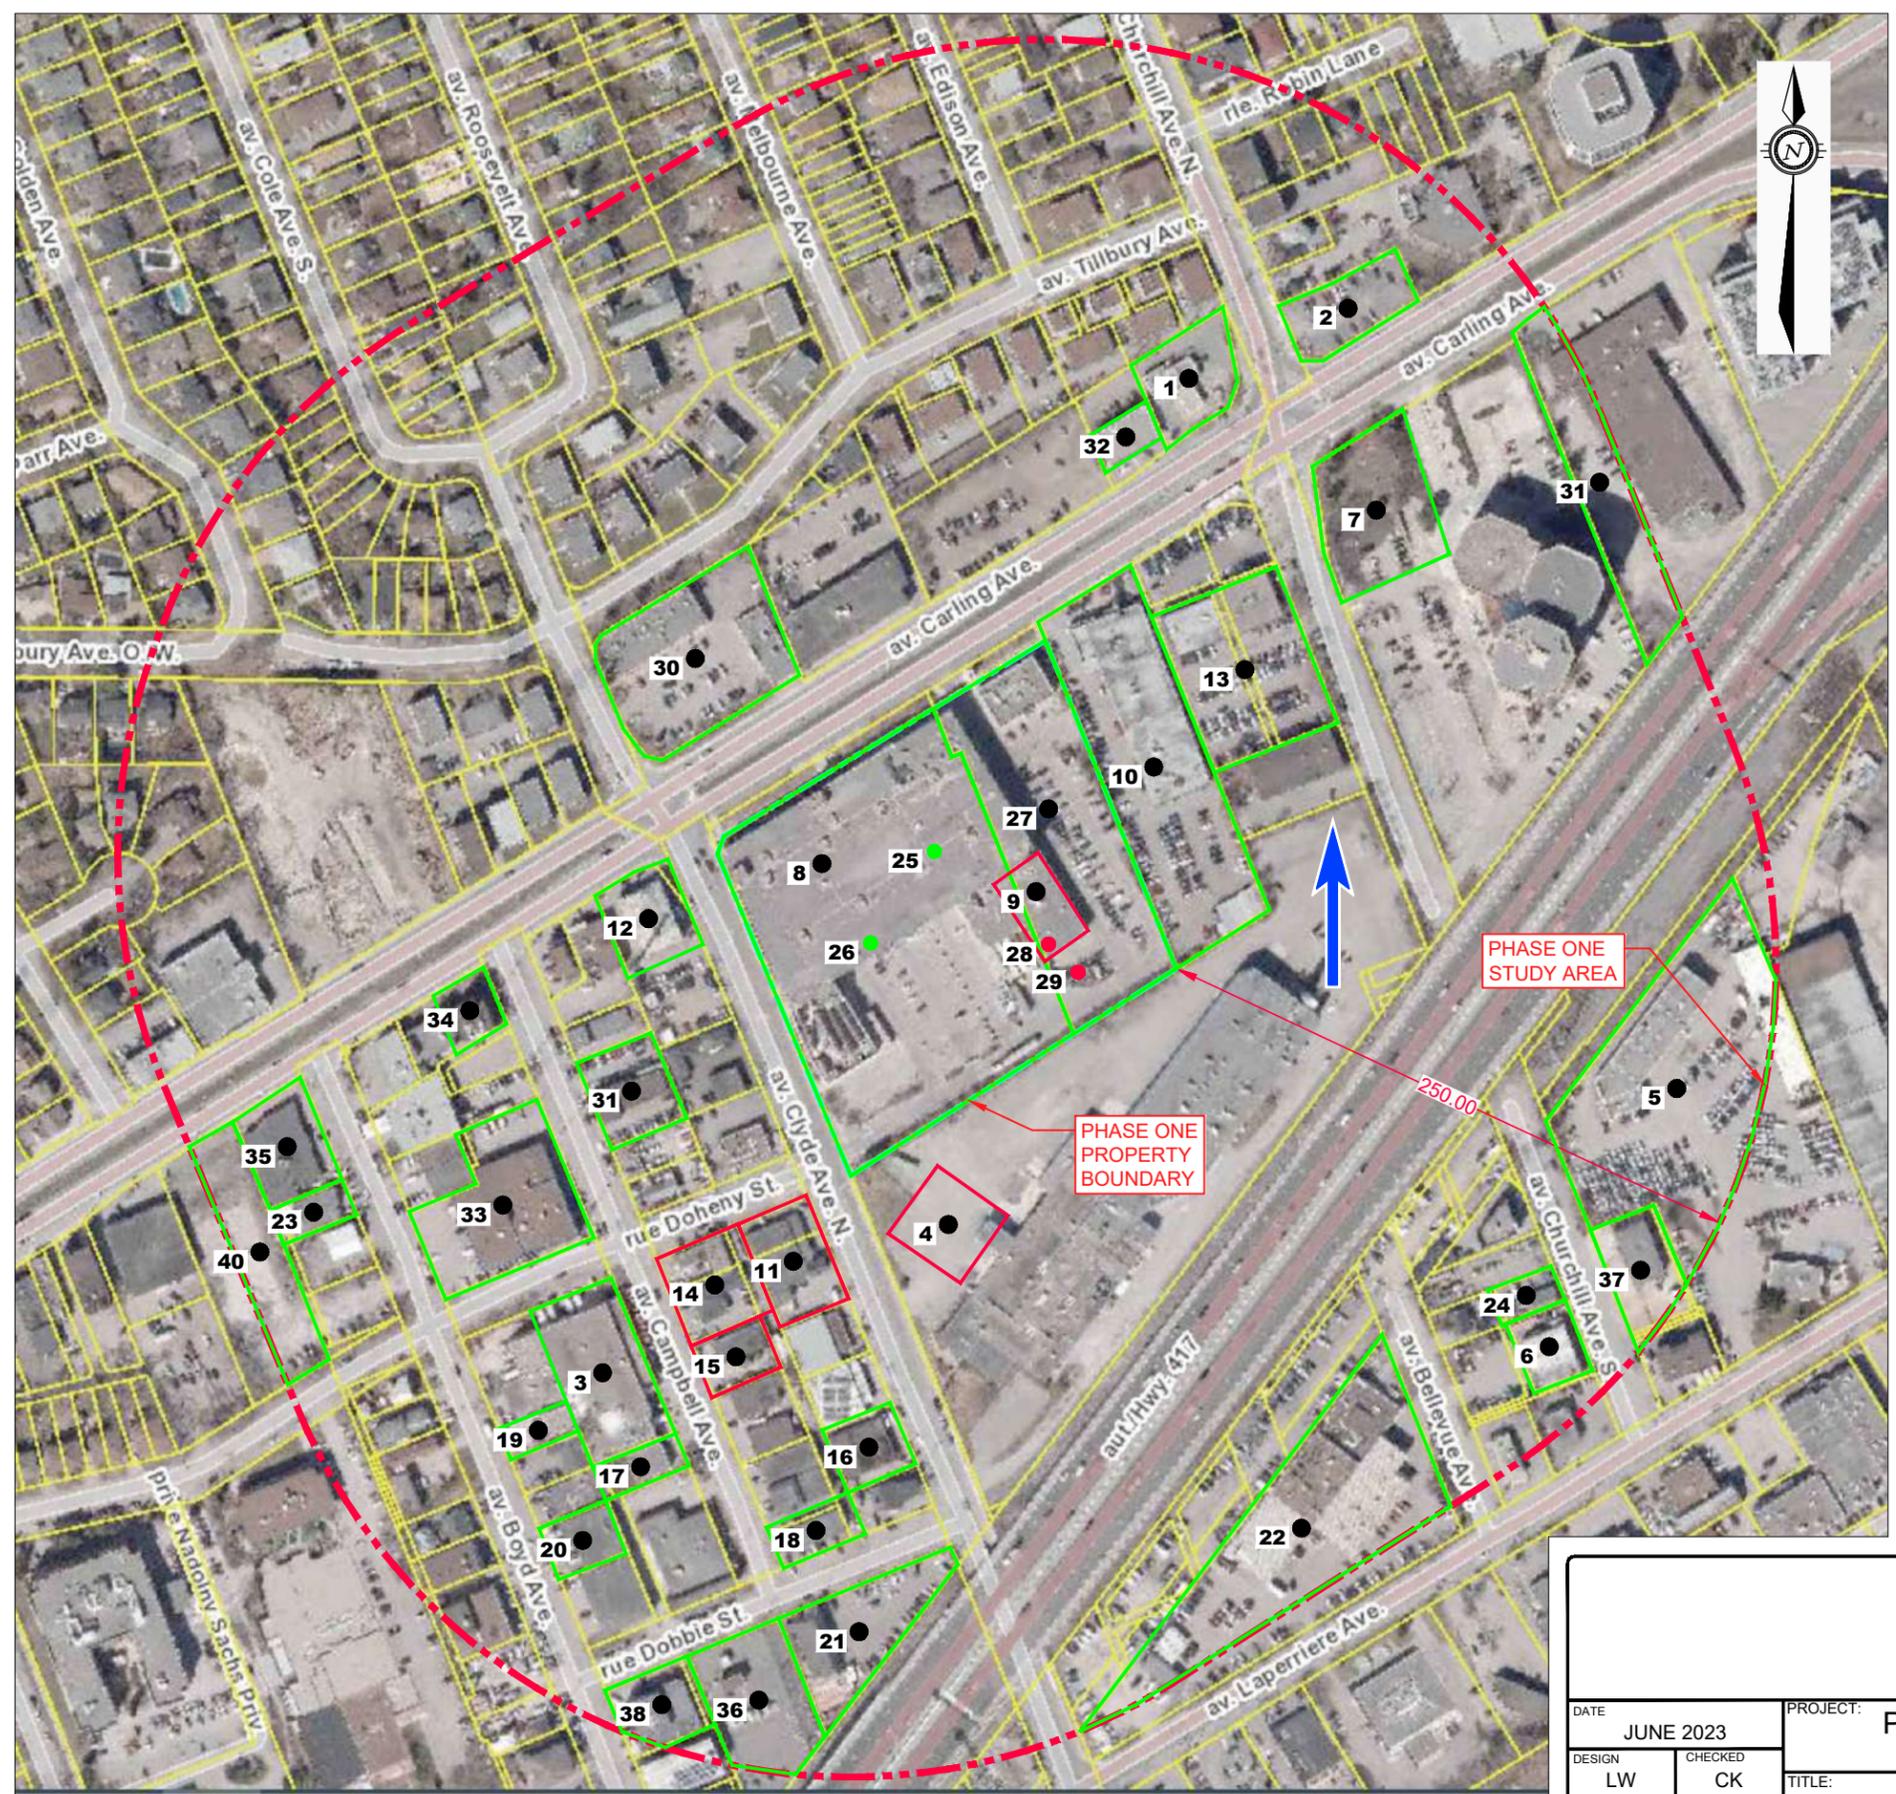
DATE: JUNE 2023		PROJECT: PHASE TWO ENVIRONMENTAL SITE ASSESSMENT 1640 & 1660 CARLING AVENUE, OTTAWA, ON		project no.: OTT-22015769-A0
DESIGN: LW	CHECKED: CK	TITLE: PHASE ONE CONCEPTUAL SITE MODEL		scale: 1:3,000
DRAWN BY: AS				FIG 2

- PCA 1 - 1621 (NOW 1607) CARLING AVENUE - GAS STATION (PCA #28)
- PCA 2 - 1593 (NOW 1599) CARLING AVENUE - GAS STATION (PCA #28)
- PCA 3 - 850 CAMPBELL AVENUE - LAUNDRY (PCA #28, PCA #37)

- PCA 4 - 861 (NOW 839 CLYDE AVENUE) - FORMER REPAIR GARAGE AT DAIRY (PCA #10, PCA #28)
- PCA 5 - 885 CHURCHILL AVENUE - REPAIR GARAGE, PRIVATE FUEL OUTLET (PCA #10, PCA #28)

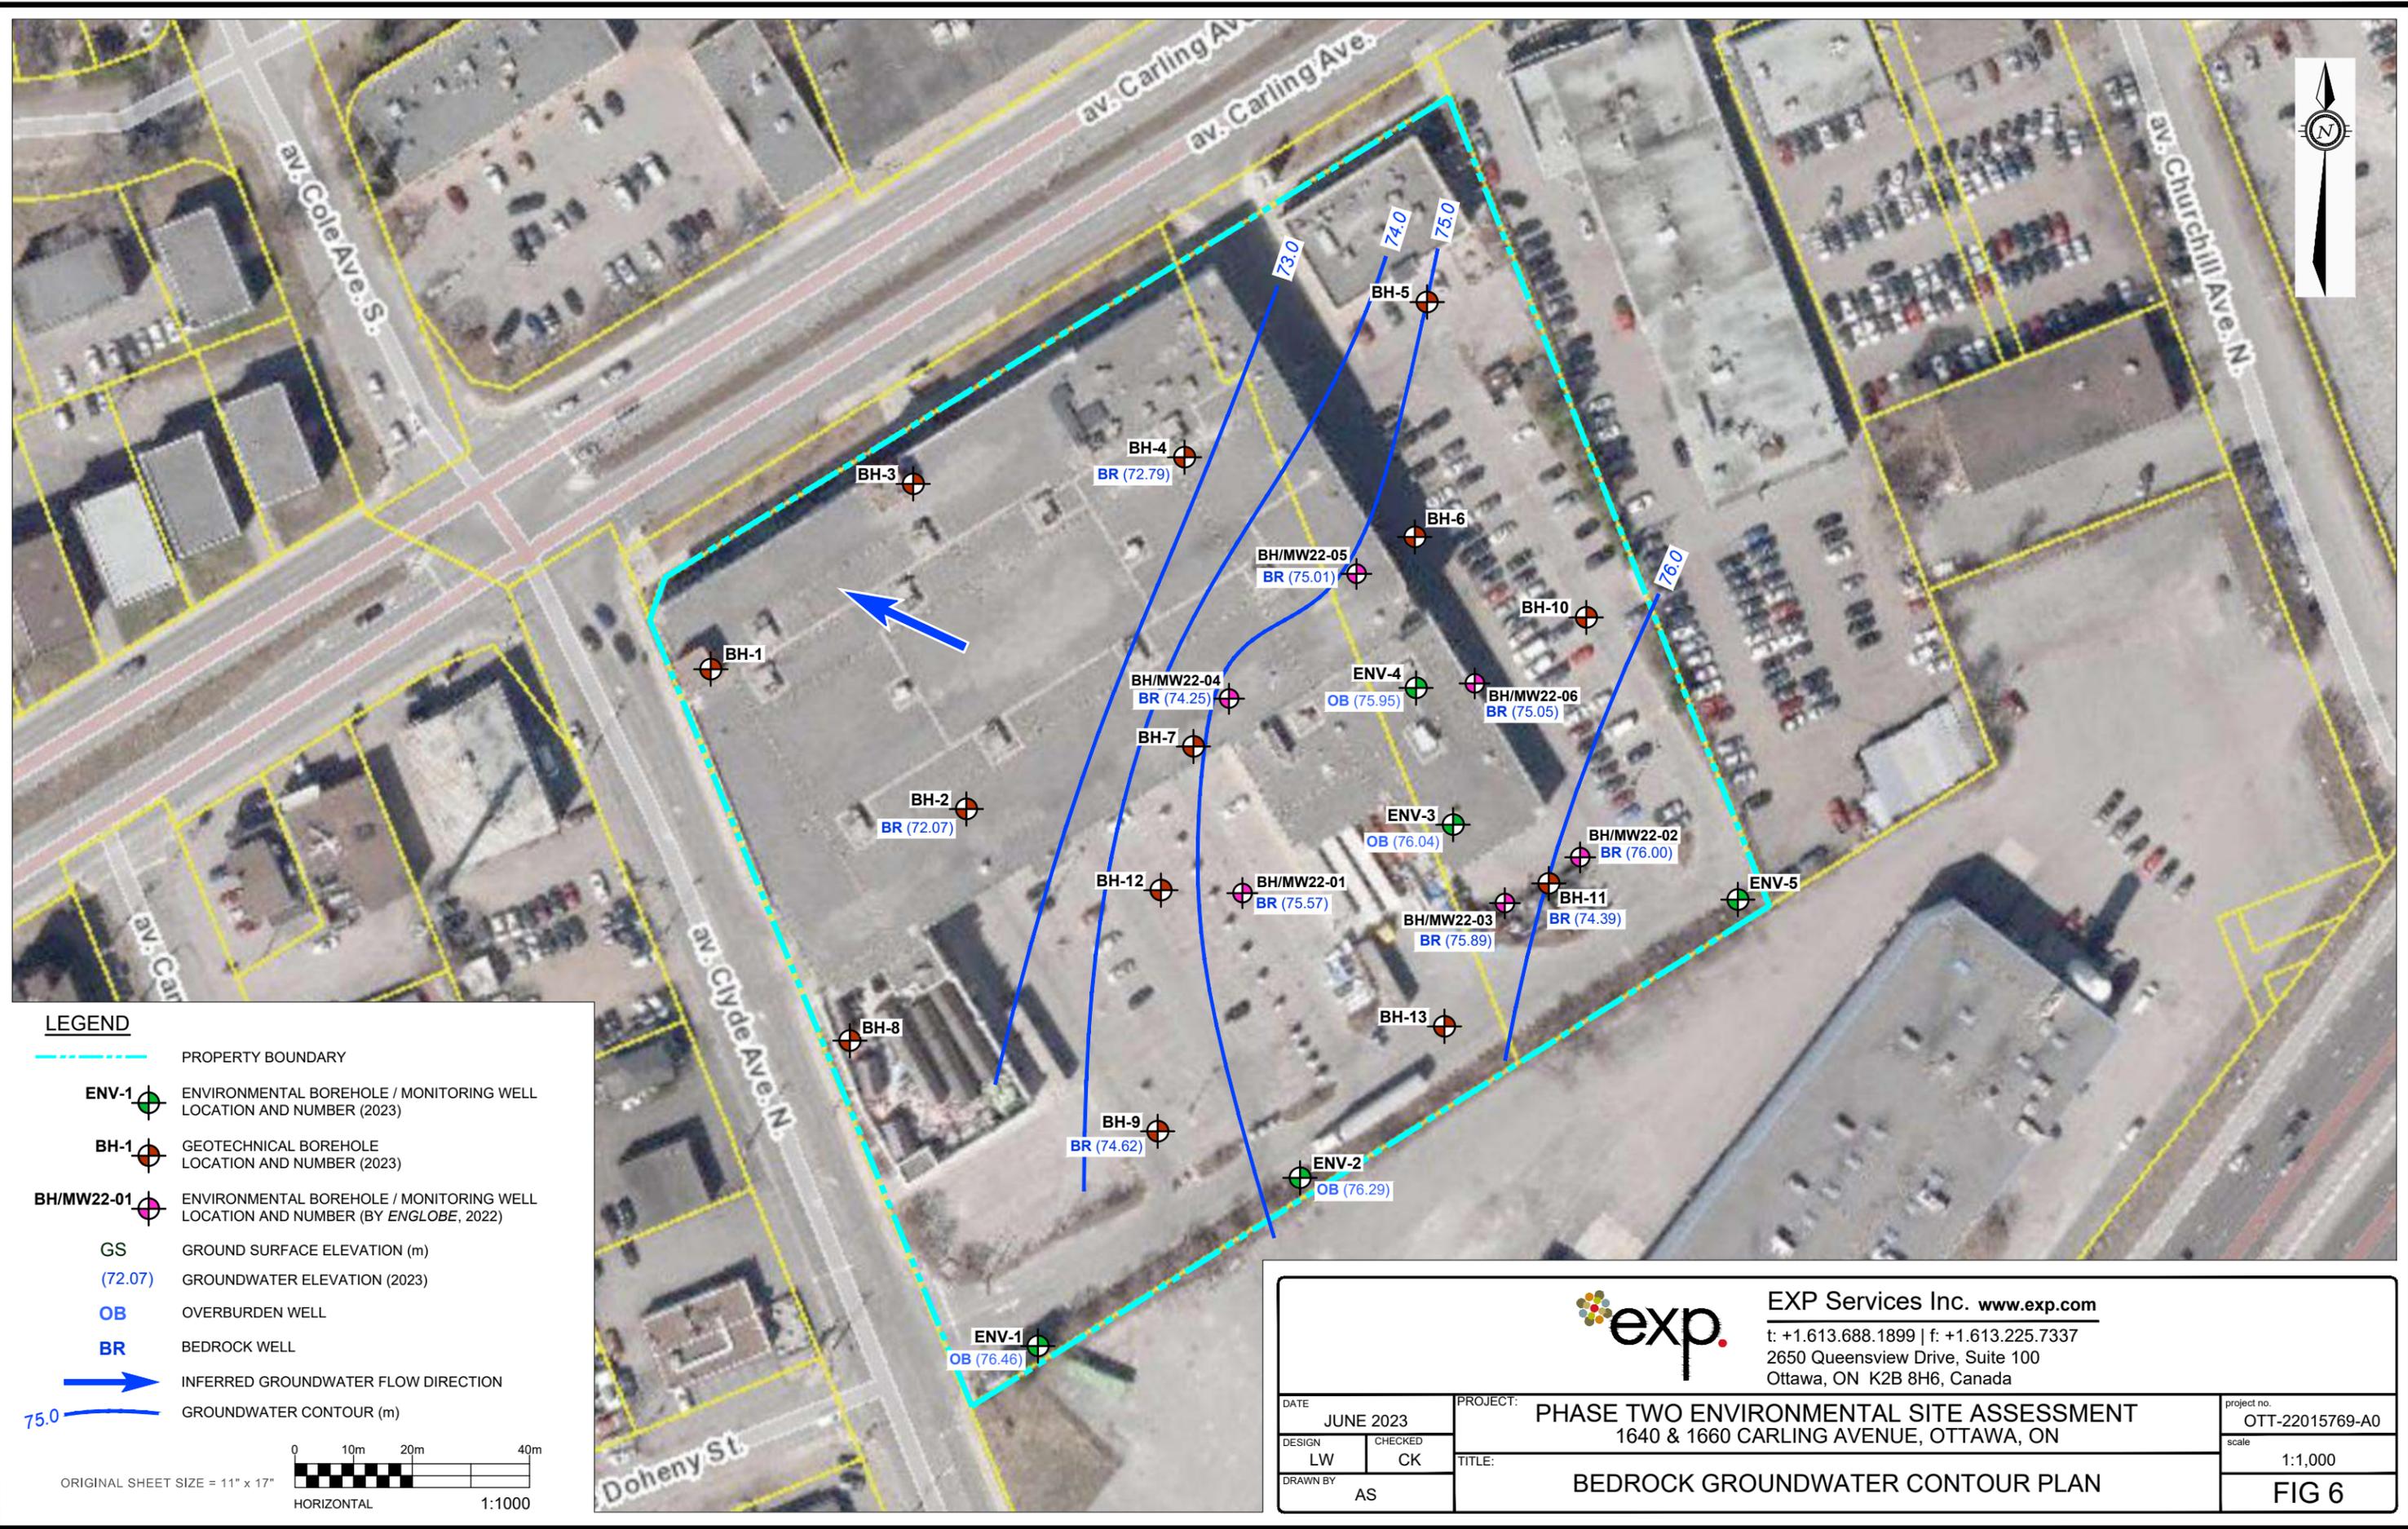
DATE: JUNE 2023		PROJECT: PHASE TWO ENVIRONMENTAL SITE ASSESSMENT 1640 & 1660 CARLING AVENUE, OTTAWA, ON		project no.: OTT-22015769-A0
DESIGN: LW	CHECKED: CK	TITLE: BEDROCK GROUNDWATER CONTOUR PLAN		scale: 1:1,000
DRAWN BY: AS				FIG 6

- PROPERTY BOUNDARY
- ENV-1 ENVIRONMENTAL BOREHOLE / MONITORING WELL LOCATION AND NUMBER (2023)
- BH-1 GEOTECHNICAL BOREHOLE LOCATION AND NUMBER (2023)
- BH/MW22-01 ENVIRONMENTAL BOREHOLE / MONITORING WELL LOCATION AND NUMBER (BY ENGLOBAL, 2022)
- GS GROUND SURFACE ELEVATION (m)
- (72.07) GROUNDWATER ELEVATION (2023)
- OB OVERBURDEN WELL
- BR BEDROCK WELL
- INFERRED GROUNDWATER FLOW DIRECTION
- GROUNDWATER CONTOUR (m)

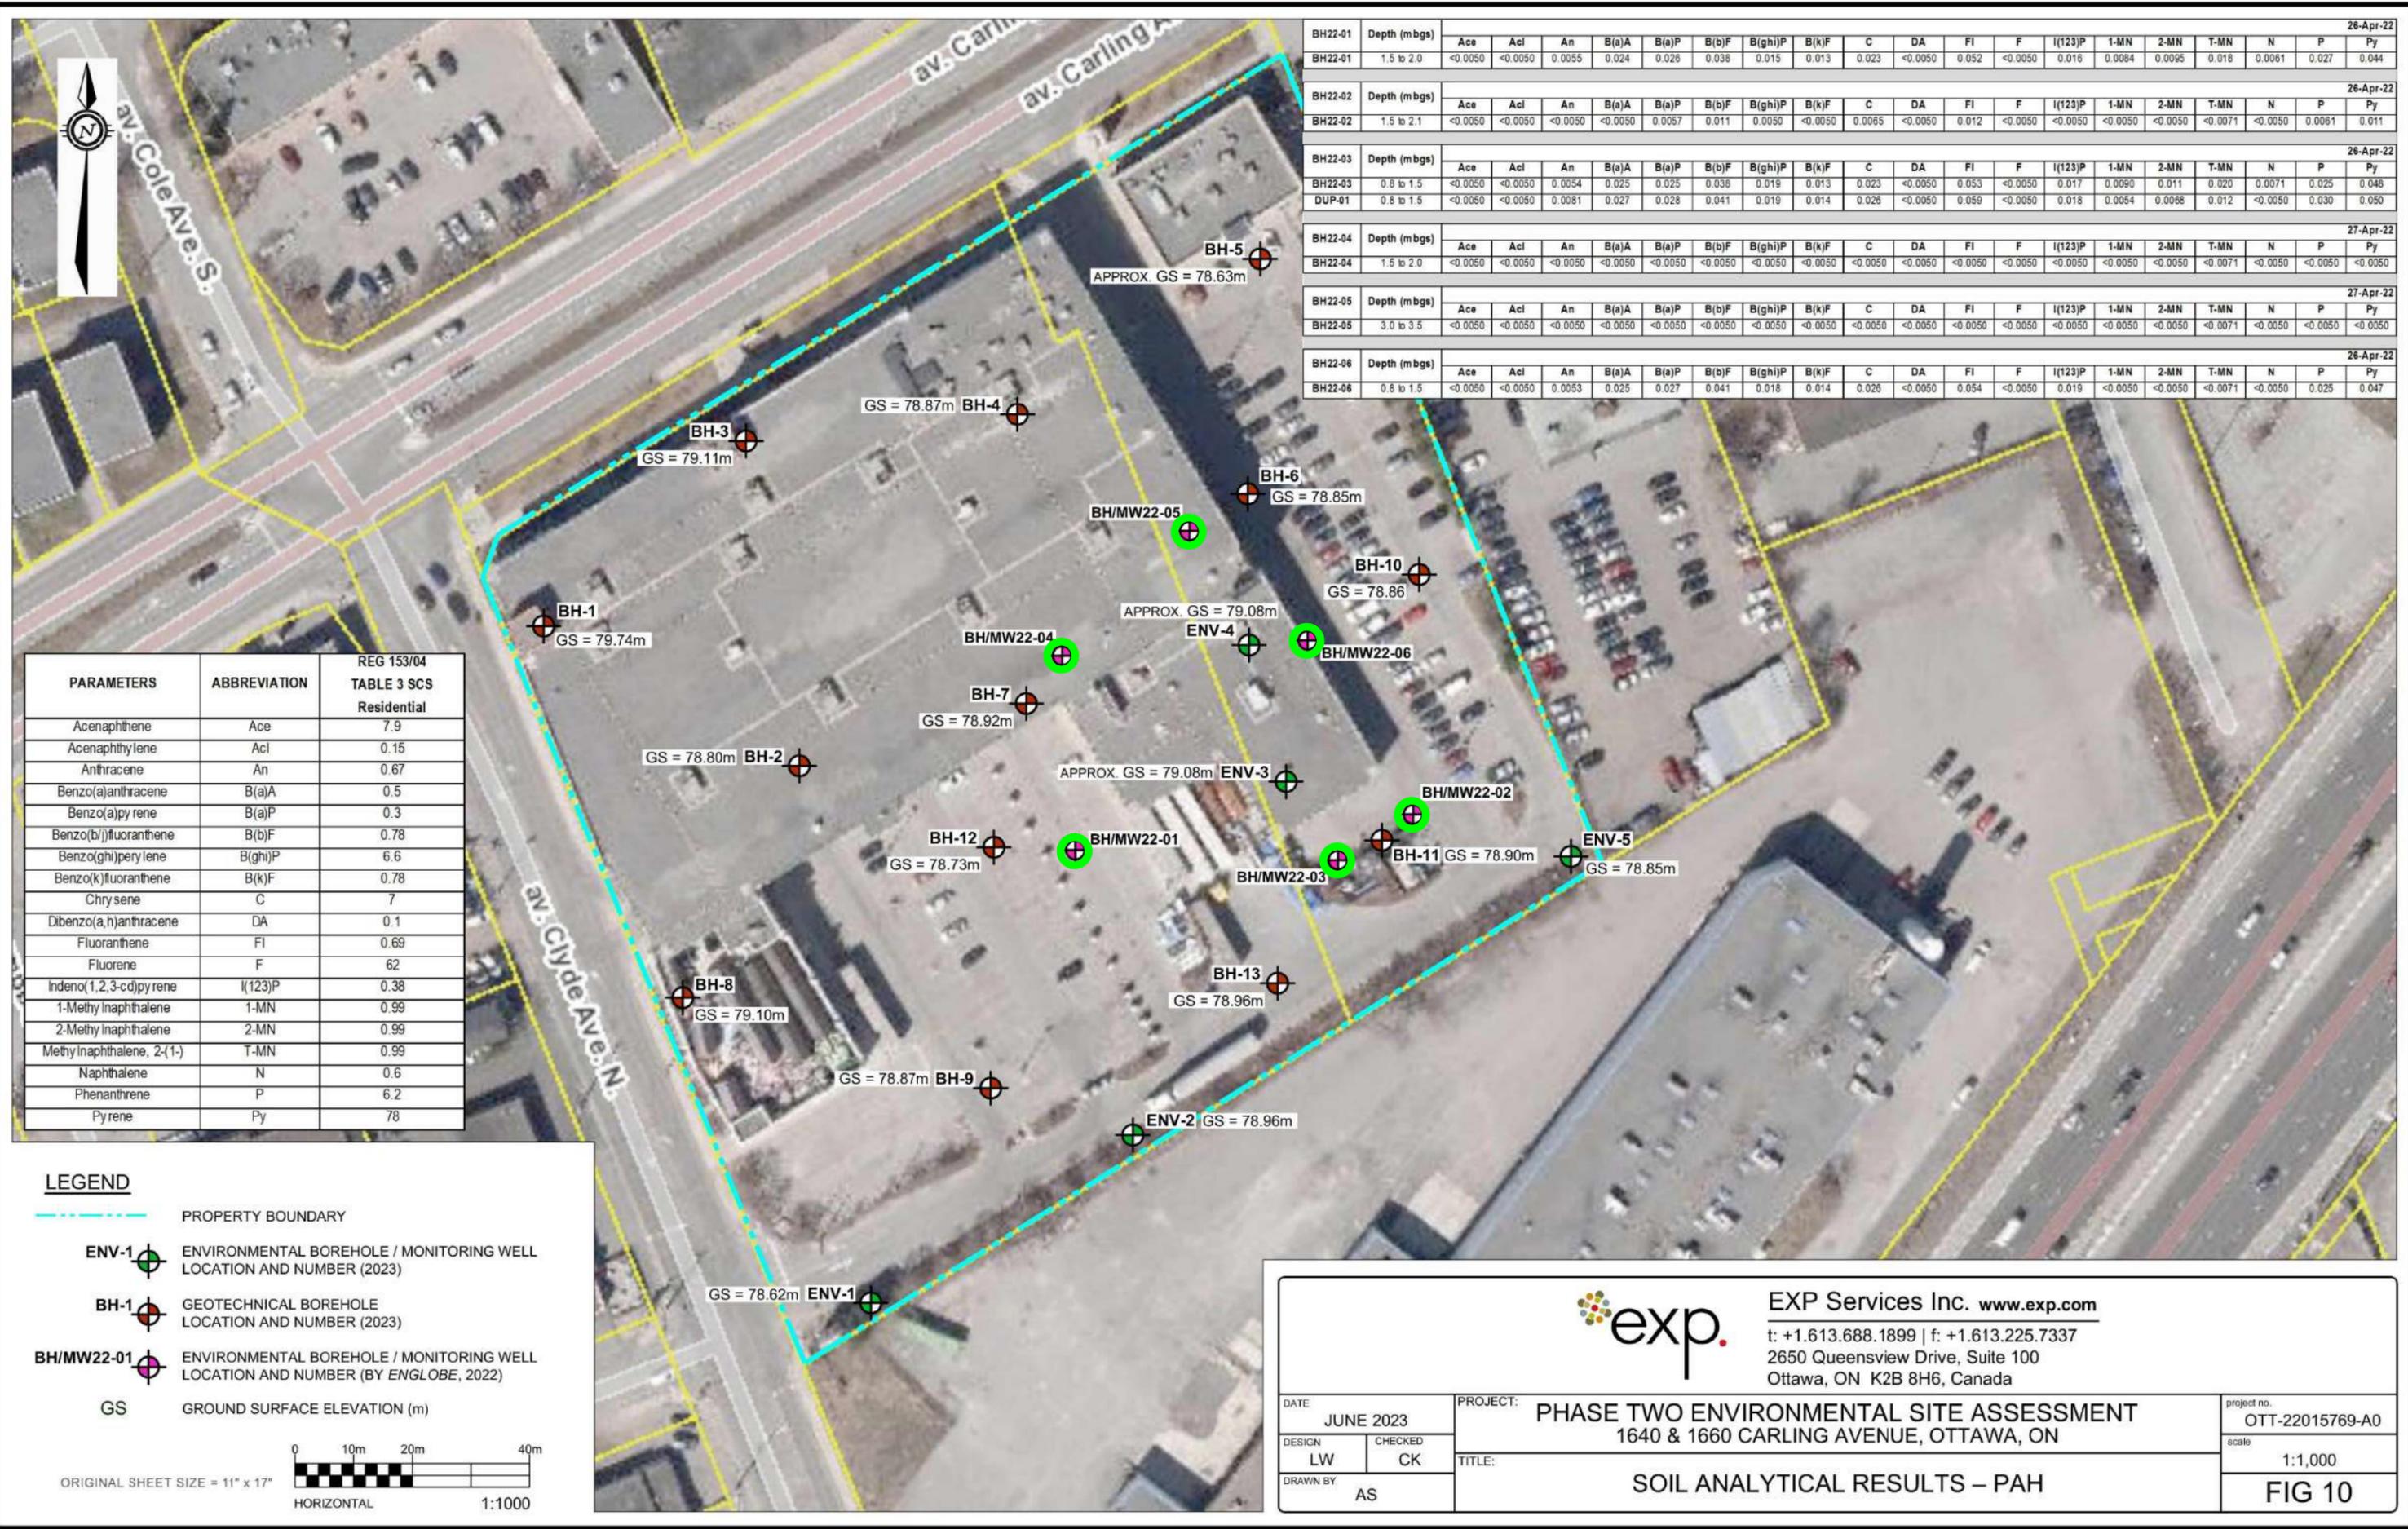
BH22-01	Depth (m bgs)	26-Apr-22																		
		Ace	AcI	An	B(a)A	B(a)P	B(b)F	B(ghi)P	B(k)F	C	DA	Fl	F	I(123)P	1-MN	2-MN	T-MN	N	P	Py
BH22-01	1.5 to 2.0	<0.0050	<0.0050	0.0055	0.024	0.026	0.038	0.015	0.013	0.023	<0.0050	0.052	<0.0050	0.016	0.0084	0.0095	0.016	0.0061	0.027	0.044

BH22-02	Depth (m bgs)	26-Apr-22																		
		Ace	AcI	An	B(a)A	B(a)P	B(b)F	B(ghi)P	B(k)F	C	DA	Fl	F	I(123)P	1-MN	2-MN	T-MN	N	P	Py
BH22-02	1.5 to 2.1	<0.0050	<0.0050	<0.0050	<0.0050	0.0057	0.011	0.0050	<0.0050	0.0065	<0.0050	0.012	<0.0050	<0.0050	<0.0050	<0.0050	<0.0071	<0.0050	<0.0050	0.011

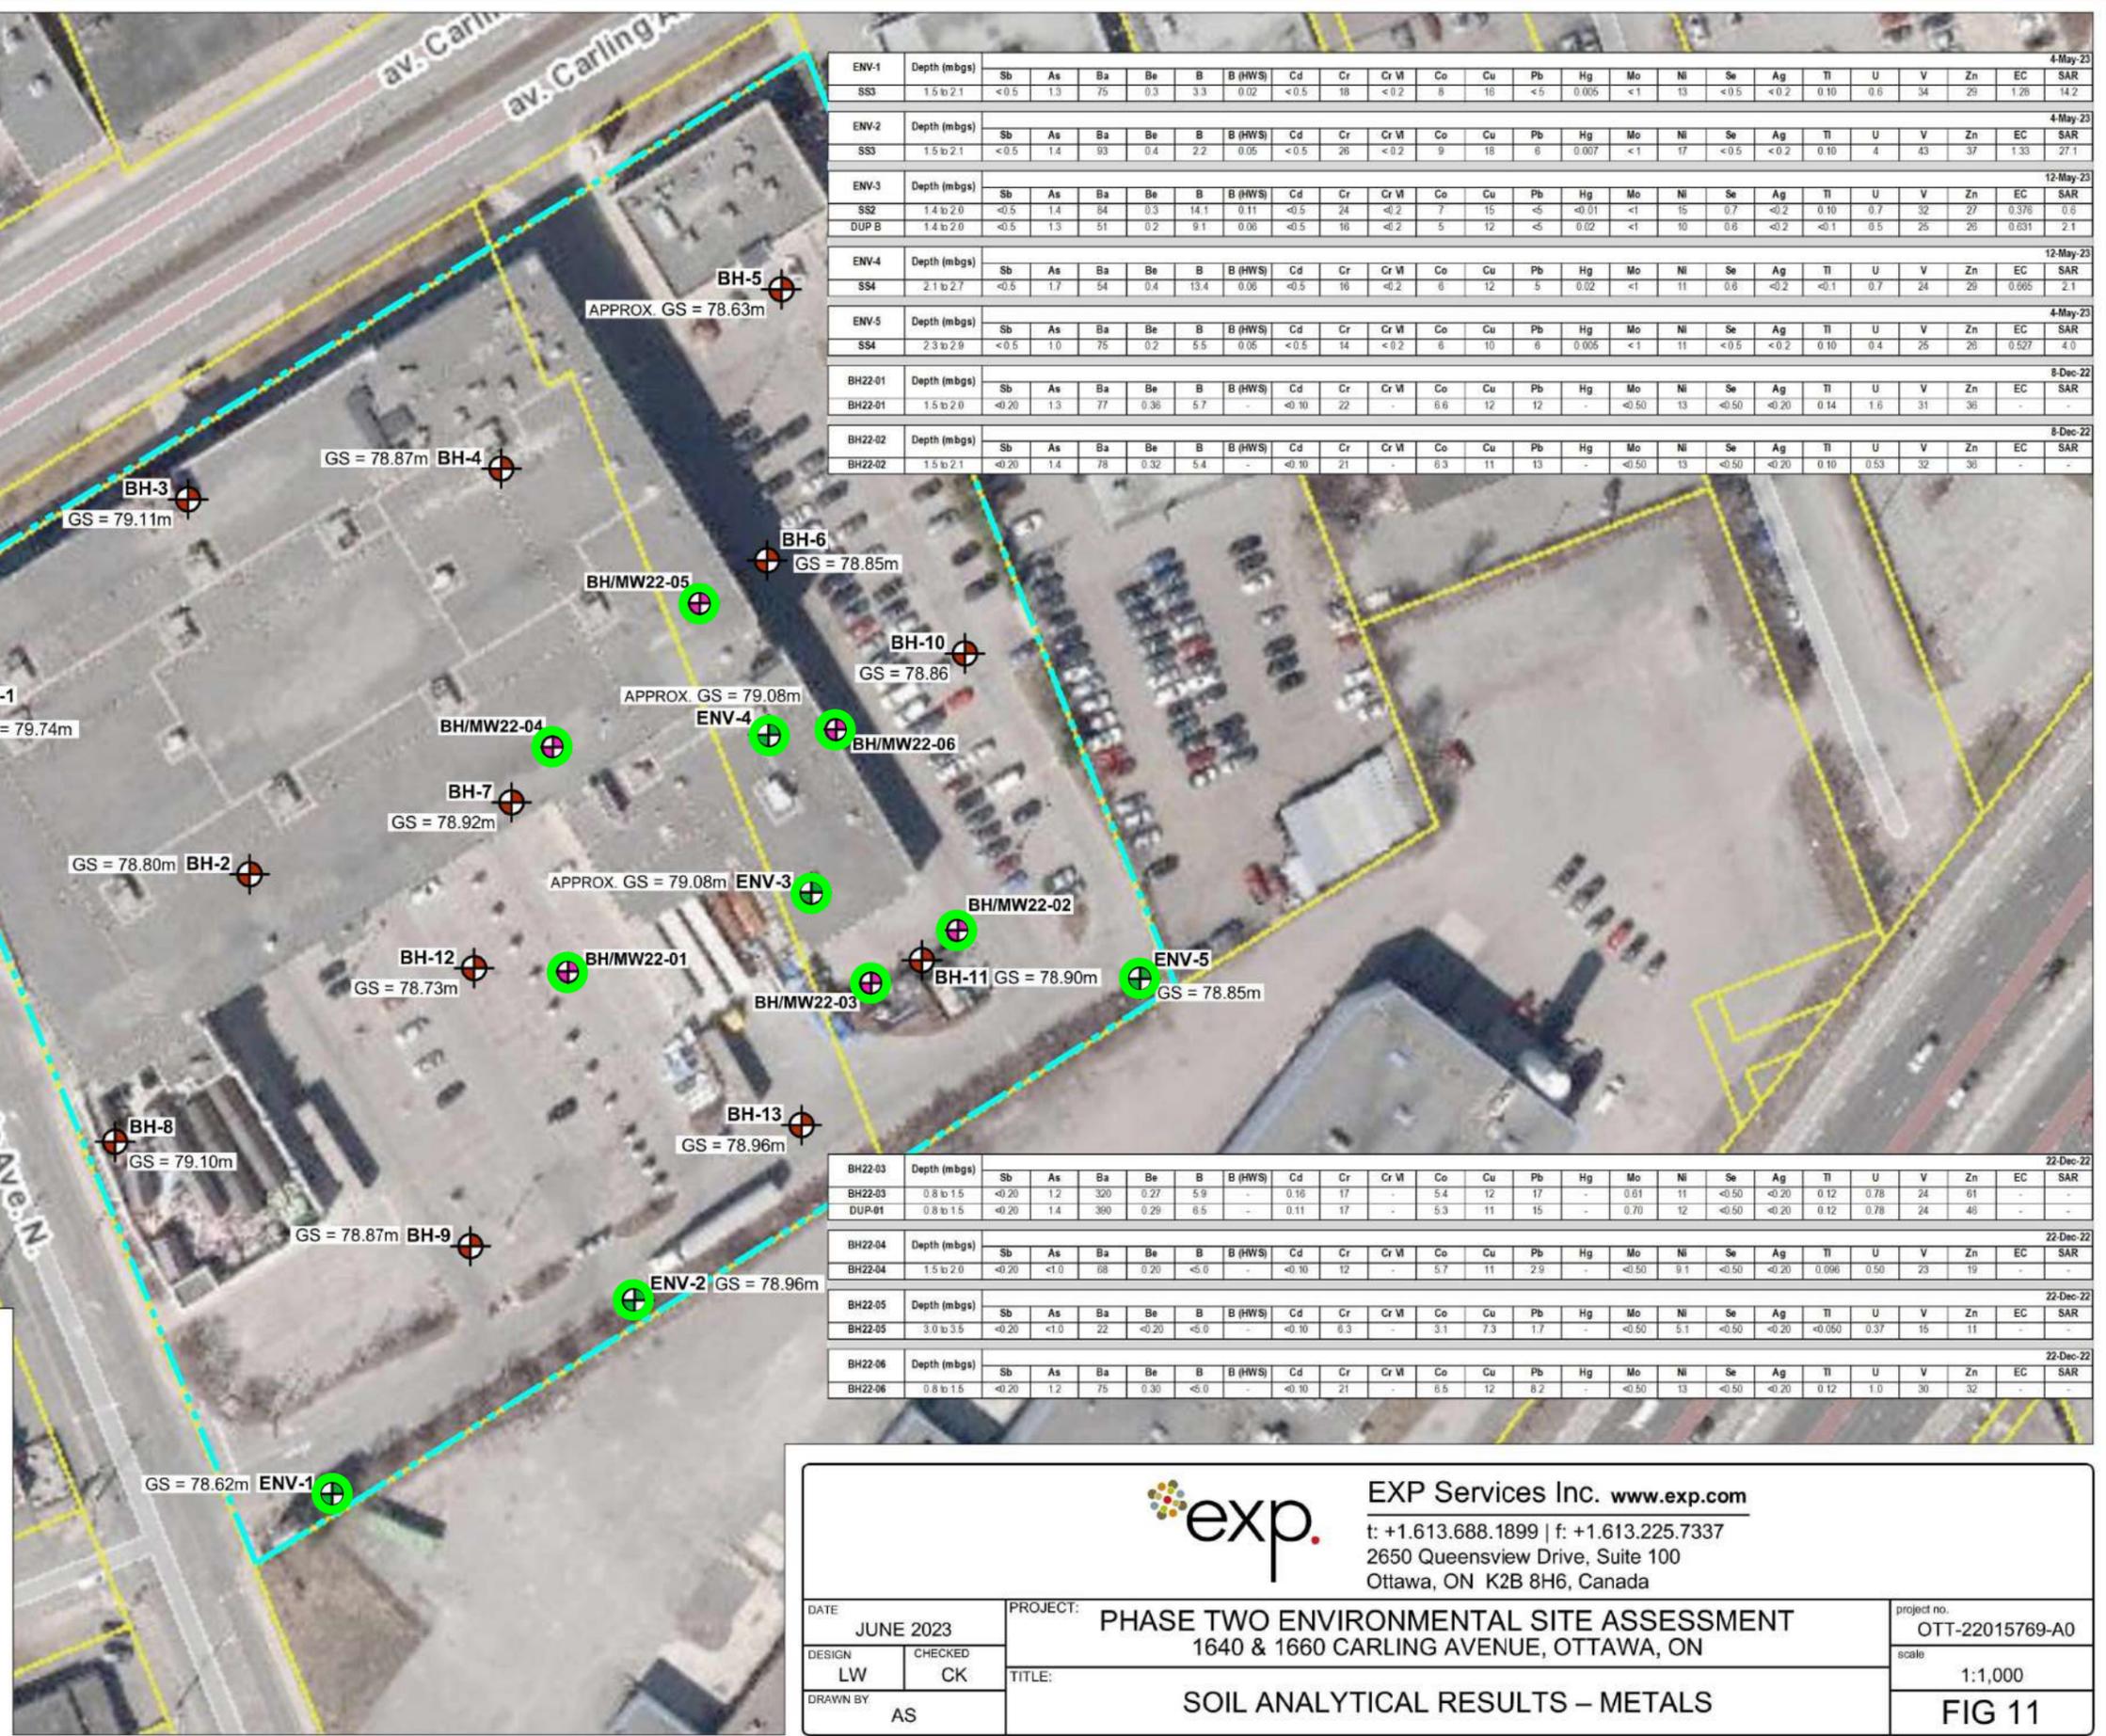
ENV-1	Depth (mbgs)	Sb	As	Ba	Be	B	B (HWS)	Cd	Cr	Cr VI	Co	Cu	Pb	Hg	Mo	Ni	Se	Ag	Tl	U	V	Zn	EC	SAR	4-May-23
SS3	1.5 to 2.1	<0.5	1.3	75	0.3	3.3	0.02	<0.5	18	<0.2	8	18	<5	0.005	<1	13	<0.5	<0.2	0.10	0.6	34	29	1.28	14.2	
ENV-2	Depth (mbgs)	Sb	As	Ba	Be	B	B (HWS)	Cd	Cr	Cr VI	Co	Cu	Pb	Hg	Mo	Ni	Se	Ag	Tl	U	V	Zn	EC	SAR	4-May-23
SS3	1.5 to 2.1	<0.5	1.4	93	0.4	2.2	0.05	<0.5	26	<0.2	9	18	6	0.007	<1	17	<0.5	<0.2	0.10	4	43	37	1.33	27.1	
ENV-3	Depth (mbgs)	Sb	As	Ba	Be	B	B (HWS)	Cd	Cr	Cr VI	Co	Cu	Pb	Hg	Mo	Ni	Se	Ag	Tl	U	V	Zn	EC	SAR	12-May-23
SS2	1.4 to 2.0	<0.5	1.4	84	0.3	14.1	0.11	<0.5	24	<0.2	7	15	<5	<0.01	<1	15	0.7	<0.2	0.10	0.7	32	27	0.378	0.8	
DUP B	1.4 to 2.0	<0.5	1.3	51	0.2	9.1	0.06	<0.5	16	<0.2	5	12	<5	0.02	<1	10	0.6	<0.2	<0.1	0.5	25	26	0.631	2.1	
ENV-4	Depth (mbgs)	Sb	As	Ba	Be	B	B (HWS)	Cd	Cr	Cr VI	Co	Cu	Pb	Hg	Mo	Ni	Se	Ag	Tl	U	V	Zn	EC	SAR	12-May-23
SS4	2.1 to 2.7	<0.5	1.7	54	0.4	13.4	0.06	<0.5	16	<0.2	6	12	5	0.02	<1	11	0.6	<0.2	<0.1	0.7	24	29	0.665	2.1

ENV-5	Depth (mbgs)	Sb	As	Ba	Be	B	B (HWS)	Cd	Cr	Cr VI	Co	Cu	Pb	Hg	Mo	Ni	Se	Ag	Tl	U	V	Zn	EC	SAR	4-May-23
SS4	2.3 to 2.9	<0.5	1.0	75	0.2	5.5	0.05	<0.5	14	<0.2	6	10	6	0.005	<1	11	<0.5	<0.2	0.10	0.4	25	26	0.527	4.0	
BH22-01	Depth (mbgs)	Sb	As	Ba	Be	B	B (HWS)	Cd	Cr	Cr VI	Co	Cu	Pb	Hg	Mo	Ni	Se	Ag	Tl	U	V	Zn	EC	SAR	8-Dec-22
BH22-01	1.5 to 2.0	<0.20	1.3	77	0.36	5.7	-	<0.10	22	-	6.6	12	12	-	<0.50	13	<0.50	<0.20	0.14	1.6	31	36	-	-	
BH22-02	Depth (mbgs)	Sb	As	Ba	Be	B	B (HWS)	Cd	Cr	Cr VI	Co	Cu	Pb	Hg	Mo	Ni	Se	Ag	Tl	U	V	Zn	EC	SAR	8-Dec-22
BH22-02	1.5 to 2.1	<0.20	1.4	78	0.32	5.4	-	<0.10	21	-	6.3	11	13	-	<0.50	13	<0.50	<0.20	0.10	0.53	32	36	-	-	
BH22-03	Depth (mbgs)	Sb	As	Ba	Be	B	B (HWS)	Cd	Cr	Cr VI	Co	Cu	Pb	Hg	Mo	Ni	Se	Ag	Tl	U	V	Zn	EC	SAR	22-Dec-22
BH22-03	0.8 to 1.5	<0.20	1.2	320	0.27	5.9	-	0.16	17	-	5.4	12	17	-	0.61	11	<0.50	<0.20	0.12	0.78	24	61	-	-	
DUP-01	0.8 to 1.5	<0.20	1.4	390	0.29	6.5	-	0.11	17	-	5.3	11	15	-	0.70	12	<0.50	<0.20	0.12	0.78	24	46	-	-

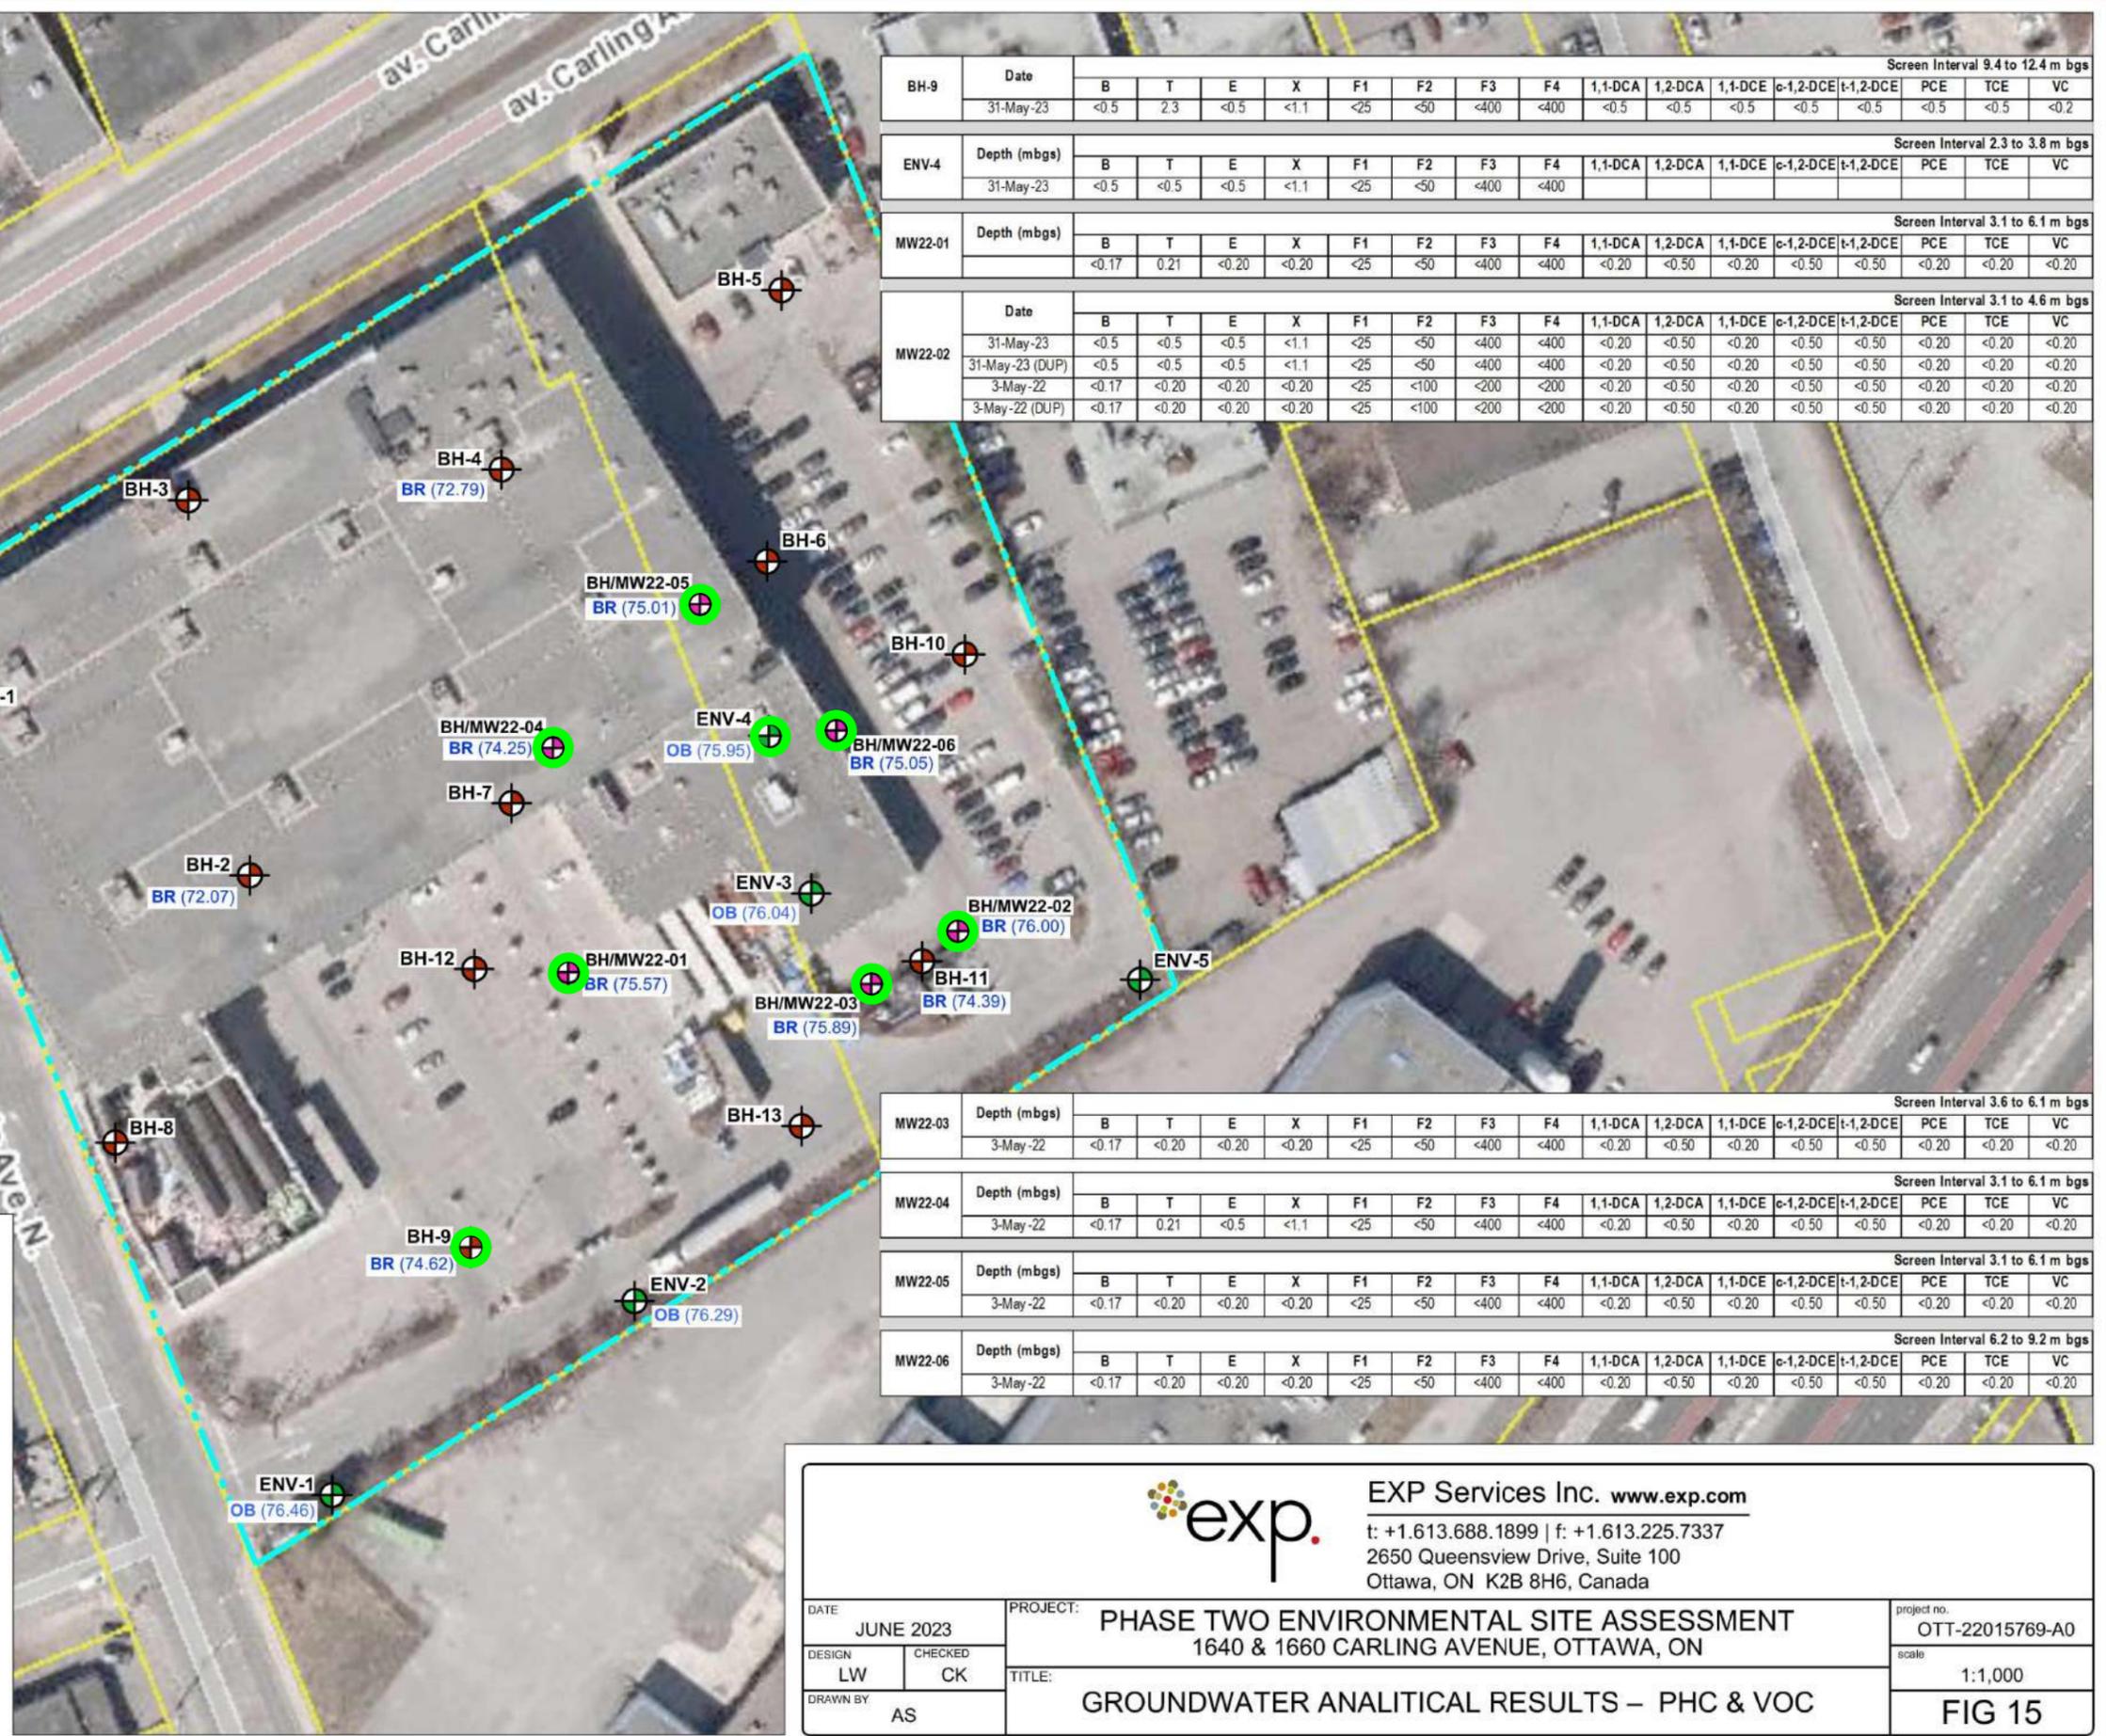
BH-9	Date	Screen Interval 9.4 to 12.4 m bgs															
		B	T	E	X	F1	F2	F3	F4	1,1-DCA	1,2-DCA	1,1-DCE	c-1,2-DCE	t-1,2-DCE	PCE	TCE	VC
	31-May-23	<0.5	2.3	<0.5	<1.1	<25	<50	<400	<400	<0.5	<0.5	<0.5	<0.5	<0.5	<0.5	<0.5	<0.2

ENV-4	Depth (mbgs)	Screen Interval 2.3 to 3.8 m bgs															
		B	T	E	X	F1	F2	F3	F4	1,1-DCA	1,2-DCA	1,1-DCE	c-1,2-DCE	t-1,2-DCE	PCE	TCE	VC
	31-May-23	<0.5	<0.5	<0.5	<1.1	<25	<50	<400	<400
