Phase Two Environmental Site Assessment 1640-1660 Carling Avenue, Ottawa, Ontario

Phase Two Environmental Site Assessment

OTT-22015769-A0

2023-07-06

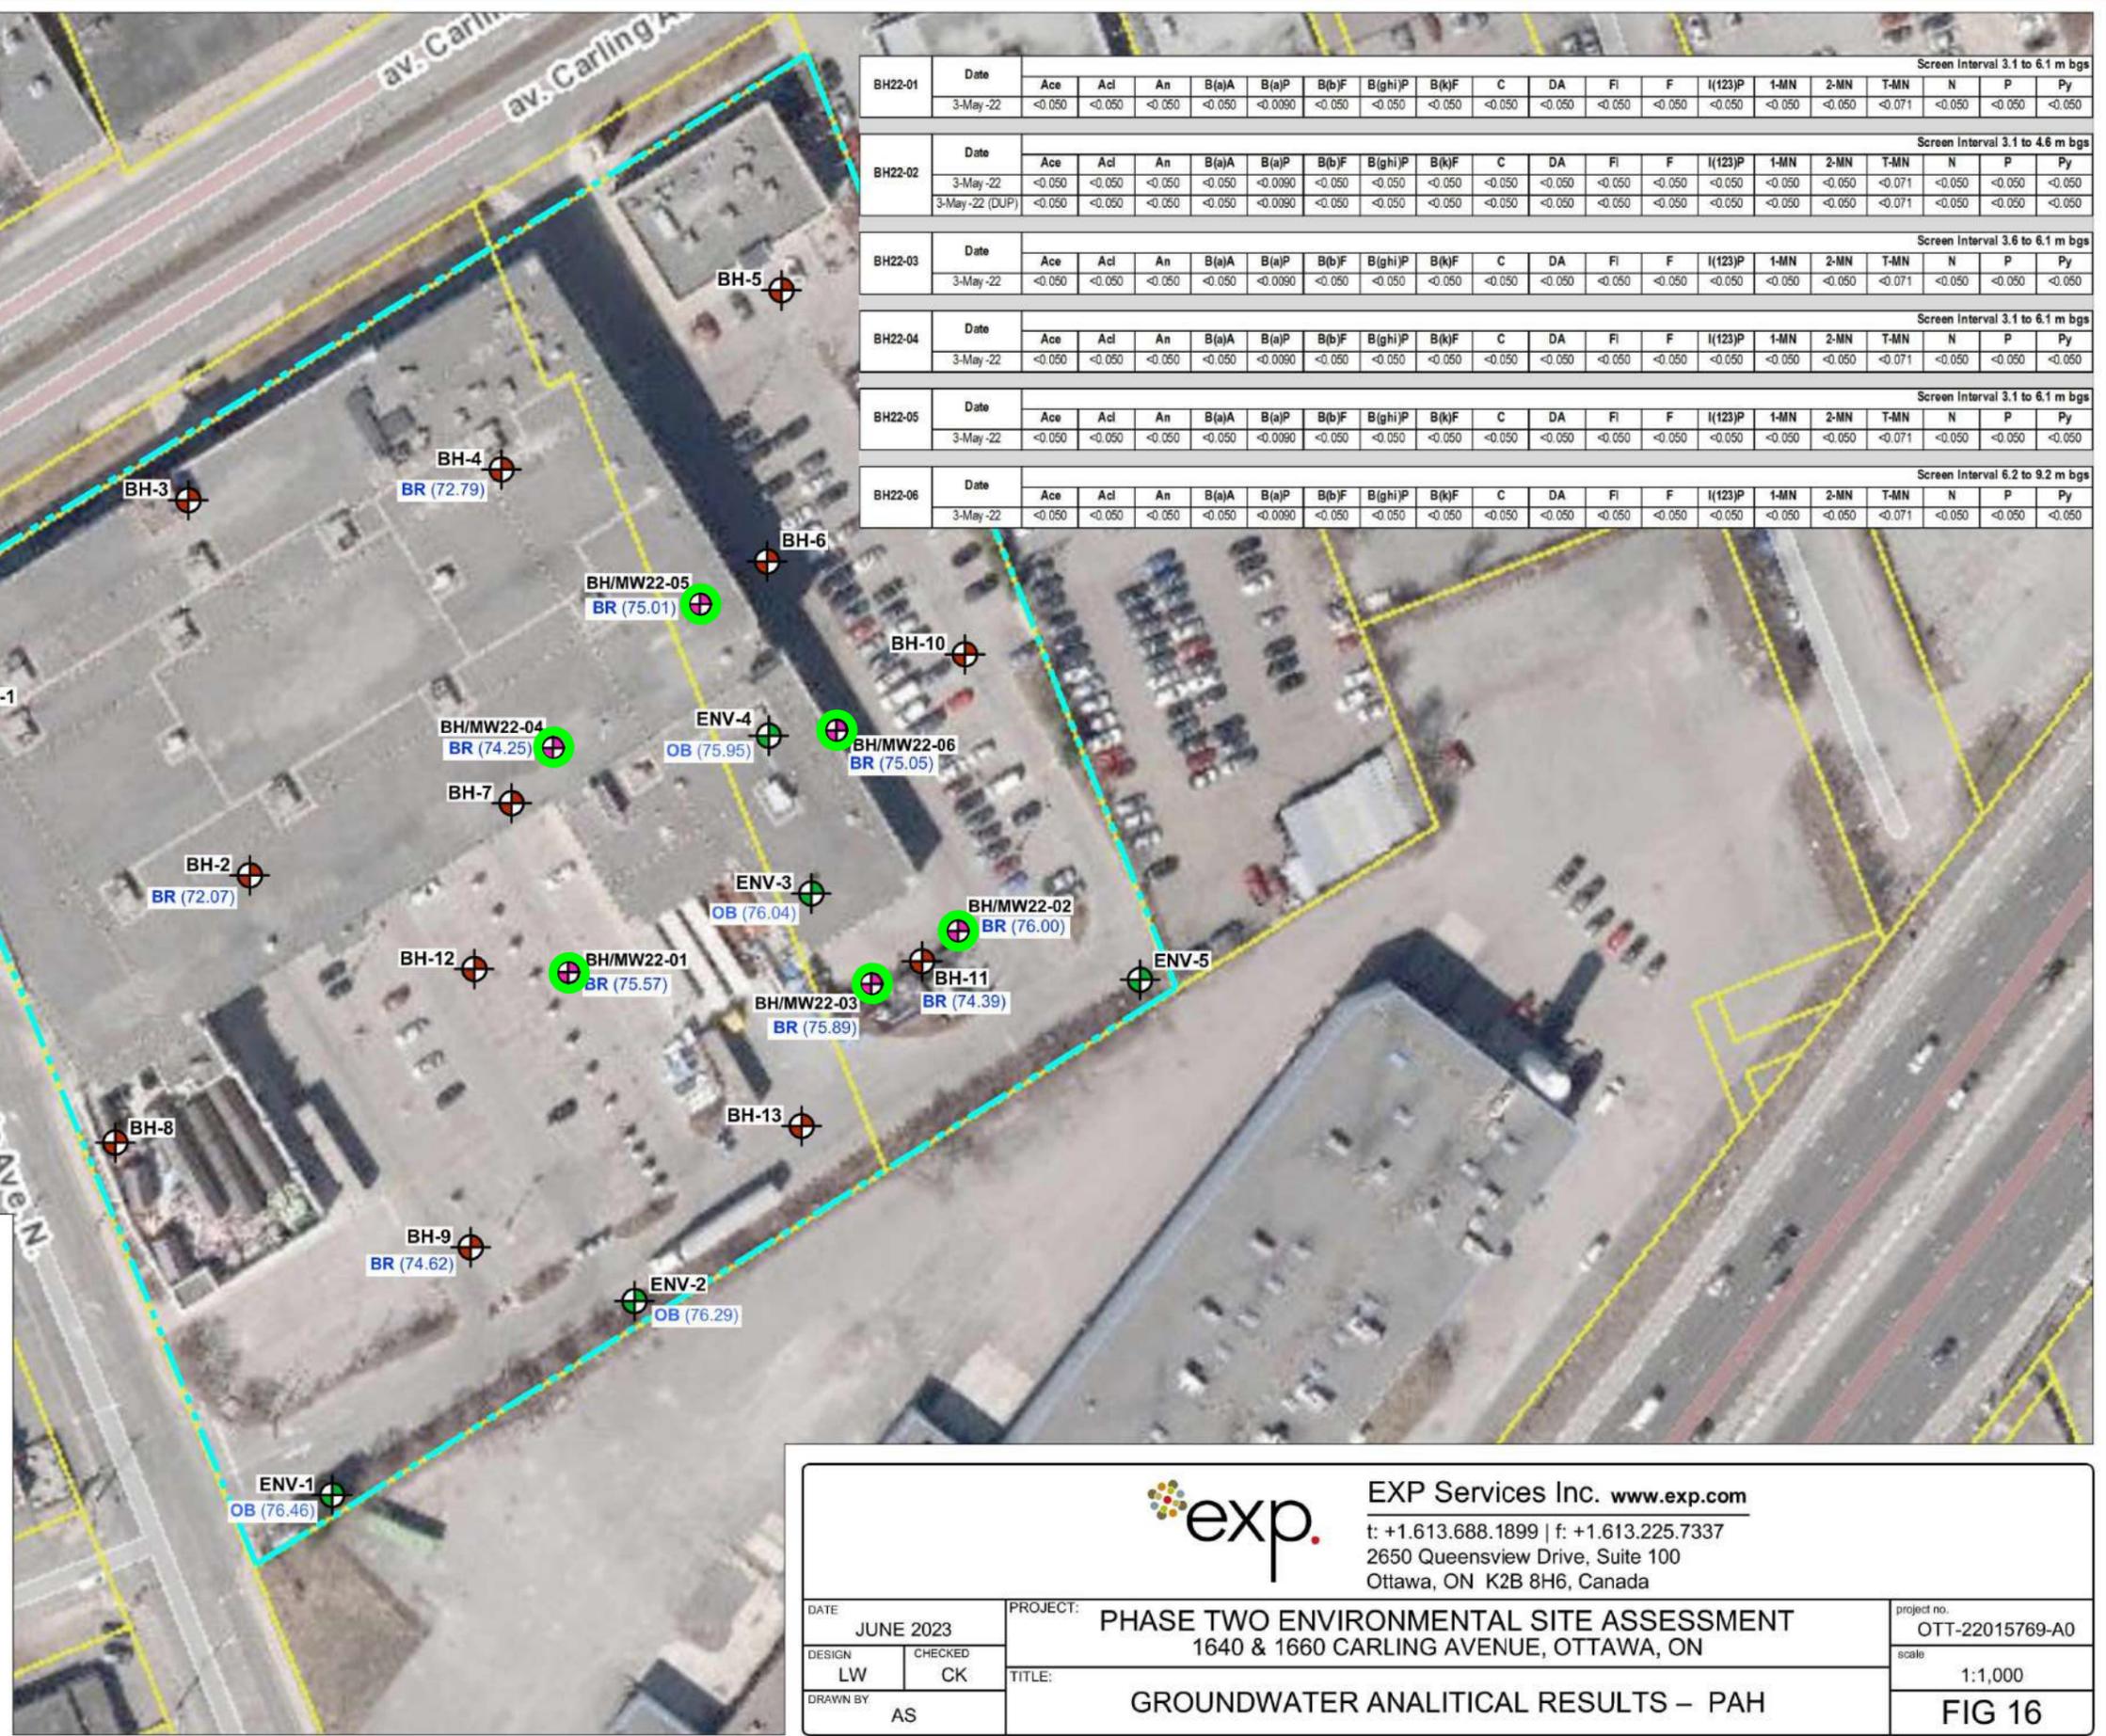
Borehole ID	Date	Screen Interval 3.1 to 6.1 m bgs																		
		Ace	Acl	An	B(a)A	B(a)P	B(b)F	B(ghi)P	B(k)F	C	DA	Fl	F	I(123)P	1-MN	2-MN	T-MN	N	P	Py
BH22-01	3-May-22	<0.050	<0.050	<0.050	<0.050	<0.0090	<0.050	<0.050	<0.050	<0.050	<0.050	<0.050	<0.050	<0.050	<0.050	<0.050	<0.050	<0.050	<0.050	<0.050
	3-May-22 (DUP)	<0.050	<0.050	<0.050	<0.050	<0.0090	<0.050	<0.050	<0.050	<0.050	<0.050	<0.050	<0.050	<0.050	<0.050	<0.050	<0.050	<0.050	<0.050	<0.050
BH22-02	3-May-22	<0.050	<0.050	<0.050	<0.050	<0.0090	<0.050	<0.050	<0.050	<0.050	<0.050	<0.050	<0.050	<0.050	<0.050	<0.050	<0.050	<0.050	<0.050	<0.050
	3-May-22 (DUP)	<0.050	<0.050	<0.050	<0.050	<0.0090	<0.050	<0.050	<0.050	<0.050	<0.050	<0.050	<0.050	<0.050	<0.050	<0.050	<0.050	<0.050	<0.050	<0.050
BH22-03	3-May-22	<0.050	<0.050	<0.050	<0.050	<0.0090	<0.050	<0.050	<0.050	<0.050	<0.050	<0.050	<0.050	<0.050	<0.050	<0.050	<0.050	<0.050	<0.050	<0.050
	3-May-22 (DUP)	<0.050	<0.050	<0.050	<0.050	<0.0090	<0.050	<0.050	<0.050	<0.050	<0.050	<0.050	<0.050	<0.050	<0.050	<0.050	<0.050	<0.050	<0.050	<0.050

BH22-04	3-May-22	<0.050	<0.050	<0.050	<0.050	<0.0090	<0.050	<0.050	<0.050	<0.050	<0.050	<0.050	<0.050	<0.050	<0.050	<0.050	<0.050	<0.050	<0.050	<0.050
	3-May-22 (DUP)	<0.050	<0.050	<0.050	<0.050	<0.0090	<0.050	<0.050	<0.050	<0.050	<0.050	<0.050	<0.050	<0.050	<0.050	<0.050	<0.050	<0.050	<0.050	<0.050
BH22-05	3-May-22	<0.050	<0.050	<0.050	<0.050	<0.0090	<0.050	<0.050	<0.050	<0.050	<0.050	<0.050	<0.050	<0.050	<0.050	<0.050	<0.050	<0.050	<0.050	<0.050
	3-May-22 (DUP)	<0.050	<0.050	<0.050	<0.050	<0.0090	<0.050	<0.050	<0.050	<0.050	<0.050	<0.050	<0.050	<0.050	<0.050	<0.050	<0.050	<0.050	<0.050	<0.050
BH22-06	3-May-22	<0.050	<0.050	<0.050	<0.050	<0.0090	<0.050	<0.050	<0.050	<0.050	<0.050	<0.050	<0.050	<0.050	<0.050	<0.050	<0.050	<0.050	<0.050	<0.050
	3-May-22 (DUP)	<0.050	<0.050	<0.050	<0.050	<0.0090	<0.050	<0.050	<0.050	<0.050	<0.050	<0.050	<0.050	<0.050	<0.050	<0.050	<0.050	<0.050	<0.050	<0.050

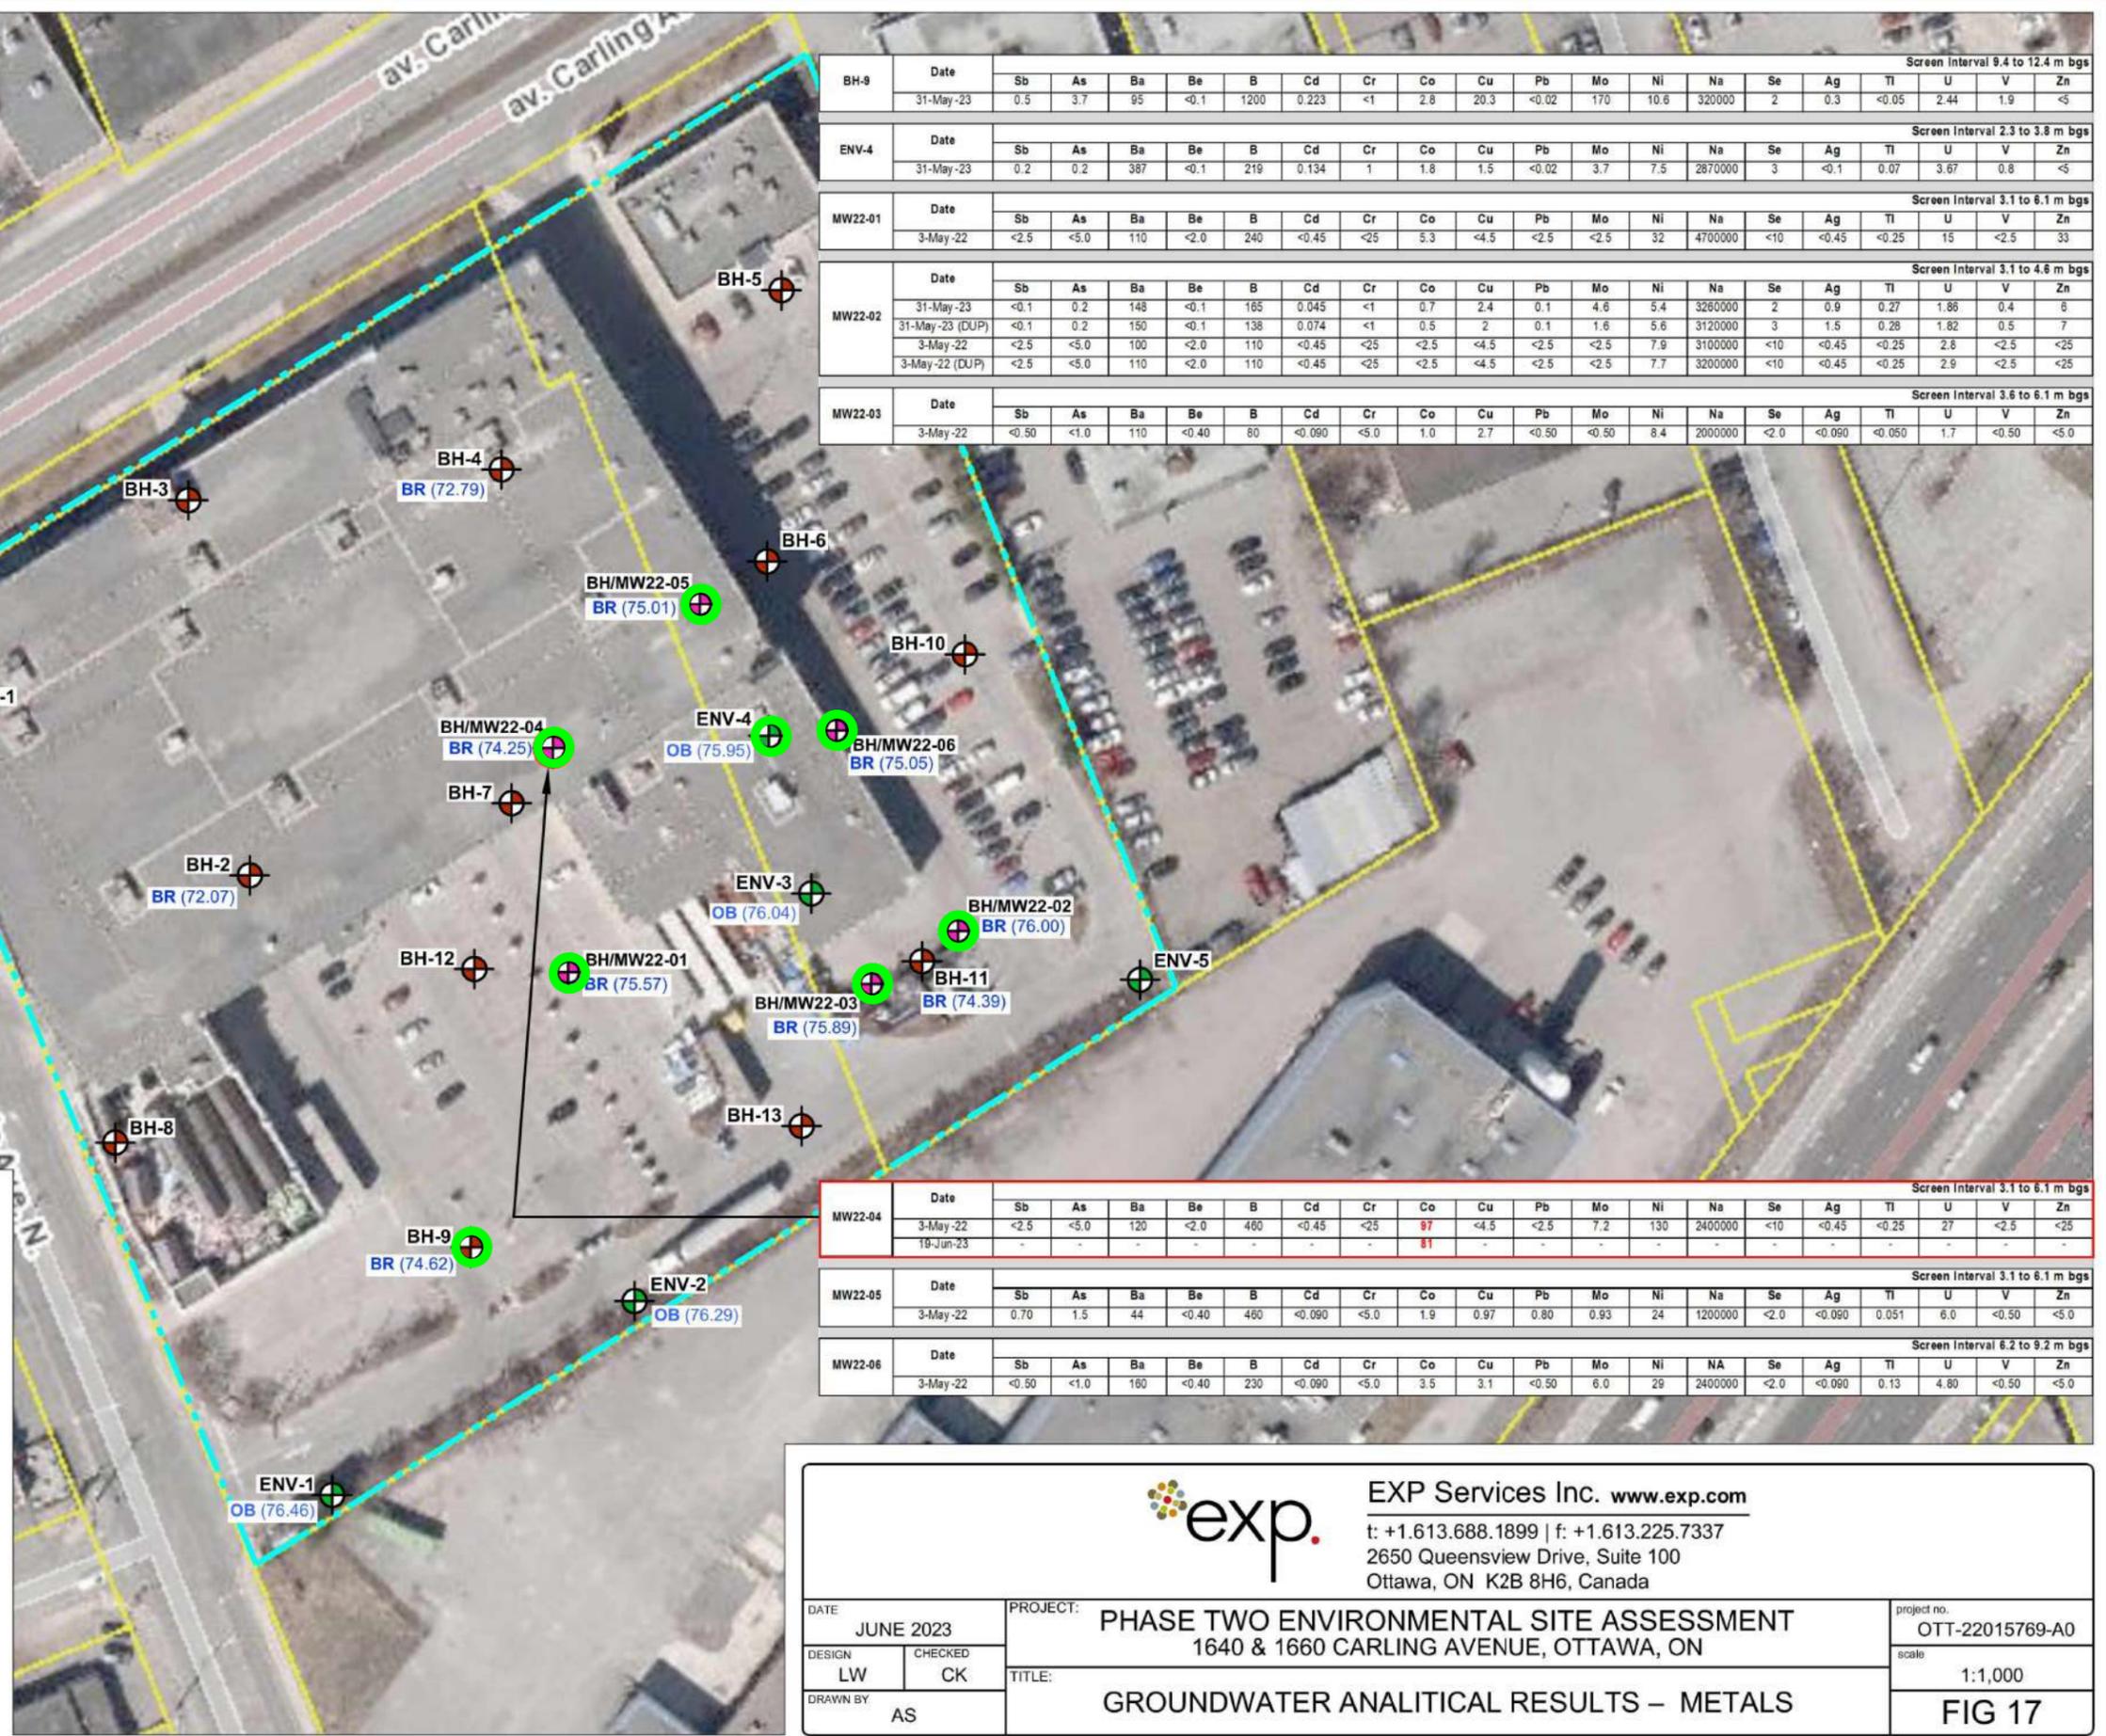
BH-9	Date	Screen Interval 9.4 to 12.4 m bgs																		
		Sb	As	Ba	Be	B	Cd	Cr	Co	Cu	Pb	Mo	Ni	Na	Se	Ag	Tl	U	V	Zn
	31-May-23	0.5	3.7	95	<0.1	1200	0.223	<1	2.8	20.3	<0.02	170	10.6	320000	2	0.3	<0.05	2.44	1.9	<5

ENV-4	Date	Screen Interval 2.3 to 3.8 m bgs																		
		Sb	As	Ba	Be	B	Cd	Cr	Co	Cu	Pb	Mo	Ni	Na	Se	Ag	Tl	U	V	Zn
	31-May-23	0.2	0.2	387	<0.1	219	0.134	1	1.8	1.5	<0.02	3.7	7.5	2870000	3	<0.1	0.07	3.67	0.8	<5

Groundwater samples collected from MW22-04 in 2022 and 2023 both exceeded the Table 3 SCS for cobalt. Although it is noted that the cobalt concentration in the sample collected by EXP in 2023 was lower than in the 2022 Englobe sample. None of the other monitoring wells had cobalt concentrations exceeding the Table 3 SCS. It recommended that MW22-04 be purged, and the cobalt concentration be monitored to assess for any trends.

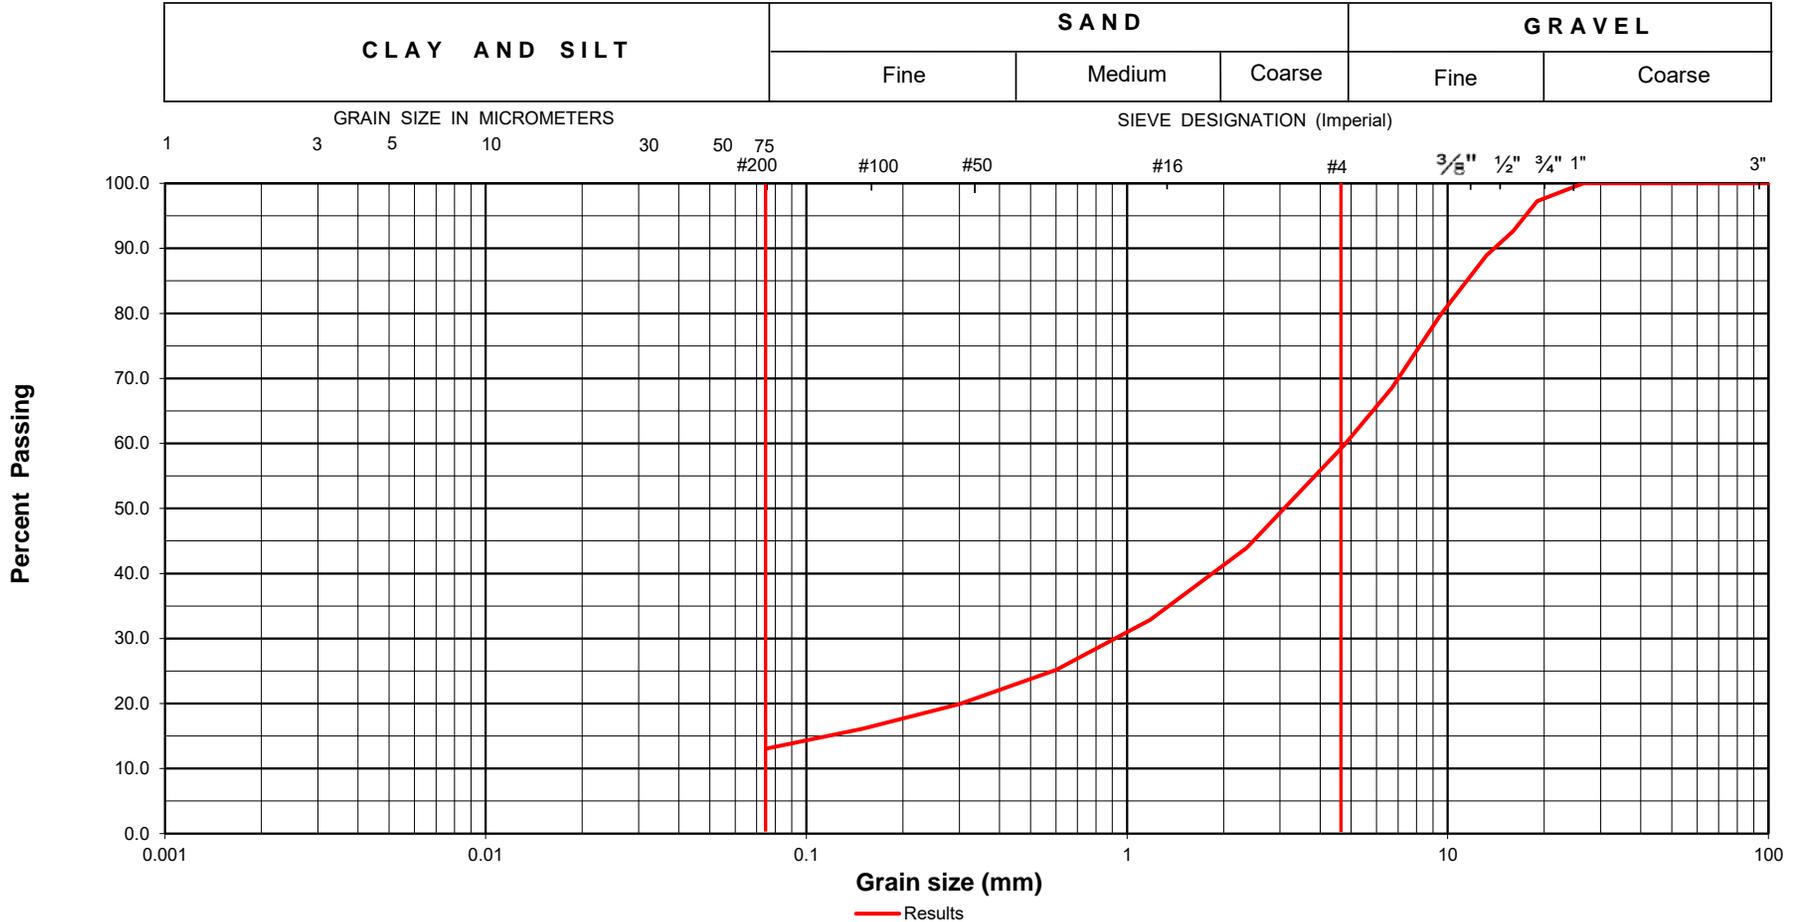
Exp Project No.: OTT-22015769-A0		Project Name : Proposed Residential High-Rise Towers	
Client : RioCan Real Estate Investment Trust		Project Location : 1640 - 1660 Carling Avenue, Ottawa, ON	
Date Sampled : May 9, 2023		Borehole: BH11	Sample: SS1
Sample Description :		% Silt & Clay 13	% Sand 47
		% Gravel 40	Depth (m) : 0.1 - 0.6
Sample Description : GRANULAR FILL: Sand and Gravel (SM) - Some Silt			Figure : 18

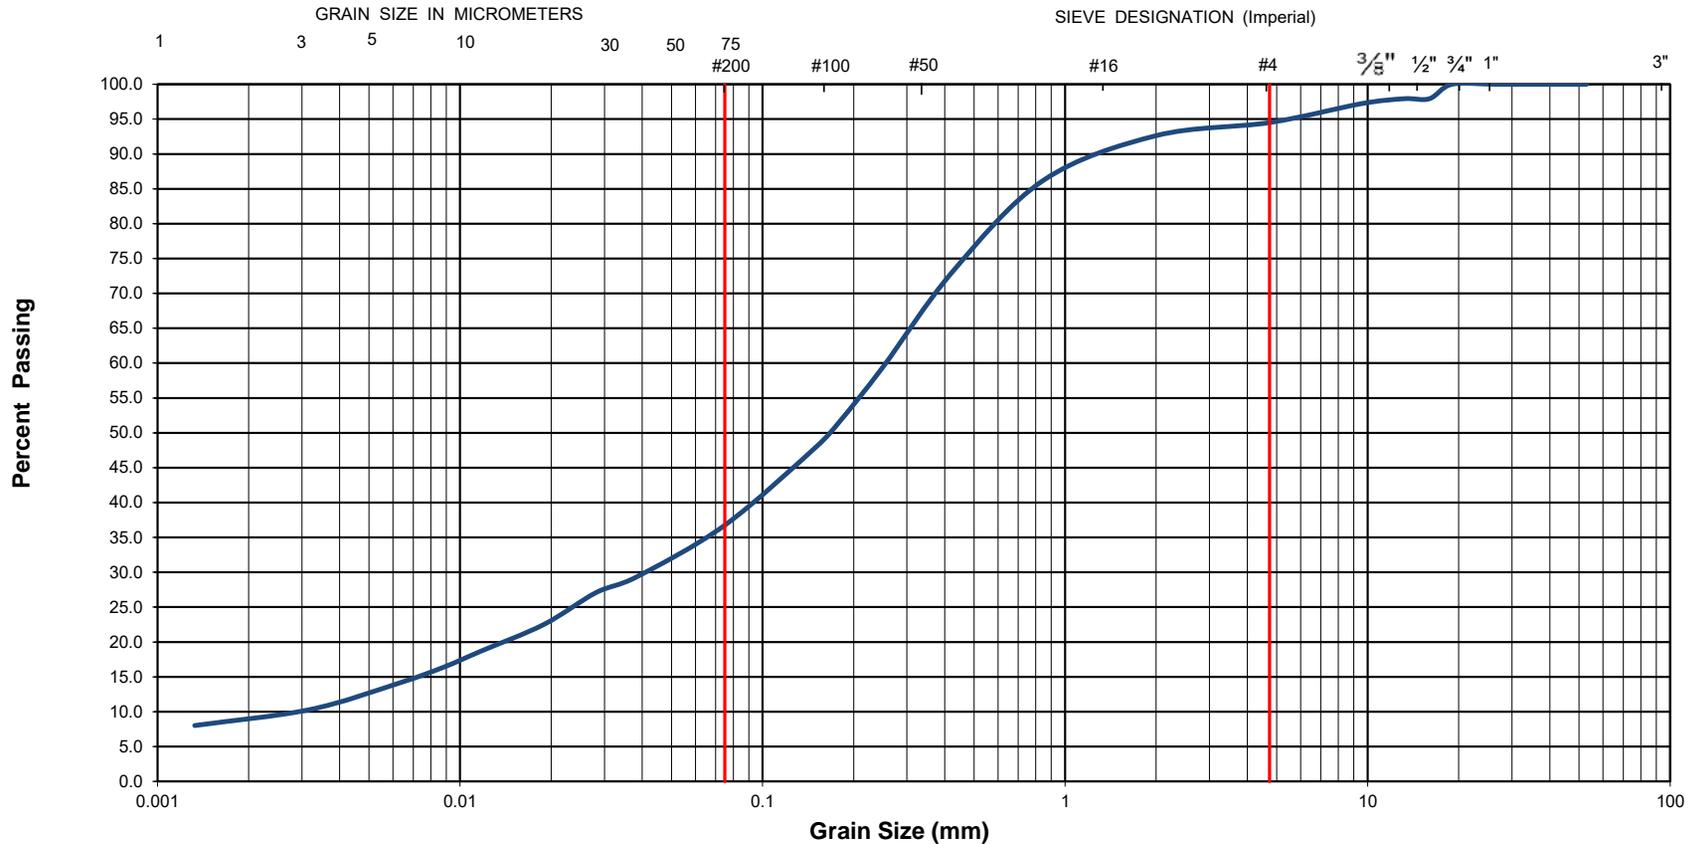
EXP Project No.:	OTT-22015769-A0	Project Name :	Proposed Residential High-Rise Towers	
Client :	RioCan Real Estate Investment Trust	Project Location :	1640-1660 Carling Avenue, Ottawa, ON	
Date Sampled :	May 8, 2023	Borehole No:	BH7	Sample No.: SS3
Sample Description :	% Silt and Clay	37	% Sand	57
Sample Description :	FILL: Silty Sand (SM) - Trace Gravel and Clay			% Gravel
				6
			Figure :	19

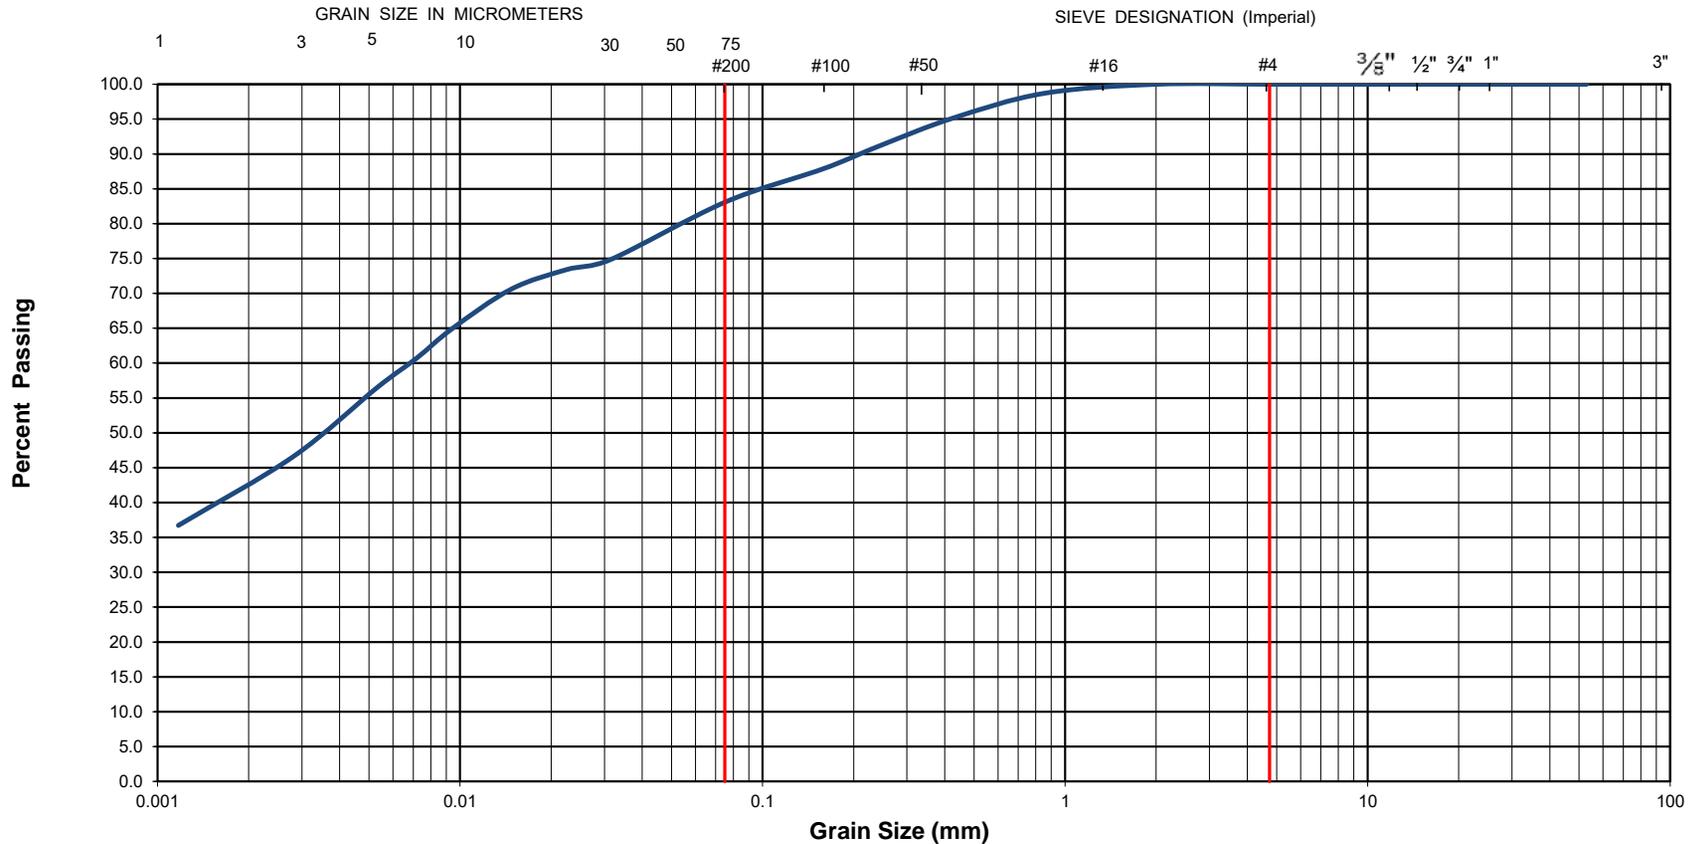
EXP Project No.:	OTT-22015769-A0	Project Name :	Proposed Residential High-Rise Towers		
Client :	RioCan Real Estate Investment Trust	Project Location :	1640-1660 Carling Avenue, Ottawa, ON		
Date Sampled :	May 9, 2023	Borehole No:	BH5	Sample No.: SS4	
		Depth (m) :	2.3-2.9		
Sample Description :	% Silt and Clay	83	% Sand	17	
		% Gravel	0		
Sample Description :	SILTY CLAY of Medium Plasticity (CL) - Some Sand			Figure :	20

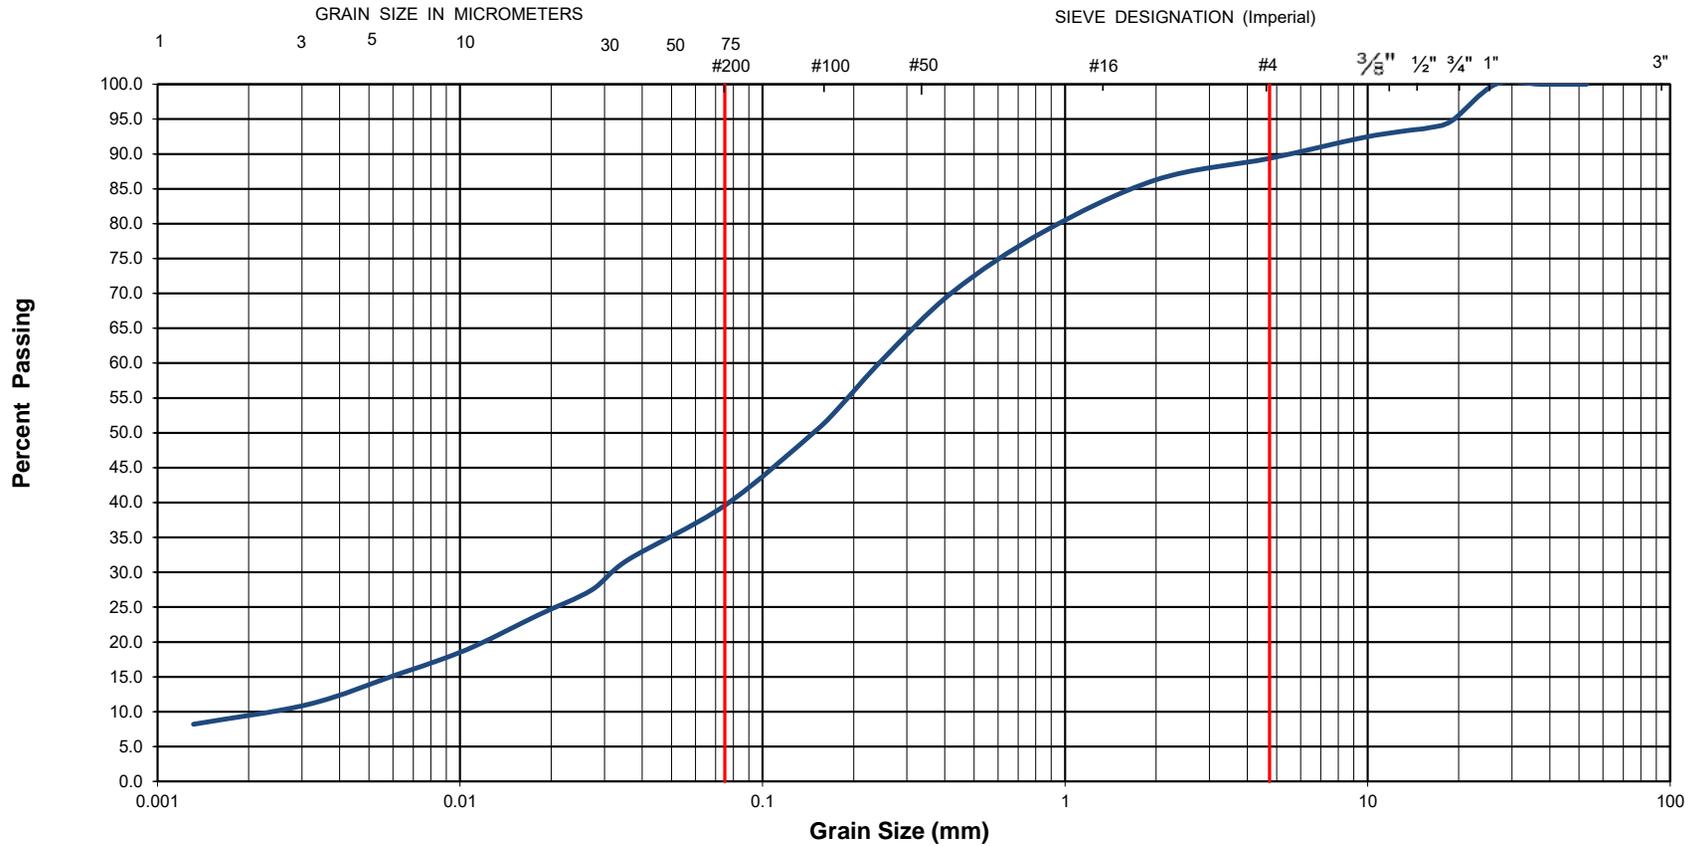
EXP Project No.:	OTT-22015769-A0	Project Name :	Proposed Residential High-Rise Towers		
Client :	RioCan Real Estate Investment Trust	Project Location :	1640-1660 Carling Avenue, Ottawa, ON		
Date Sampled :	May 5, 2023	Borehole No:	BH4	Sample No.: SS4	
Sample Description :	% Silt and Clay	40	% Sand	49	
Sample Description :			% Gravel	11	
Sample Description :	GLACIAL TILL: Silty Sand (SM) - Some Gravel and Clay			Figure :	21

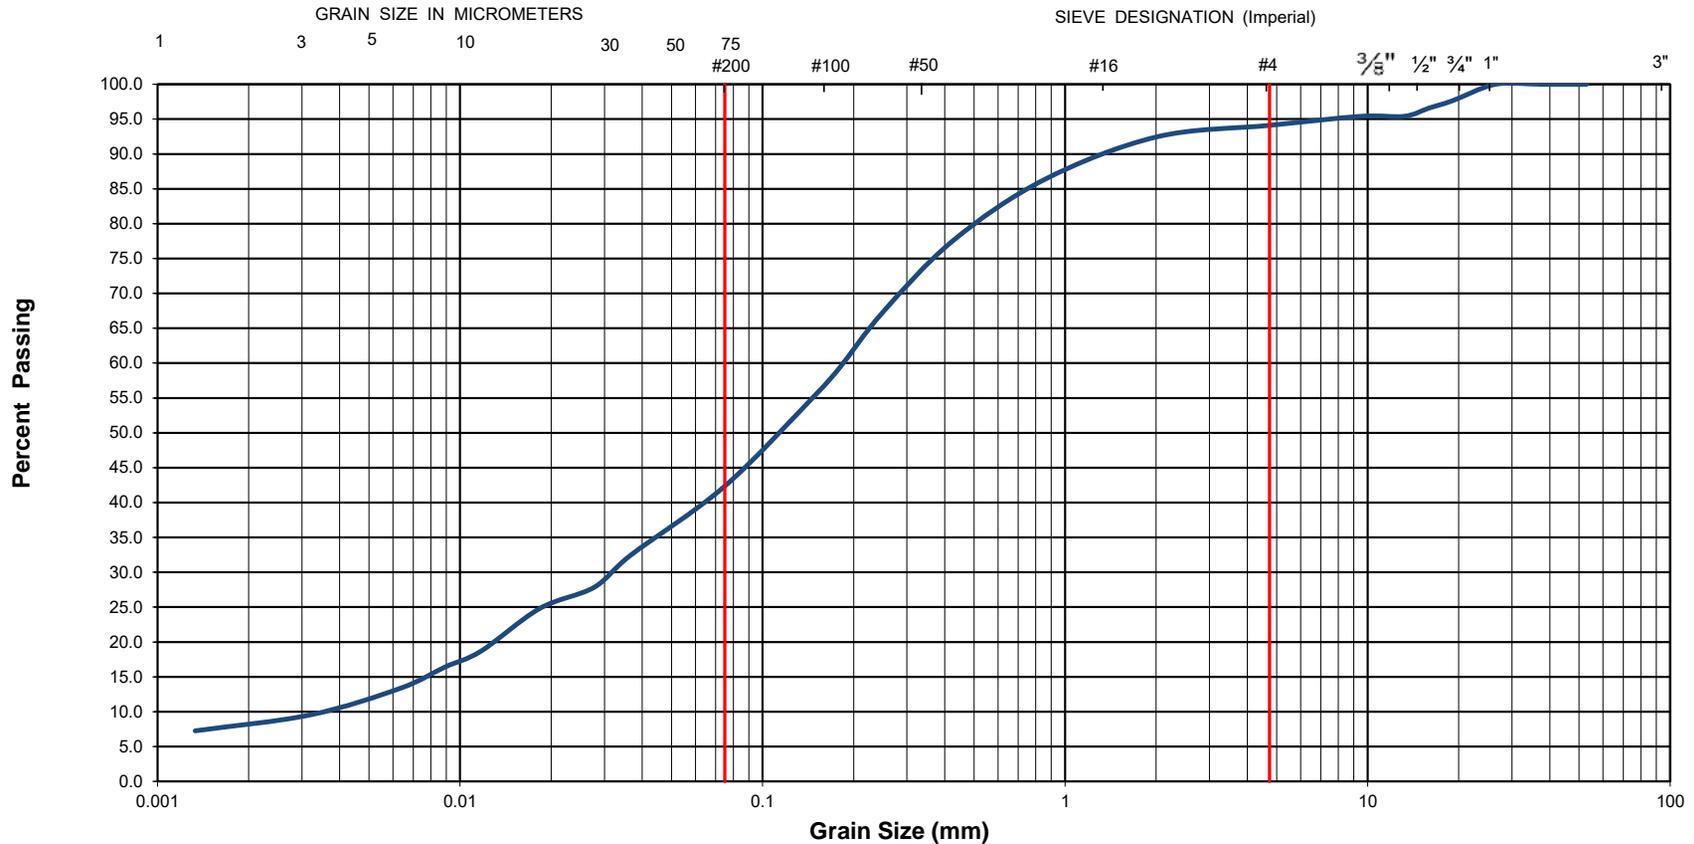
EXP Project No.:	OTT-22015769-A0	Project Name :	Proposed Residential High-Rise Towers		
Client :	RioCan Real Estate Investment Trust	Project Location :	1640-1660 Carling Avenue, Ottawa, ON		
Date Sampled :	May 5, 2023	Borehole No:	BH8	Sample No.: SS3	
Sample Description :	% Silt and Clay	42	% Sand	52	
Sample Description :	GLACIAL TILL: Silty Sand (SM) - Trace Gravel and Clay			% Gravel	6
Sample Description :				Figure :	22

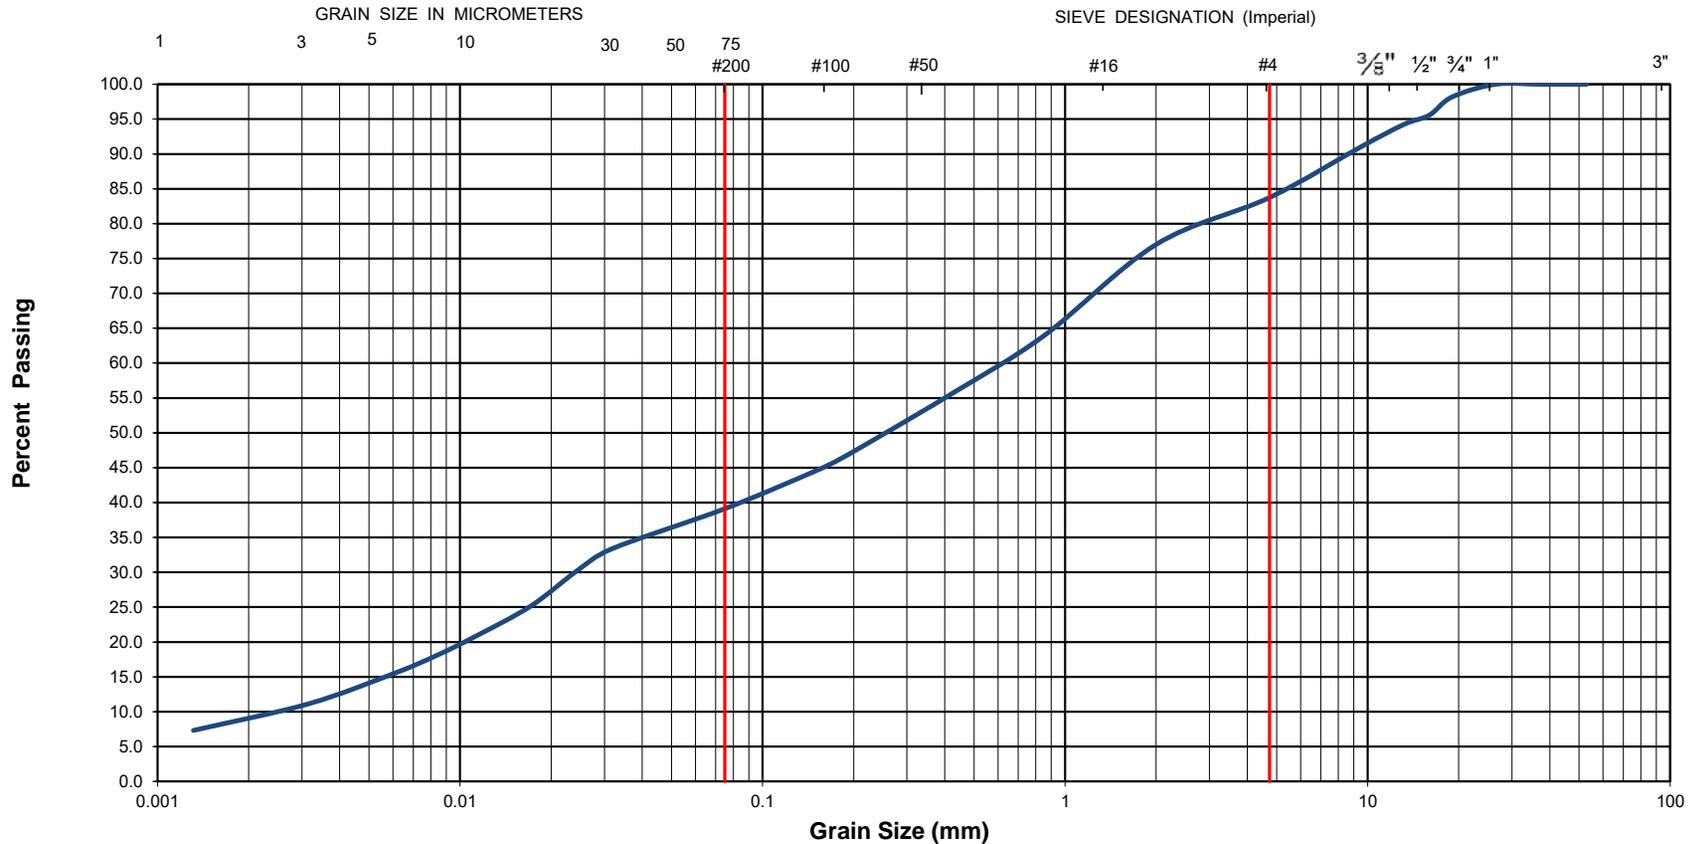
EXP Project No.:	OTT-22015769-A0	Project Name :	Proposed Residential High-Rise Towers		
Client :	RioCan Real Estate Investment Trust	Project Location :	1640-1660 Carling Avenue, Ottawa, ON		
Date Sampled :	May 4, 2023	Borehole No:	ENV-5	Sample No.: SS4	
Sample Description :	% Silt and Clay	39	% Sand	45	
Sample Description :	GLACIAL TILL: Silty Sand (SM) - Some Gravel and Trace Clay			% Gravel	16
Sample Description :				Figure :	23

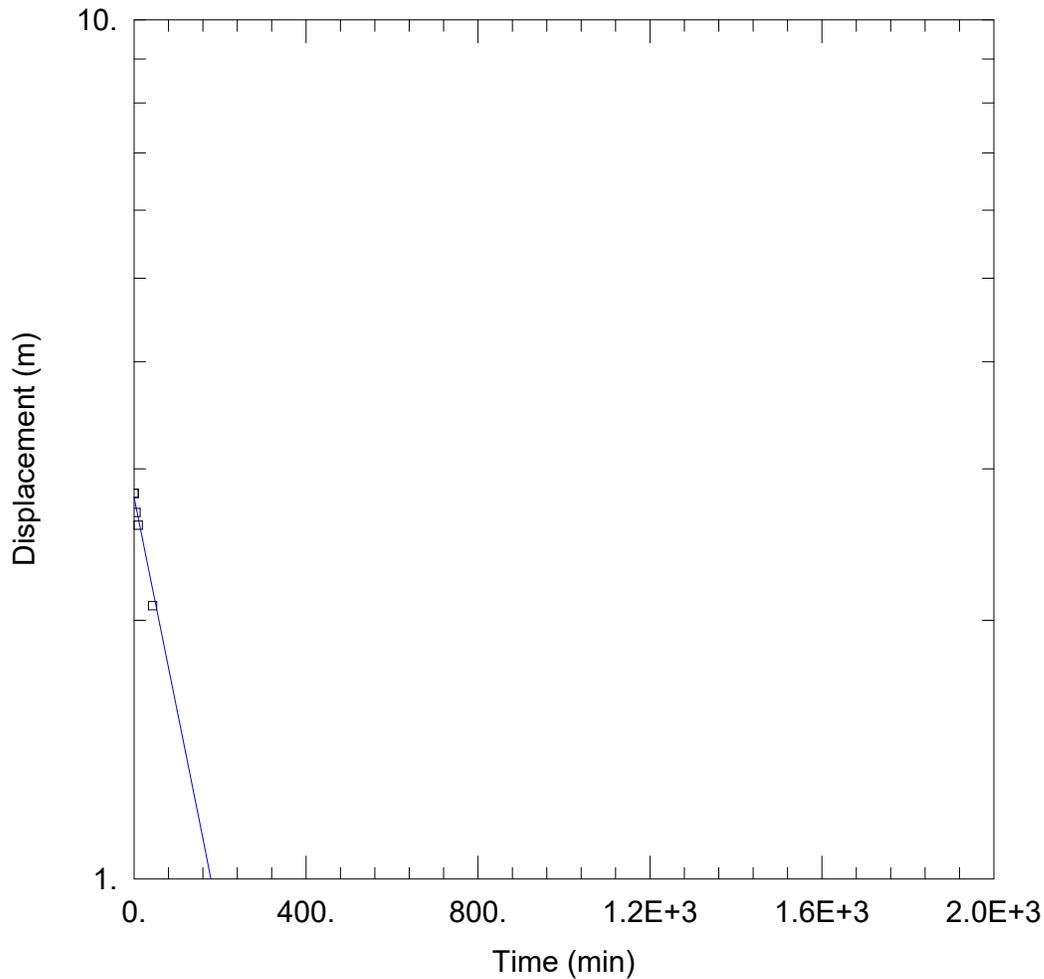
WELL TEST ANALYSIS

K = 7.566E-6 cm/sec
T = K*b = 2.27E-7 m²/sec (0.00227 sq. cm/sec)

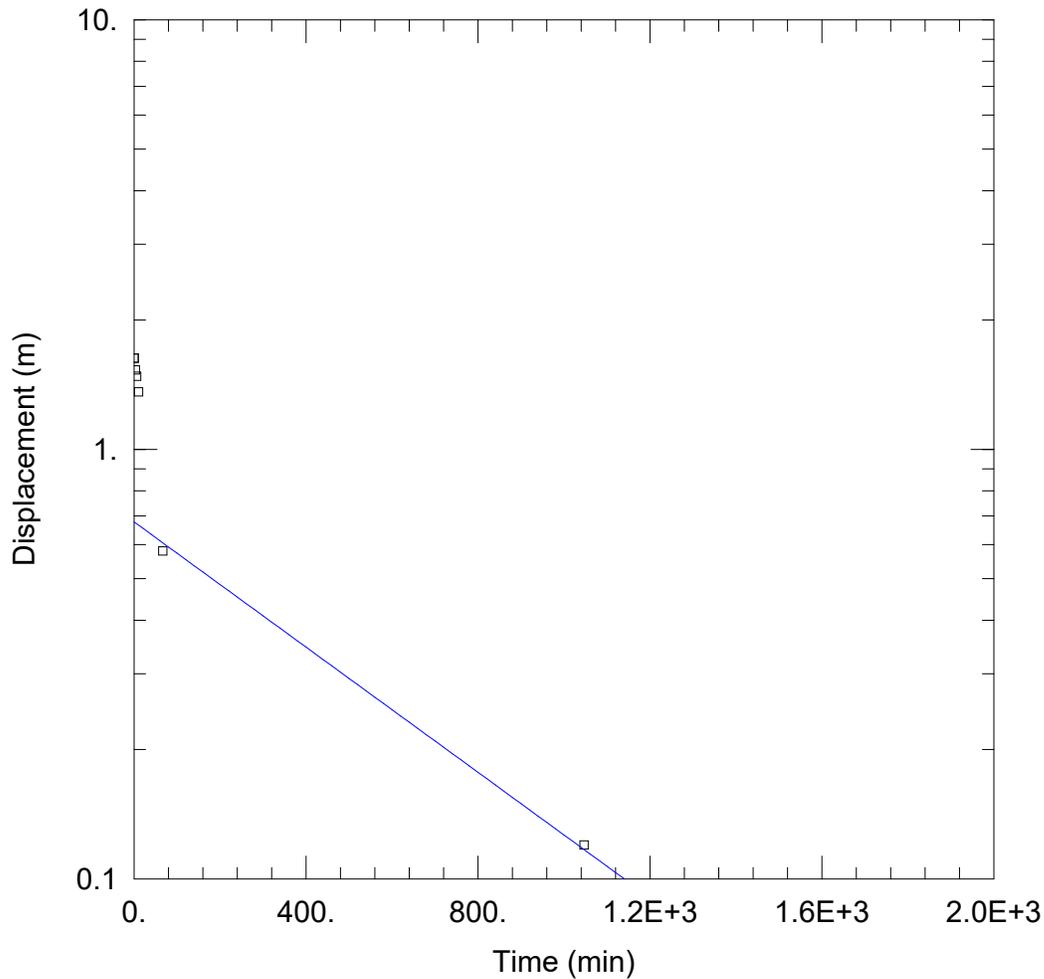
WELL TEST ANALYSIS

K = 2.223E-6 cm/sec
 T = K*b = 6.668E-8 m²/sec (0.0006668 sq. cm/sec)

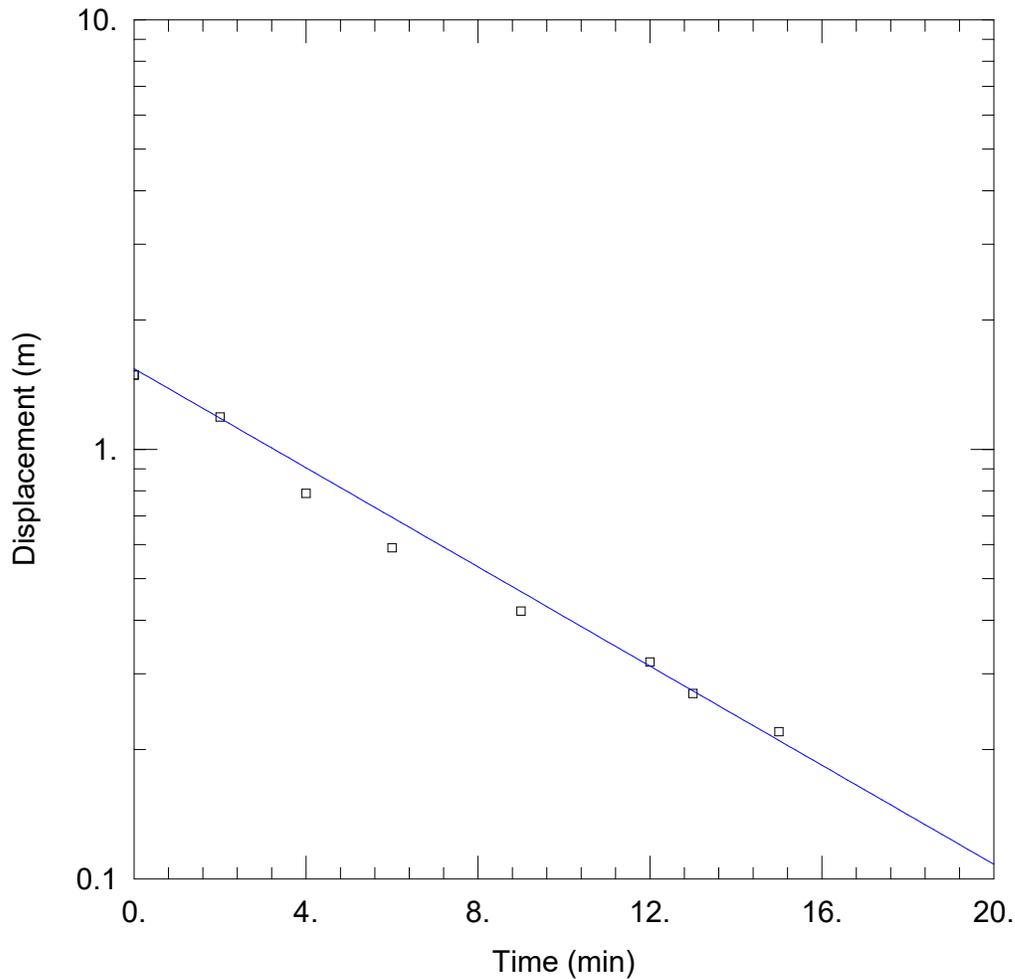
WELL TEST ANALYSIS

K = 0.0001759 cm/sec
T = K*b = 5.277E-6 m²/sec (0.05277 sq. cm/sec)
