## Phase I Environmental Site Assessment

8 Withrow Avenue  
Ottawa, Ontario

Anglican Diocese of Ottawa

Report: PE4799-1

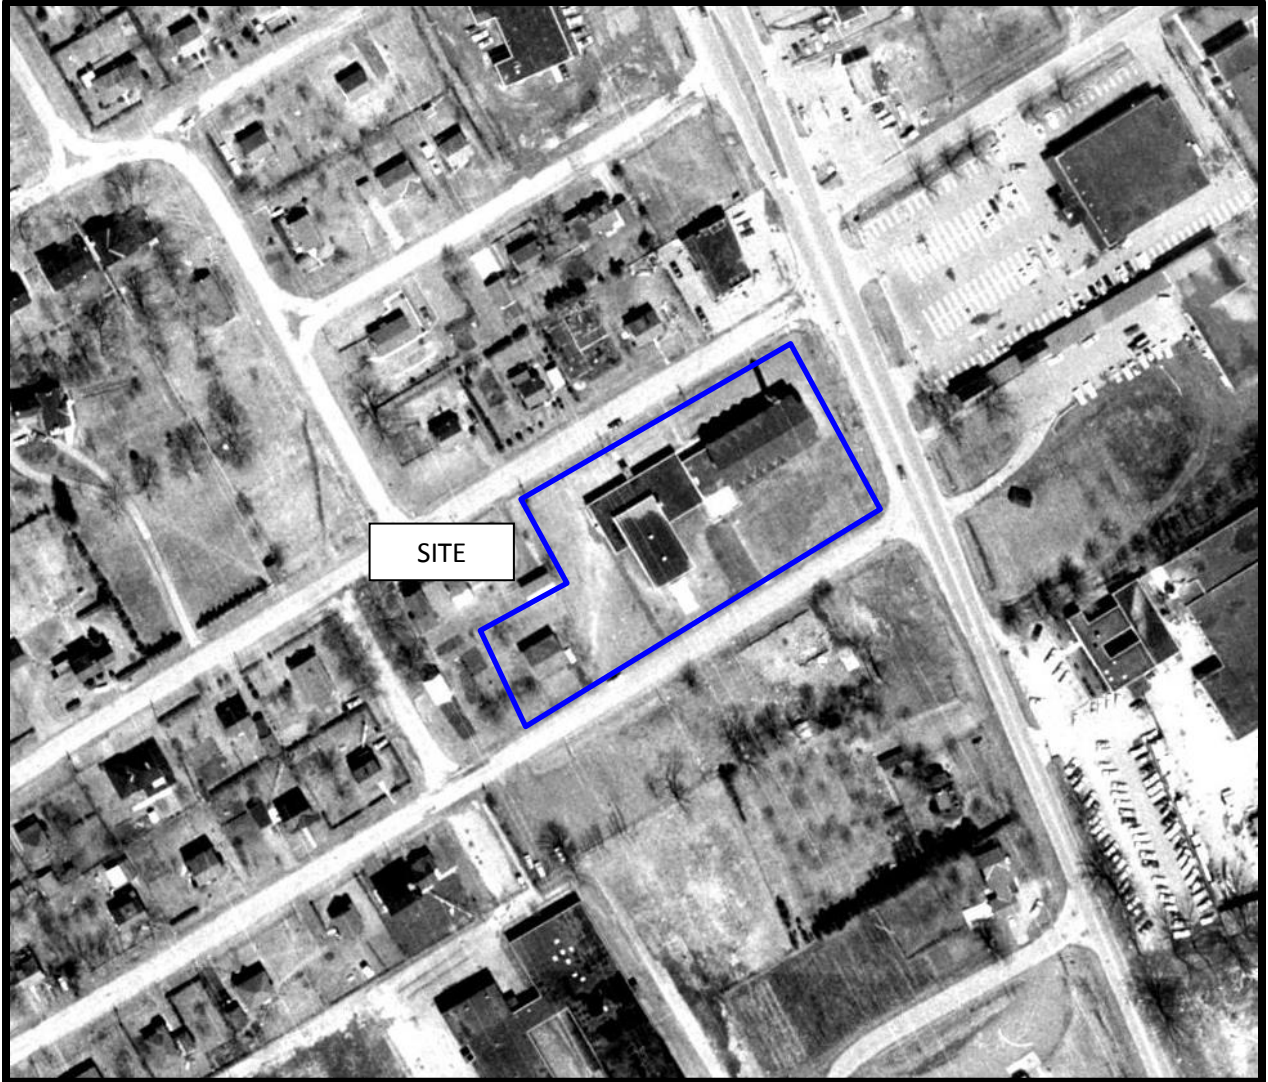
AERIAL PHOTOGRAPH  
1965

| 1965 | A church occupies the central/eastern portion of the subject site at this time, while a dwelling occupied the western portion. The subject |

site occupies most of a city block between Withrow Avenue and Rossland Avenue and fronts onto Merivale Road. To the west of the subject site, the land appears to be residential in use while properties fronting onto Merivale Road appear to be mostly commercial.

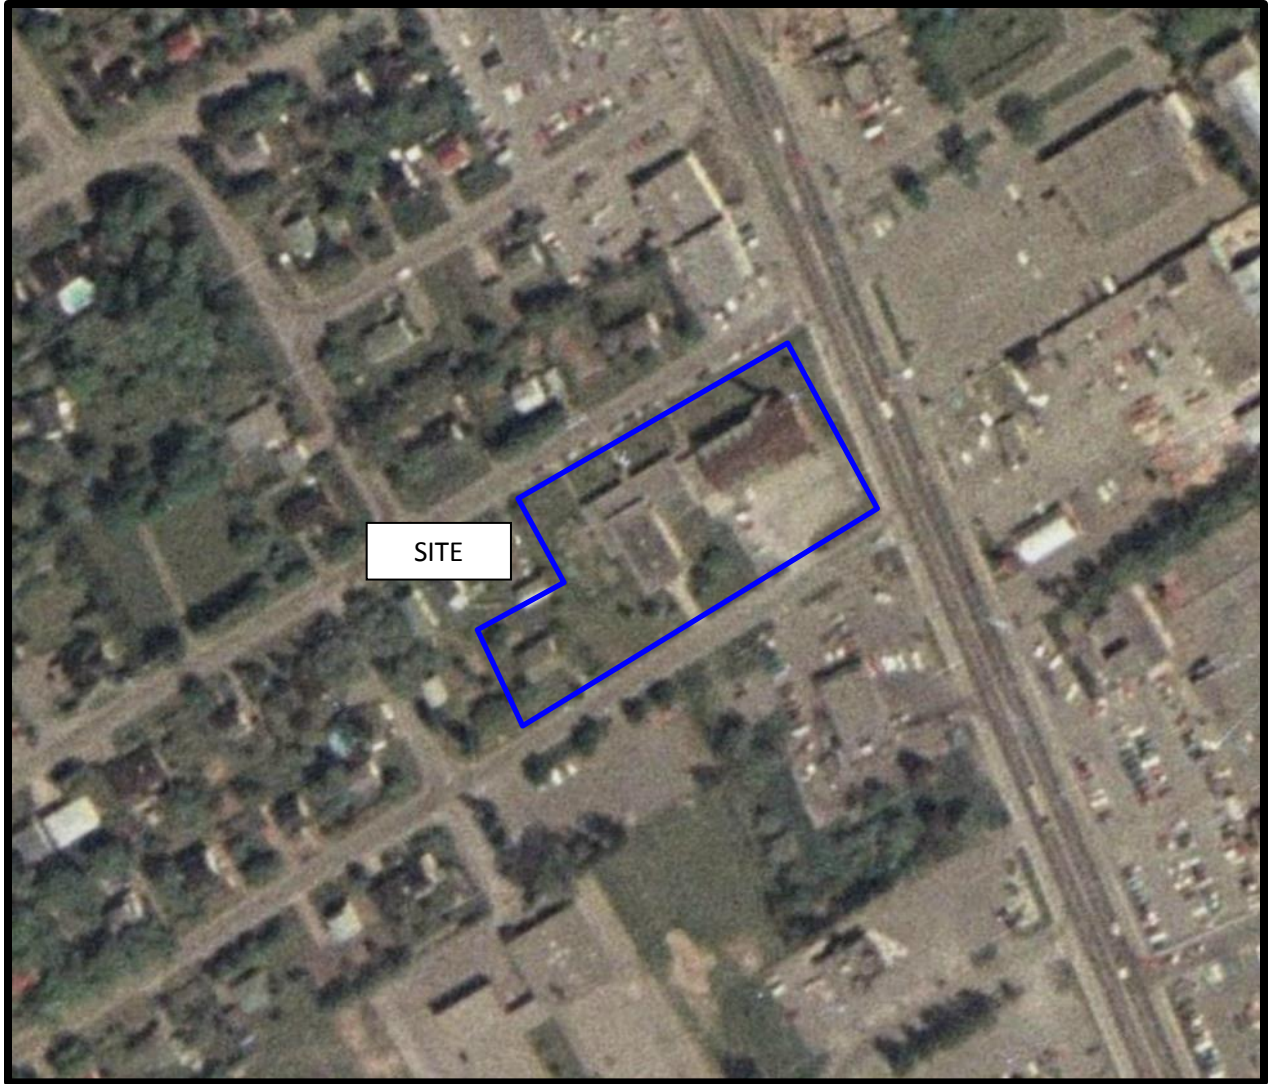
AERIAL PHOTOGRAPH  
1976

- 1976      No significant changes have been made to the subject site. In the surrounding area, retail fuel outlets can be seen to the south, across Rossland Avenue and to the east across Merivale Road.

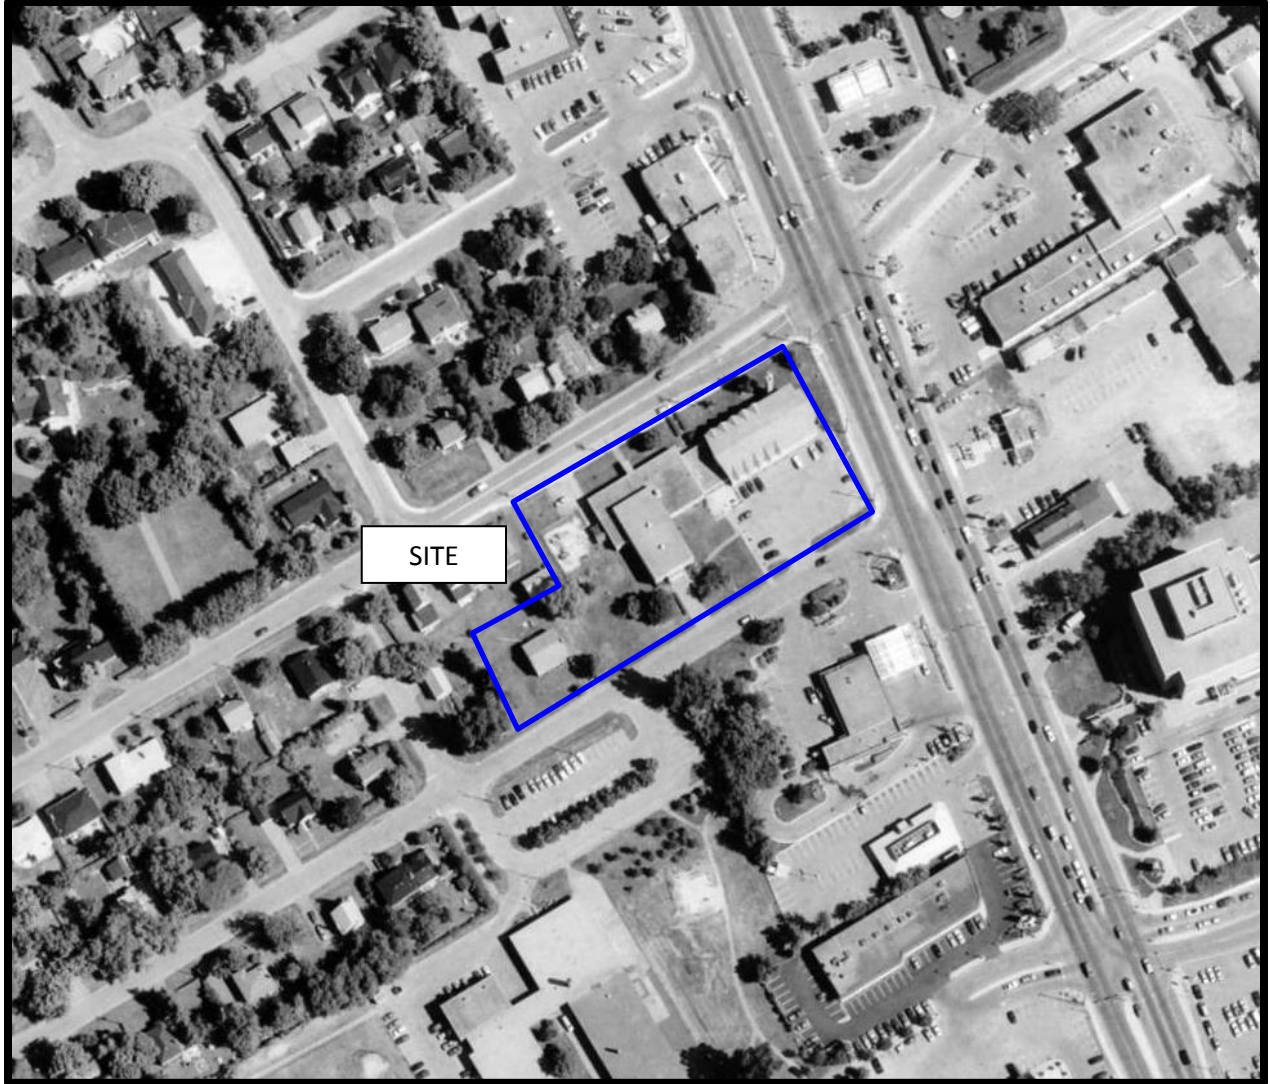
AERIAL PHOTOGRAPH  
1991

- 1991      No significant changes have been made to the subject site. In the subject area, retail fuel outlets can be identified immediately south of the subject site, to the east on the opposite side of Merivale Road and north of the intersection between Capilano Drive and Merivale Road. Significant commercial retail development has occurred east and north of the property.

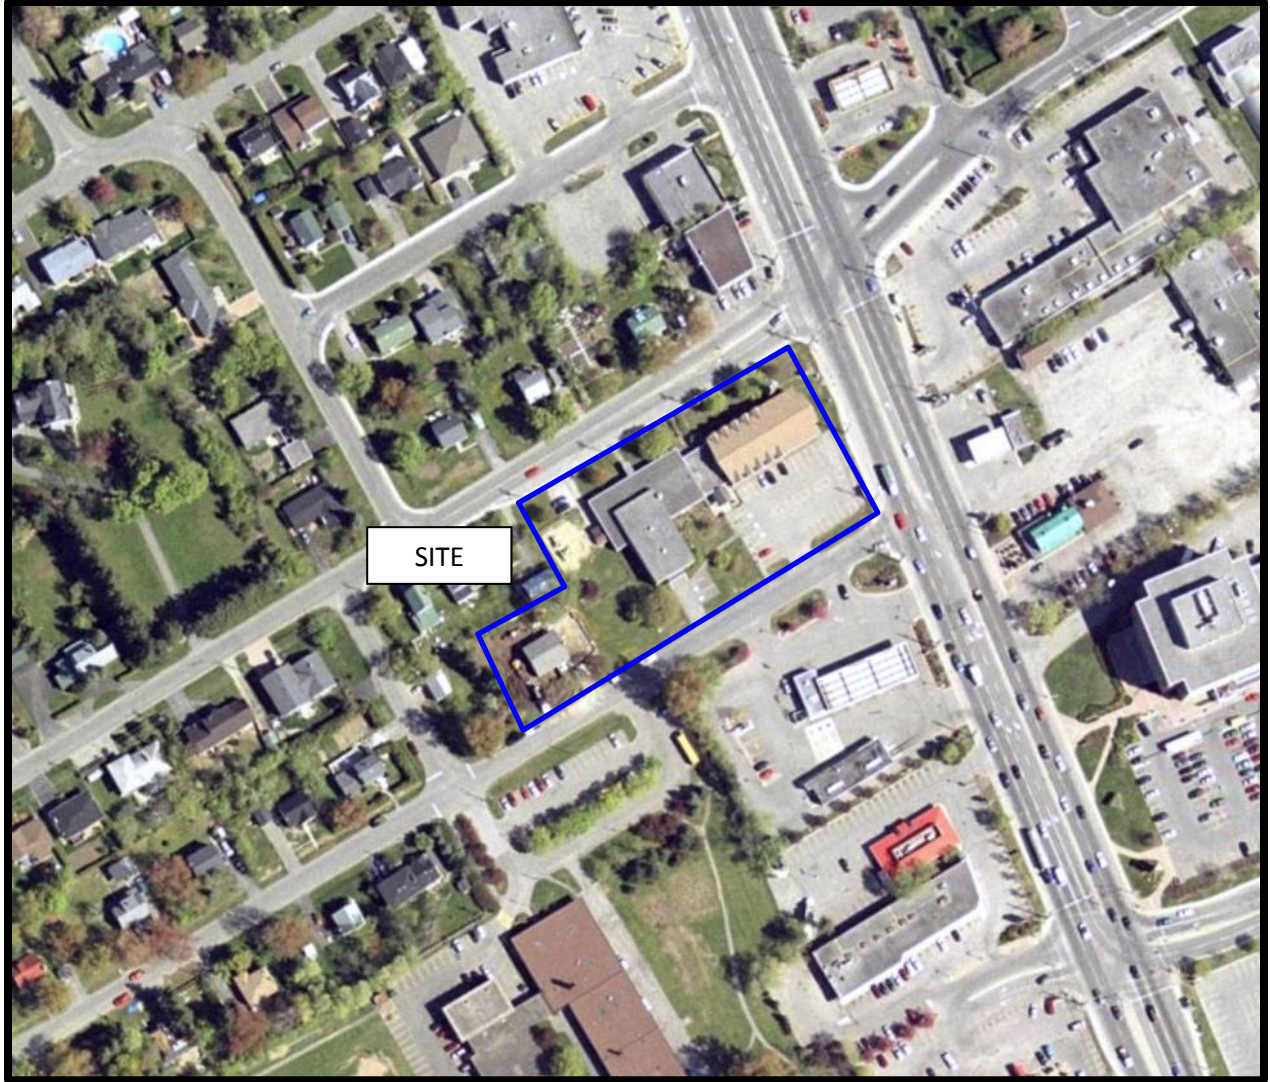
AERIAL PHOTOGRAPH  
2002

- 2002      No significant changes have been made to the subject site or surrounding properties.
- 2011      The house on the western portion of the subject site was extended at this time. The RFO north of the intersection between Capilano Drive and Merivale Road was demolished at this time.

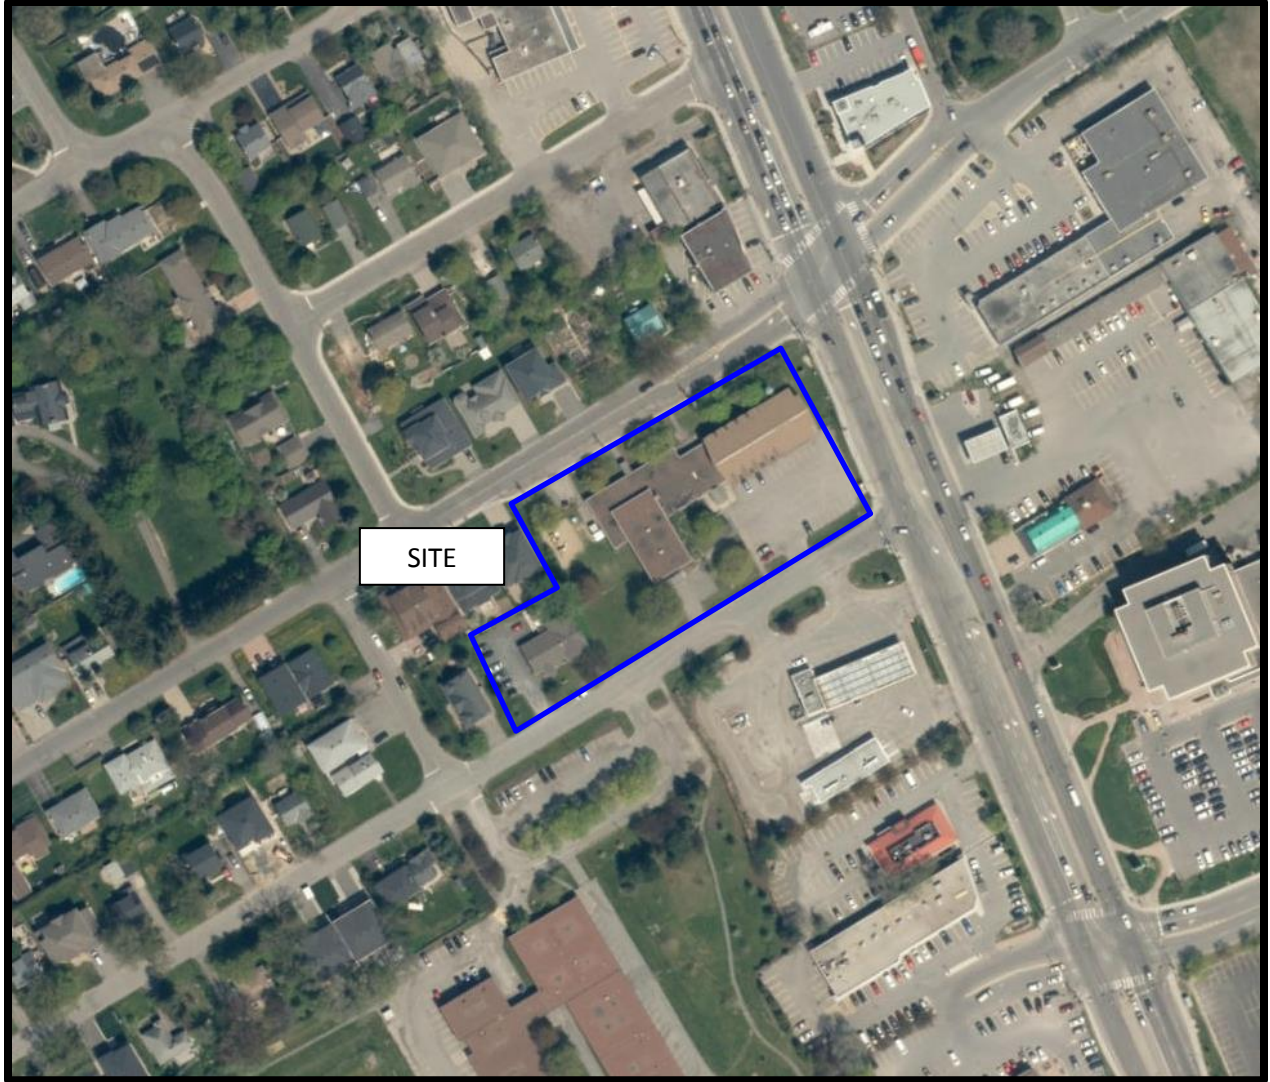
AERIAL PHOTOGRAPH  
2017

- 2017      No significant changes have been made to the subject site or surrounding properties.

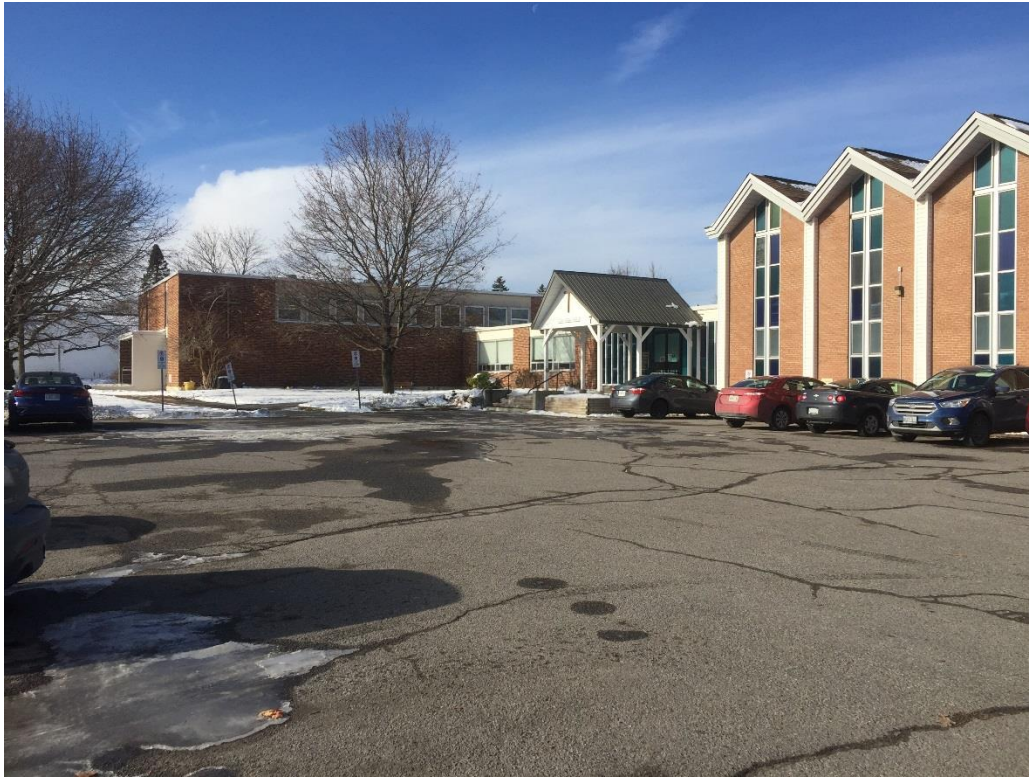
Following the historical review, a site visit was conducted. An underground storage tank, that stored fuel oil, is believed to be located towards the centre of the subject site and represents a PCA and an APEC.

Photograph 1: Southern face of the building with the church to the right and church hall to the left. The UST was reportedly located left of the porch towards the centre of the photo.

Based on the results of the Phase I - Environmental Site Assessment, it is our opinion that **a Phase II - Environmental Site Assessment is required for the subject site.**

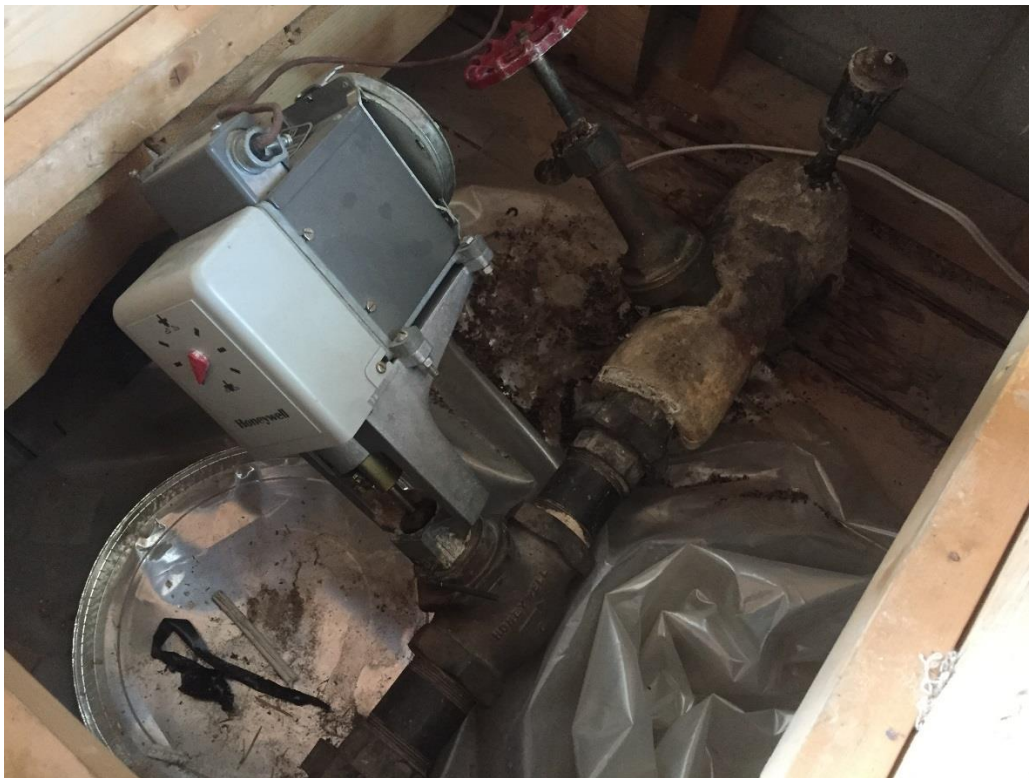
Based on the approximate age of the buildings (1955), asbestos-containing materials may have been used during construction and may still be present within the structures. These materials include drywall joint compound, plaster, stippled plaster, pipe insulation and vinyl tiles. Generally, materials were in good condition with the exception of some of the pipe insulation.

Photograph 2: Pipe lagging in poor condition. Located in the church balcony floor panel.

Based on the age of the subject buildings, asbestos-containing materials (ACMs) are potentially present in the subject structures. These materials include drywall joint compound, plaster, stippled plaster, pipe insulation and vinyl tiles. Generally, these materials were in good condition with the exception of some of the pipe insulation. An asbestos survey of the building must be conducted in accordance with Ontario Regulation 278/05, under the Occupational Health and Safety Act, if one has not already been done.

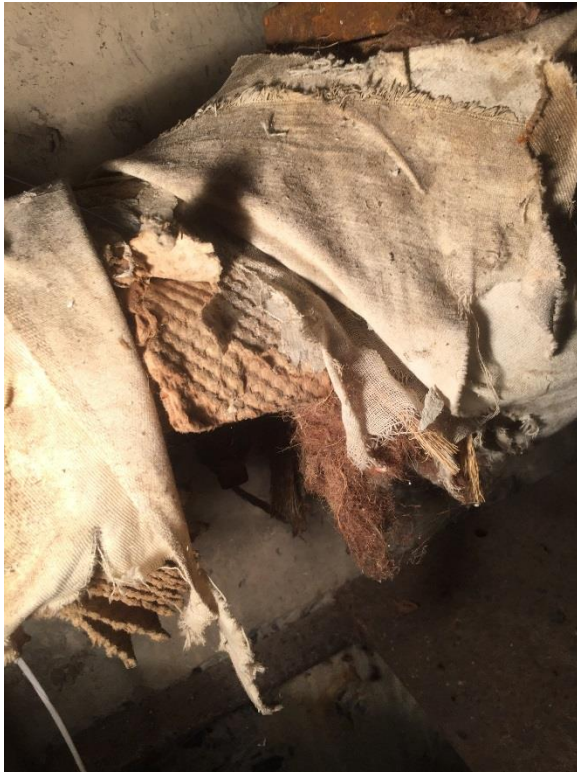
Photograph 3 – Pipe lagging in poor condition located beside the basement sump pit.

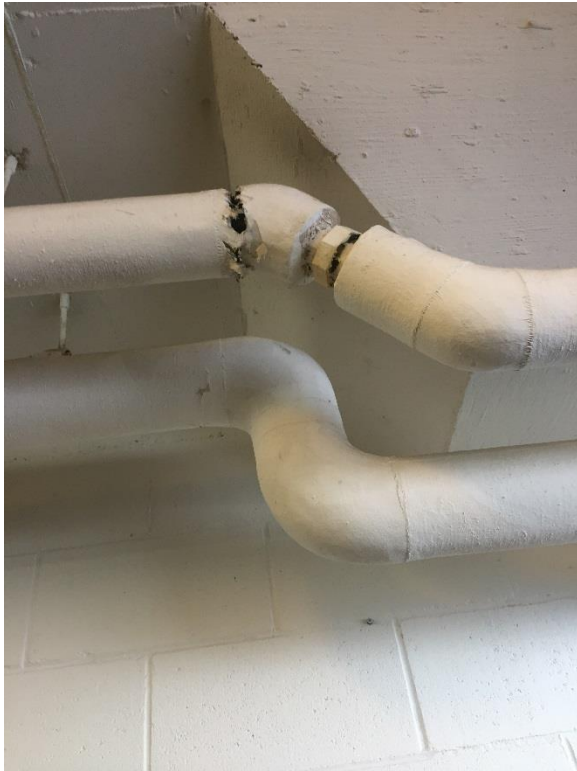
Photograph 4 - Pipe lagging in poor condition located in the book shop.

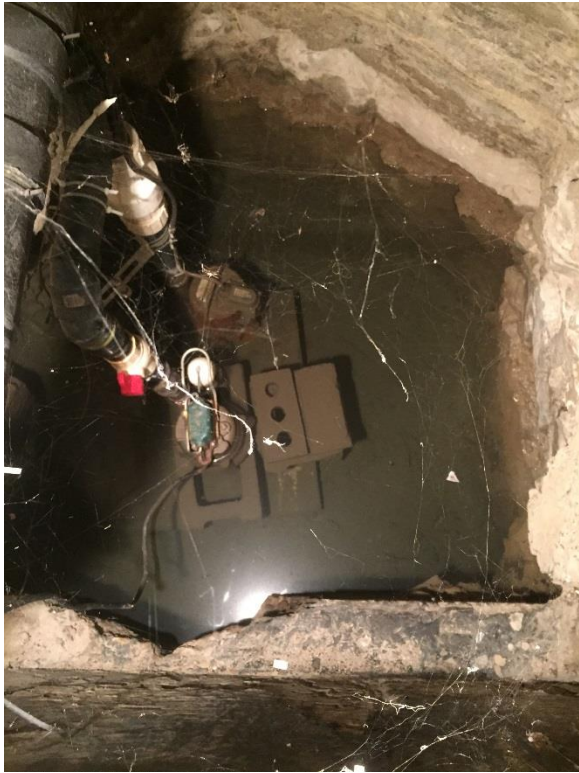
Photograph 5 – Basement sump pit.

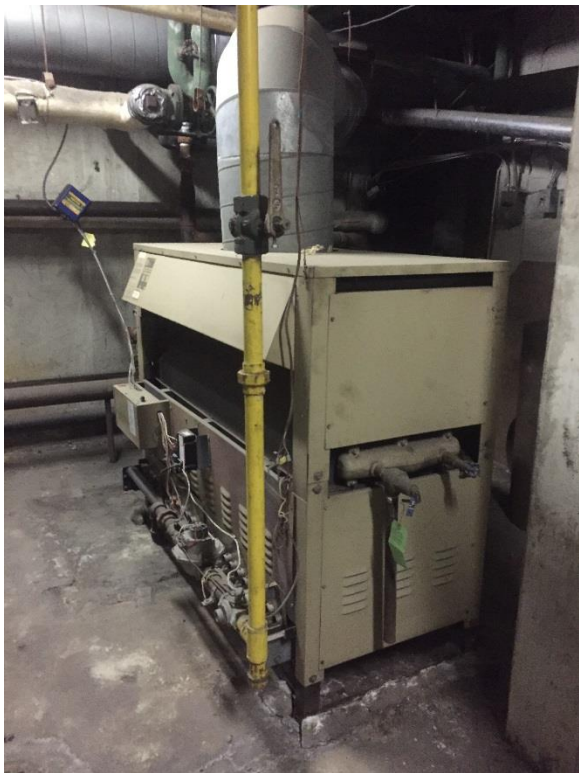
Photograph 6 – Gas-fired furnace.
