HERITAGE IMPACT ASSESSMENT & STAGE I CONSERVATION PLAN

211-231 BANK STREET & 178 NEPEAN STREET

Commonwealth Historic Resource Management
Revised August 2023

Applications D02-02-22-0127 / D07-12-22-0188 and plan number 18910

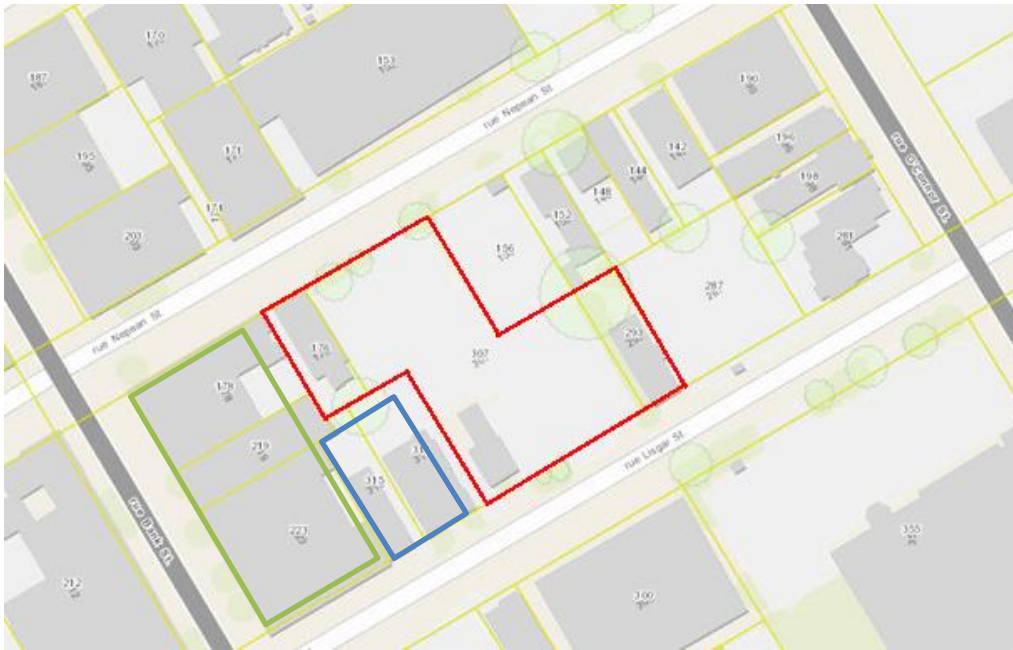
Figure 2: Bank St. development site is delineated in **green**, next to the Richcraft development site delineated in **red**. The Block plan of the area surrounding the site illustrates the context and lot divisions. The buildings at 311 and 315 Lisgar Street (delineated in **blue**) are separately owned and not part of either development. Source: Google Earth.

Adjacent to the Bank Street proposed development is the Richcraft property that extends through the block from Lisgar to Nepean. Richcraft has City approval to construct two mixed-use towers 29 and 27 storeys high located on the large, irregularly shaped site, currently used as a surface parking lot. The approved rezoning application included a request for additional height and relief on requirements for rear and side yard setbacks. The development abuts rear facades of the mixed-use buildings at 211-231 Bank Street, which is part of the Smart Living lands. Two brick clad brick clad buildings constructed in the 1920s at 311 – 315 Lisgar are located outside the limits of the HCD. These two properties are highlighted in blue in Figure 2.

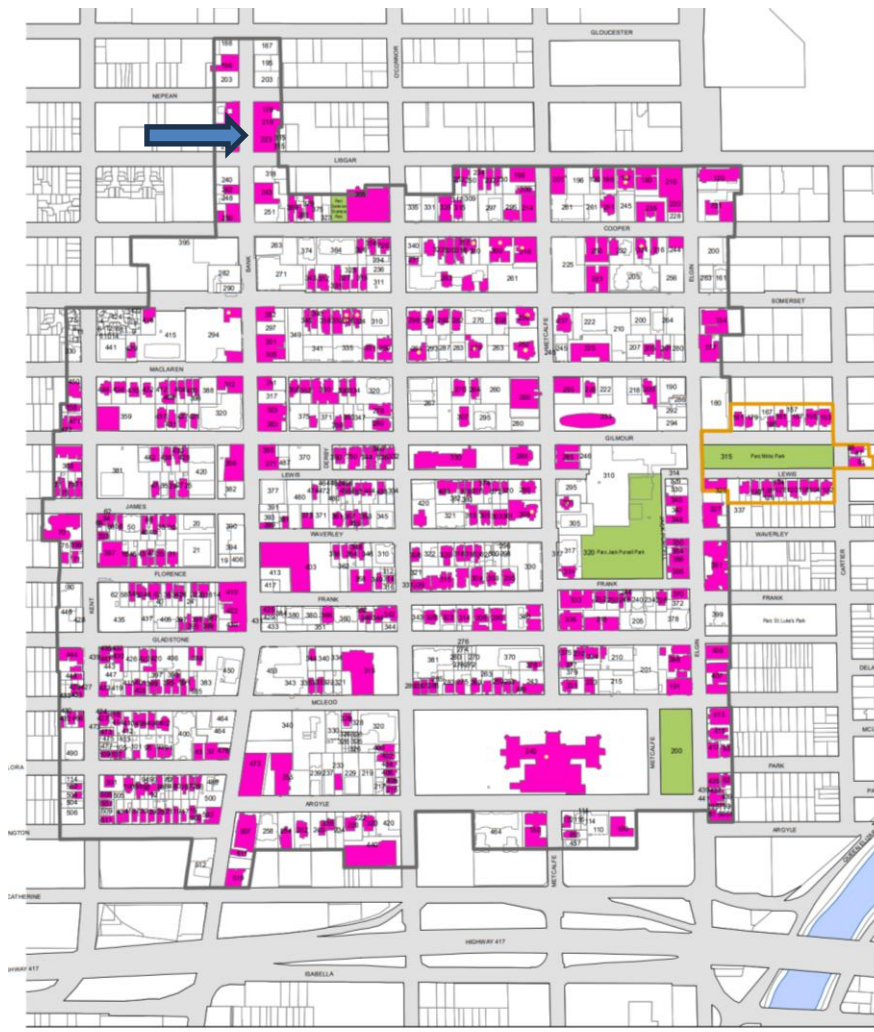
**Centretown and Minto Park Heritage Conservation Districts /
Secteur de Conservation des Biens Culturels - Centretown et Parc Minto**

Figure 3: Site map plan of the CMPHCD. Properties have been categorized as ‘Contributing’ or ‘Non-Contributing.’ ‘Contributing properties (fuchsia) are considered to have design, historic and/or associative value or contextual value, as determined through the inventory. For the purposes of this Plan Contributing properties are those classified as Significant Resources, Character- Defining Resources and Character-Supporting Resources and are intended to be retained and conserved.

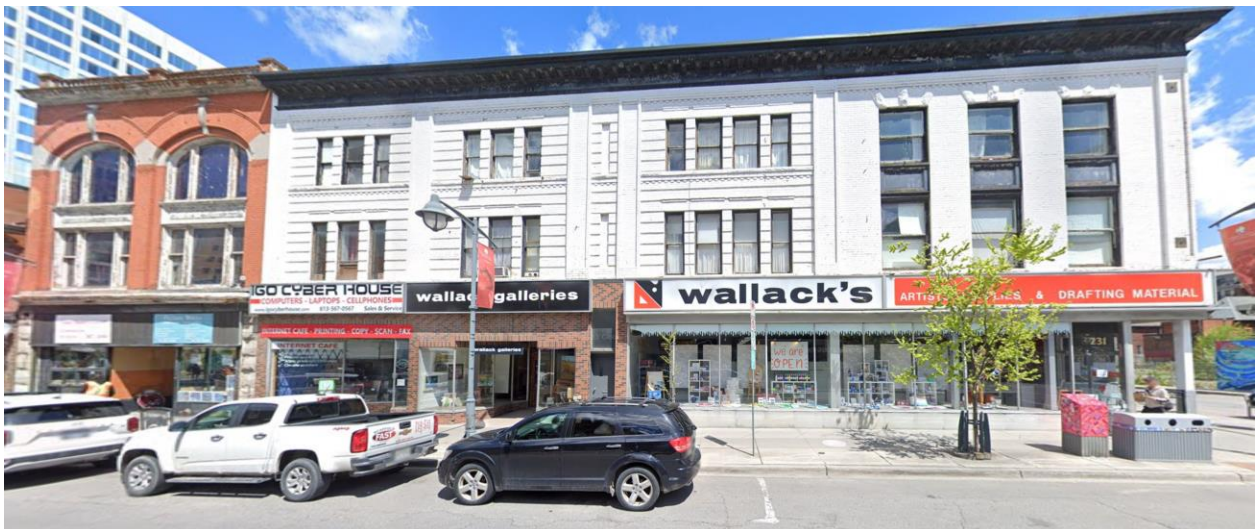
Figure 14: The painted brick commercial range 223-231 occupies the southern half of the block with the Wallacks Art Supply wrapping around the corner and extending along Lisgar Street.

The building's footprint suggests different construction dates, but since 1912 it has not been altered. The brick has been painted and the three storefronts have been infilled with transoms removed and the recessed entrances relocated. Figure 10 documents the earlier storefronts along the street.

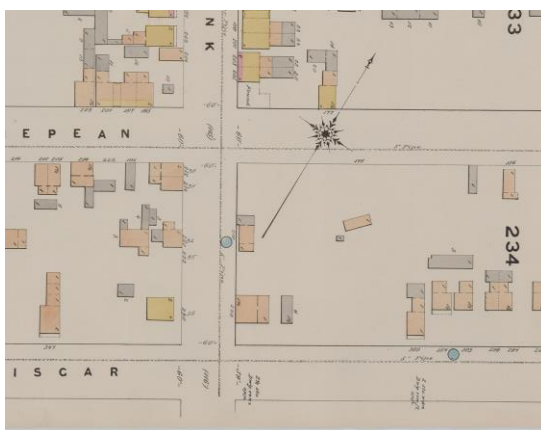
Figure 14: 1878 Fire Insurance Plan with Block 234 on the right. The plan illustrates the early development along Bank Street. In the block 234 bound by Nepean and Lisgar Streets none of the properties had been constructed. Source: Collections Canada

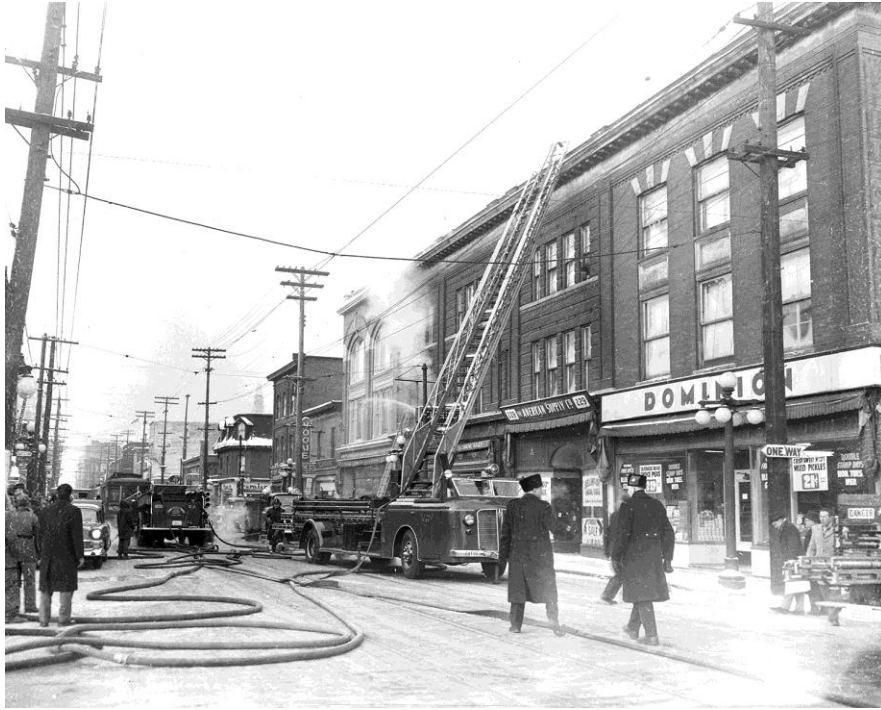
Figure 17: A view of the 211-231 block with fire trucks in the street. Note the unpainted facades with the decorative keystone with spandrels between the 2nd and 3rd floors. The photo provides a record of the earlier retail storefronts. Source: City of Ottawa Archives c. 1950.

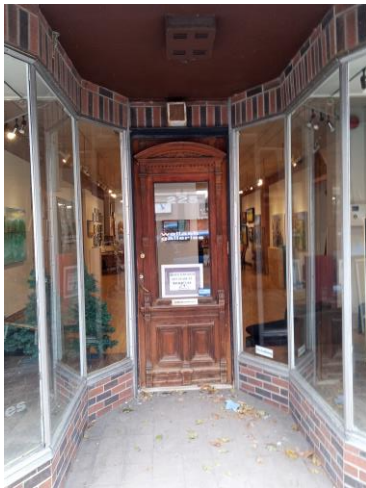
Figure 18: Although the shopfronts have been dramatically altered elements such as the recessed shopfront at 227 Bank Street are still evident. The leaded transom and vaulted arch have been covered over. Based on the 1950 photo it would appear that the three shopfronts at 215, 217 and 219 were similar with recessed entrances and decorative transoms.

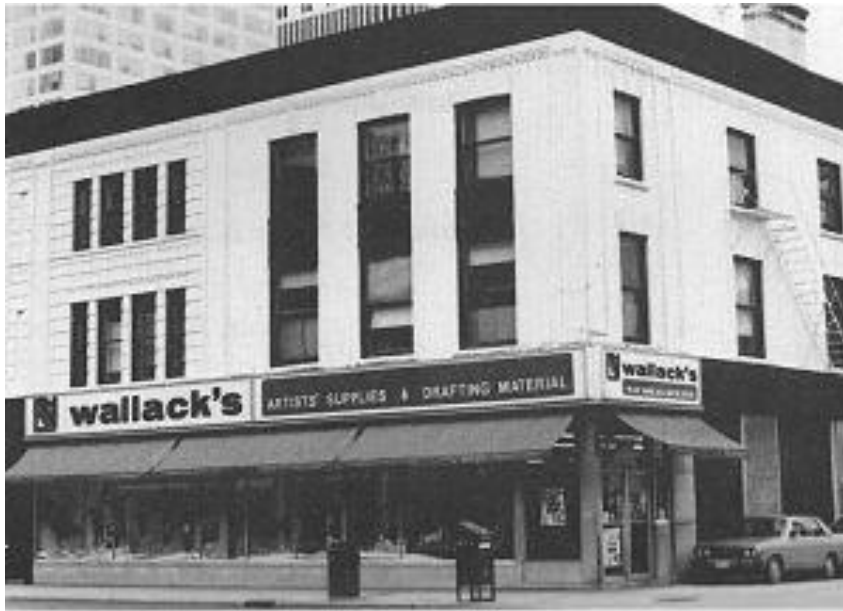
Figure 19: A view of 231 with the retail entrance shifted from its original central location to the corner and the upper façade painted white.

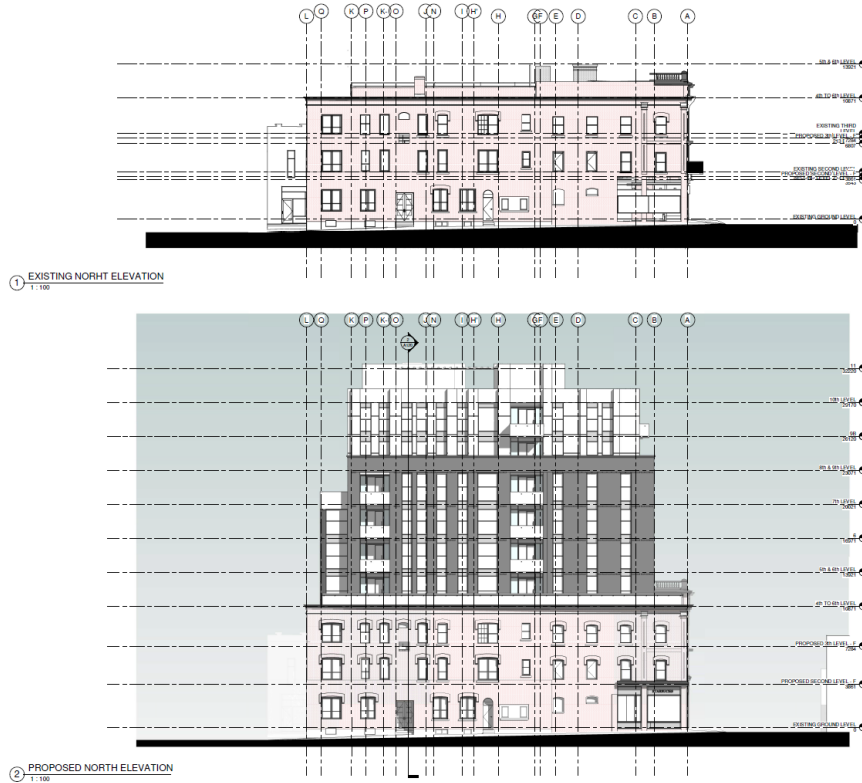
Figure 18 & 19 : Nepean Street elevation looking south and perspective views of the intersection of Bank Street and Nepean Lisgar with the proposed 9-storey development. Woodman Architecture 2023.

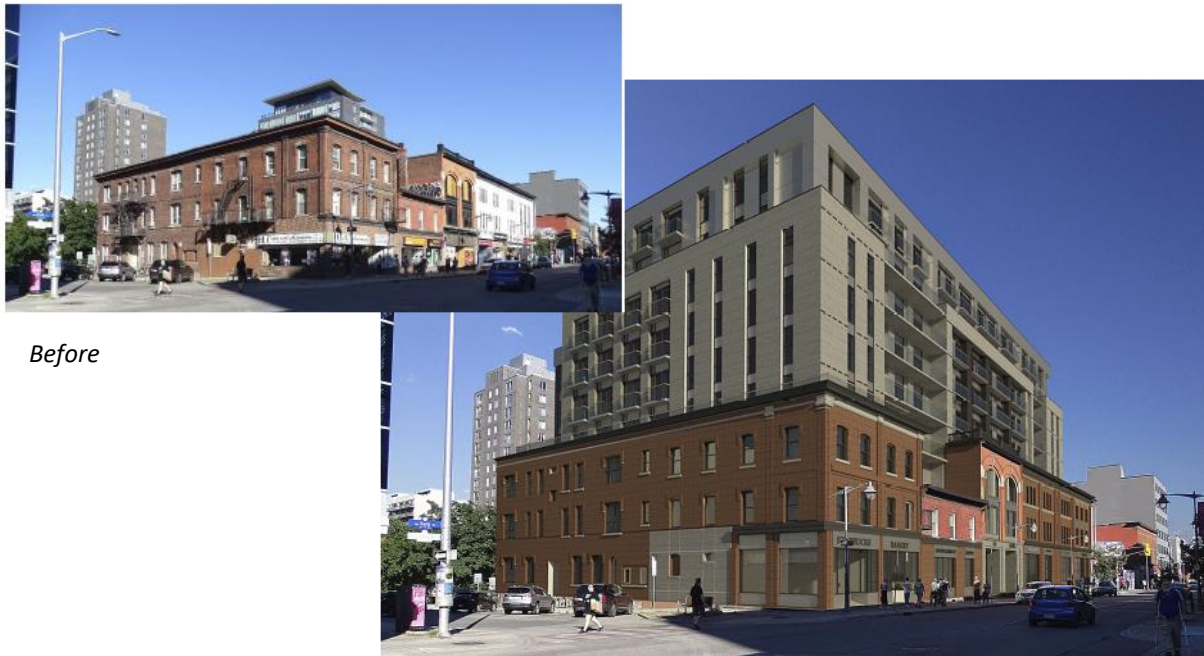
Before

Figure 22: View of the development site looking south-east showing the existing buildings and the new 9-storey development. Source: Woodman Architecture 2023

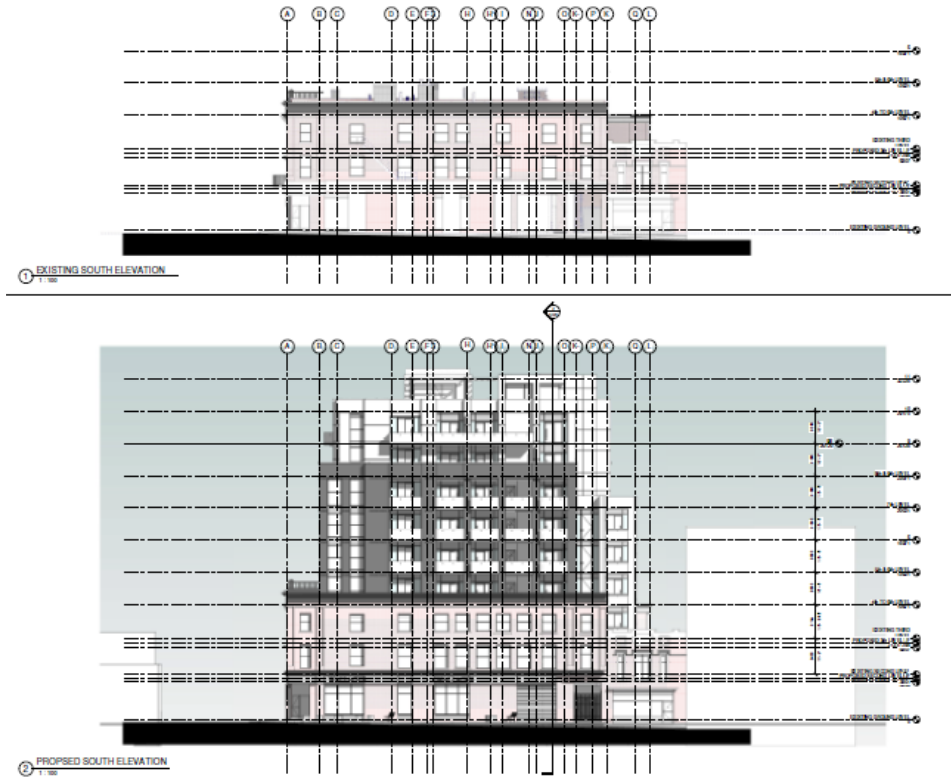
Figure 24 & 25 : Lisgar Street elevation & the Rear elevation with the proposed 9-storey development. Source: Woodman Architecture 2023.

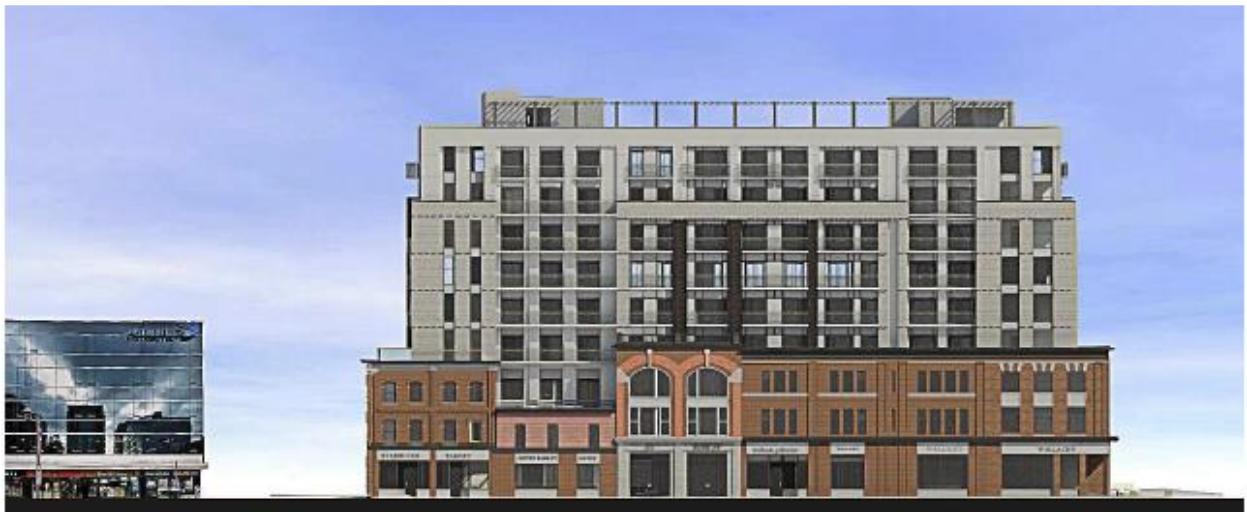
Figure 27: Contextual Elevation along Bank Street. Woodman Architecture. 2023

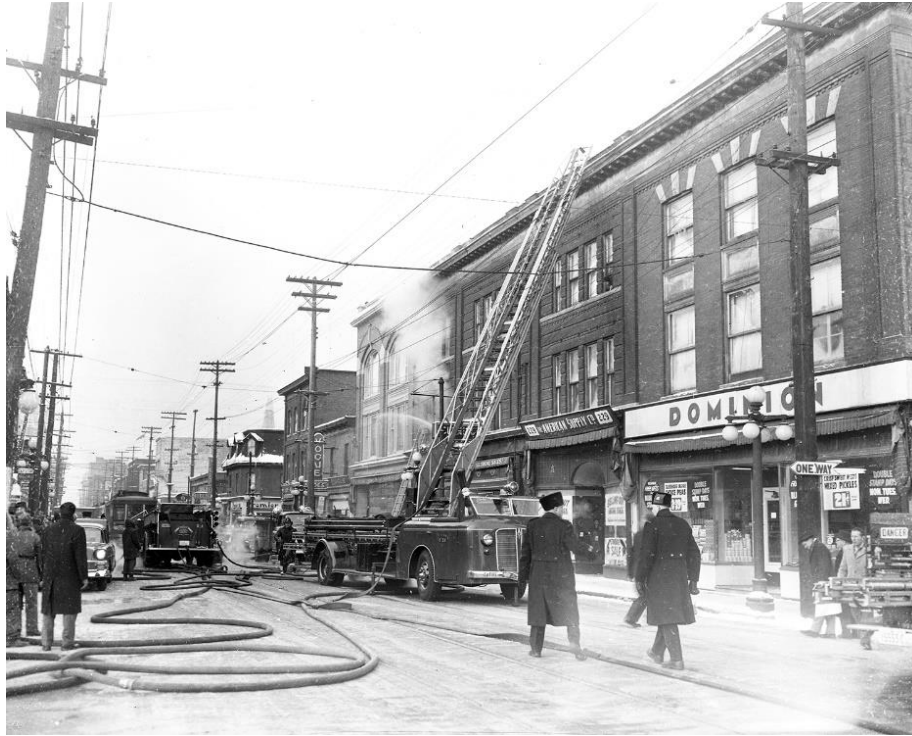
A section of the 1901, revised 1912, Fire Insurance Map along Bank Street between Nepean and Lisgar Streets documents the ground floor occupants and the division of frontages onto Bank Street.

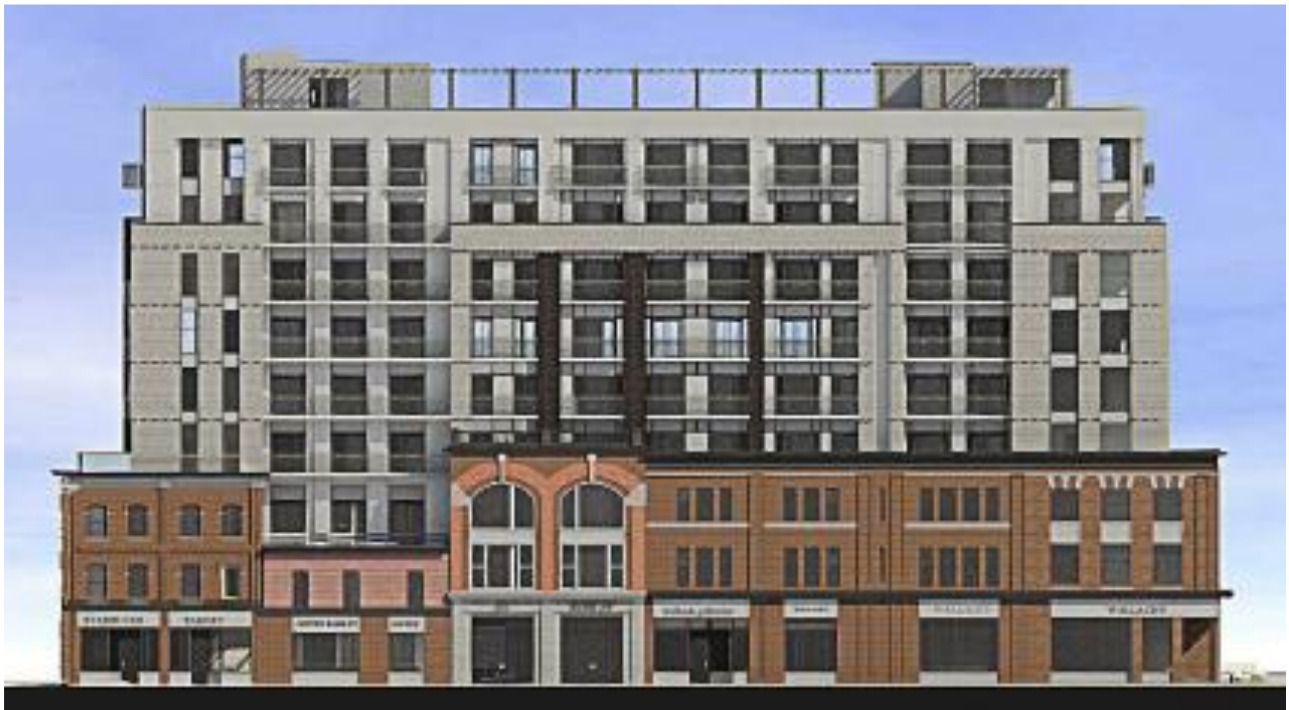
*Figure: Restored Elevations along Bank Street between Nepean and Lisgar illustrating the building's revival.
Source: Woodman Architects Inc 2023.*

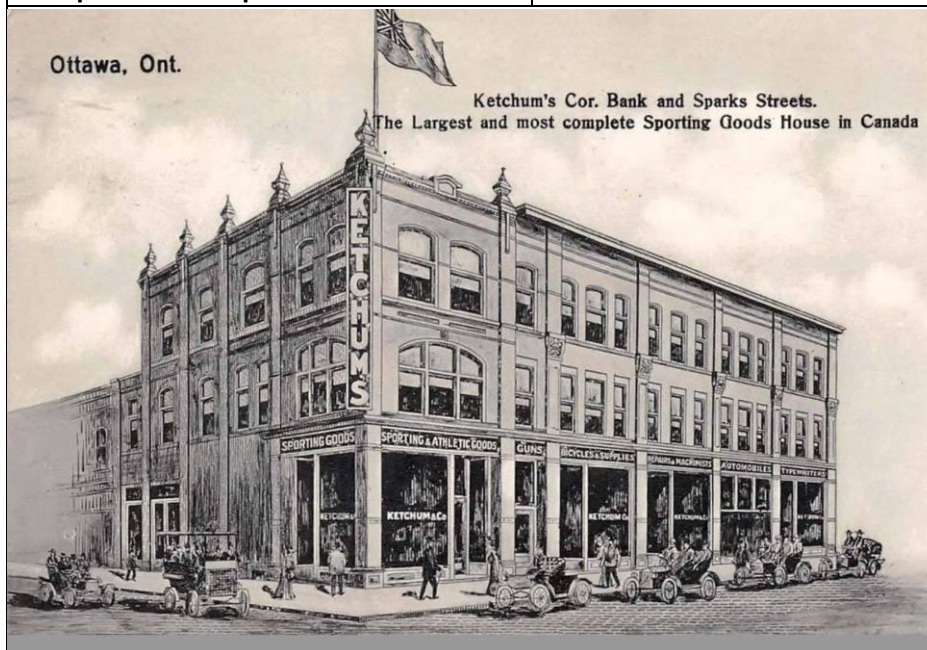
This sketch of Ketchum’s Bank at the corner of Bank & Sparks Streets provides an excellent example to model the replacement shop front with the raised pilasters framing, commercial units, cornice and sign board wrapping around the corner.

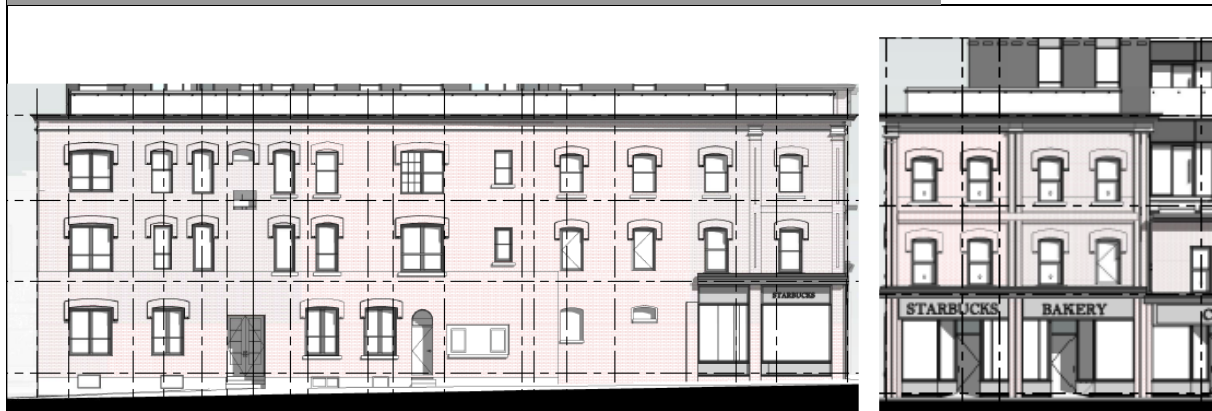
Restored Elevations of the Nepean and Bank Street facades. Woodman Architects

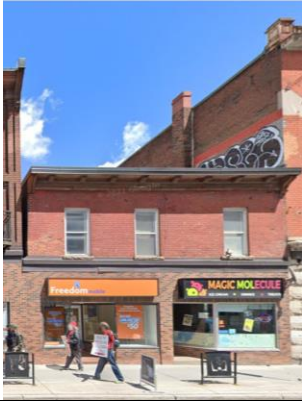
<p>215-217 Bank St.</p>

Upper storey is intact with replacement windows. The original signboard, historic transom, and display windows have been removed and the brick piers reclad with a variegated brick siding.

<p>Character Defining Features</p> <ul style="list-style-type: none"> • Elaborate metal cornice. • Frame construction with 2 storey painted brick façade on Bank Street. • Slightly uneven second floor window configuration. • Lower height of the commercial ground floor compared to adjacent buildings. • Elaborate metal cornice at the roof line.
<p>Removals, Interventions and Conservation Guidelines</p> <ul style="list-style-type: none"> • Chemical wash to remove paint. • Selective repointing of brick, and sills . • The three second floor windows replaced with new double hung units • Remove variegated brick from the ground floor storefront(s) • Restore the ground floor brick pilasters with a capital to frame the two retail spaces • Insert large glazed commercial store fronts into the two bays • Introduce commercial cornice with signboard, knee wall at base, recessed flared entrances. See comparative illustrations • Repair as necessary the elaborate metal cornice.

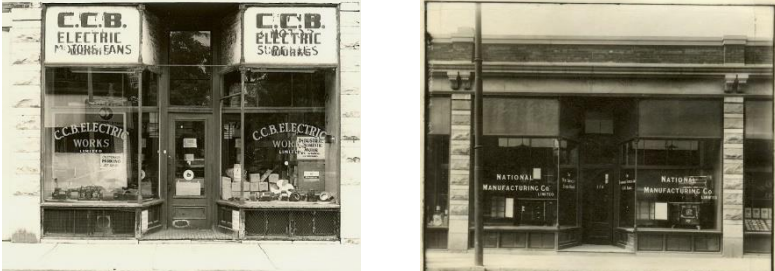
<p>Comparable Example</p>

<p><i>Storefronts along Bank Street dating from the turn of the century are in keeping with the modest 2-storey building at 213-215 Bank Street.</i></p>

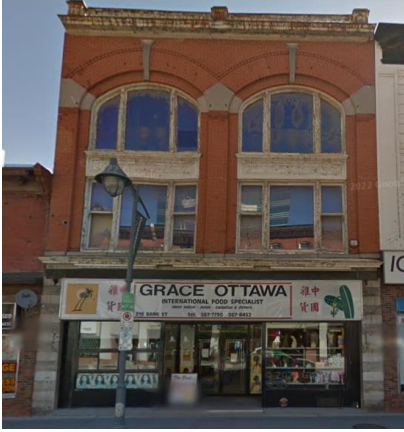
219 -221 Bank Street	Character Defining Features

<ul style="list-style-type: none"> • <i>Cornice and balustrade</i> • <i>Large two storey elliptical windows with metal spandrels,</i> • <i>Distinct glazing pattern</i> • <i>Masonry construction Red brick with limestone capitals and decorative quoins.</i> • <i>Shopfront Recessed central entrance framed by stone pillars concealed columns with a stepped foyer.</i> • <i>Limestone header below second floor windows</i> • <i>Shopfront cornice with dentelles above the fascia board</i>
<p>Removals, Interventions and Conservation Guidelines</p> <ul style="list-style-type: none"> • Repair as necessary the elaborate metal cornice and balustrade.

- Chemical wash.
- Repair pitted brick in arches, selective repointing of brick, and sills .
- All Windows replaced with new units retaining the mullion pattern. .
- Remove variegated brick from the ground floor storefront(s).
- Retain and repoint ground floor stone pilasters with a capital to frame the commercial entrance.
- Insert large glazed commercial store front, setting it back to create a foyer with double entrance doors.
- Insert a support column
- Introduce commercial cornice with signboard, knee wall at base.
- See comparative illustrations.
-

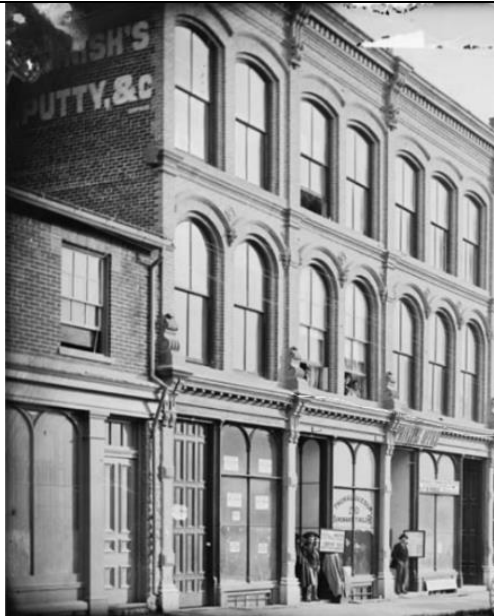
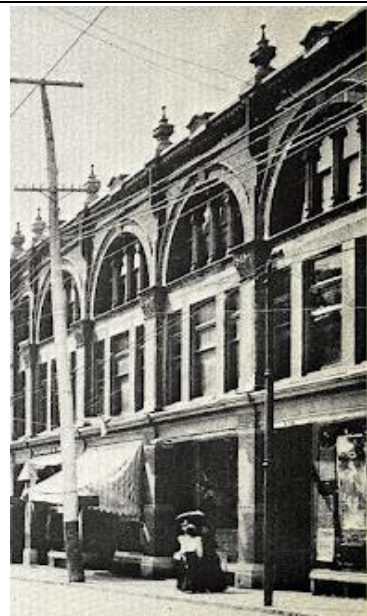
two examples of Ottawa commercial buildings illustrating features comparable to the 219 Bank St.

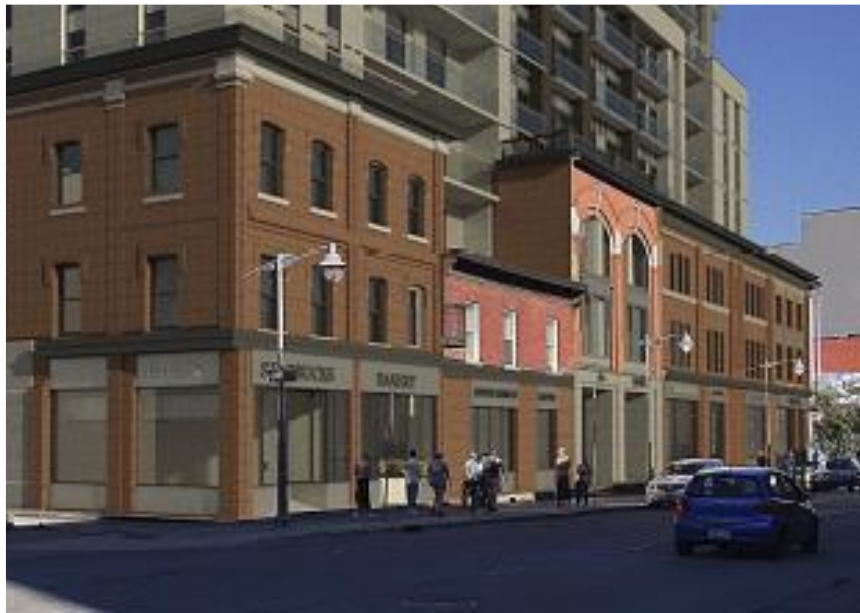
Midblock view of the planned entrance to the development.

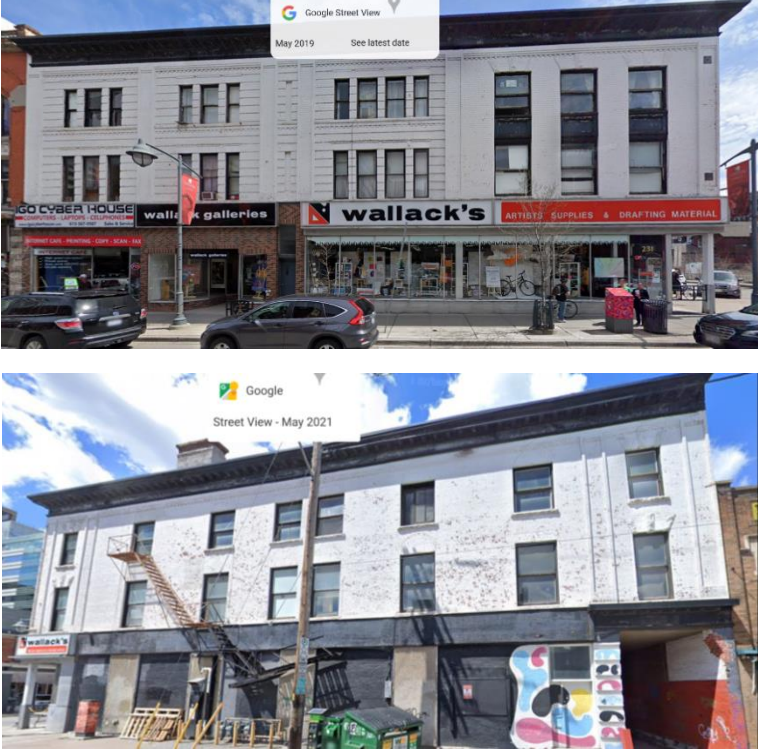
223 -225 - 227 229 & 231 Bank Street	Character Defining Features

<ul style="list-style-type: none"> • Large, pressed metal cornice extending around the Bank and Lisgar frontages. Raised brick banding framing the 3rd floor • A range of 4 bays separated by raised brick pilasters. • Access to the upper floors defined with an entrance midblock and accented with a double pilaster on the 2nd and 3rd floors. • Large 2 storey windows at the corner with stone keystones at headers and metal spandrels. • Red brick with a horizontal stepped treatment in 3 of the bays • Corner entrance recessed. • Ground floor commercial windows along Lisgar Street highlighting its two facades. • Large rectangular blind windows extend along Lisgar with the carriage access in the last bay.

<ul style="list-style-type: none"> • Lisgar façade less imposing treatment with raised pilasters at the ends of the façade with window surrounds including stone keystones.
	<ul style="list-style-type: none"> • One over one vertical hung windows arranged evenly along the upper floors of the façade. •
<p>Removals, Interventions and Conservation Guidelines</p> <ul style="list-style-type: none"> • Repair as necessary the elaborate metal cornice . • Chemical wash to remove paint . • Selective repointing of brick, and sills . • All Windows replaced with new units retaining the mullion pattern. . • Remove variegated brick and framing from the ground floor storefront(s). • Retain and repoint ground floor brick pilasters to follow the upper floor organization of bays. • Retain the residential entrance with paired pilasters. . • Insert large glazed commercial store fronts, with transoms and commercial entrances. • Reorganize the Wallack Storefront to interpret occupying 3 of the bays • Introduce commercial cornice with signboard, knee wall at base. • Consider undertaking the restoration of the shopfront at 227 Bank. • See comparative illustrations. <i>c1950 view: source City of Ottawa</i>

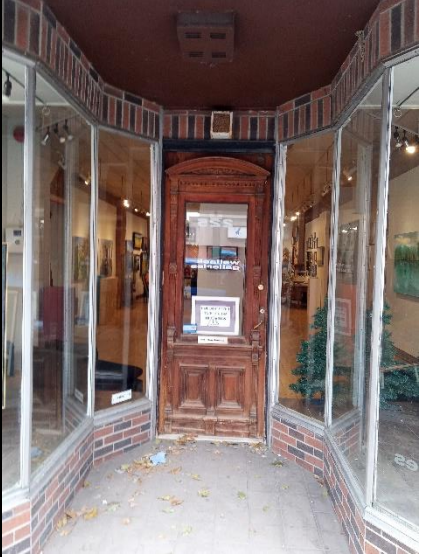
<p><i>The shopfronts have been dramatically altered. Elements such as the recessed shopfront at 227 Bank Street are still evident. The leaded transom and vaulted arch have been covered over or removed.</i></p>
