Phase I – Environmental Site Assessment

266 Park Street
Ottawa, Ontario

Prepared for Concorde Properties

Report: PE5651-2
February 8, 2023

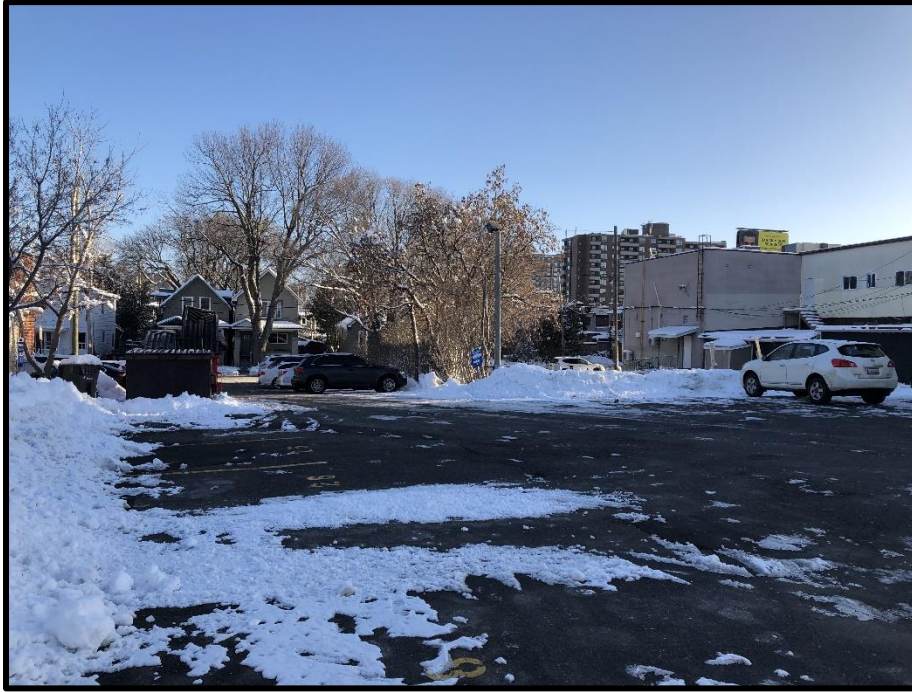
Photograph 1: View of the southern portion of the Phase I Property, facing east.

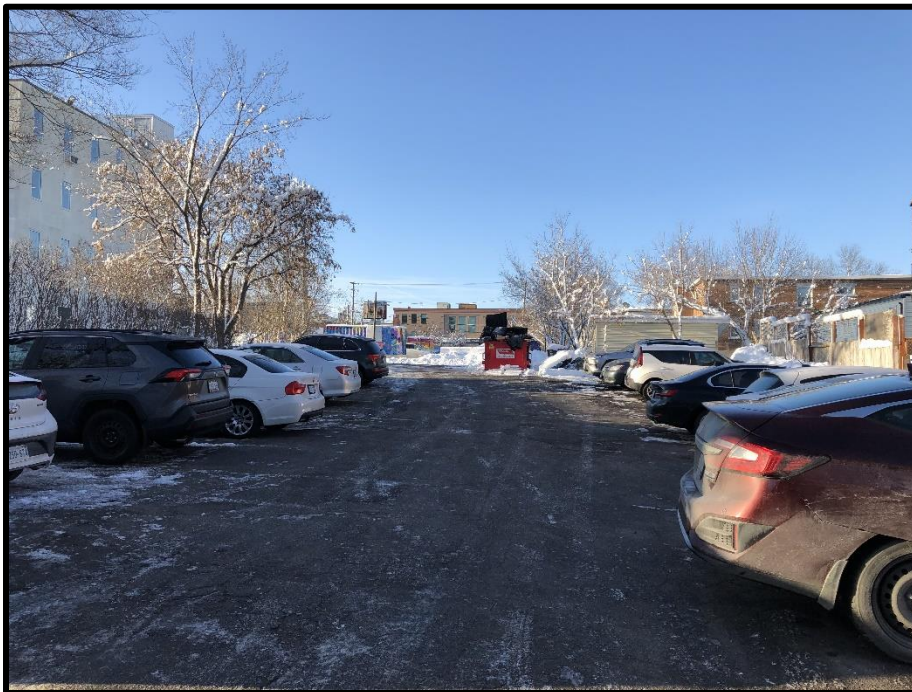
Photograph 2: View of the eastern portion of the Phase I Property, facing west from Park Street.
