## Phase Two Environmental Site Assessment 56 Capilano Drive, Ottawa, Ontario

Phase Two Environmental Site Assessment

OTT-22003851-A0

2022-05-27

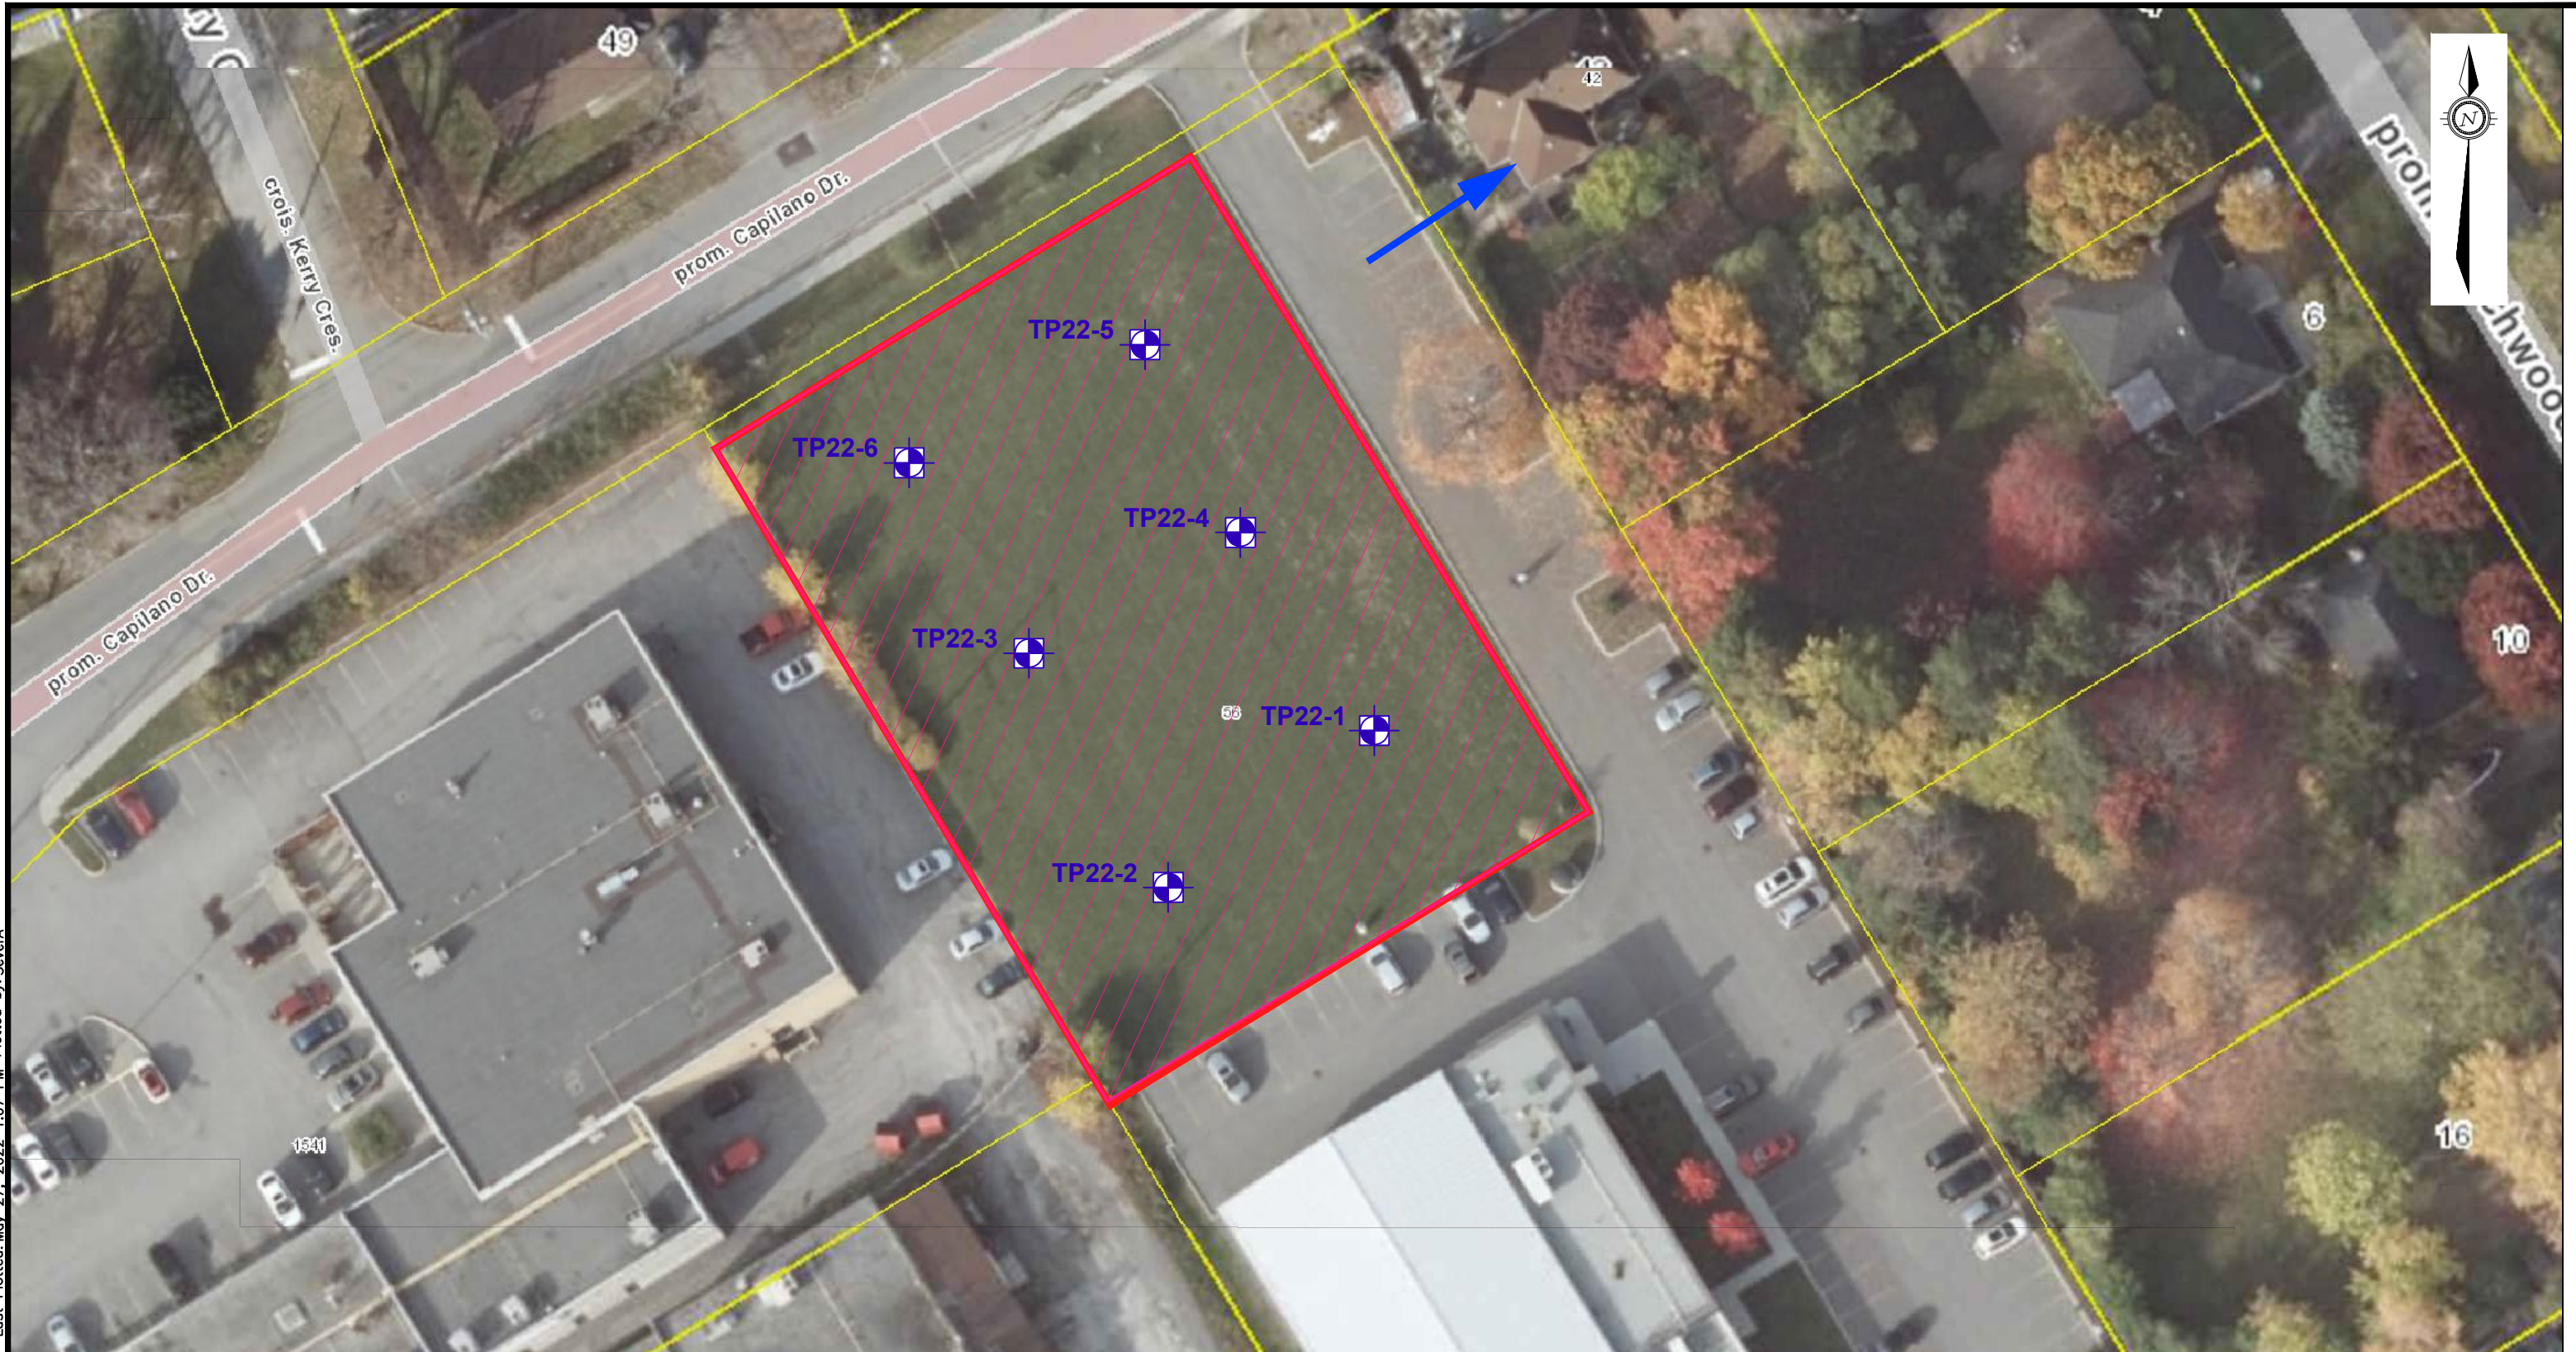
DATE MAY 2022	<b>PHASE TWO ENVIRONMENTAL SITE ASSESSMENT</b>	project no. OTT-22003851-A0
DESIGN LW		scale 1:500
CHECKED MM		
DRAWN BY AS	TITLE: <b>TEST PIT LOCATION PLAN</b> 56 CAPILANO DRIVE, OTTAWA, ONTARIO	<b>FIG 2</b>

On May 16, 2022, six test pits (TP22-1 to TP22-6) were advanced at the Phase Two property by Lacroix Equipment Rentals Ltd. (Lacroix) under the full-time supervision of EXP staff. Test pits were excavated to refusal on bedrock surface. Dedicated nitrile gloves (one pair per sample) were used during sample handling. No petroleum-based greases or solvents were used during excavation activities. EXP staff continuously monitored the excavating activities to log the stratigraphy observed from the pits, to record the depth of the samples, to record total depths of excavation, and to screen the samples by recording visual or olfactory observations of potential impacts and measuring petroleum vapours.

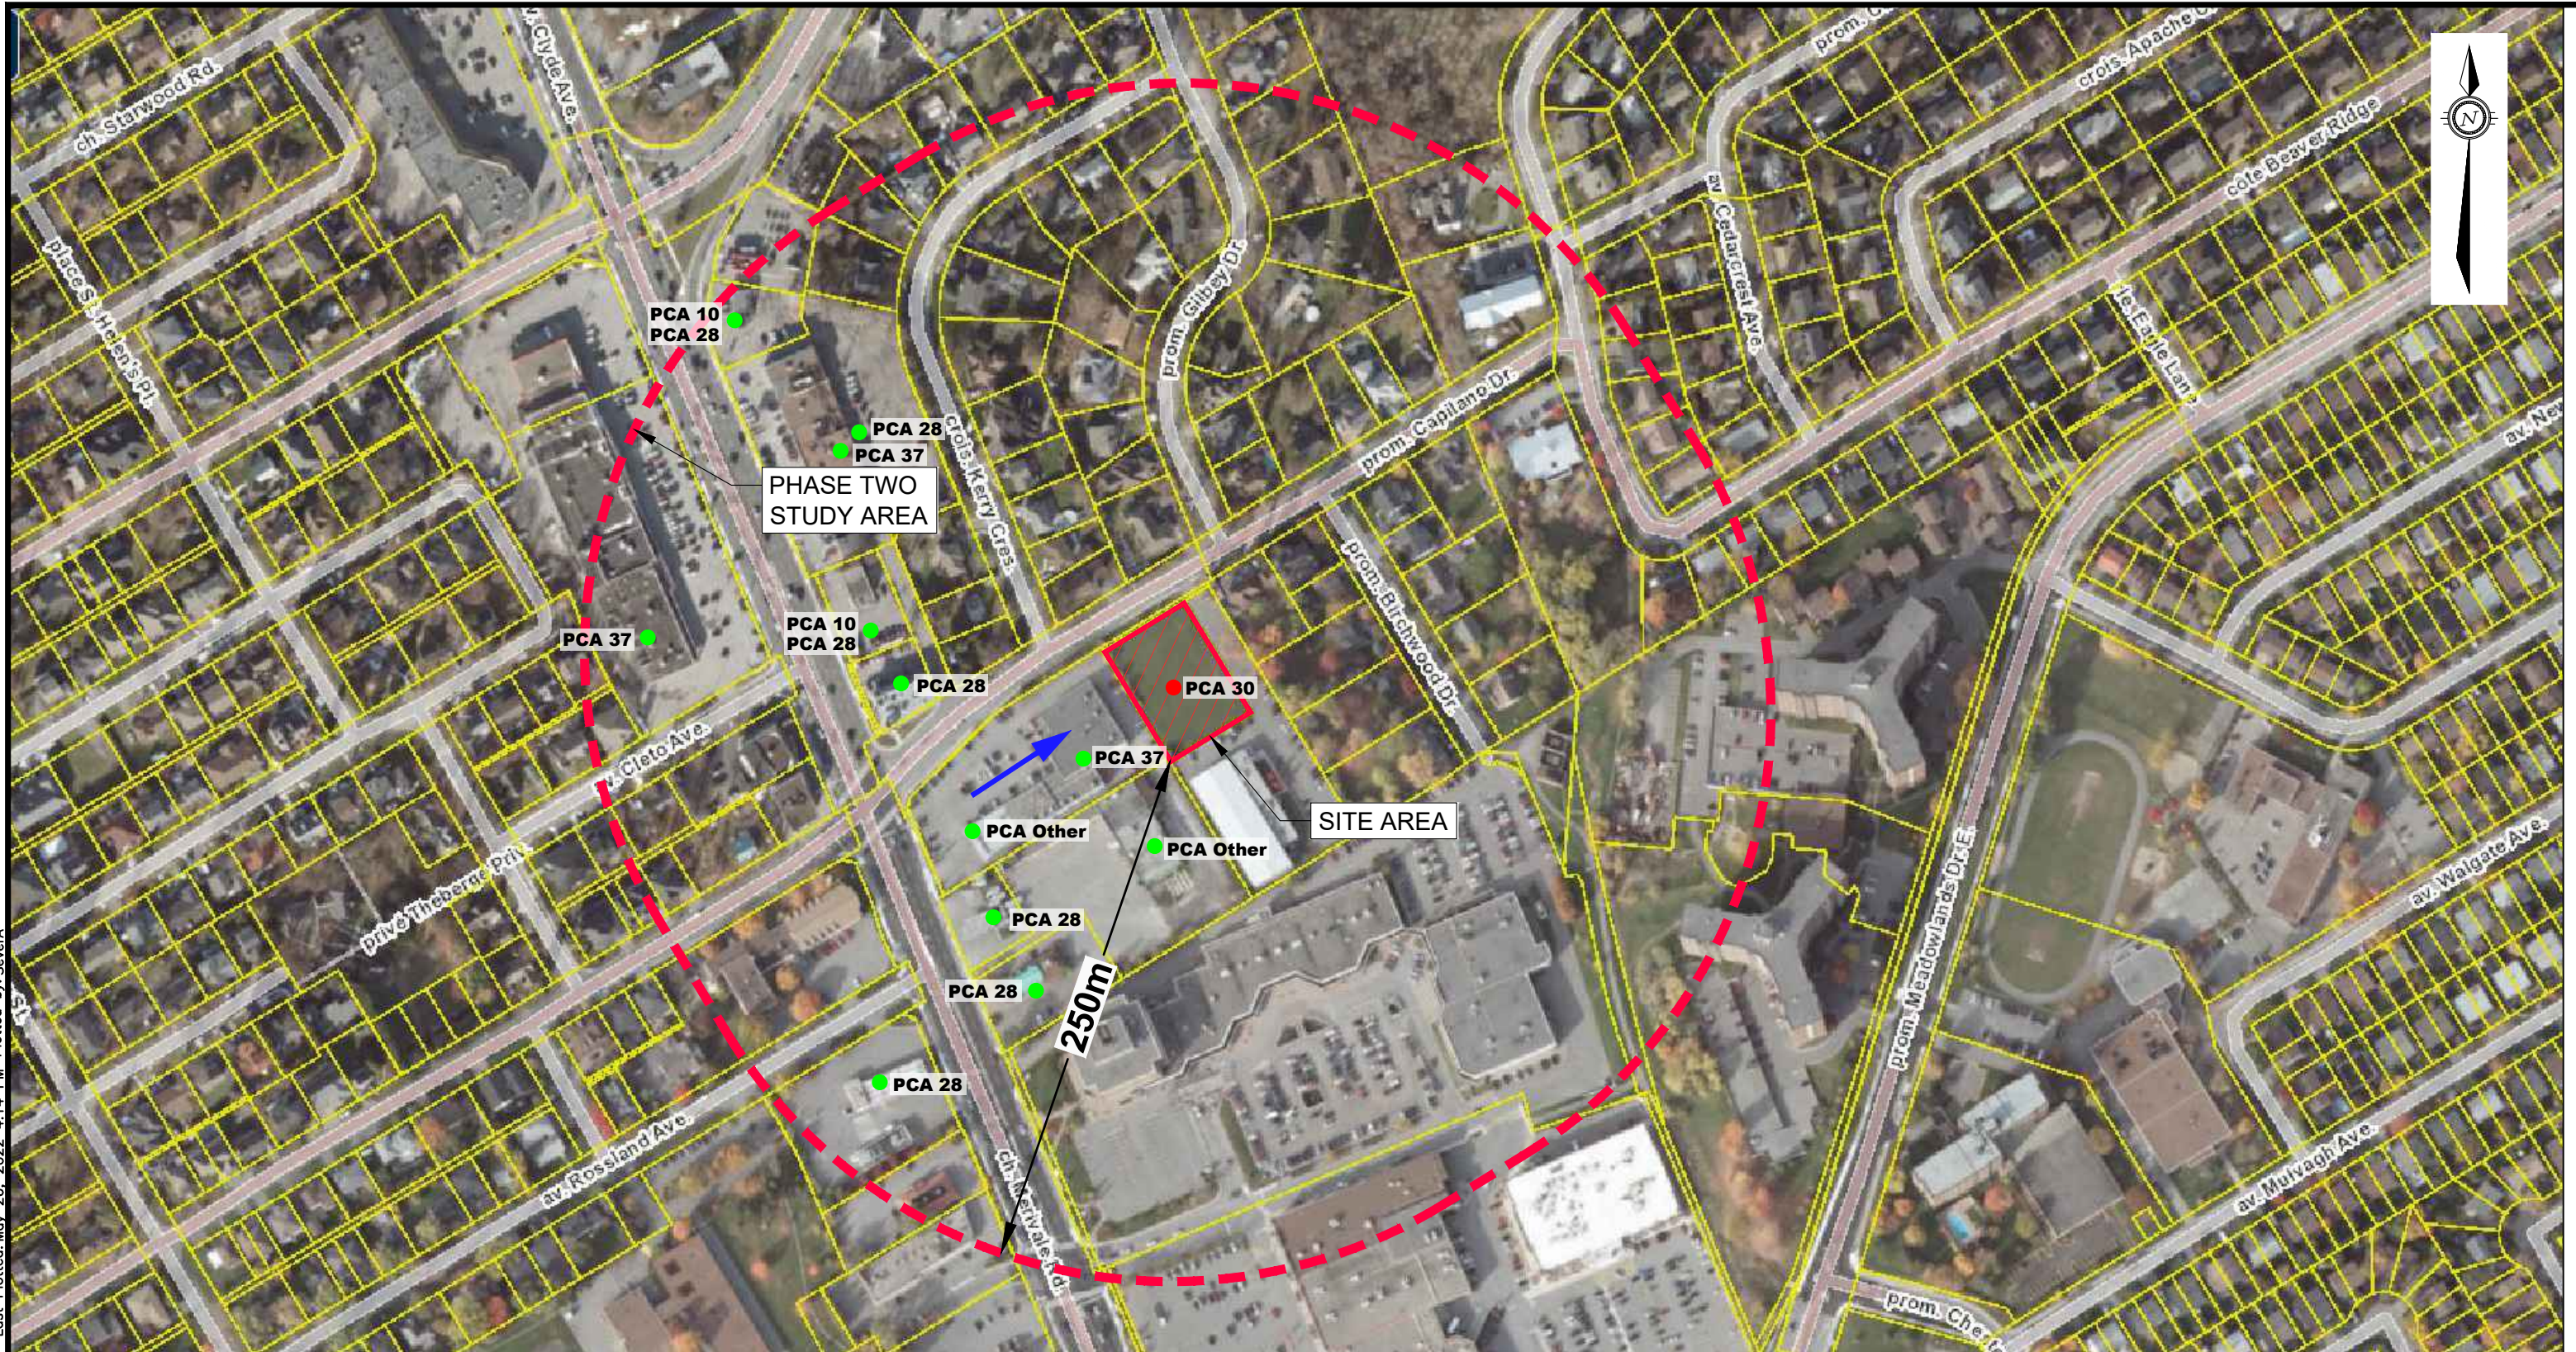
DATE MAY 2022	PHASE TWO ENVIRONMENTAL SITE ASSESSMENT	project no. OTT-22003851-A0
DESIGN LW		CHECKED MM
DRAWN BY AS	TITLE: CONCEPTUAL SITE MODEL – PHASE TWO STUDY AREA 56 CAPILANO DRIVE, OTTAWA, ONTARIO	FIG 3

A Conceptual Site Model (CSM) provides a narrative, graphical and tabulated description integrating information related to the Phase Two property's geologic and hydrogeological conditions, areas of potential environmental concern/potential contaminating activities, the presence and distribution of contaminants of concern, contaminant fate and transport, and potential exposure pathways.

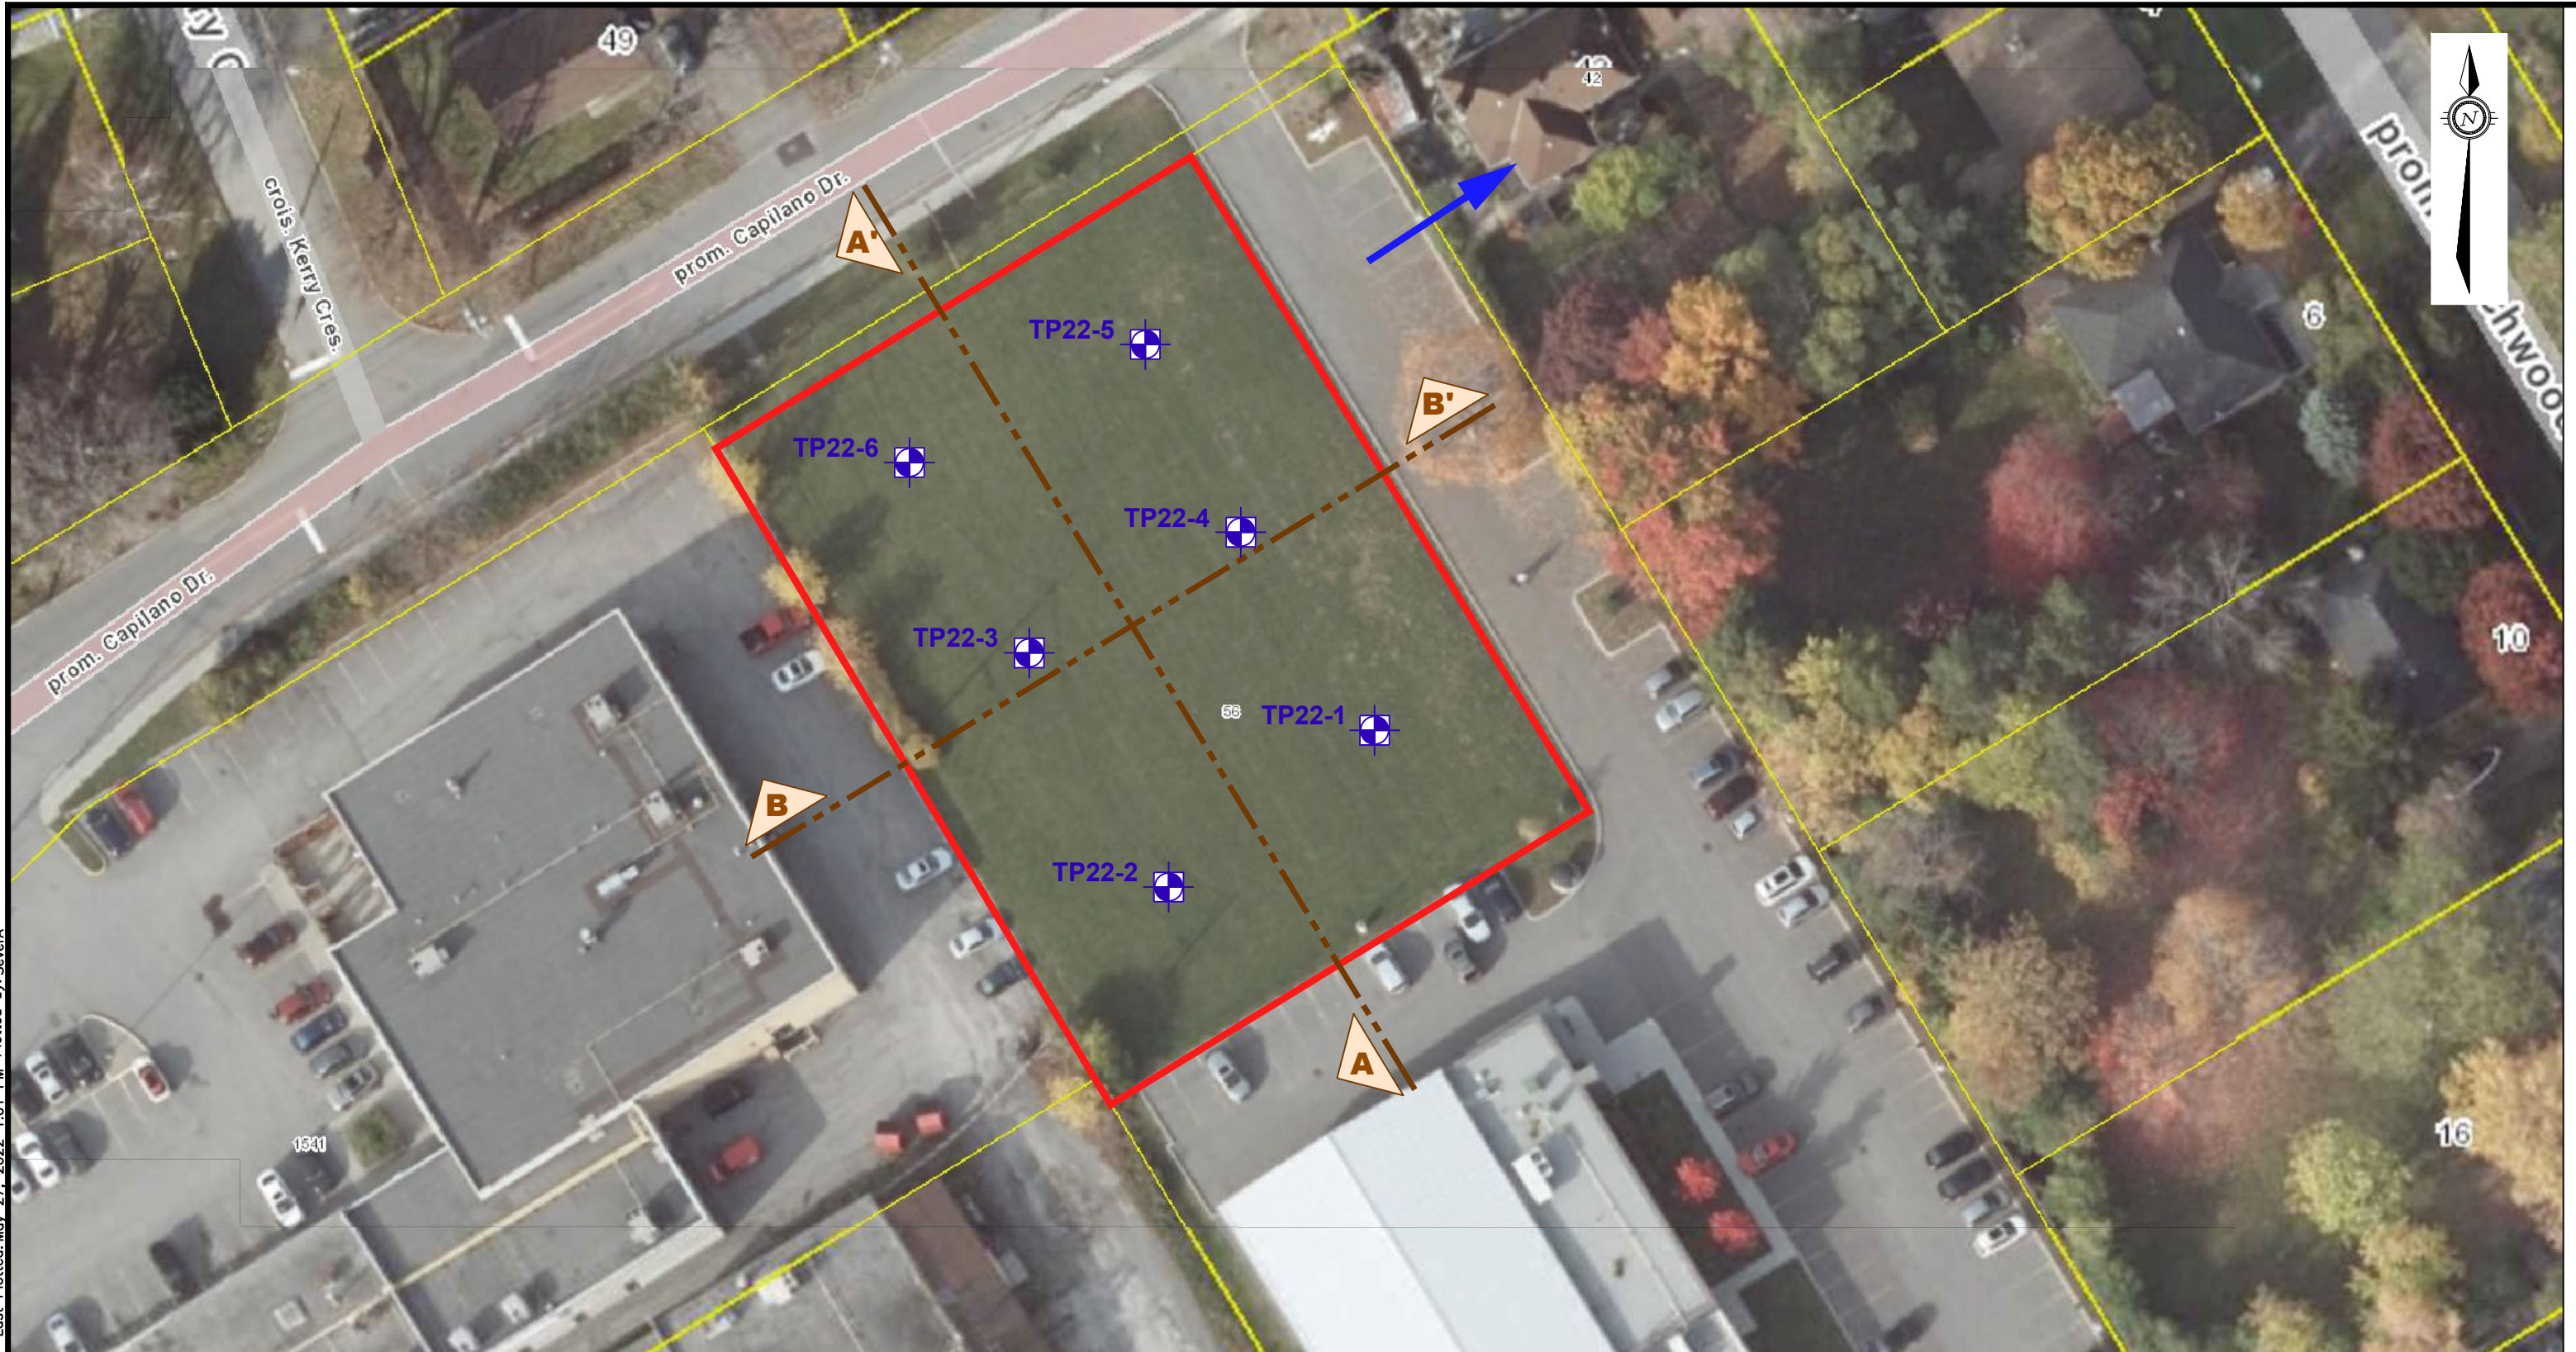
DATE MAY 2022	<b>PHASE TWO ENVIRONMENTAL SITE ASSESSMENT</b>	project no. OTT-22003851-A0
DESIGN LW		checked MM
DRAWN BY AS		scale 1:500
<b>CROSS-SECTIONS A-A' &amp; B-B'</b> 56 CAPILANO DRIVE, OTTAWA, ONTARIO		<b>FIG 5</b>

A plan view showing cross-sections is provided as Figure 4 in Appendix A, while the Phase Two property geology is depicted in cross-sections on Figure 5 in Appendix A.

A plan view showing cross-sections is provided as Figure 4, while the Phase Two property geology is depicted in cross-sections on Figure 5.

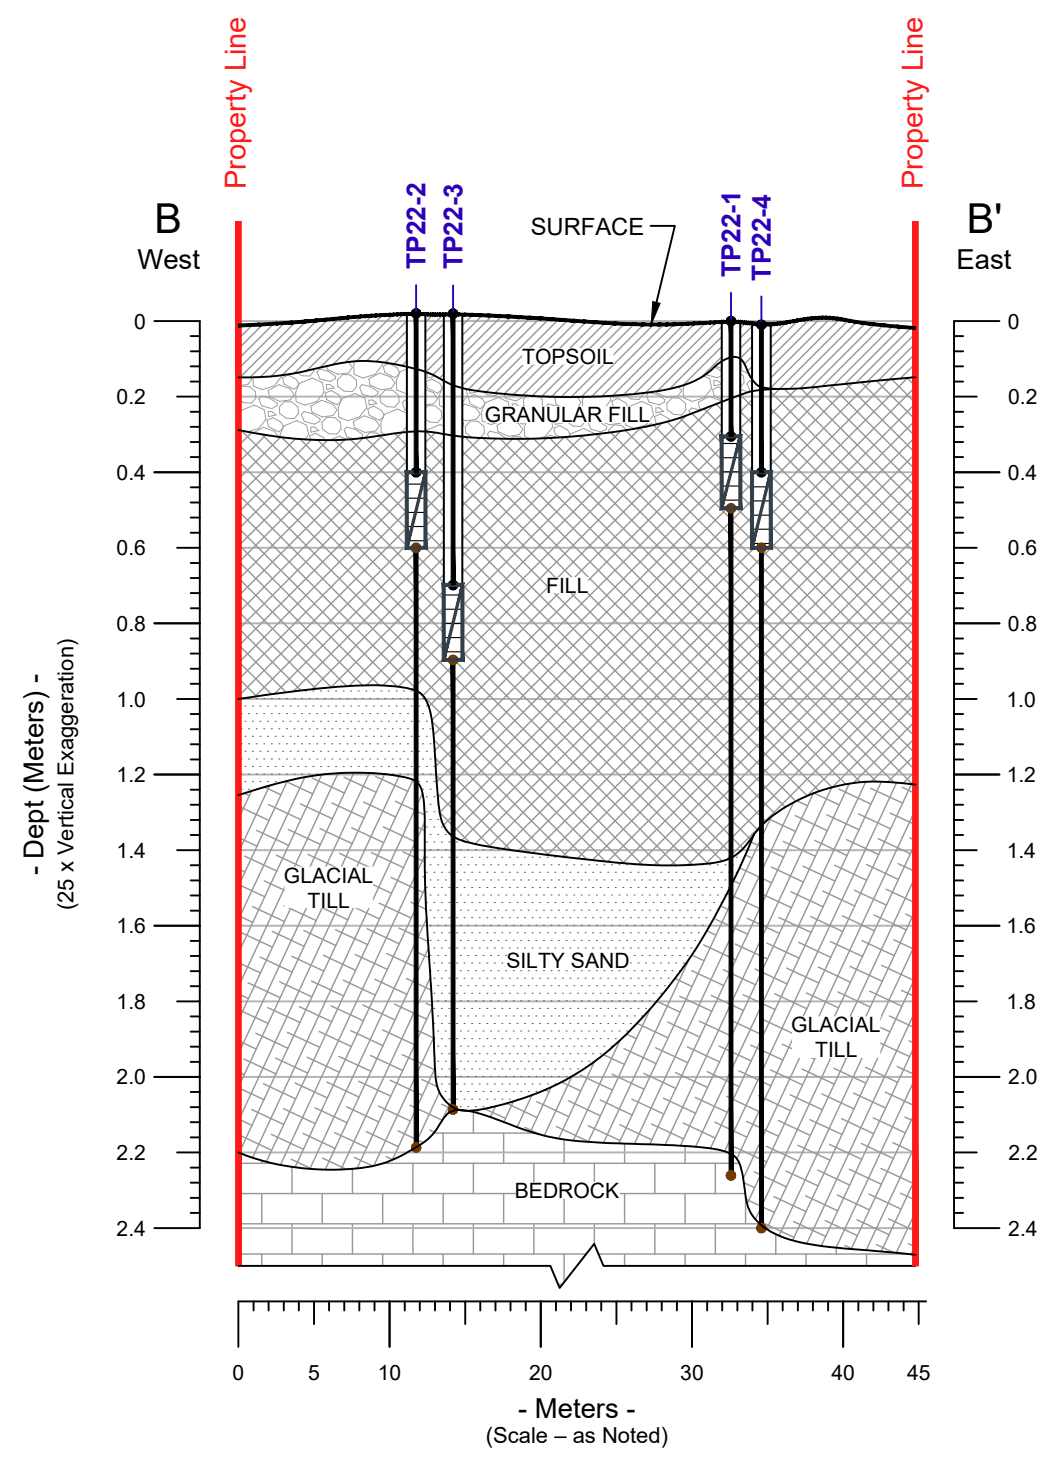
Soil at the Phase Two property generally consisted of sandy clay and gravel fill material overlying silty clay and glacial till. Small amounts of debris material (bricks, concrete, rubber debris) were present in the fill material in TP22-5 and TP22-6. There were no odours or staining observed in the fill or native material in any of the test-pits. Refusal was met in all the test pits at depths ranging between 2.0 m to 2.4 m.

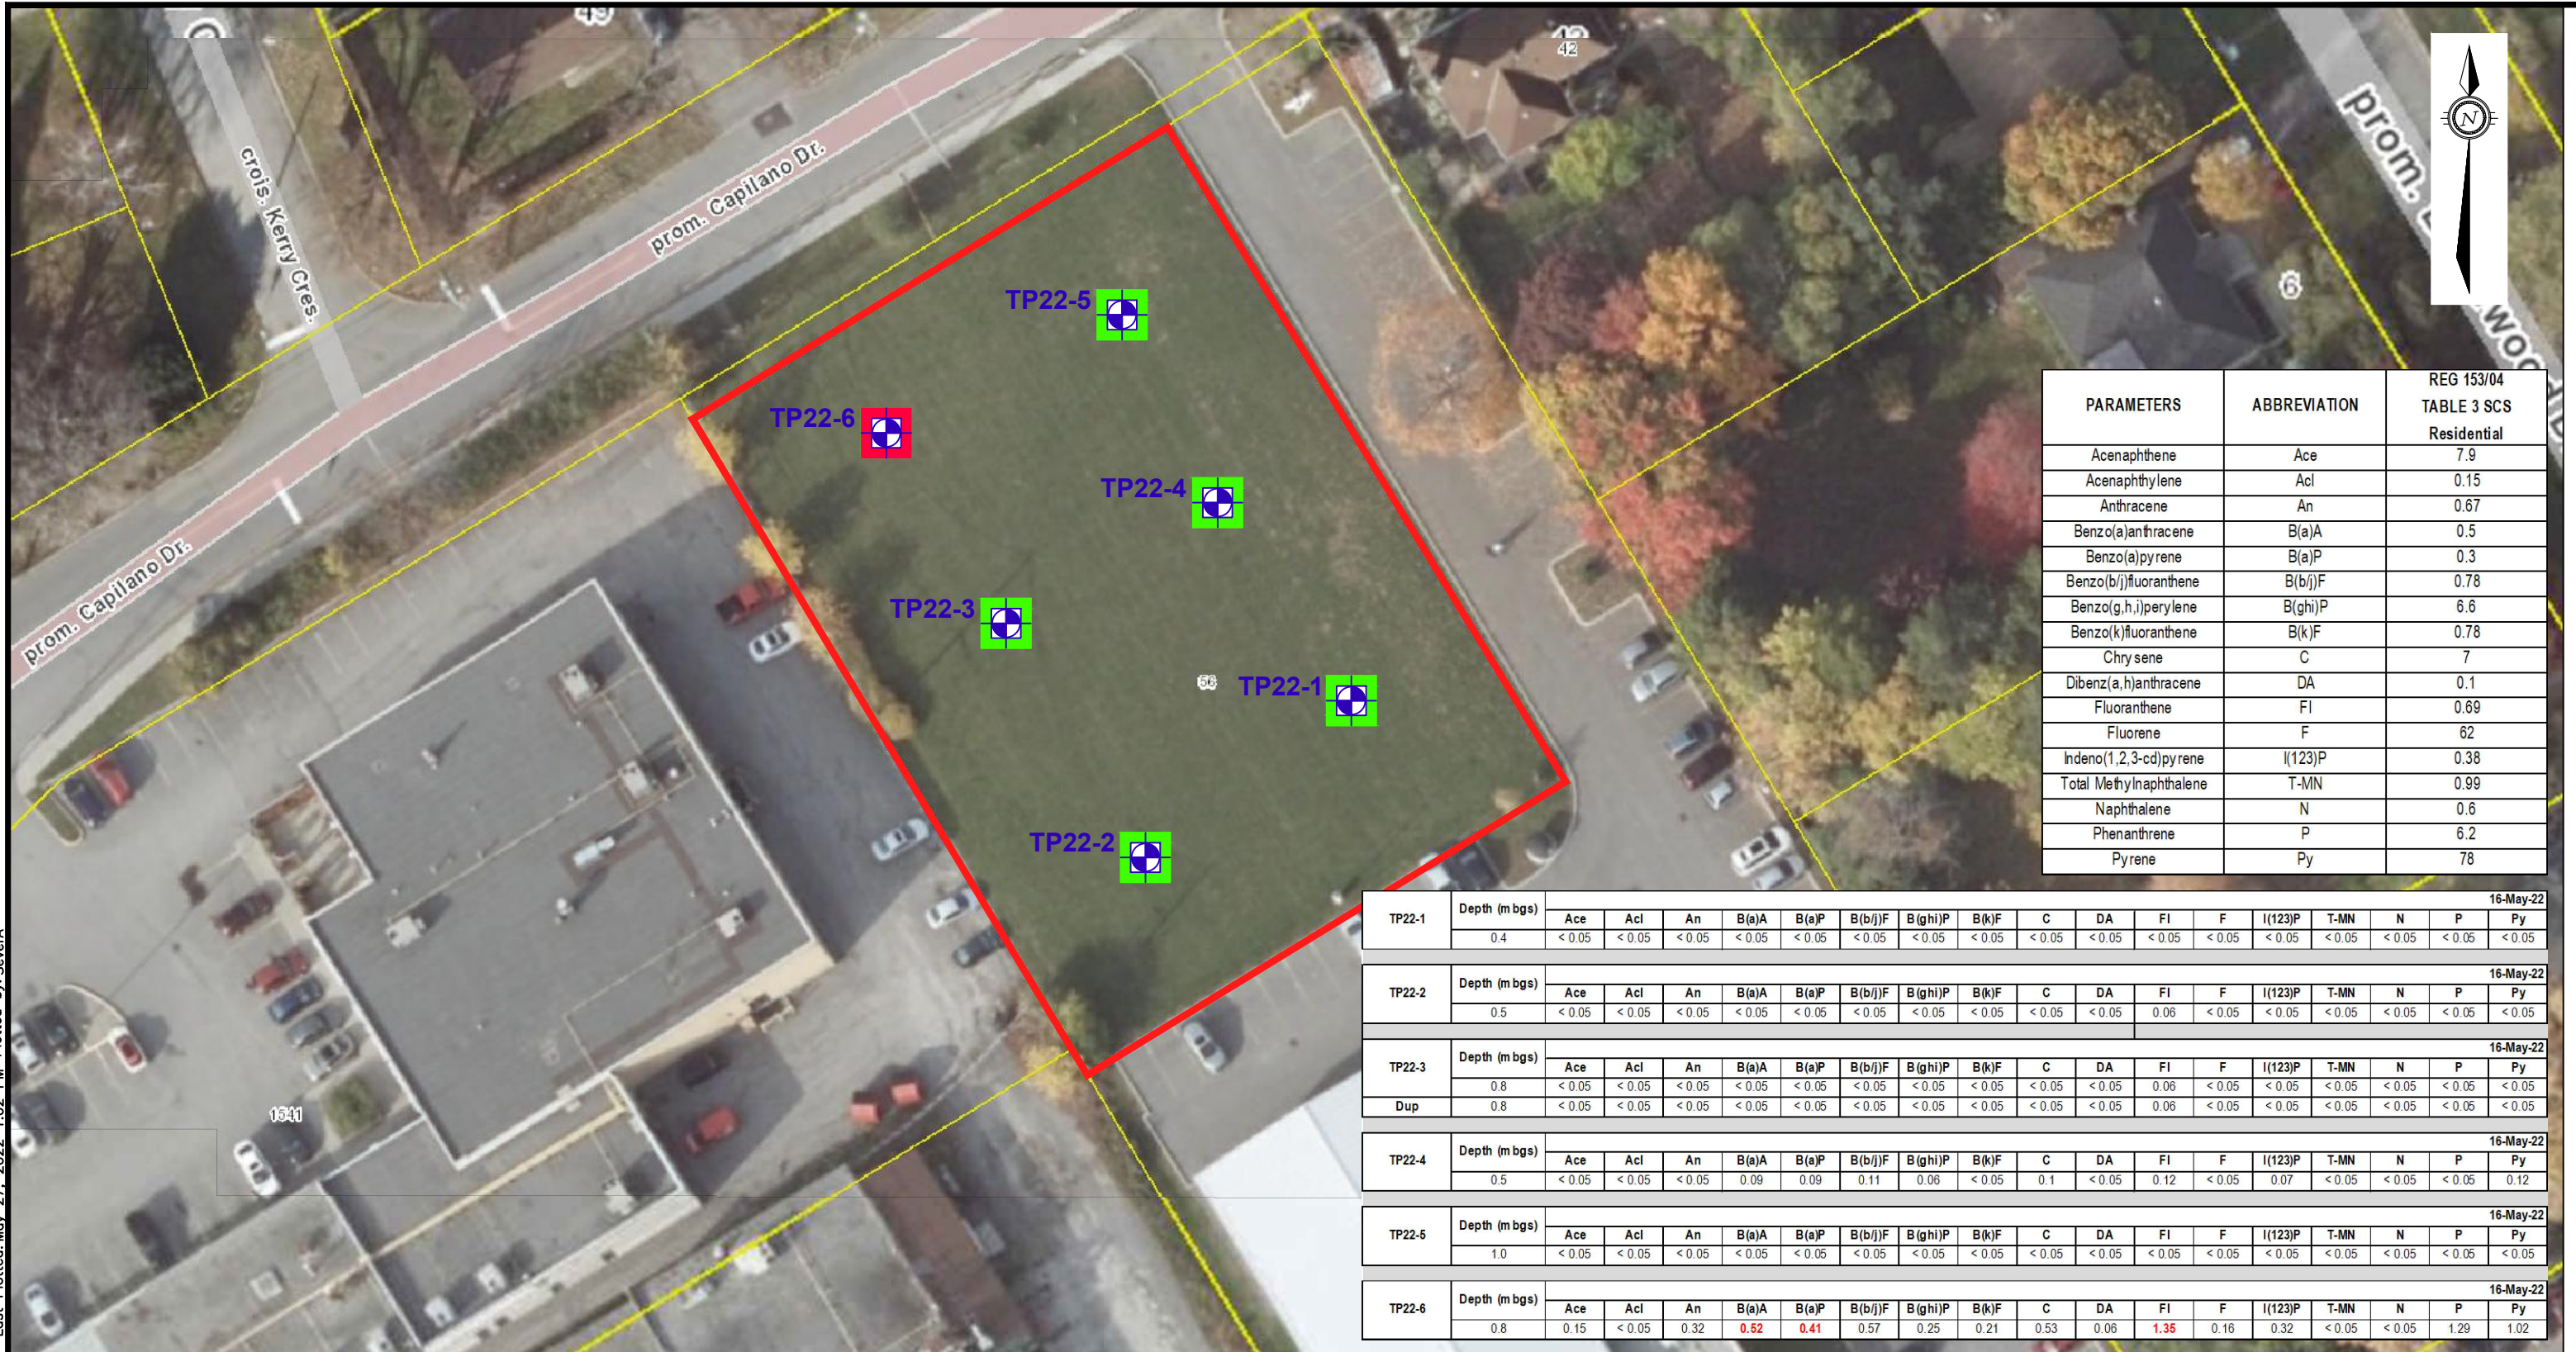
All of the fill samples had concentrations of VOC, PHC, PAH, and metals that were within the Table 3 residential Site Condition Standards (SCS), with the exception of the fill sample from TP22-06 which exceeded the Table 3 residential SCS for benzo(a)anthracene, benzo(a)pyrene, and fluoranthene.

PAH impacted soil was identified in one fill sample from TP22-6 and is associated with poor fill quality, miscellaneous debris was also observed in the fill material at this location. The depth of fill at this location was 0.2 to 1.5 m bgs. Only a small part of the Phase Two property appears to be impacted and the contaminants do not appear to be migrating. It is recommended that the impacted soil be removed from the Phase Two property when the property is re-developed.

Only a small part of the Phase Two property appears to be impacted and the contaminants do not appear to be migrating. It is recommended that the impacted soil be removed from the Phase Two property when the property is re-developed.

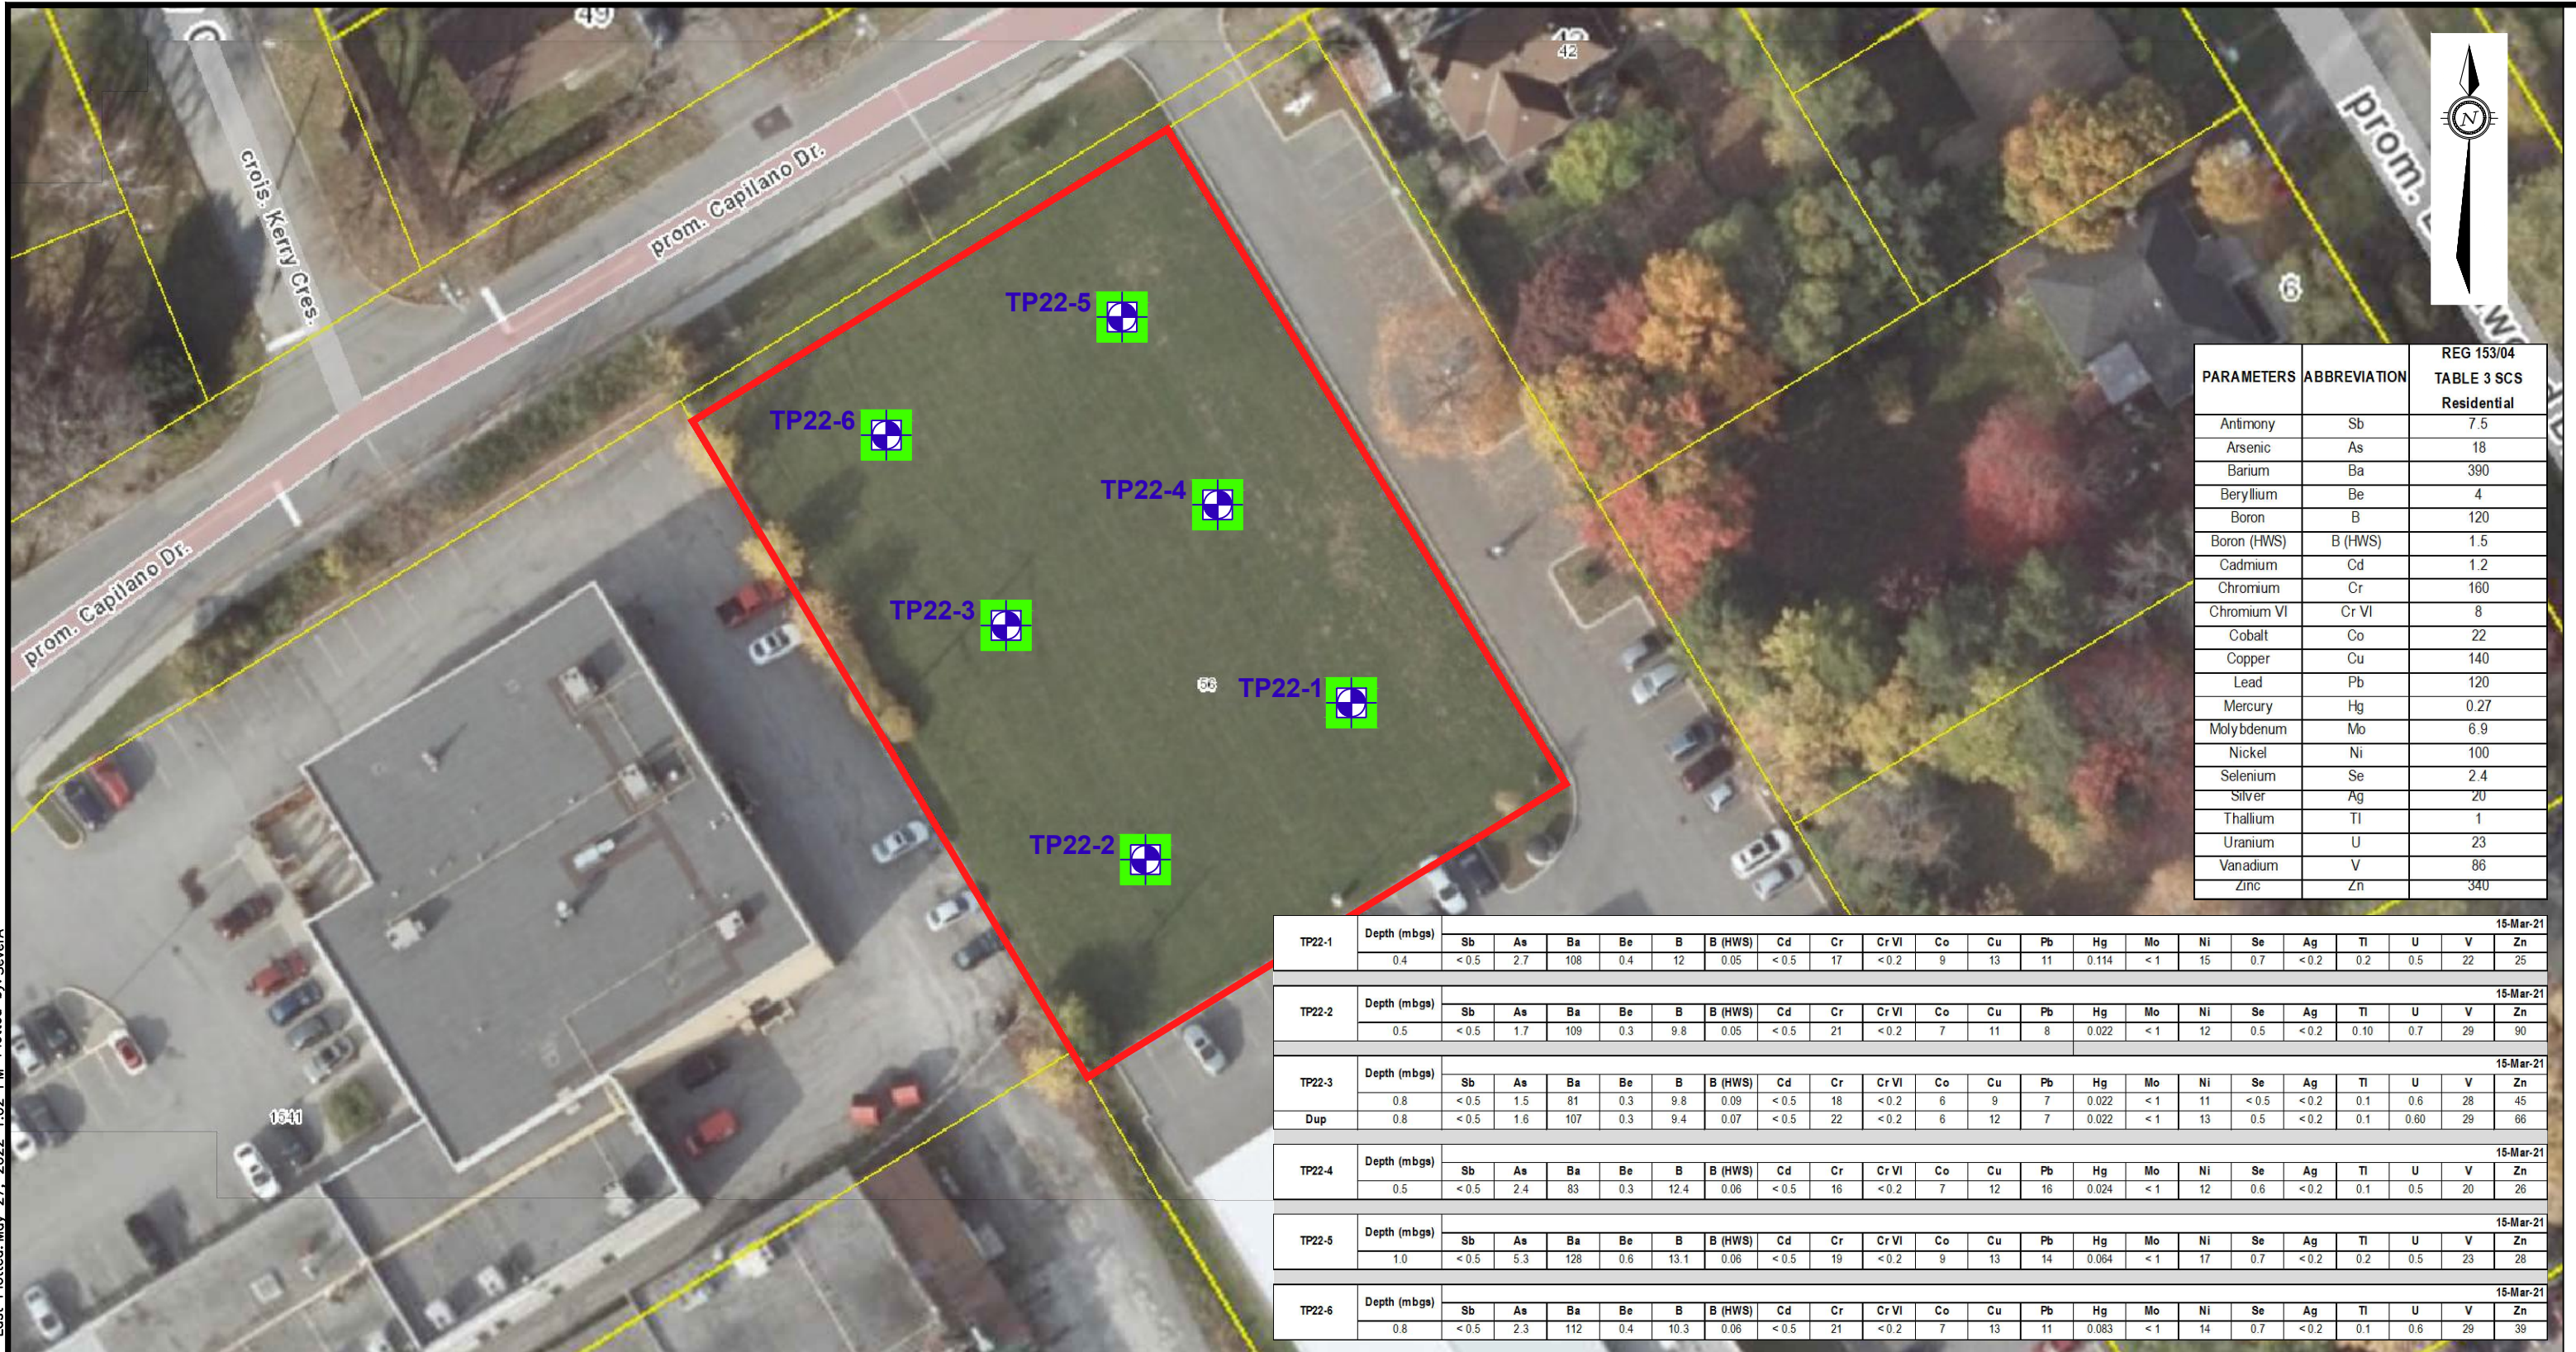
PARAMETERS	ABBREVIATION	REG 153/04 TABLE 3 SCS Residential
Antimony	Sb	7.5
Arsenic	As	18
Barium	Ba	390
Beryllium	Be	4
Boron	B	120
Boron (HWS)	B (HWS)	1.5
Cadmium	Cd	1.2
Chromium	Cr	160
Chromium VI	Cr VI	8
Cobalt	Co	22
Copper	Cu	140
Lead	Pb	120
Mercury	Hg	0.27
Molybdenum	Mo	6.9
Nickel	Ni	100
Selenium	Se	2.4
Silver	Ag	20
Thallium	Tl	1
Uranium	U	23
Vanadium	V	86
Zinc	Zn	340

TEST PIT	Depth (mbgs)	PARAMETERS																			DATE			
		Sb	As	Ba	Be	B	B (HWS)	Cd	Cr	Cr VI	Co	Cu	Pb	Hg	Mo	Ni	Se	Ag	Tl	U	V	Zn	15-Mar-21	15-Mar-21
TP22-1	0.4	<0.5	2.7	108	0.4	12	0.05	<0.5	17	<0.2	9	13	11	0.114	<1	15	0.7	<0.2	0.2	0.5	22	25	15-Mar-21	15-Mar-21
TP22-2	0.5	<0.5	1.7	109	0.3	9.8	0.05	<0.5	21	<0.2	7	11	8	0.022	<1	12	0.5	<0.2	0.10	0.7	29	90	15-Mar-21	15-Mar-21
TP22-3	0.8	<0.5	1.5	81	0.3	9.8	0.09	<0.5	18	<0.2	6	9	7	0.022	<1	11	<0.5	<0.2	0.1	0.6	28	45	15-Mar-21	15-Mar-21
Dup	0.8	<0.5	1.6	107	0.3	9.4	0.07	<0.5	22	<0.2	6	12	7	0.022	<1	13	0.5	<0.2	0.1	0.60	29	66	15-Mar-21	15-Mar-21
TP22-4	0.5	<0.5	2.4	83	0.3	12.4	0.06	<0.5	16	<0.2	7	12	16	0.024	<1	12	0.6	<0.2	0.1	0.5	20	26	15-Mar-21	15-Mar-21
TP22-5	1.0	<0.5	5.3	128	0.6	13.1	0.06	<0.5	19	<0.2	9	13	14	0.064	<1	17	0.7	<0.2	0.2	0.5	23	28	15-Mar-21	15-Mar-21
TP22-6	0.8	<0.5	2.3	112	0.4	10.3	0.06	<0.5	21	<0.2	7	13	11	0.083	<1	14	0.7	<0.2	0.1	0.6	29	39	15-Mar-21	15-Mar-21

<b>LEGEND</b>	PROPERTY BOUNDARY	SAMPLE MET TABLE 3 RESIDENTIAL SCS
TP22-1	TEST PIT NAME & LOCATION	SAMPLE EXCEEDED TABLE 3 RESIDENTIAL SCS
