**ALL SAINTS DEVELOPMENT LP**

**UPDATE TO PHASE ONE**

**ENVIRONMENTAL SITE ASSESSMENT**

**315-317 Chapel Street, Ottawa, Ontario**

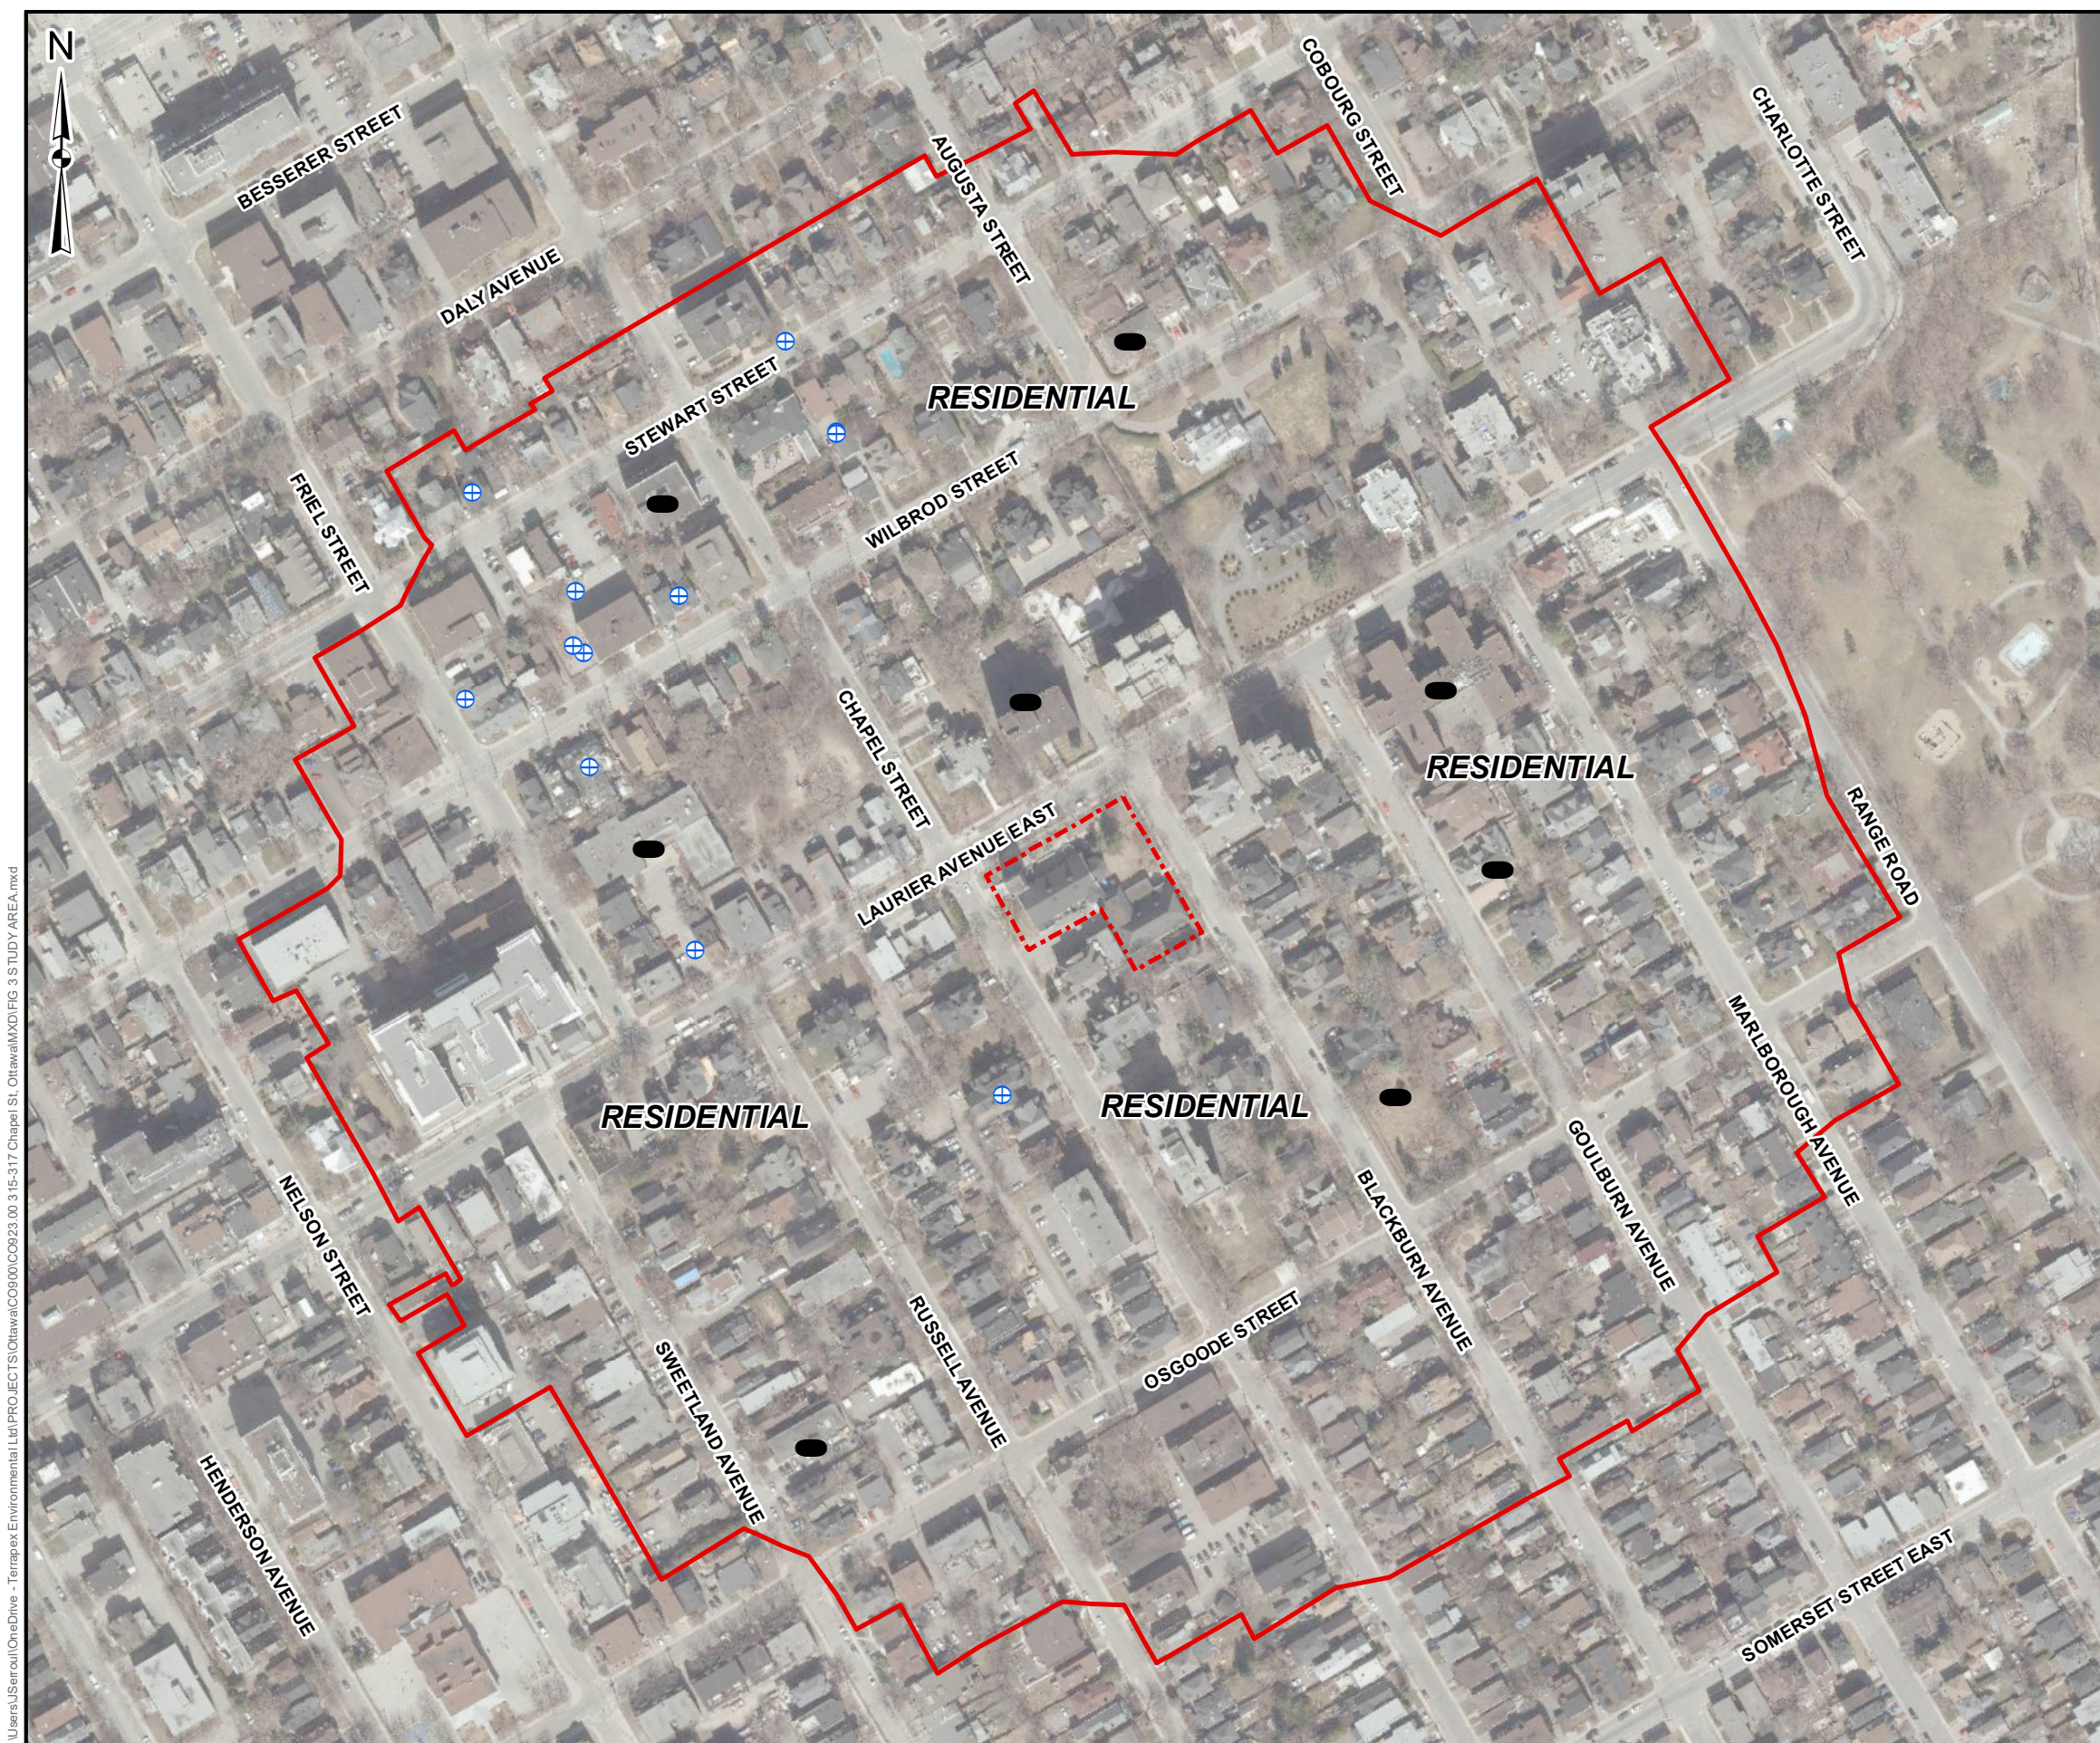
DRAWN BY: JS	PROJECT NO.: CO923.00	CHECKED BY: JOB
REVISION: 00	DATE: JULY 2023	FIGURE: <b>3</b>

TITLE:  
**PHASE ONE STUDY AREA AND SURROUNDING LAND USES**

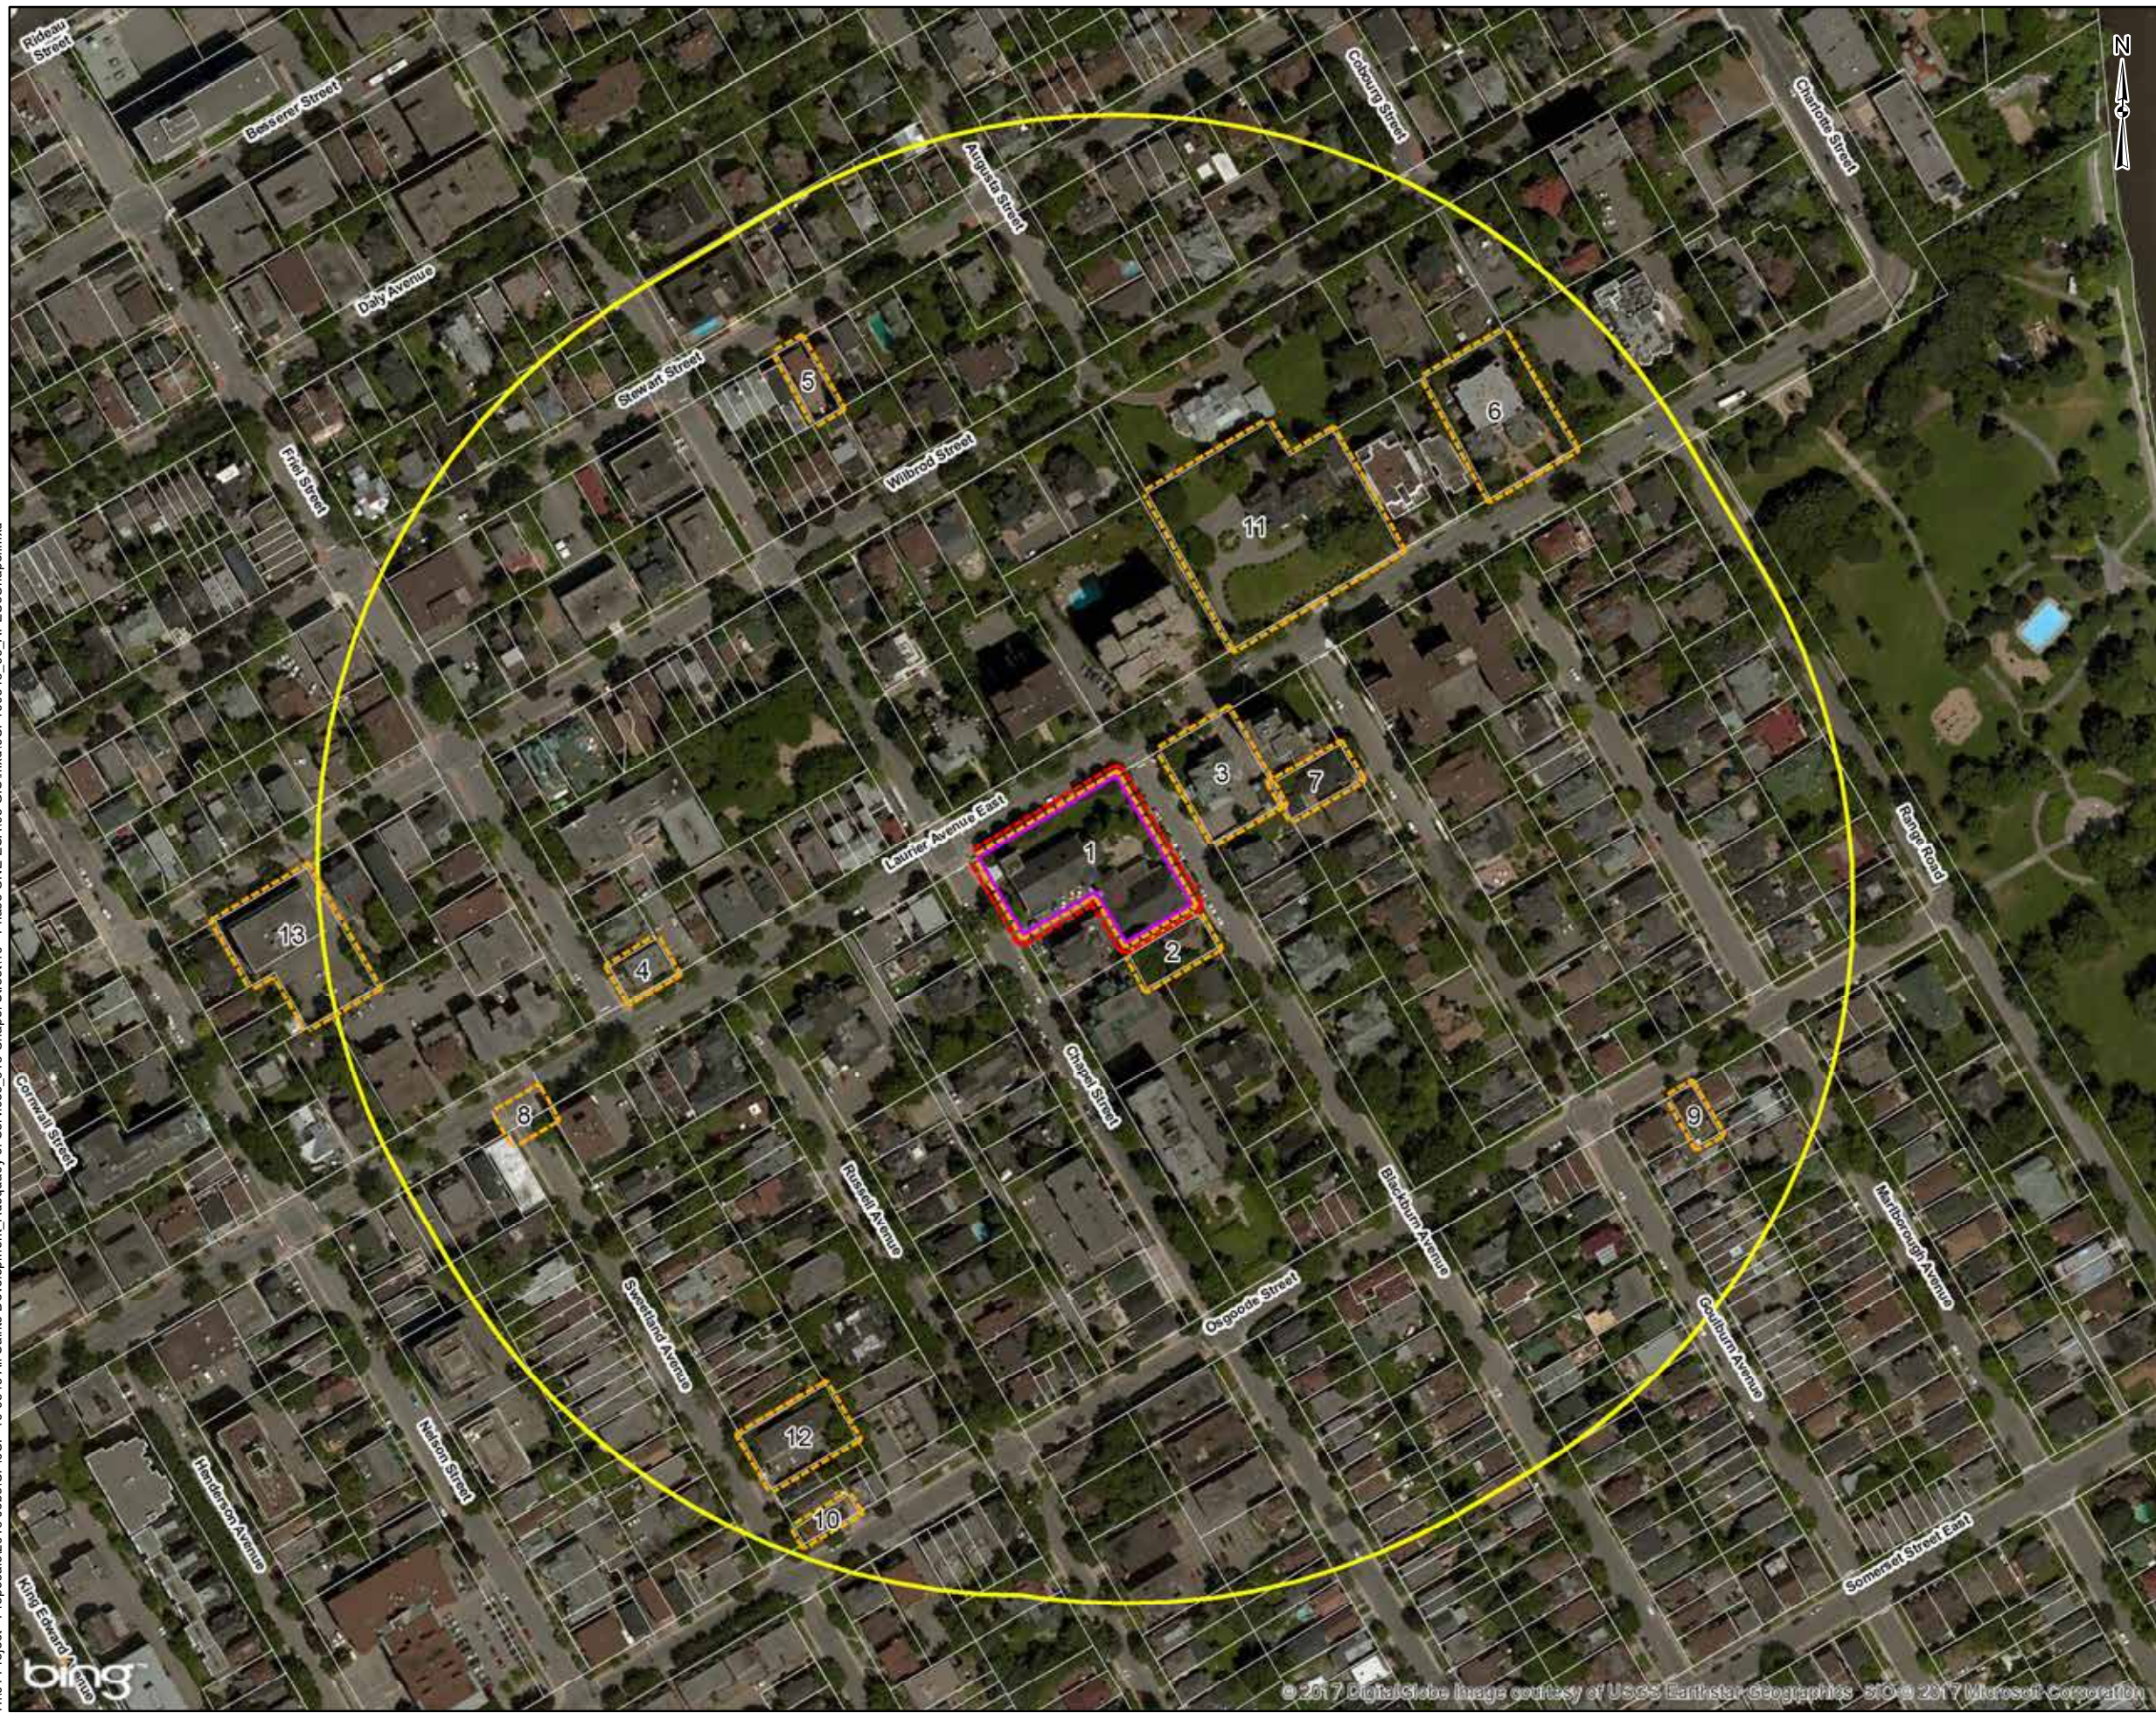
- Area of Potential Environmental Concern (APEC)
- Potentially Contaminating Activity (PCA)
- Property Boundary
- 250m Buffer
- Property Parcel

Areas of potential environmental concern (APEC) are indicated on Figure 6. It is noted that by definition, an on-site PCA results in an APEC under O.Reg. 153/04 as amended. However, based on our review of relevant documentation, the potential for actual impacts to the natural environment is minimal, and these historical activities are not considered to represent a concern with respect to the current use of the Site. It is further noted that groundwater impacts are not anticipated, given the silty clay soil reported at the site by Houle Chevrier’s borehole logs. The low conductivity of this soil is considered to limit contaminant transport to groundwater.

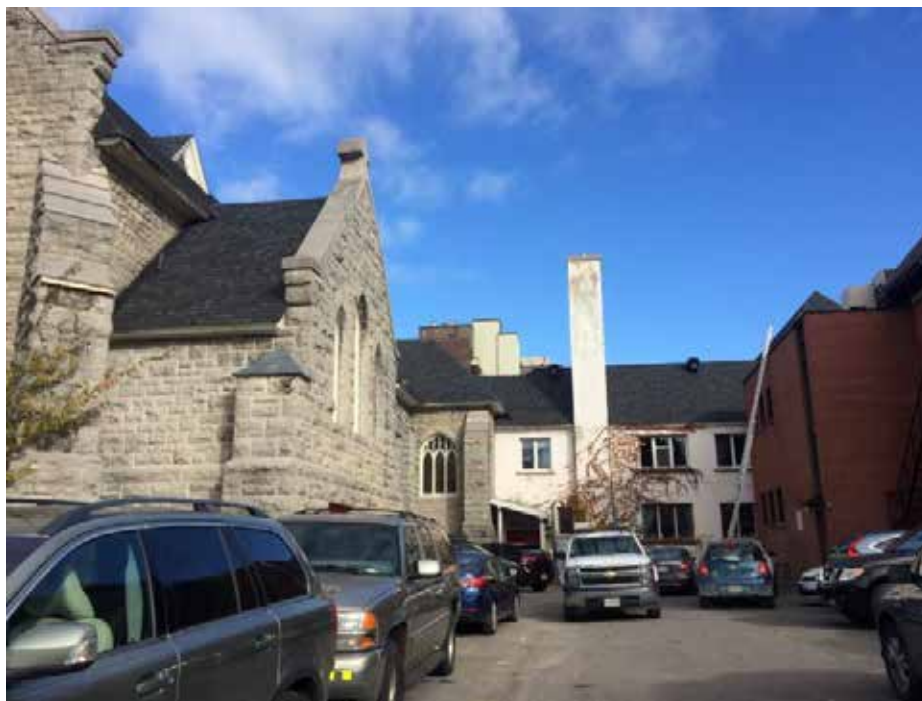
Photograph 3. View, looking northwest, of the playground located on the subject property

The Site is currently occupied by the All Saints Church and Bates Memorial Hall, which are attached by a vestibule. There are office spaces and rental spaces within the Hall. There is a small asphalt parking area and a play structure and public garden also located on the Site (Photos 1, 2, 3 and 5).

The ground surface at the Site that is not covered by the structures is either vegetated with grass and some trees or asphalt/concrete (Photos 2 and 3).

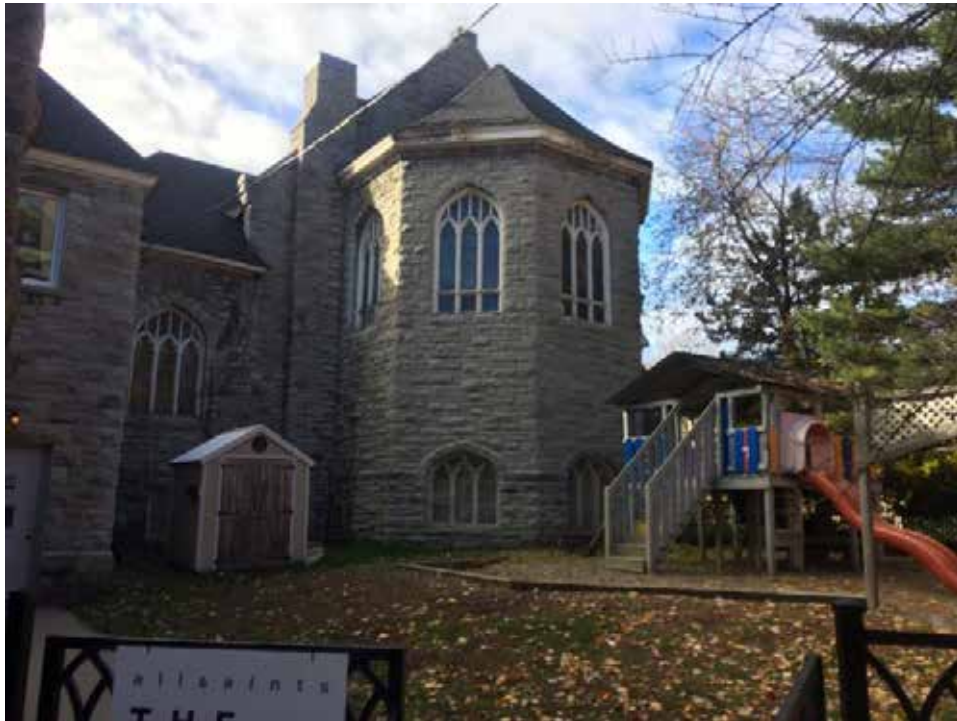
Photograph 4. View, looking southeast, of a monitoring well and fence line located to the north of the play structure, located on the subject property

Two monitoring wells were recently installed by Houle Chevrier, as part of the geotechnical investigation. The wells were completed to 11.96 and 17.40 m bgs. Bedrock was encountered at 11.96 and 14.22 m bgs (Houle Chevrier, 2016). One well was observed during the Phase One reconnaissance (see photo 4)

One monitoring well was observed on Site (Photo 4). This and another well were recently installed as part of a geotechnical investigation for the subject property. These well are temporary and used to measure groundwater elevation on Site. The wells were completed to 11.96 and 17.40 m bgs. Bedrock was encountered at 11.96 and 14.22 m bgs (Houle Chevrier, 2016).

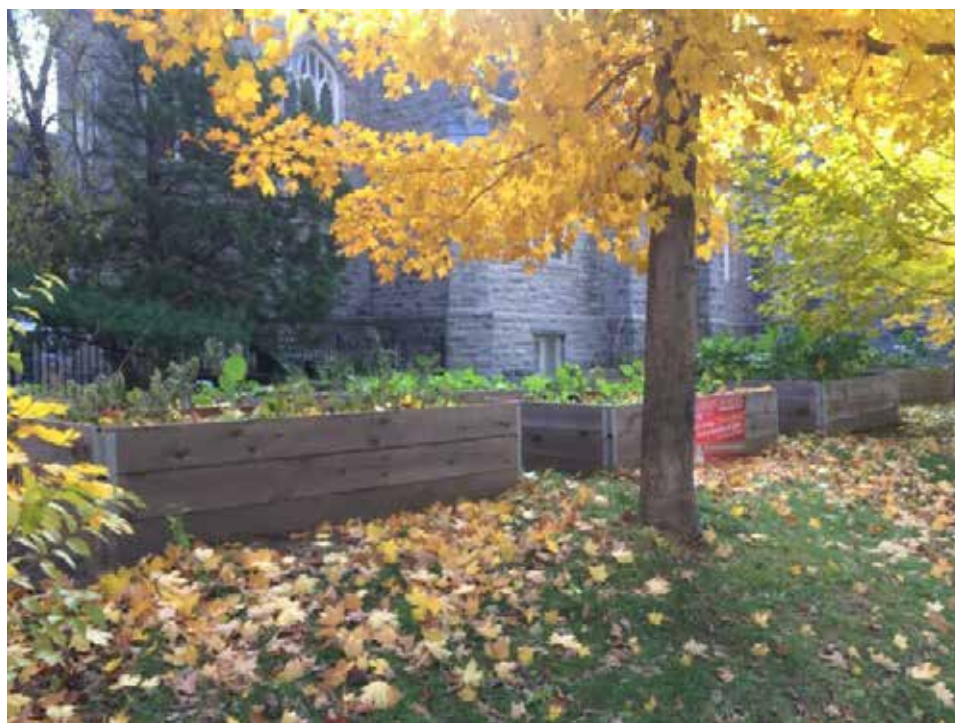
Photograph 5. View, looking northwest, of community gardening boxes, located on the subject property

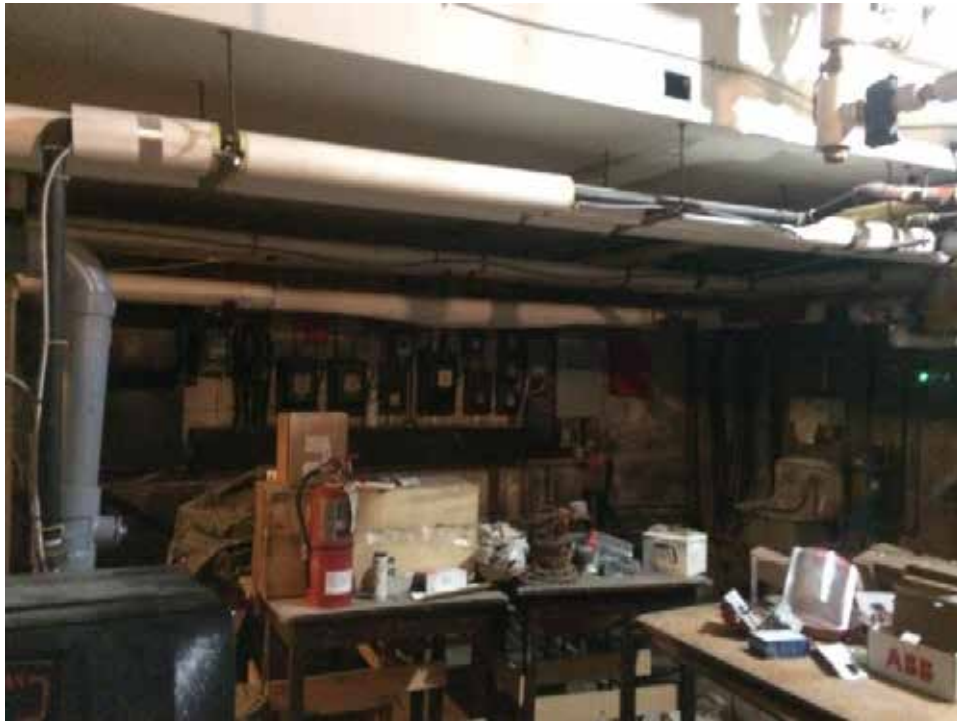
Photograph 11. View of the mechanical room, located in the basement of the church

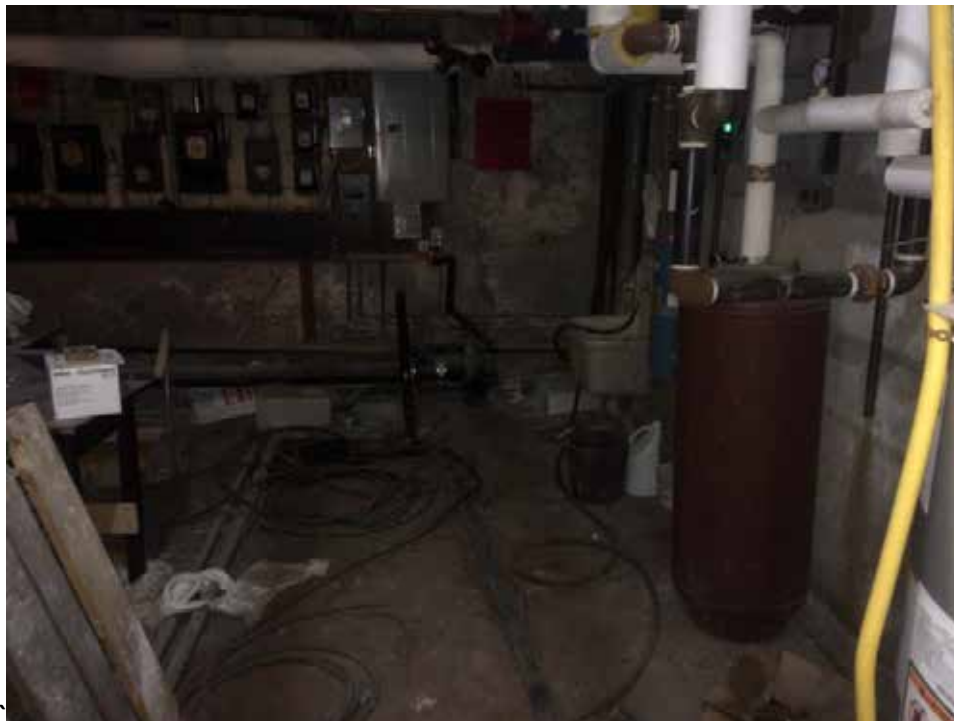
Photograph 12. View of the mechanical room, located in the basement of the church

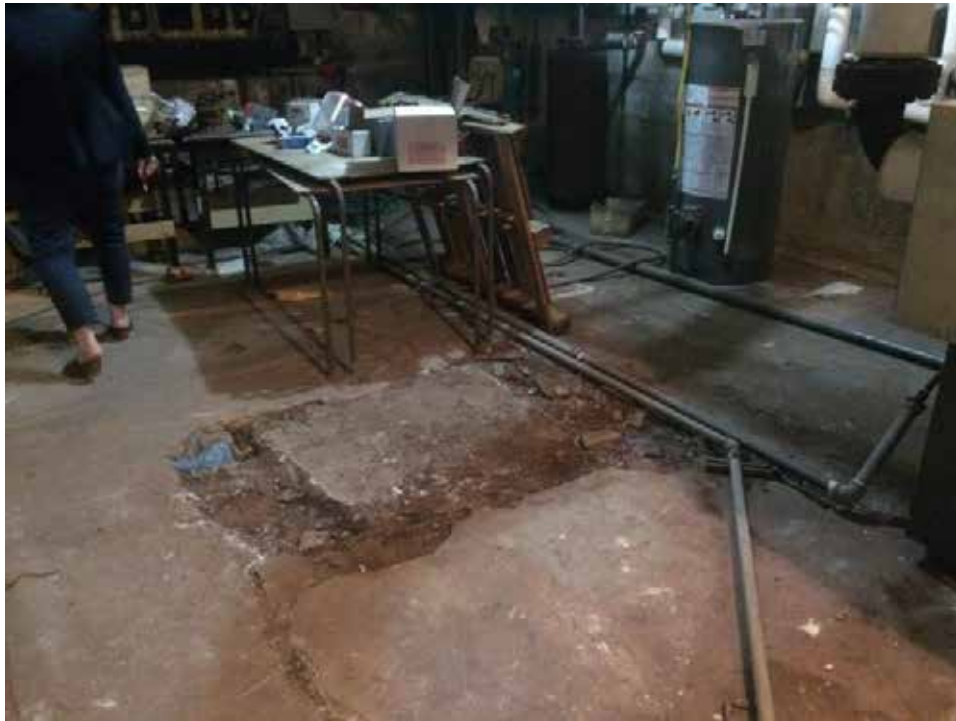
Photograph 13. View of the mechanical room, located in the basement of the church

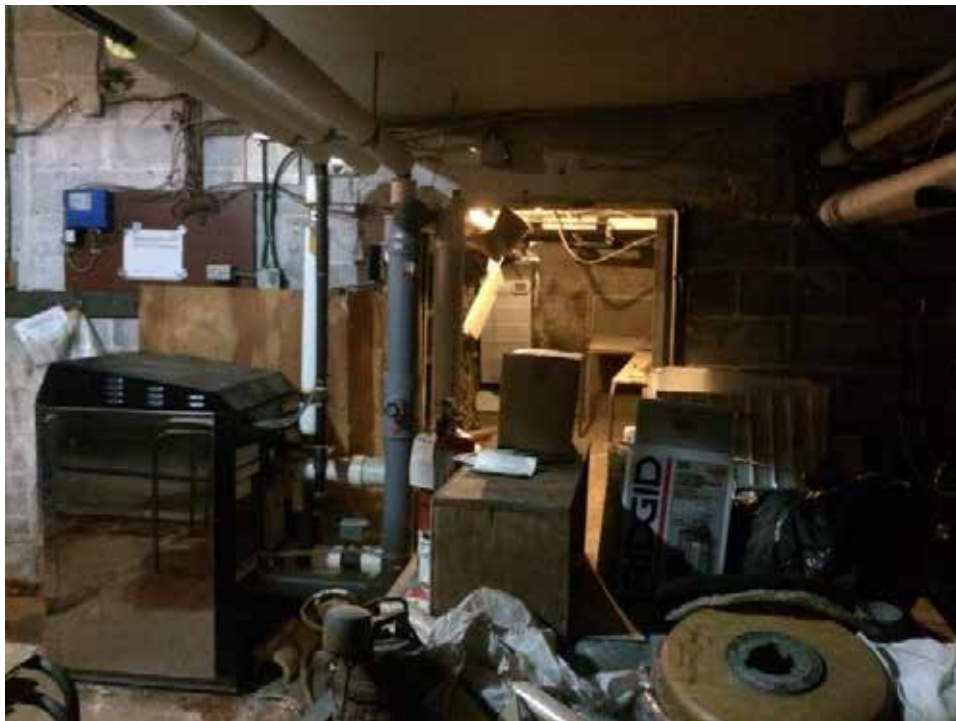
Photograph 14. View of a furnace, located in the mechanical room of the church

**Heating and Cooling:** At the time of Site reconnaissance the buildings at the Site were heated with a natural gas-fired boiler and cooled with a central air conditioning system. It was noted that water from the boiler was leaking to a basement sump.

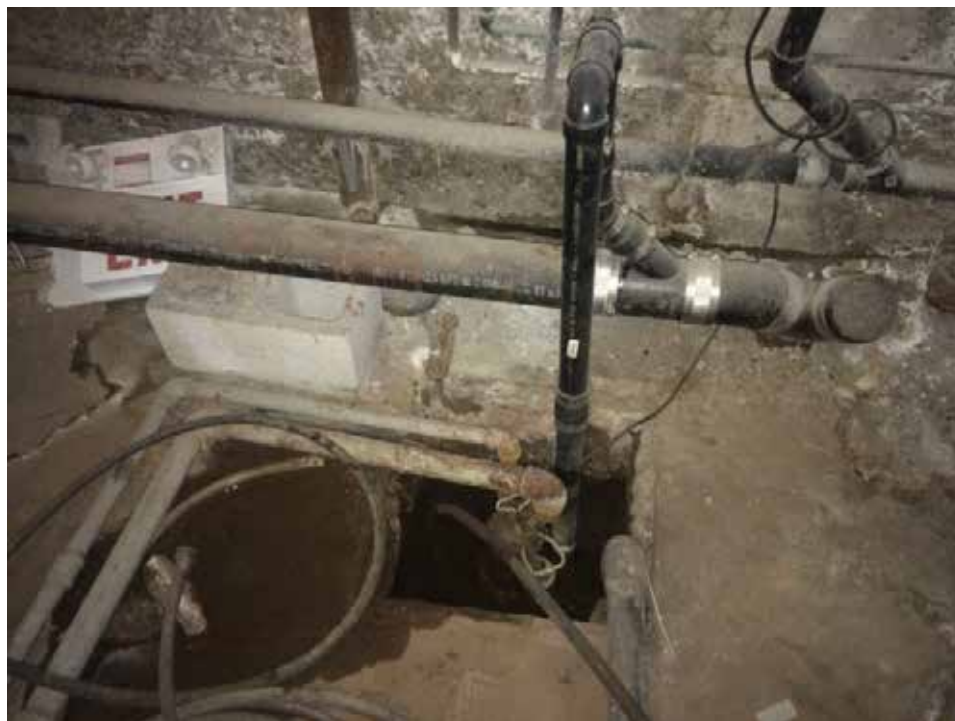
Photograph 15. View of a sump pit, located in the mechanical room of the church

**Drains, pits or sumps:** Floor drains were observed in the bathrooms and kitchen and a sump was observed in the basement. It was anticipated that each of the drains and sump were connected to the sanitary sewer.
