5494, 5500 and 5510 Boundary Road

Environmental Impact Statement

Fisheries Component

April 2021
(Updated November 2021)

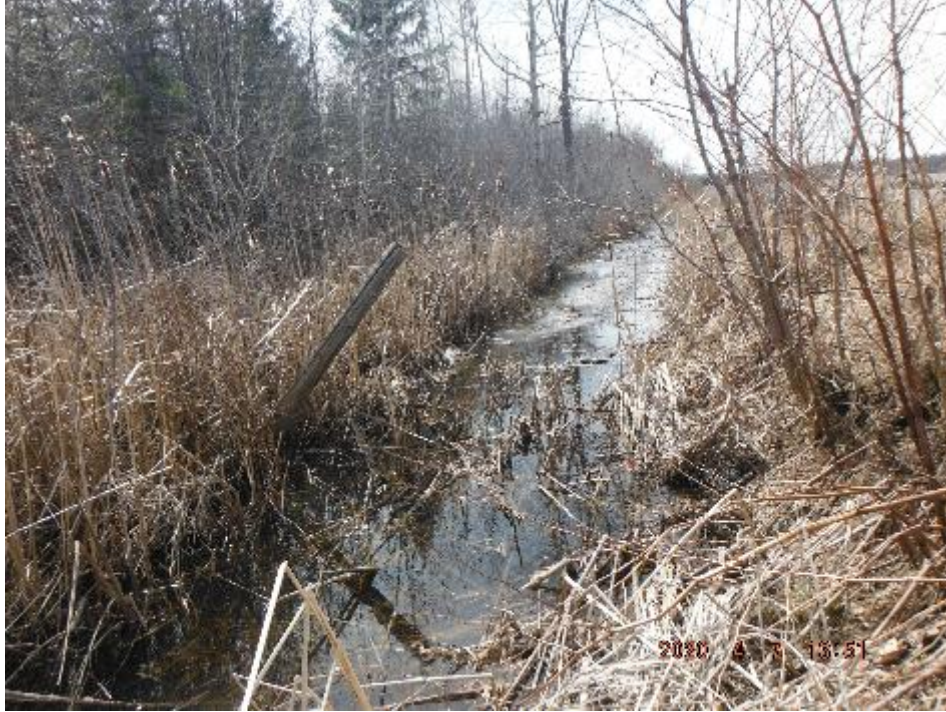
Photo 3: Feature 1a, downstream of station 2, looking upstream (April 4, 2020)

The substrate consisted primarily of fines and the stream morphology was standing water. The in-water cover throughout the station was provided by aquatic vegetation (reed canary grasses, cut-leaved water horehound, lakebank sedge, purple loosestrife, smartweed, broad-leaved cattail, and cow vetch). The top of the banks was fully vegetated (reed canary grass, water horehound, lakebank sedge, purple loosestrife, smart weed, broad-leaved cattails, willow, speckled alder, and glossy buckthorn). Much of the station contained areas of no canopy cover on the north side but was entirely shaded by the dense woody vegetation on the south and inside the channel by the dense common reed.

The area was not fished in the spring because it was covered in snow and ice during the sampling visit. A few days later, when the water melted, it was confirmed to be connected to the Roadside Ditch without any barriers to fish movement along the first 100 m. No sampling took place during the summer as the station was dry (July 29, 2020).

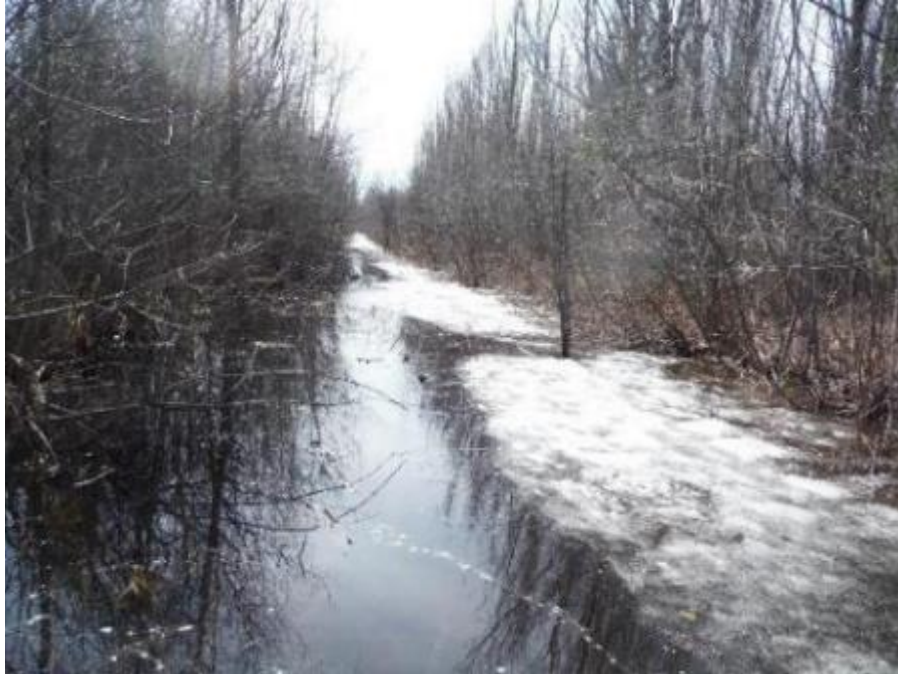
Photo 6: Feature 2, upstream of station 3, looking downstream (April 7, 2020)

The substrate consisted primarily of fines and the stream morphology was a glide. The in-water cover consisted of leaf litter, and large and small woody debris. There was also overhanging vegetation providing some cover. The banks were fully vegetated with trees (red maple and green ash), shrubs (speckled alder and glossy buckthorn) and herbs (purple loosestrife, sensitive fern, broad-leaved cattail, narrow-leaved and tall meadowsweet, and lakebank sedge). Most of the station contained little to no canopy cover.

During the April 7, 2020 visit, the station was electroshocked over an area of approximately 153 m² (1274 seconds). The electrofishing effort was of 8 s/m². A total of 4 central mudminnow

(size range: 28 – 100 mm) and one brook stickleback (45 mm) were captured. In addition, 3 central mudminnows were observed but not captured. No sampling took place during the summer as the station was dry (July 29, 2020)

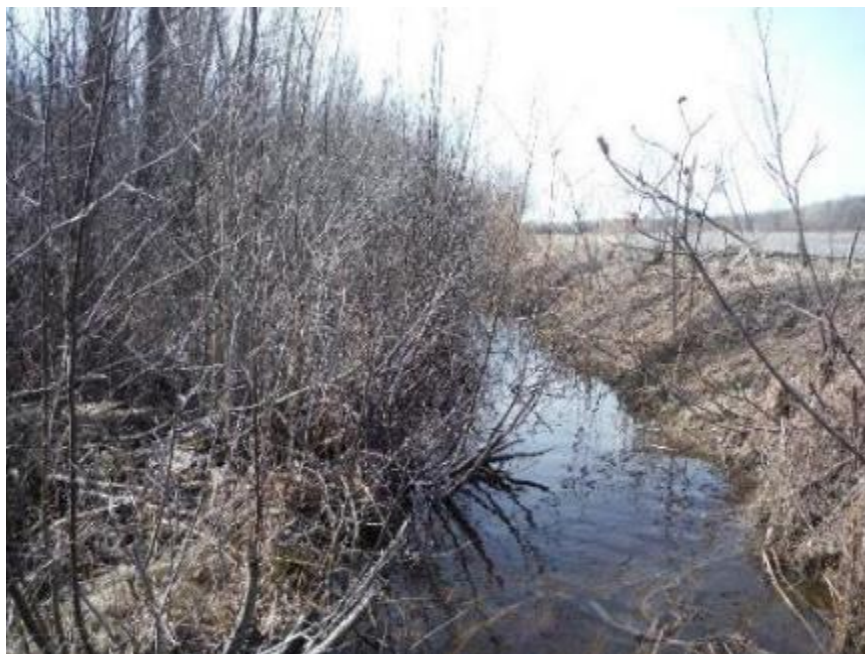
Photo 8: Feature 3a looking upstream from its connection with Feature 2 (April 7, 2020)

The substrate consisted primarily of fines and the stream morphology was a glide. The in-water cover throughout the station was provided by overhanging vegetation, aquatic vegetation, and small wooded debris. The top of the banks was fully vegetated (speckled alder, glossy buckthorn, willow, lakebank sedge, sensitive fern, purple loosestrife, glossy buckthorn, grasses, and horsetail). The left bank was a treed swamp (willow, red maple). Much of the station had complete canopy cover.

The area was not sampled in the spring. Even during the first visit only the downstream 20 m was accessible to fish. The remaining 110 m is not considered fish habitat due to its lack of connectivity with feature 2. No sampling took place during the summer as the station was dry (July 29, 2020).

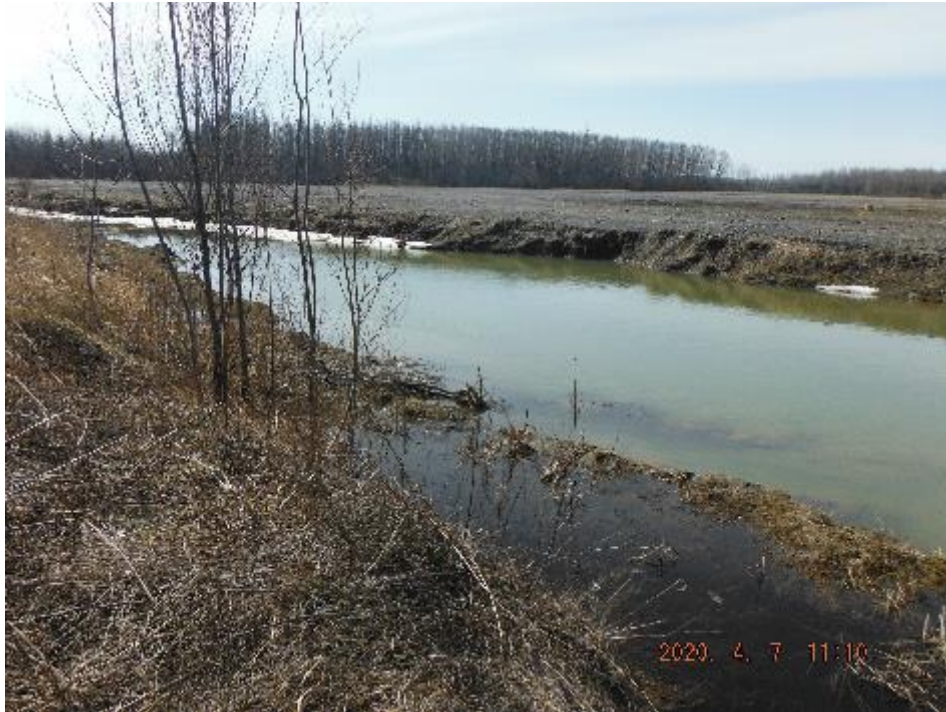
Photo 15: Feature 5 (pond), downstream of station 7, looking southwest (April 7, 2020)

The entire pond was 75 m in length and Station 7 was placed in the permanent habitat (northern 35 m). The average channel width was 10.9 m and the average bankfull height 46 cm. The spring wetted width and depth were 7.0 m and 80 cm, respectively. In the summer, the southern 44 m in length of the pond was dry. The remainder had a summer average wetted width and depths of 6.7 m and 33 cm, respectively. A seasonal barrier to fish movement was found on the northern edge of this pond. This berm was overtopped during the spring. In the summer, the soil berm created a seasonal barrier and was 49 cm high (Photo 13).

The substrate consisted of fines and the stream morphology was a pond. The in-water cover consisted of aquatic vegetation (softstem bulrush, narrow-leaved cattail, purple loosestrife, stonewort, common reed, water plantain, and woolgrass). The banks were mostly vegetated (willow, common reed, wild carrot, sensitive fern, common vetch, narrow-leaved cattails, and purple loosestrife). The station contained no canopy cover.

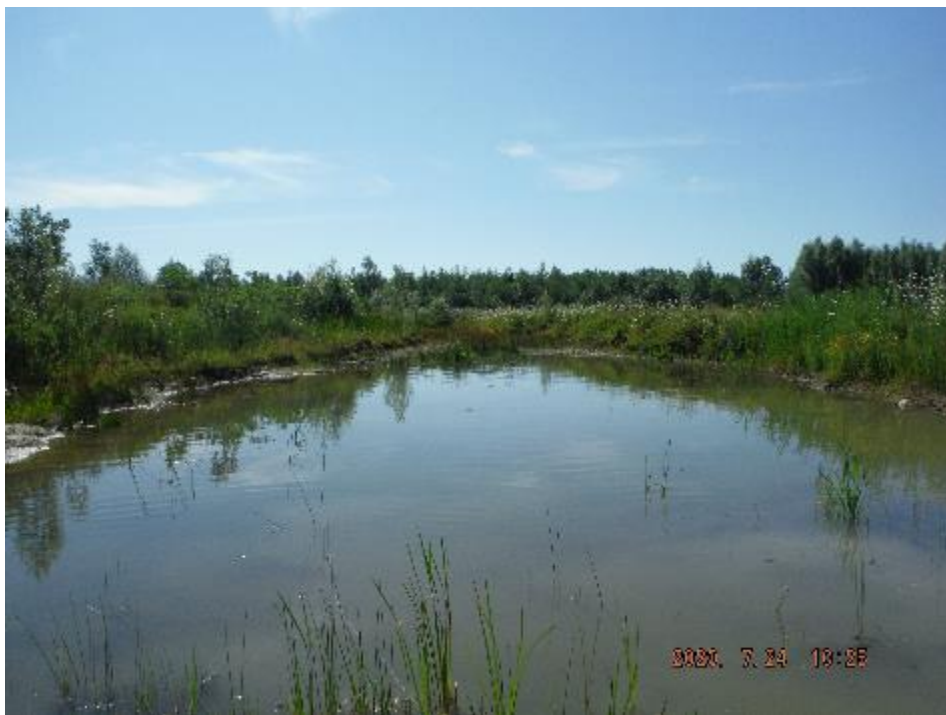
Photo 16; Feature 5 (pond), downstream of station 7, looking south (July 24, 2020)

This station was not sampled in the spring as it shared fish habitat with station 8. The station was sampled in the summer using two hoop nets. Two central mudminnows (length 76 and 90 mm) and three pumpkinseeds (size range: 86 to 89 mm) were captured. A brook stickleback (approximately 15 mm in size) was observed in the water and a painted turtle was also captured in the nets.

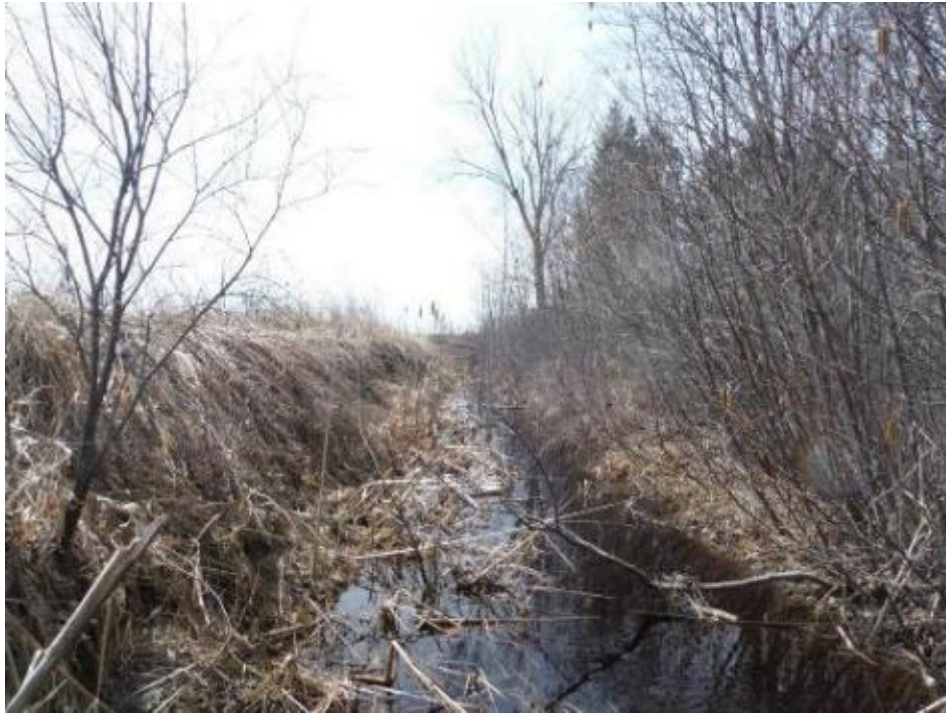
Photo 17: Feature 5 (ditch), downstream of station 8, looking upstream (April 7th, 2020)

The substrate consisted primarily of fines and the hydrological flow was a glide. The in-water cover consisted of aquatic vegetation (narrow-leaved cattail, and purple loosestrife). The top of the banks was mostly vegetated with grasses and shrubs (goldenrod, cow vetch, willows, Manitoba maple, and sensitive fern). Most of the station contained areas of good canopy cover.

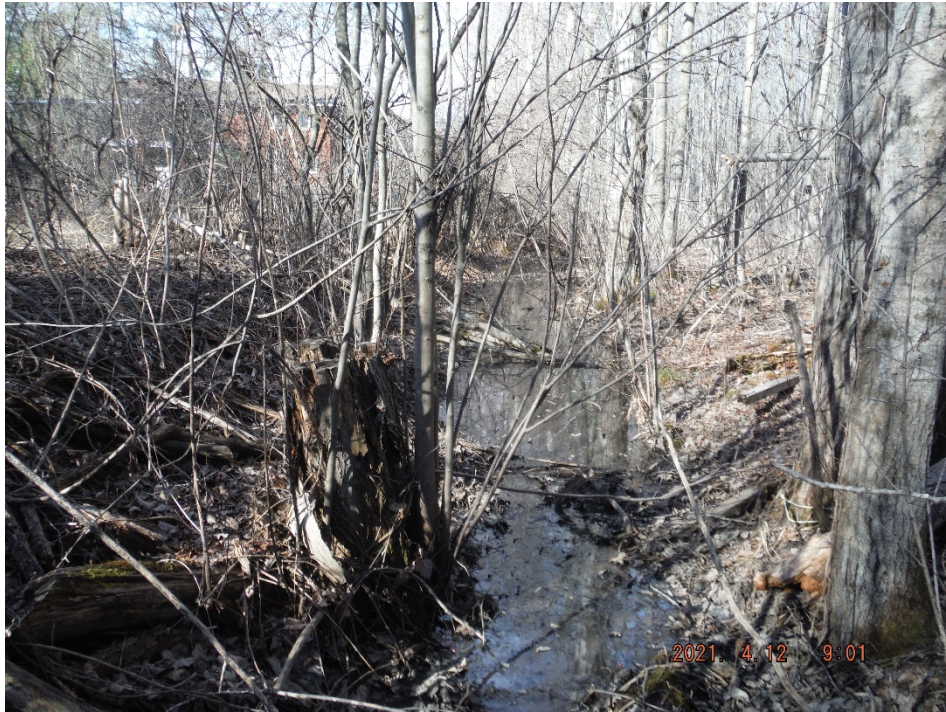
Photo 23: Downstream of the station, looking at the standing water (April 12, 2021)

The substrate consisted primarily of soil (no sorting) and the hydrological flow consisted of standing water (held back by the humps of soil). The in-water cover consisted of leaf litter. The top of the banks was mostly vegetated with trees and shrubs. The station had good canopy cover overall.

During the April 13, 2021 visit, the station was fished using a dipnet over an area of approximately 120 m² (over 50 dipnets). No fish were seen or caught.
