**Preliminary Geotechnical Investigation
Report**

Proposed Development – 1495 Heron Road

Ottawa, Ontario

Project No. 160410368

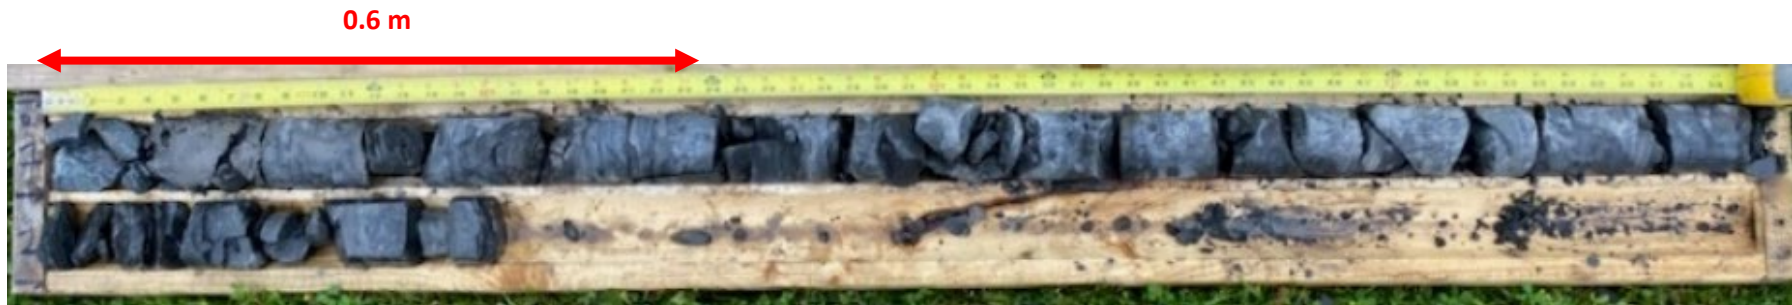
Rock Core Photo No.:	3	Borehole:	MW22-4	Depth:	4.6 m to 6.3 m
----------------------	---	-----------	--------	--------	----------------

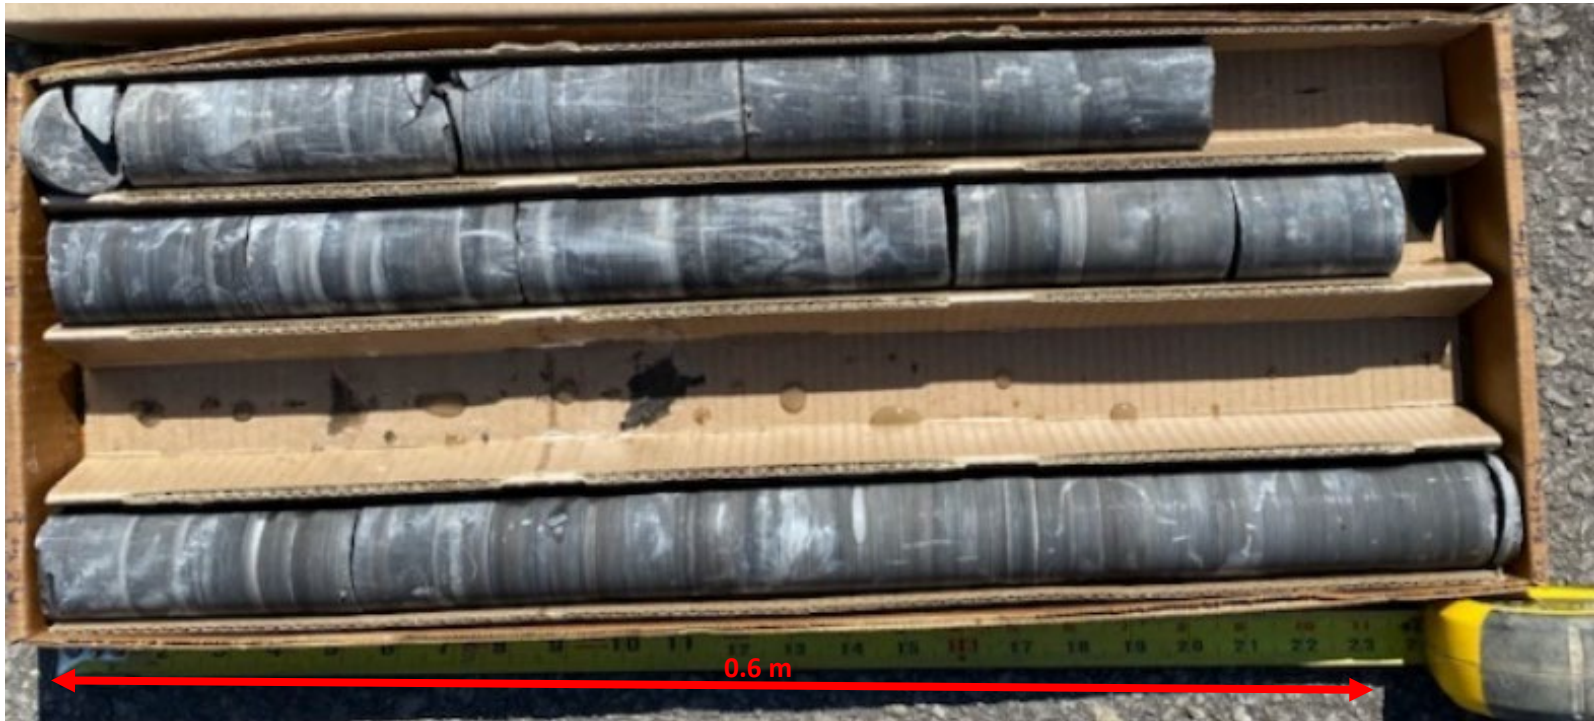
Rock Core Photo No.: 4

Borehole: BH22-6

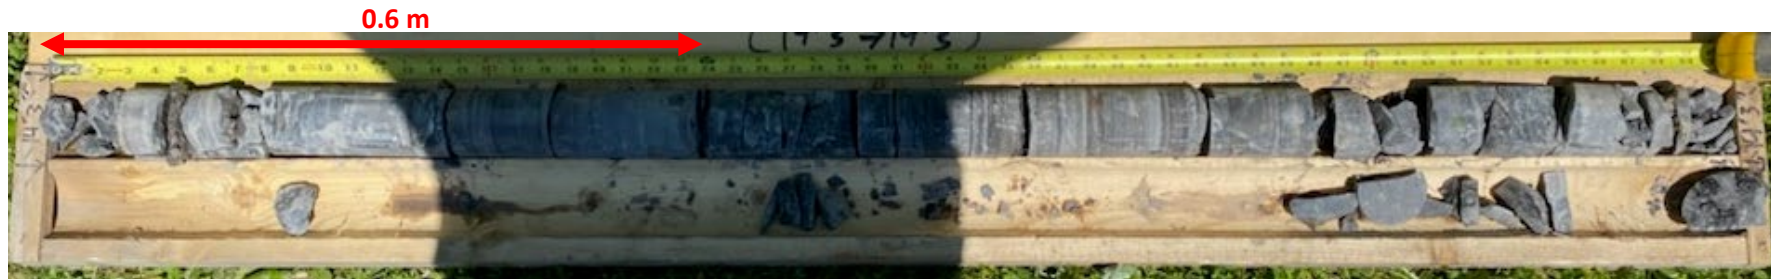
Rock Core Photo No.: 5

Borehole: MW22-8

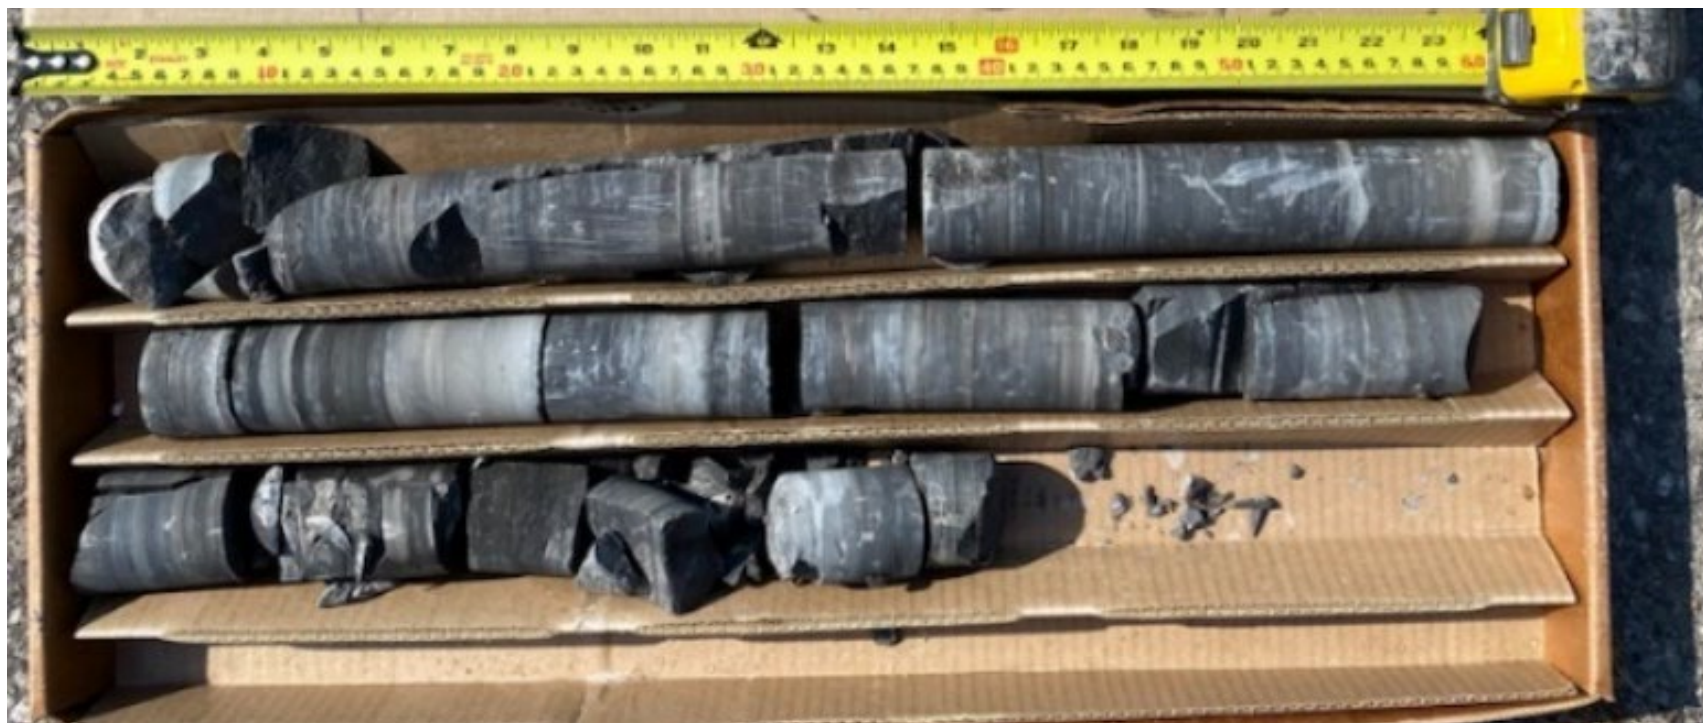
Rock Core Photo No.: 6

Borehole: BH22-9

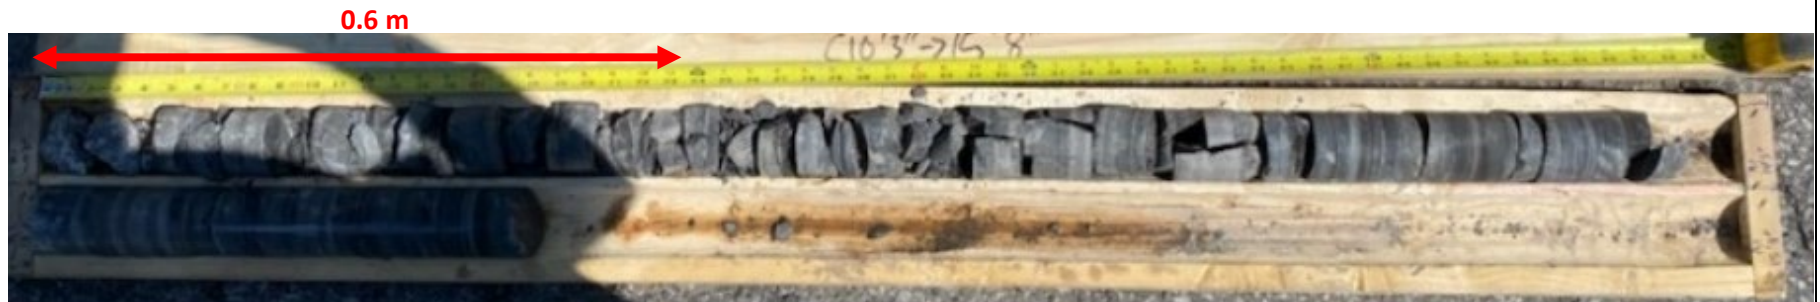
Rock Core Photo No.: 7

Borehole: MW22-11
